Landslide Research in China

Zuyu Chen^{1*}, Xingmin Meng², Yueping Yin³, Tom Dijkstra⁴, Mike Winter^{5,6} and Janusz Wasowski⁷

During the spring of 2000 (9 April), a 91 Mm³ rock avalanche occurred in Linzhi Prefecture, Tibet (the 'Roof of the World'). The event was accompanied by a deafening noise, with the rock mass traveling from a maximum elevation of 5132 m asl and coming to a rest at an elevation of 2163 m asl. It formed a landslide dam in the Yigong Zangbo River of some 55 m high impounding a reservoir of some 2 Gm³ for a period of 62 days after which it emptied in less than 12 hours (Delaney and Evans 2015). The event forewarning of a period of frequent geological disasters in China during the start of the 21st Century. The ensuing Wenchuan earthquake (surface-wave magnitude Ms 8.0; May 2008), Zhouqu debris flow (August 2010) and Ludian earthquake (Ms 6.7; August 2014) urged China to renew its campaign against geological disasters and the Chinese Government has since invested heavily in scientific research to guide efforts to mitigate the impact of such natural disasters. A thematic set on Landslide Research in China was initiated to highlight this research. This paper pro

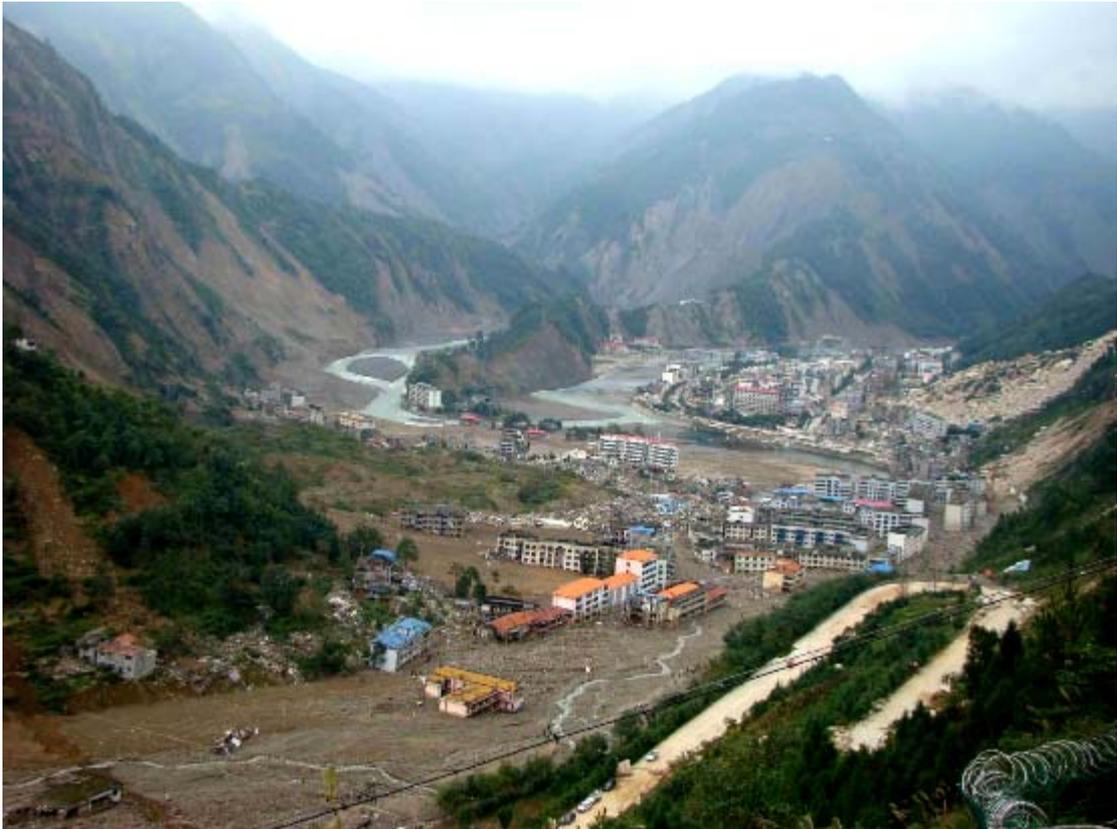
Figure 1

368 **Fig. 1** A view of Beichuan County town shortly after it was buried by the Weijiagou landslide of
369 the 24th of September 2008

52 On 24 September 2008, Beichuan County, previously destroyed by the
53 Wenchuan Earthquake, experienced yet another debris flows which led to a further 42
54 fatalities (Tang and Liang, 2008; Tang *et al.* 2011a; Figure 1).

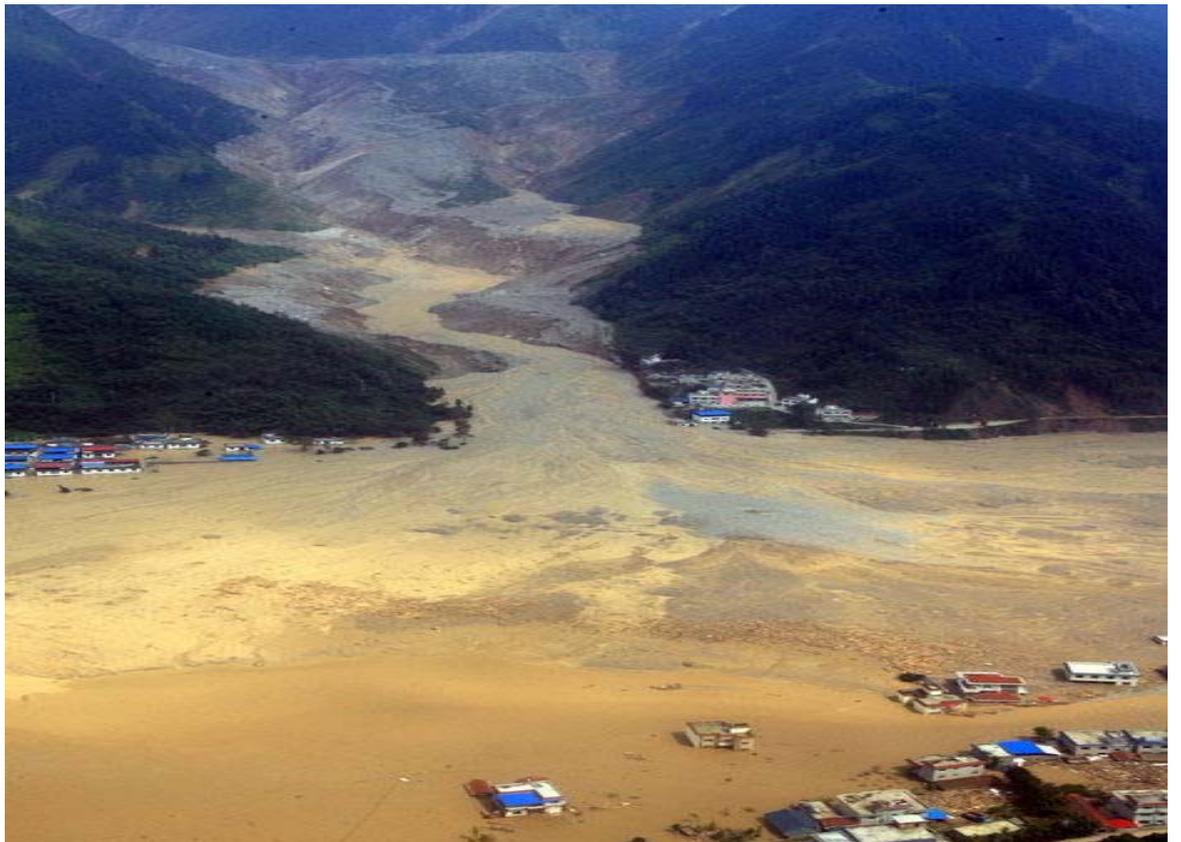
Figure 3.

373 **Fig. 3** The market town of Qingpingxiang covered by silt and buried by the “8.13” torrent and
374 mudslide. The mudslide volume reached 6,000,000m³ and far exceeded that of the Zhouqu
375 mudslide (i.e. 1,800,000m³) (Extracted from www.nandu.com).

55 On 13 August 2010, Qingpingxiang (a town in Mianzhu County), Yingxiu (a
56 town in Wenchuan County) and Hongkou Township (in Dujiangyan county), all
57 severely affected by the Wenchuan Earthquake, experienced torrential floods and
58 landslides (dominated debris flows). The total landslide volume for these regions
59 exceeded 13 million m³ causing the partial or total destruction of roads and houses
60 and the interruption of traffic (Figures 2 and 3).

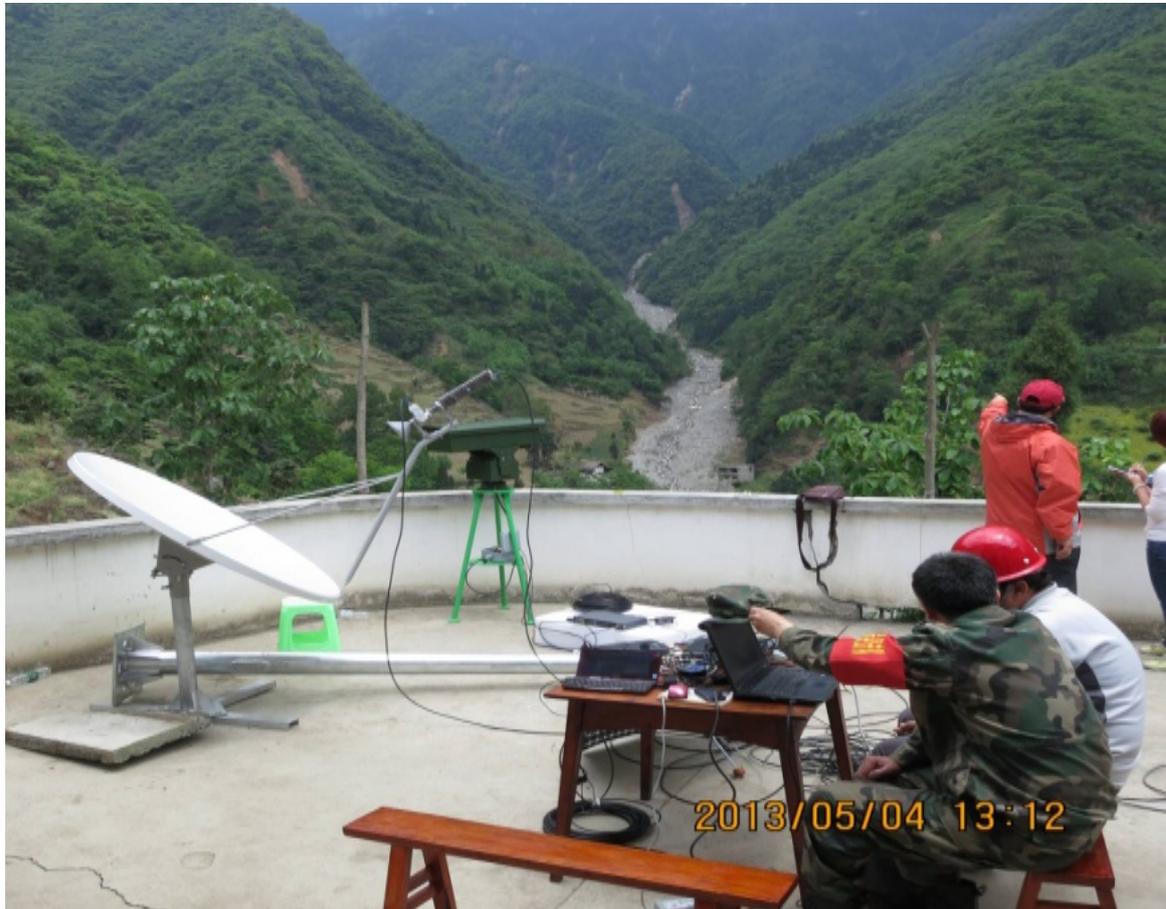
Figure 6.

385 **Fig. 6** Geological disaster monitoring and warning apparatus used in cold alpine and
386 densely-fogged mountainous areas.

75 intense rainfall and the area affected by the debris flow. For this reason, the Ministry
76 of Land and Resources launched a program to implement a warning system used in
77 high, cold mountainous areas that experience dense fog. A remotely-operating video
78 platform was installed in Zhouqu County, with the purpose of transmitting
79 information to the monitoring and warning center on a real-time basis via sensors and
80 communication satellites (Figure 6).

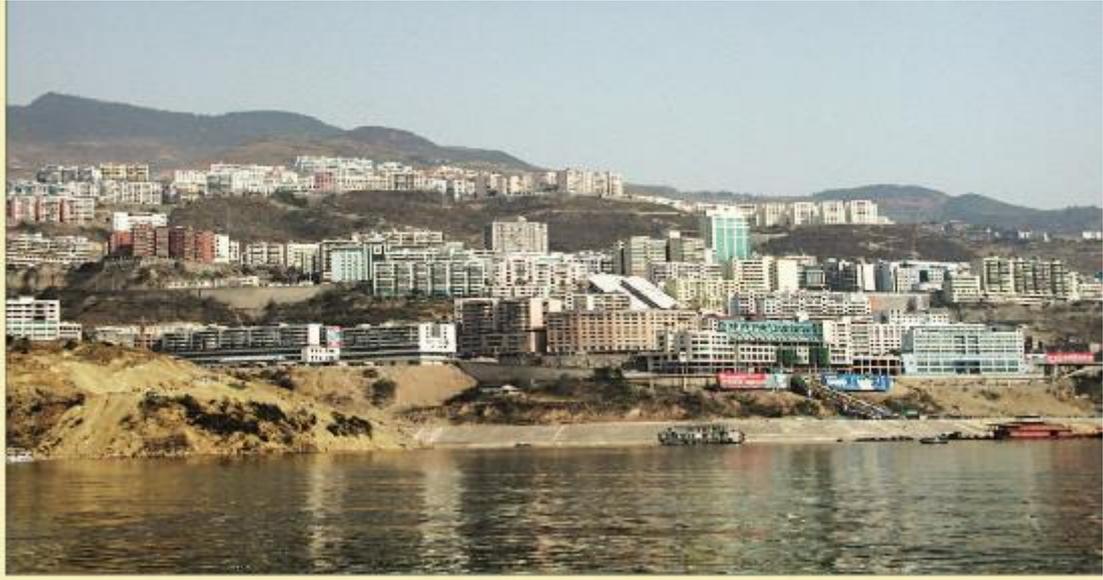
387 **Fig. 7** The Monkey Stone landslide prevention and control projects and relocated households in
388 Fengjie County. The red line indicates the outline of the landslide.

126 The surface of the bedrock landslide in central Fengjie, the Monkey Stone
127 landslide, had an elevation of 90 m at the front-edge and 250 m at the back-edge, a
128 160 m elevation difference with the water level varying between 145 m and 175 m
129 elevation as shown in Figure 7 (Chen and Feng, 2008) and occupied an area of
130 $12 \times 10^4 \text{ m}^2$ and a volume of $450 \times 10^4 \text{ m}^3$. The engineering mitigation involved two
131 stages (Zou *et al.*, 2008). Stage I consisted of water discharge measures, loading the
132 toe of the slope, and erosion protection of the slope surface. Stage II extended the
133 project and consisted of cascaded slide-resistant shear keys at the level of the slip
134 plane, rock fill dumped underwater to further load the toe, and further slope protection
135 and water discharge measures. The project started in May 2006 and was completed in
136 May 2008, enhancing the safety of the population of this densely populated town as

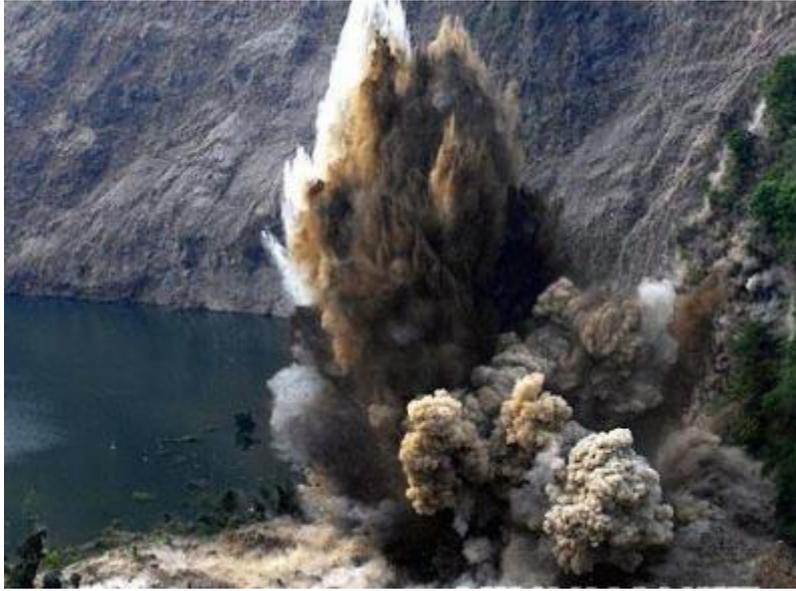
396 **Fig. 11** Excavation of a drainage channel at the Hongshiyuan barrier lake during the first phase of
397 the emergency response mission.

202 Xiaogangjian (Jinyuan River) barrier lakes. Channel drainage is the most common
203 method of reducing the risk associated with barrier dam outburst both in China and
204 other countries. Other examples include the Yigong, Tangjiashan, Xiaojiaqiao and
205 Hongshiyan barrier lakes as shown in Figure 11 (Liu, et al., 2016).
