# Norham West Mains Farm Borehole: operations report

Geology and Regional Geophysics Programme  
Internal Report IR/13/033

D Millward, T Kearsy, M A E Browne

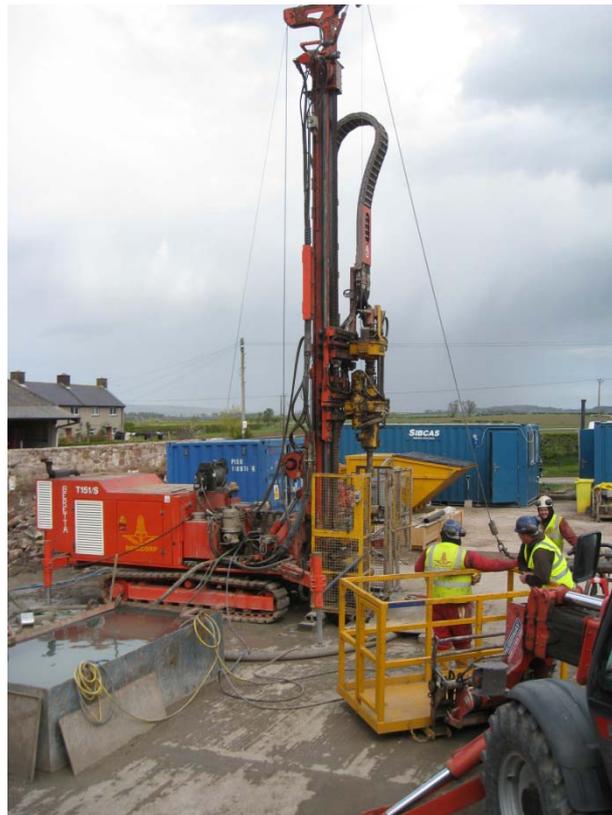
Drilcorp Ltd Beretta T151S top  
drive drilling rig at Norham,  
Berwick upon Tweed.

Drilcorp Ltd planned and drilled the borehole using a Beretta T151S track-mounted top drive drilling rig (see cover photograph) using a biodegradable polymer-based mud-flush circulated with a positive displacement mud pump through settling tanks and mud-cleaning facility. The Atlas Copco Geobor-S wireline triple-barrel coring system was used throughout. The original plan included reaming and casing the upper part of the borehole at 250–300 m. During this stage a diverter would be fitted to the top of the borehole to control any gas encountered during drilling of the lower part.
