# The geomorphology of the River Tyne at Clerkington Weir, East Lothian

Open Report OR/18/063

Andrew Finlayson, Chris Thomas, Katie Whitbread

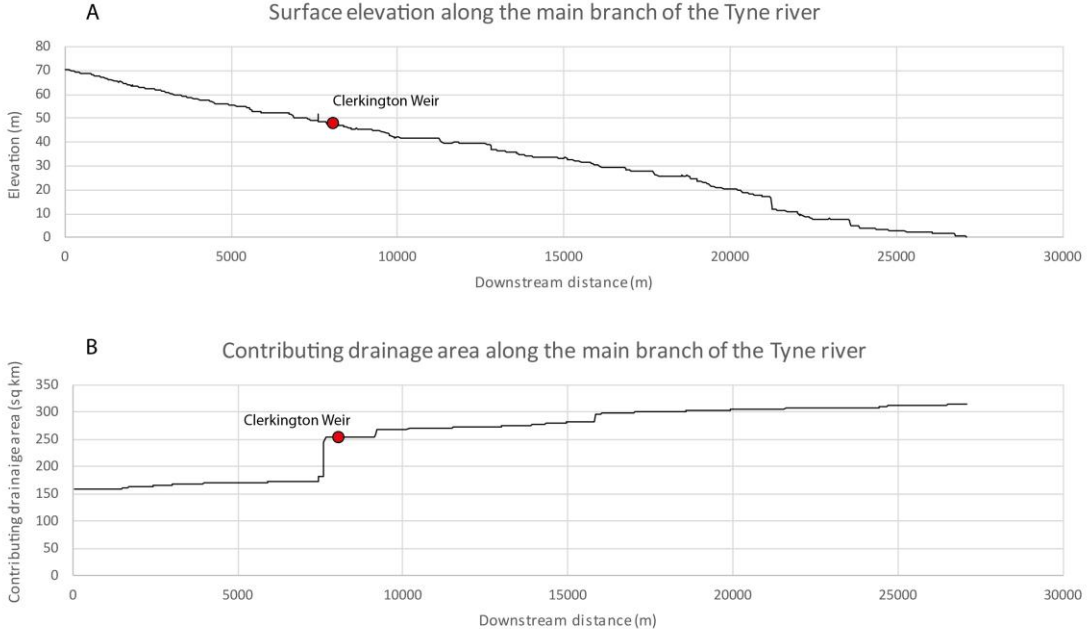
Figure 2. A. Elevation profile of the main branch of the river Tyne, with the position of Clerkington Weir shown. B. Contributing drainage area along the main branch of the river Tyne.

stream initiation, which matches reasonably well with water courses shown on Ordnance Survey maps. The main stem of the River Tyne can be described as a 6<sup>th</sup> order stream, using the terminology of Strathler (1952). Clerkington Weir [NGR 350610 672345] is located approximately one third of the way down the main stem, at an elevation of 48 m above Ordnance Datum (O.D.) (Fig. 2A). The weir lies approximately 400 m downriver from the confluence of the 5<sup>th</sup> order Coulston Water [NGR 350490 672000]; the subcatchment above Coulston Water increases the contributing drainage area by some 70 km<sup>2</sup>. At the Clerkington Weir, the river drains a total area of approximately 250 km<sup>2</sup>, representing some 79% of the entire Tyne catchment (Fig. 2B).

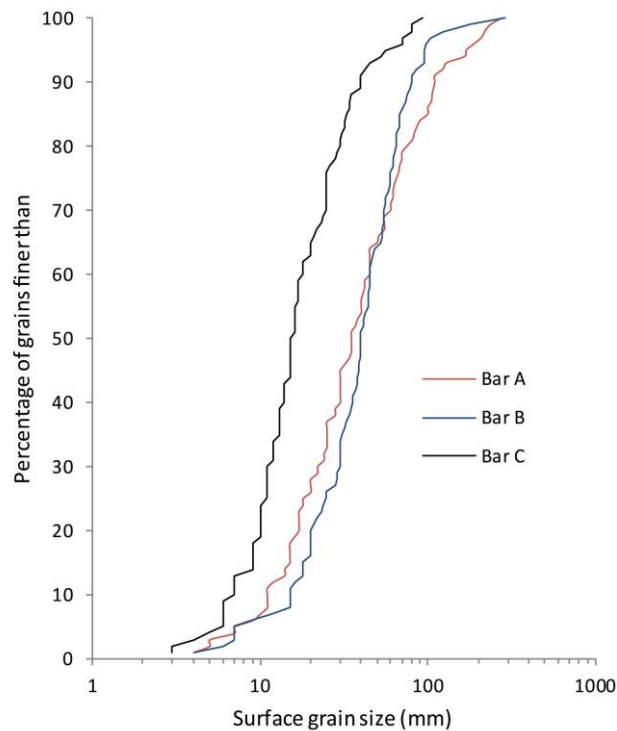
**Figure 7. Size distribution of grains on the gravel river bed taken from three bars, based on measurements of 100 clasts at each site. The locations of the bars are shown on Fig. 5.**

The river bed materials are predominantly gravel; clast sizes were measured at three gravel bars within the study area (Figs. 5,7). Median clast sizes at bars A and B were 35 and 45 mm respectively, while at bar C, the median clast size was just 15 mm. Possible reasons for the differences in clast size are discussed further below. Also of note is that for a distance of approximately 300 m upstream from the weir, the gravel bed was covered by a very thin drape of silt.

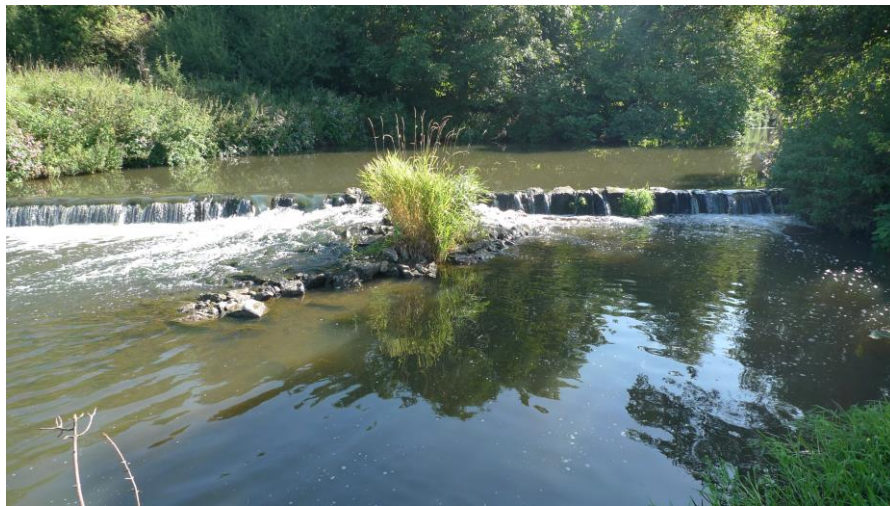
**Figure 9.** The lower weir (approximately 400 m downstream from Clerkington Weir), which was previously covered by alluvium, and has once more become exposed by channel migration.

The river bank positions are shown on the map in Figure 5. The areas in red and green indicate where the 2018 river bank position differs from that shown on the most recent aerial photograph held by BGS (2009). These are interpreted as zones of recent bank erosion and deposition. Of note is the large area of deposition at the north-eastern corner of the site, where the river is continuing to erode the outside bend and deposit a gravel bar on the inside bend. This recent river migration has revealed a second smaller weir within the study area (Fig. 9). This lower weir had previously been buried by alluvial sediments and is now once more uncovered as a result of repeated migration of the river.

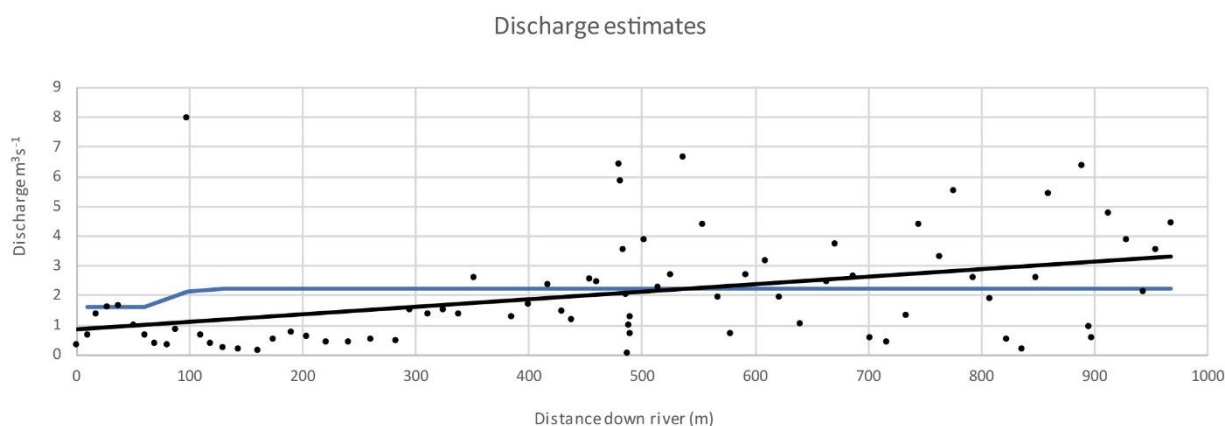
**Figure 15. Graph showing different calculations for discharge through the survey area. Black dots show the scatter in calculated discharge at the long profile survey points (described in text) highlighting, amongst other factors, uncertainty in knowledge about channel cross sectional geometry. The black line shows the trend of these values. The blue line shows the discharge values calculated from the mean flow area-discharge relationship derived from catchment gauging station data.**

Using these velocity values, discharge ( $Q(\text{m}^3\text{s}^{-1})$ ) was calculated along the study profile (Figure 15). The scatter in the calculated values reflects, amongst other factors, uncertainty about the true cross-sectional channel geometry and how it varies down the profile, uncertainty of local water surface slope values, and assumptions in the use of a constant roughness coefficient,  $n$ , down the profile. There may also be losses and gains of water through processes such as groundwater-river interaction and seepage through the weir, which may impact on  $Q$ ; these may be small but are unknown. Despite the uncertainties, the average discharge value for the ‘triangle-shaped channel’, calculated using the above approach over the whole 970 m long profile ( $2.06 \text{ m}^3\text{s}^{-1}$ ) agrees reasonably closely with the mean discharge value at the site that was extrapolated from the gauge station area-discharge relationship ( $2.225 \text{ m}^3\text{s}^{-1}$ ).

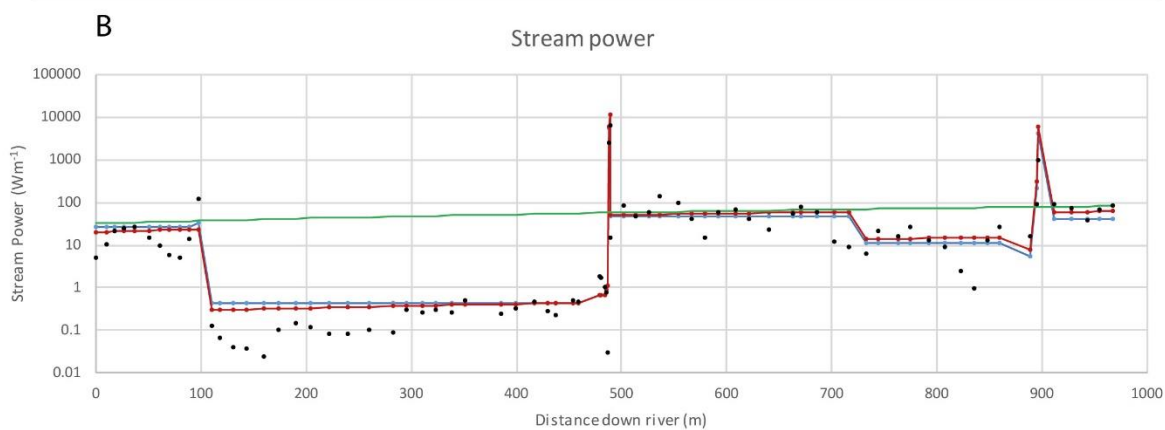
**Figure 16. A. Plot of stream power along the survey profile. RGB Aerial Photography © GeoPerspectives. B. Graph showing stream power calculations obtained using different approaches. The dots show values derived from the long profile survey. The red line is derived using the discharge trend obtained from the survey points. The blue line is derived using the drainage area-discharge relationship. The green line represents stream power values that might be expected under a more evenly graded river if the surface slope was constant along 970 m-long profile.**

Stream power ( $\gamma(\text{Wm}^{-1})$ ) is plotted in Figure 16 and was calculated from:

$$\gamma = \rho g Q S$$

using both sets of estimated values for  $Q$ . Figure 16 also shows the stream power that might be expected under a more evenly-graded river, given a constant surface slope along the 970 m profile (green line).

Figure 16 B shows stream power values that might be expected along the surveyed section of the river Tyne, if the river became more evenly graded with a more constant water surface slope (i.e. with no weirs). The reach upstream of the Coulston Water confluence and the reach below Clerkington Weir appear to most closely match those ‘stream power conditions’. Perhaps these reaches offer an illustration as to the conditions that the river would evolve towards in a scenario where the weir is lost.
