1 The influence of the physical environment on self-recovery after 2 disasters in Nepal and the Philippines

3 S. Sargeant¹, A. Finlayson, T. Dijkstra, B. Flinn, H. Schofield, L. Miranda Morel, J. Twigg, E. Lovell, V.
4 Stephenson and B. Adhikari

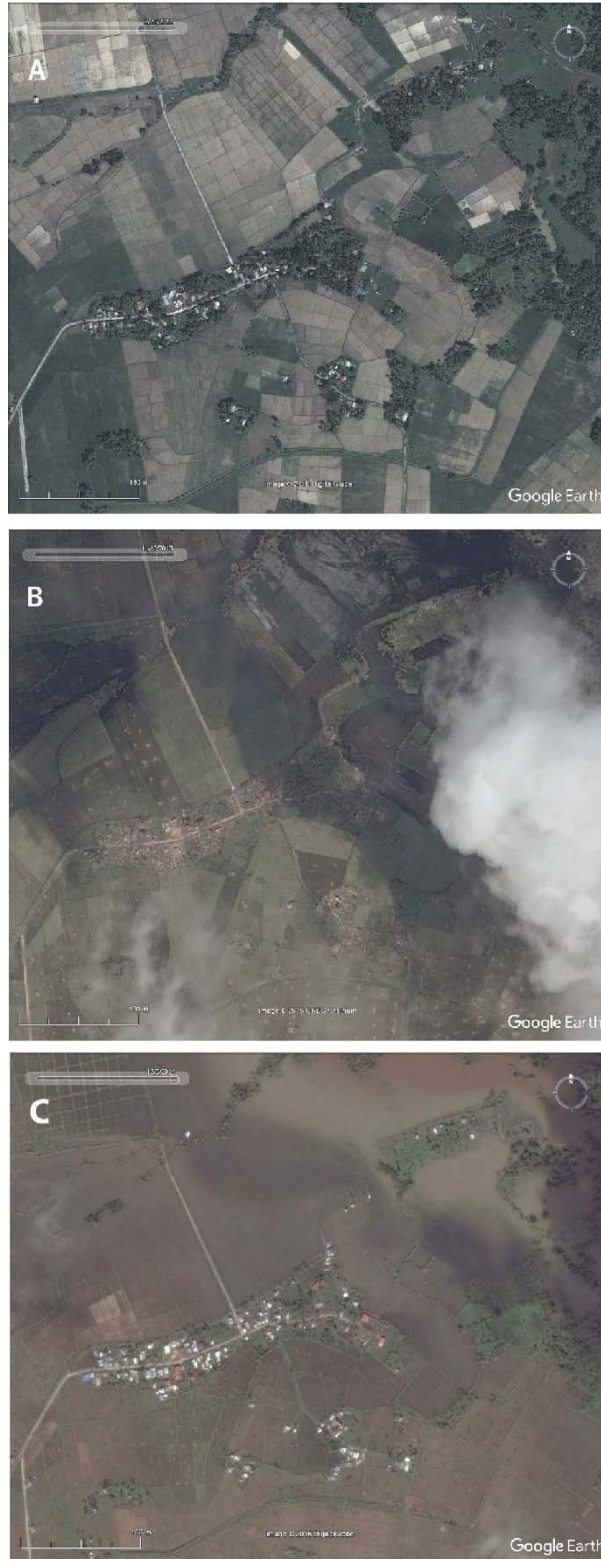
337 Figure 2. (A) DigitalGlobe image (23 February 2012) courtesy of Google Earth showing the community of
 338 Badiangay prior to Typhoon Haiyan. (B) CNES/Airbus image (13 November 2013) courtesy of Google Earth
 339 showing the severe wind damage to the community five days after Typhoon Haiyan passed through. (C)
 340 DigitalGlobe image (9 December 2014) courtesy of Google Earth, showing the extent of flooding around
 341 reconstructed houses following heavy rainfall associated with Typhoon Hagupit.

313 The primary cause of damage in this community during Typhoon Haiyan was the intense wind
314 speeds that destroyed 125 out of 128 houses (Fig. 2A, B). Flooding also impacted the community,
315 with residents reporting that water levels reached “*knee to waist depth*”. Flooding was a common
316 theme in the focus group discussion about recovery, as might be expected in a community located
317 within the floodplain landsystem: “*we experience flooding every year... water can stay high for*
318 *several days*”. The extent of flooding during Typhoon Hagupit (associated with lower wind speeds
319 than Typhoon Haiyan, but high total rainfall), which occurred one year after Typhoon Haiyan,
320 illustrates this kind of impact on the community (Fig. 2C). Repeated flooding causes rot and termite
321 infestation, both of which increase the vulnerability of wooden housing.

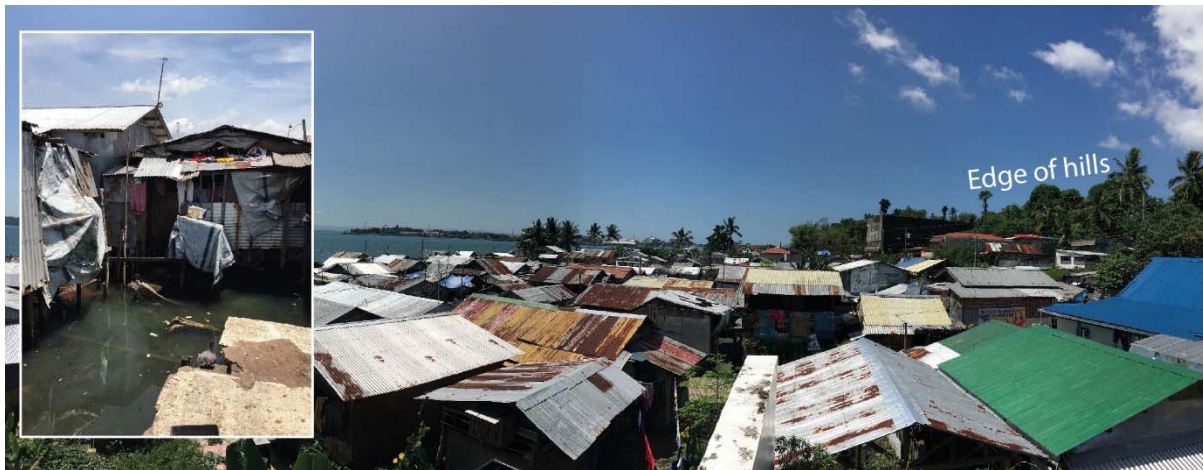
352
 353 Figure 3. Photograph illustrating context for the community of Anibong, Tacloban. Closely spaced houses are
 354 located between the sea and a group of outlying hills. Inset: Shelters encroaching into the sea and are
 355 vulnerable to frequent low severity tidal flooding.

343 outlying hills with slopes up to 30° (composed of weathered sedimentary rocks) all occur in very
 344 close proximity (Fig. 3). As a result, a number of shelters encroach out into the sea. At the opposite,
 345 south-eastern side of Tacloban City, the barangay of San Juan (Brgy 88) is located on a coastal sand
 346 spit where the ground surface rarely rises above a few meters above sea level, and everywhere is
 347 within 500 m of the coastline. Both Anibong and San Juan are located in areas where published maps
 348 indicate a high storm surge hazard level – and are now classified as no-dwelling zones (Ong et al.,
 349 2016; NOAA, 2018). Anibong also includes areas exposed to flood hazard from the Mangonbangon
 350 River and a landslide hazard from the hills that the community backs onto. Barangay 83-C is located
 351 along the banks and close to the mouth of the Burayan River, and is also exposed to river flooding.

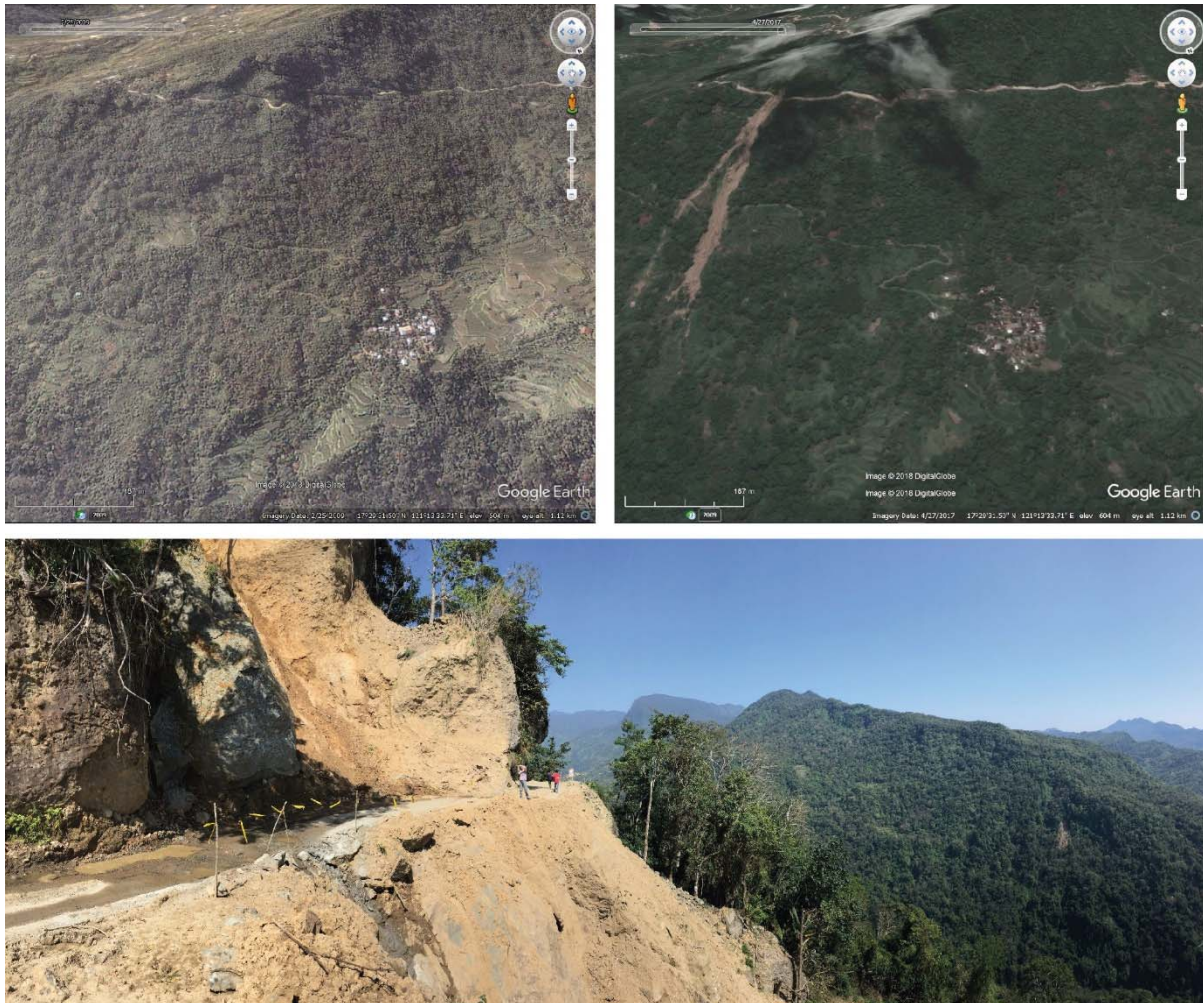
450 Figure 4. (A) Digital Globe Image (25th February, 2009) courtesy of Google Earth illustrating the context for the
 451 community at Sitio Bolo. (B) Digital Globe Image (5th February 2017) courtesy of Google Earth showing the
 452 extent of a debris flow adjacent to the community, that was triggered by heavy rainfall during Typhoon Haima.
 453 (C) Photograph illustrating conditions on the only access road in March 2017, 6 months after the typhoon. A
 454 large landslide scar is clearly evident and unstable blocks remain above the road. Local people spoke of
 455 concerns about the continued threat of landslides here.

435 In the mountain slope community some building damage was caused by high winds, but this was
436 generally limited to roof damage. Numerous landslides blocked the access road (e.g. Fig. 4B) and
437 affected the community's irrigation system, and one house in a neighbouring community was
438 buried. River bank erosion at the valley base also destroyed a bridge preventing access to fields on
439 the opposite side of the valley.

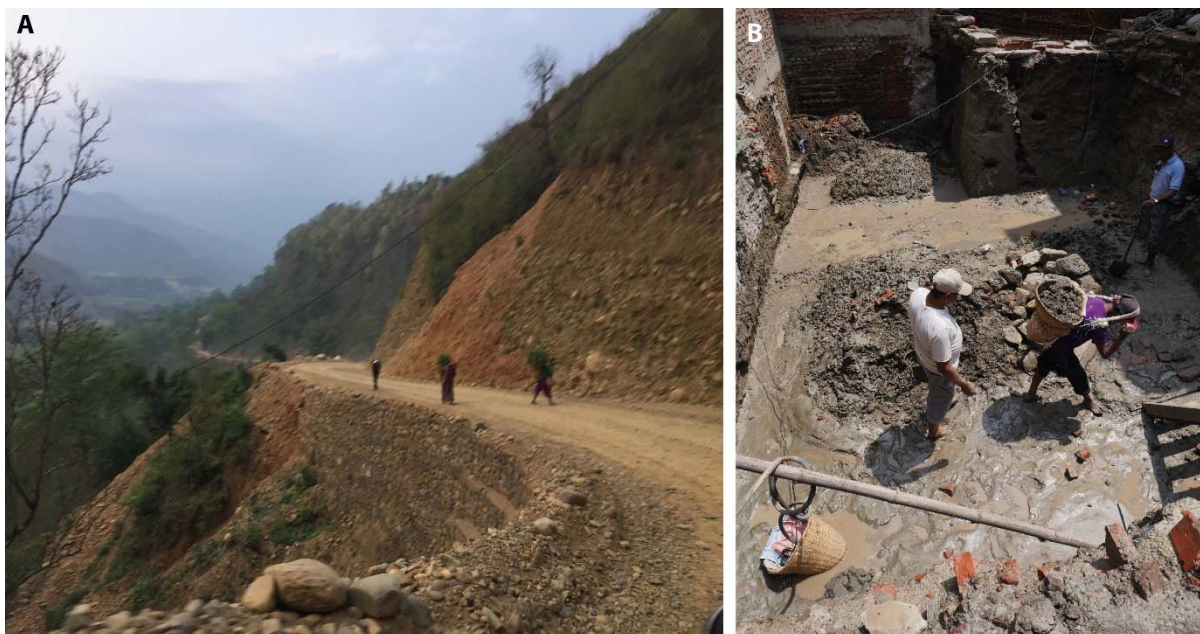
634
635 Figure 7. (A) The road that accesses communities on the Salyantar terrace is cut into a steep escarpment that is
636 vulnerable to instability during monsoon rains. (B) Excavation in silts and fine sands with a sump pump, for
637 building foundations in Bhaktapur in April 2018. Evidence for liquefaction below the feet of the construction
638 workers. Local people reported that this stage of reconstruction is not possible during the monsoon.

610 The clayey and silty nature of the sediments under Bhaktapur make foundation excavation
611 particularly challenging in wet conditions (Fig 7B). Another interviewee in Bhaktapur also described
612 how the occurrence of dry spells can have an impact on rebuilding when mixing mortar: *“Water is*
613 *scarce here but it is important for the building”* and people had to buy water from tankers to use in
614 housing reconstruction, which increased the cost of rebuilding. The limited weather-controlled
615 ‘windows’ for different building stages compounded delays caused by blocked roads and access
616 difficulties, further slowing down peoples’ recovery.

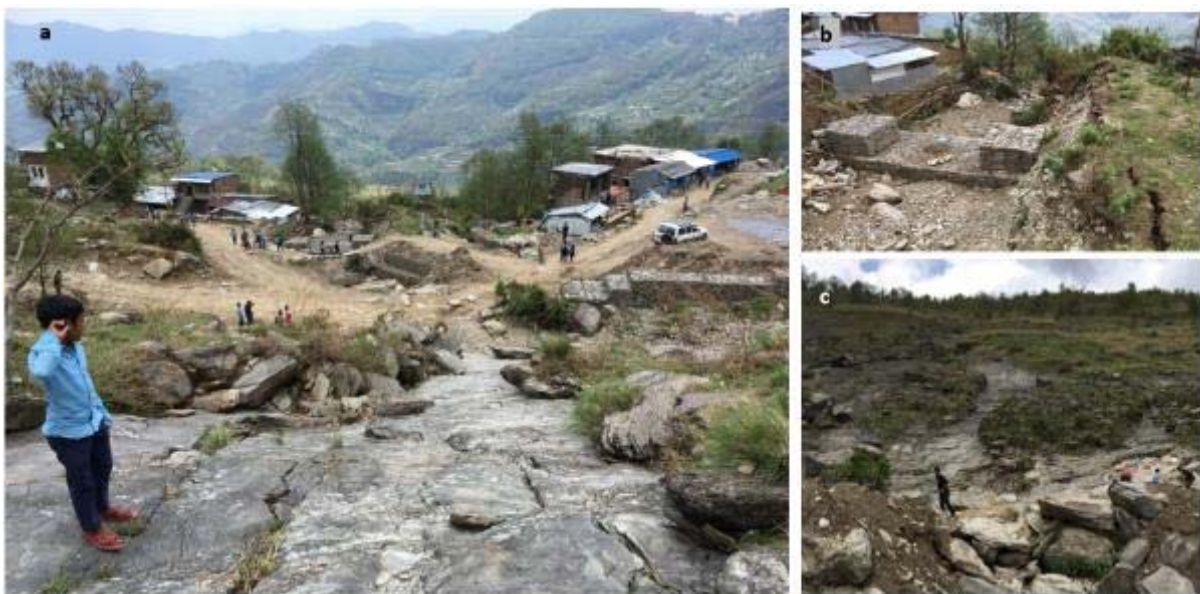
673 Figure 8. The community of Phulkarka is at risk from high stream flow, overland flow and landsliding. (A) The
 674 slopes above the community are widely stripped of their soil cover and this results in very rapid and
 675 destructive floods during the monsoon. A system of gabions is being constructed to direct flows and reduce
 676 their erosion potential. (B) A close-up of a gabion structure intended to control flow in a stream channel. Bank
 677 stability is still very poor (large cracks are visible) and housing is in very close proximity to the stream channel.
 678 (C) an view of the slopes above the community highlights the absence of suitable slope and vegetation cover. It
 679 is reported that the treeline visible to the left were planted by the community in an attempt to stabilise a
 680 landslide.

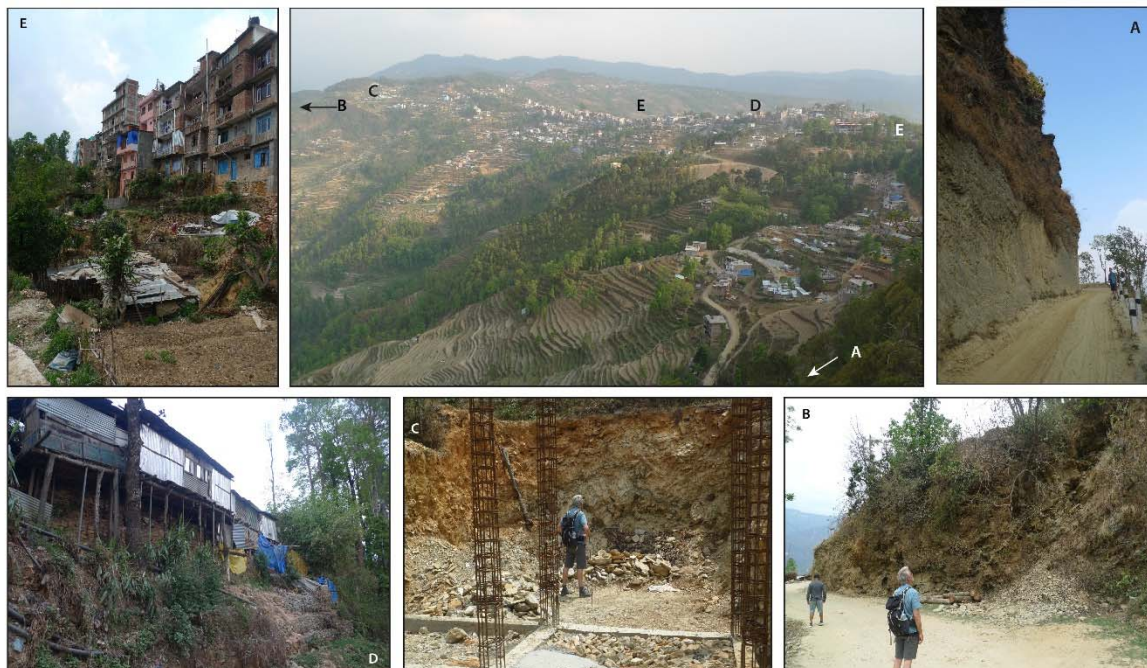
698
699 Figure 9. Central image provides a context for the ridge-top urbanised community of Chautara. (A) Vulnerable
700 and exposed access road beneath a steep rock wall to the north of the town. (B) An active landslide at the
701 southern edge of the town. Local people reported that the large block moves every monsoon and impacts the
702 road. (C) Conditions for excavating foundations are challenging. The surface material comprises weathered
703 and fractured bedrock, and has been affected by slope movement. (D) Informal housing at a slope edge,
704 illustrating the challenges of building where flat space is limited. (E) There is a lack of flat building space at the
705 town edge and buildings are constructed several storeys high at the slope edge.

682 The urban context of Chautara has also led to a shortage of space for building, so that people are
 683 increasingly having to build on or close to steeper slopes (Fig. 9D, E). The highly fractured and, in
 684 places, weathered nature of the bedrock in Chautara (Fig. 9C) was also reported to be challenge for
 685 people digging foundations for their reconstructed homes:
