Scoping study examining
the behaviour of Boom
Clay at disposal depths
investigated in OPERA

OPERA-PU-BGS523&616

Authors: Harrington, J. F., Cuss, R. J., Wiseall, A. C., Daniels, K. A., Graham, C. C., and Tamayo-Mas, E.,

Date of publication: 2017

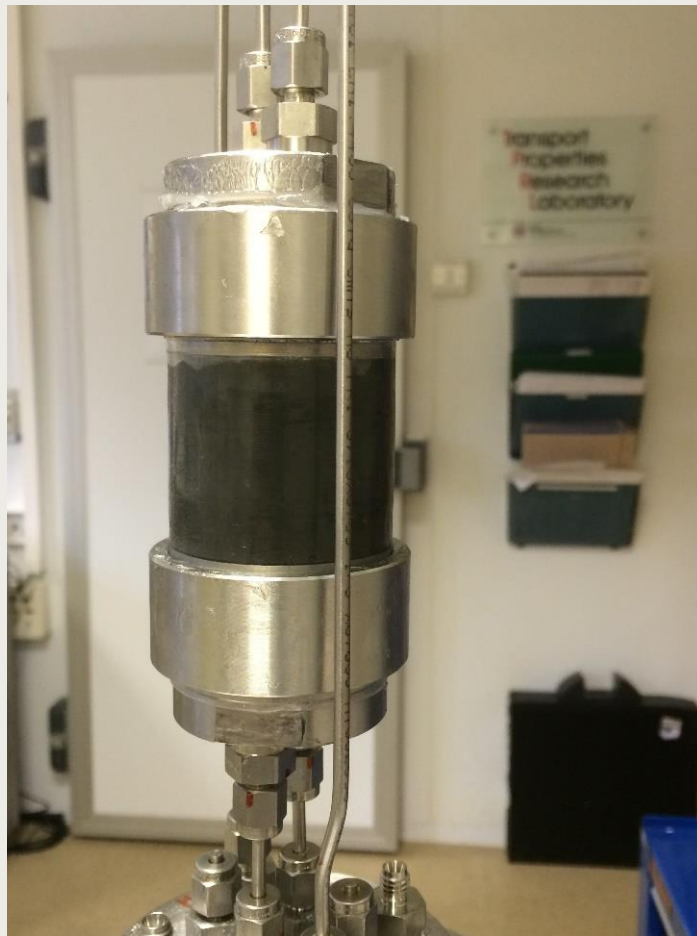
Figure 3-3: Isotropic test assembly, containing a sample of Boom Clay.

The cylindrical rock specimen is sandwiched between two end-caps and jacketed in heat-shrink Teflon to exclude confining fluid. A unique ‘lock-ring’ arrangement (**Figure 3-3**) is then placed over the jacketed specimen, so as to provide a leak-tight seal. The inlet and outlet zones for permeant flow through the specimen are provided by porous filter discs, 50 mm in diameter, which rest on the bearing surface of the end-caps. During hydraulic testing, all the filters are saturated with a synthetic porewater solution, based on the pore fluid chemistry at HADES URL (see Section 1-1).

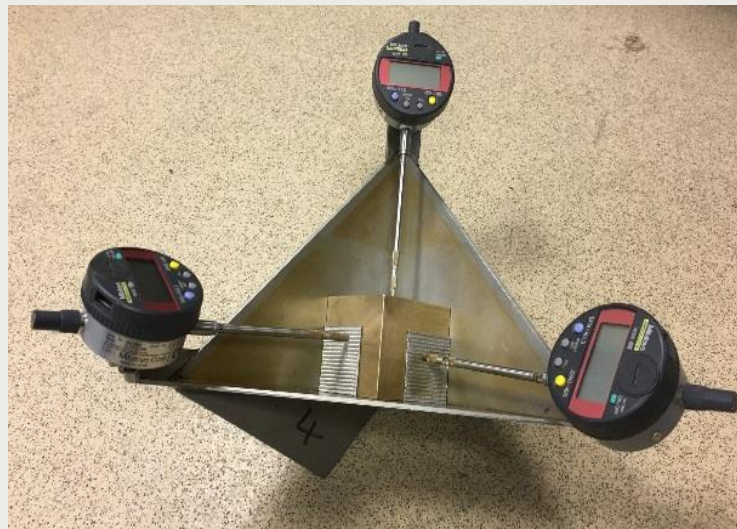
The 3D swell apparatus consisted of a three-sided triangular dish, in which a cubic sample of material sits (**Figure 4-1**). Three-dimensional swelling was measured using three Mitutoyo digital dial gauges, these were arranged perpendicularly to each other to measure swelling in three dimensions. Sample preparation was carried out carefully in order to ensure that one of the dial gauges was set up to measure swelling perpendicular to bedding. The rod of the dial gauge was in constant contact with the face of the sample. The cubic sample was placed in the centre of the triangular dish and the dial gauges were set to zero. The dish was then flooded with the SCKCEN pore fluid (see Section 1) until the sample was fully submerged. Swelling was measured over time using a bespoke version of LabVIEW™ logging software. Tests ran until swelling was no longer observed, however some tests would swell for extended periods so tests were terminated when no more swelling was observed.

Figure 4-1: Free swell apparatus.

The two free swell tests were ran for an extended amount of time. The aim was to run until no further swelling occurred. However, the first sample swelled so much the cube became too large to be constantly submerged, meaning the test was terminated. The second test ran for over 3 months until almost no swelling was observed.

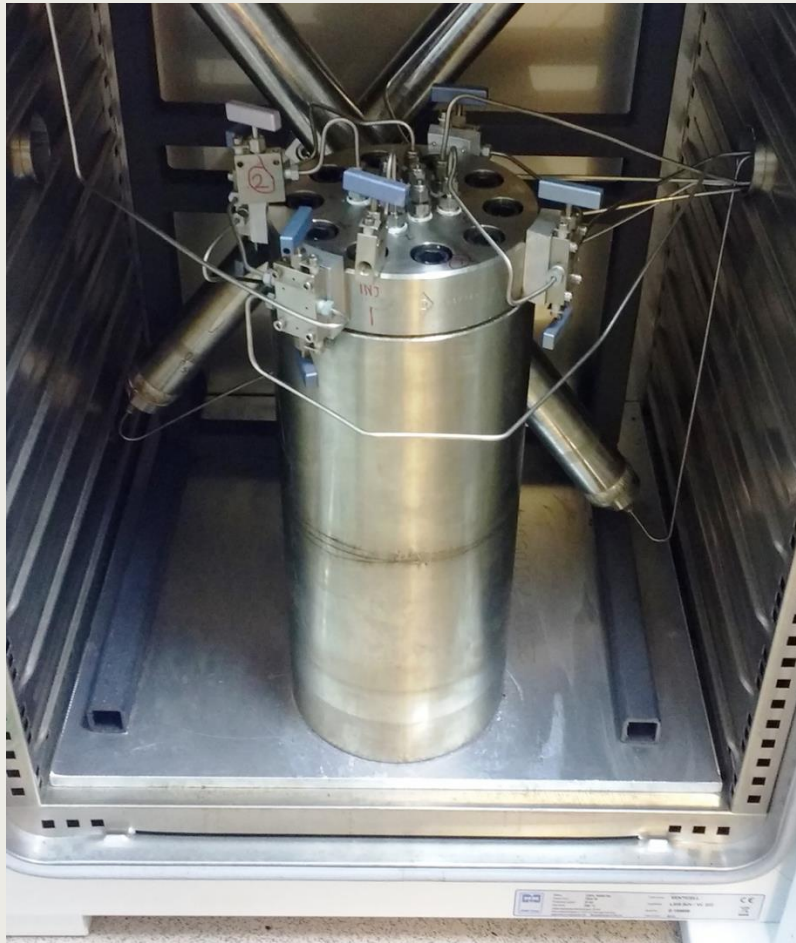
To examine if Boom clay exhibits thermally induced dilation or contraction on heating at representative depths of a Netherlands repository, a specimen of clay taken from the Hades underground laboratory was subject to an ascending history of thermal load. The apparatus used for this study was, in principal, exactly the same as that described in Chapter 3, with the exception that the pressure vessel and sample assembly were housed within a MMM Venticell 222 fan-assisted oven that had a temperature range of 5°C above room temperature to 300°C (Figure 5-1).

Figure 5-1: Photo showing pressure vessel and associated tubing located within a MMM Venticell 222 fan-assisted oven.

As before the cylindrical specimen cut perpendicular to bedding, designated Covra-1 (taken from core 76/77D), was sandwiched between two end-caps and jacketed in heat-shrink Teflon to exclude confining fluid. Volumetric flow rates were controlled or monitored using a pair of high-precision ISCO 260-D syringe pumps, operated by a digital control unit. Confining pressure was applied using a third ISCO pump connected to the same digital control unit. Each pump was calibrated using a Druck PTX610 pressure transmitter in ascending-descending increments to delineate potential hysteresis. The flow direction was from top to bottom across the sample.

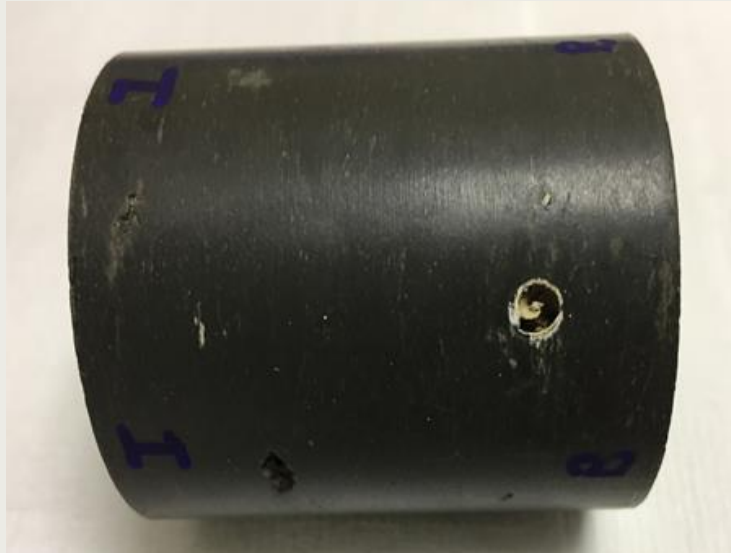
Figure 5-2: Photo of sample Covra-1 (CGR 76/77D) showing the carbonate feature and resulting void, which is thought to have caused the leakage problems noted in test Stages 4 and 7.

Note, testing was momentarily interrupted during stage 4 and stage 7 when the flexible Teflon sheath which excluded the confining fluid was accidentally pierced as the sheath deformed in and around a carbonate feature, shown in Figure 5-2. After each event, the sample was re-jacketed, the test permeants replaced with new synthetic porewater solution and the test stage repeated. Following the second jacket failure during Stage 7, the void was infilled with a low swelling clay to prevent further jacketing problems. The full experimental test history is given in Table 5-2.

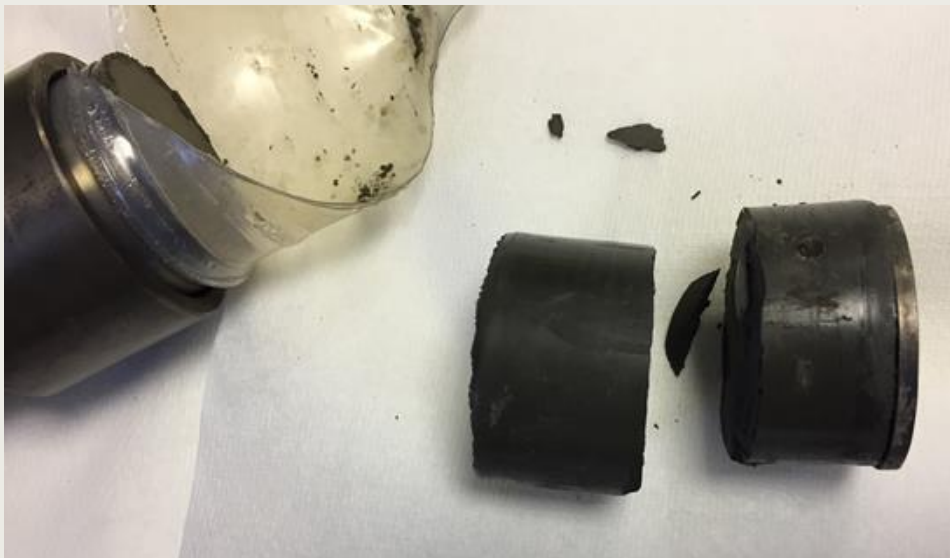
Figure 5-6: Post-test image of sample Covra-1 immediately after removal from the sample assembly.

However, the sample exhibited some interesting behaviour when removed from the sample assembly. Figure 5-6 shows the sample immediately after removal having spontaneously fissured part-way along the axis of the core. This process rapidly continued as the thermal energy stored within the clay lead to further drying, cracking and fragmentation of the

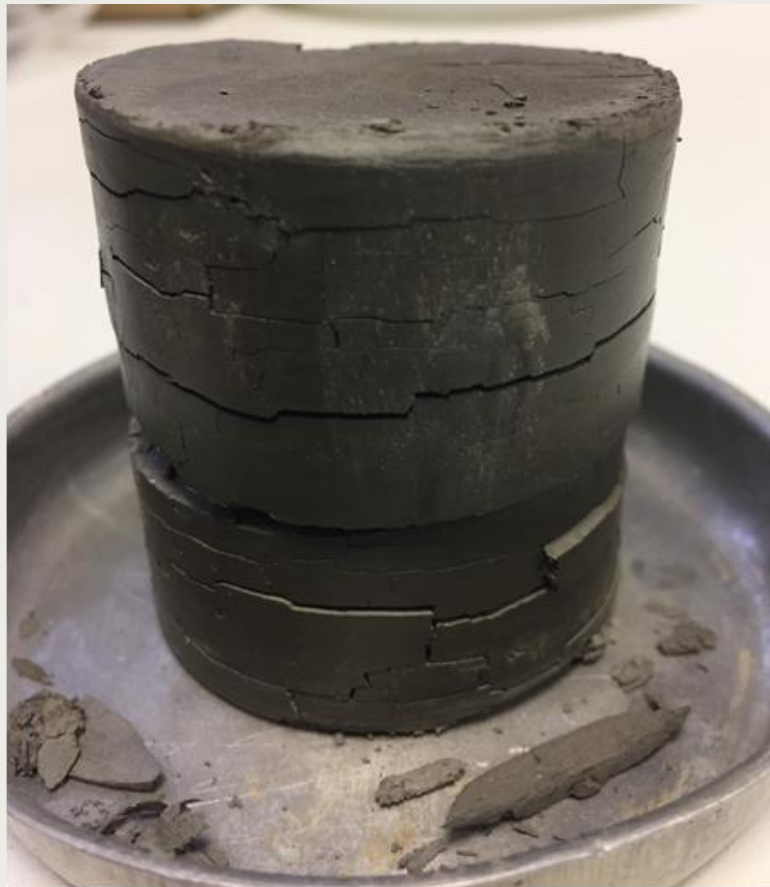
core (Figure 5-7). While cracking is predominantly focussed along the bedding planes, some fractures were observed cross-cutting the fabric.

Figure 5-7 shows that under the conditions of this test and the subsequent removal of the sample, significant thermally induced damage can occur to Boom Clay when subject to high temperature conditions. While this damage is an artefact of sample drying, the potential for moisture redistribution under a thermal gradient (rather than the isothermal loading imposed during this scoping study) remains entirely possible, and could lead to similar cracking under *in-situ* conditions.

Figure 5-7: Post-test image of sample Covra-1 shortly after removal from the apparatus. Rapid drying of the sample due to the thermal energy stored within the clay has resulted in cracking and fragmentation of the sample.

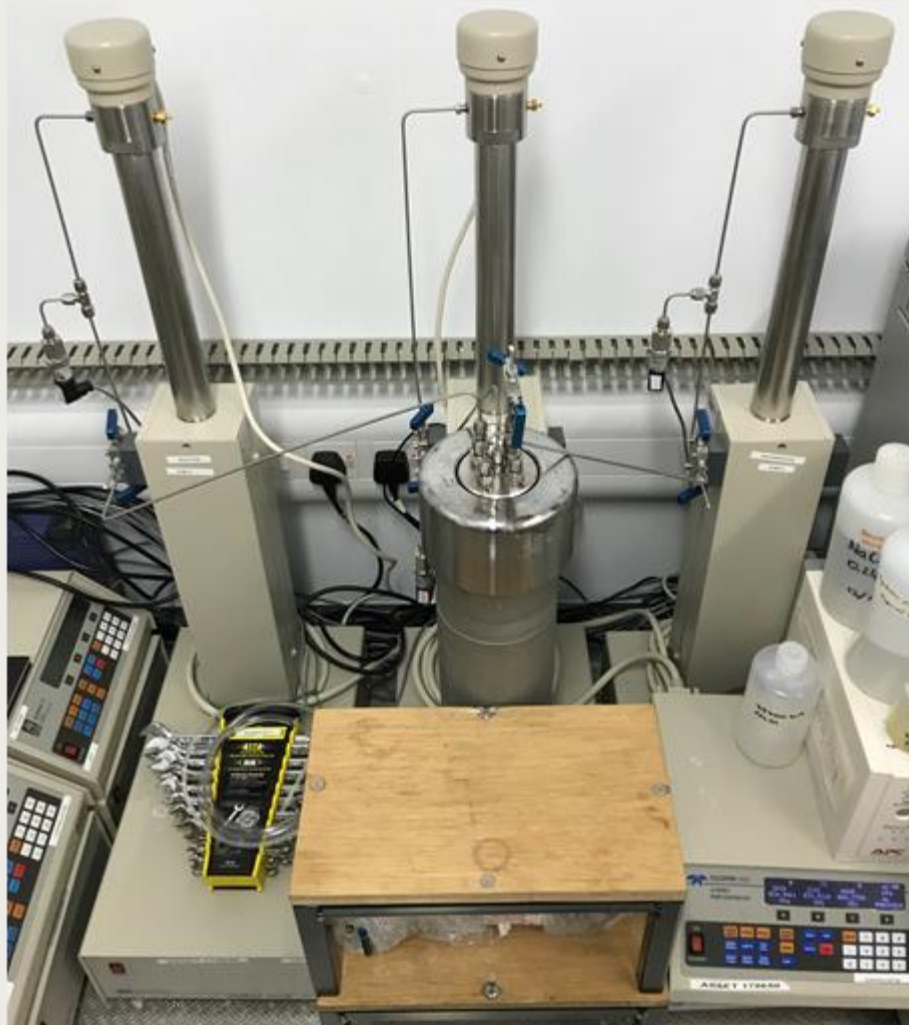
Figure 6-1: Photo showing pressure vessel, connecting tubes and the three control pumps used to monitor inflow (left pump), outflow (right pump) and maintain confining pressure (centre pump).

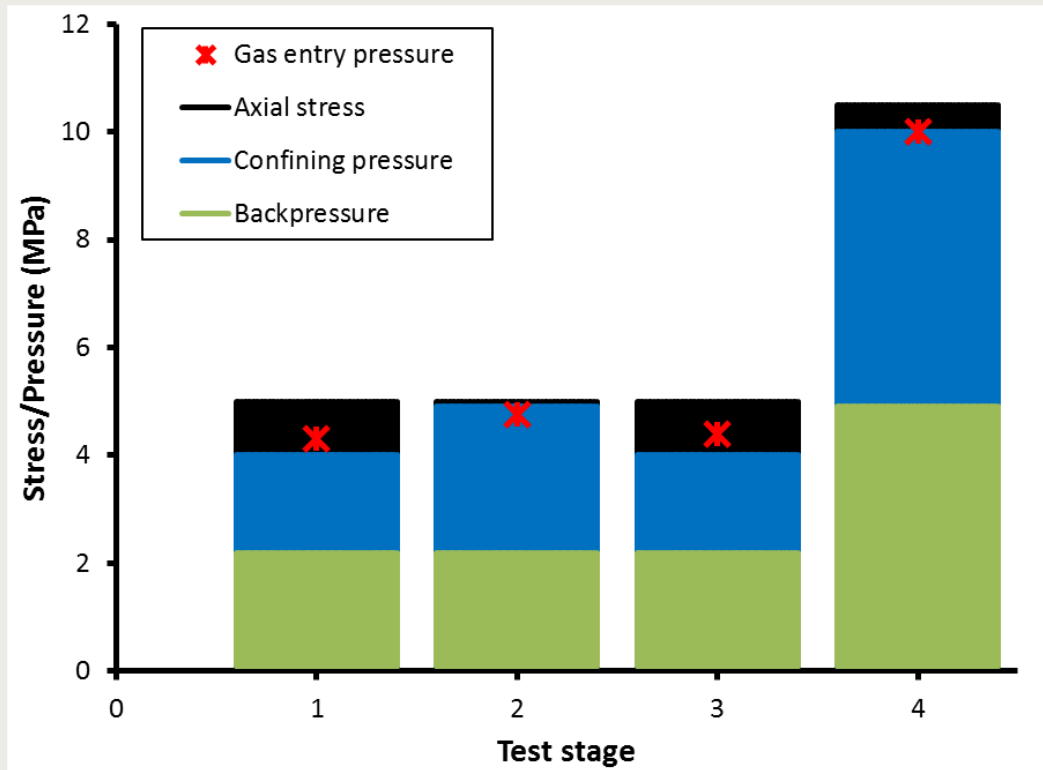
Figure 7-21: Comparison of boundary conditions with gas entry pressure for the four gas injection tests conducted. Test stages 1 and 2 represent test OPERA_SPP-1, stages 3 and 4 represent test OPERA_SPP-2.

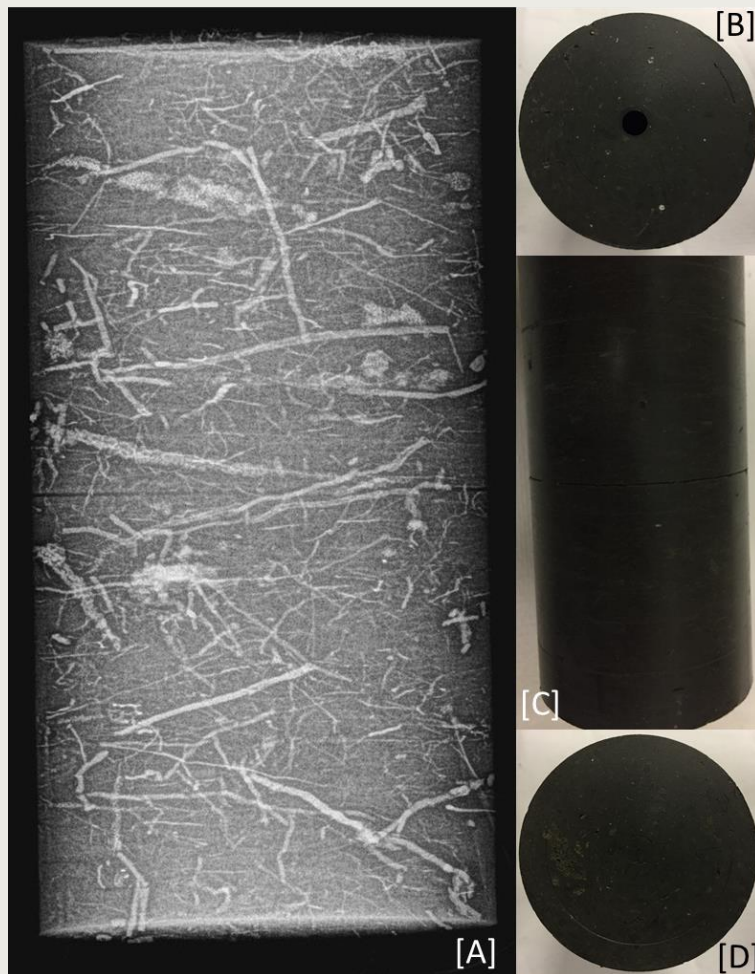
Figure 7-24: Pre-test images of sample Covra-3. A) X-ray image of core (note the dark horizontal line around the mid-plane of the sample is an artefact of imaging). B) End-face showing central hole to accommodate the injection tube. C) Side view of core. D) Backpressure end-face. Minor shallow surface striations are evident in images [B], [C] and [D], which are caused when a hard nodule of material is ‘plucked’ by the lathe and dragged across the sample surface. However, these features are discontinuous, shallow, and do not have a deleterious effect on the sample properties (Table 7-6).

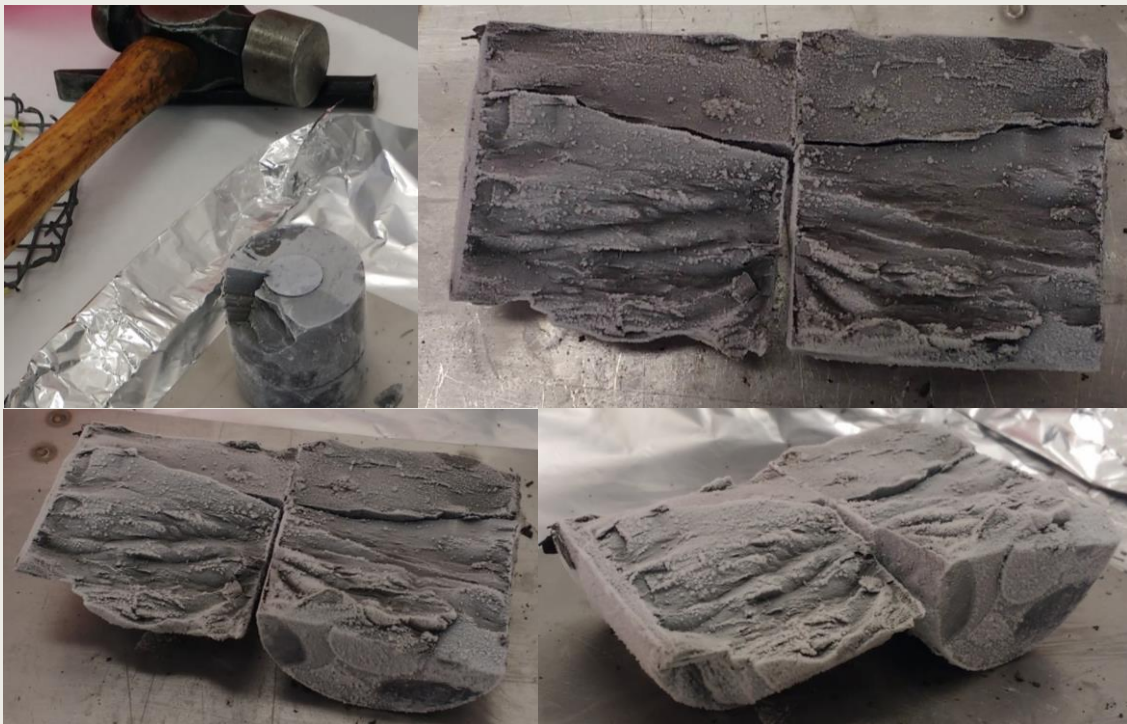
Figure 7-41: After submersion in liquid nitrogen, the frozen and embrittled clay was split axially parallel to its length using a hammer and chisel. Initially pieces broke off the clay, but then the sample split cleanly along a plane of weakness.

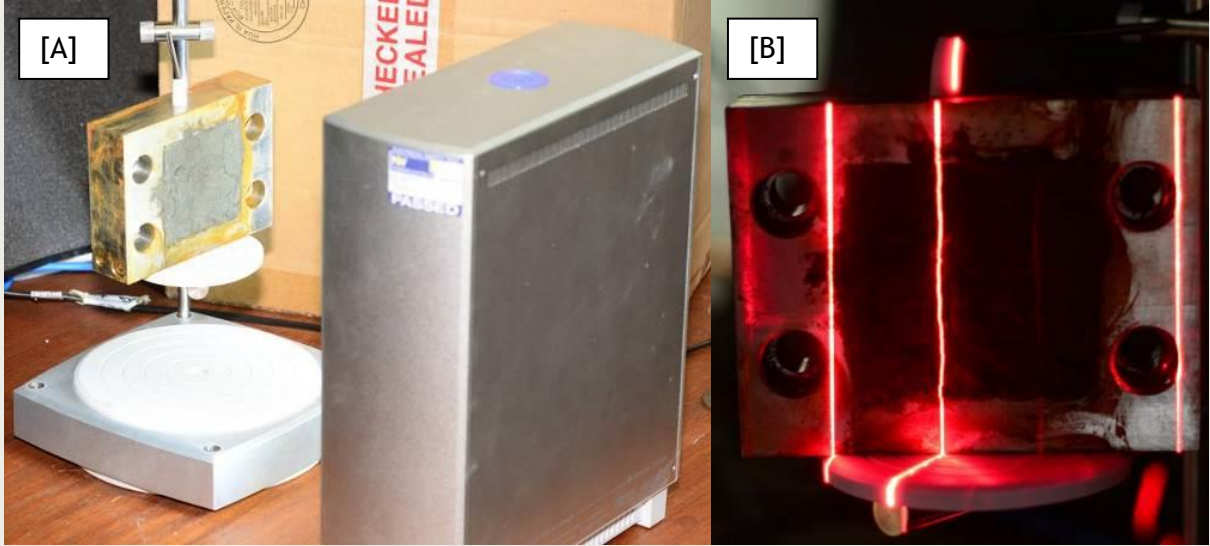
In the present study, laser triangulation method was adopted, whereby the fracture surfaces were scanned using a NextEngine 3D Scanner HD, as shown in Figure 8-3. This produced a 3D mesh model of the fracture surface accurate within an error of ± 65 microns. Algorithms inbuilt within the data acquisition ScanStudio HD software produced clean surface data, which were used in subsequent empirical and statistical analysis.

Figure 8-3: [A] NextEngine 3D Scanner with lower block sample. [B] Laser scanning in process.

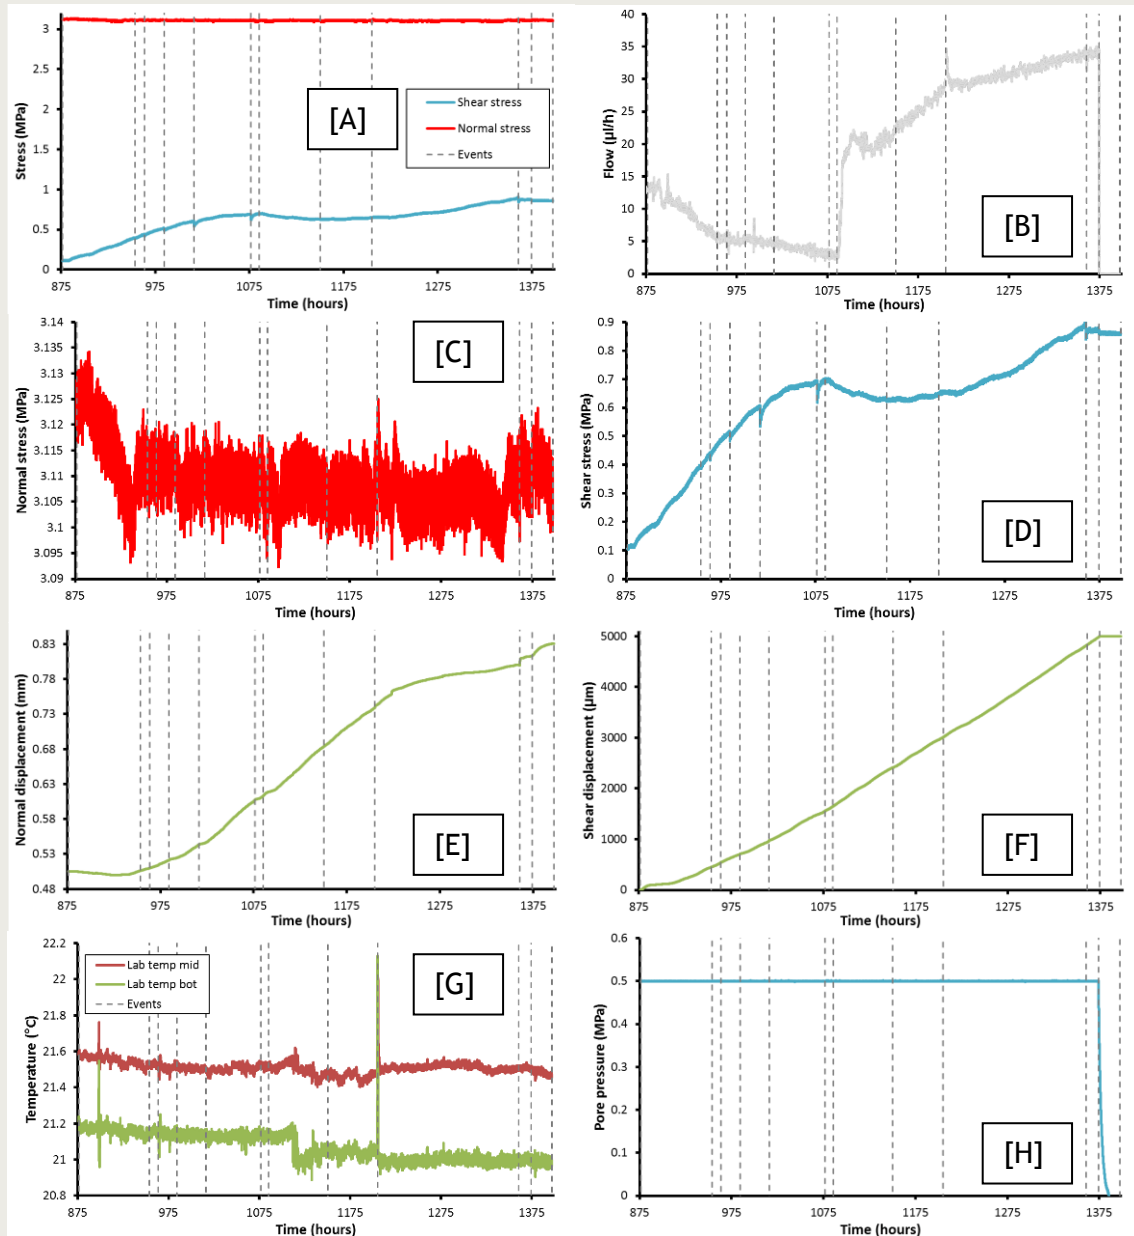
Figure 8-11: Data for shear test 2 of test OPERA_Shear-1. [A] Stress history. [B] Flow into the sample. [C] Normal stress. [D] Resultant shear stress. [E] Normal displacement of the sample. [F] Shear displacement. [G] Temperature. [H] Pore pressure. Dashed lines represent events of note.

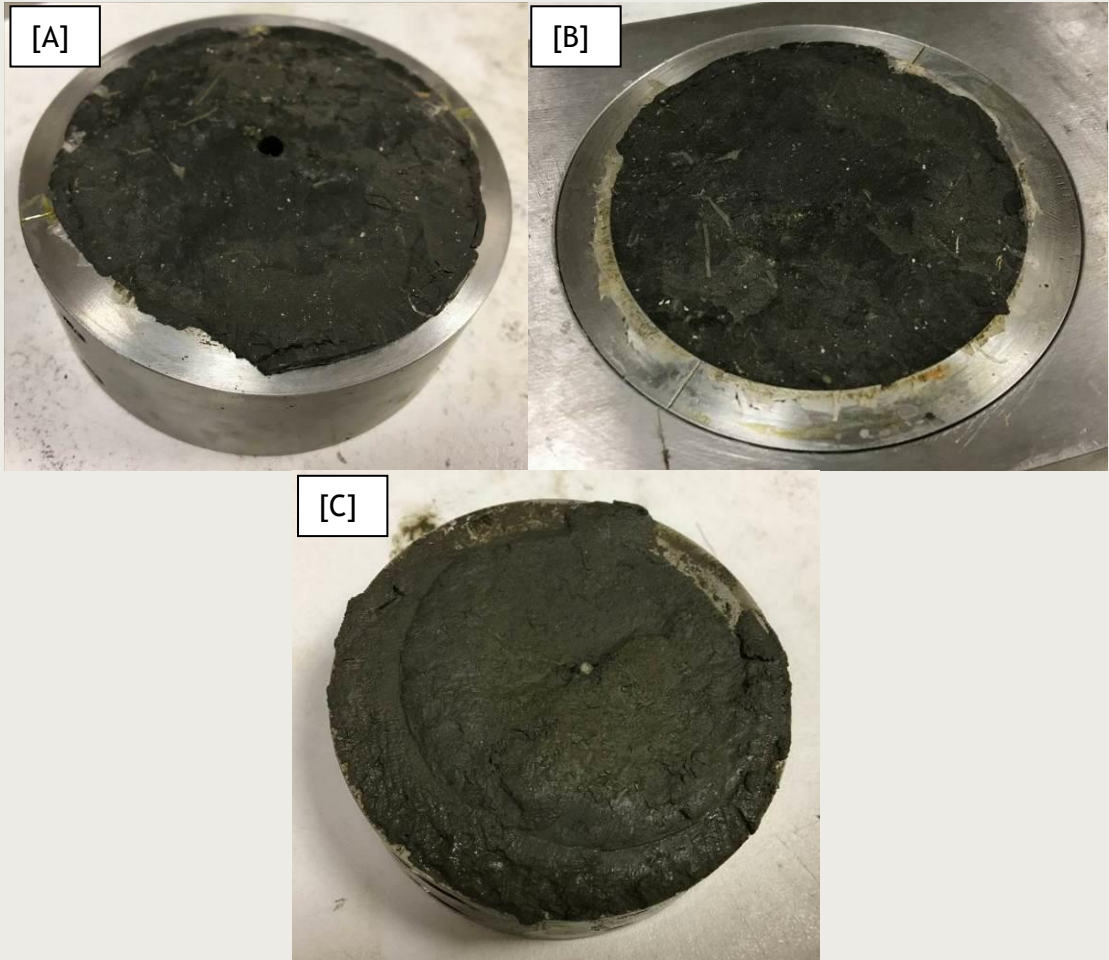
Figure 8-13: Observations of fracture surfaces in test OPERA_Shear-1. [A] Shear test 1 top surface. [B] Shear test 2 bottom surface. [C] Shear test 2 bottom surface.
