Natural and anthropogenic halite karst subsidence in north Cheshire, UK; comparison of Rostherne Mere, Melchett Mere, Tatton Mere and their surroundings

Colin J Serridge & Anthony H. Cooper

**Photofeature: Natural and anthropogenic halite karst subsidence in north Cheshire,
UK; comparison of Rostherne Mere, Melchett Mere, Tatton Mere and their
surroundings.**

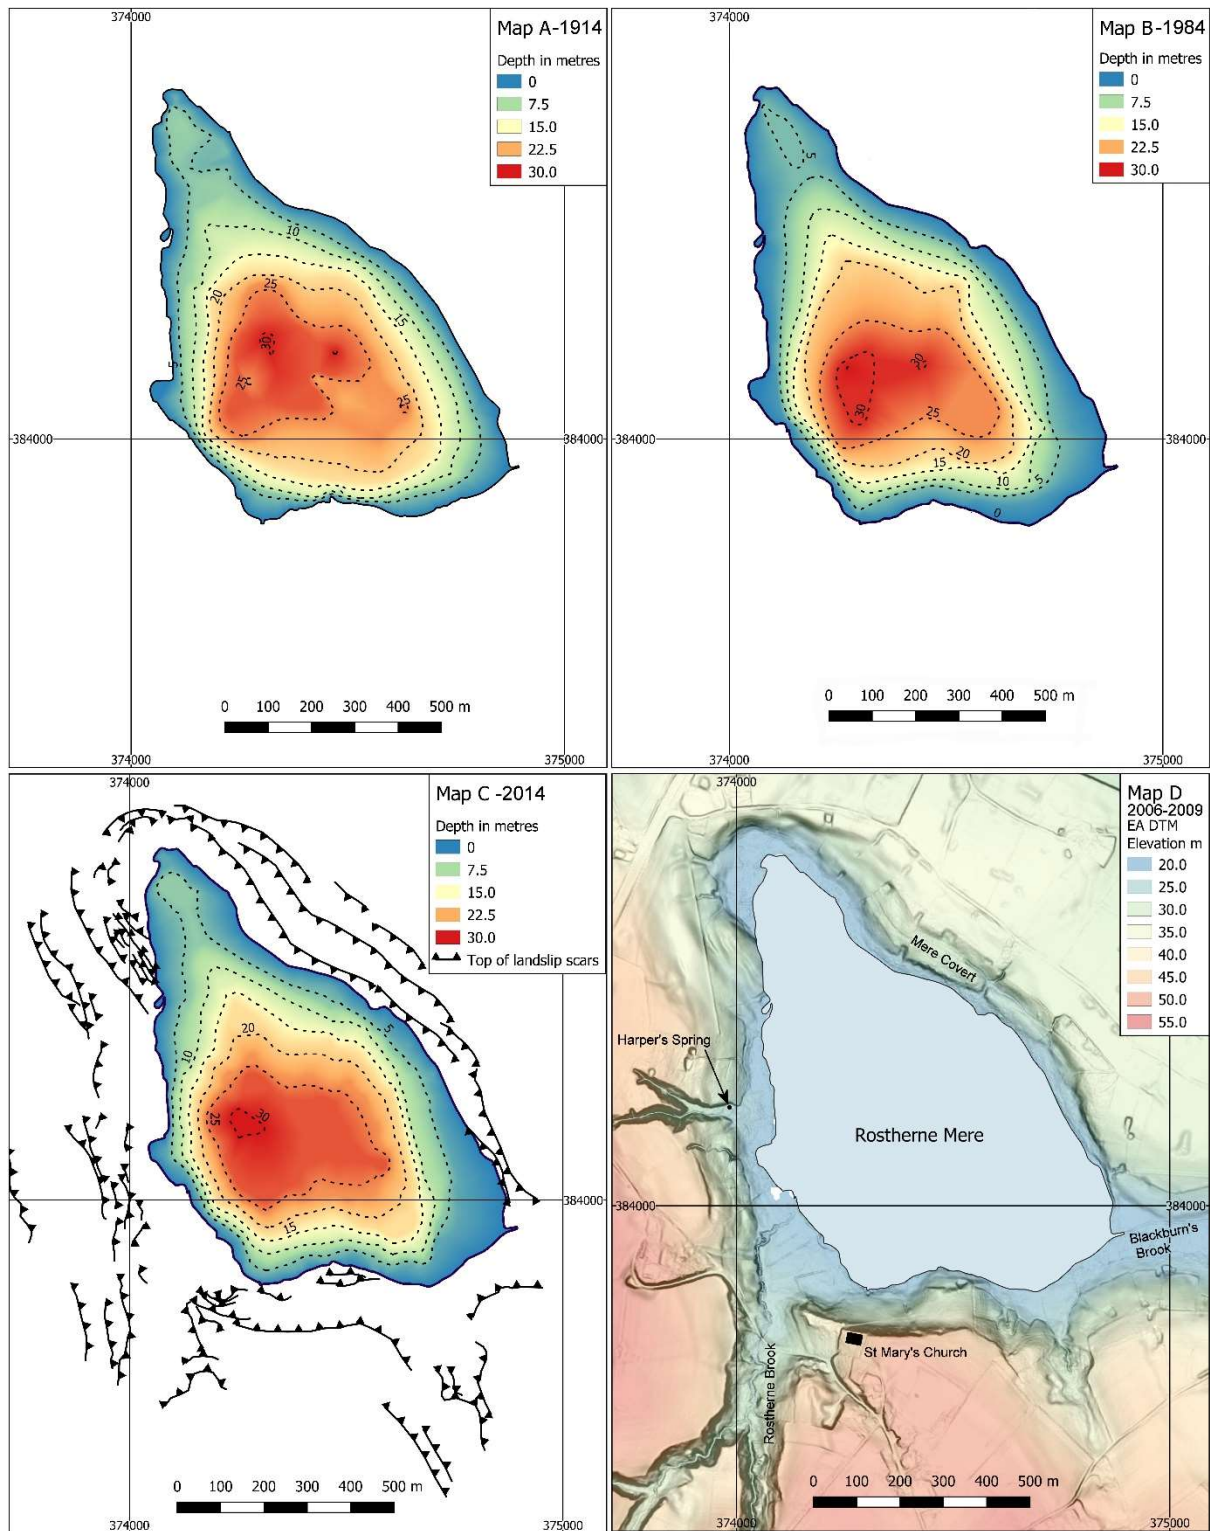
Figure 4. Rostherne Mere: A. Bathymetric survey after Tattersall and Coward, 1914 (depths converted to metres); B, Bathymetric Survey, after Woof and Wall, 1984; C, Bathymetric Survey May 2010, (after Scott, 2014) with landslip scars digitised from EA 2006-2009 1m Lidar BGS © UKRI; D. EA 1m Lidar 2006-2009 processed in QGIS with hillshade and coloured elevation © Environment Agency copyright and/or database right 2021. All rights reserved.

The first accurate (rope and weight) bathymetric survey of the mere was in 1912-13 by Tattersall and Coward (1914). Their contours, metricated in Figure 4A, show a deep 'cup-shaped' depression with a relatively steep profile, most notably in the south-west part. A maximum depth of around 30 m was recorded slightly south of the centre of the mere. Towards its northern end a shallow ridge/plateau of lake bed was recorded about 6 m deep, lined with peat and interpreted by them as a former shoreline.

Woof and Wall (1984) surveyed Rostherne Mere with sonar equipment and recorded a maximum water depth of 31 m with a bathymetric profile (Fig. 4B) broadly similar to that of Tattersall and Coward (1914). However, significant differences were identified along the south and south-east shores, where a larger area of shallow water was recorded, coincident with the main inflow of Rostherne Brook (Fig. 4). They considered this to relate to an increase in surface area of the mere and sediment accretion between the two survey dates (Woof and Wall, 1984). More recently, Scott (2014) presented the results of a bathymetric survey undertaken in 2010, employing a dual beam sonar transducer and built in GPS; a profile broadly similar to that presented by Woof and Wall (1984) was obtained (Fig. 4 C)

The bathymetric surveys suggest that in 1912-13 the deepest part was just over 30 m with a 25 m deep area towards the south-west and a shallow area in the south-east. On the later surveys by Woof and Wall (1984) and Scott (2014) the mere appears to have become deeper in these areas. There may be some errors in the contouring due to the small number of depths recorded by Tattersall and Coward, but they did have a plumbed depth over their 25 m location. Differences in these surveys suggest some deepening of the mere by up to about 5 m between 1914 and 1984. Between 1920 and 2020, there has also been sedimentation in the deeper parts of the mere with up to 0.6 m of sediment deposited over 100 years equating to about 0.6 cm of sediment per year (David Ryves pers. comm. 21/12/2021). The surface area of the mere varies seasonally and with climatic variations as water levels fluctuate by around 1 m (Ryves et al., 2020). Some sediment accretion is also to be anticipated around the inflow of Rostherne Brook into the mere.

Airborne LiDAR (Light Detection And Ranging) data for the area (Fig. 4 D) provides more recent high-resolution information about the subsidence depression and tension (slip) scars. The LiDAR derived Digital Terrain Model (DTM) also reveals details obscured by vegetation and not visible on aerial photographs, such as the wooded area of Mere Covert when Worsley (1967) published his survey. The slip scars were digitised from the 2006-2009 LiDAR DTM information (Fig. 4D). More features were recognised than were recorded by Worsley (1967), but the increase most likely relates to the ease with which the DTM displays them, rather than a large increase in their number. This information does not preclude that some movement may have occurred between 1967 and 2006-2009. However, the lack of subsidence damage to the mid-18th to late 19th century St Mary's Church, located near the south-west edge of Rostherne Mere, indicates a relatively long period of stability just outside of the slip scar area.

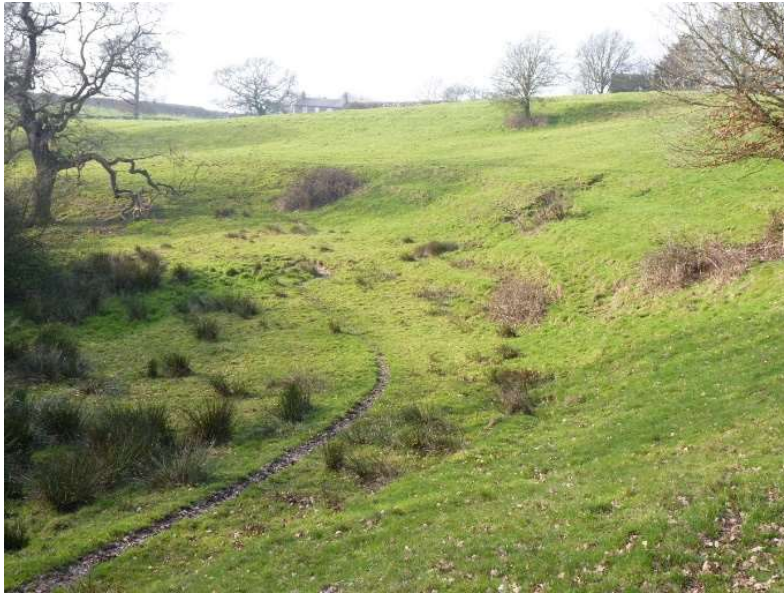
Figure 5: Partially degraded (dormant) slip scars (looking north west) around northern perimeter of Rostherne Mere, adjacent to Gale Bog (left of picture) – photo Colin Serridge.

the long-wall mining of coal and brine-related subsidence. The vertical displacement along the scars is typically less than 1.0 m (Fig. 5) and they are still relatively well preserved.

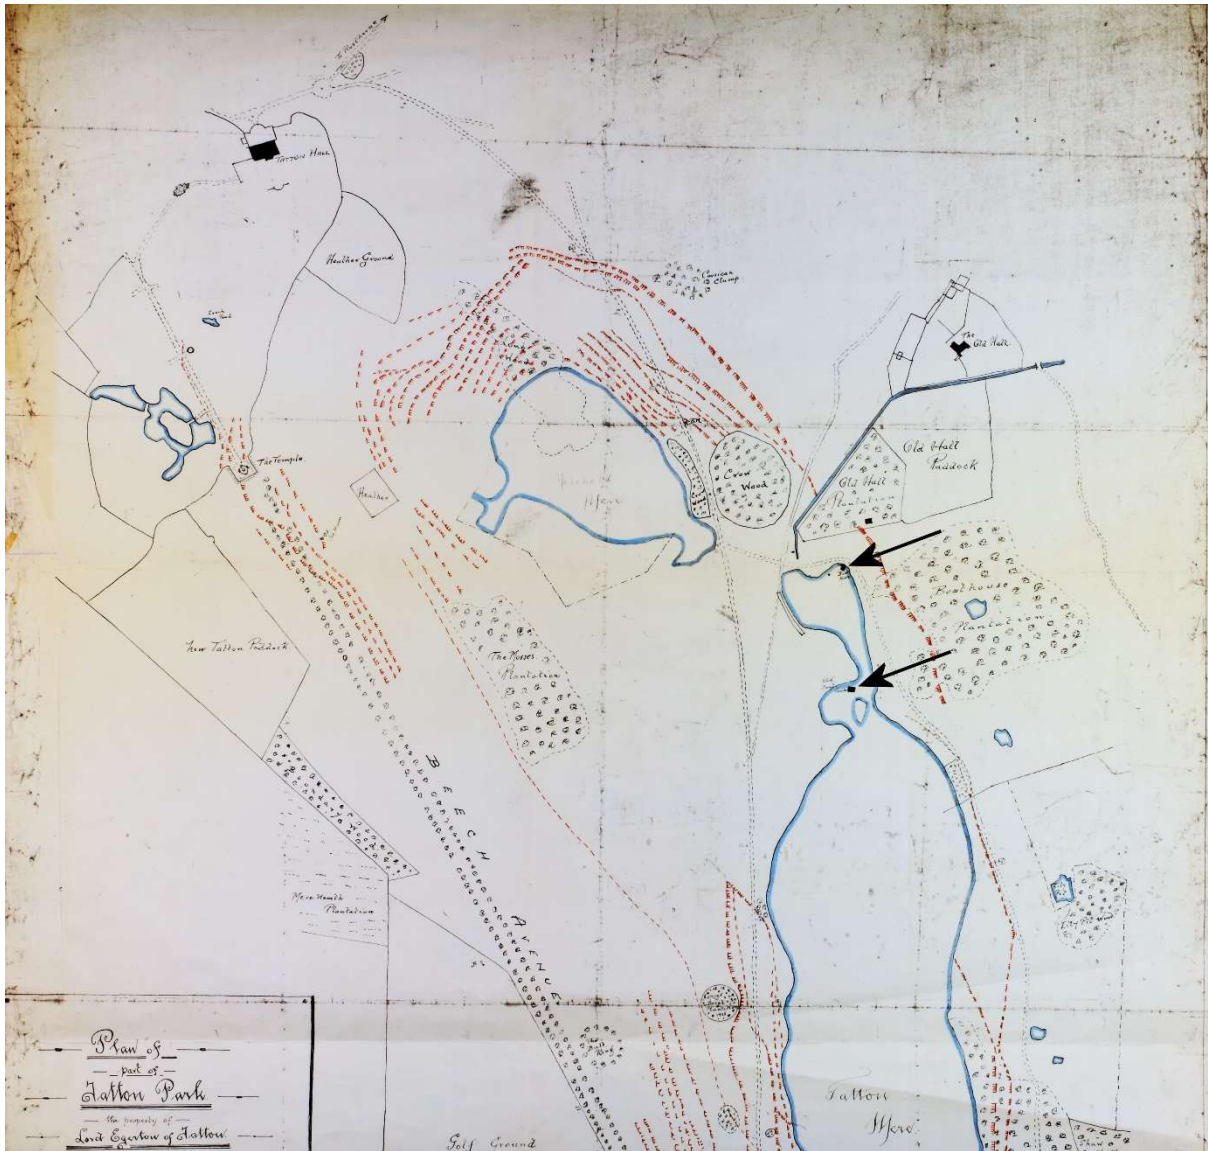
Figure 9: Map extract of Melchett Mere and northern half of Tatton Mere dated 1948 showing associated slip scar development (red dashed lines), during on-going subsidence. The former position of the boat house near the island and the new boat house position at northern end of Tatton Mere are both arrowed - Source: courtesy Cheshire Archives and Local Studies Ref: DET 2389).

The slip scars around Melchett Mere were first mapped in 1948 for the Tatton Park Estate (Fig. 9). While most of the features are tensional slip scars, compression ridges (probably reactivated slip scars) were clearly visible in 1951 on the north-eastern side of the mere (Fig. 11), their relationship to the subsidence area is illustrated in Figure 3. The subsidence scars are typically less than 1 m in height, but public access and grazing of livestock has led to some deterioration of these features, closest to the mere. Photographs from circa 2017 show that the scars were still visible, particularly on the eastern flanks of the subsidence depression (Fig. 12) while trees leaning towards the mere near the northern/north-eastern shoreline (Fig. 13) provide a visual record of recently active subsidence.

From the historical maps and aerial photographs for Tatton Mere Jenkins (1983) noted changes in the mere and in the surrounding slip scars from c.1935, c. 1946 and c. 1978. Dated information for the same area is also seen in Figure 9 for 1948 and Figure 6 highlighting the features shown in the LiDAR 2006-2009 DTM. There are no maps of the slip scars prior to 1935, but Ordnance Survey maps illustrate that Tatton Mere shows considerable changes in width and shape from 1875 to 2021. As slip scars were mapped later than 1935 it seems likely that earlier subsidence and enlargement of the mere would also be associated with slip scar movement around its margins. Many of the changes to Tatton Mere have occurred on a similar timescale to the formation of Melchett Mere and it is likely they relate to the same brine extraction events.

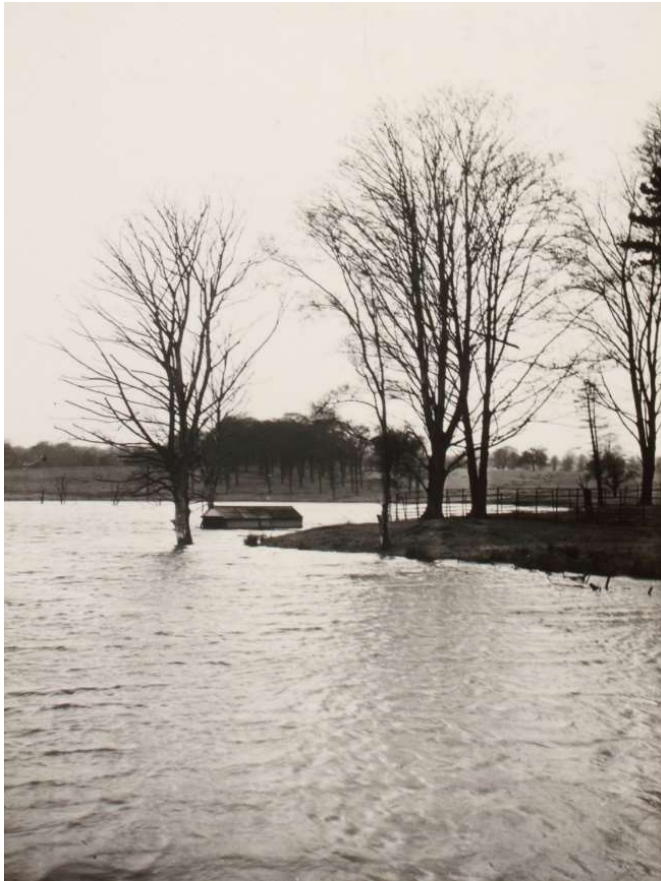
Figure 10: Melchett Mere, loss, due to subsidence, of boat house and trees on west side of Crow Wood (middle of picture) and the southern end of Long Wood in the background, circa 1951. (Source: courtesy Cheshire Archives and Local Studies Ref: DET 2389).

extent of the two former wooded areas is shown in Figure 8. Trees being engulfed by on-going subsidence and the submerged boat house at Melchett Mere are shown in Figures 10 and 11 while slip scars and tilted trees are notable in Figures 11, 12 and 13.

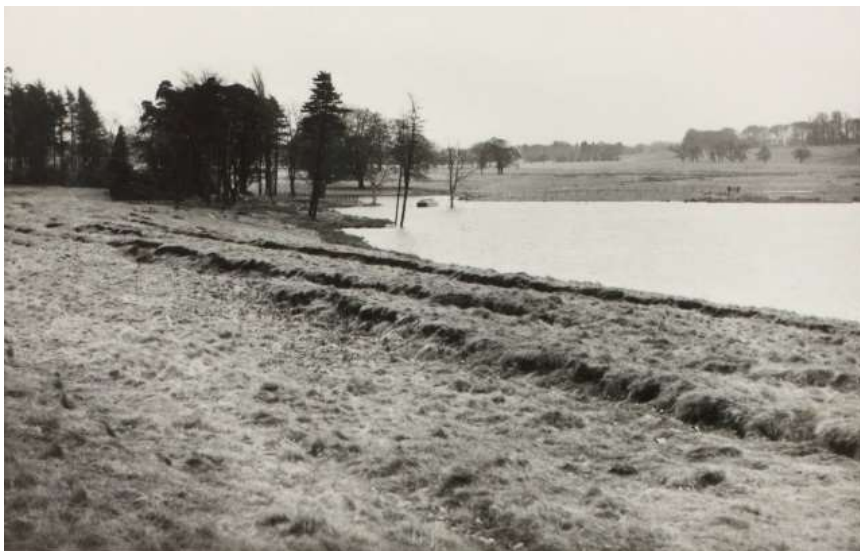
Figure 11: Compression scars and ridges on eastern flanks of Melchett mere, 1951. Submerged boat house and trees can also be clearly seen. (Source: courtesy Cheshire Archives and Local Studies Ref: DET 2389).

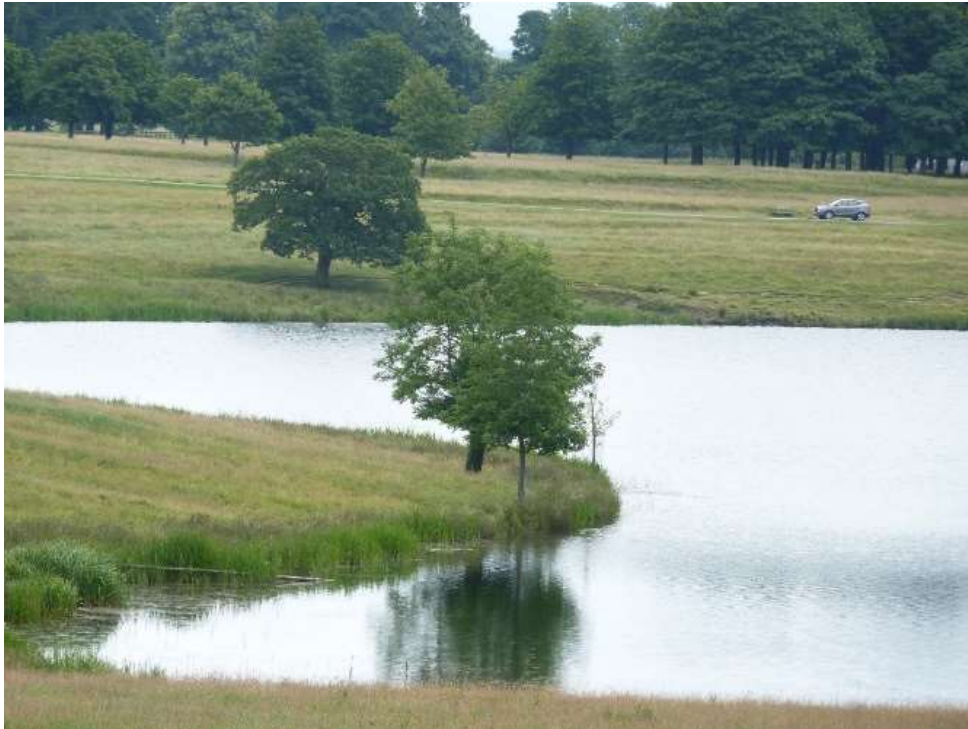
Figure 12: Slip scars developed on the flanks of Melchett Mere during subsidence event. Vehicle provides an indication of scale. Photograph taken 2017 by Colin Serridge.

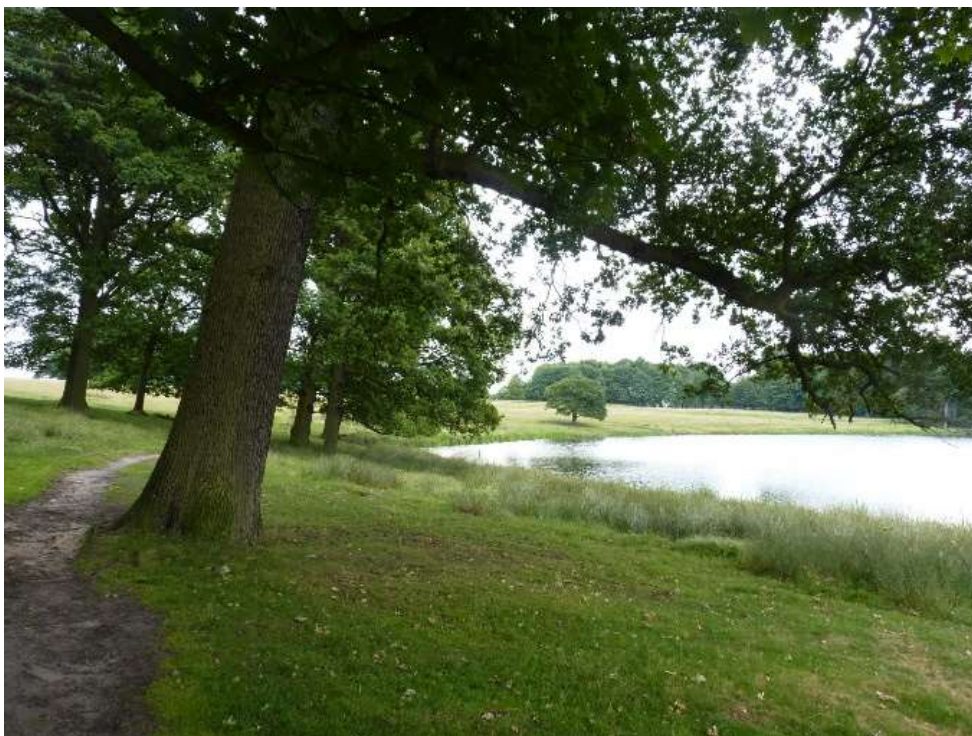
Figure 13: Leaning trees on north bank of Melchett Mere (edge of Long Wood), attributed to subsidence. Photograph taken 2017 by Colin Serridge.

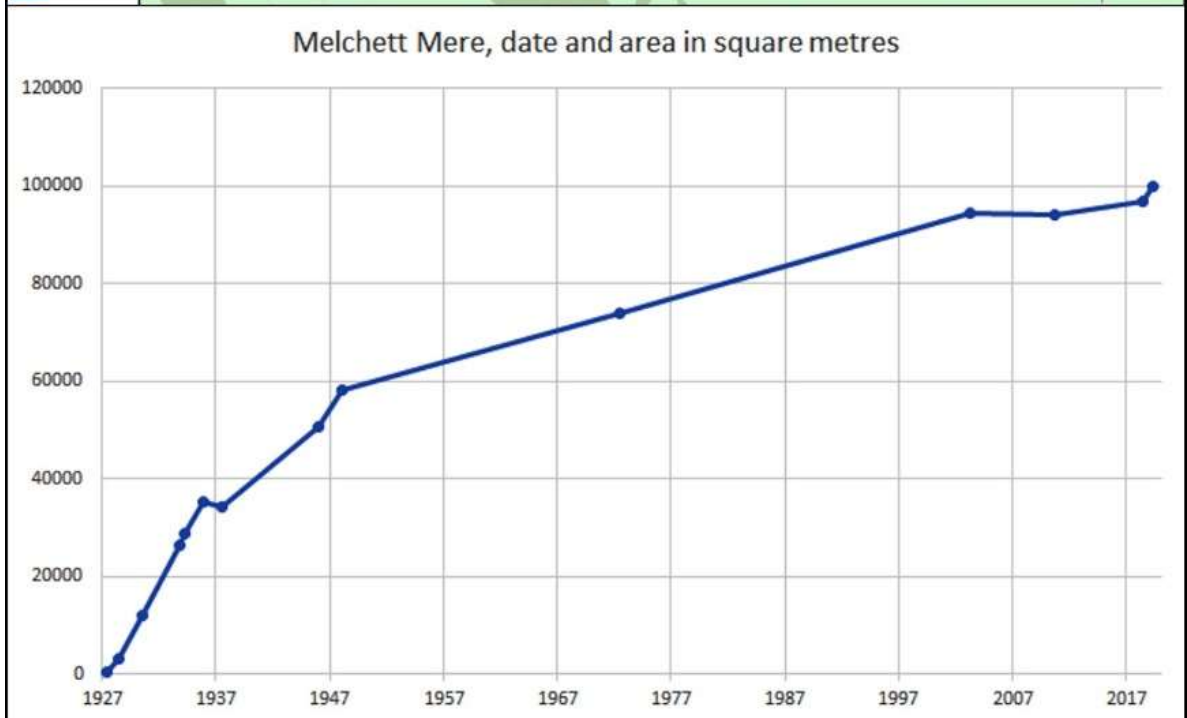
Figure 14: Interpreted growth in surface area of Melchett Mere 1927-2019, BGS © UKRI. Datasets used 1927-1937 and 1948 Tatton Park records (Cheshire Records Office; Figs 8 and 9); 1945 and 1972-2019 aerial photography from Google Earth or Tithemaps online (<https://maps.cheshireeast.gov.uk/tithemaps/>) Contains OS data © Crown copyright 2022. Digitised in QGIS.

Numerous datasets allow the formation history of Melchett Mere and its surroundings to be elaborated. The earliest map of Tatton Park by Hussey in 1773 (Cheshire Archives DET 3229/152) shows Turn Mere a small (subsidence generated) lake near the house with fields shown in the area that became Melchett Mere. Turn Mere is also shown on a map by Earl from 1787 (Cheshire Archives: DET/3299/153). Records from Historic England (1985), document the landscape changes here noting 'Turn Mere, nearer the Hall, was drained in 1816 under the direction of John Webb, who in 1818 was credited with 'improvements' at Tatton.' The landscaped gardens occupying what was Turn Mere and parkland to the south-east in what was to become Melchett Mere are shown on the c. 1848 Tithe map (Cheshire Archives and Local Studies 2021). Subsequently the Ordnance Survey maps of 1882, 1899 and 1910 all show parkland in the area that became Melchett Mere. The historical records of Melchett Mere held by the Cheshire County Records Office, plus historical air photography from Google Earth and the Tithe Maps online website show the development with time of Melchett Mere. Figure 14 summarises the changes in the shape and area of Melchett Mere from the initial subsidence in 1927 in the south-east part to a larger subsidence to the north-west in what is now the deepest part of the mere. The mere developed rapidly in size to 1948, then grew less quickly to 2003. More recent images from 2010-2019 have shown only slight changes in area, some of which might be a function of water levels or marginal vegetation confusing the boundary (Fig. 14).

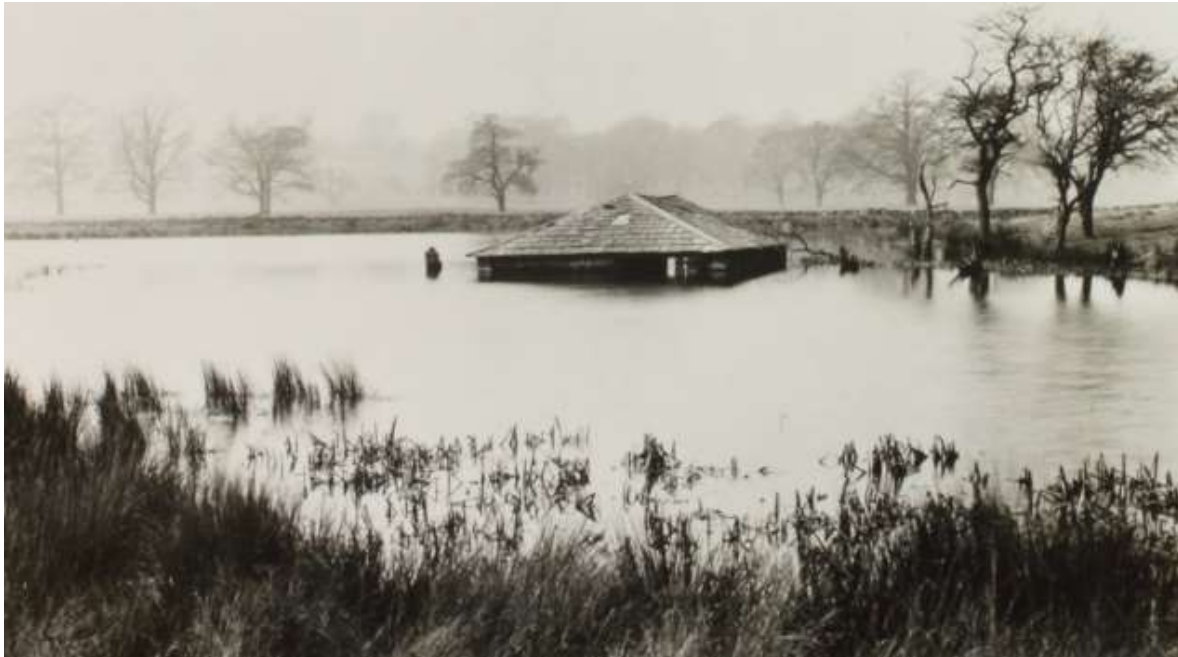
Figure 15: Submerged boat house (also submerged trees) at northern end of Tatton Mere, circa 1951 (Source: courtesy Cheshire Archives and Local Studies Ref: DET 2389).

Comparing the Ordnance Survey maps from 1910 with the aerial photography of 1948 (Google Earth) changes at the north end of Tatton Mere show subsidence and lake enlargement around the boat house. This sank as illustrated by the c. 1951 photograph (Fig. 15). These changes, increases in mere size, increases in boggy areas and increased numbers of subsidence scars around the lake were also noted by Jenkins (1983) who recorded differences between c.1935, c.1946 and c.1978 based on Tatton Park records, Ordnance Survey maps and aerial photography (Jenkins, 1983 thesis figures 63, 64 and 65). Other changes are also visible between the 1971-3 air photographs when a small island that was present then near the east bank (also shown on Fig. 9 from 1948) is not visible on the later images from 1999.
