A walkover survey of the Oxwich Bay landslide

Open Report OR/10/001

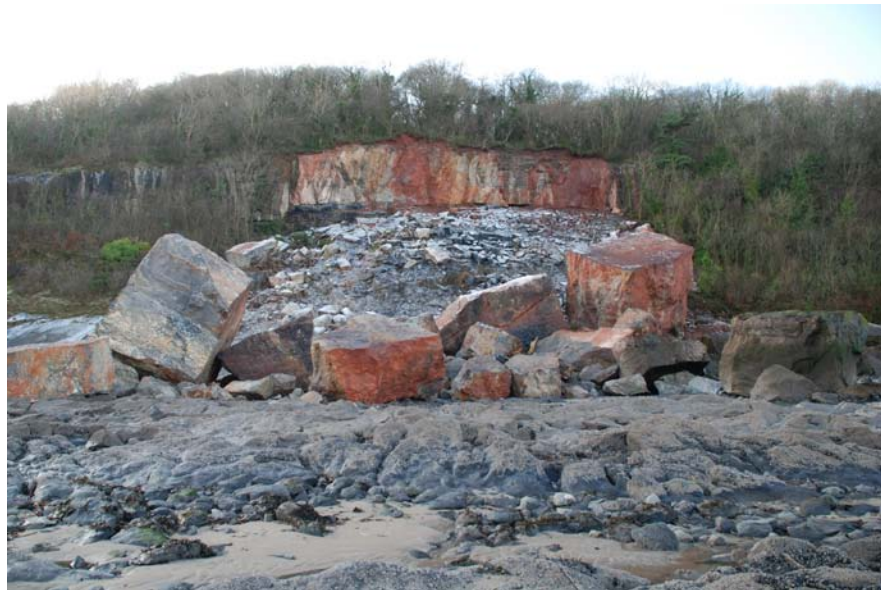
Oxwich Bay landslide (photo P. M. Williams with permission)

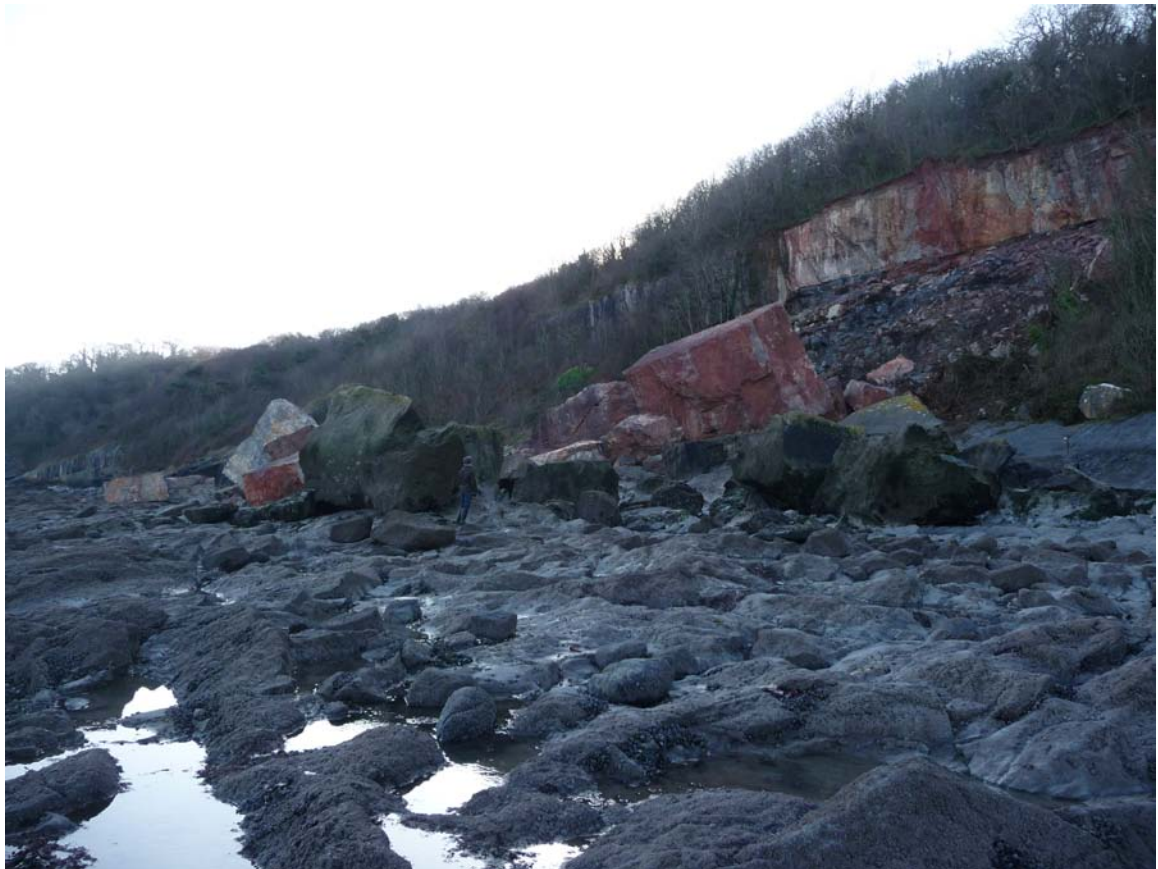
Figure 3. Oxwich Bay landslide. Photograph taken from NGR 250657 185944 looking south.

Evidence of a previous rockfall activity is present in the form of weathered boulders of limestone (known locally as “The Dices”) on the foreshore in the immediate vicinity of the December 2009 landslide (Figures 3 and 4).

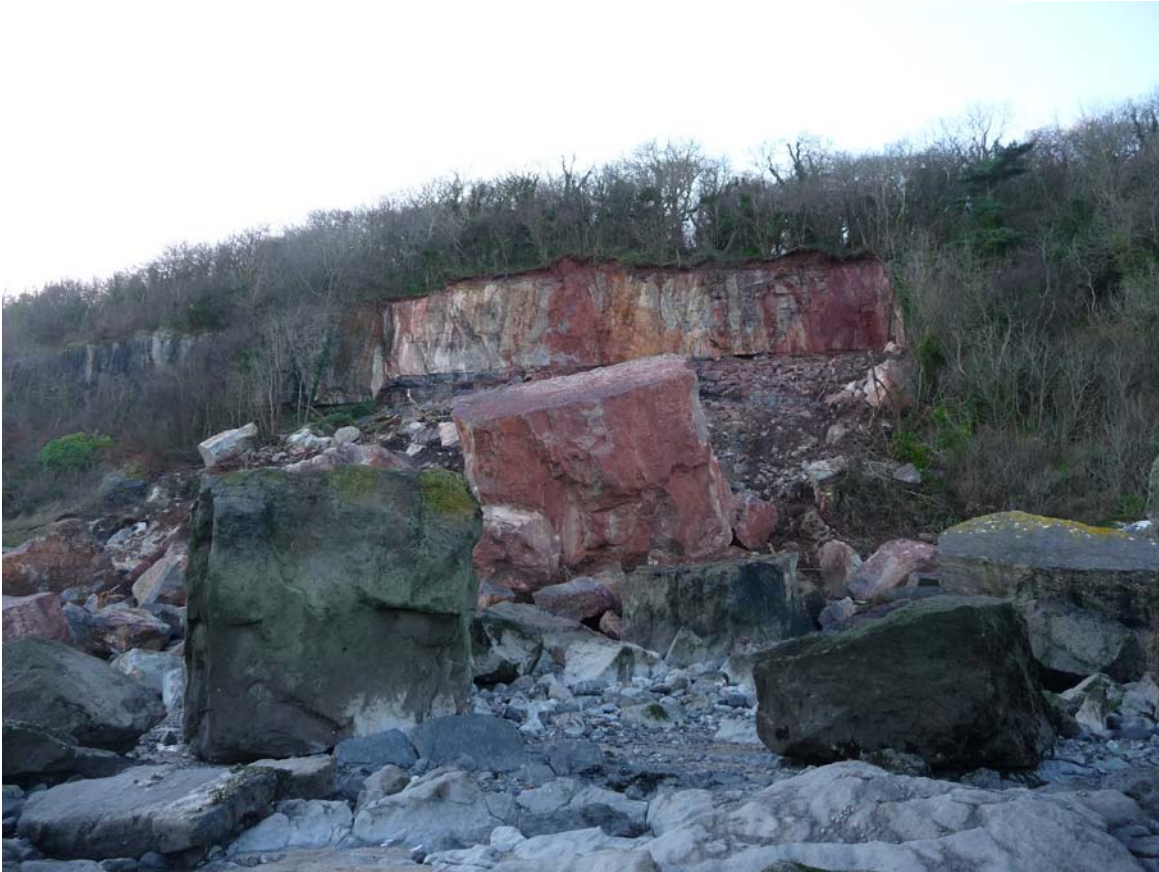
Figure 4. Close-up view of the Oxwich Bay landslide. Photograph taken from NGR 250692 185923 looking south-west.

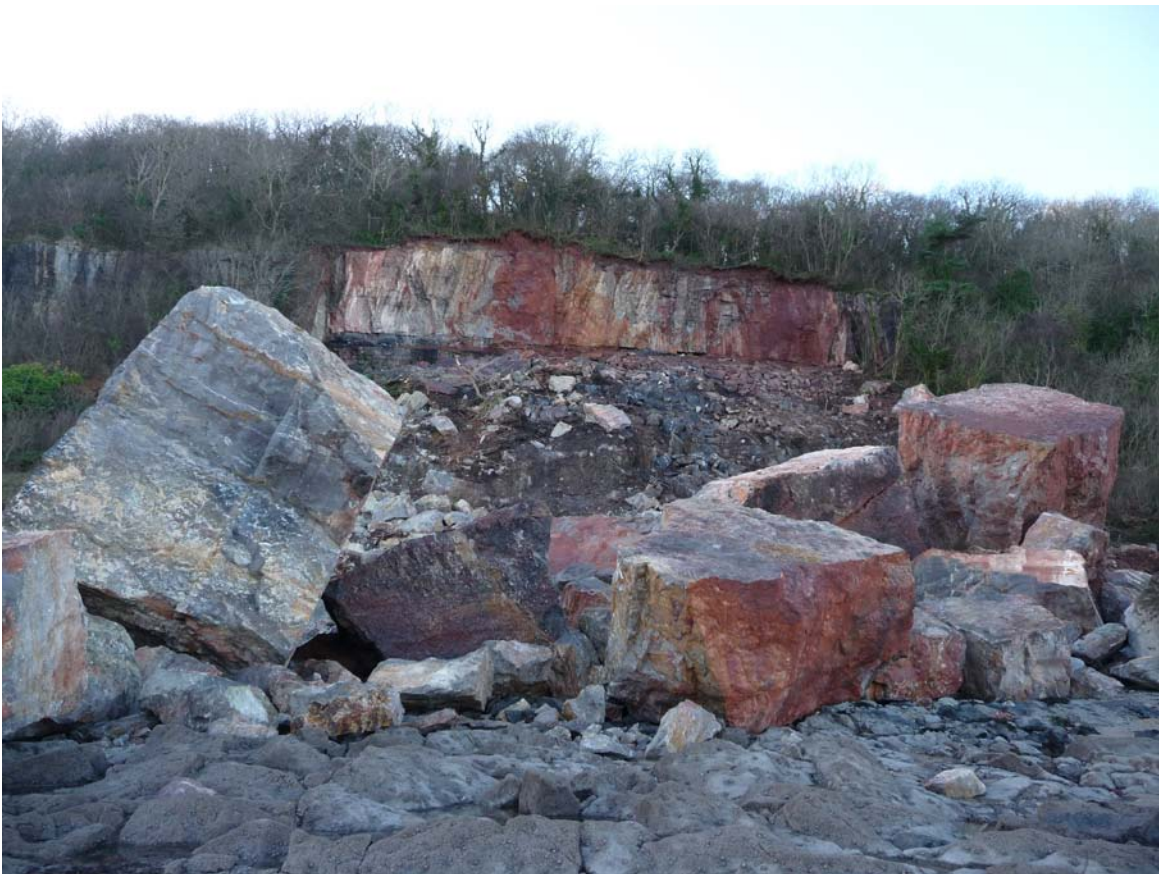
Figure 5. Close-up view of the Oxwich Bay landslide. Photograph taken from NGR 250710 185896 looking west.

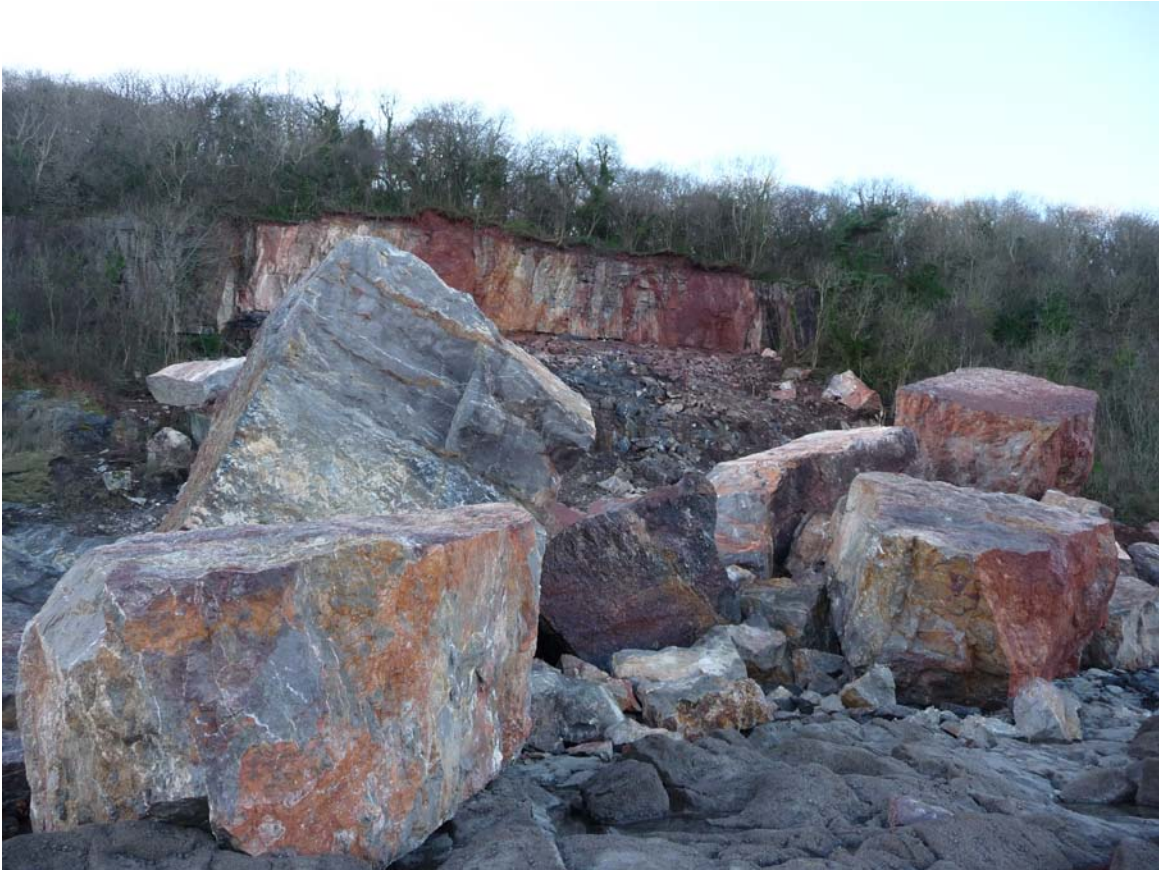
Figure 6. Close-up view of the Oxwich Bay landslide. Photograph taken from NGR 250710 185887 looking west.

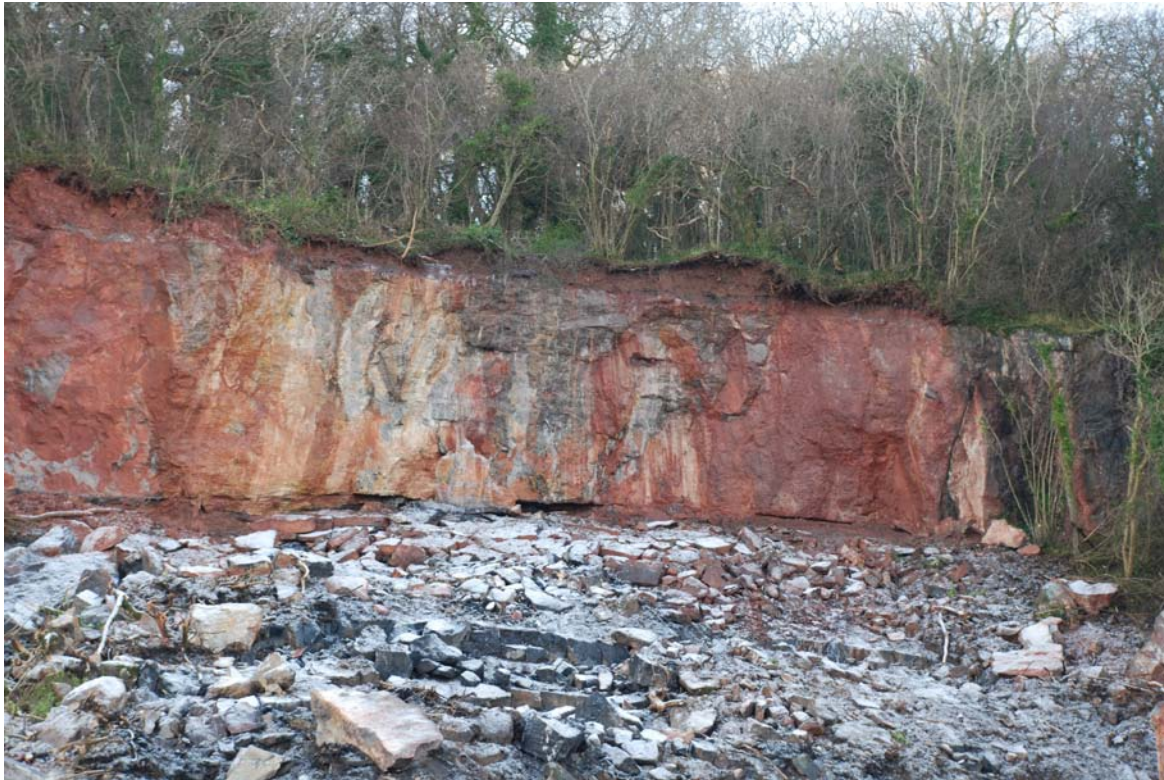
Figure 7. Close up of the back wall of the landslide. Red iron-oxide weathering caused by water percolation into former fracture. (Photograph courtesy of Mr P. M. Williams).

The cause of the failure is likely to have been due to freeze thaw. It is most likely that water has penetrated into the fractures which during periods of cold weather has frozen and expanded, increasing the in situ stress acting in the fracture and causing the rock to fail.

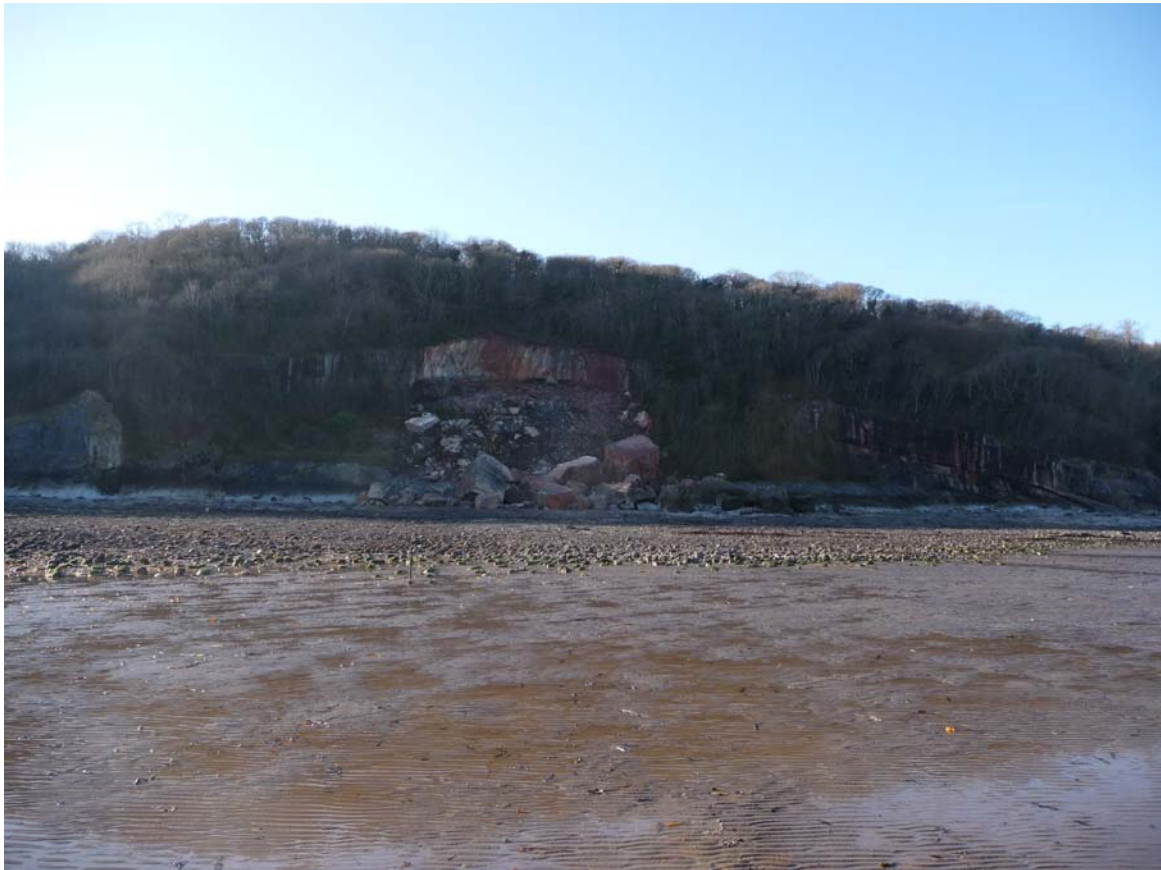
Figure 8. Wide angle view of the Oxwich Bay landslide showing its position within a disused limestone quarry. Photograph taken from NGR 250782 185968 looking west.

The Oxwich Bay landslide has occurred within a disused quarry, with blocks of limestone dislodged from the old working face at the back of the quarry. The structural and lithological characteristics of the Oxwich Head Limestone Formation provide the ideal mechanism for rock falls, similar to those observed in Tertiary basalts in Northern Ireland (Prior *et al.*, 1971, Douglas, 1980, Wilson & Cunningham, 2002) and more recently in Utah (Elliot & Giraud, 2009). Observation of the rock fall during the walk over survey showed it to be approximately 30 metres in width (across slope) and 50 metres in length (downslope). Large blocks (up to 6 metres by 6 metres) have been dislodged from the cliff face and tumbled 50 metres down the dip slope
