Figure 1. Schematic overview of the beach profile at Easington.

Figure 2. Layout and local topography survey site at Easington

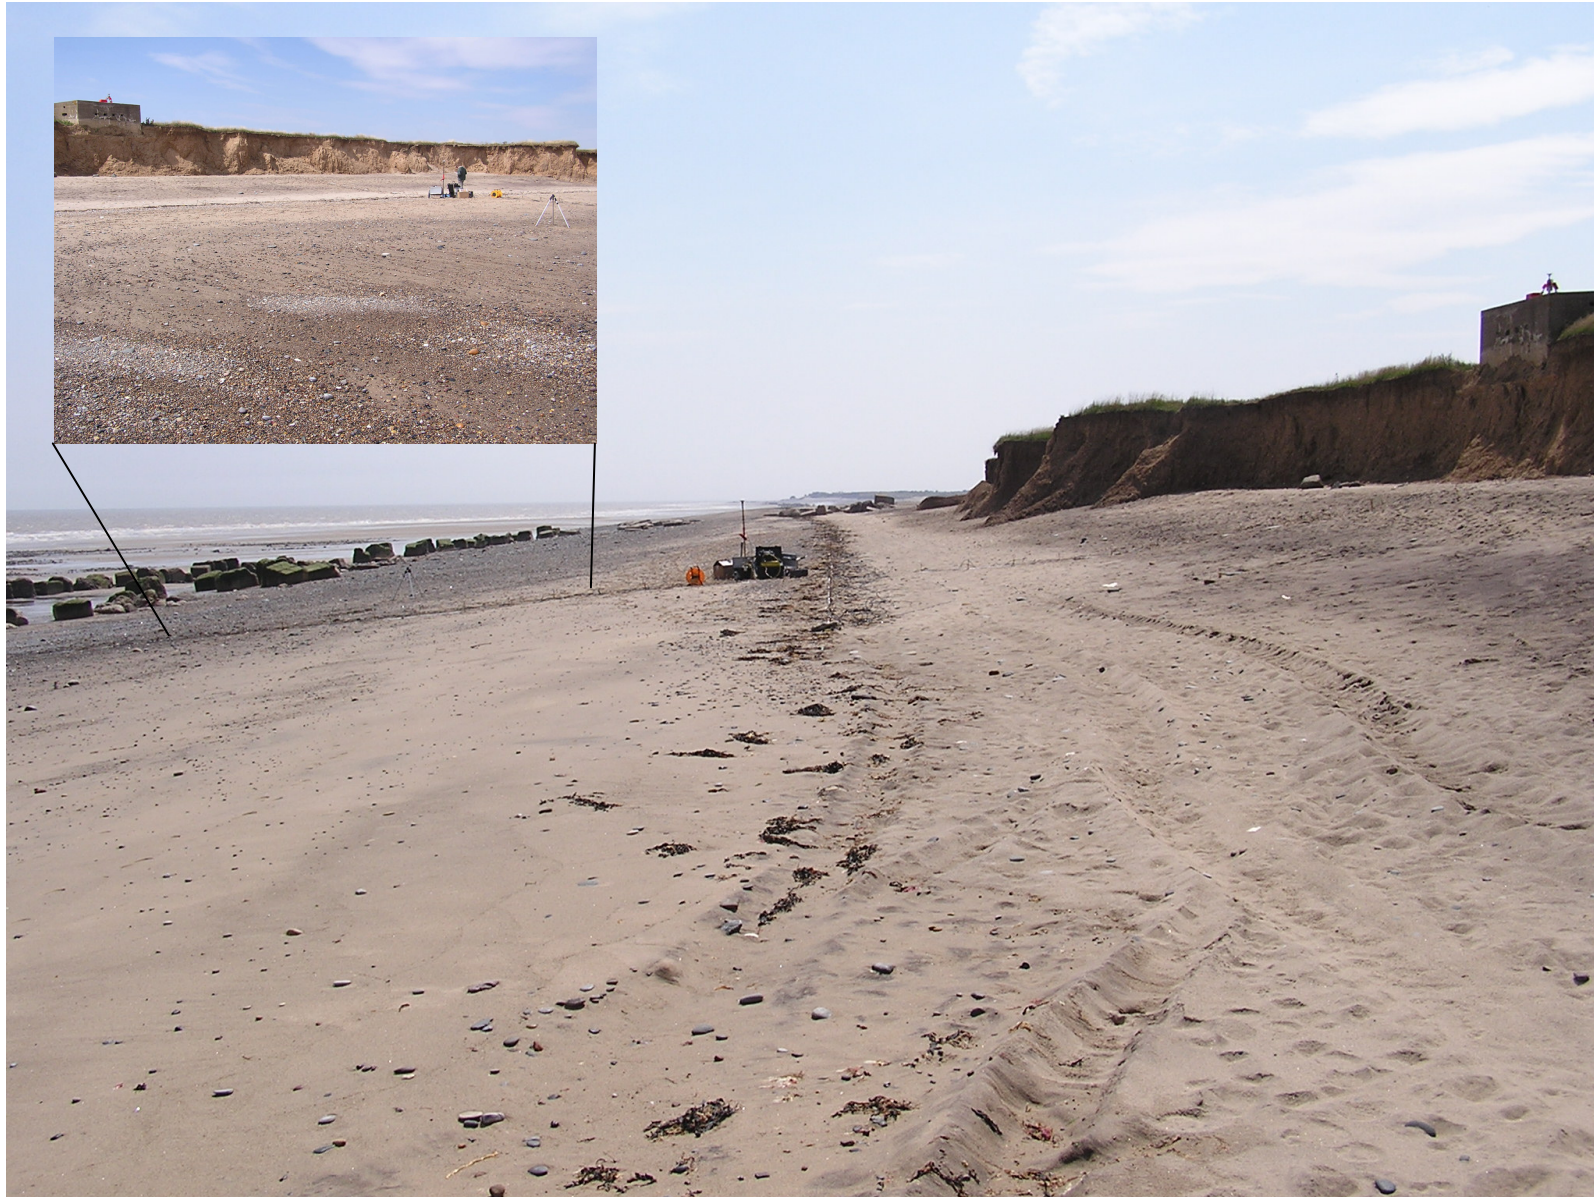
Plate 1. Beach profile at Easington looking south. Picture, taken during July 2004. Inset shows a gravel layer exposed on the lower foreshore

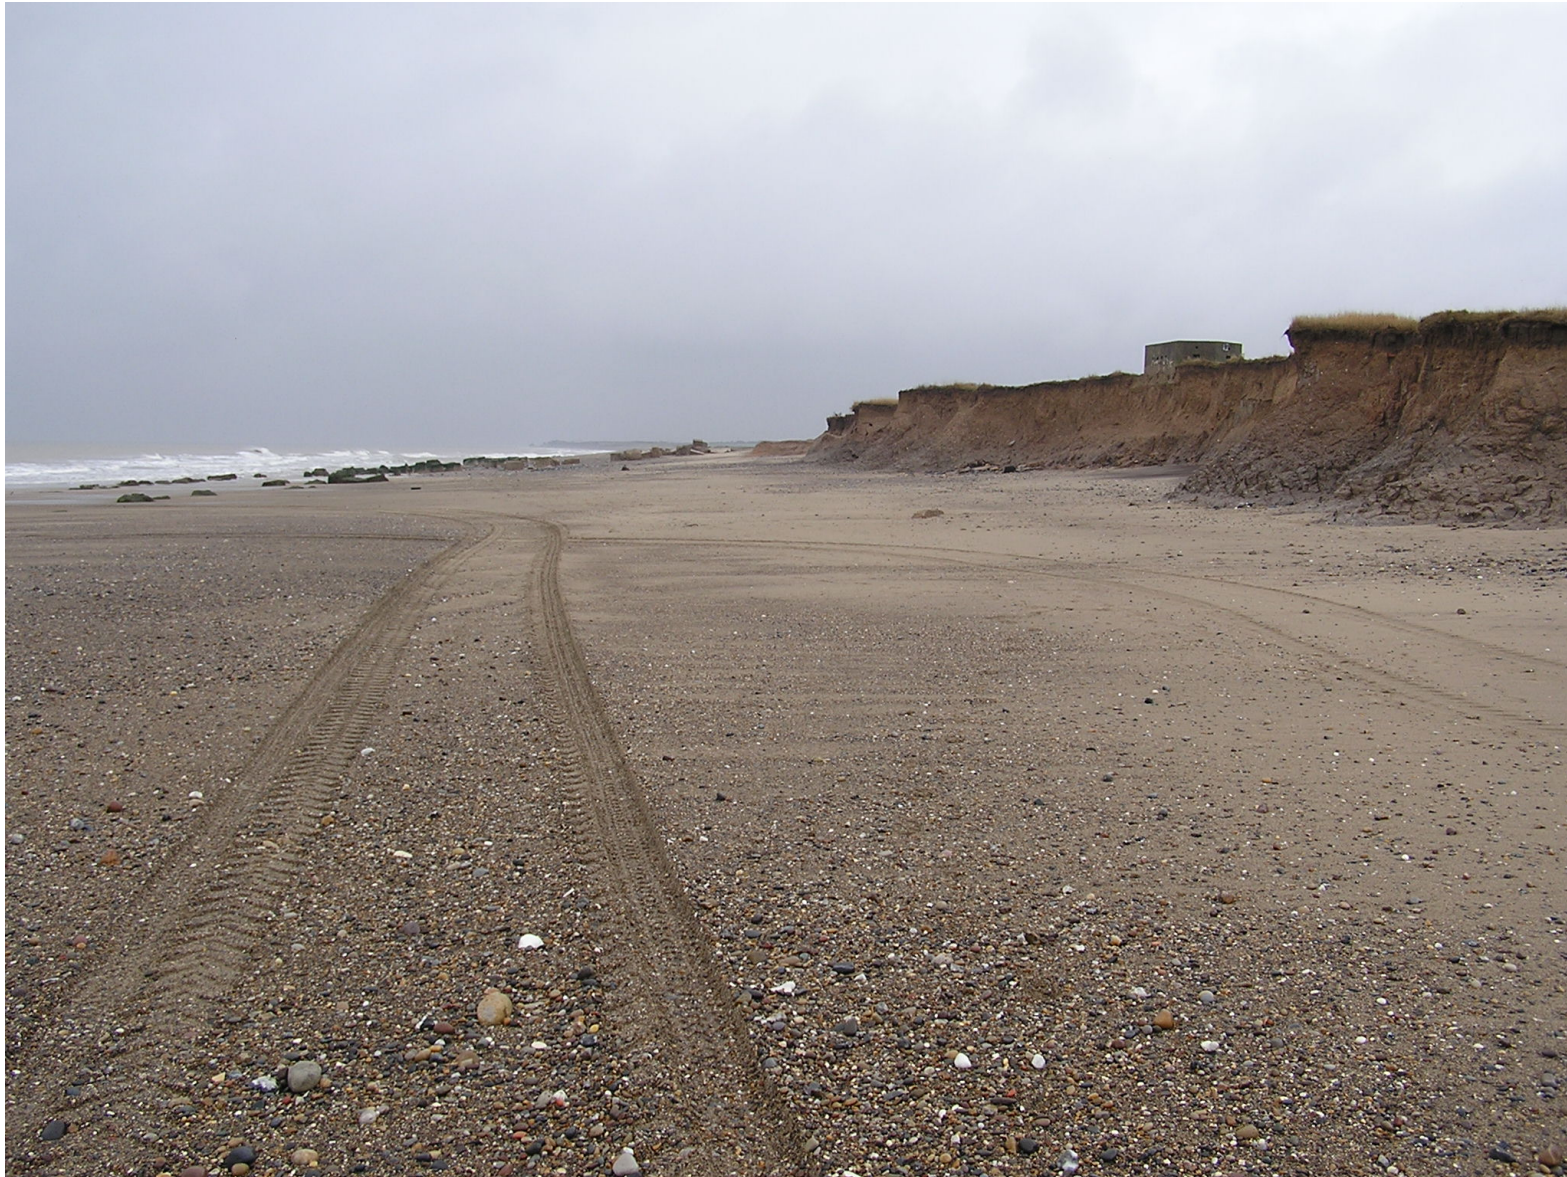
Plate 2. Beach profile at Easington looking south. Picture, taken during October 2004.

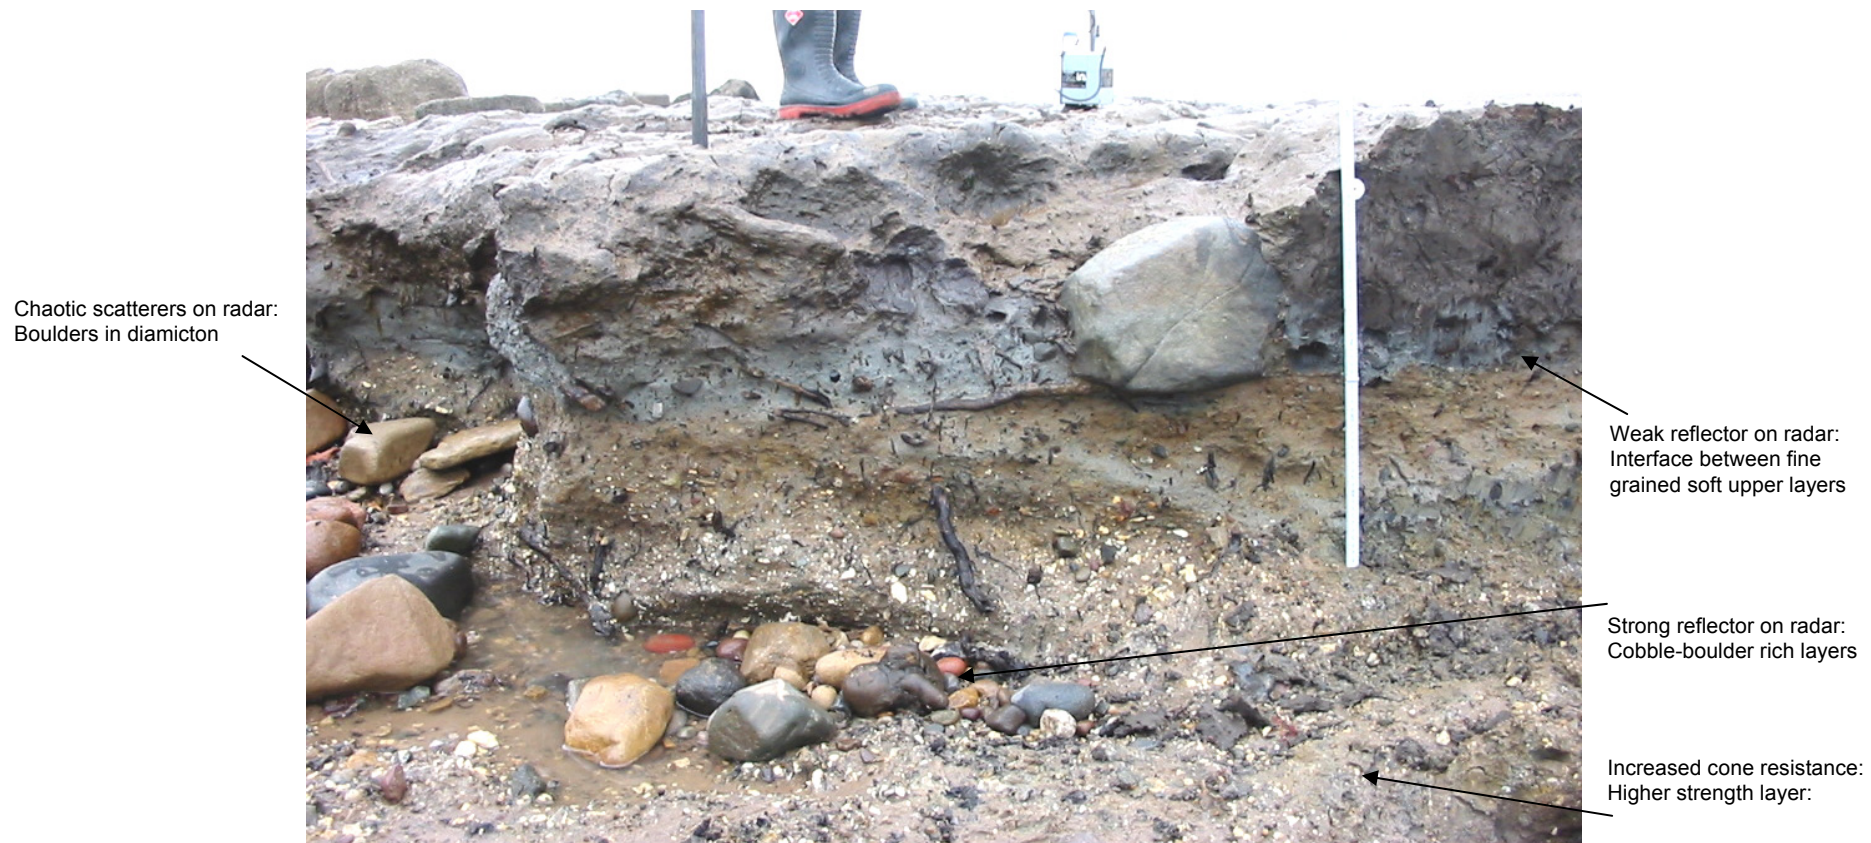
Plate 3 . Example of the near-surface heterogeneity in the till platform near the survey site at Easington.
