**DEVELOPMENT OF SMALL SCALE
IRRIGATION USING LIMITED
GROUNDWATER RESOURCES**

**RECONNAISSANCE GROUNDWATER
RECHARGE STUDY:
TAMWA/SIHAMBE/DHOBANI KRAALS**

ODA REPORT 93/2

D.J. PRICE

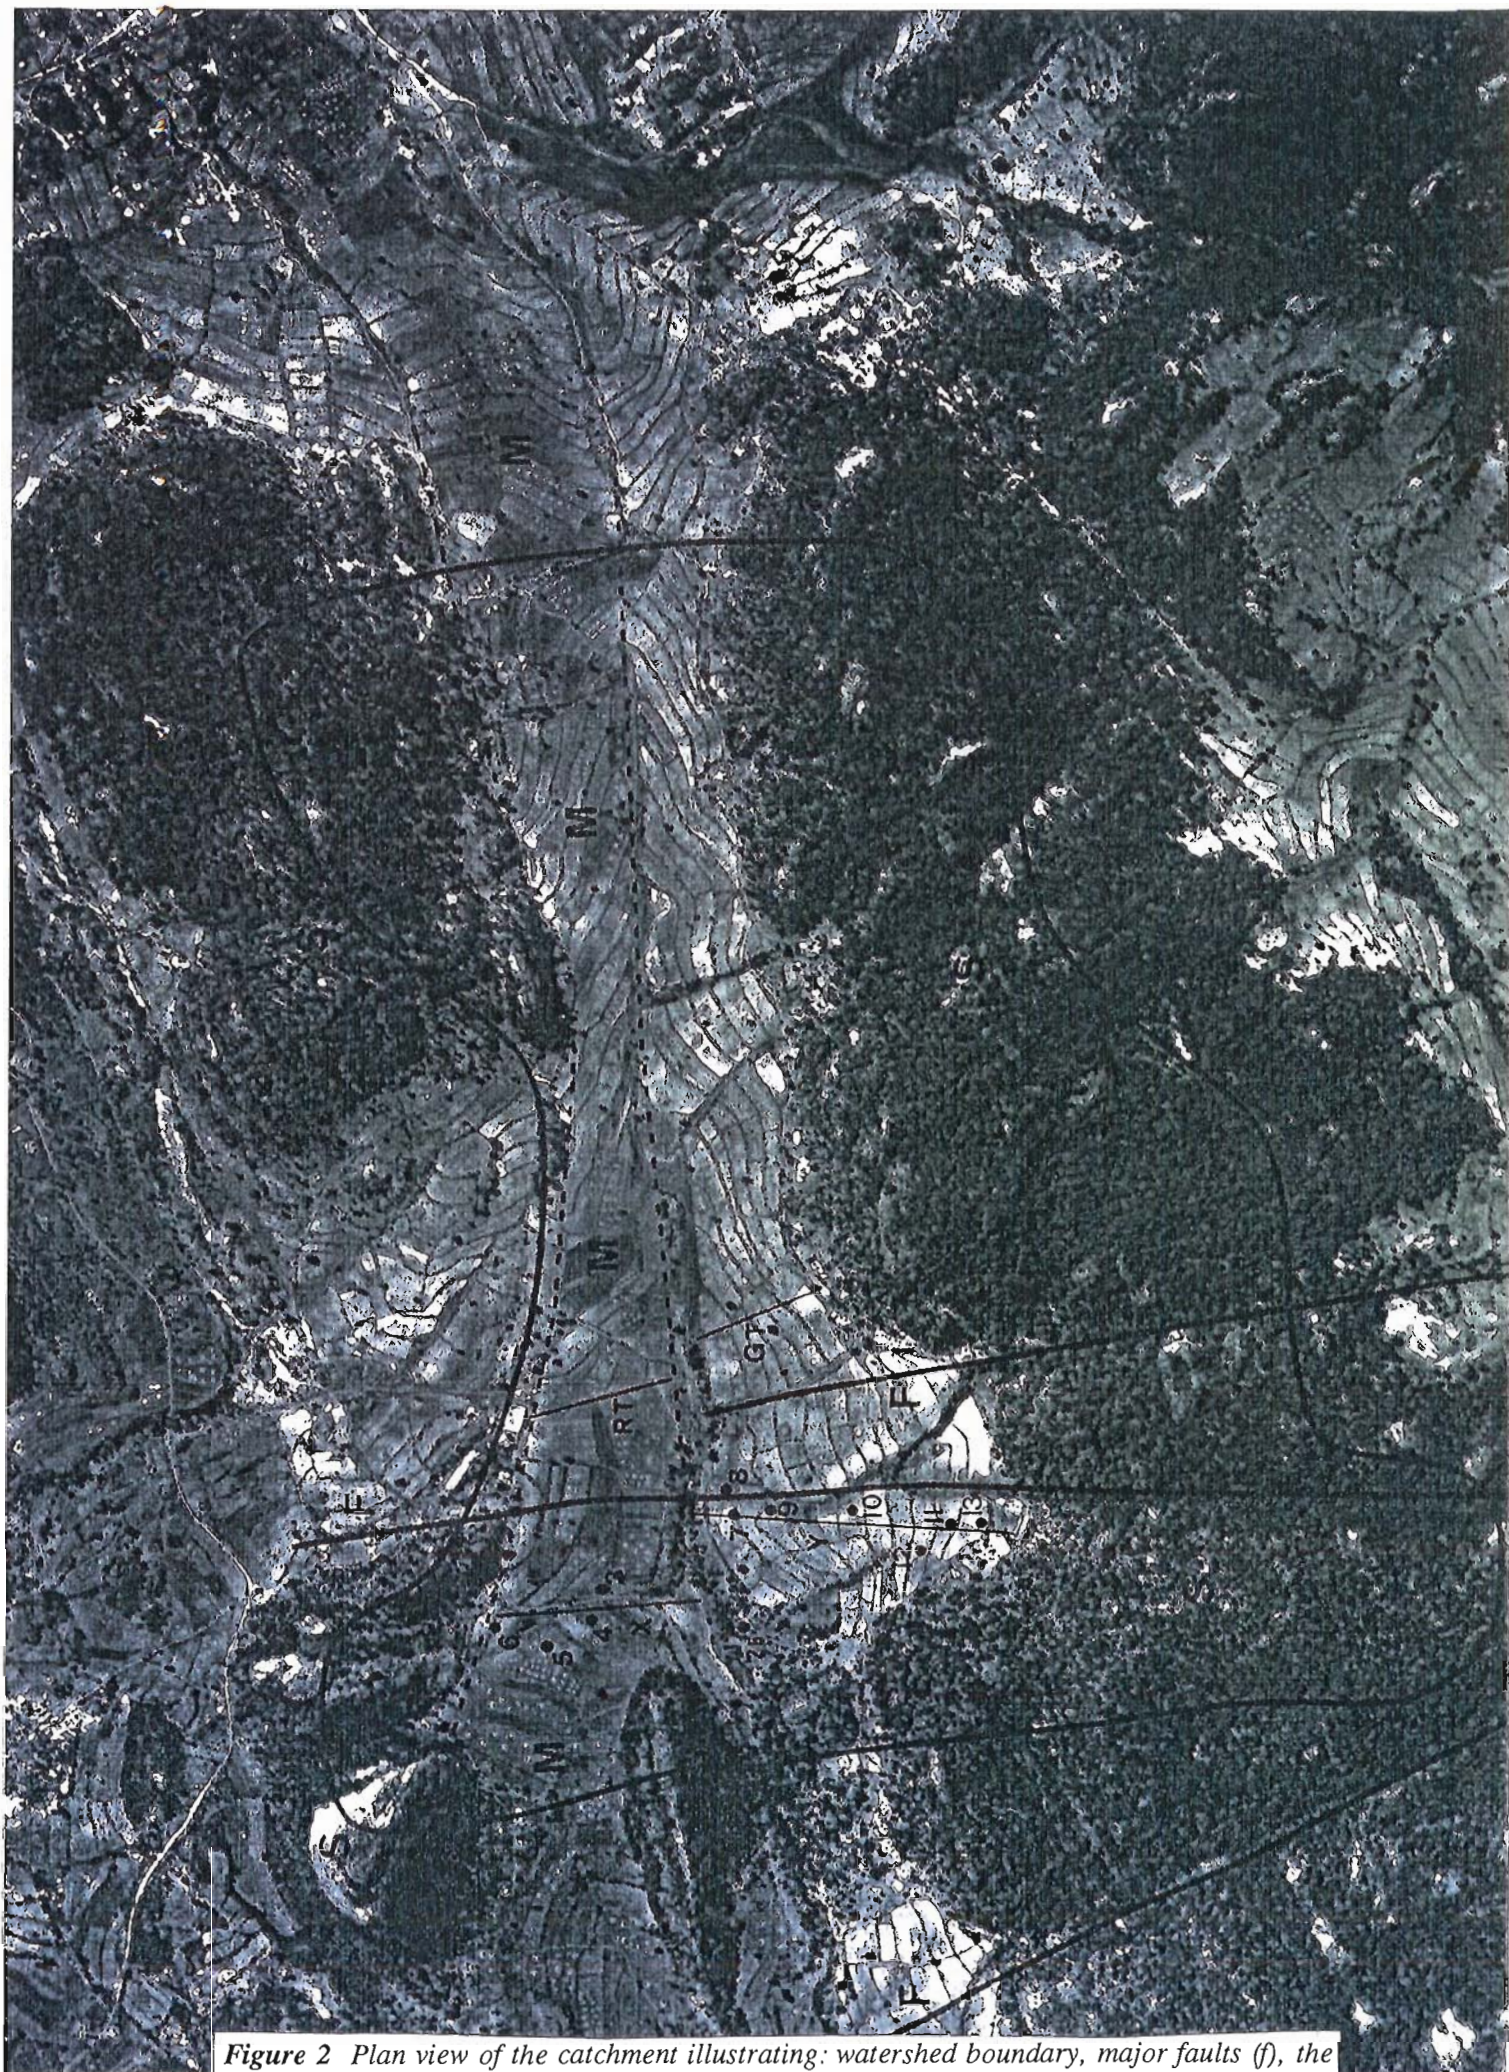
Figure 2 Plan view of the catchment illustrating: watershed boundary, major faults (f), the location of siliceous (S) and mafic (M) gneisses, red and grey transects (RT, GT), well lines X and Y together with the numbered wells associated with these two lines.

The hills surrounding the valley are comprised of Precambrian granulite gneiss from the Limpopo Mobile Belt. A band of Precambrian mafic granulite is found just to the north of the stream bed in the valley bottom and runs through the entire length of the valley, (Muchenga, F., 1975), (Figure 2).

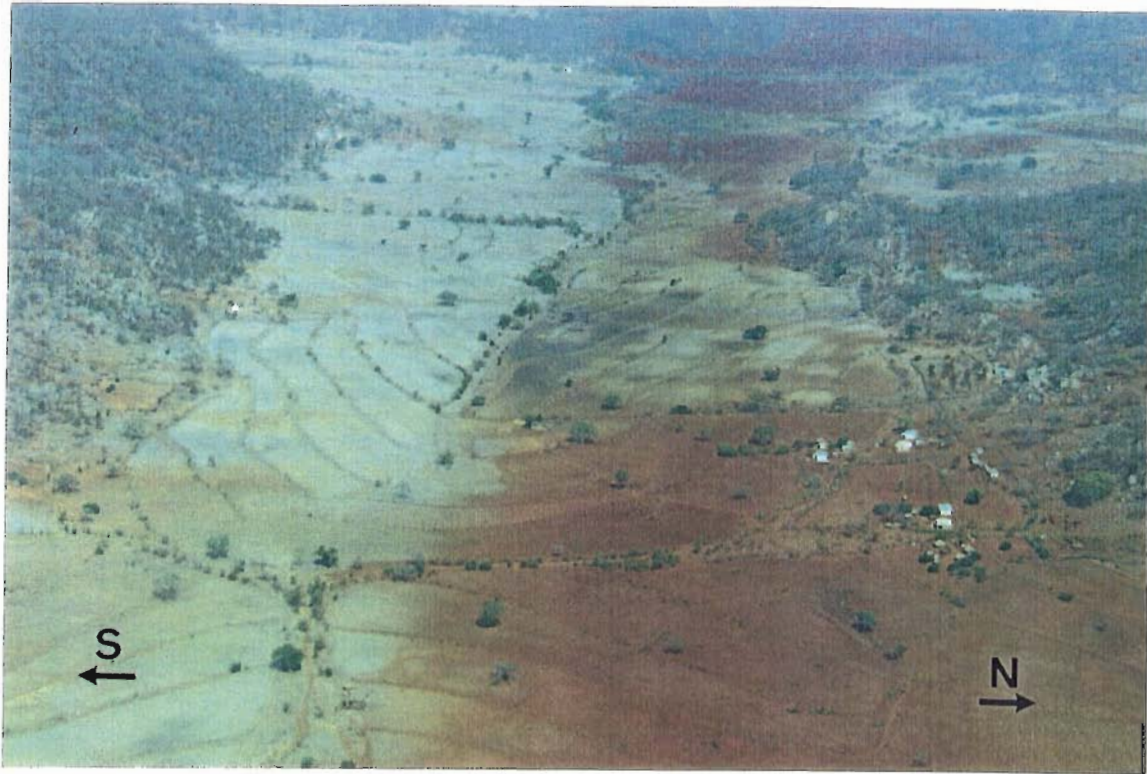
Photograph 3 *Distribution of the two dominant soil types within the catchment's valley bottom.*

The dominant soils of the catchment are derived from the granulite gneiss and are classified in the Zimbabwean classification system as: Kaolinitic, fersiallitic soils derived from siliceous gneisses, (III 5 P). These give rise to light textured soils in which the sand fraction is generally fine to medium. The soil forms a catenal sequence which is observed to the south of the main stream bed where the influence of the mafic rock band is not felt, (Photograph 3).

Where the mafic band is found it has brought about the genesis of a quite different red soil which has disrupted the catenal sequence to the north of the stream bed, (Photograph 3). Also on the northern side there are relatively small areas of brown and black clays that occur in relatively flat hollows downslope of the red soil. These probably owe their formation to a number of factors. Firstly their location at the bottom of a slope where eluviation processes tend to concentrate the finer particles. Also to the mineral rich weathering products of the mafic granulite.

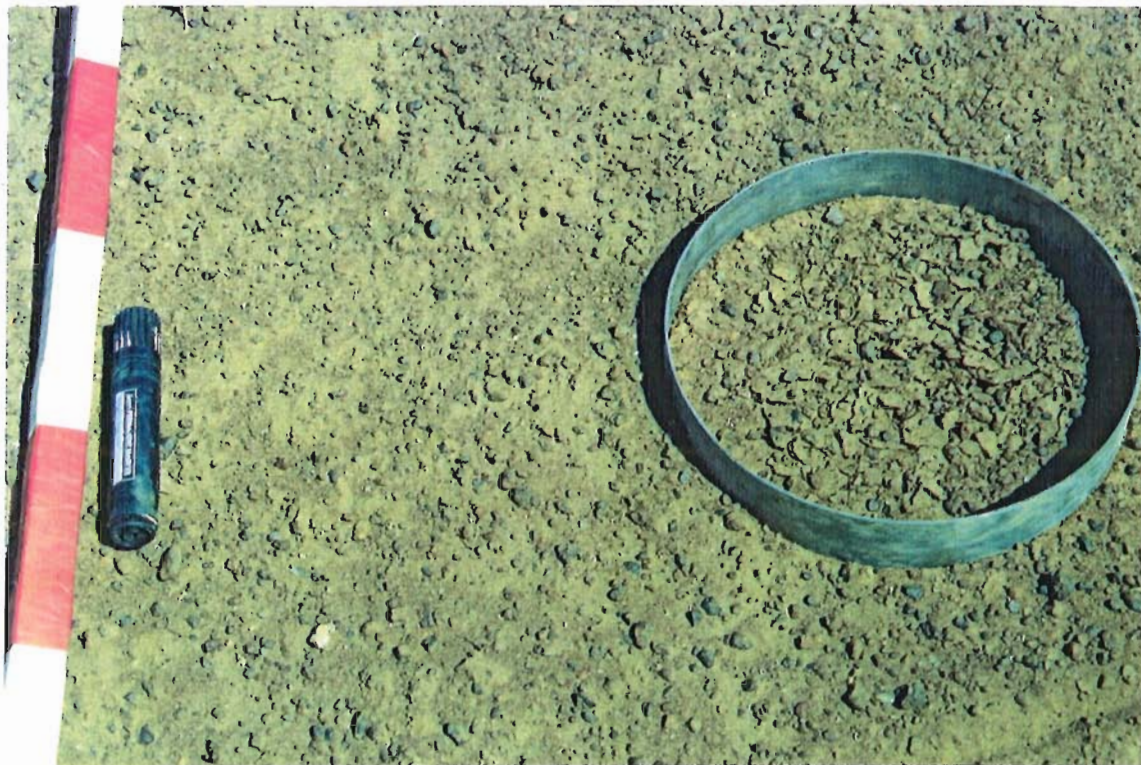
Photograph 7 Site preparation for a broken crust test.

One of the advantages of this method over the Guelph is that the top surface of the soil can be investigated. Of particular interest are the properties of the crust. It is generally assumed that the crust promotes runoff and is therefore less permeable. To investigate this, tests were conducted upon both intact crust and crust broken into pieces smaller than about 2cm², (Photograph 7).

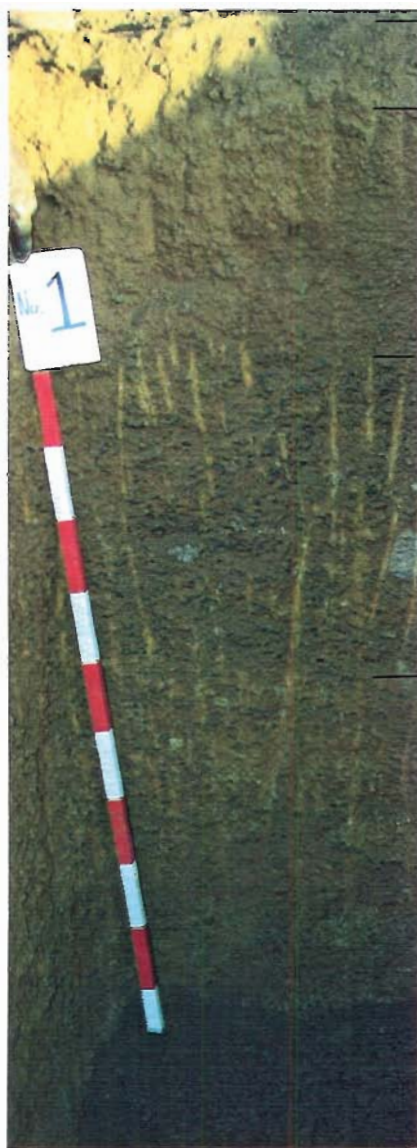
Figure 7 Soil pit 1.

Munsell colour: 10YR 4/4 (dry), 7.5Yr 3/3 (wet) Hardness 1
 Flora & fauna: Roughly 40 roots per 100cm². Root diameter < 0.5mm
 Texture: (Awaiting lab. classification) Mainly fine, nodules < 1cm common
 Structure: No visible cracks, v. poorly defined medium subangular blocky
 Surface crust, about 1cm thick
 Comments: Ploughed layer.

Munsell colour: 5YR 4/6 (dry), 5YR 3/4 (wet) Hardness: 4
 Flora & fauna: Nil.
 Texture: Majority is nodular < 2cm.
 Structure: Nil
 Comment: Slight cementing, yet easily broken.

Munsell colour: 5YR 5/6 to 5/8 (dry), 5YR 4/4 (wet) Hardness 4
 Flora & fauna: Nil
 Texture: Similar to horizon 3 but nodules less well defined
 Structure: Nil
 Comment: Slightly damp.

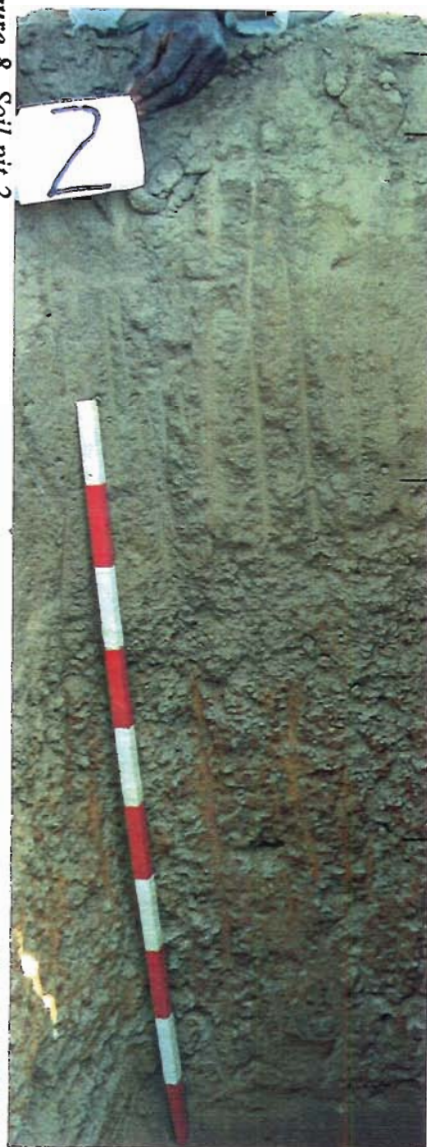
Figure 8 Soil pit 2.

Munsell colour: 2.5Y 6/2 (dry), 2.5Y 3/2 (wet). Hardness: 2.
 Flora & fauna: Roughly 1 root per 100 cm². Most > 1mm thick. Probable termite
 activity in the form of holes.
 Texture: Sandy and finer.
 Structure: 3 to 4 vertical cracks per metre, that run from top to bottom.
 Round holes, running in all directions, about 1mm diameter, about 10
 per 100cm².
 Comments: Hard pan. The progression into the lower layer is gradual

Munsell colour: Matrix 10YR 8/2 (dry). Nodules from the YR charts. Hardness 3
 Flora & fauna: Few very fine roots, <0.05mm. 1 or 2 per 100cm².
 Texture: Orange/brown nodules, < 2cm, set in a fine matrix. Occasional
 rounded crystalline stone.
 Structure: Trace of above cracks from horizon 2. Obvious feature: gaps
 up to 8mm across, irregular shape, between the nodules, nearly as common
 as the nodules themselves.
 Comments: Notable for high porosity.

Munsell colour: Mottled. Matrix 10YR 7/2 plus orange, red & brown
 mottles/particles. Hardness: 2
 Flora: Very few fine roots.
 Texture: Majority is fine with crumbly nodules/particles.
 Structure: No cracks. Irregularly shaped gaps, < 155mm, common
 Comments: Notable for high porosity

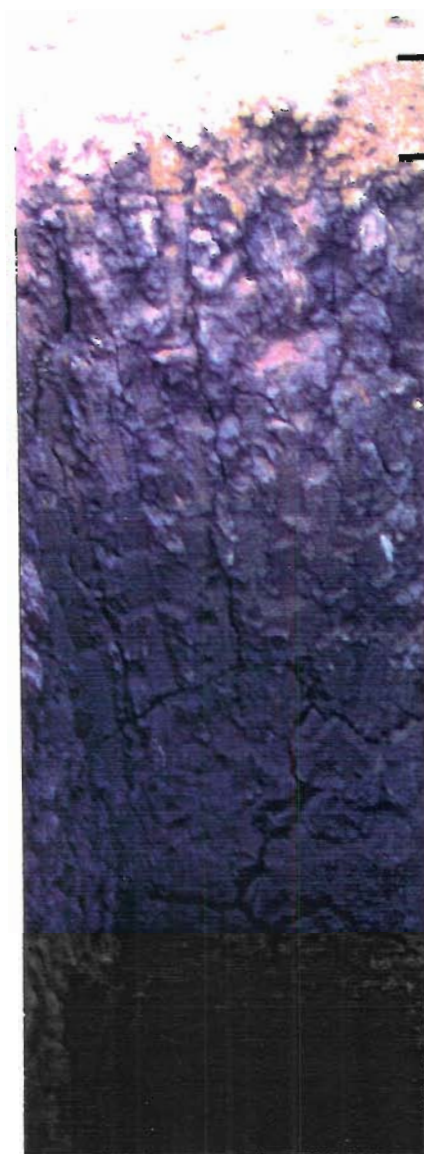
Figure 9 Soil pit 3.

Munsell colour: 2.5Y 4/2 (dry), 10YR 3/1 (wet). Hardness: 1
 Flora & fauna: More than 50 roots per 100cm². Mainly fine roots < 1mm.
 Texture: (Awaiting laboratory analysis) Predominantly very fine.
 Structure: Slight cracking but no clearly defined internal structure. There is a crust, about 1cm thick, that has developed some fine cracks.
 Comments: Ploughed layer.

Munsell colour: 2.5Y 5/2 (dry), 10YR 3/1 (wet). Hardness: 2
 Flora & fauna: Limited no. of roots, < 5 per 100cm². But locals say rhizomes favour this soil.
 Texture: Sandy plus particles < 0.5cm common.
 Structure: Fine vertical and horizontal cracks, about 5 per metre. The soil is honeycombed with small circular holes. Possibly of termites origin.
 Comments: This soil is regularly found in the clay areas, usually several metres in extent. It is noted by the locals as producing the best crops.

Munsell colour: 2.5Y 3/2 (dry), 10YR 3/1 (wet). Hardness: 4
 Flora & fauna: Only fine roots, < 0.5mm thick, found in the top 40cm. Roughly 15 roots per 100cm².
 Texture: Dominantly clay. Orange particles, <1mm, and stones, <10mm, common.
 Structure: Very coarse prismatic, especially near the top. Some cracks are up to 1cm across and extend down to 140cm below the surface.
 Comments: Very shiny surfaces when sheared. The lower soil is damp.

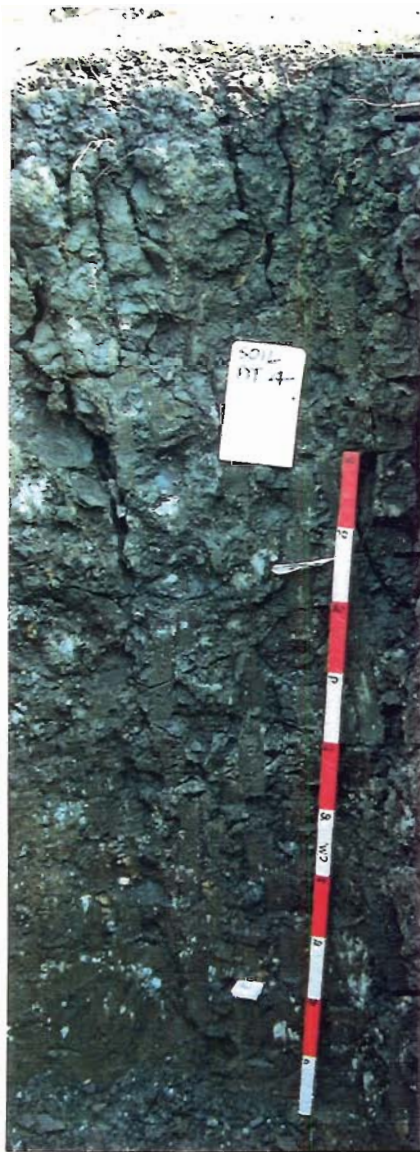
Figure 10 Soil pit 4.

Munsell colour: 5Y 2.5/1 (dry), 5Y 2.5/1 (wet). Hardness: 5.
 Flora & fauna: Few fine roots, <10 per 100cm².
 Texture: Clay. Few small stones plus occasional carbonate concretion.
 Structure: Very coarse prismatic. Vertical cracks dominant, up to 3 cm across.
 Comments: Layer slightly moist at bottom.

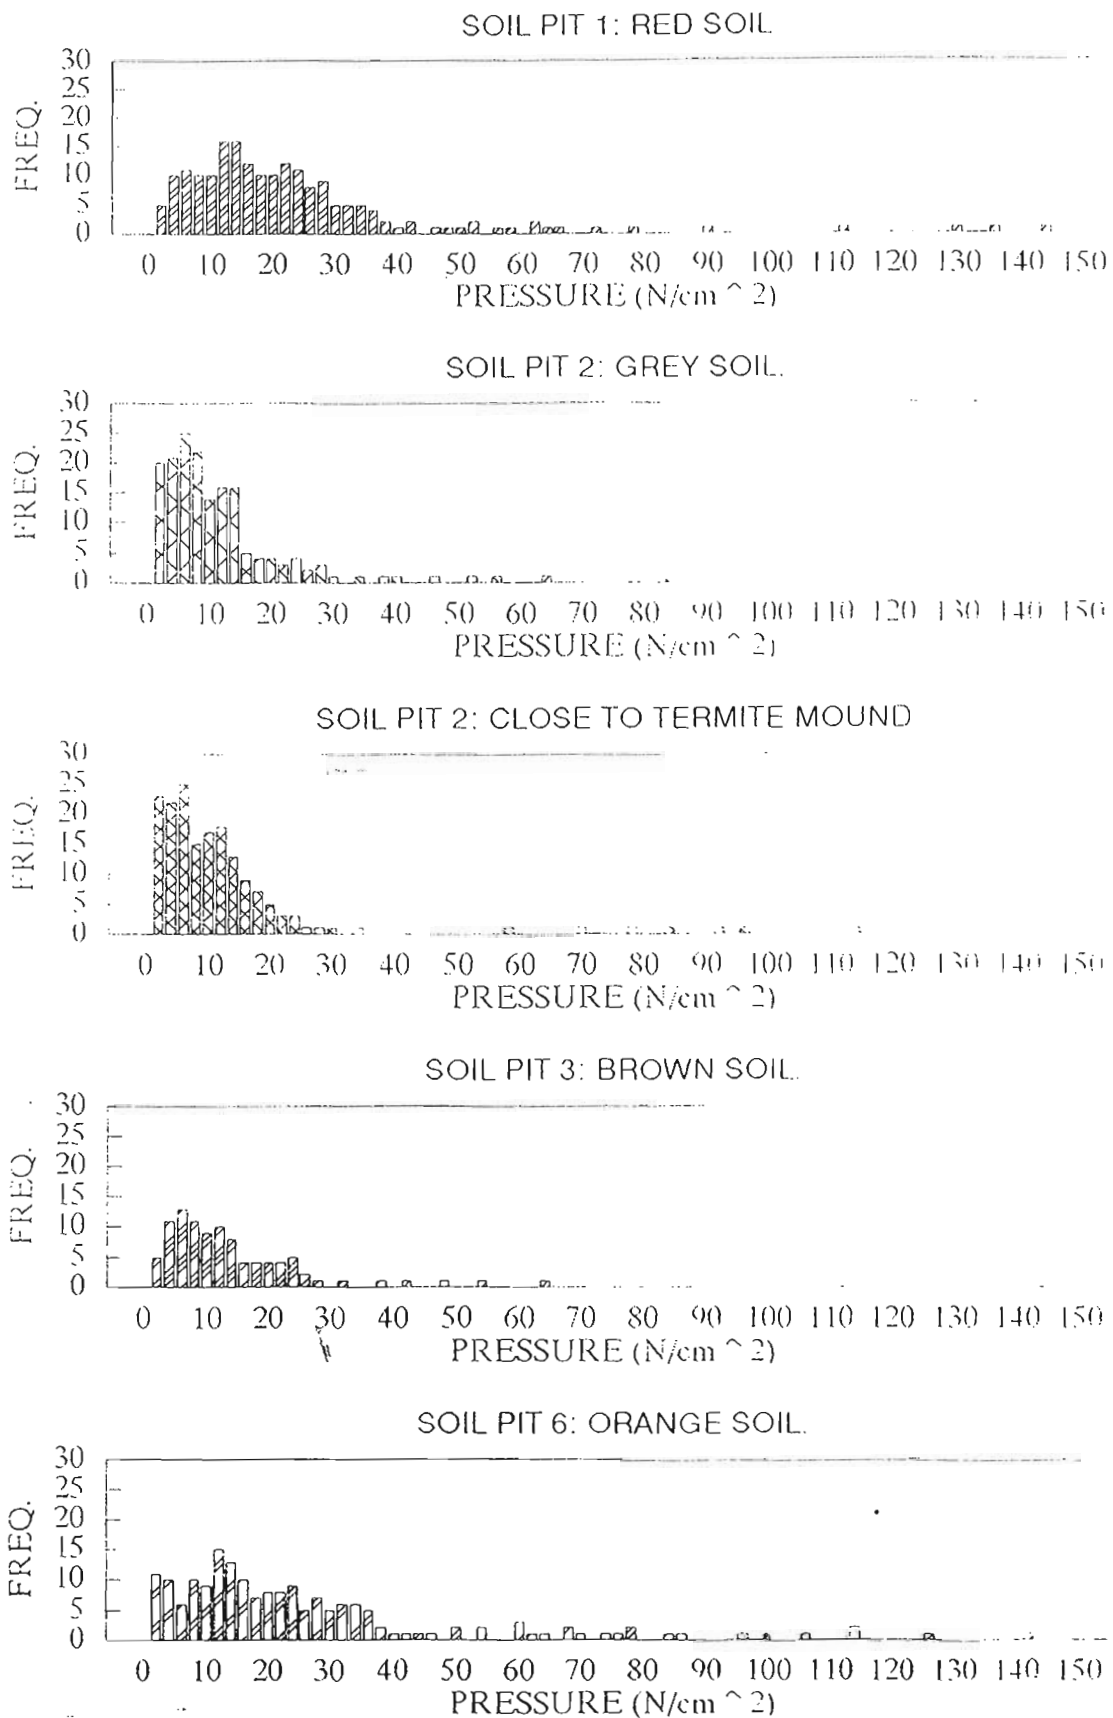
Figure 14 Crustal strengths.

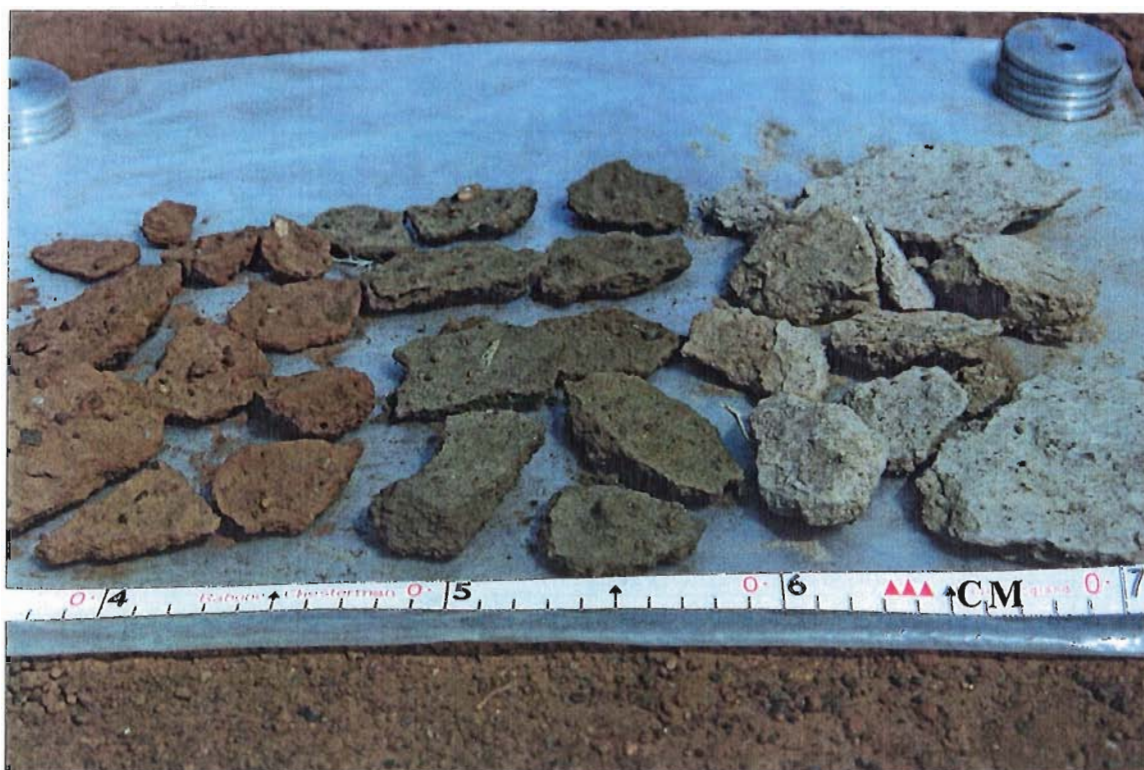
Photograph 10 Pieces of crust collected from soil pit 1 (left), 3 (centre) and 2 (right).

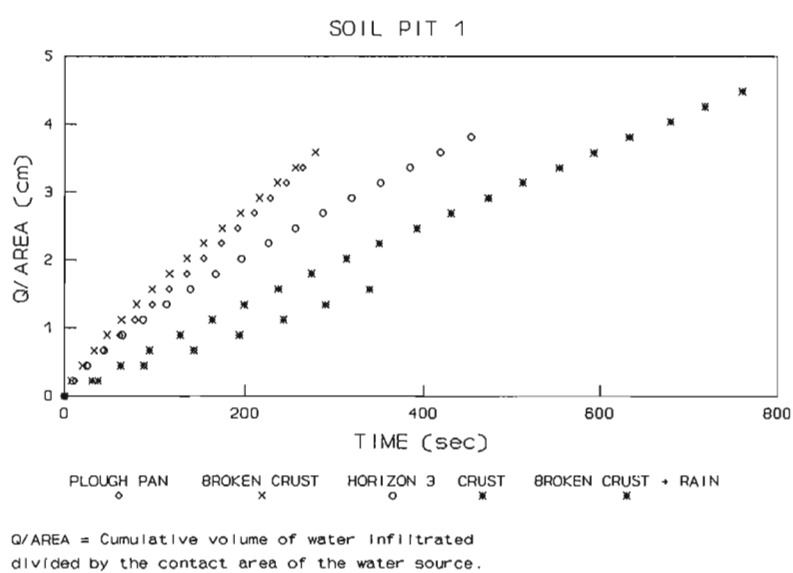
Figure 15 Typical set of permeameter readings for soil pit 1.

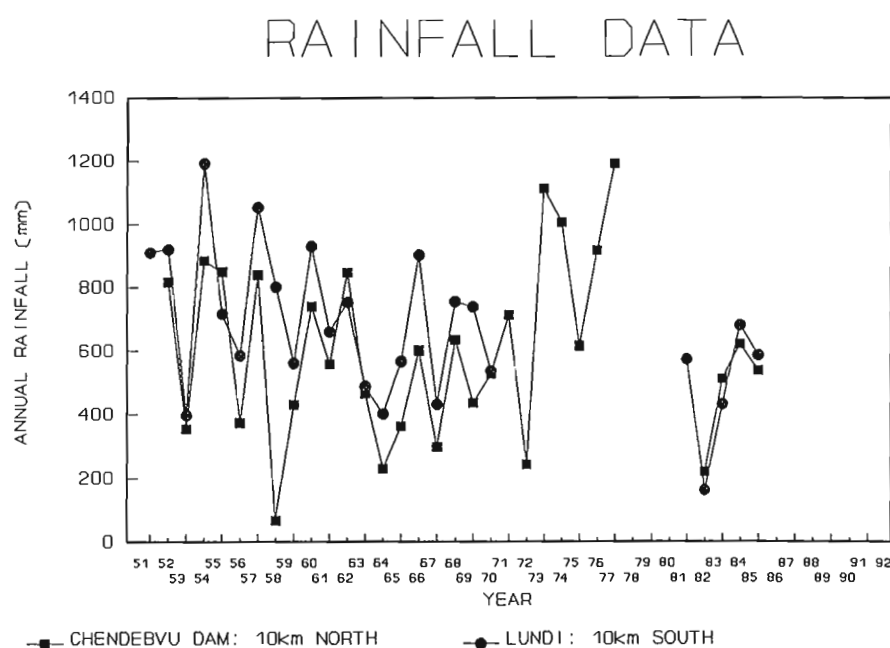
Figure 18 Rainfall data from stations close to Tamwa.

Subsequent analysis of rainfall data, dating back to 1951, from two weather stations 10km north and 10km south of the valley suggests that the rainfall in the valley would be highly variable and that there is no discernable long term trend¹⁰, (Figure 18).

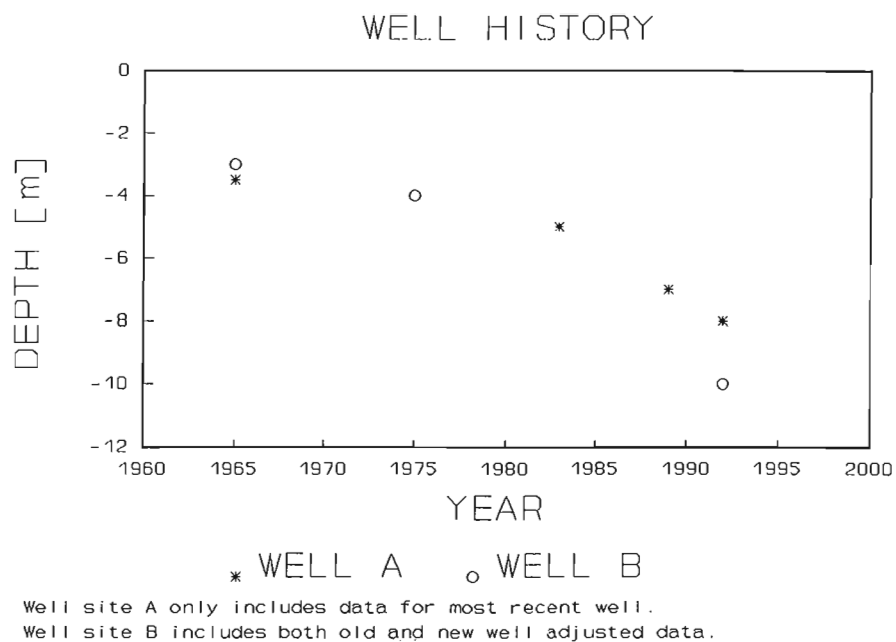
Figure 19 Water level history of wells A and B.

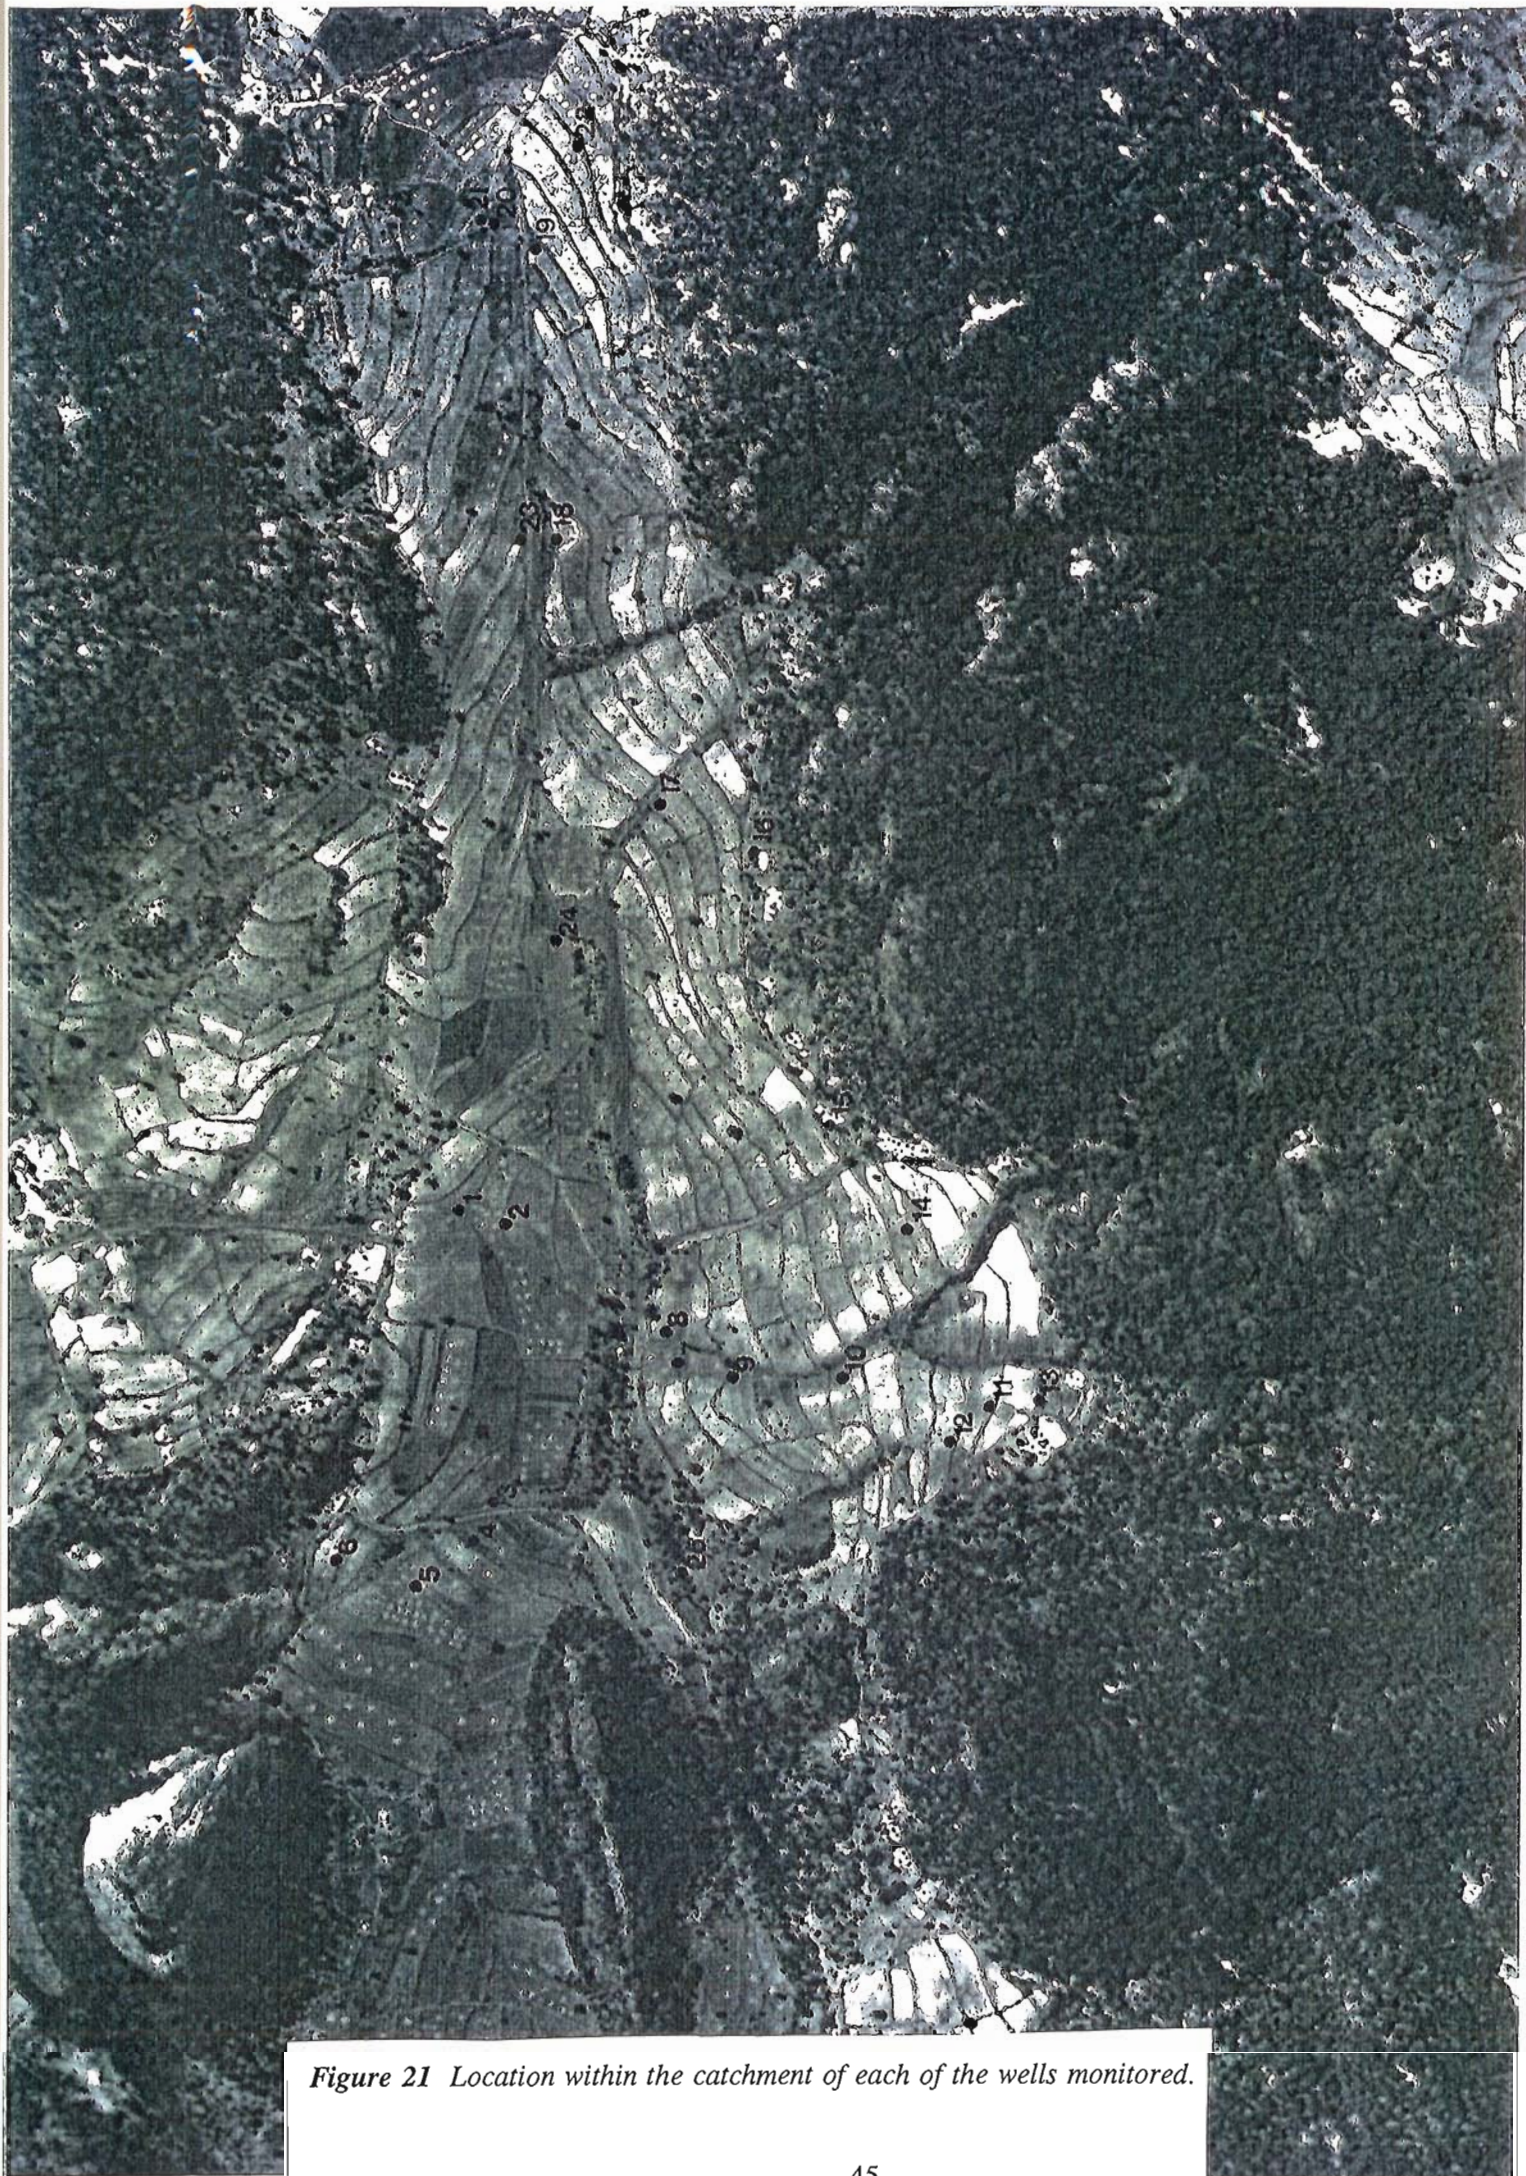
Figure 21 Location within the catchment of each of the wells monitored.

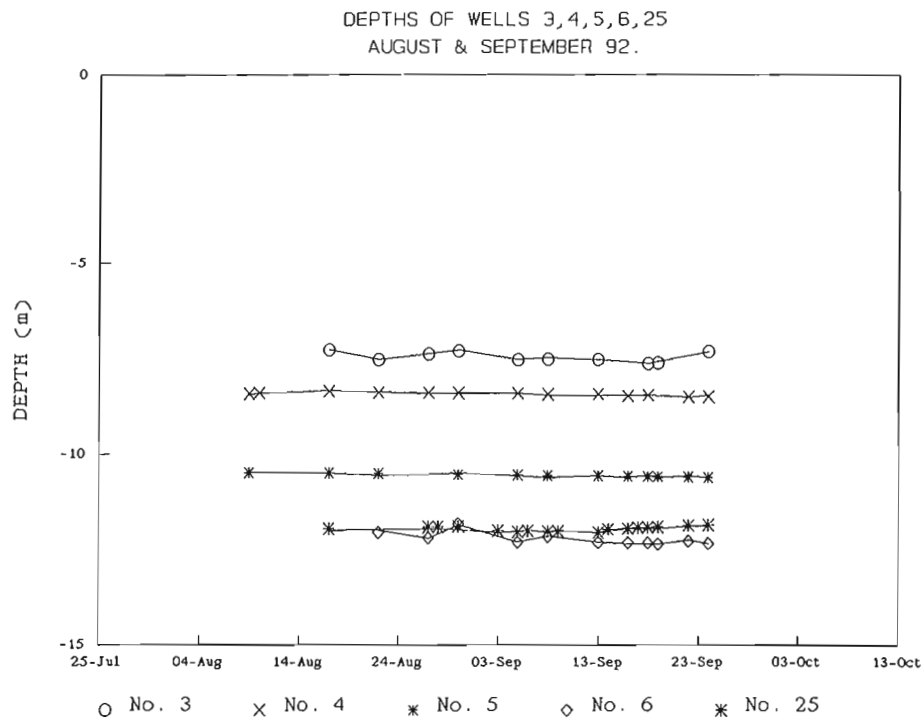
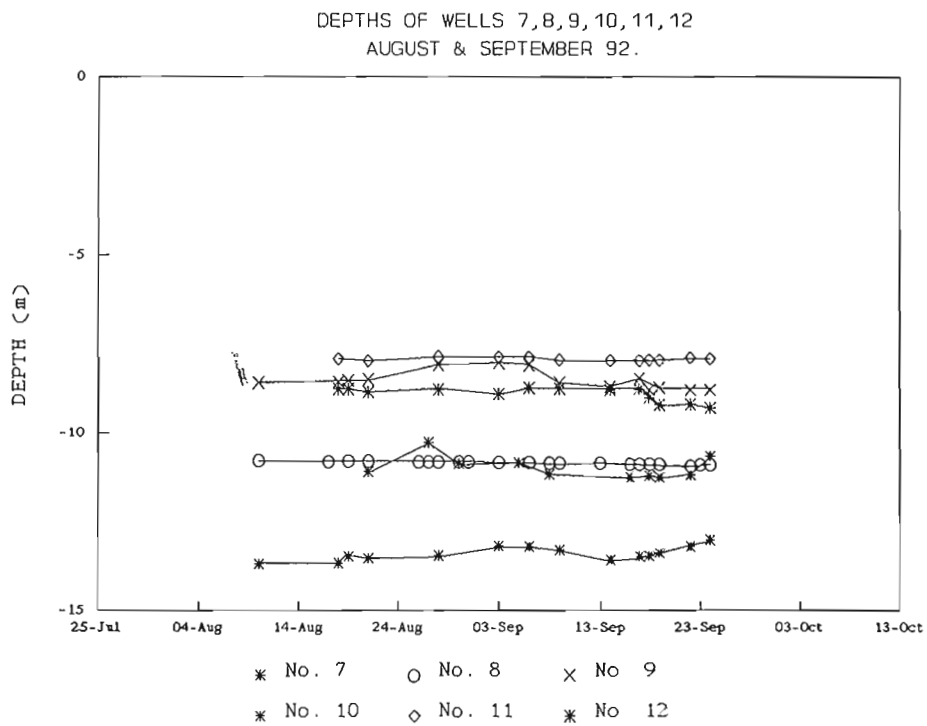
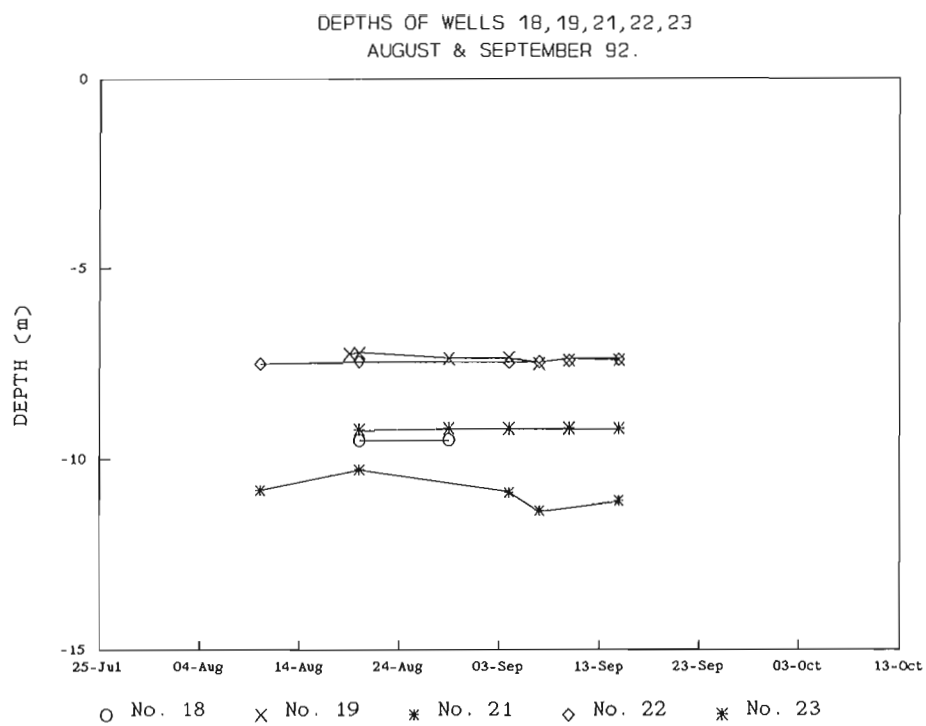
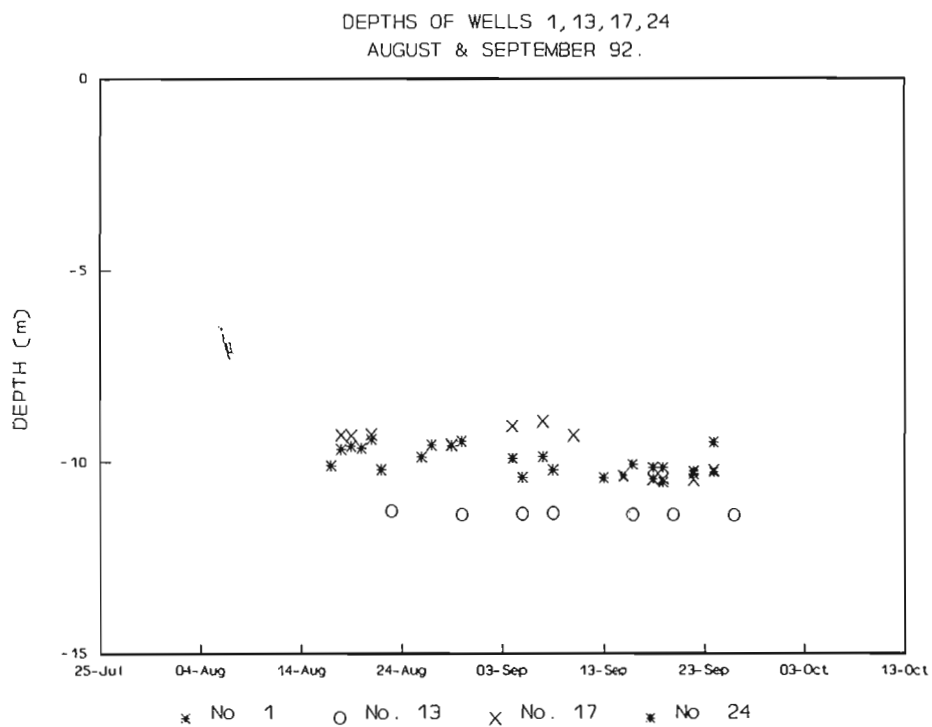
Figure 22 Well depths.

Figure 22 (cont.): Well depths.

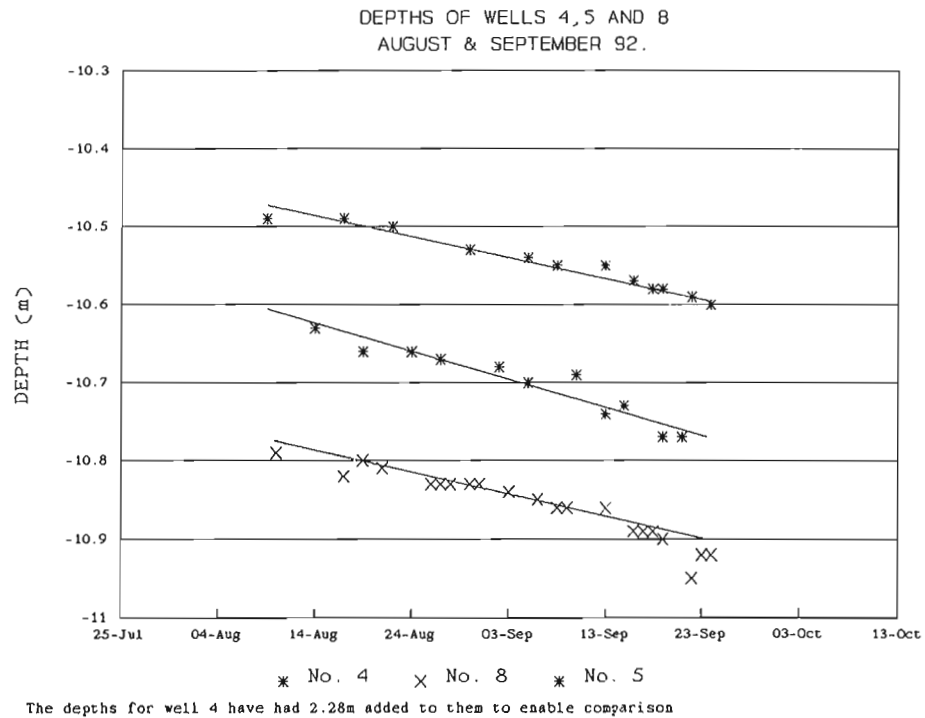
Figure 23 Rate of water level lowering in wells 4, 5 and 8.

Table 3 The rate at which the ground water was lowering.

WELL NUMBER	RATE OF DROP OF WATER
8	- 2.8 mm/day
4	- 3.2 mm/day
5	- 2.7 mm/day

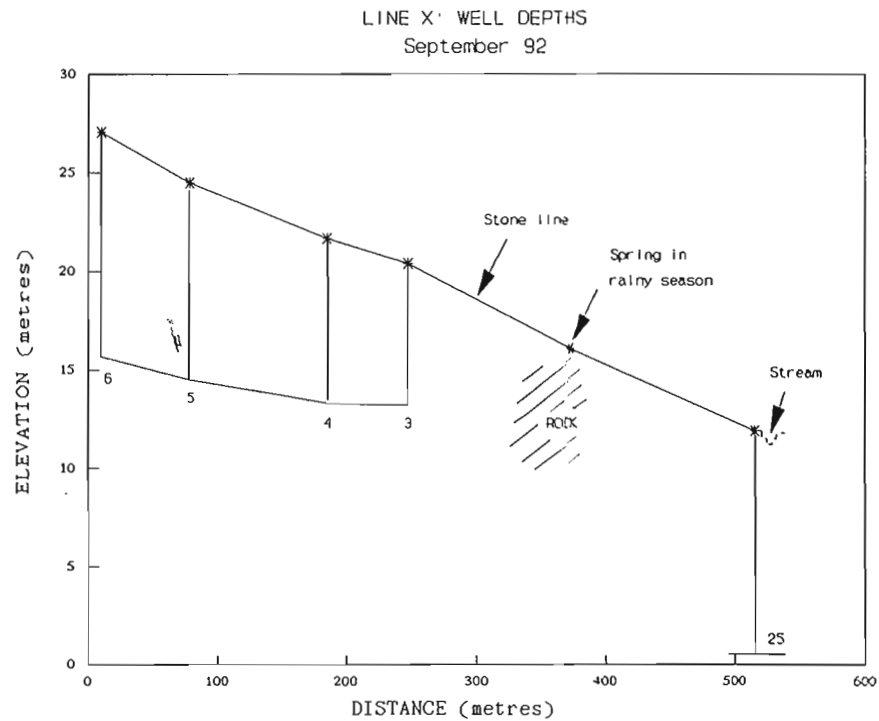
Figure 24 Water level along line X.
