BGS flood response

Introduction

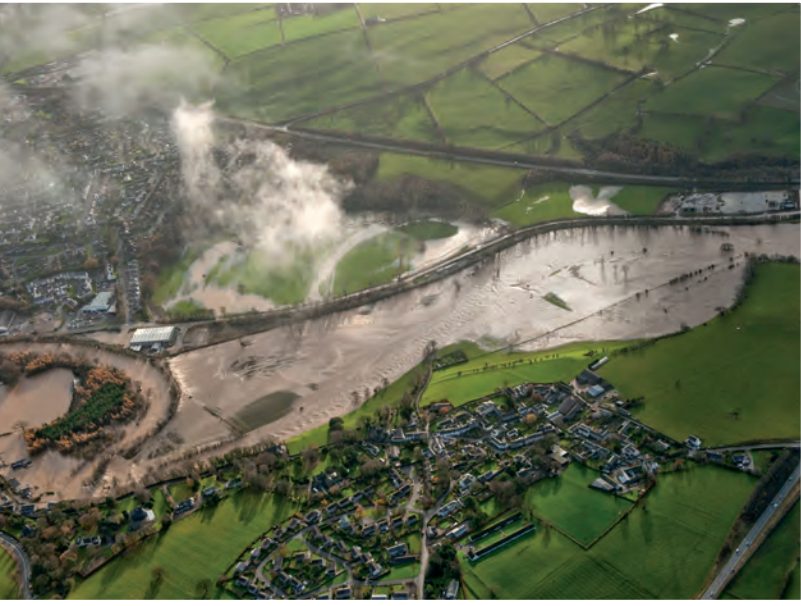
Figure 1 Aerial photograph of flood waters near Papcastle, west Cockermouth (2009).

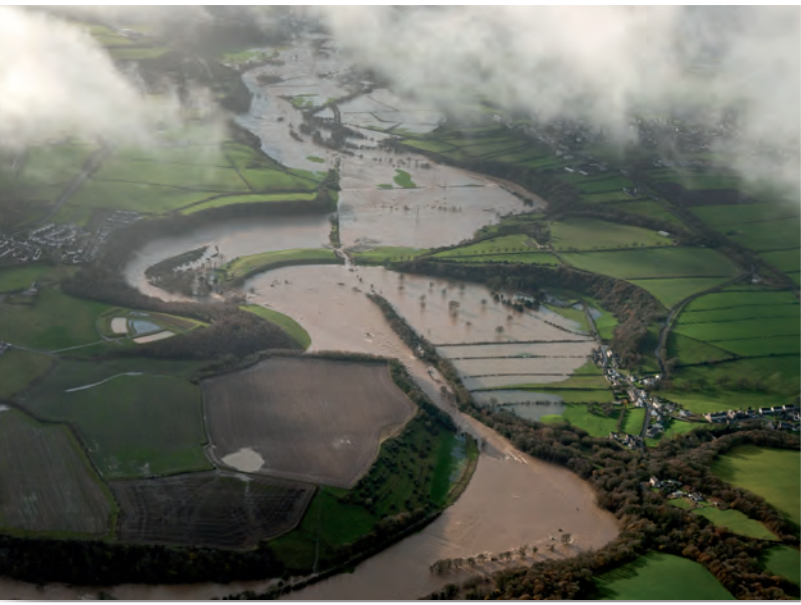
Figure 3 Aerial photograph of flood waters in Great Clifton east of Workington, Cumbria (2009).

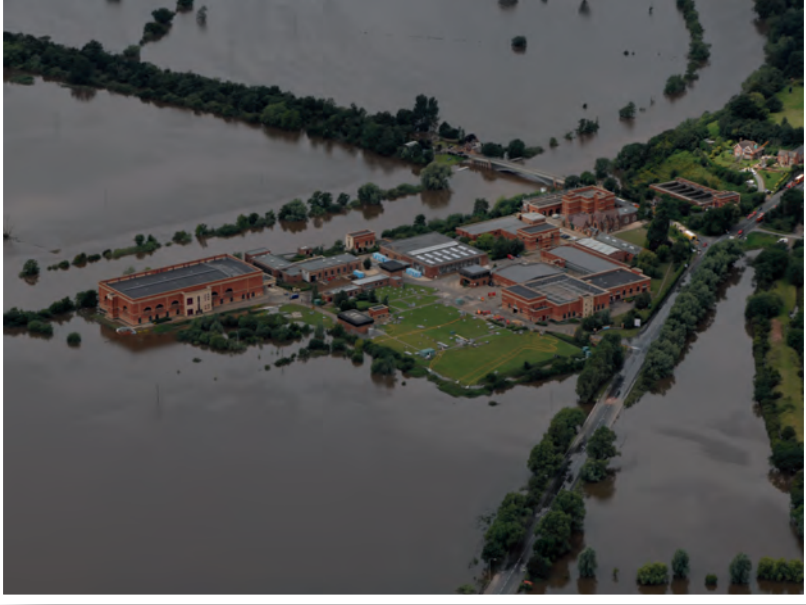
Figure 5 Aerial Photograph of flooding around Mythe Waterworks, Tewkesbury (2007).

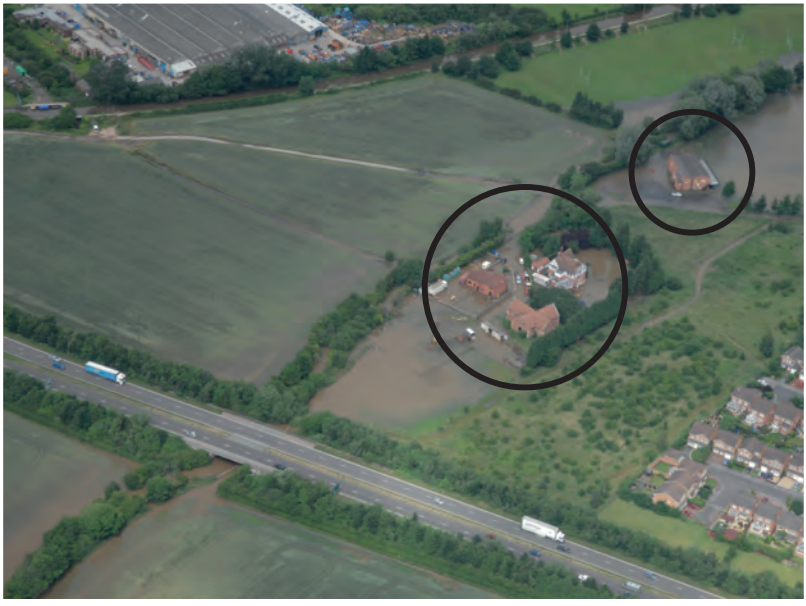
Figure 7 Aerial photograph of flood waters in Worksop, Nottinghamshire (2007).

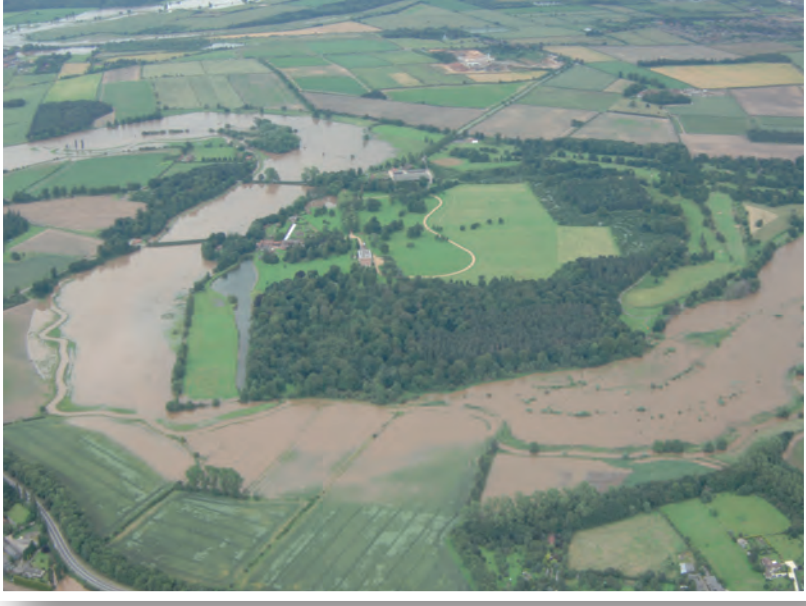
Figure 9 Aerial photograph over the River Ryton, Bircotes, south of Doncaster. It illustrates that fluvial flooding takes place within low-lying tracts — the floodplains — bordering the main river channel (2007).

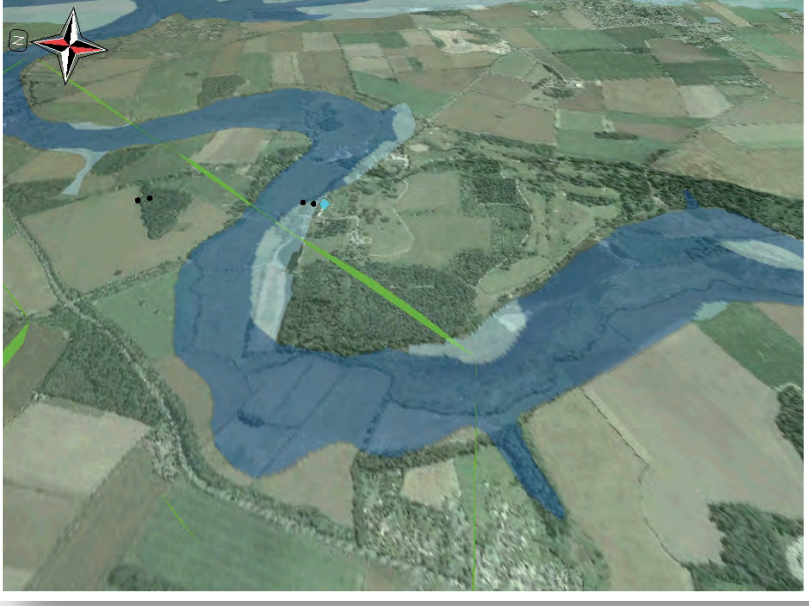
Figure 10 Virtual image showing GIF with two zones of vulnerability. Zone 1: dark blue, highlights initial extent of flooding, Zone 2: pale blue, has been partially encroached upon by flood waters.
