TERRAFIRMA PRODUCT

Case study for the application of Terrafirma ground
motion services to areas of abandoned mining:
Northumberland, UK.

Luke Bateson and David Lawrence, BGS.

Northumberland and Durham Case Study

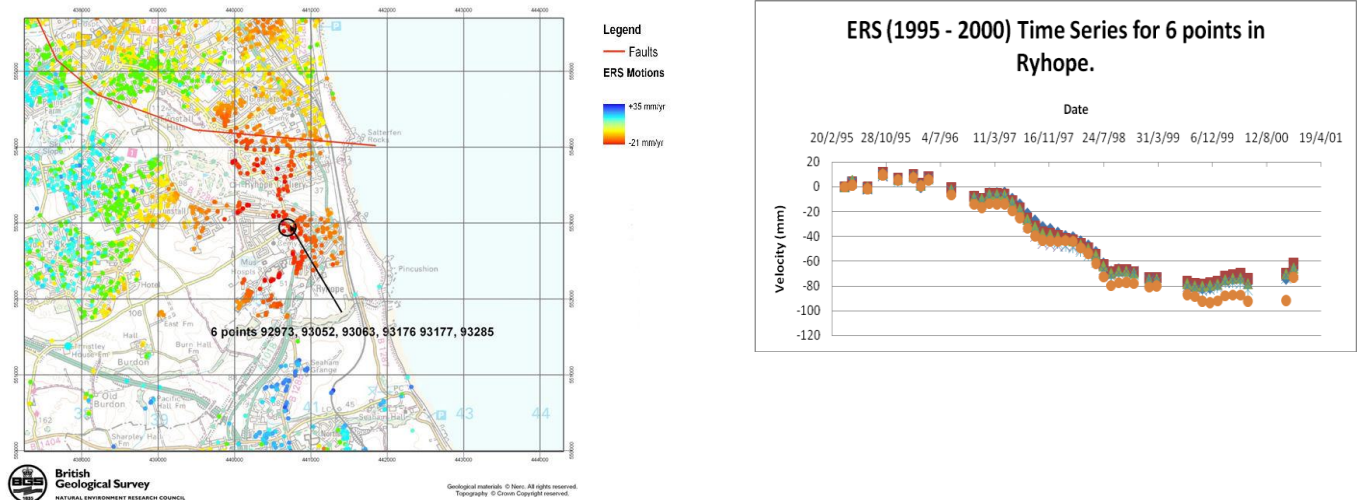
Figure 4: ERS PSI result for the Ryhope area

Ryhope colliery was closed in 1966 (Figure 4), according to common opinion subsidence relating to the extraction of coal using the long wall technique would take place within 5-7 years of extraction. The ERS PSI data shows subsidence in this area occurring more rapidly but with an especially rapid motion from 1997 – 1998. It is not currently known if this subsidence is caused by coal extraction or if ground water levels have an effect.

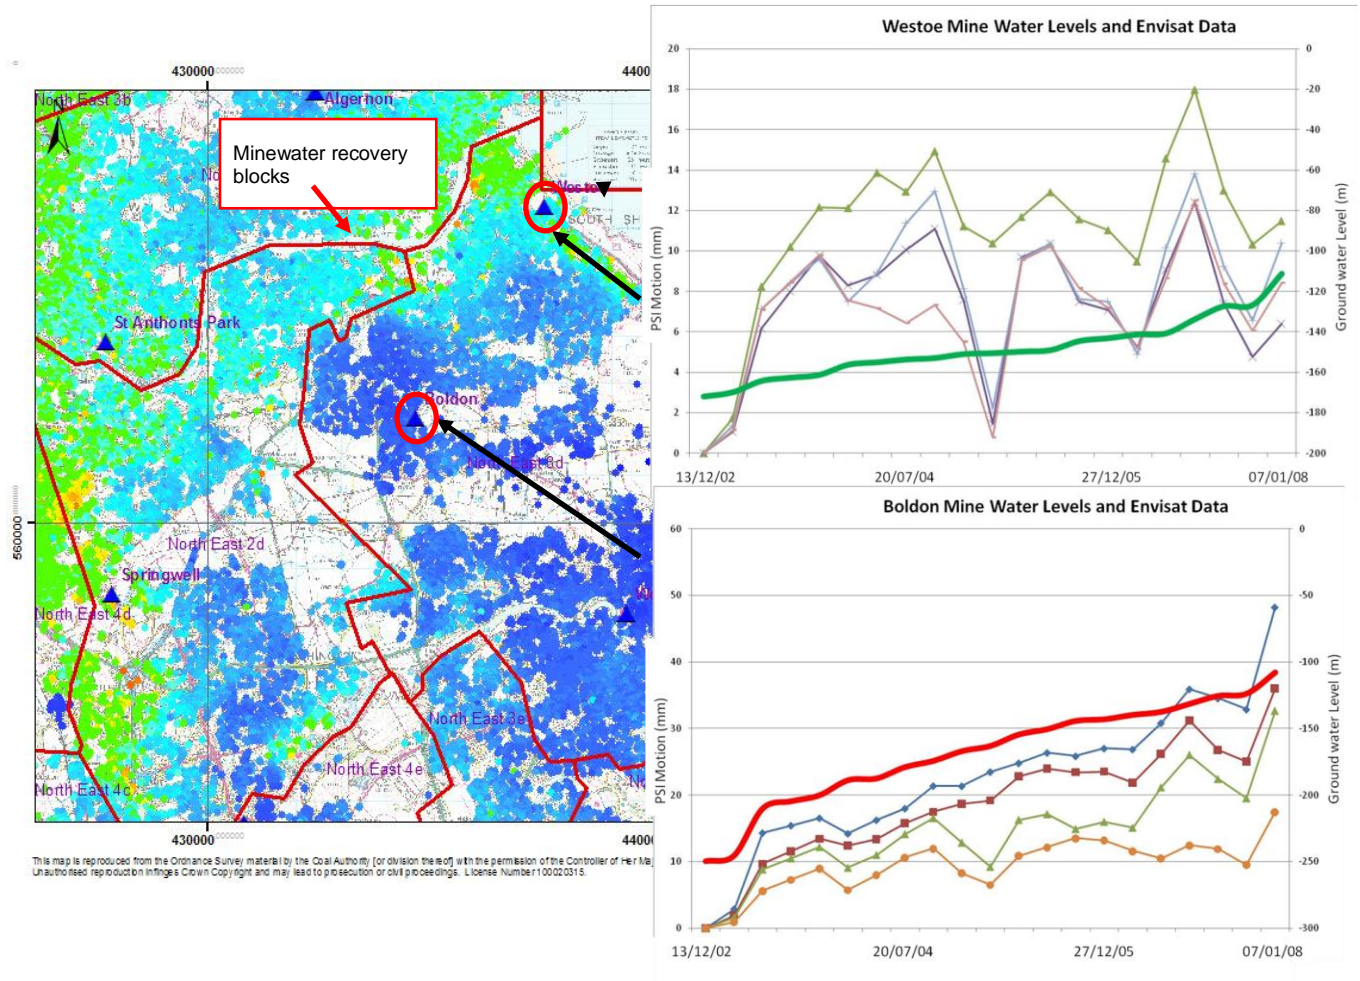
Figure 5: Minewater recovery curves (thick green and red lines) compared with PSI derived ground motions for the monitoring stations highlighted by red circles.

There are dramatic changes in the sense of ground motion between the 1995-2000 ERS result and the 2002-2008 Envisat result. This change appears to fit reasonably well with the recovery of minewater levels after pumping from the mines ceased, as shown by the PSI vs. minewater rise curves in Figure 5. The recovery of minewater levels following the cessation of takes place in 'minewater recovery blocks', water level recovers within a block until it reaches a tipping point at which point it will flow in to the adjacent block. Blocks are commonly defined by the faulting.
