Building Stone Assessment:
Playfair Paving Schemes in Edinburgh:
An investigation of materials and paving patterns

Ewan Hyslop & Emily Tracey

Report: *GR_200560/1*

Old College
University of Edinburgh
EH1 1QL
United Kingdom

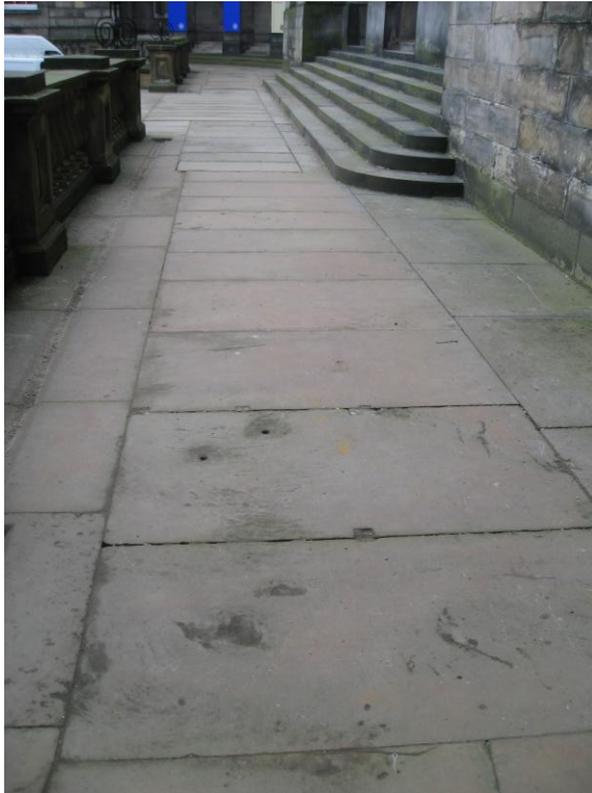
Fig. 1. Terrace pavement at west end of Old College, showing area of replacement paving with new slabs immediately adjacent to the steps. The terrace pavement and the steps below to the courtyard are replacement 'York-type' sandstone. Note the visual disruption to the original paving pattern where the new slabs have been inserted (3062).

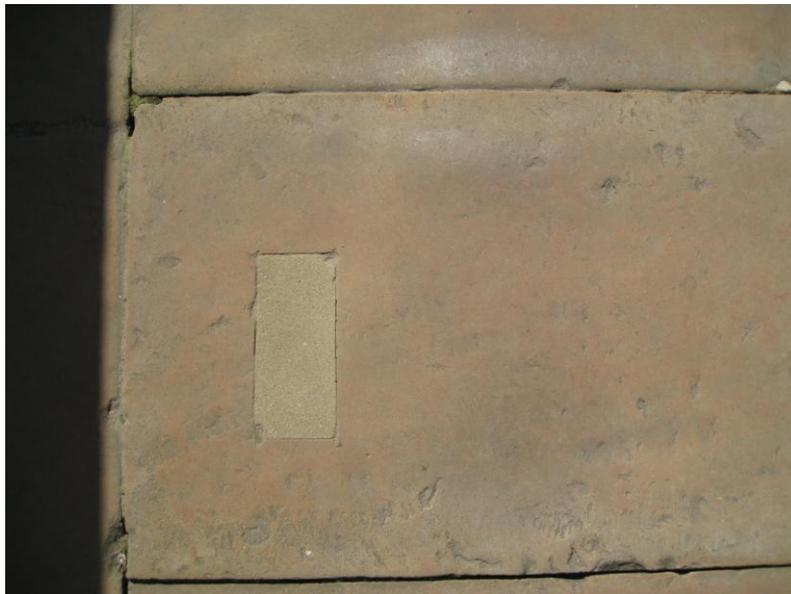
Fig. 2. Detail of original paving slab of Hailes-type sandstone showing indent repair using northern England ('York-type') sandstone, highlighting the contrasting coarse grained 'gritty' texture and bland buff colour compared to the original Hailes stone (3450).

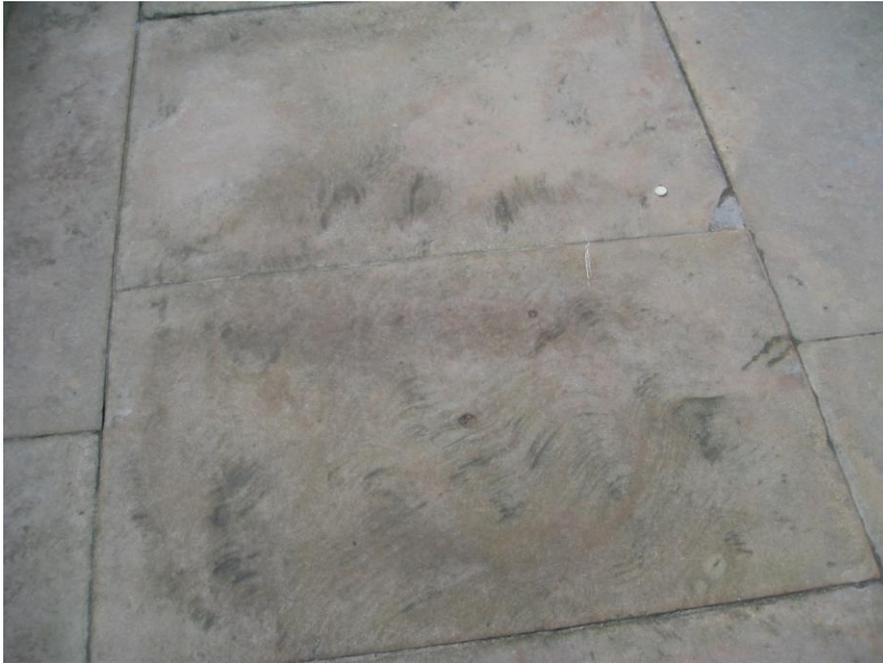
Fig. 3. Typical 'contour' surface pattern of paving slab in Old College, caused by the presence of ripple-bedding in the sandstone. This distinctive texture, and the associated variable colour, is typical of Hailes sandstone (see section 9 for full explanation). (3070)

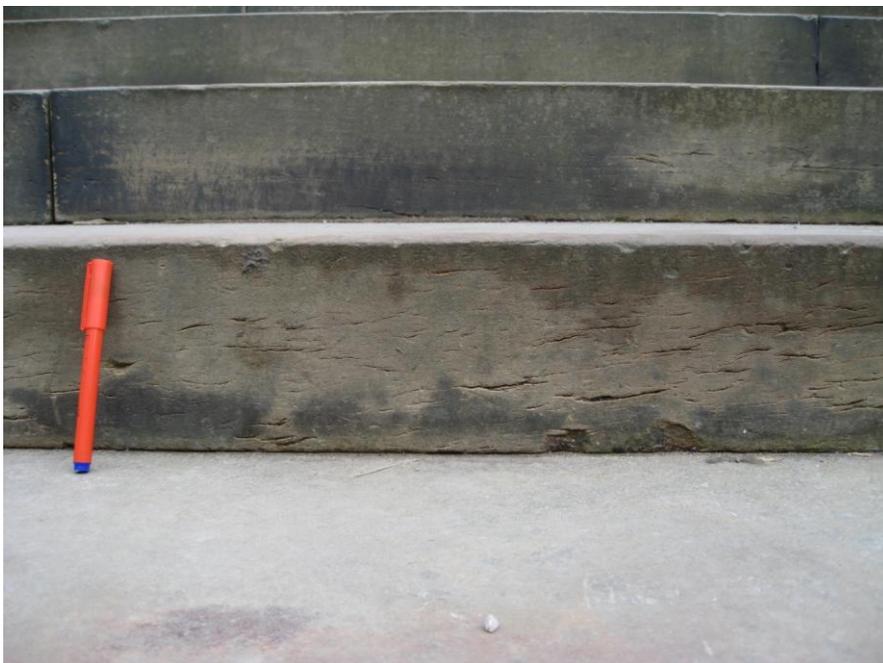
Fig. 4. Detail of step showing the presence of ripple bedding (small irregular discontinuous bedding planes) in the sandstone. This is typical of Hailes sandstone (and also some Craigleith sandstones), resulting in the distinctive 'contour' pattern to the slab surface. The same 'Hailes-type' sandstone appears to have been used for both the steps and paving at Old College. (3056).

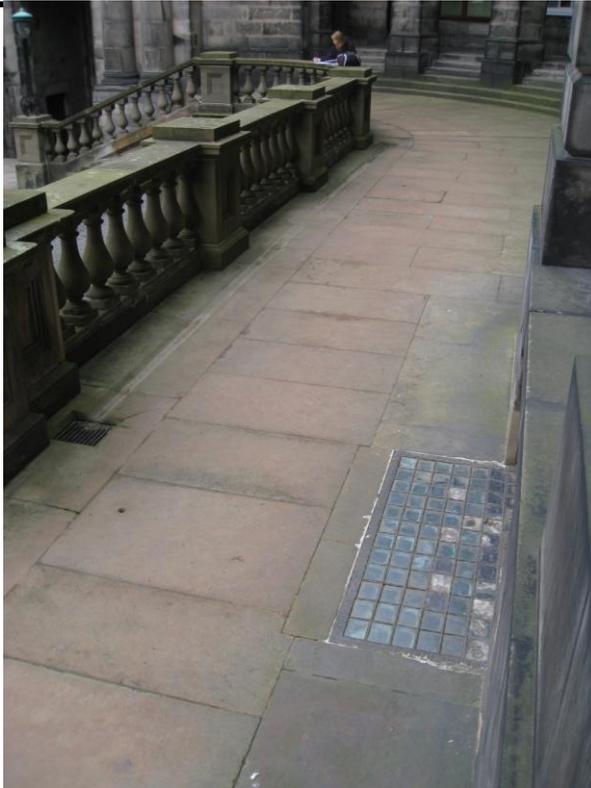
Fig. 5. Southeast corner of the terrace pavement, illustrating the three main paving components described in the text (Narrow area in the foreground; Wide area in centre of image; Curved corner at back). (3080)

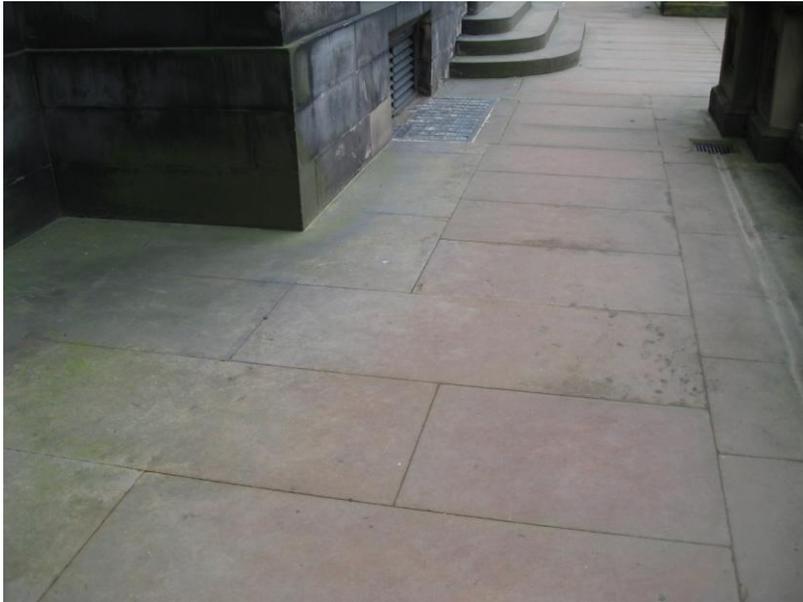
Fig. 7. Transition between wide pavement area and narrow area. Note continuation of the paving pattern with edge courses at each side (dished gutter to balustrade on right-hand side), and single central slab laid perpendicular to pavement direction. Note the regularity of slab sizes (3075).

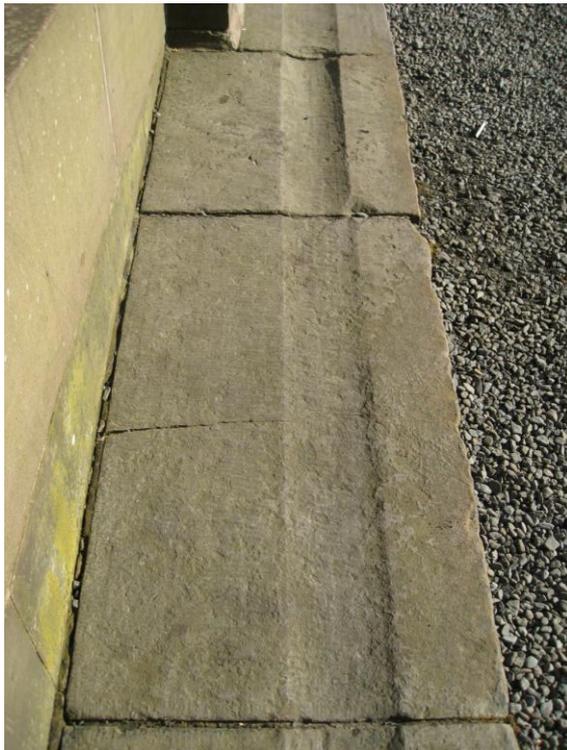
Fig. 9. Detail of 'original' dished sandstone gutters at base of terrace wall adjacent to gravel of central courtyard (east end), showing traces of the original broached tooling. (3472)

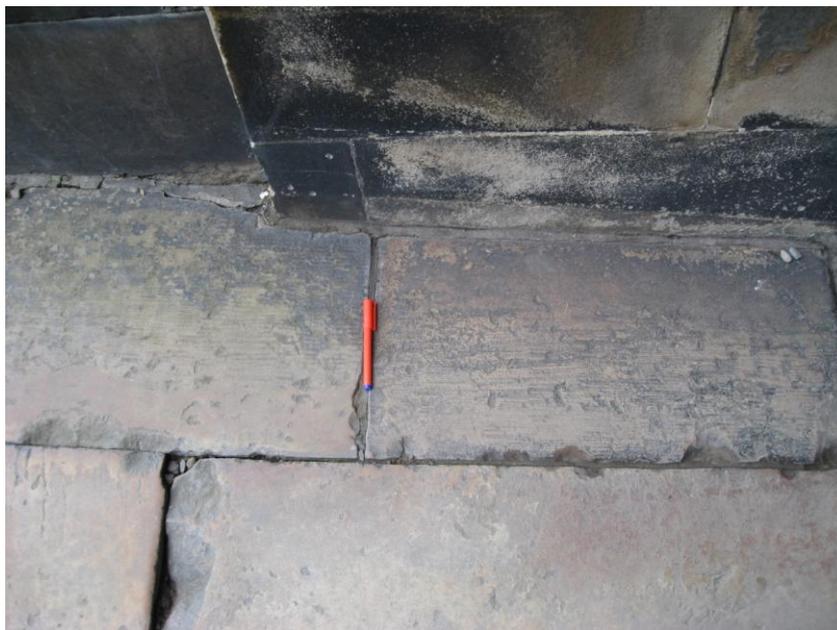
Original surface tooling on the paving slabs is visible in only a few places of low footfall where it has been fortuitously preserved (Fig. 10). Where present it consists of multiple parallel rows of fine droving running across the slab. This surface finish is typical of that seen at the other Playfair paving schemes examined in this study (see below). It is not known whether this tooling was executed to provide a flat surface, a decorative finish or a non-slip surface. It is important to note that although the paving slabs have been worn smooth over most of the pavement, the surface retains a natural non-slip character due to the fact that the Hailes-type sandstone has a grain size which gives an inherent 'coarseness' to the surface.

Fig. 10. Remnants of surface tooling on paving, generally preserved only in areas of low footfall or adjacent to buildings. The tooling consists of a series of narrow rows of fine droving running across the slab. In most places the tooling has worn away, although the grainsize of the sandstone gives the stone a natural slip resistance. (3051)

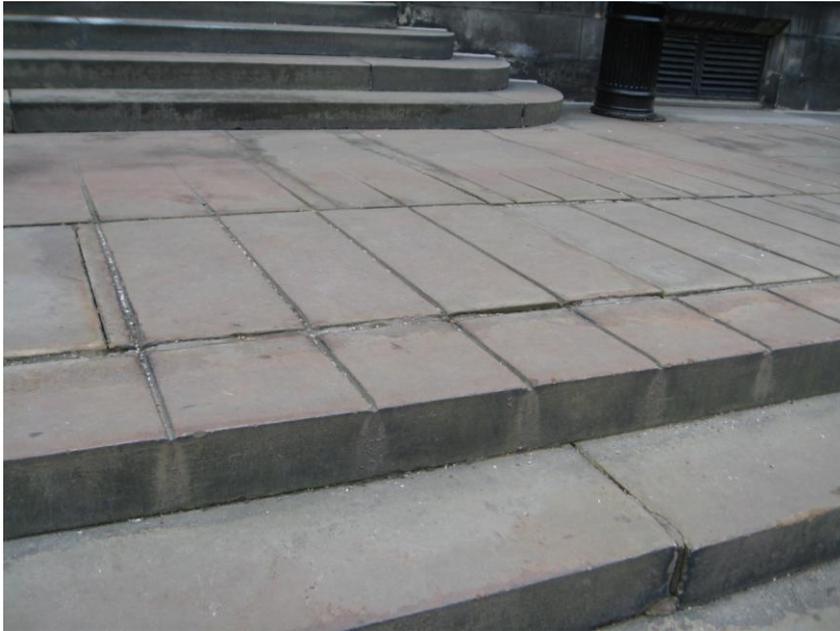
Fig. 11. Terrace pavement adjacent to steps leading down to gravel courtyard (south side of quad), showing narrow channels cut into pavement to provide drainage allowing rainwater to flow down the steps. This tooling (present in a number of places on the terrace), is presumably not part of the original paving design and was undertaken retrospectively to improve drainage. It is disruptive to the uniform paving pattern. (0898)

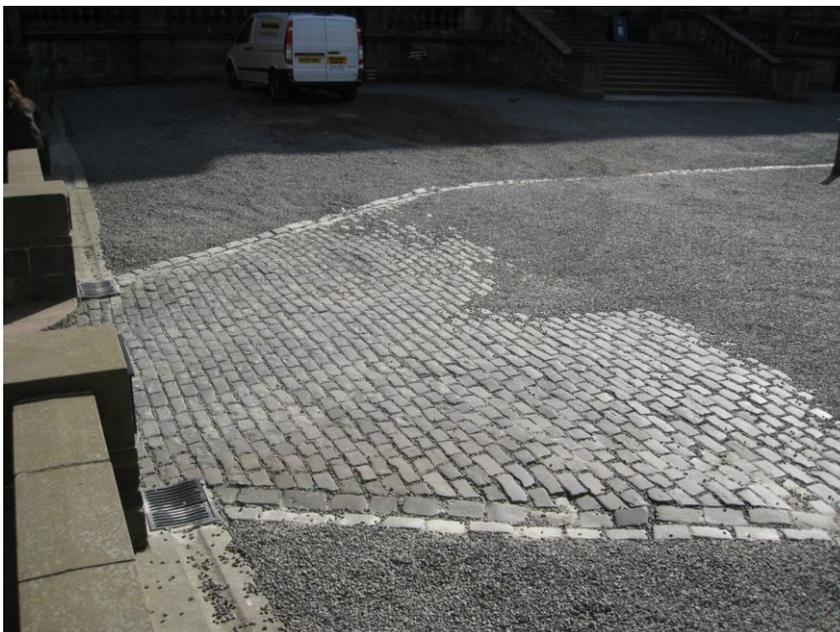
Fig. 12. Inner vehicle entrance to Old College, comprising dark whinstone setts leading to the gravel courtyard. (3430)

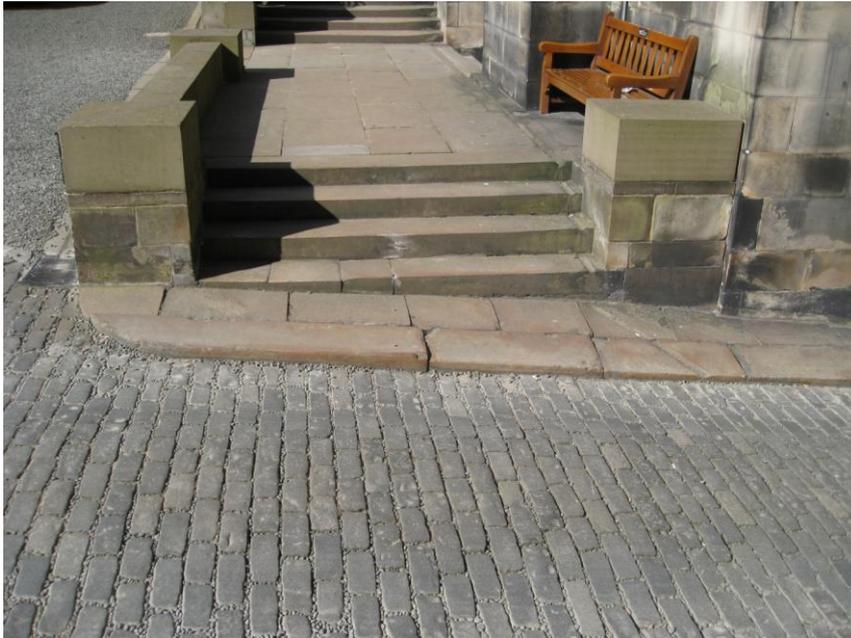
Fig. 13. Inner part of vehicle entrance to Old College, showing dark whinstone setts against original Hailes-type sandstone pavement (note distinctive orange-brown patina). A drainage channel has been cut diagonally across the pavement below the right-hand side of step. Note also the large 'recent' replacement copestones on the terrace wall using a grey-buff Northern England sandstone, giving a 'blocky' appearance uncharacteristic of the Playfair detailing. (3431).

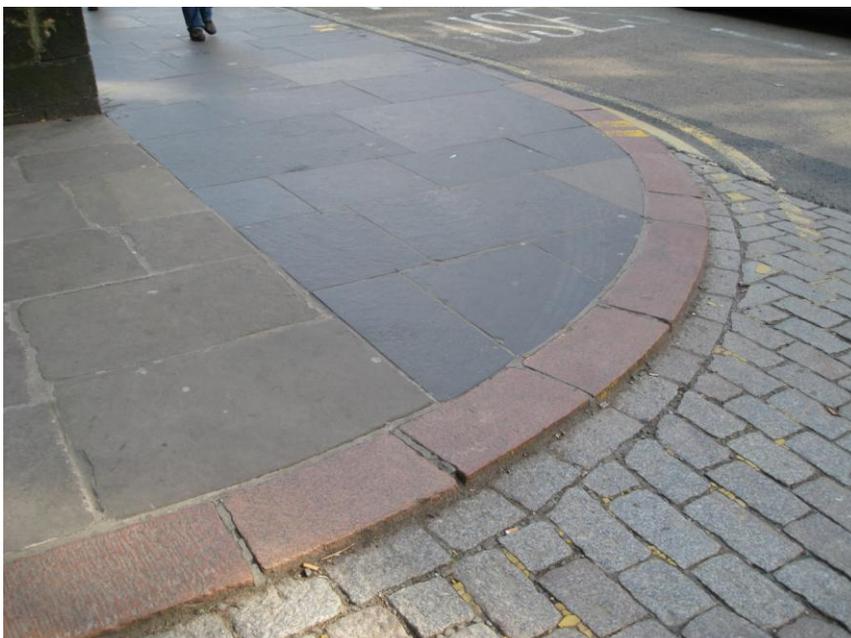
Fig. 14. Entrance to Old College at South Bridge, showing 'modern' dark blue-grey Caithness flagstone on the public pavement adjacent to the paler original Hailes-type sandstone paving of Old College. The vehicle entranceway comprises grey granite setts with wide kerbstones of pink Corrennie (Aberdeenshire) granite. (3444).

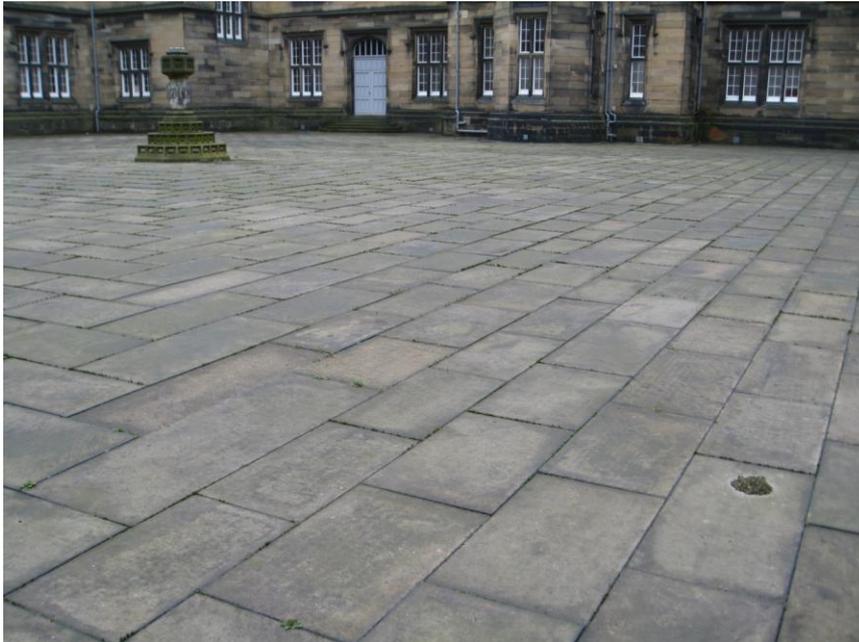
The courtyard is paved in a simple rectangular pattern centred on a central sandstone fountain (Fig. 15). The paving slabs are a light grey to pale orange sandstone, with a variable orange-brown surface patina. The lack of wear has preserved the original finely droved tooling on the slab surfaces (Fig. 16). There is a gradual fall in height from the centre to the edges, where a broad shallow dished gutter in the same sandstone removes surface water to a series of underground drains. The gutter stones are well executed with curved details at corners and around the large ventilation grills (Figs. 17 and 18).

Fig. 15. General view of flagstone paving in central courtyard, showing centred rectangular paving pattern with central fountain. The flagstone is sandstone with a variable orange-brown surface patina (rather dull due to biogenic soiling). The pavement shows a gradual fall in height from centre to margins to allow drainage of water. Donaldson's Hospital (987)

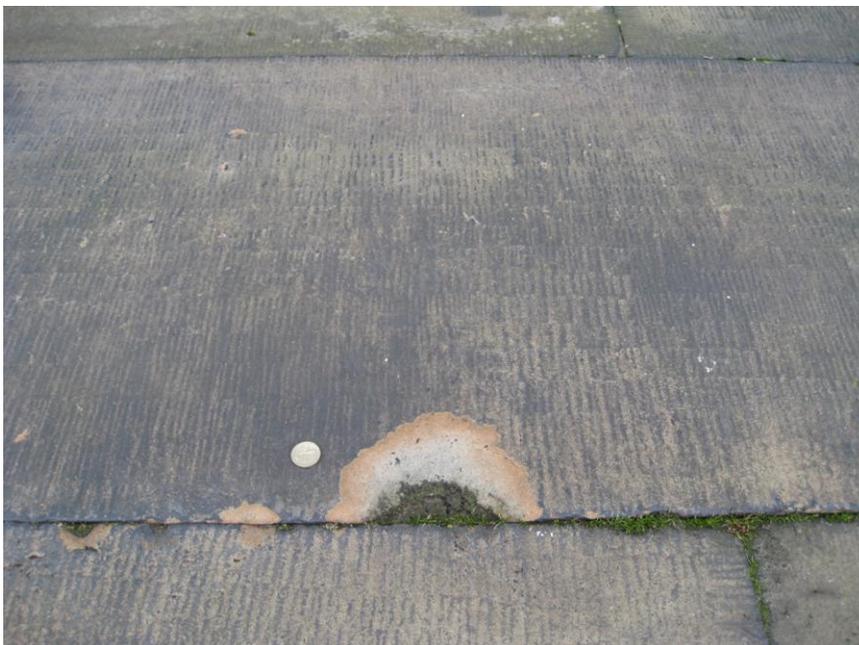
Fig. 16. Detail of paving slab showing tooled surface, detailed as a series of droved bands. The damaged edge reveals the stone to be a pale grey/cream coloured sandstone weathering to a strong orange surface patina, typical of local Edinburgh sandstone such as Hailes. Donaldson's Hospital (3204)

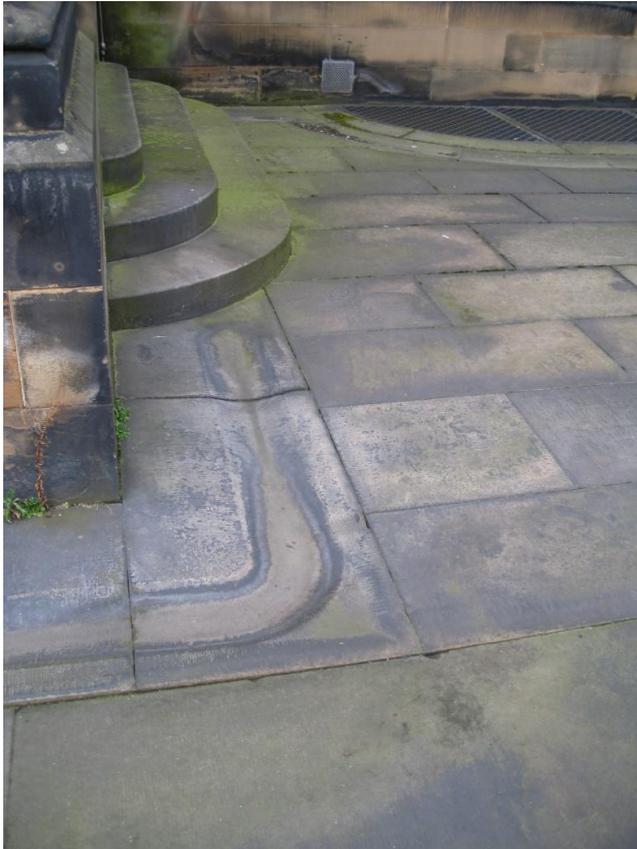
Fig. 17. Drainage channel and step edge detail at perimeter of main courtyard, showing dished gutters cut into single sandstone blocks. Donaldson's Hospital (3214).

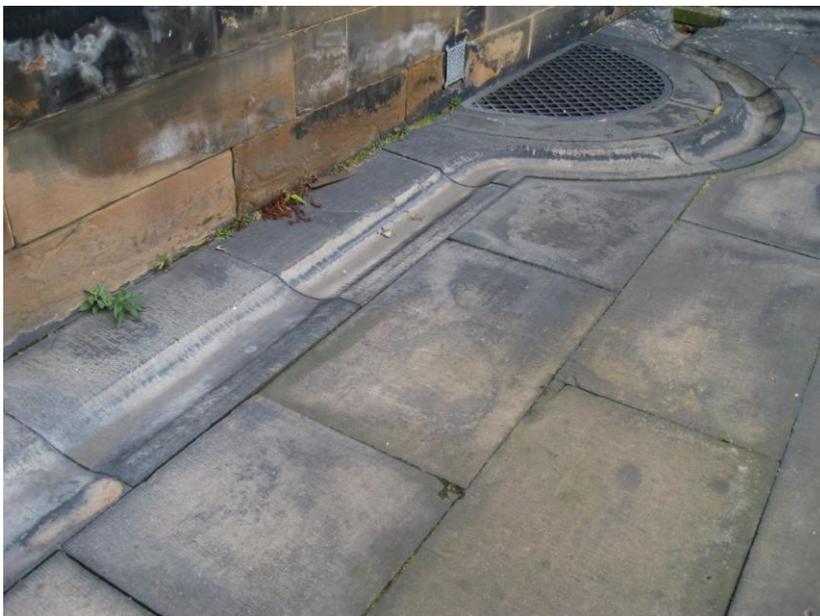
Fig. 18. Drainage channel at edge of main courtyard, showing dished gutters cut into single sandstone blocks. The depth of the cut channel varies along the length of the gutter to control water flow (here deepening from left to right). Note curved detail around ventilation grill. Donaldson's Hospital (3205).

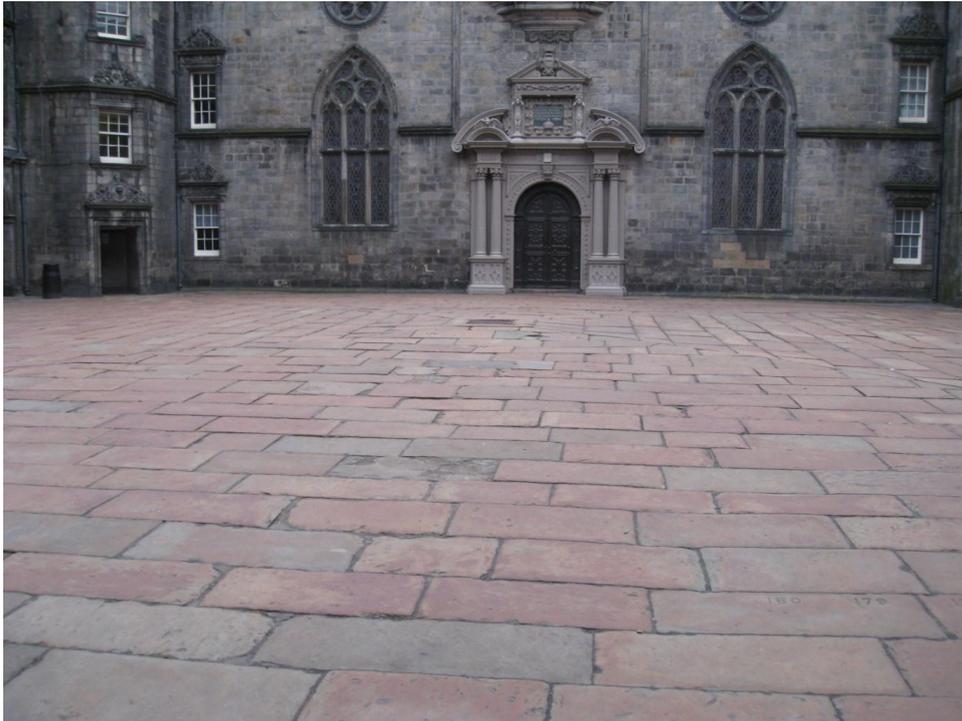
Fig. 19. General view of central courtyard showing rectangular centred paving pattern with strong variable orange-brown patina to flagstone slabs, typical of Hailes-type sandstone. The pavement shows a gradual fall in height from centre to margins to allow drainage of water. George Heriot's School (3234)

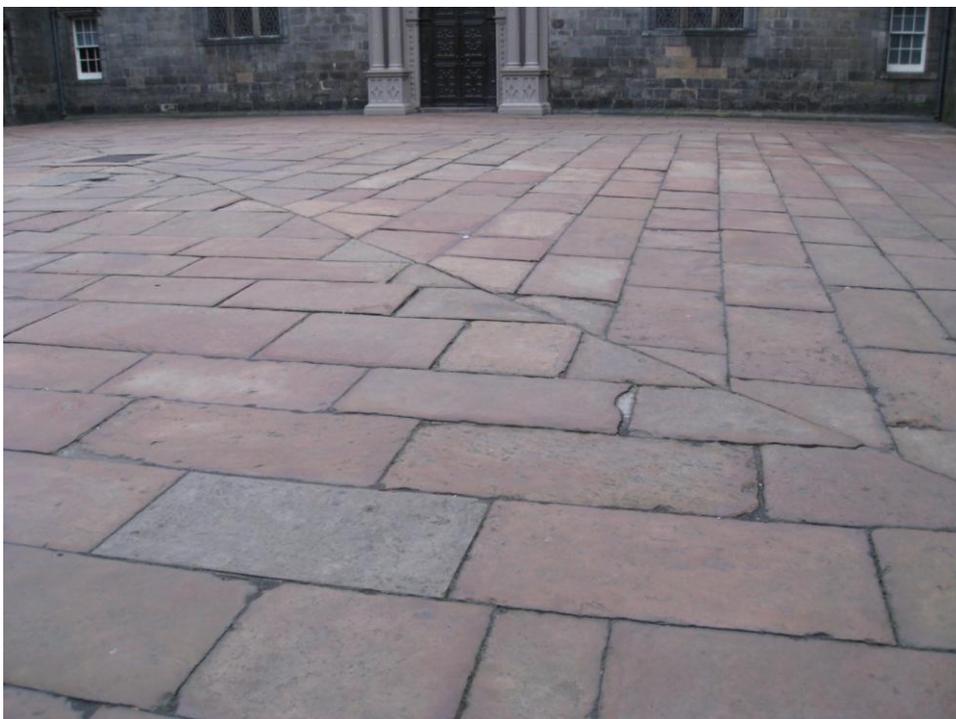
Fig. 20. General view of central courtyard showing rectangular centred paving pattern with diagonal linear joins at corners. The flagstone is Hailes-type sandstone showing a characteristic orange-brown patina with 'contour-bedded' surface. George Heriot's School (3247)

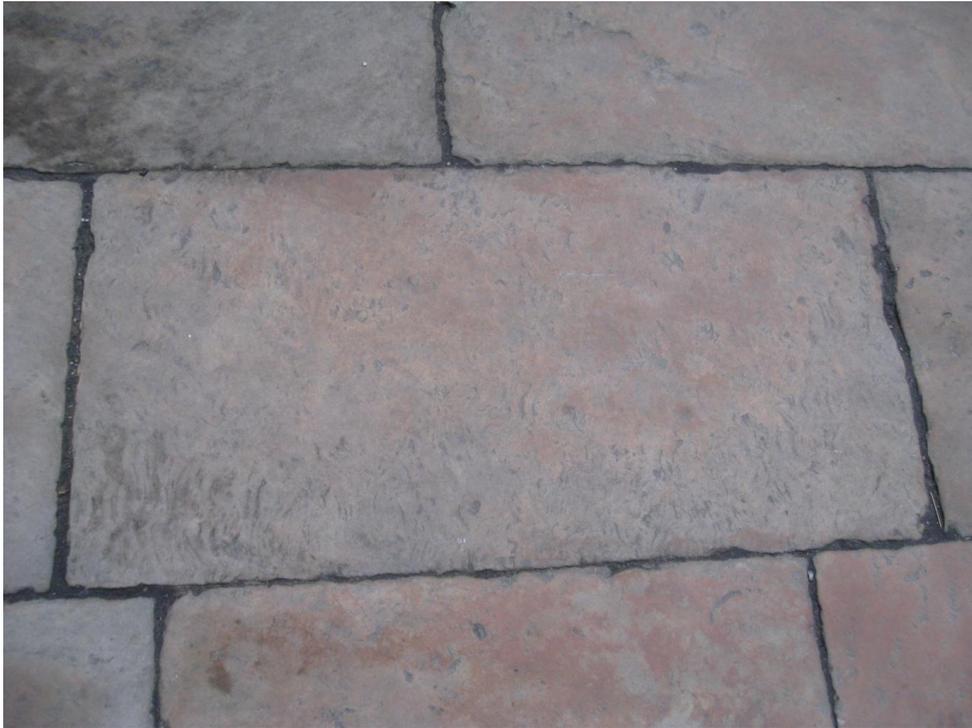
The paving stone has a variable strong orange-red surface patina and a 'contour'-textured natural surface, characteristic of Hailes type sandstone (Fig. 21). This strongly coloured patina and 'worn' surface texture is likely to be a result of a high degree of foot traffic causing exposure of the ripple-bedding and oxidation of iron minerals (see description in section 9). The wear has also produced a rounding to the appearance of the stone (Fig. 2), which, combined with the hand cut slabs and variable joint sizes, gives a natural 'soft' appearance to the scheme. There is no evidence of surface tooling details in the courtyard, probably as a result of the wear to the stone.

Fig. 21. Detail of paving slab showing orange-brown patina and 'contour-bedded' surface characteristic of Hailes type sandstone. George Heriot's School (3245)

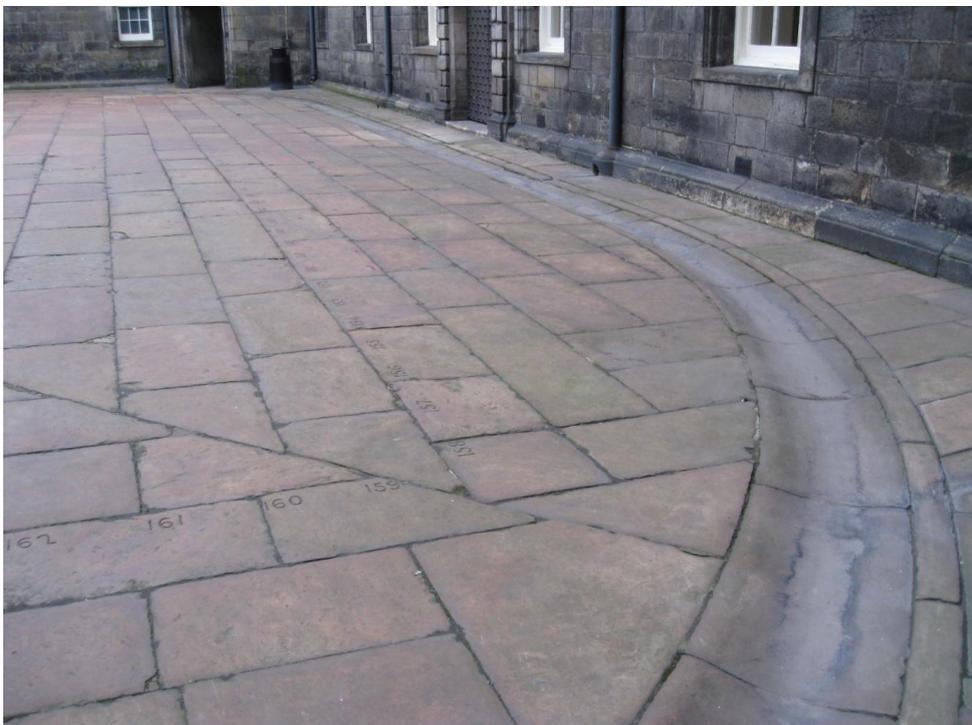
Fig. 22. Details of corner in central courtyard showing radial linear junction and curved dished gutter at corner. George Heriot's School (3251)

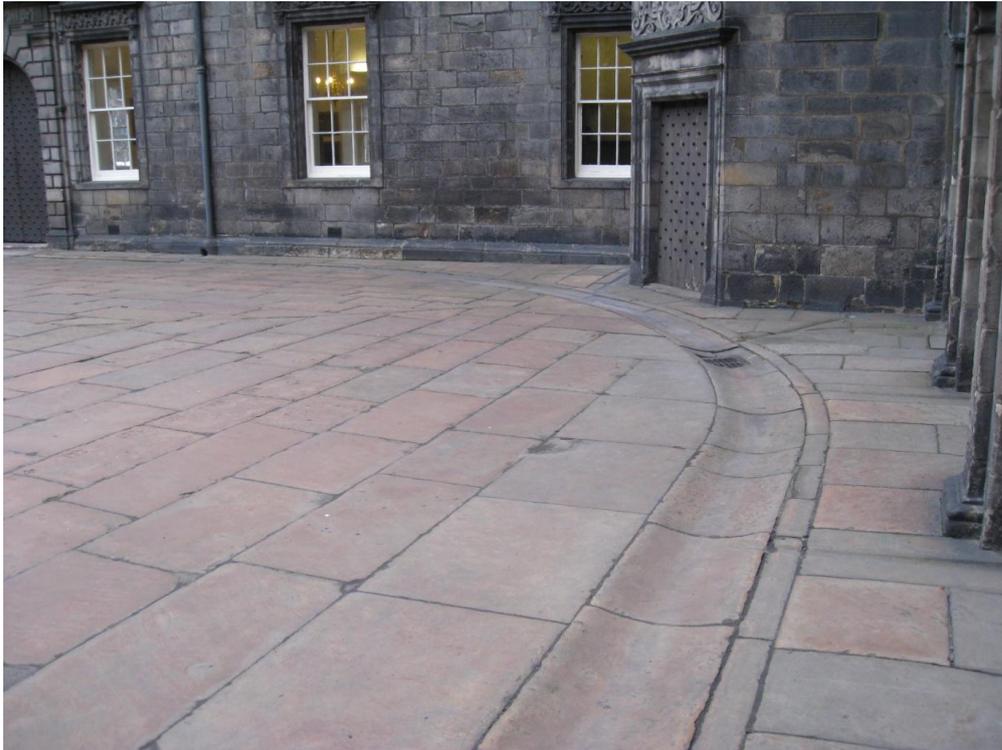
Fig. 23. Detail of corner in central courtyard showing curved dished gutter at corner. George Heriot's School (3235)

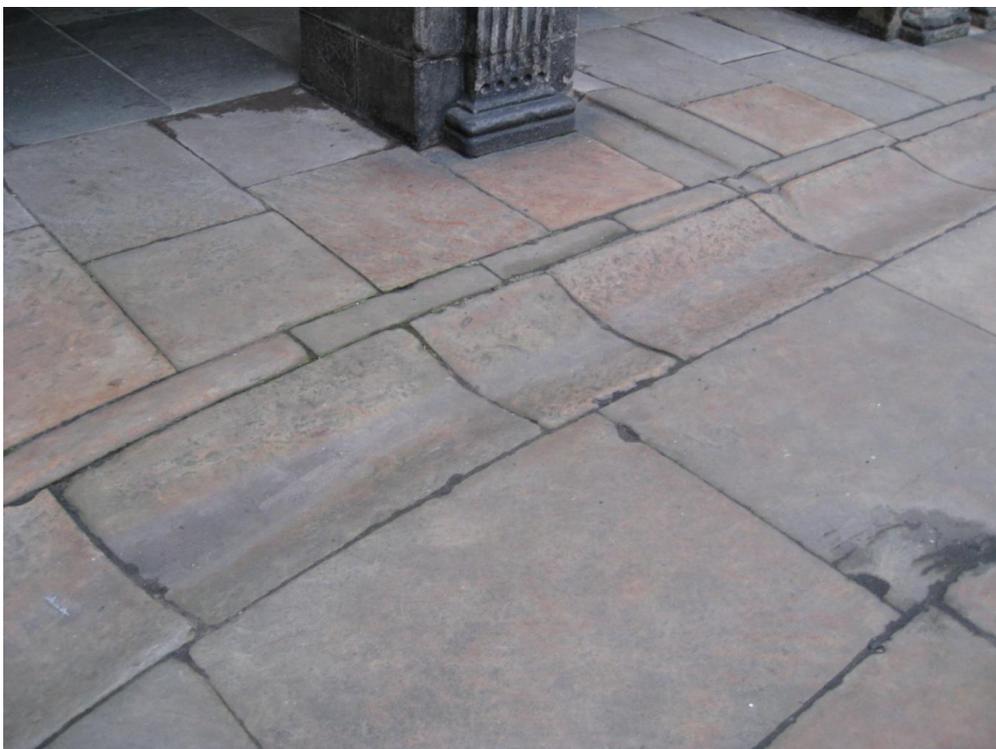
Fig. 24. Details at edge of central courtyard showing dished gutter with outer kerb, all made from Hailes-type sandstone. The kerb blocks are bedded on edge. George Heriot's School (3250)

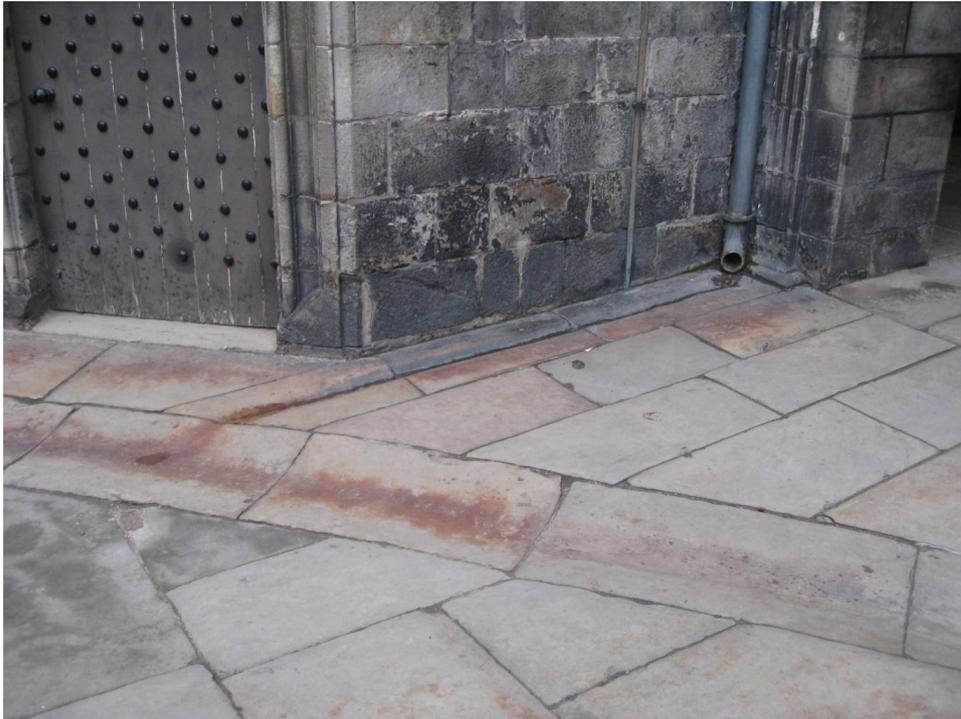
Fig. 25. Edge of central courtyard at north entrance showing main curved dished gutter with adjoining smaller gutter from downpipe outlet, made from Hailes-type sandstone. George Heriot's School (3242)

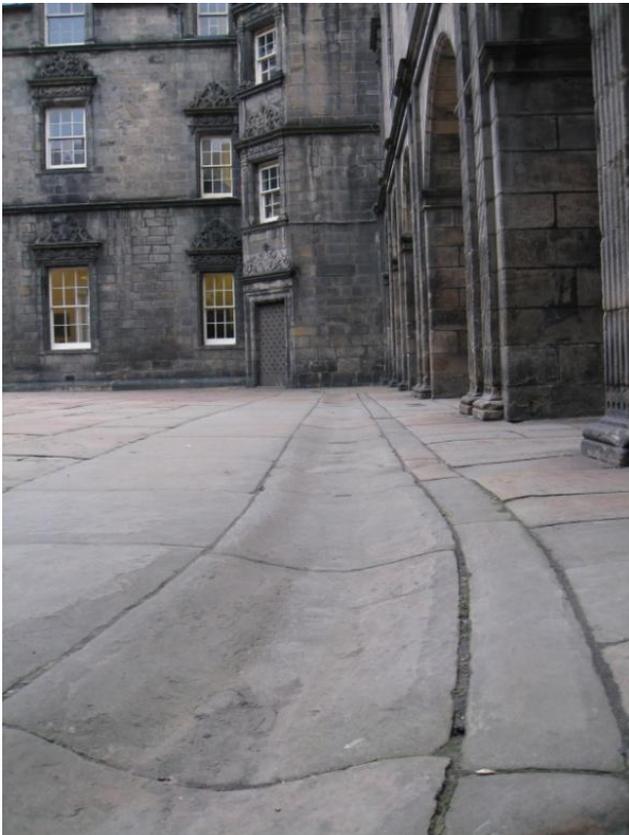
Fig. 26. Details at edge of central courtyard showing dished gutter with outer kerb, all made from Hailes-type sandstone. The kerb blocks are bedded on edge. George Heriot's School (1023)

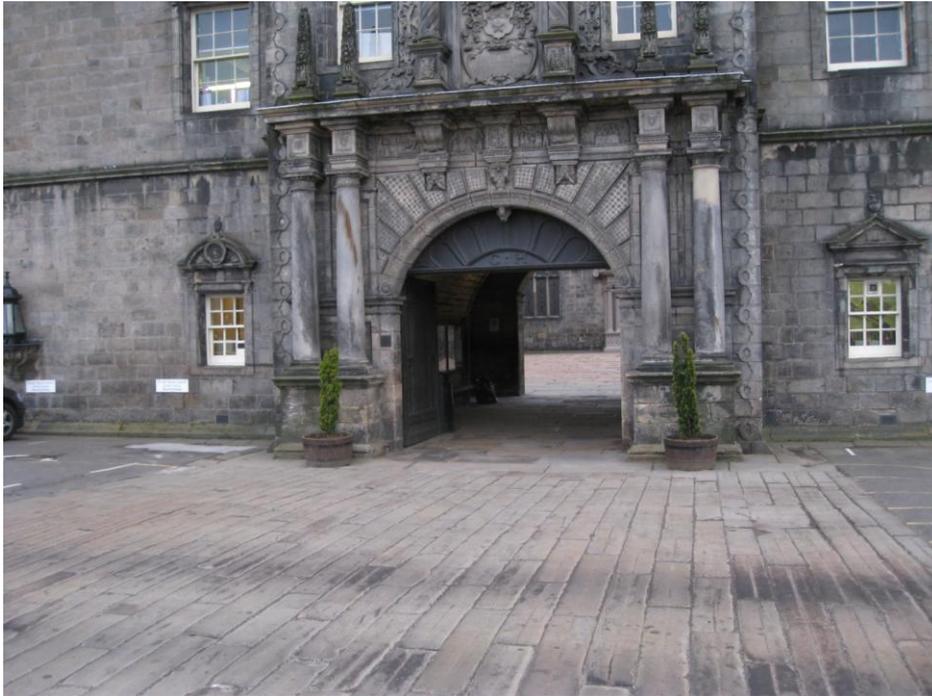
Edge-bedded sandstone blocks are used outside the north entrance to the courtyard (Fig. 27), and at the vehicle entrance to Lauriston Place (Fig. 28). The blocks have worn smooth, but have a single or twin broad central tooling cut along the length of the block (probably to prevent skidding). At both localities the elongate blocks are laid with block length perpendicular to the direction of traffic. This stone also appears to be a Hailes-type sandstone, the same as that used in the courtyard.

Fig. 27. North entrance to central courtyard showing stone paving on roadway, consisting of elongate sandstone blocks on edge, each with a single centre groove cut along the length of the block. The stone appears to be a Hailes-type sandstone, the same as that used in the courtyard. George Heriot's School (3230)

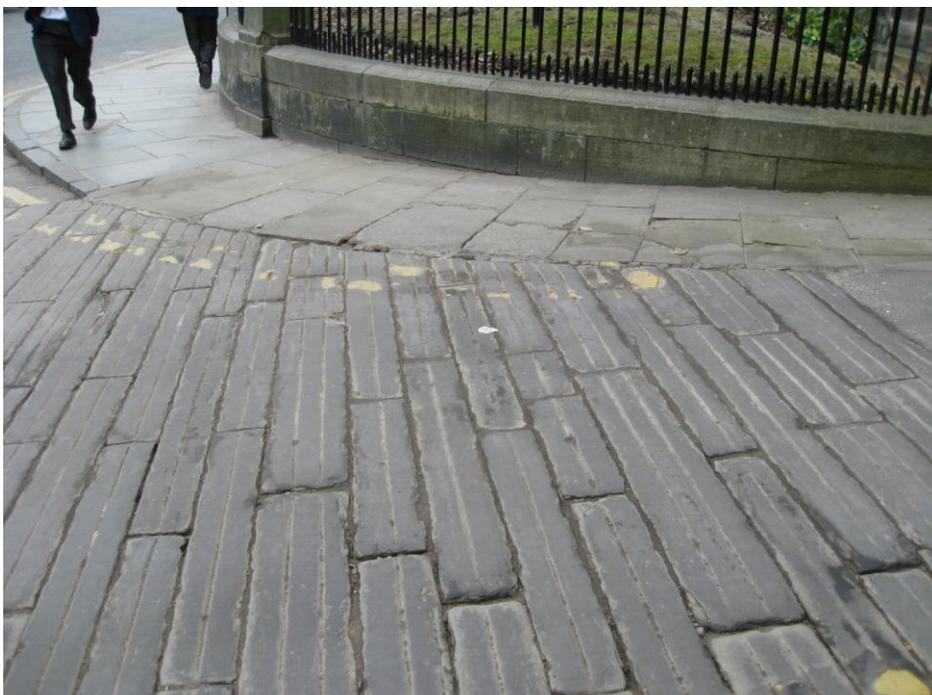
Fig. 28. Entrance to George Heriot's School on Lauriston Place consisting of elongate sandstone blocks on edge, each with a simple coarse groove cut along the length of the block, probably to prevent skid. The stone appears to be a Hailes-type sandstone, the same as that used in the courtyard. George Heriot's School (3087)

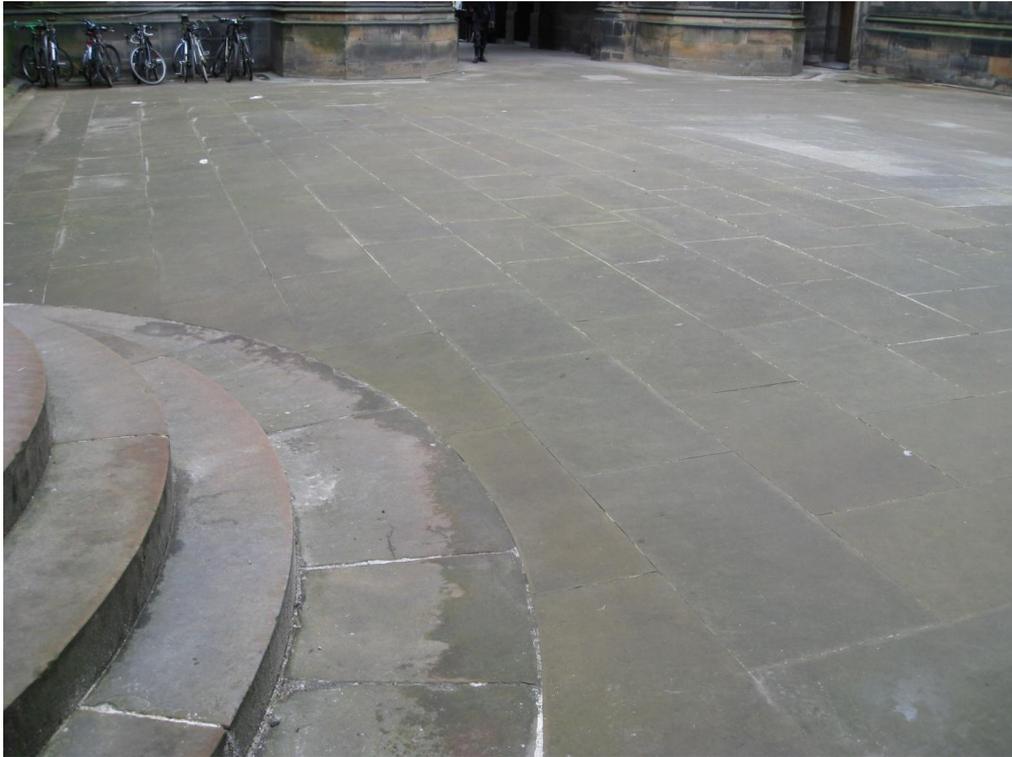
Fig. 29. Edge of curved entrance steps showing junction with replacement courtyard paving. New College (3104)

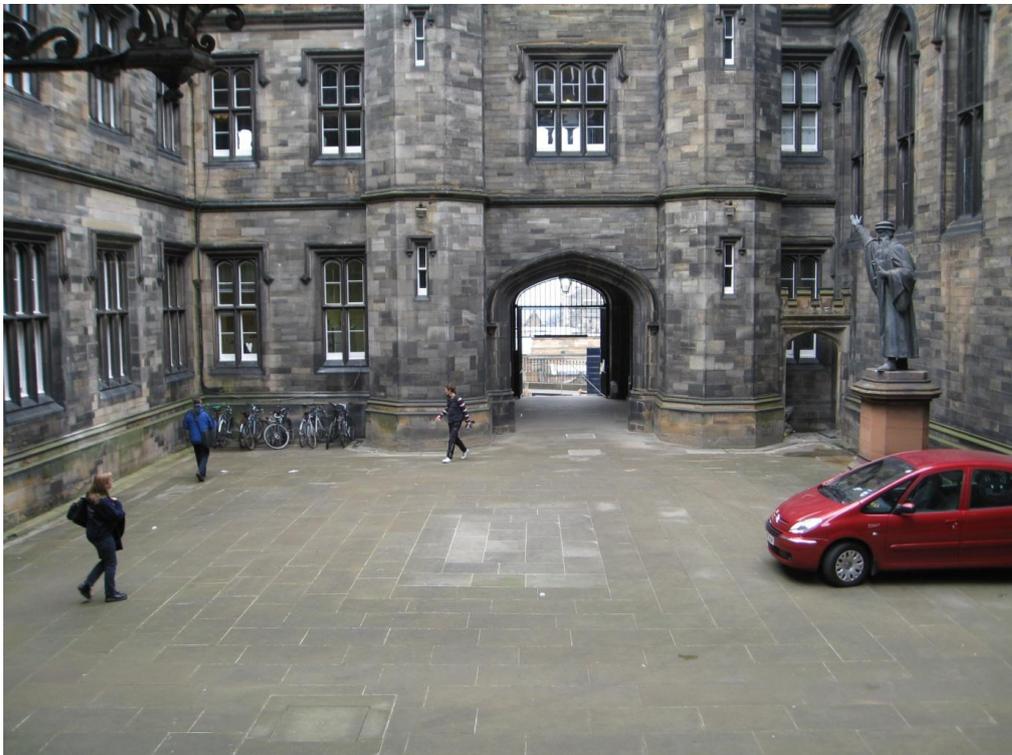
This A-Listed building was designed by William Playfair and constructed c.1845-50. The courtyard appears to have been 'recently' repaved using a new replacement sandstone. Although no details of the repaving are known, the condition of the flagstone suggests this is likely to have occurred in the last few decades. From a preliminary visual examination the replacement stone appears to be a York-type sandstone. The new paving has a relatively uniform appearance both in colour and texture (Fig. 29). The paving has been laid in a rectangular pattern centred around the middle of the courtyard, with a gradual fall in height to the outer drains (Fig. 30).

Fig. 30. General view of courtyard showing rectangular centred paving pattern. New College (0912)

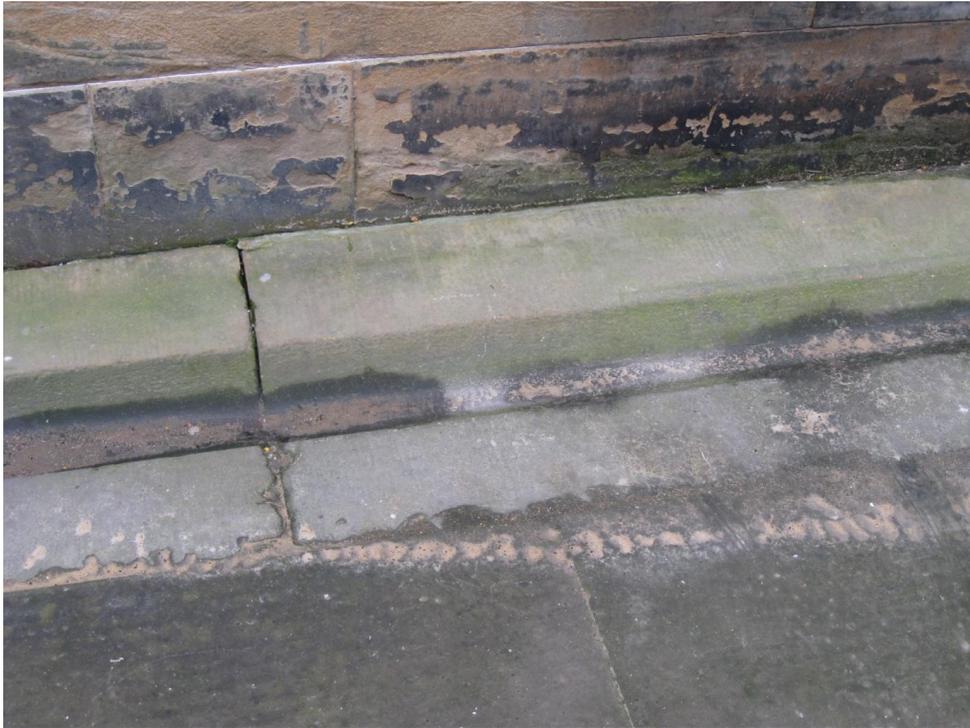
The replacement stone appears to have a flat sawn surface, and has not been tooled. The original dished gutters show finely droved surface tooling (Fig. 31). No evidence remains of the original paving slabs from the courtyard, other than the dished gutters and steps.

Fig. 31. Remaining section of original dished sandstone gutter at edge of replacement paving to courtyard. Note the finely tooled (droved) surface finish. New College (3099)

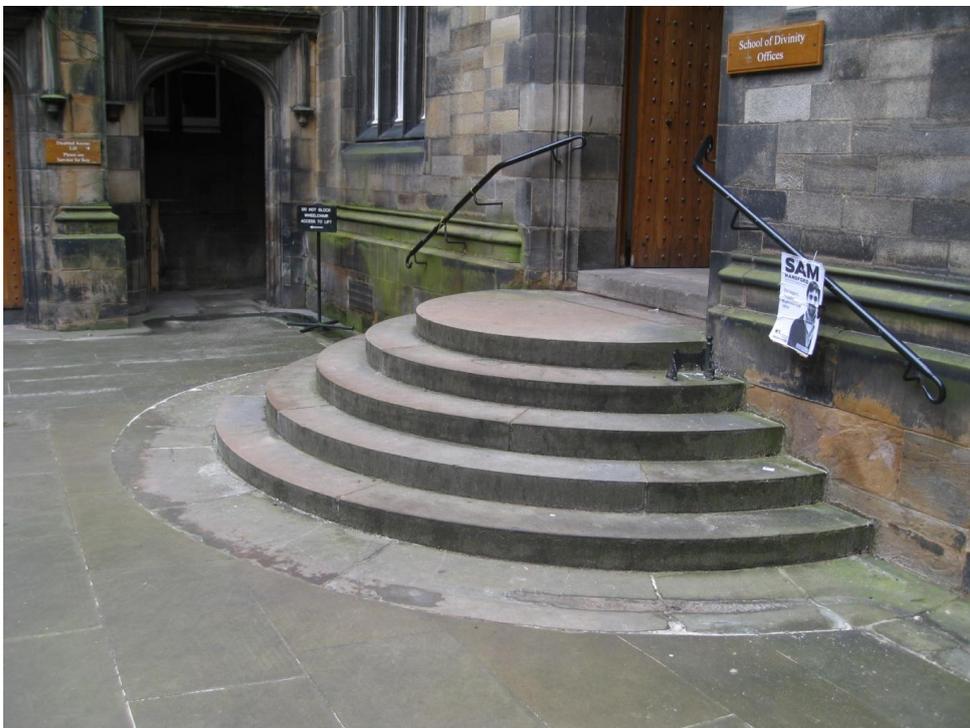
Fig. 32. Curved entrance steps of Hailes-type sandstone showing variable colours with orange-red patina, adjacent to replacement paving in courtyard which is a more uniform 'York-type' sandstone. New College (3102)

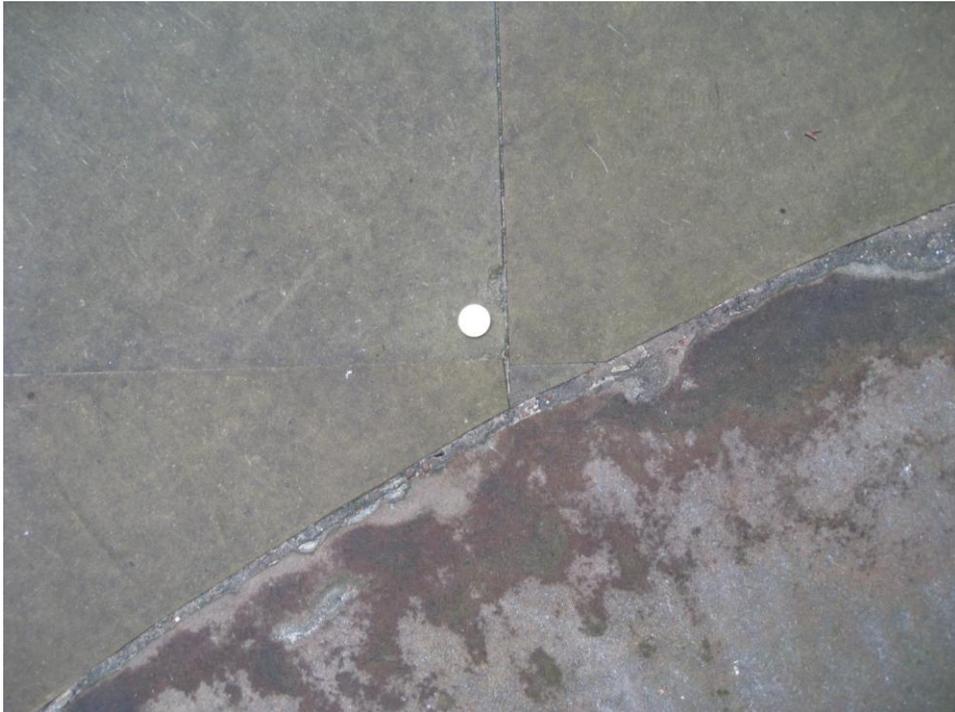
The contrast between the replacement paving and the original stone is marked, particularly at the base of the curved entrance steps to the School of Divinity Offices (Fig. 33). The replacement paving has been precisely sawn, producing a very regular slab size and tight joints -giving a rather angular or 'harsh' appearance to the central courtyard, compared to the 'softer' appearance of the remaining original stone.

The entrance to the courtyard shows a mixture of three types of stone; original Hailes-type sandstone, replacement York sandstone, and dark Caithness flagstone which has been used for the public pavement. The detailing (particularly the laying of the Caithness stone) is poor, and the contrast between the three the different stone types is marked (Fig. 33).

Fig. 33. Detail of junction between original curved steps (Hailes-type sandstone) and replacement 'York-type' sandstone flags. The York stone has a more uniform greyish colour compared to the orange-red patina on the Hailes sandstone. New College (3111)

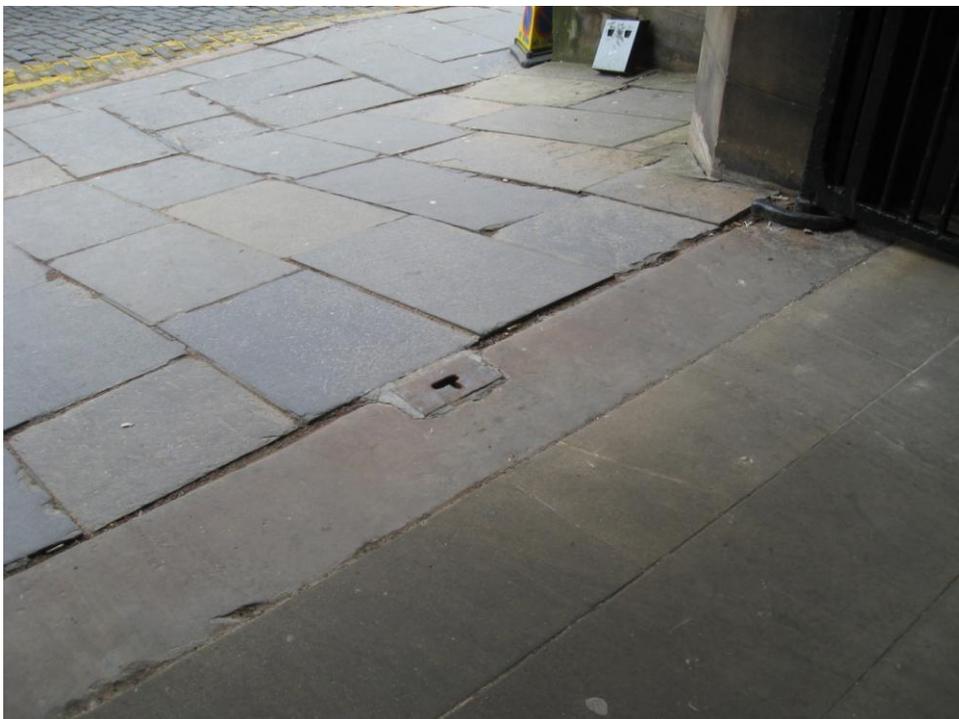
Fig. 34. Entrance to New College, showing a mixture of three types of paving stone. The long entrance sill is the original Hailes (or Craigleith) type stone; the courtyard (bottom-right) has been repaved using a greenish-buff York-type sandstone; and the external pavement has been paved using 'modern' dark grey Caithness flagstone.
