Building Stone Assessment:
Playfair Paving Schemes in Edinburgh:
An investigation of materials and paving patterns

Ewan Hyslop & Emily Tracey

Report: *GR_200560/1*

Old College
University of Edinburgh
EH1 1QL
United Kingdom

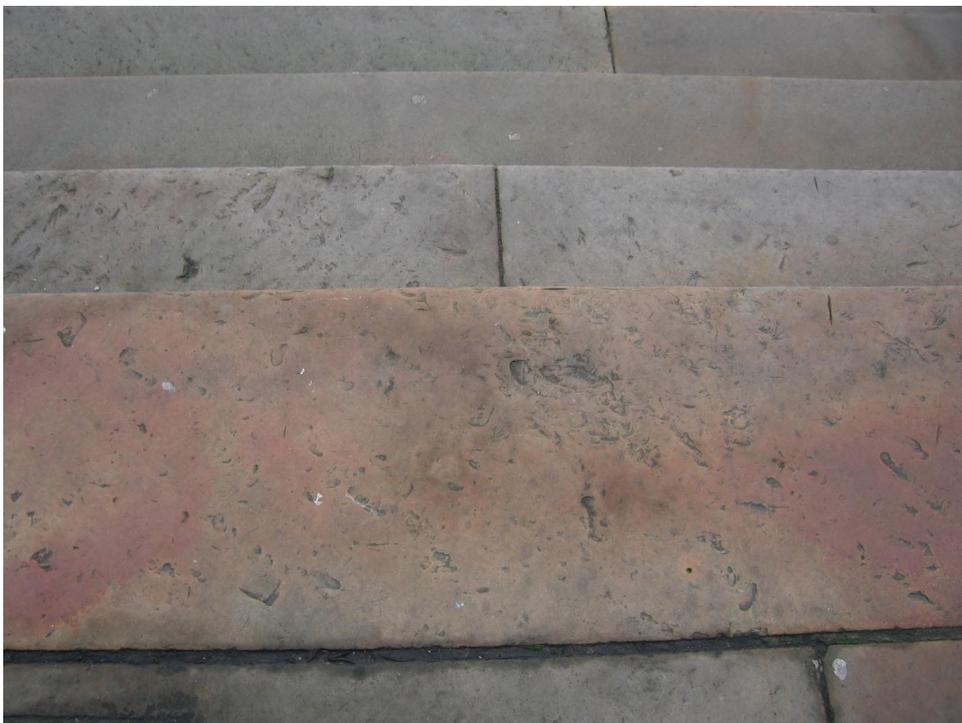
Fig. 34. Detail of entrance steps to General Register House showing characteristic variable orange-red patina and 'contoured' natural surface texture, all typical of Hailes sandstone.

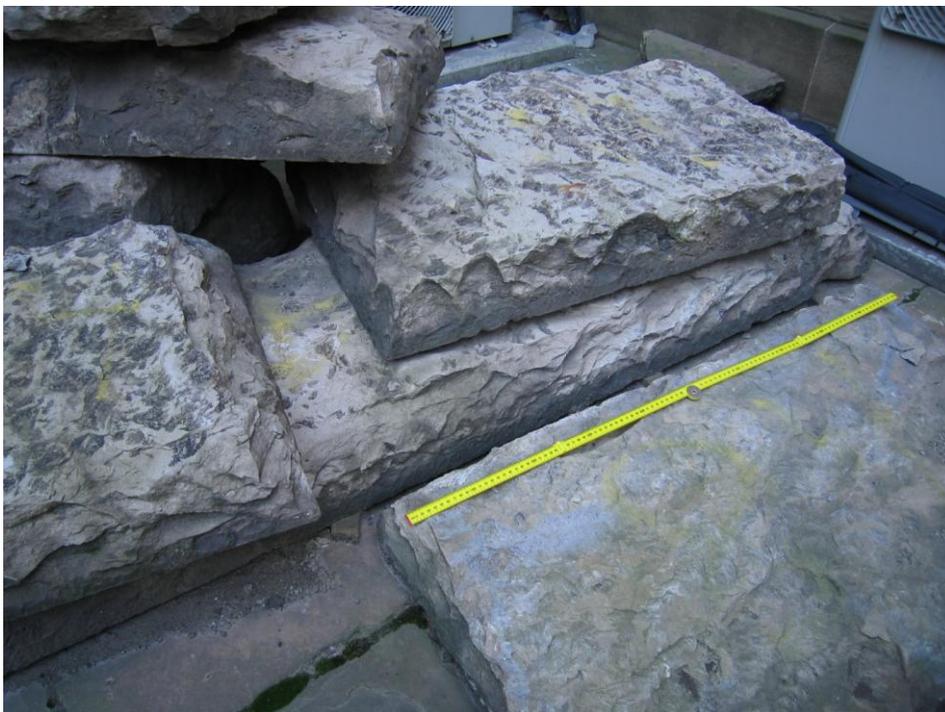
Fig. 35. External paving slabs from rear of General Register House, lifted for re-laying of the surrounding footpaths during 2007. Note the dark bedding planes characteristic of Hailes sandstone. The undersides have been marked with unique numbers to identify the blocks for reinstatement (photo taken 2007).

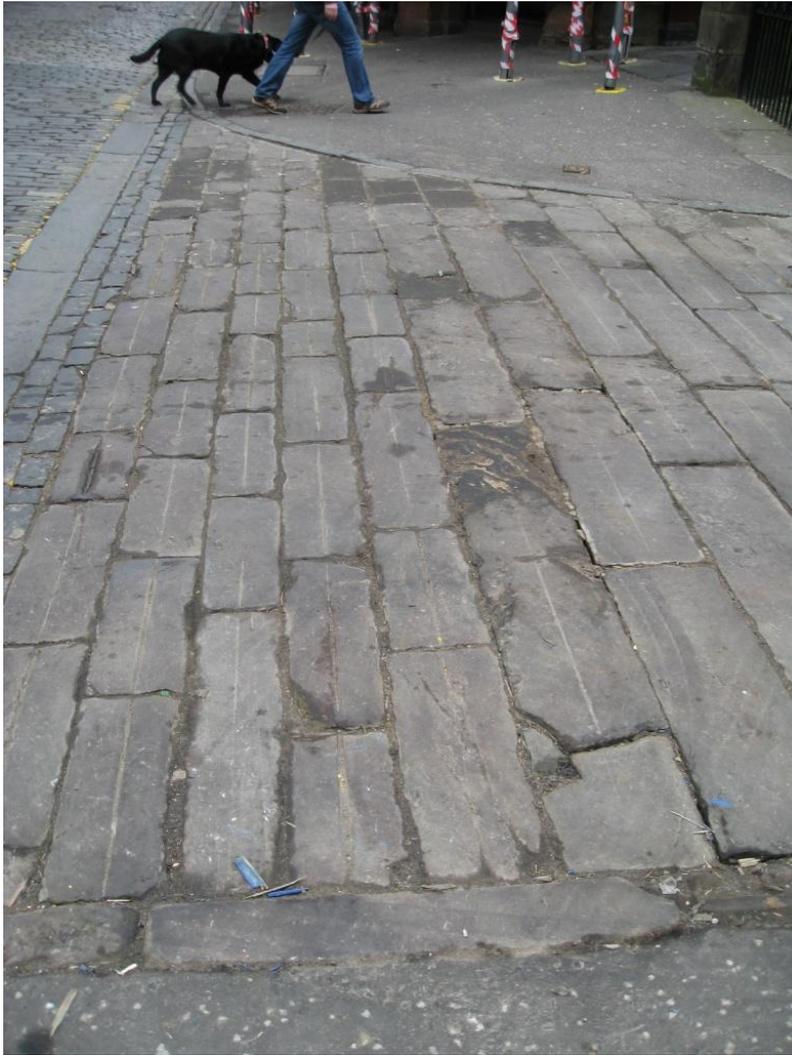
Fig. 37. Part of vehicle entrance to New Register House with sandstone blocks laid on edge, each with a simple tooled groove cut along the block length. This pattern is almost identical to George Heriot's School (Figs. 27 and 28) (3184)

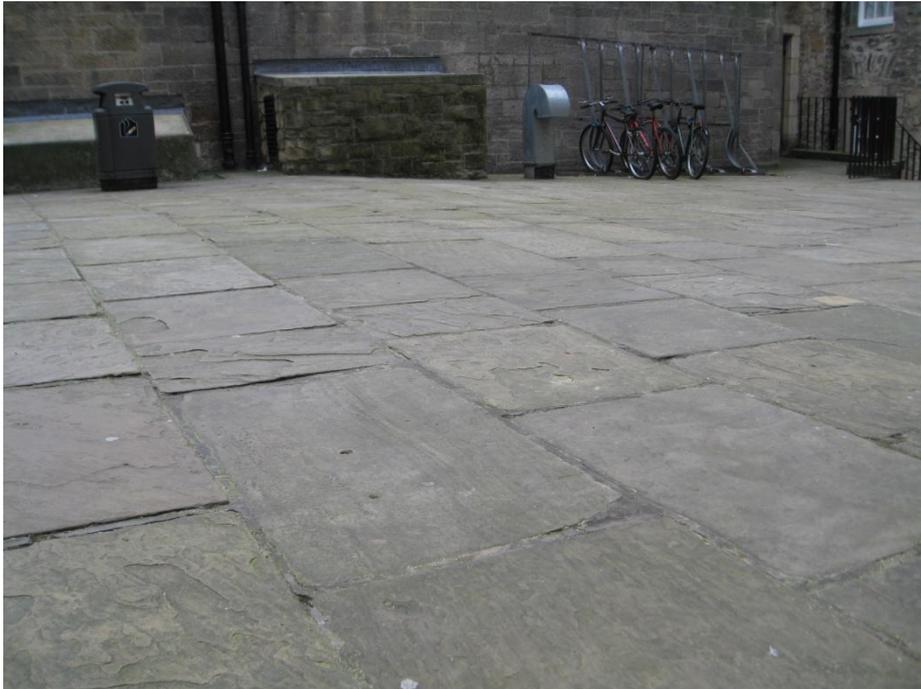
Fig. 38. Sandstone paving, probably re-laid in the 1960s, showing the typical variable appearance and natural 'contoured' surface texture typical of local sandstone such as Hailes. Milne's Close (909)

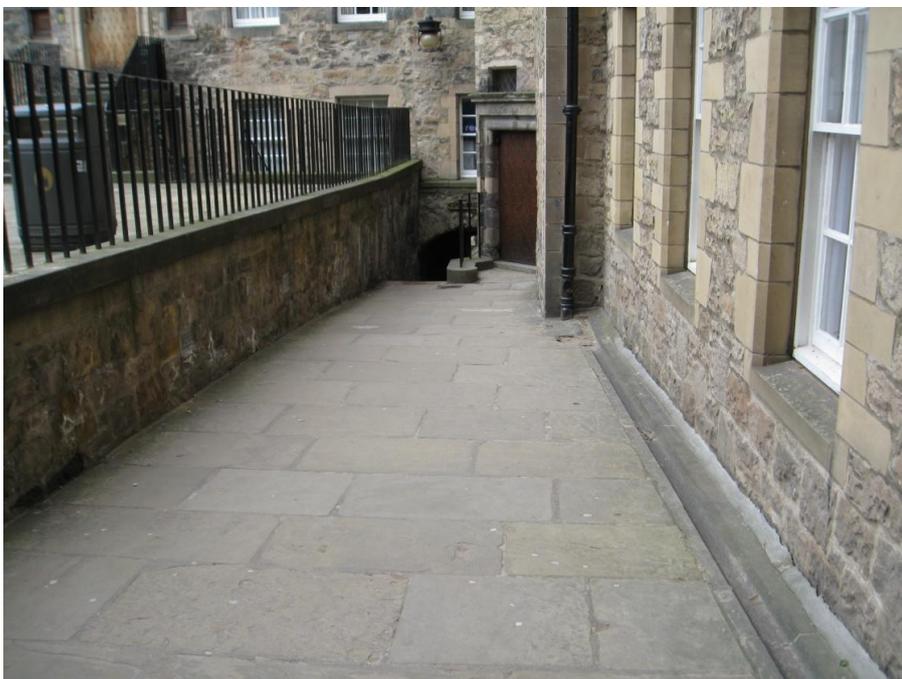
Fig. 39. Sandstone pavement (probably re-laid in the 1960s) with new sandstone dished gutter. The paving flags have the variable appearance typical of local Hailes sandstone. Milne's Close (907)

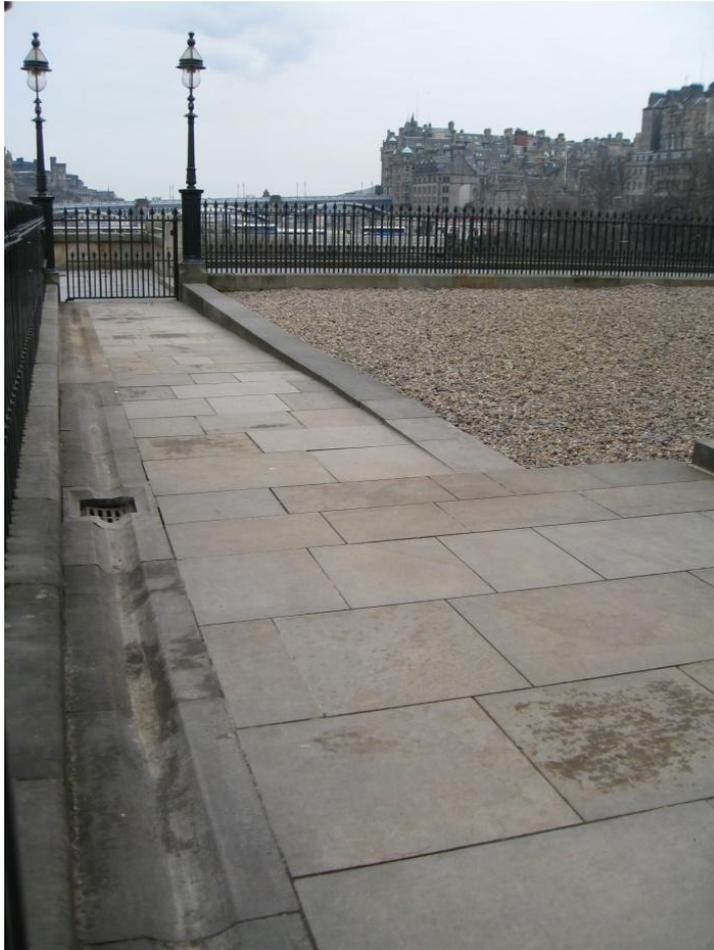
The paved footpath has a dished sandstone gutter along the edge with the railings (Fig. 40). The surfaces of the slabs has a droved tooled finish, replicating hand-tooling observed in original paving at other Playfair localities (Fig. 41). As well as visually reflecting the original finish, this will also add to the anti-slip qualities of the stone.

Fig. 40. General view of recently paved area showing new flagstone footpath, edging to gravel area and dished gutter, all using Clashach sandstone. Note the variable colours in the flagstone paving which resembles historic Hailes sandstone paving. National Galleries (935)

One of the most similar currently-available stone types to the local Edinburgh sandstone –and a stone type that is also suitable for use as paving– is Clashach sandstone from Moray. It has a very similar grain size and composition to Hailes and Craighleith sandstone, and although lacking the ripple bedded texture, it commonly shows varying colours which can give it a similar appearance to weathered and worn Hailes-type sandstone. The recent (2007) use of Clashach paving at the National Galleries illustrates the success of this stone type at replicating the historic Hailes-type pavement (e.g. Fig. 40).

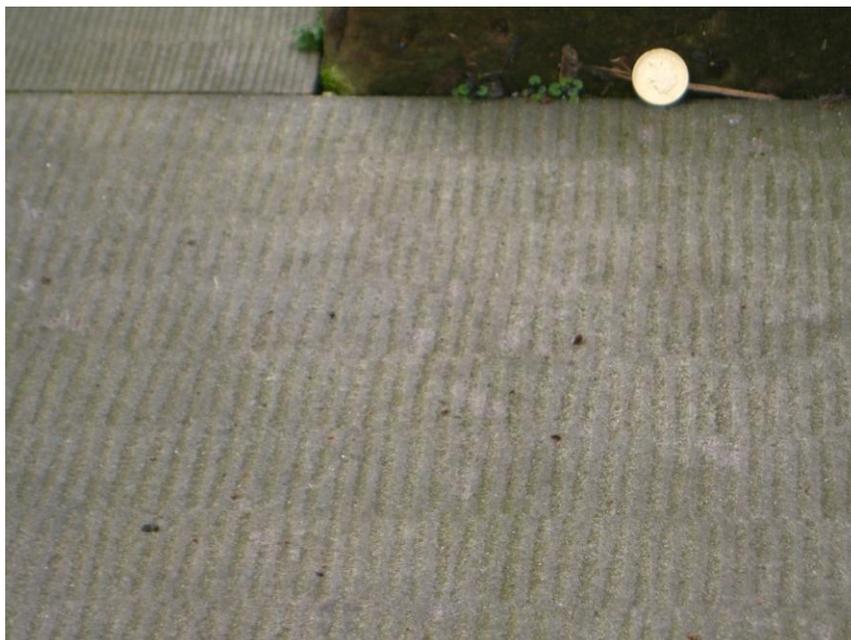
Fig. 41. Detail of surface of replacement Clashach sandstone paving slab, showing hand-tooled droved surface finish, similar to those observed on well preserved examples of original sandstone paving at other Playfair sites. National Galleries (949)

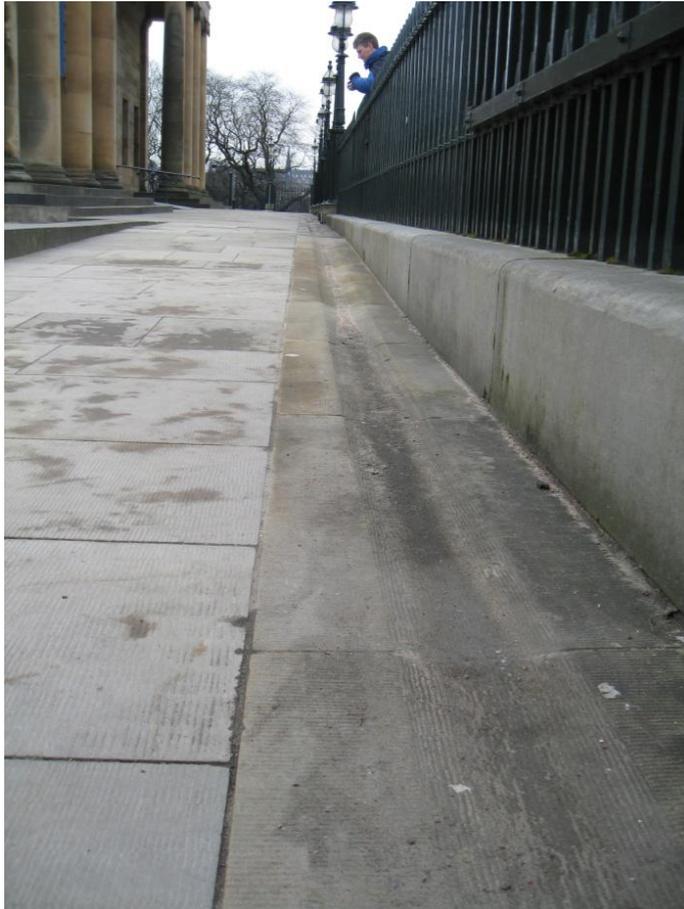
Fig. 42. Replacement sandstone paving showing dished gutter at edge, with hand-tooled droved surface finish. National Galleries (930)

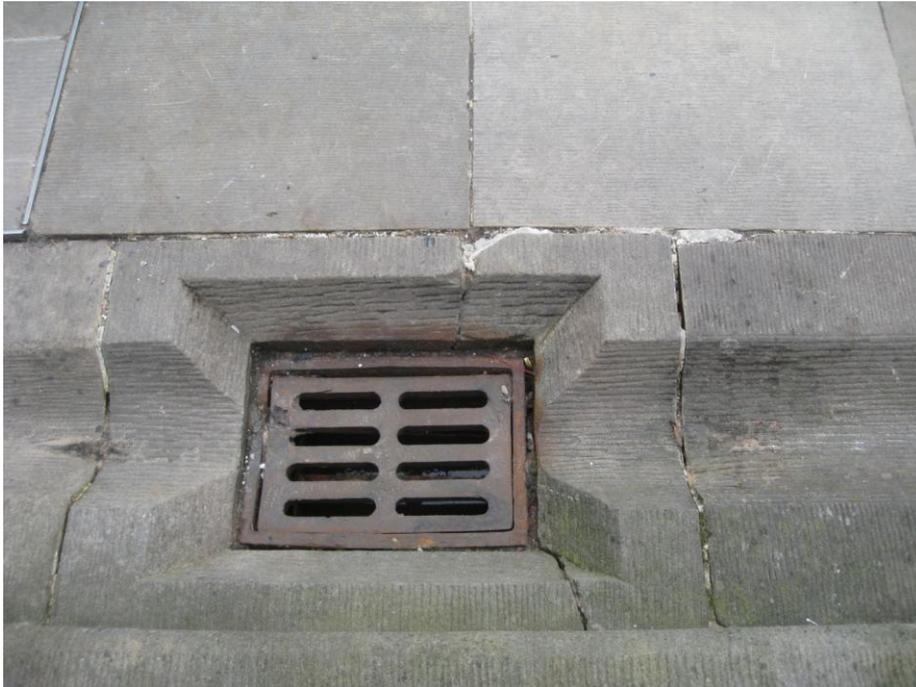
Fig. 44. Well executed masonry detailing around drain in dished gutter in recent paving using Clashach sandstone. Note traditional fine droved tooling finish, replicating that seen on original historic sandstone paving in Playfair schemes. National Galleries (3140)

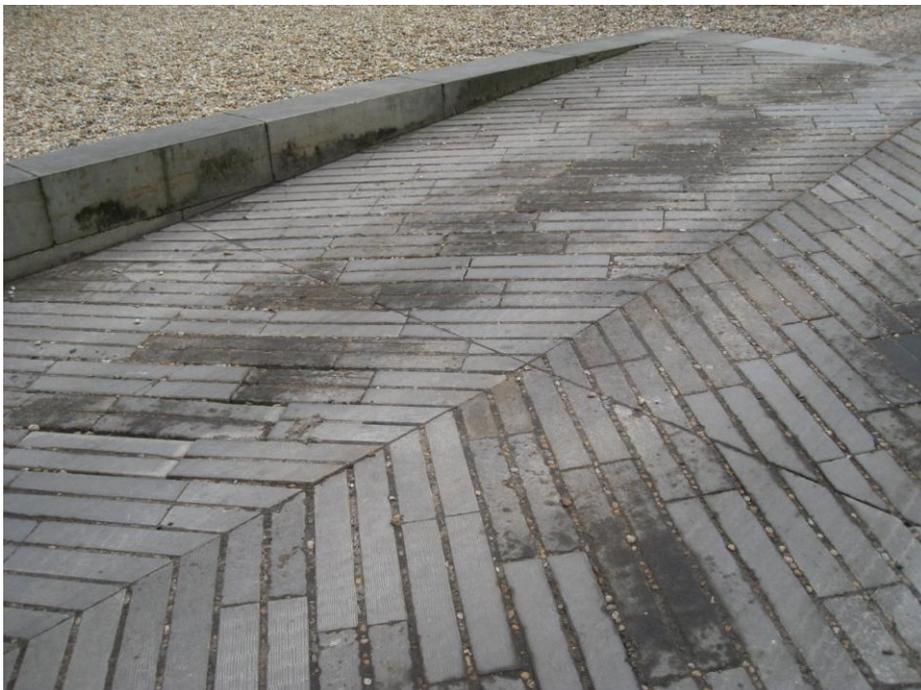
Fig. 45. Vehicle access area executed using elongate sandstone blocks, showing coarse tooling to mimic the historic sandstone setts at entranceways to historic Playfair paving schemes. National Galleries (3144)

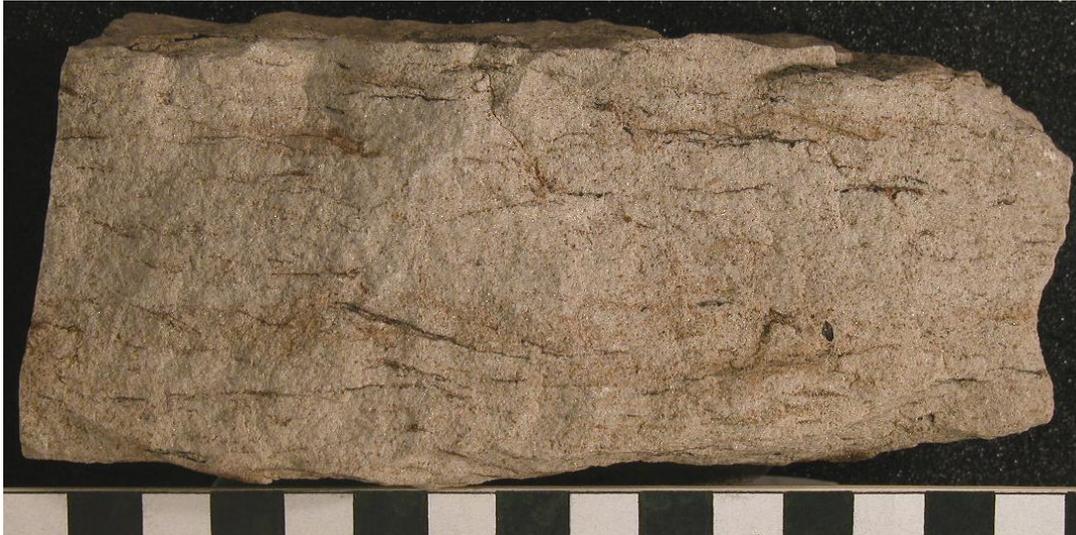
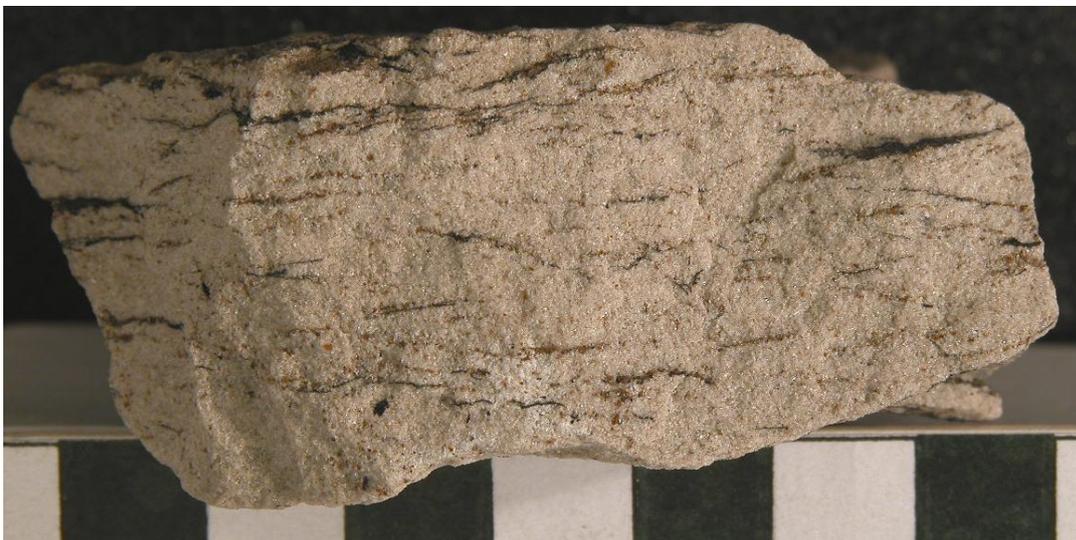
The weathered surface of Hailes sandstone when used as paving is very distinctive with a variable colour ranging from grey to orange-brown, combined with a 'contour-effect' surface pattern created by wearing through different ripple bedding layers. The mechanism for the formation of ripple bedding and its resultant visual effect on the surface of paving slabs is illustrated in Fig. 46. Characteristic examples of Hailes sandstone, showing the ripple bedded textures are shown in Figs 47 and 48.

Fig. 47 (top image): Sample of typical Hailes-type sandstone from paving at Charlotte Square, showing the characteristic irregular dark ripple bedding laminae. Fig. 48 (bottom image): Sample of sandstone pavement from Calton Hill, showing the typical characteristics of Hailes-type sandstone, in particular the presence of irregular dark coloured bedding planes. Scale divisions are centimetres.

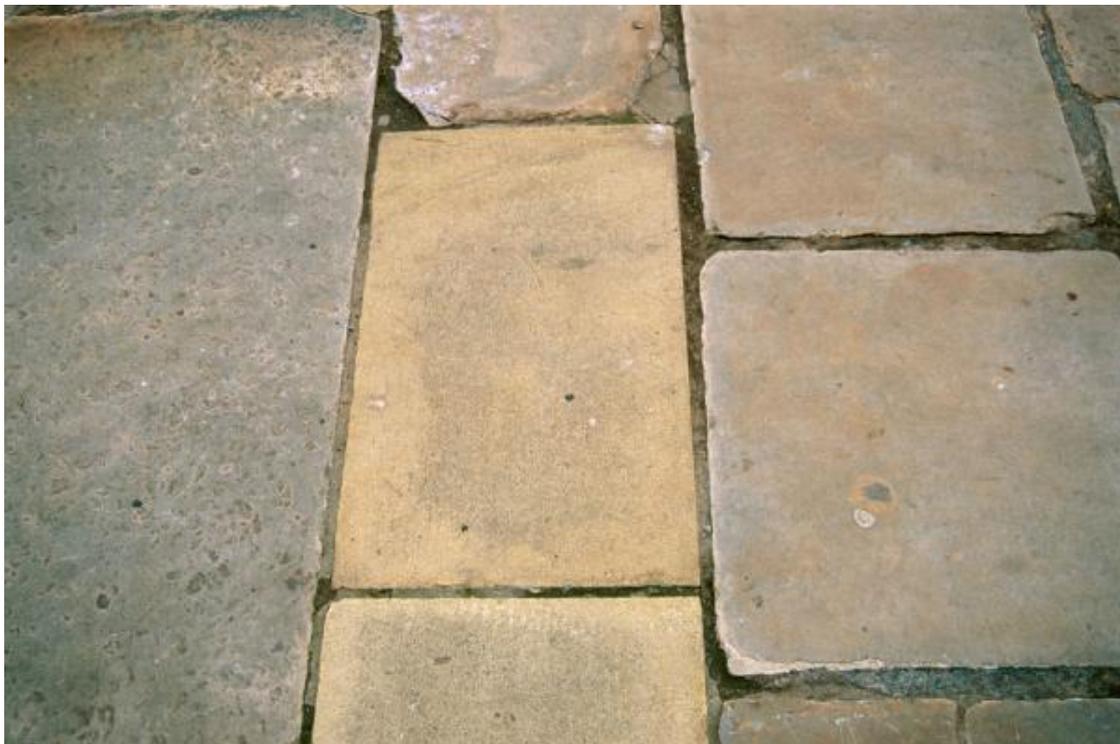
Fig. 49. Small area of modern replacement paving in Charlotte Square, with two slabs of York-type sandstone (centre of image) showing typical uniform, strong yellow-buff appearance, contrasting with the original 'Hailes type' sandstone (to either side) showing a more variable appearance ranging from grey to orange-brown colour.

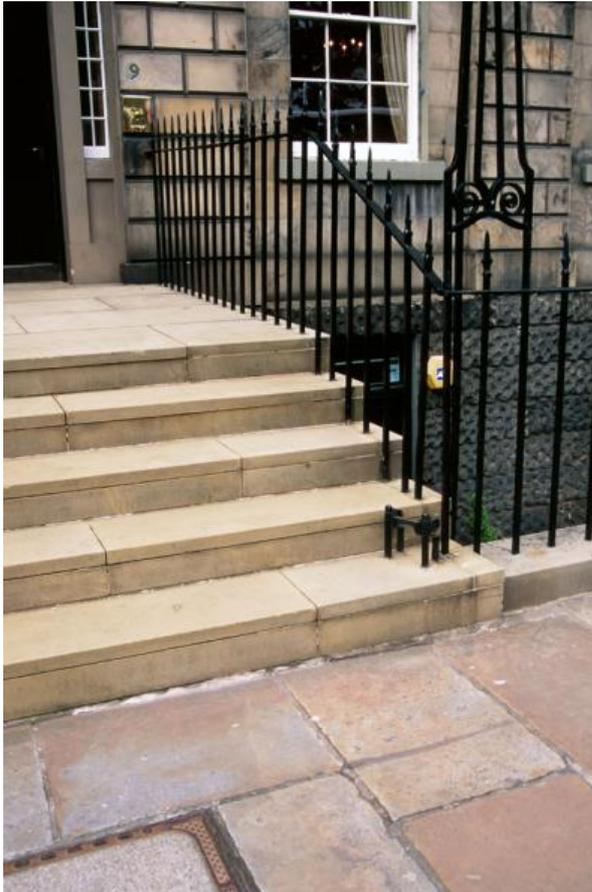
Fig. 50. Use of replacement Yorkshire sandstone as replacement steps adjacent to original 'Hailes type' sandstone paving (Charlotte Square). The typical uniform yellow-buff colour of the York stone contrasts with the more variable and stronger coloured original paving slabs. Note also the poor detailing of the replacement steps, particularly the use of a thin slab.

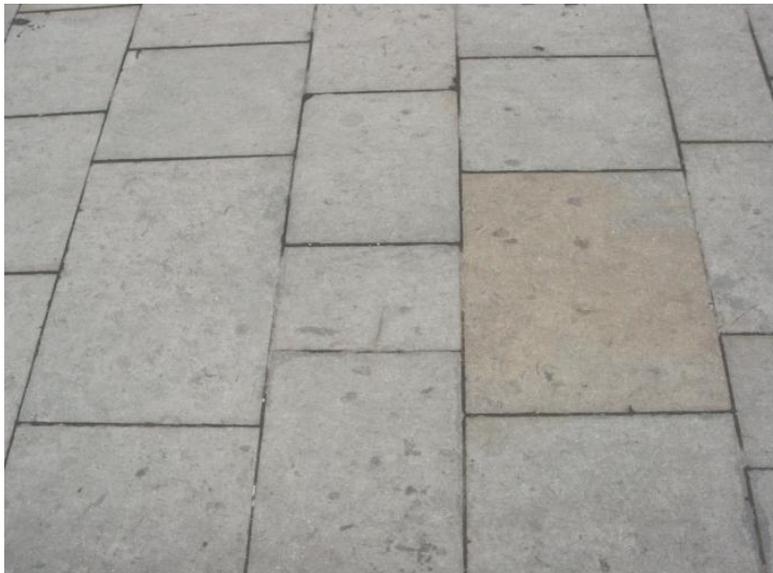
ripple bedded texture resulting in a 'contoured' surface to paving slabs, and has been used successfully in several parts of Edinburgh (e.g. Waverley Bridge, Fig. 51). However, Scoutmoor sandstone generally has a finer grain size and a more grey colour, although bands of orange iron staining can give it a variable appearance.

Fig. 51. Modern natural stone pavement on Waverly Bridge, typical of sandstone from Scout Moor quarry. This stone type has some similar characteristics to historic Hailes-type sandstone paving used in Edinburgh, in particular a variable colour from pale grey to orange-brown and the presence of bedding planes on the surface providing a 'contour surface' effect.
