THE BUILDING STONES AND SLATES OF KILLIN

an investigation of stone for the built heritage

GEOREPORT GR_138832_1

E.K. Hyslop, E.A. Tracey, L.J. Albornoz-Parra, P. Everett, S.F. Parry & A.B. Custance-Baker. 2010. A Building Stone Audit for Killin *British Geological Survey GeoReport*, GR_138832_1.

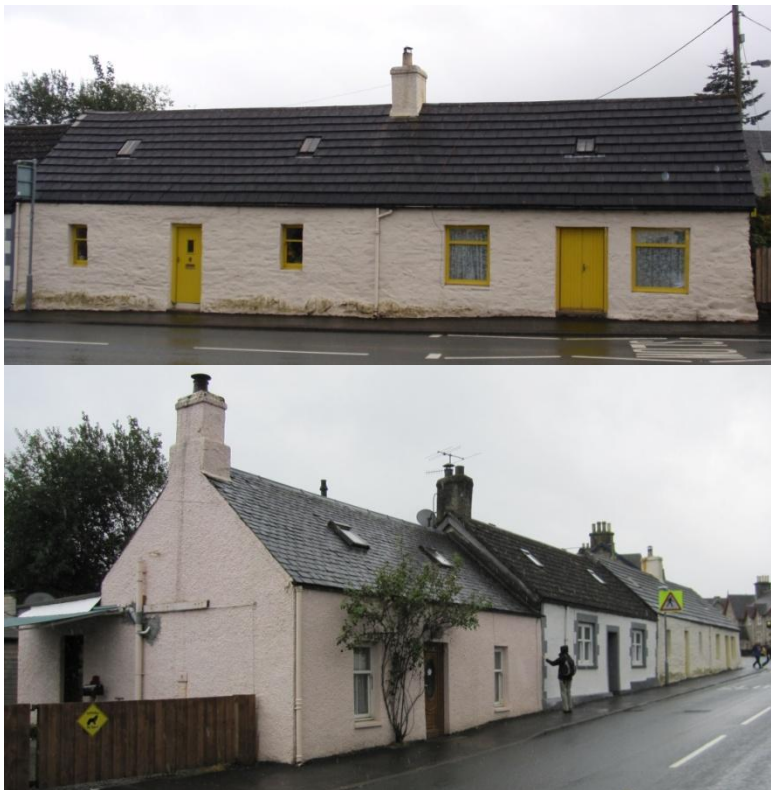
These form some of the earliest buildings in the village (probably 18th century), constructed from random rubble of local stone and boulders; now all harled and painted. Many of the cottages are characterised by large boulder footings present at base of walls, a feature commonly used in very early cottages to help protect the structure from damp from the ground (as well as providing strong foundations). Alterations to the cottages over time have resulted in a break-up on the uniform appearance of the buildings which masks their historic origins. The cottages on Grey Street are masked by modern additions, replacement windows and harling, but show early features such as large boulder footings at base of walls and presence of thackstones on chimneys (suggesting original thatch roofing).

Fig. 7: Early cottages on Main Street, typical of Type 1 masonry.

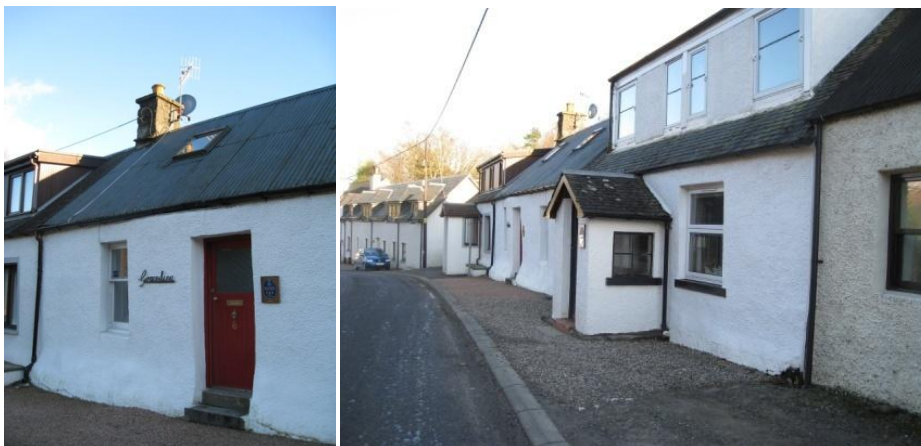
Fig. 8: Early Type 1 cottages on Gray Street (No. 7 and 'Gracedieu'). Note the protruding large boulder footings at the base of the walls.

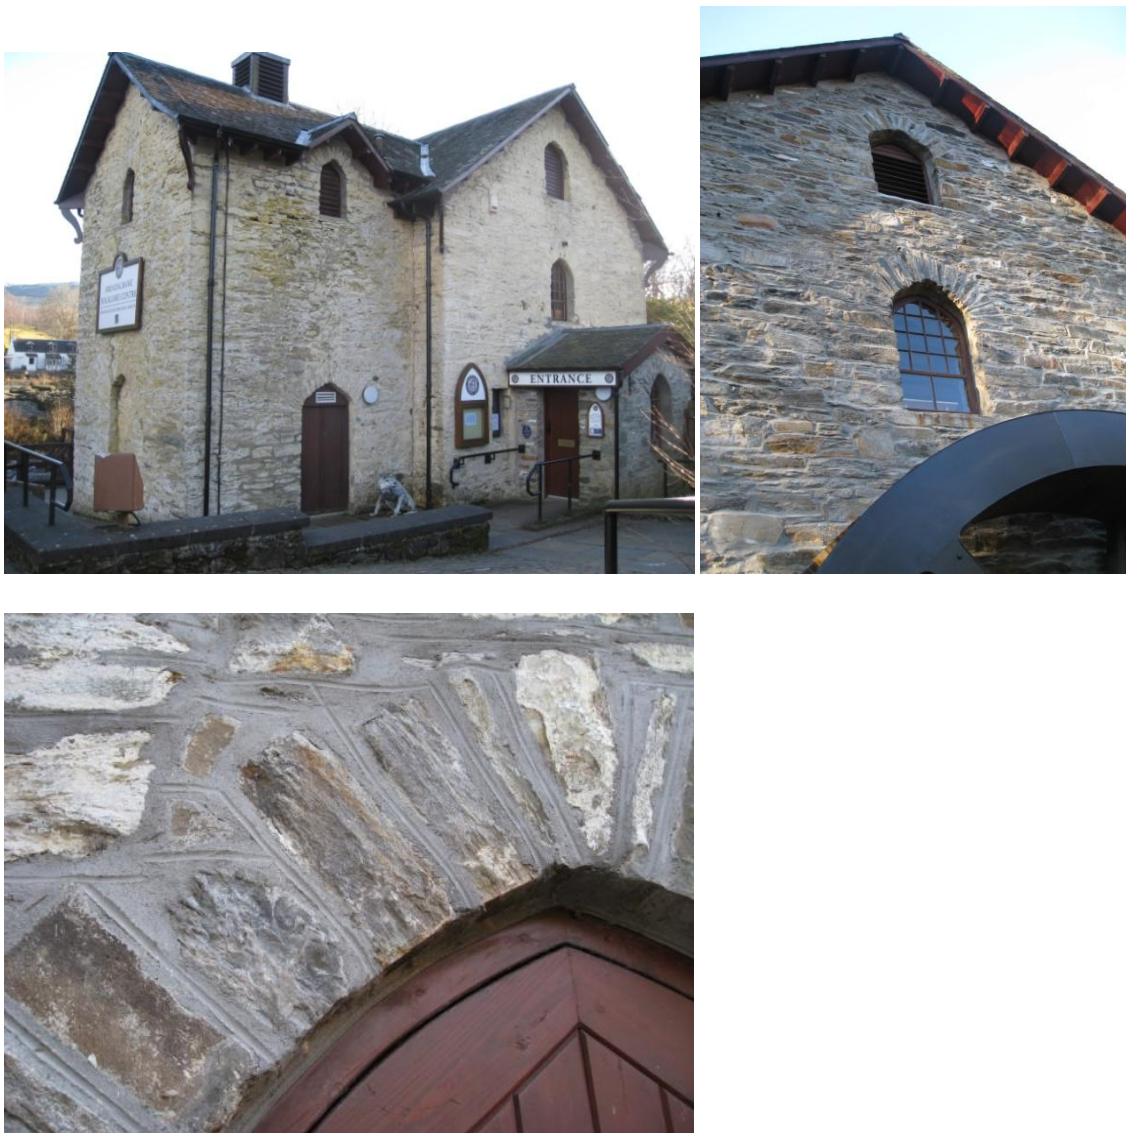
Killin Mill (Fig. 9)

This building is likely to have been originally harled but has been stripped to expose the original Type 1 masonry. It is believed that the current (B-listed) building was built c.1840 on the site of an earlier structure founded by St Fillan in 700AD. It is constructed of simple random rubble walling, dominated by slabs of flaggy mica schist, of relatively small block sizes. There are minimal dressings consisting of the same flaggy schist typically laid on end to forming arched surrounds to openings. The stone is identical to the rocky outcrops in the adjacent river bed, and is likely to have been obtained from this locality. The building has previously been painted, or possibly lime washed or harled at one time. A relatively recent porch addition appears to be constructed from reclaimed local stone with much cement pointing (the latter also characterising recent repairs to the main building).

Fig. 9: Killin Mill showing exposed Type 1 masonry dominated by flaggy mica schist, used as random rubble walling and for dressings around openings. Note the over-use of cement pointing for recent repairs which detracts from the original stonework.

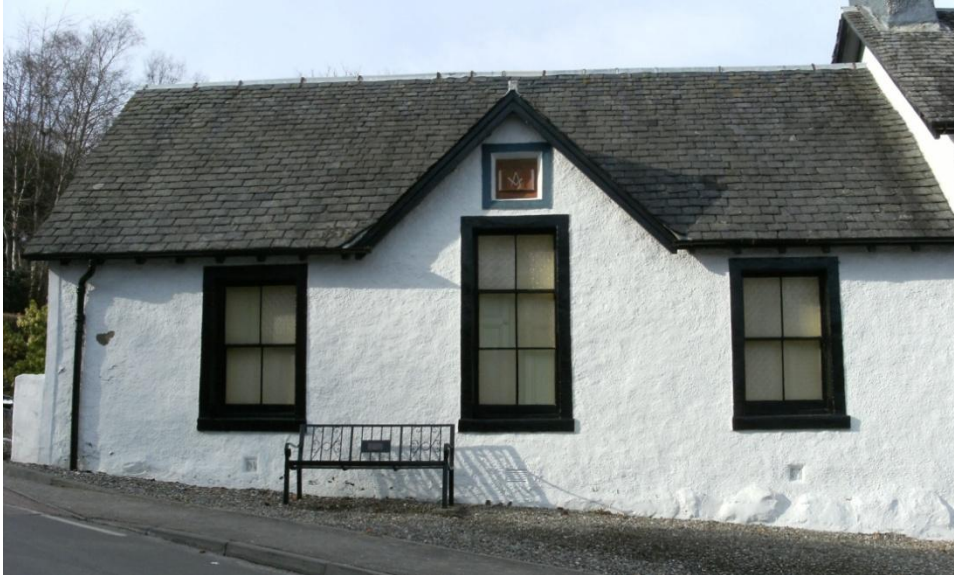
Fig. 10: Masons Hall (Manse Road), likely to be constructed of Type 1 rubble with harling. Note the prominent boulder footings to the wall.

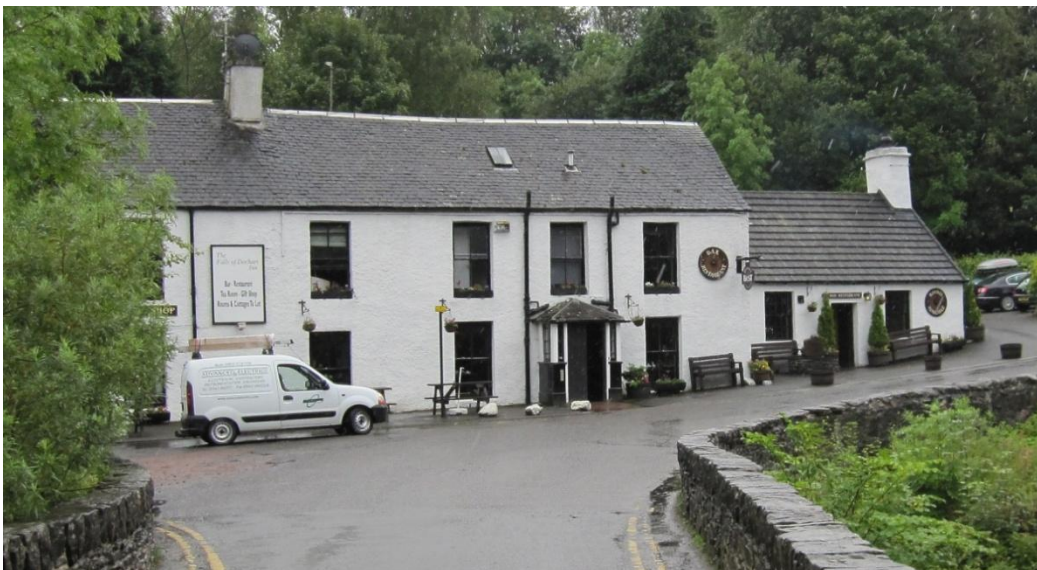
Fig. 11: The Falls of Dochart Inn, likely to be constructed from Type 1 masonry.

Other buildings constructed from this type of stone include Masons Hall on Manse Road (Fig. 10) and the Falls of Dochart Hotel (Fig. 11).

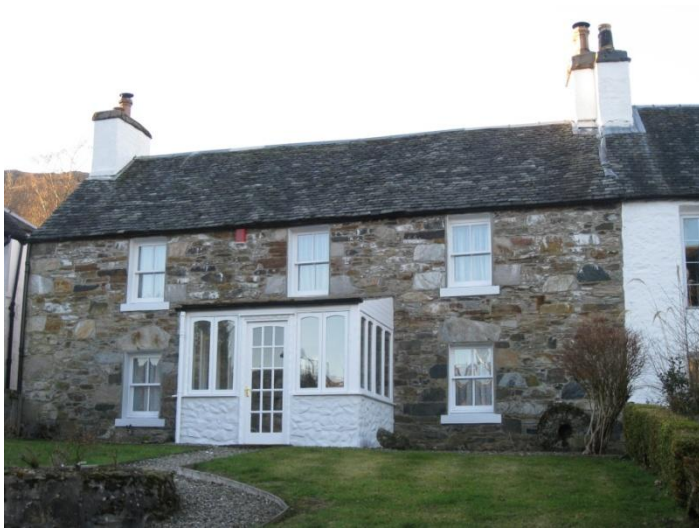
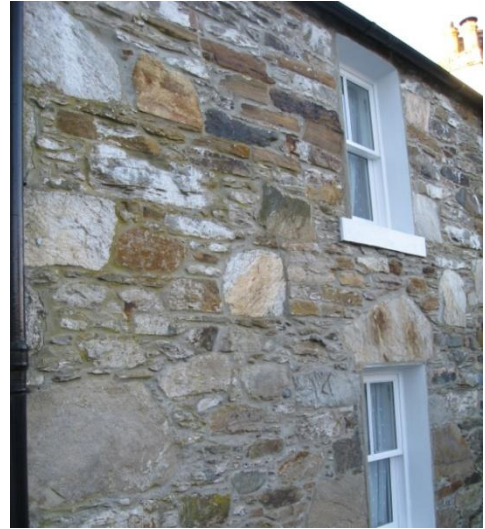
Fig. 12: 'Birchbank', the southernmost of a B-listed terrace of late 18th century two-storey housing at the south end of Main Street, showing random rubble walling with distinctive large silver-grey actinolite schist dressed stone around windows and at corners.

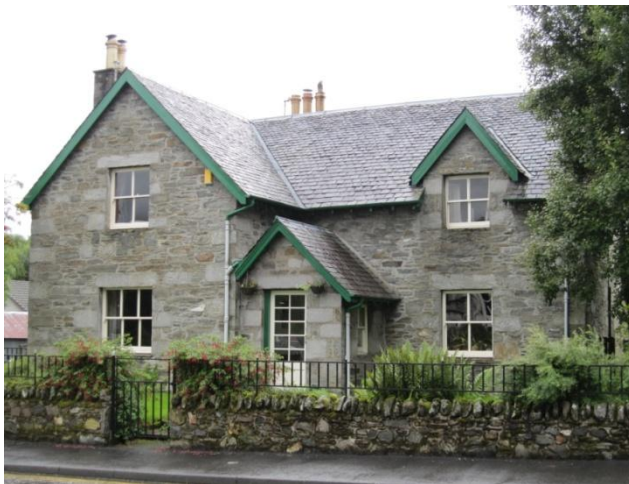
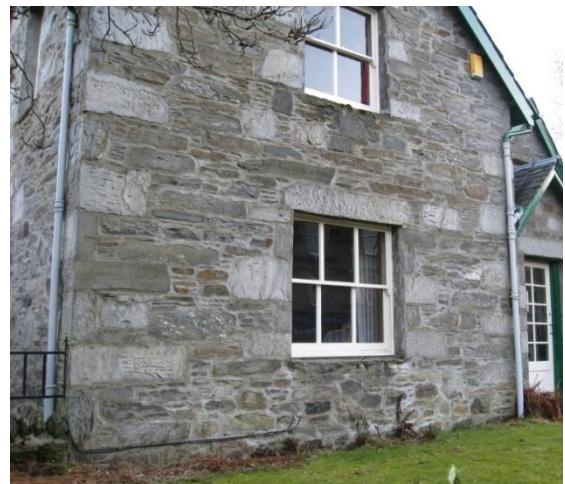
Fig. 13: 'Loch Tay Cottage', north end of Main Street, constructed from irregularly coursed rubble walling of mica schist and meta-psammite, with distinctive large silver-grey coloured dressings of actinolite schist. The size, shape and consistency of the latter suggests that the actinolite schist has been specifically quarried and dressed.

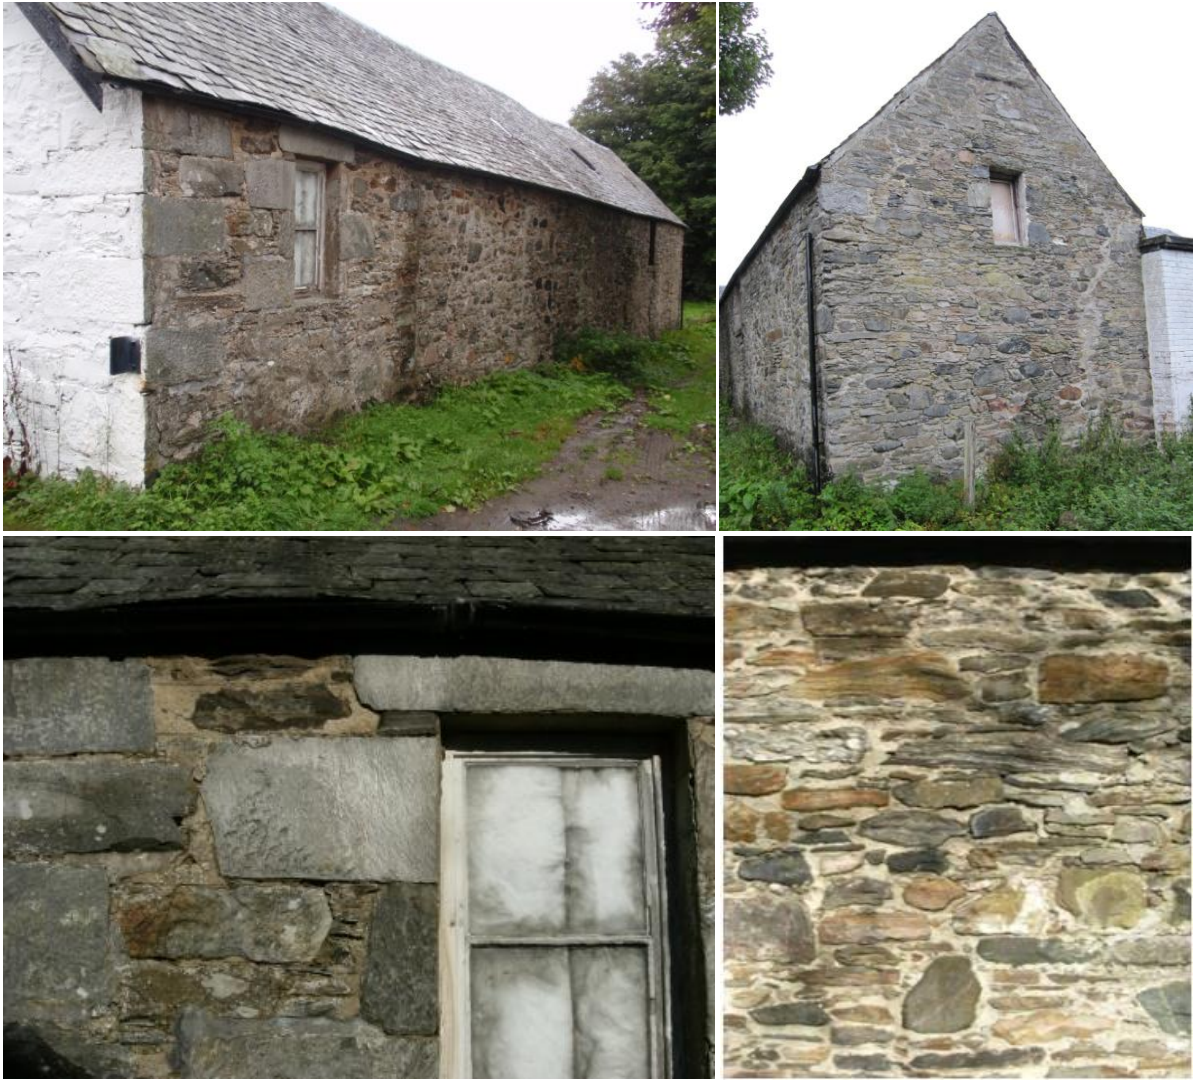
Fig. 14: 'Low status' service buildings adjacent to the Killin Hotel showing 'informal' random rubble walling (mostly mixed mica schist and assorted boulders) with higher quality dressings of actinolite schist. The dressings have been carefully worked to give roughly squared block with flat outer surfaces.

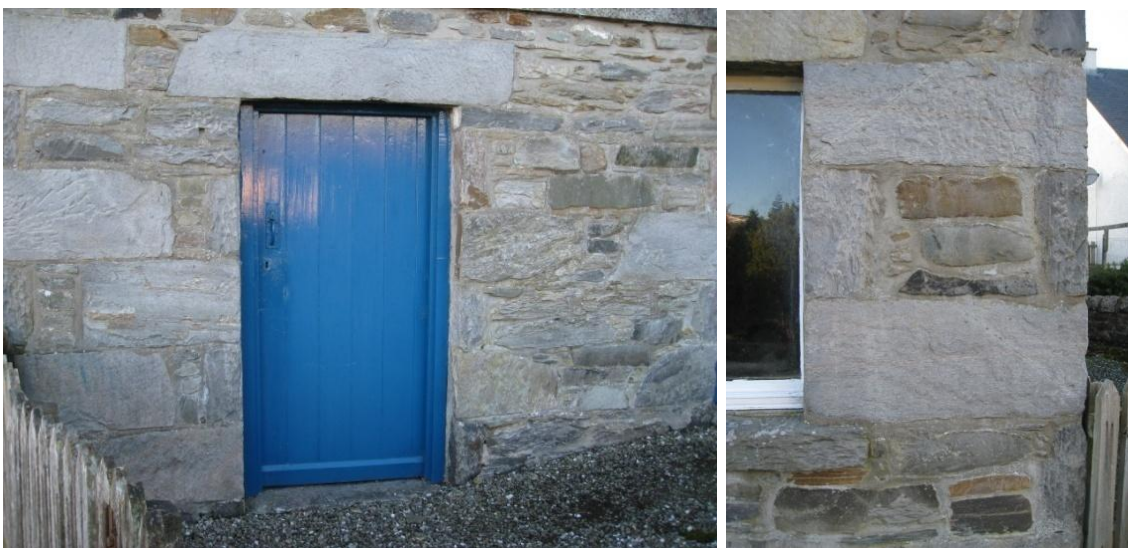
Fig. 15: Detail of Type 2 masonry on the coach-house behind the Tighnabruaich Hotel, showing large squared blocks of actinolite schist used for dressings, with roughly chiselled surfaces. The random rubble walling is a mixture of local mica schist, meta-sandstone and actinolite schist.

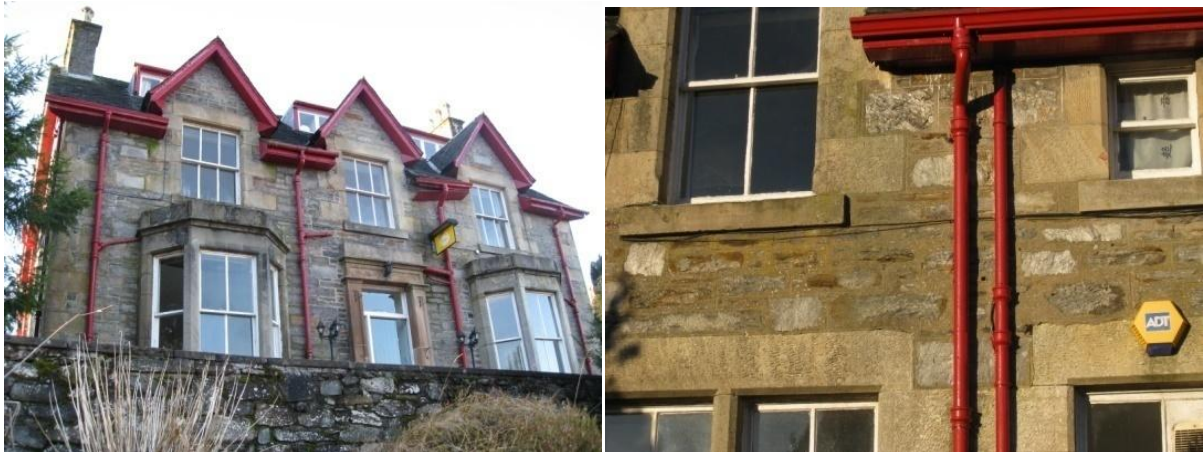
Fig. 16: Tighnabruaich Hotel (Main Street). Constructed using irregularly coursed actinolite schist and squared rubble walling on the front elevation, with mixed mica schist and meta-sandstone random rubble on the sides and rear elevation (right-hand image). The dressings are imported blonde sandstone. Note the presence of bay windows and large window openings on upper floor made possible by the large block size of the sandstone (such spans would not have been possible in earlier buildings using the local stone).

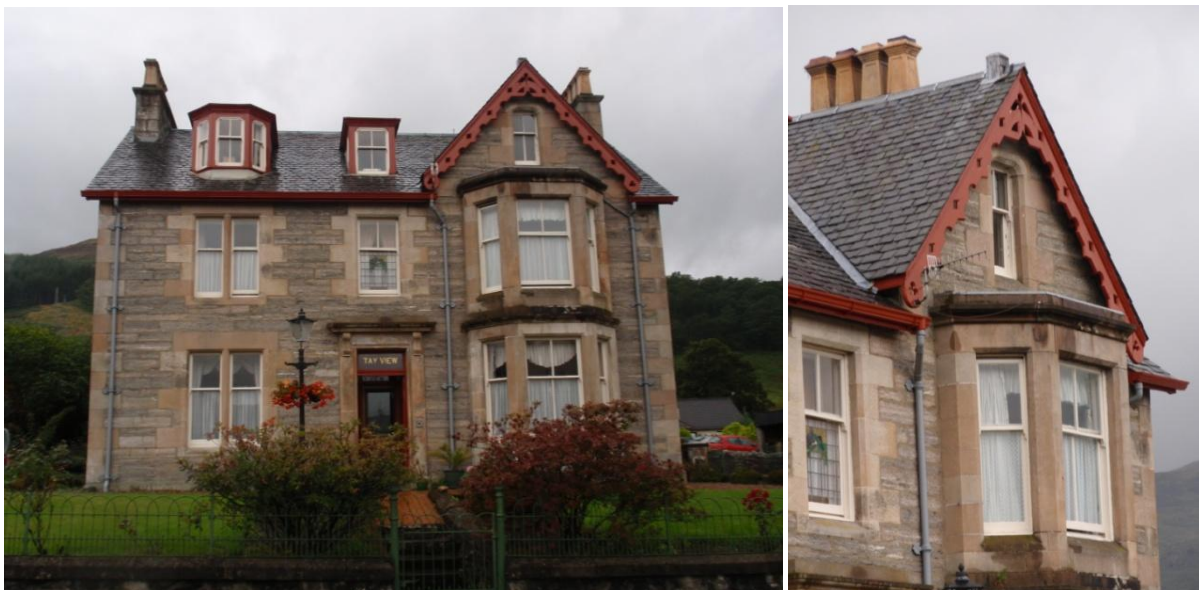
Fig. 17: Tay View House (Main Street). Constructed from irregularly coursed and squared actinolite schist rubble with blonde sandstone dressings on the front elevation. The gable ends are mixed mica schist and meta-sandstone rubble.

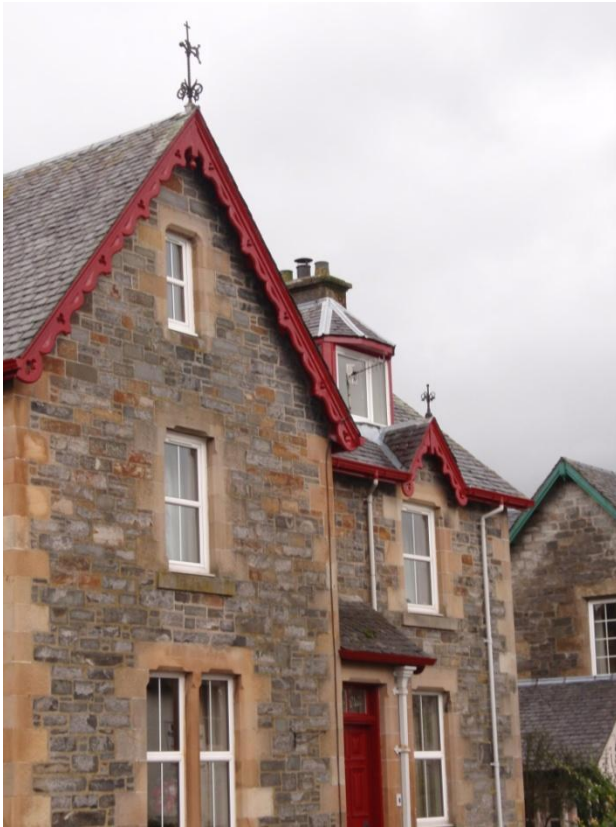
Fig. 18: Fingal Villa (Main Street). Constructed using squared and irregularly coursed actinolite schist rubble walling with sandstone dressings. The variable colour of the rubble masonry is due to the presence of natural iron staining on the surfaces of some blocks.

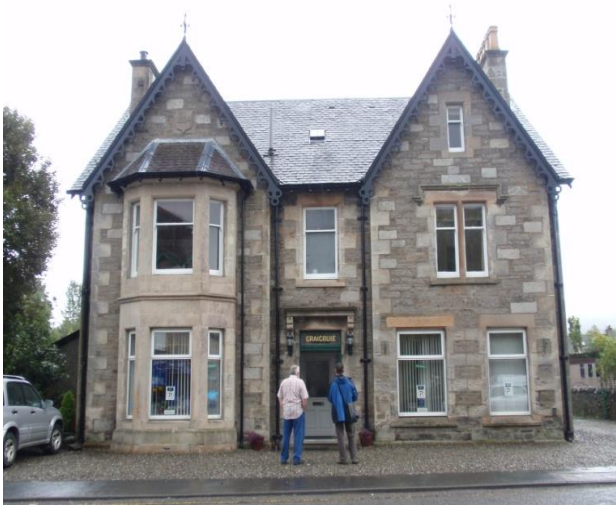
Fig. 19: 'Craigbuie' (Main Street). Showing squared and irregularly coursed actinolite schist rubble on front elevation with sandstone dressings. Side and rear elevations are mixed mica schist rubble. Note the occasional silver grey squared rubble block of actinolite schist which has been placed 'on edge'.

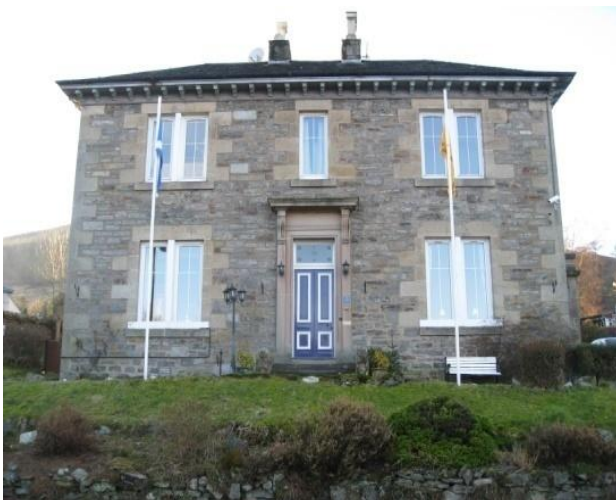
Fig. 20: Drumfinn House (Main Street). Constructed from squared and irregularly coursed actinolite schist on front elevation, with sandstone dressings. Gable ends mixed mica schist and meta-sandstone.

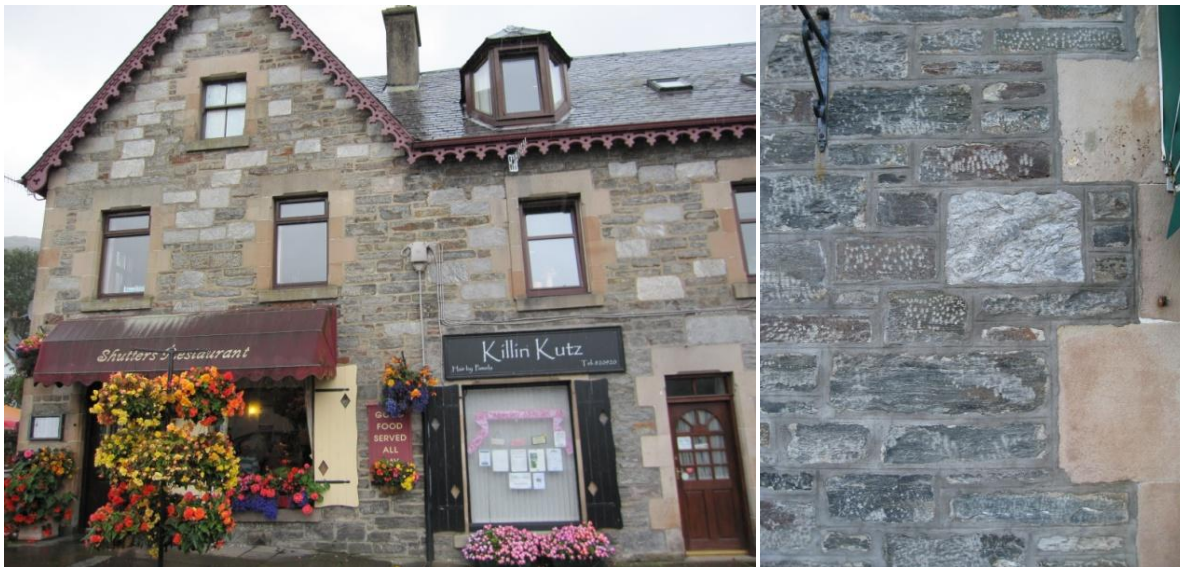
Fig. 21: 'Craiglea' (Main Street), constructed using irregularly coursed rubble of mixed actinolite schist and mica schist walling, with imported blonde sandstone dressings. The walling is characterised by occasional silver-grey squared rubble blocks where the actinolite schist has been placed 'on edge'. Detailed image shows contrast between grey actinolite schist rubble and large sandstone dressings (the latter with pale orange-brown weathering). Note also the point-tooling to the dark natural joint surfaces of the schist, revealing the light silver-grey colour of the fresh stone beneath.

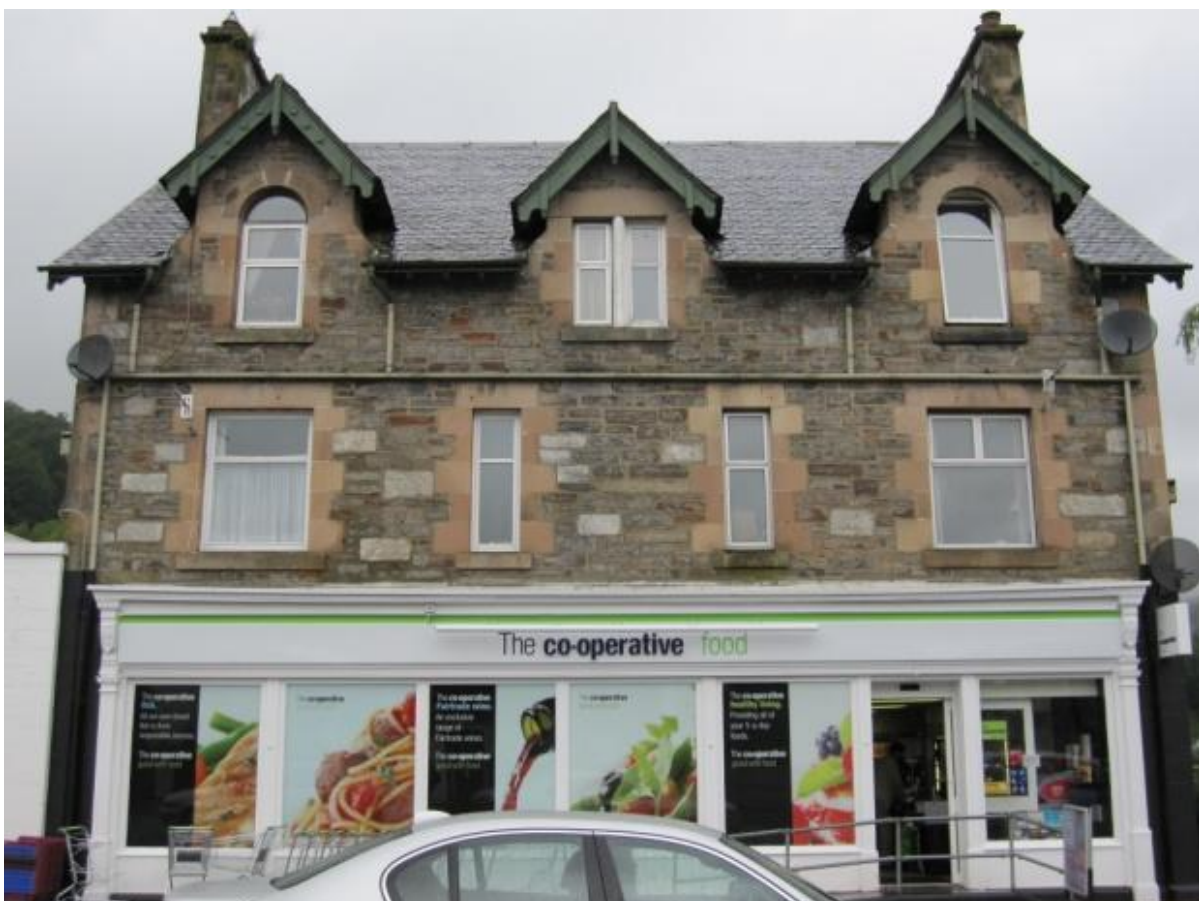
Fig. 22: 'Fassifern' (Main Street), constructed using irregularly coursed squared actinolite schist rubble (note occasional silver-grey blocks 'on edge'), with blonde sandstone dressings. Note the relatively large window openings made possible by the large sandstone blocks, contrasting with earlier buildings in the village using only local stone.

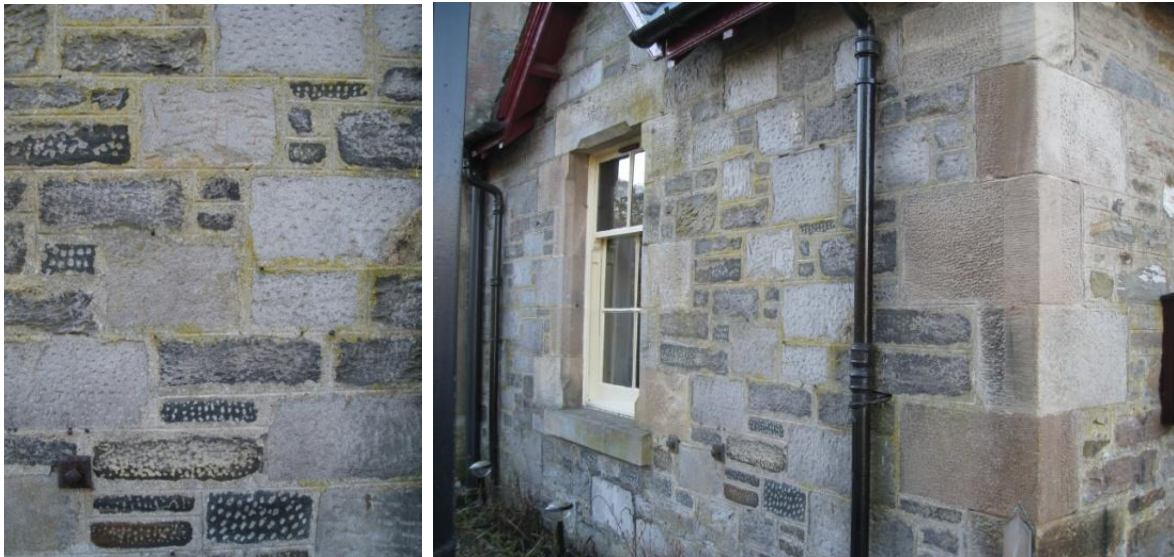
Fig. 23: Smiddy Restaurant (corner of Main Street and Riverview), showing front elevation walling of irregularly coursed, squared actinolite schist rubble with a point-studded tooled finish. Note the characteristic silver-grey colour of the actinolite schist when laid 'on edge', and the dark grey-brown colour when laid 'on bed'. The gable ends (and entrance) consist of the Type 1 random rubble mixture of mica schist, meta-sandstone, whinstone and quartz vein. The dressings are imported blonde sandstone, with punched tooling and drafted margins.

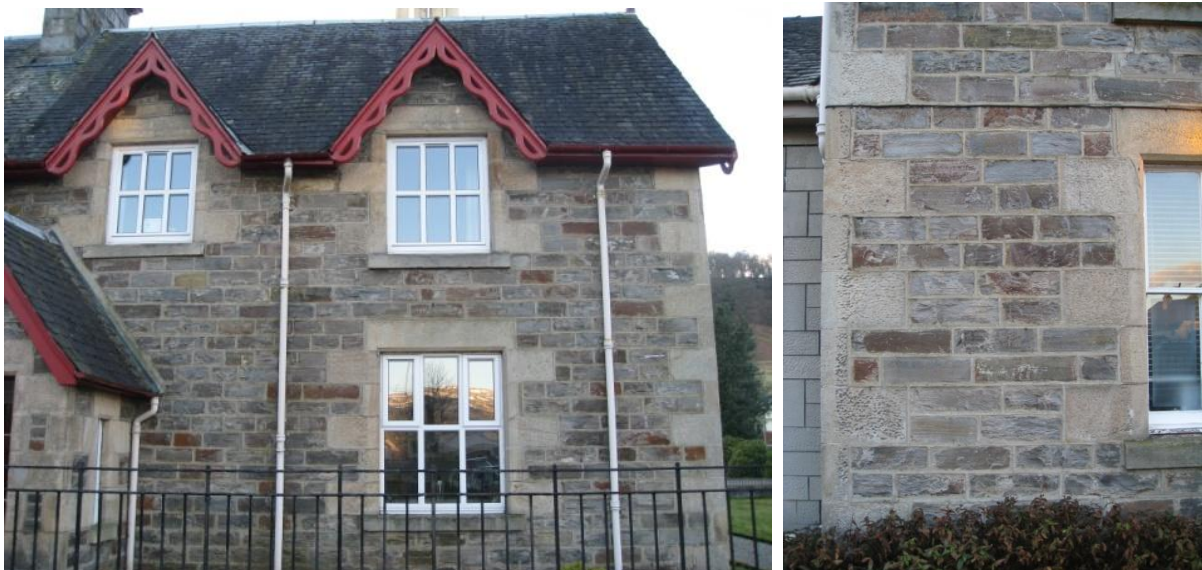
Fig. 24: Bank of Scotland (Main Street). Constructed of Type 4 masonry with regularly coursed squared meta-sandstone rubble and blonde sandstone dressings. The meta-sandstone varies in colour from grey (fresh surfaces) to orange-brown (natural iron staining along joint surfaces). The extension on the south side of the building is cement block tooled to look like stone.

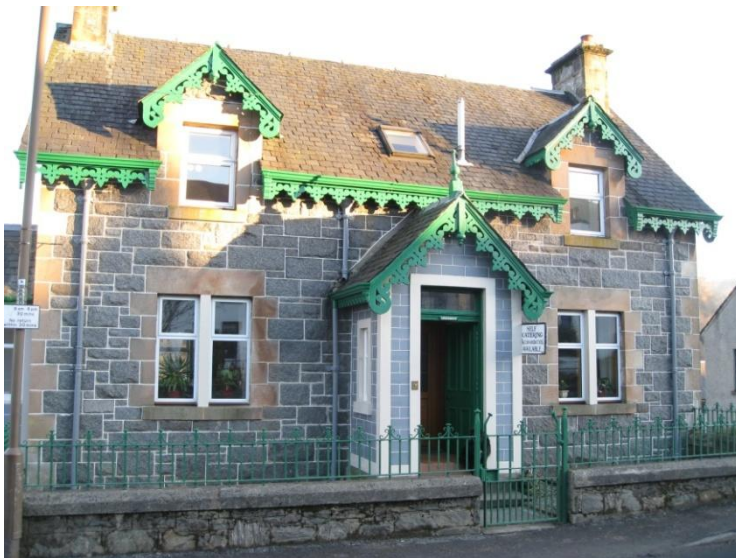
Fig. 25: 'Greenbank' (Main Street), constructed using irregularly coursed, squared rubble of dark grey uniform basic igneous rock of unknown origin (imported into the village). Dressings are imported blonde sandstone, weathered to a pale orange-brown colour. The gable ends of the building are local mica schist and meta-sandstone rubble.

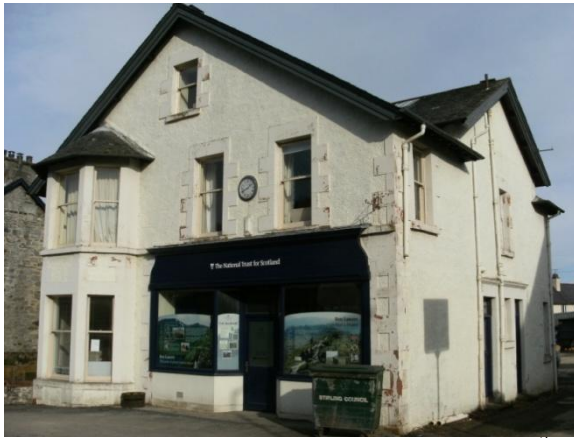
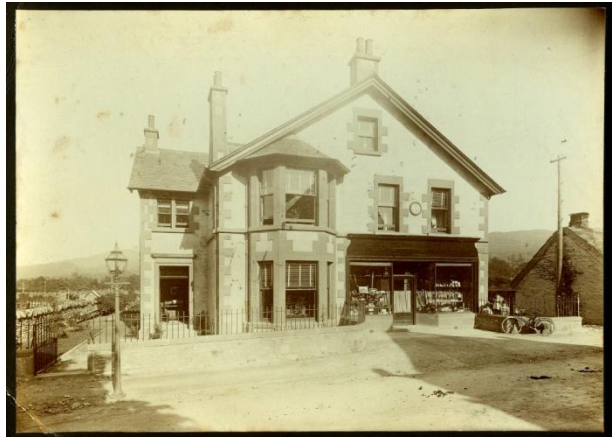
Fig. 26: 'Lynedoch' (Main Street), a C(s) listed, late 19th century building (currently National Trust Offices). The dressings (painted) are a fine grained red sandstone of probable Corsehill/St Bees type, probably imported by rail from the south of Scotland. The walling is harled and unexposed (and therefore cannot be ascertained without further investigation). The historic photograph of Lynedoch (unknown date, Killin Heritage Group) illustrates the once exposed red sandstone dressings.

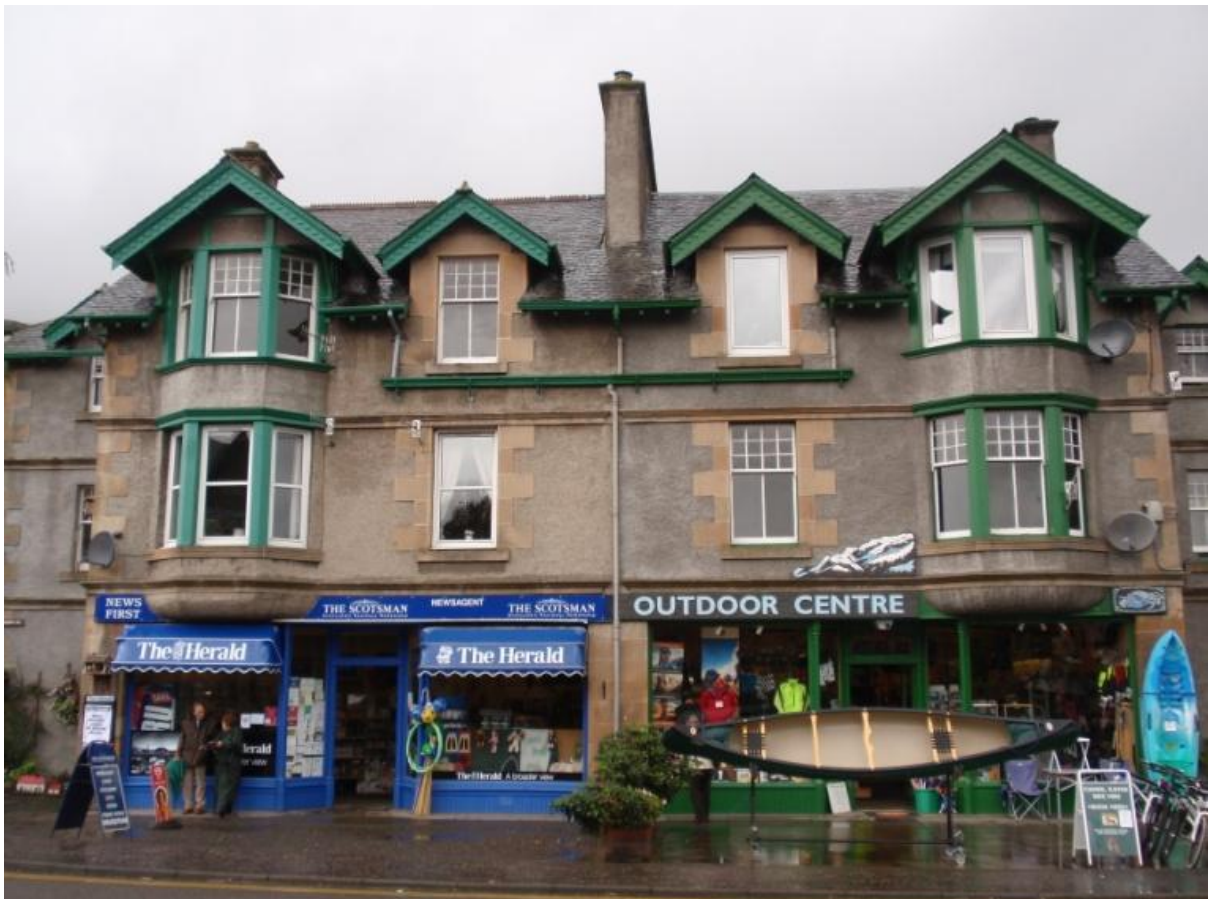
Fig. 27: Dreadnaught Buildings (Newsagent & Outdoor Centre, Main Street), a C(s) listed tenement building constructed c.1898. The walling material is obscured by cement render, with imported blonde sandstone dressings (window surrounds, quoins, moulded string courses and ground floor masonry).

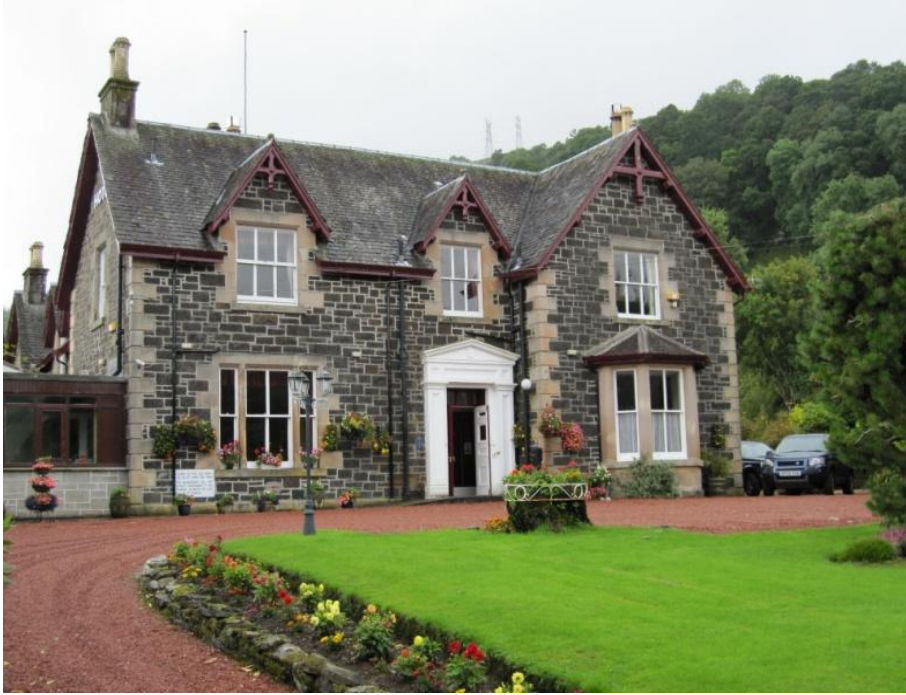
Fig. 28: Dall Lodge Country House, constructed using irregularly coursed squared and snecked whinstone with imported blonde sandstone dressings. Sources of whinstone are present in the district (e.g. the metabasite quarry at Fearnan on Loch Tay)

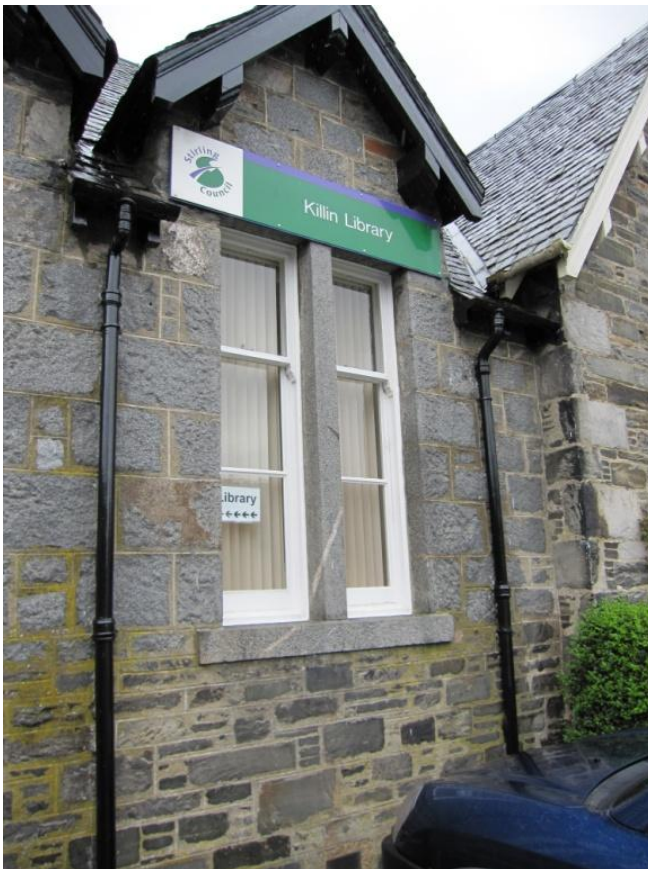
Fig. 29: Killin Library is built using local meta-sandstone squared and snecked rubble, with dressings of grey granite allowing particularly large spans to the windows. The very long lengths of granite suggest it has been imported from elsewhere in Scotland (e.g. Aberdeenshire).

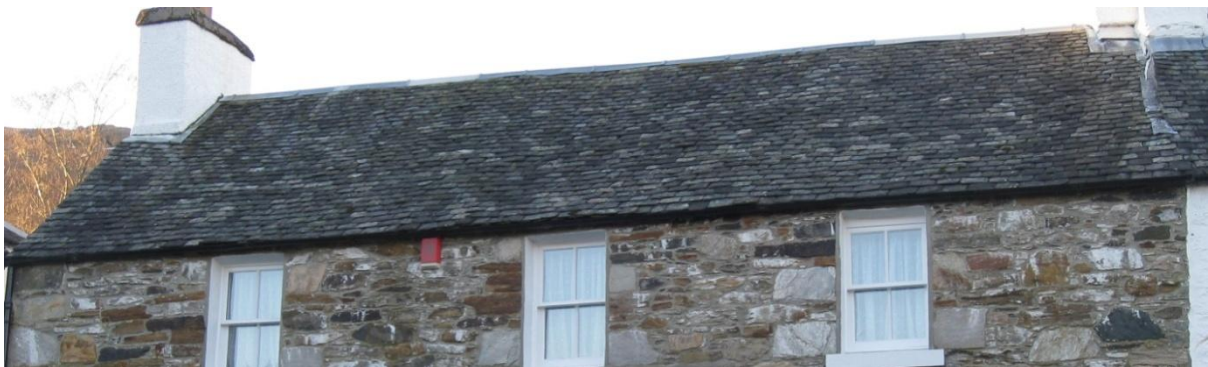
Fig. 30: Birchbank (Main Street). Highland Border slate roof with typical rough texture and variable grey colour, characteristic of this slate type.

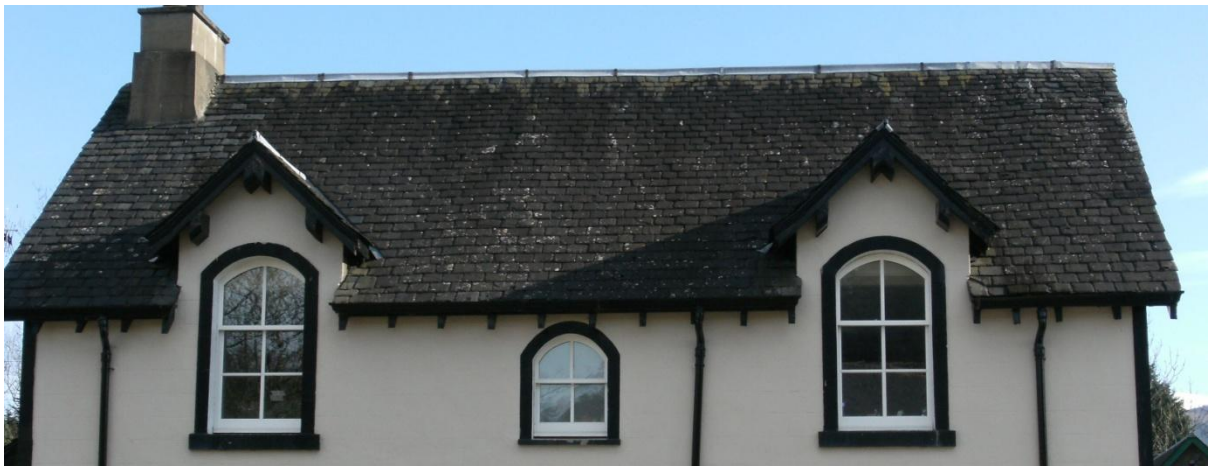
Fig. 31: Larachbeg, Main Street showing dark grey rather dull 'sooty' appearance typical of Highland Border slate

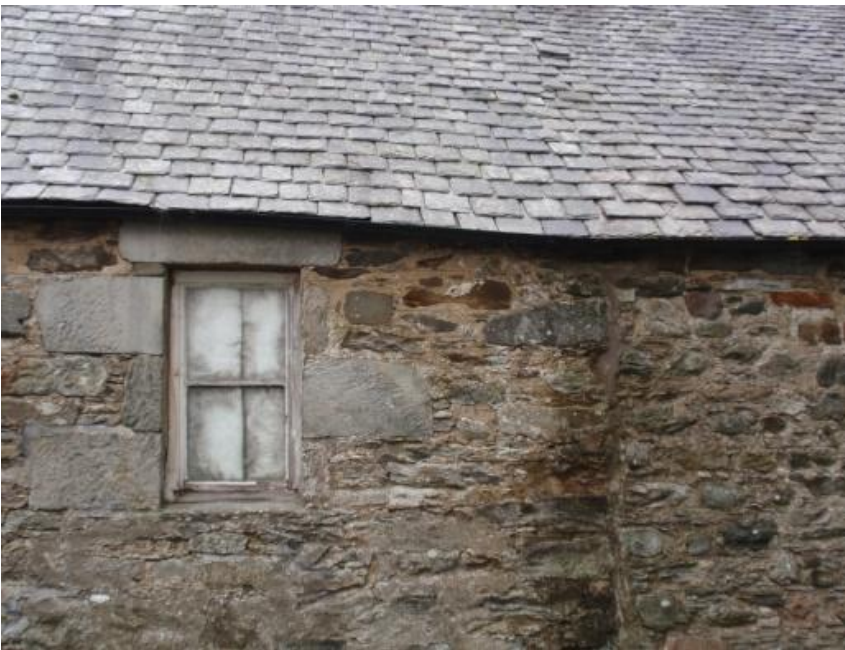
Fig. 32: Service buildings at side of Killin Hotel with Highland Border slate showing typical rough surface texture and irregular widths.

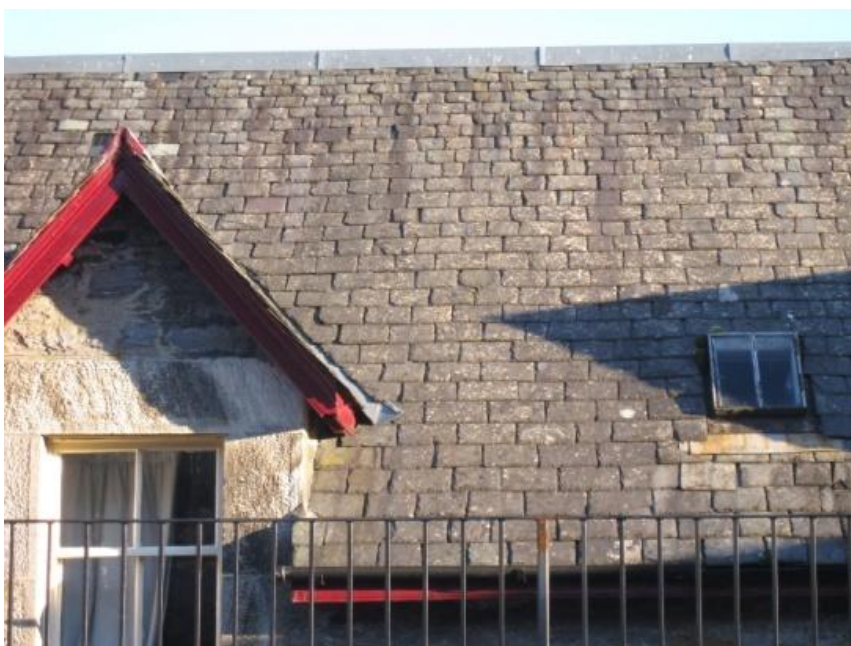
Fig. 33: Rear elevation of Smiddy Restaurant (south end of Main Street) showing typical thick and variable texture, with random widths and diminishing courses (note particularly small sizes at top of roof). Note also biogenic colonisation and staining which is typical of Highland Border slate.

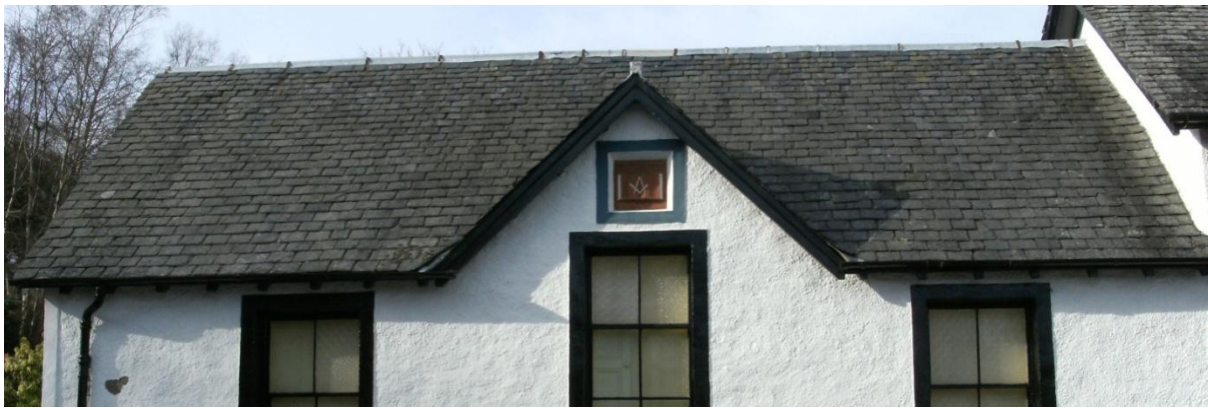
Fig. 34: Masonic Hall, Manse Road showing West Highland slate roof (confirmed from examination of fallen slates) with typical dark blue-grey colour and rough appearance.

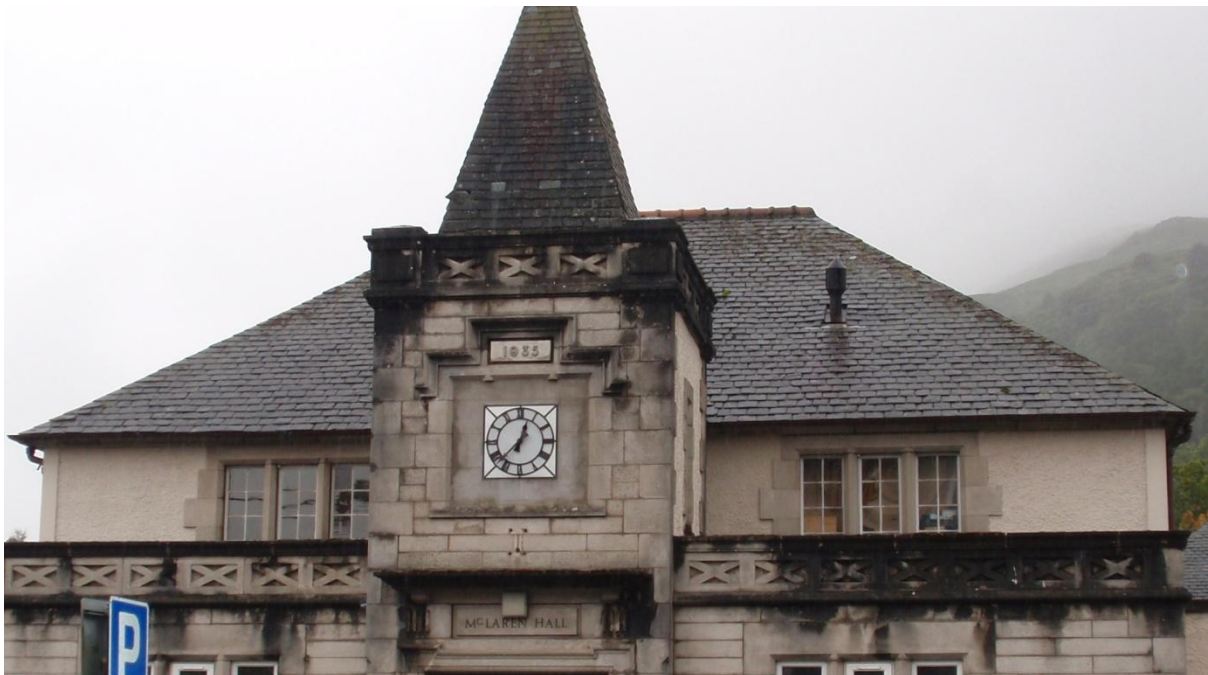
Fig. 35: McLaren Hall showing West Highland slate with typical dark blue-grey appearance and reflective lustre. (Note the walling is cement block made to look like stone).

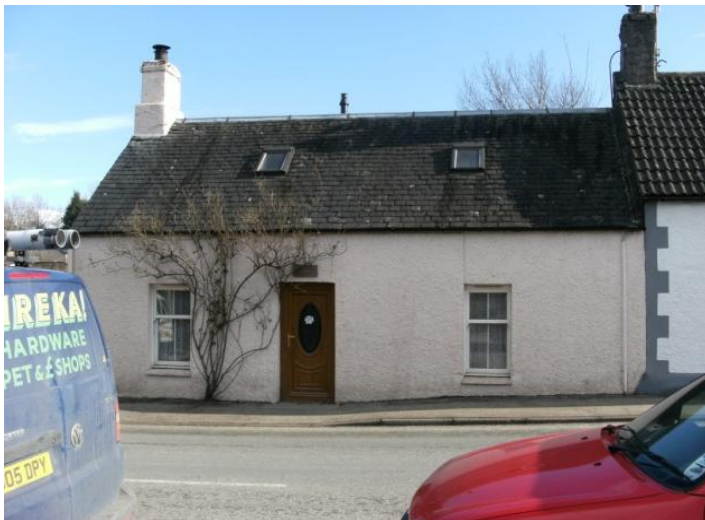
Fig. 36: Cottage, Main St showing typical Scots slate roof.

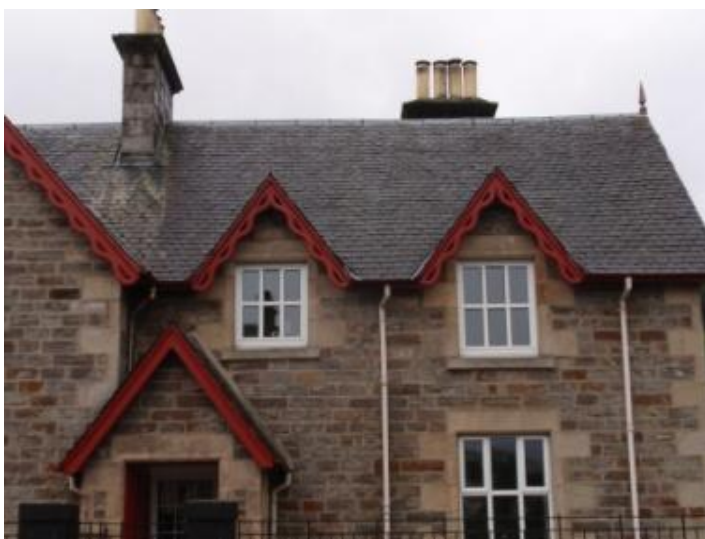
Fig. 37: Bank of Scotland, Main Street showing typical Scots slate roof with dark bluish-grey appearance and 'rough' surface texture.

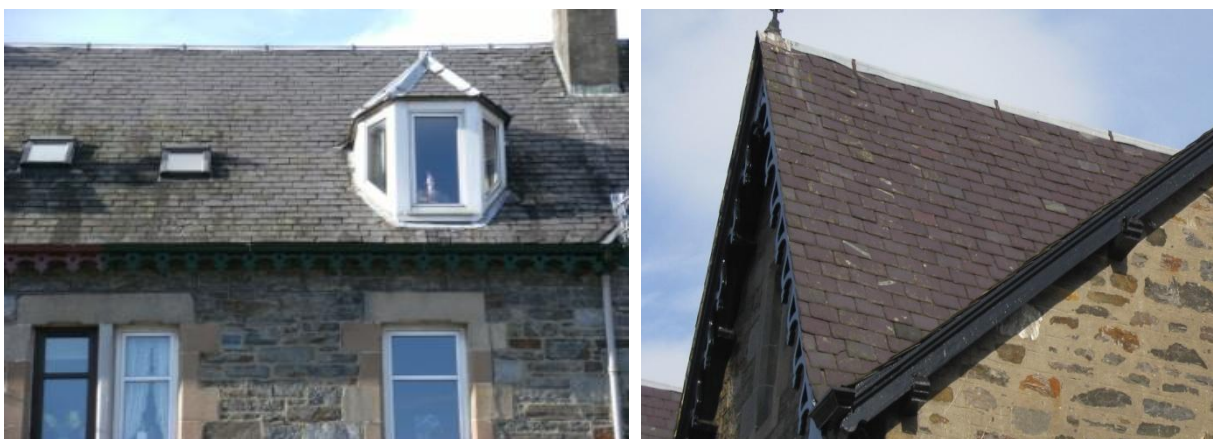
Fig. 38: 'Craiglea', Main Street, showing typical smooth texture, regular tile size and uniform appearance of purple Welsh Slate.
