THE BUILDING STONES AND SLATES OF KILLIN

an investigation of stone for the built heritage

GEOREPORT GR_138832_1

E.K. Hyslop, E.A. Tracey, L.J. Albornoz-Parra, P. Everett, S.F. Parry & A.B. Custance-Baker. 2010. A Building Stone Audit for Killin *British Geological Survey GeoReport*, GR_138832_1.

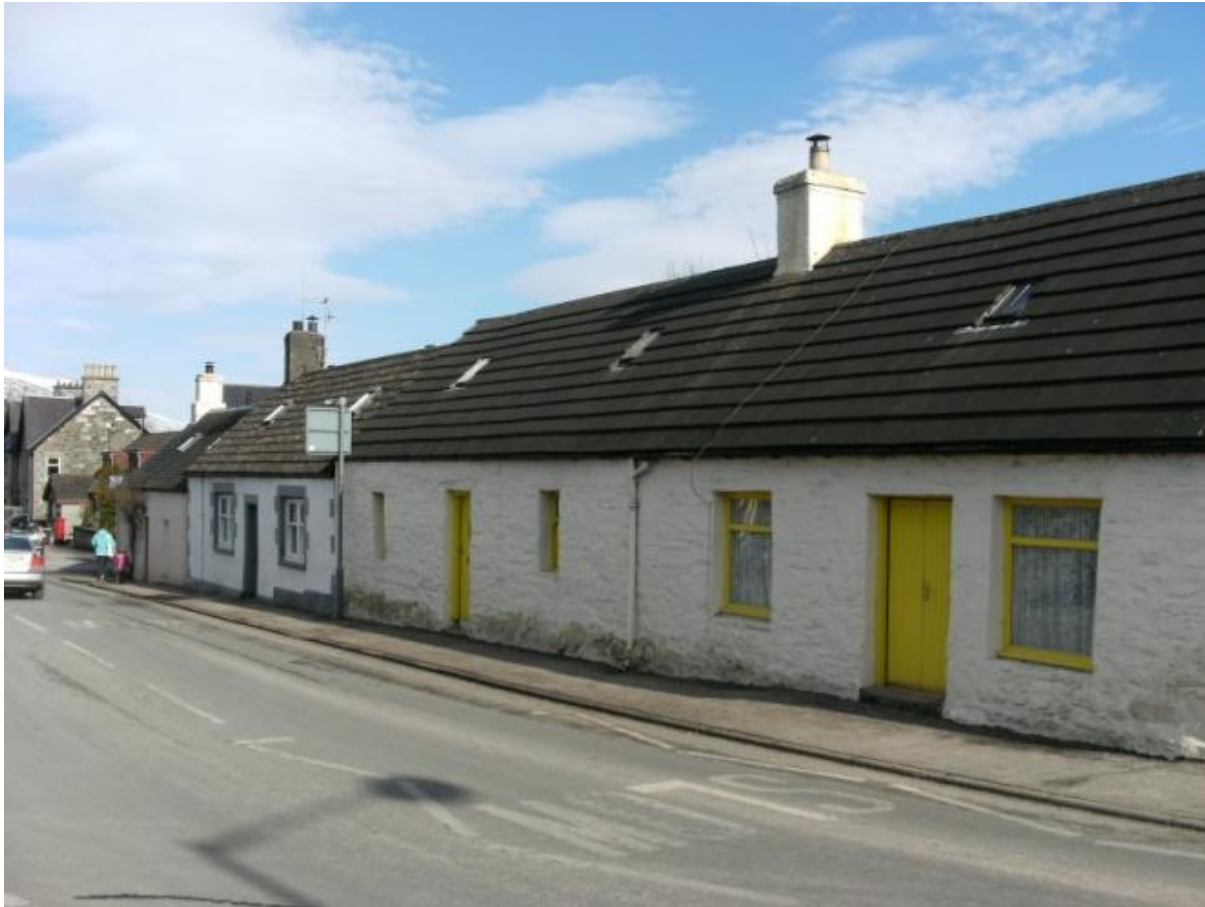
Fig. 39: Cottages in Main Street roofed using cement tiles, detracting from the overall appearance of the building.

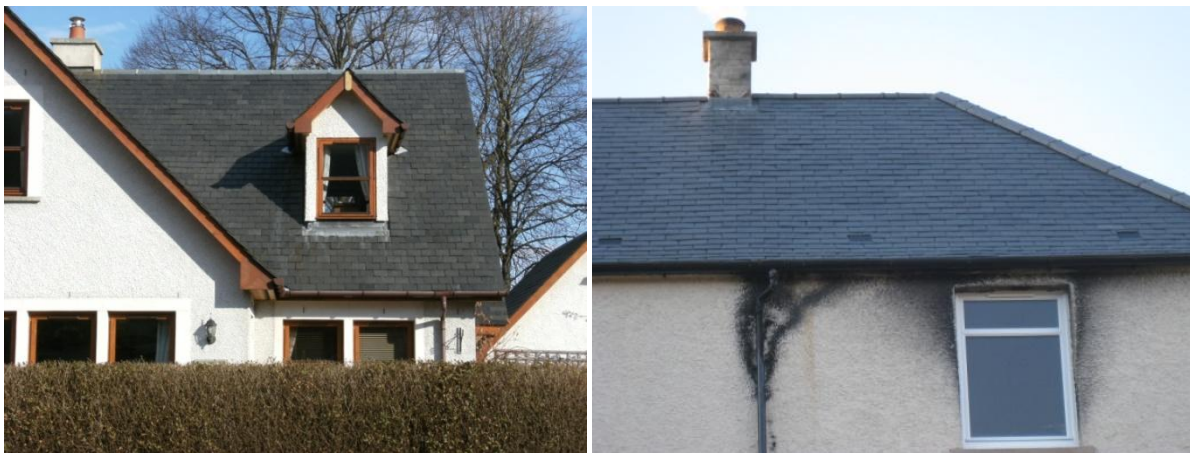
Fig. 40: Recently constructed house (a: Left) using probable Spanish slate and recently re-roofed house (b: Right) using Welsh Ffestiniog slate. These have a similar colour to some types of Scots slate, but lack the random sizes (variable widths and diminishing courses), which fails to replicate the appearance of a traditional Scots slate roof.

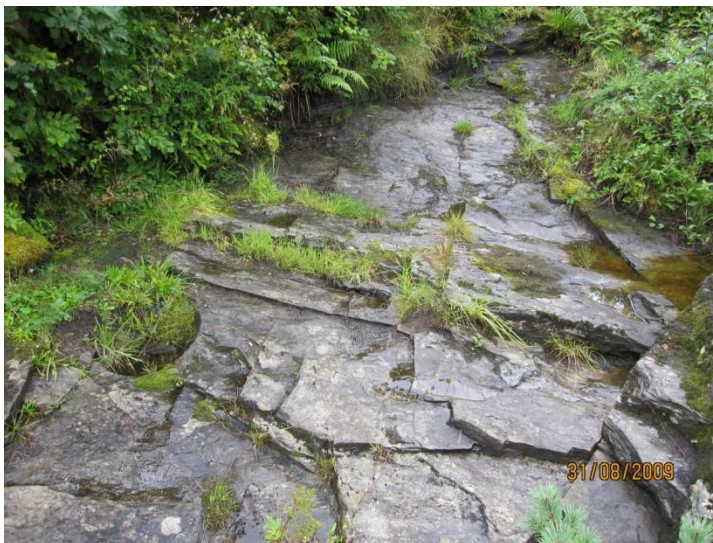
The bridge is constructed almost entirely of very local stone types, probably derived from the adjacent outcrops in the river (Fig. 41). It is built mostly of irregular-sized flags of mica schist and more blocky meta-sandstone (Fig. 42). The mica schist varies from blue grey to black, having been split along cleavage planes. Meta-sandstone varies from fine to coarse grained (gritty), typically dark grey, often with a brownish colour on fracture surfaces caused by natural iron staining. The block height of the rubble masonry is variable, reflecting the range of bed thicknesses of the rocks found in the adjacent riverbed, typically c.70mm to 300mm; the most common heights being 130-150mm.

Fig. 41: Rock outcrop at southwest side of bridge, showing local meta-sandstone bedrock. The abundant natural vertical joints and horizontal bedding (cleavage) planes allow the rock to be easily extracted for rubble masonry blocks. Much of the Dochart Bridge is constructed from this very local material.

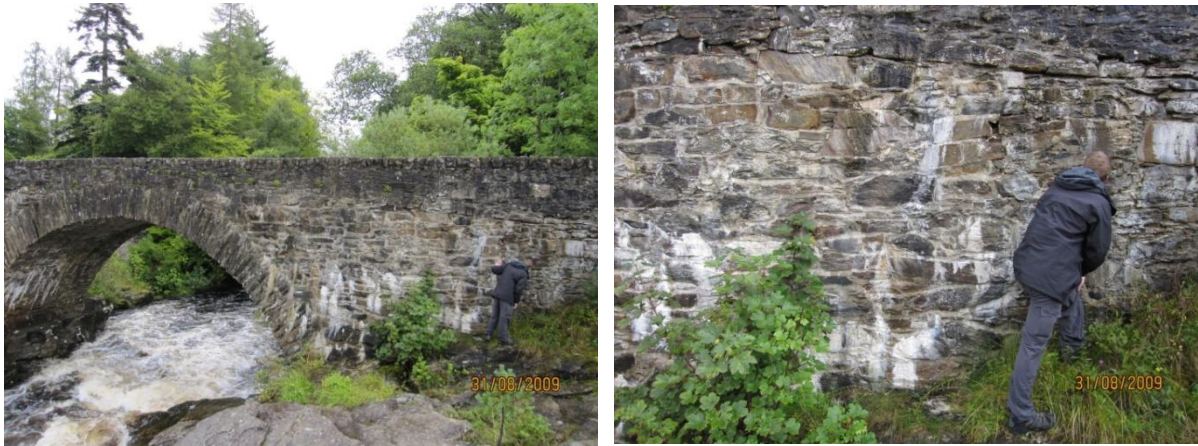
Fig. 42: Southern arch of bridge, west side, showing irregularly coursed random-sized rubble corresponding to the local meta-sandstone and mica schist bedrock on which the bridge stands. The walls are stained due to leaching of mortar from the inside of the structure. Note the discontinuity between the main body of the bridge and the parapet wall, suggesting the latter has been rebuilt (albeit using largely the same stone types).

Both the main body of the bridge and most of the parapet walls are constructed from these stone types. The masonry has been used as random rubble, laid in irregular courses (Fig. 42). The bridge appears to have undergone several phases of both minor and major repairs. There is evidence for previous major repairs present at the south arch where several stages of build are visible (Fig. 43). Much of the parapet walls appear to have been repaired, both in historical and recent times, mostly reusing the original rubble walling stone (Fig. 44).

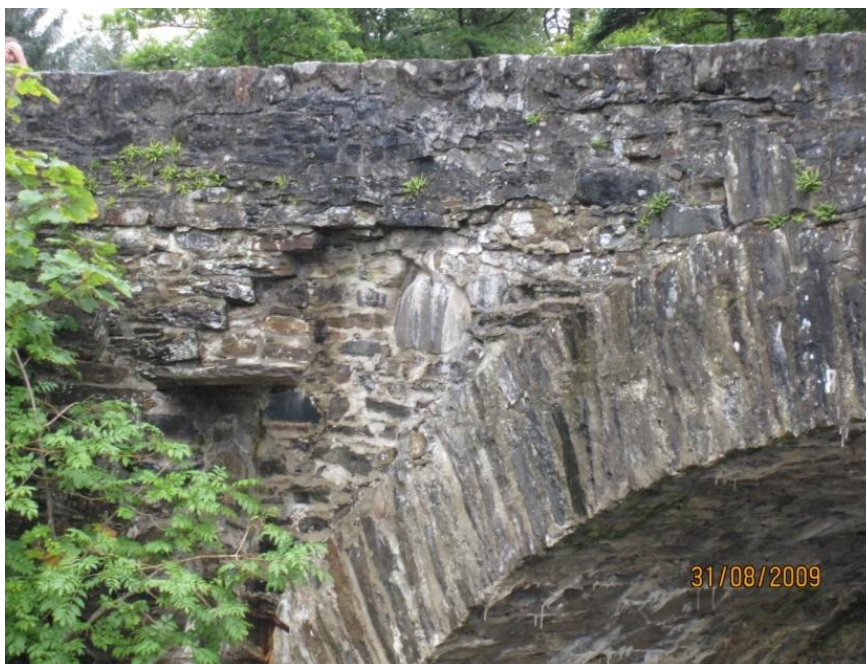
Fig. 43: The main body of the southern arch shows evidence of several phases of repair, some poorly detailed with thick mortar joints with flaggy rubble blocks type laid in irregular courses. The stone type is mostly local mica schist and meta-sandstone, probably largely re-used original masonry.

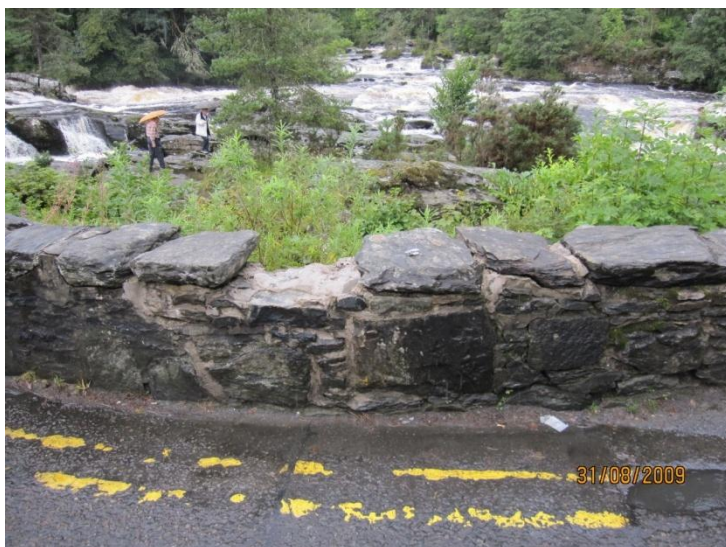
Fig. 44: South-west corner of bridge parapet with copestones (possibly original) of large flat blocks of local mica schist. Some blocks are loose/missing due to inadequate mortar repairs presumably following a vehicle strike. Most of the parapet wall is mica schist and meta-sandstone, probably reworked original masonry representing a 20th century repair.

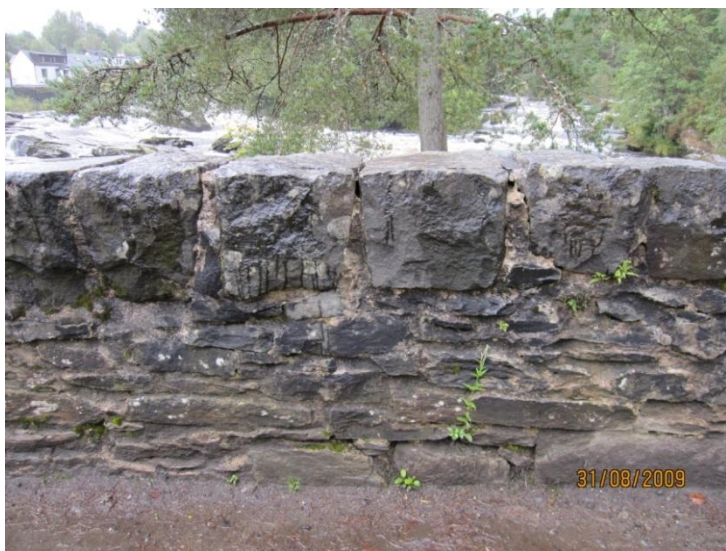
A major phase of repairs has involved the use of new copestones of basic igneous rock (probable dolerite) which have a distinctive dark appearance and roughly squared shape, contrasting with the more flaggy original stones (Figs. 45 & 46). These roughly squared blocks have dimensions typically 240-300 high, 300-360 length. The dolerite is probably not a local (Killin) stone and is likely to have been imported into the area. The regular size and shape of the blocks suggests it has been formally quarried and worked, unlike the local schists and meta-sandstone which have been crudely extracted from local surface outcrops. These replacement copestones are present in several parts of the bridge, used on much of the east side, north of main central arch on the west side.

Fig. 45: Parapet wall on the south-eastern part of bridge with copestones of massive roughly squared blocks of basic igneous rock (probable dolerite), with dimensions typically 240-300 high, 300-360 length. The parapet wall itself is typical flaggy mica schist rubble walling of bed heights 90-100mm.

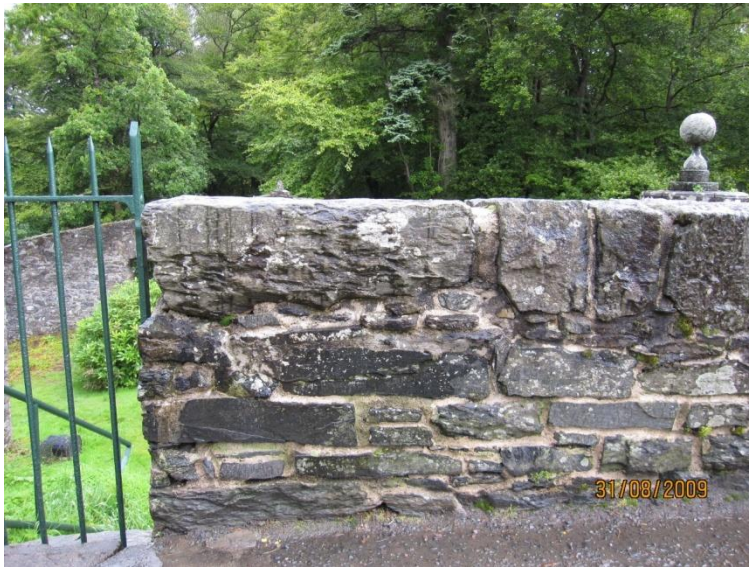
Fig. 46: The parapet on east side above the south arch is dominantly dark flaggy mica schist, with copes of massive dolerite. The large end-stones flanking the gateway to cemetery are large blocks of local meta-sandstone.

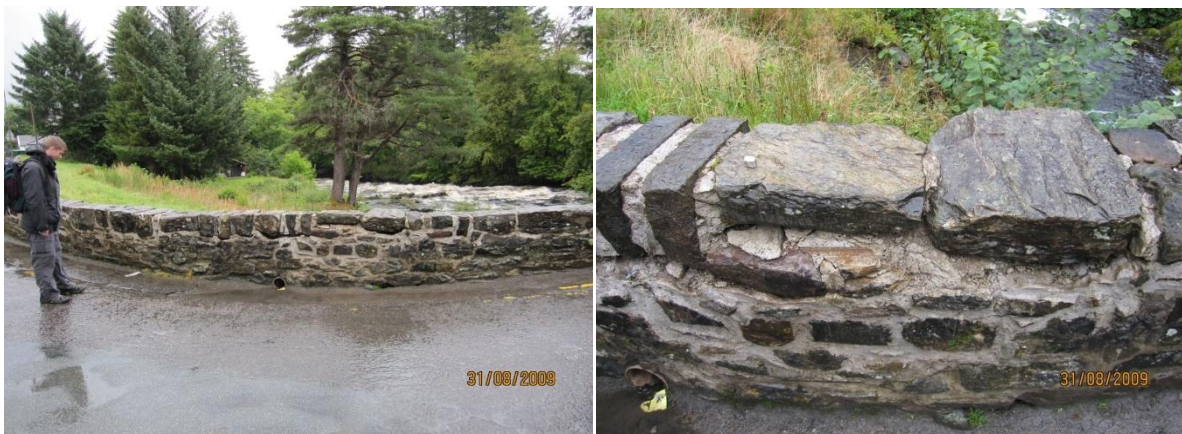
Many smaller localised repairs to the parapet walls appear to have been made in more recent times, probably as a result of vehicle strikes. These typically involve the crude reuse of the original stones with excessive use of cement mortar, and many of these repairs have subsequently failed resulting in loose blocks. At the northeast corner of the bridge the parapet appears to have been repaired several times (presumably repeated vehicle strikes) resulting in a mixture of copestone types of original flaggy mica schist and later replacement squared dolerite. Some of the mica schist copes are edge-bedded. Much of the repairs are poor quality with thick mortar joints which have failed resulting in loose stone (Fig. 47). The parapet wall here is typical mica schist. The retaining wall between the north end of the bridge and the mill is built from more random block sizes with roughly shaped copestones placed on edge (Fig. 48).

Fig. 47: Parapet at the northeast corner of the bridge showing repairs resulting in a mixture of copestone types of original flaggy mica schist and later replacement squared dolerite. Some of the mica schist copes are edge-bedded. Much of the repairs are poor quality with thick mortar joints which have failed resulting in loose stone. The parapet wall is typical mica schist.

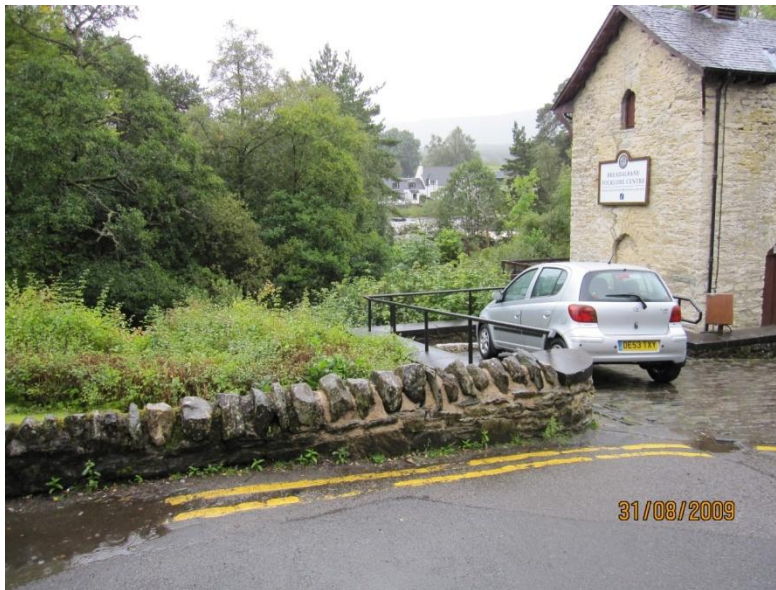
Fig. 48: The retaining wall at the north end of bridge running westwards to the mill has more random block sizes with roughly shaped copestones placed on edge of both mica schist and meta-sandstone (varying in grainsize from fine to gritty).

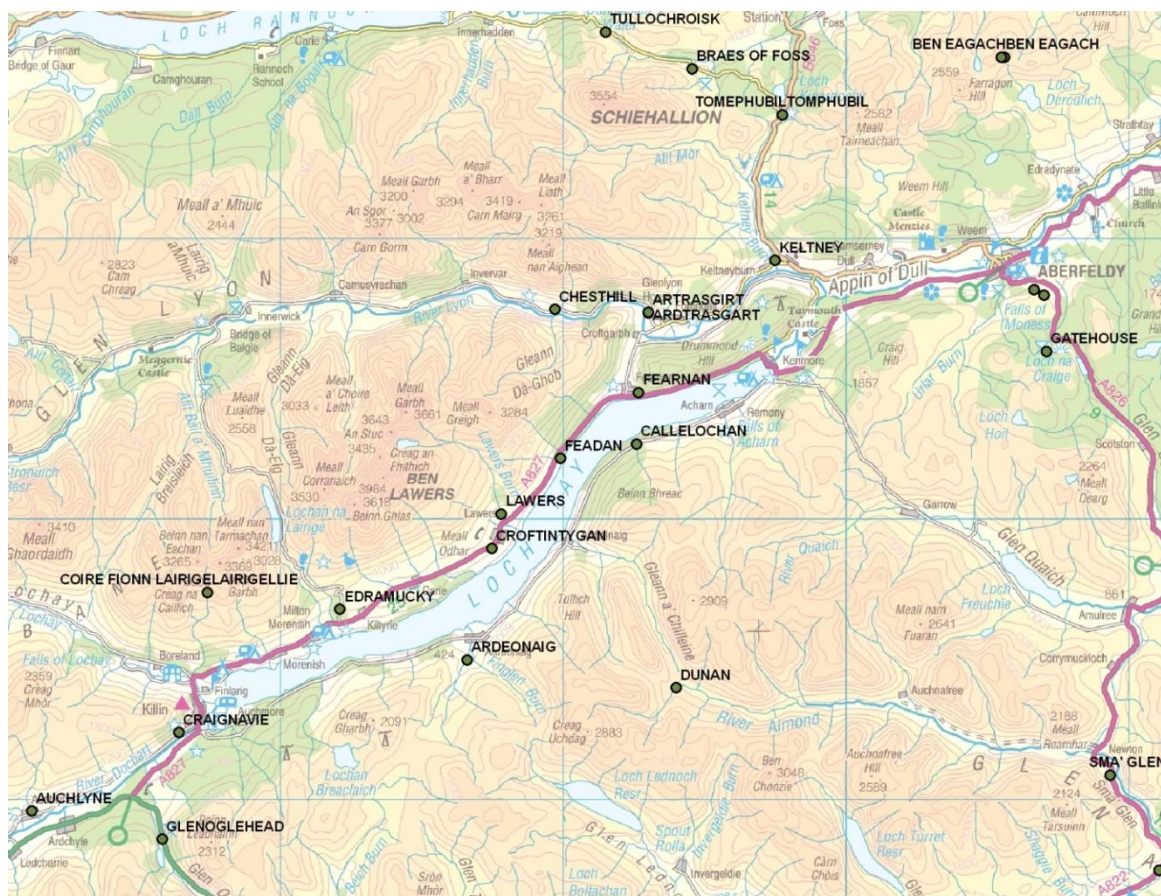
Quarry Name	Easting	Northing	Lithology	Lithostratigraphy	Location
ARDEONAIG	266600	735000	Limestone	Psammite and Semipelite	Ardeonaig
ARTRASGIRT	273000	747390	Whinstone	Gritty Psammite	Artrasgairt, near Fortingall
AUCHLYNE	251200	729600	Granite	Semipelite	Auchlyne, near Ardchyle
BEN EAGACH	285600	756500	Unknown	Graphitic Pelite	Beinn Eagagach
BRAES OF FOSS	274550	756090	Igneous	Metalimestone and Pelite	Braes of Foss
CALLELOCHAN	272600	742700	Igneous	Semipelite	Callelochan
CHESTHILL	269700	747500	Granite	Calcareous Pelite	Chesthill
CRAIGNAVIE	256400	732400	Limestone	Metalimestone	Killin
CROFTINTYGAN	267480	738970	Limestone	Semipelite	Croftintygan
DUNAN	274000	734000	Granite	Semipelite	Dunan
EDRAMUCKY	262100	736800	Schist	Metalimestone	Edramucky
FEADAN	269900	742180	Hornfels	Metagabbro and Metamicrogabbro	Balnearn
FEARNAN	272660	744540	Metaigneous	Psammite and Semipelite	Fearnan
GATEHOUSE	287100	746000	Unknown	Psammite and Semipelite	near Aberfeldy

GLENOGLEHEAD	255800	728600	Limestone	Metalimestone	near Ardchyle
KELTNEY	277500	749250	Limestone	Psammite and Semipelite	Keltneyburn
LAIRIGELLIE	257400	737400	Igneous	Calcareous Pelite and Pelite	north of Finlarig
LAWERS	267800	740200	Limestone	Metalimestone	Lawers
SMA' GLEN	289350	730880	Igneous	Metasandstone	near Glenalmond
TOMPHUBIL	277750	754450	Limestone	Metalimestone	Tom Phobuill
TULLOCHROISK	271500	757400	Limestone	Metalimestone	near Crossmount
UNNAMED	287000	748000	Metamorphic	Amphibolite	Aberfeldy
UNNAMED	286650	748200	Unknown	Metalava and Metatuff	Aberfeldy

Fig. 49: Quarry locations in the Loch Tay area from the BGS quarries database. Table shows grid reference and rock type (Lithology = worked rock type where known; Lithostratigraphy = Main geological unit at locality). No data is available regarding which quarries extracted building stone, roadstone, agricultural limestone etc. All of these quarries are recorded as inactive.

Examination of historic sources and BGS databases has identified a number of former stone quarries in the district (Fig. 49). Quarries in the Loch Tay area appear to have worked several different stone types (see table in Fig. 49), most notably for limestone which was burnt for agricultural use. Although it was beyond the scope of this study to visit each of these quarries, it is considered unlikely that any of these supplied the basic metamorphic rubble building stone used most commonly in Killin (i.e. meta-sandstone/psammite, mica schist and actinolite schist). All of these quarries are closed today and many are infilled and difficult to locate.

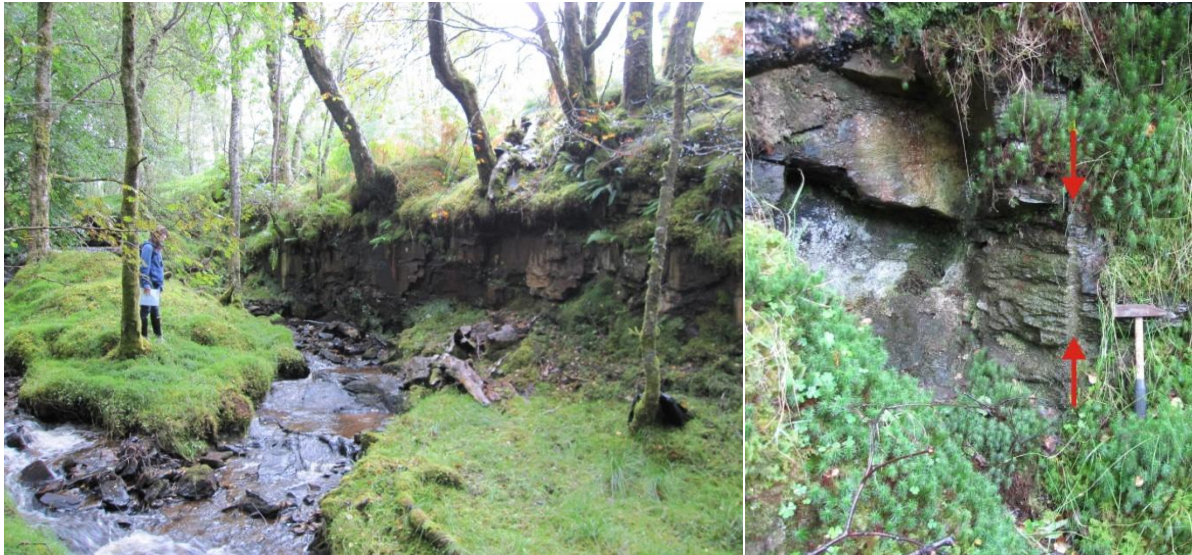
Fig. 51: Former building stone quarry south of Killin (see previous map for location). This quarry is likely to have provided squared meta-sandstone block for walling. Right-hand image shows a vertical mark from a 'jumper', a typical tool used in building stone quarries in the 19th century (mark highlighted on image by arrows).

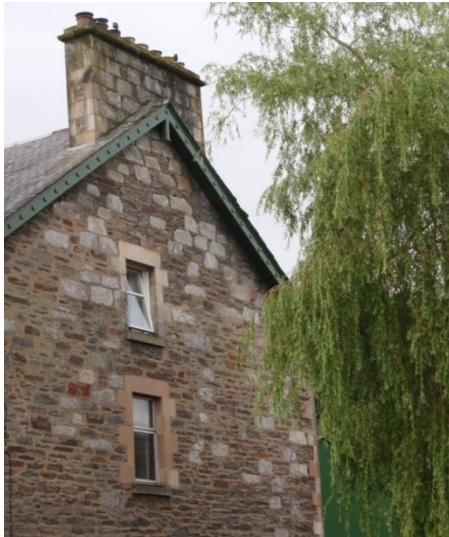
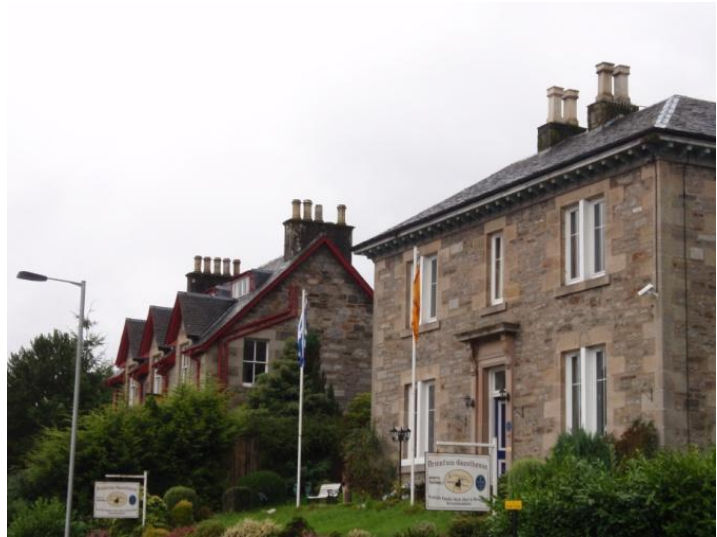
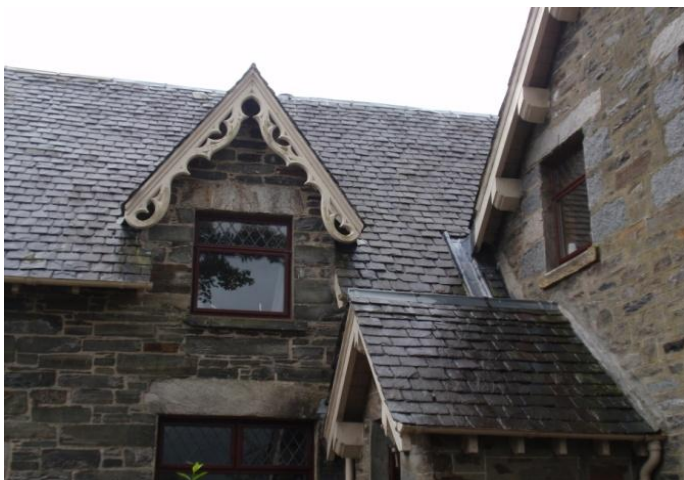
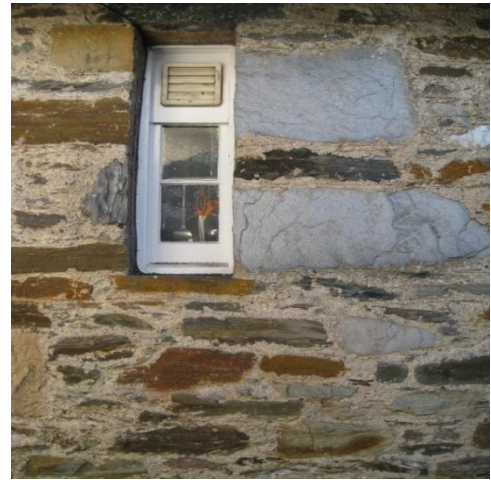
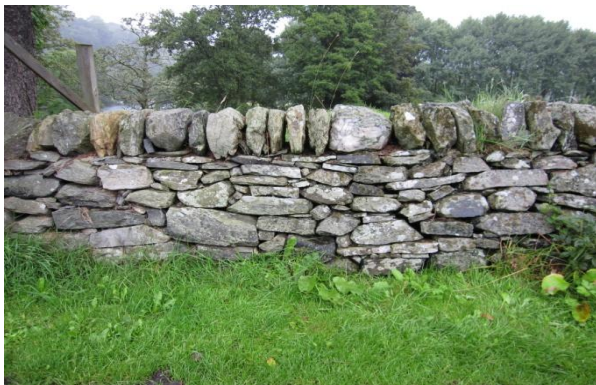
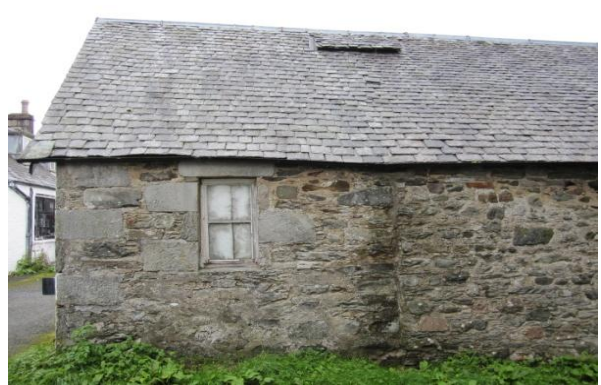
Fig. 52: Selection of images of different stone types and building styles in Killin, illustrating the importance of stone and slate in defining the character of the village. Because most of the stone types are from the local area there is a direct link between the buildings and the geology, rooting the village in its landscape.

The contribution of the different types of stone and slate to the character of the built environment in the Killin Conservation Area is illustrated in Fig. 52.
