Hunting for Landslides in St Lucia... by Catherine Pennington

Hunting for landslides from the office

Landslide hunting on the ground

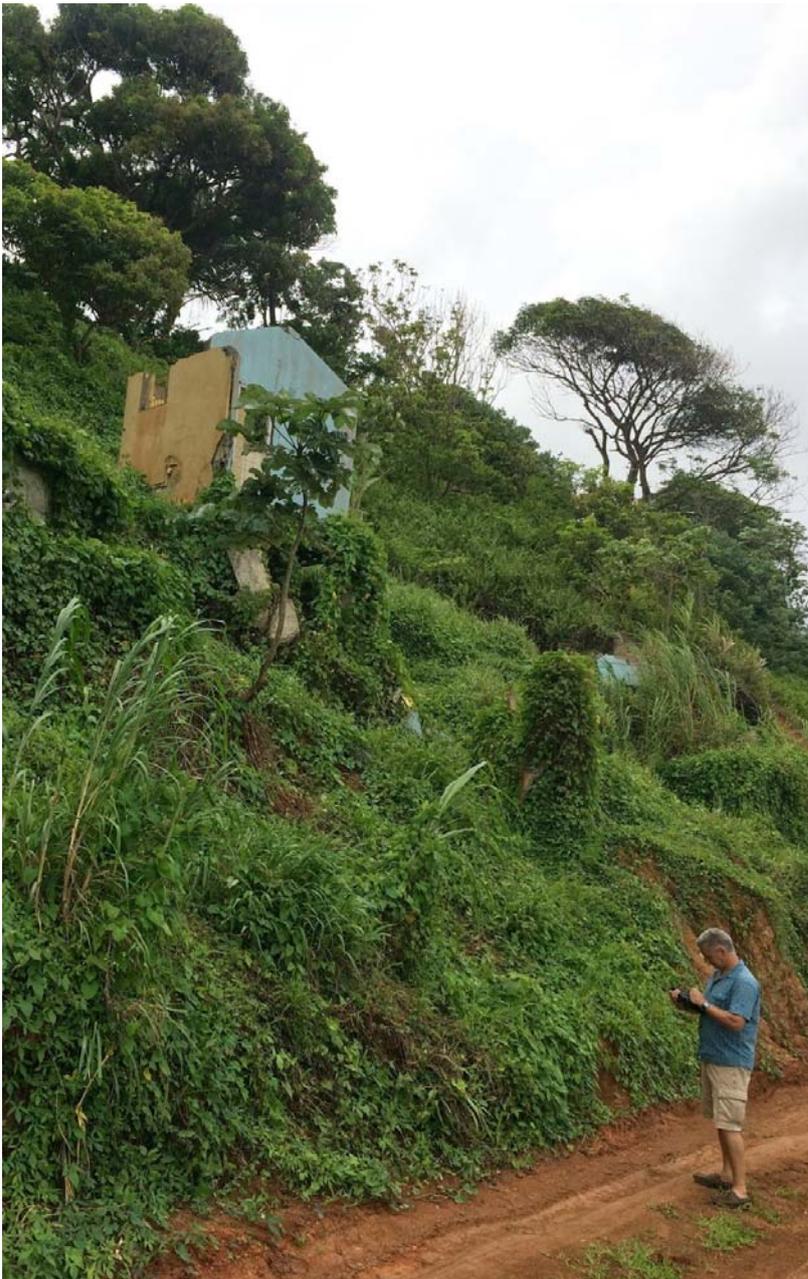
Tom updating the outline of a landslide in Guesneau, St Lucia
[Dr Colm Jordan](#) and [Dr Tom Dijkstra](#) have both just returned from a trip to the Caribbean. This may sound like a glamorous location, but their work is associated with more serious matters.

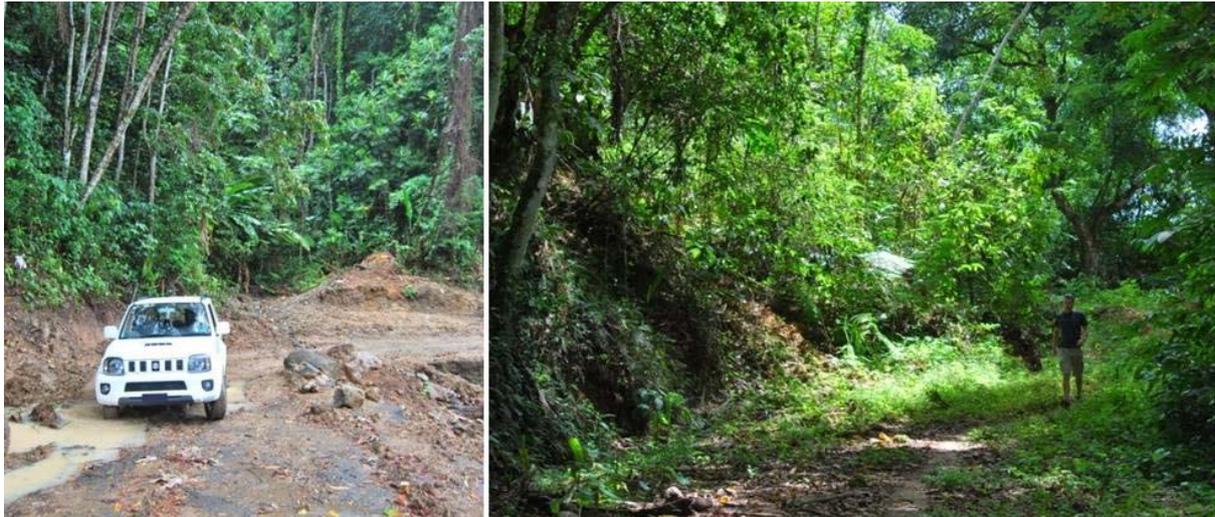
Left: Some conditions typical of the smaller roads. Right: Colm trying to find a way through a road blocked by landslide debris and vegetation – now only passable on foot.

“In the five days we were there, we drove over 650 kilometres. Some of the small roads in the centre of the island were still barely passable and we regularly had to abandon the car and continue on foot”.

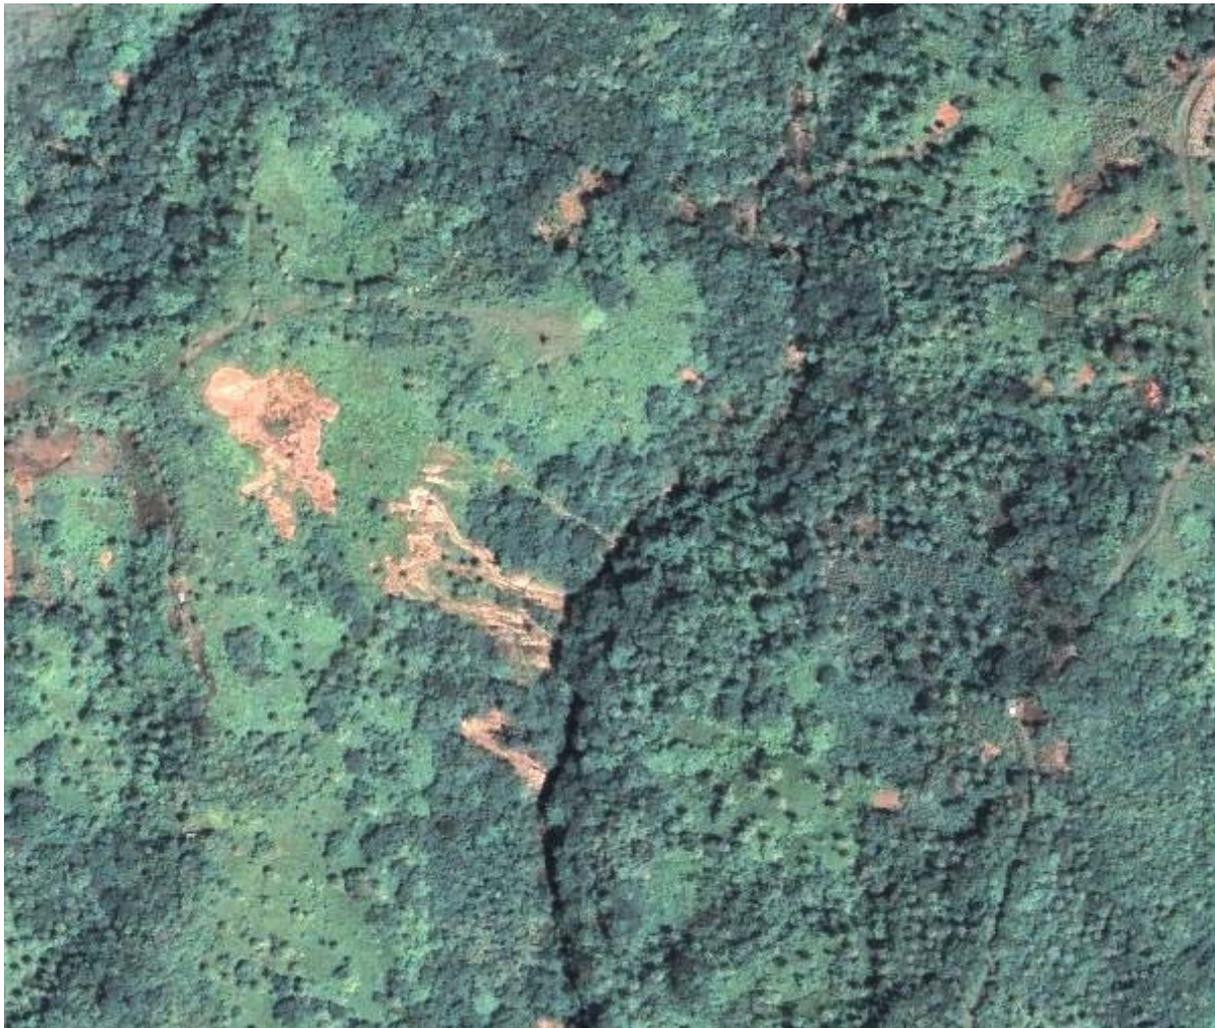
The satellite image. Here, not only was it possible to map the outline of the landslide but the details within it were visible too.

This is an example of how the work done in the office translated to that on the ground:

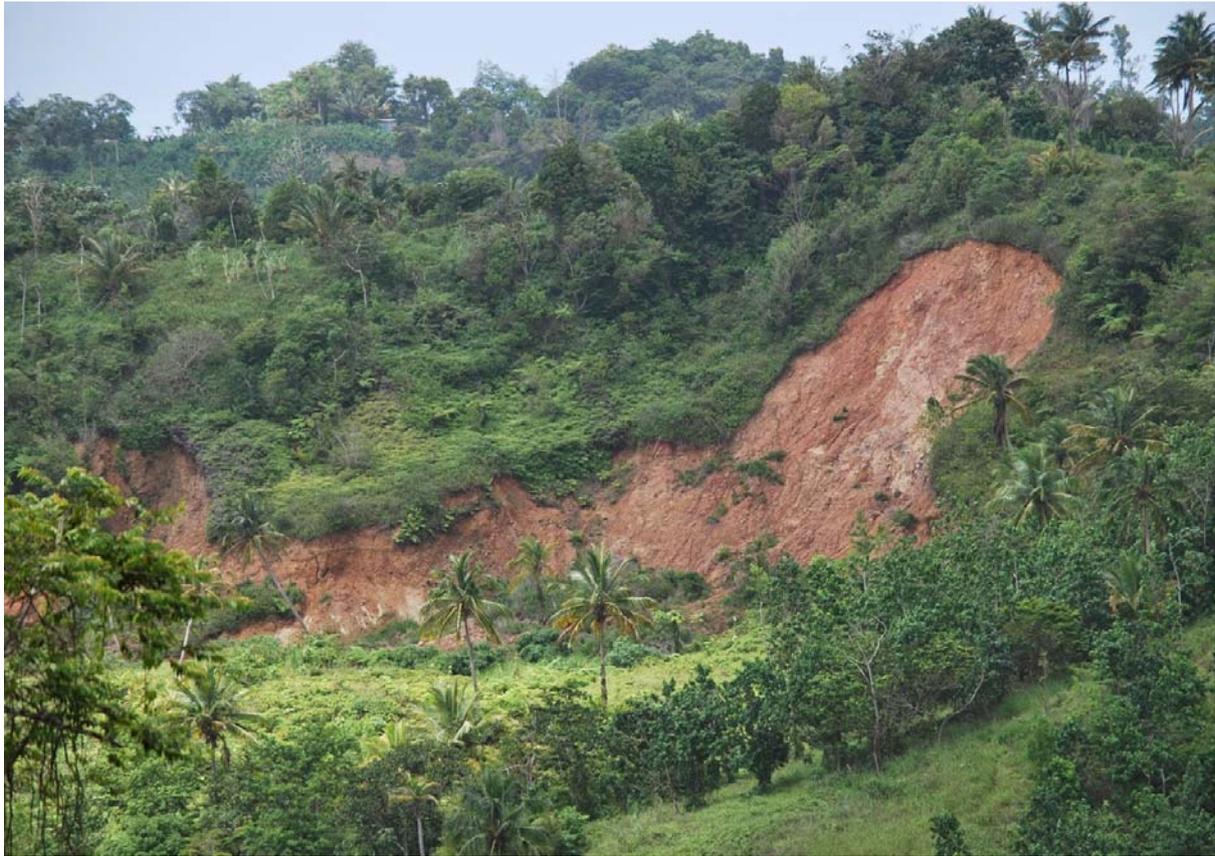
What Tom and Colm saw in St Lucia which matched very closely with the satellite interpretation.
