# Landslides and coastal erosion at Aldbrough, East Riding of Yorkshire

As part of the continued programme of work monitoring coastal erosion and landsliding at several sites around the coast of Great Britain, BGS is studying, monitoring and laser-scanning the cliffs at Aldbrough in Yorkshire.

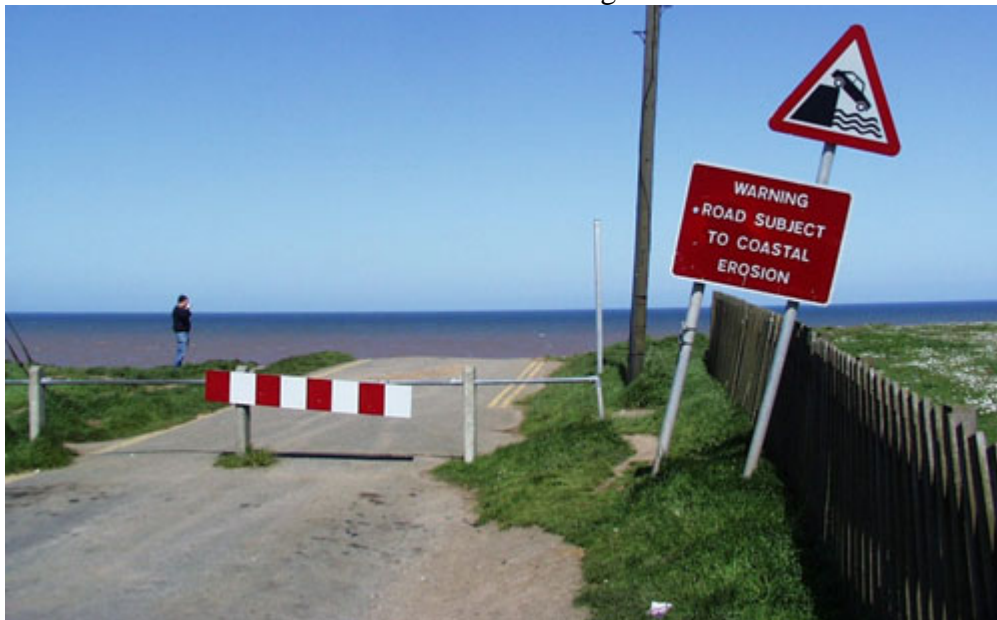
Aldbrough is located approximately 10 km south-east of Hornsea. The cliffs here are rapidly eroding so that Seaside Road now terminates at the cliff edge (Figure 1). Several buildings have been lost to the sea since 1885 including the Spa Inn, the Talbot Hotel and the Royal Hotel.

**Figure 1** Seaside Road in 2003 cut off by the cliff.

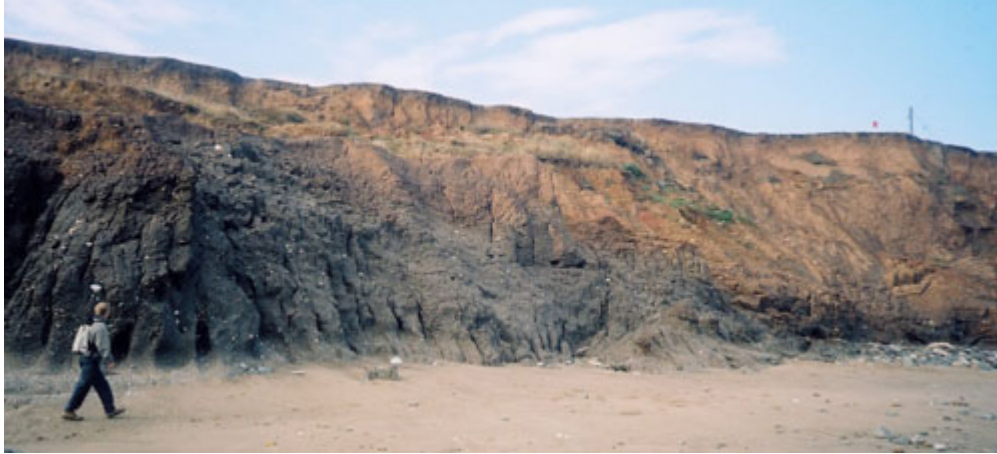
The steep cliffs at Aldbrough face north-east and have a regular height of about 20 m (Figure 2). The cliffs are actively receding and the cliff profile is stepped due to the contrasting erosion resistances of the tills and the different landslide processes in the upper and lower parts of the cliff. At high tides the lower, and in some case middle, sections of the cliff are subject to considerable erosion by wave action.

**Figure 2** The cliffs at Aldbrough.

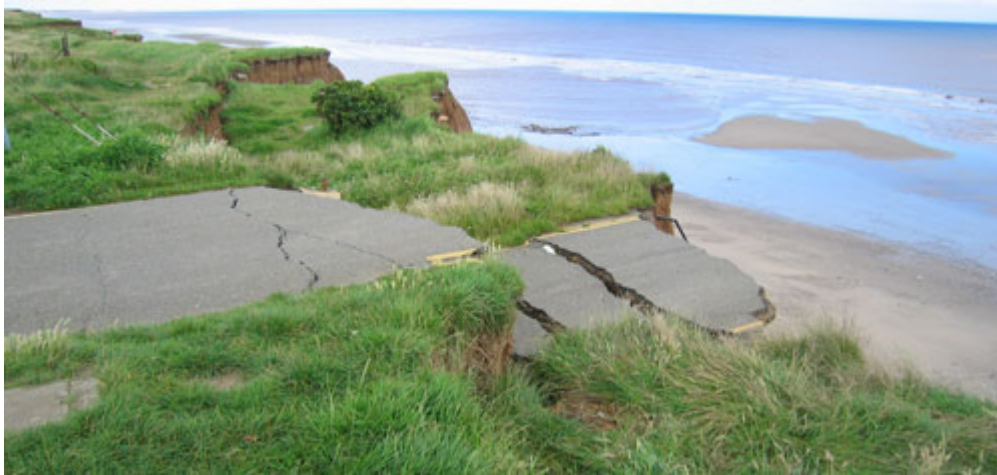
Active landsliding has been observed at the Aldbrough site. The principal mode is that of rotational slumping ([Figure 4](#) and [Figure 5](#)). The secondary mode is toppling and falls ([Figure 6](#)). Toppling failures, though relatively small, are sudden and frequent, and present a major hazard in this area. Mudflows form a third minor mode, given the morphology of the cliff and the strong action of the sea, these are small and short-lived.

Principal mode of landsliding in upper cliff: rotational slumping
