Large scale gas injection test (Lasgit) performed at the Äspö Hard Rock Laboratory: Summary report 2008

Commissioned Report CR/08/173

R.J. Cuss, J.F. Harrington, and D.J. Noy

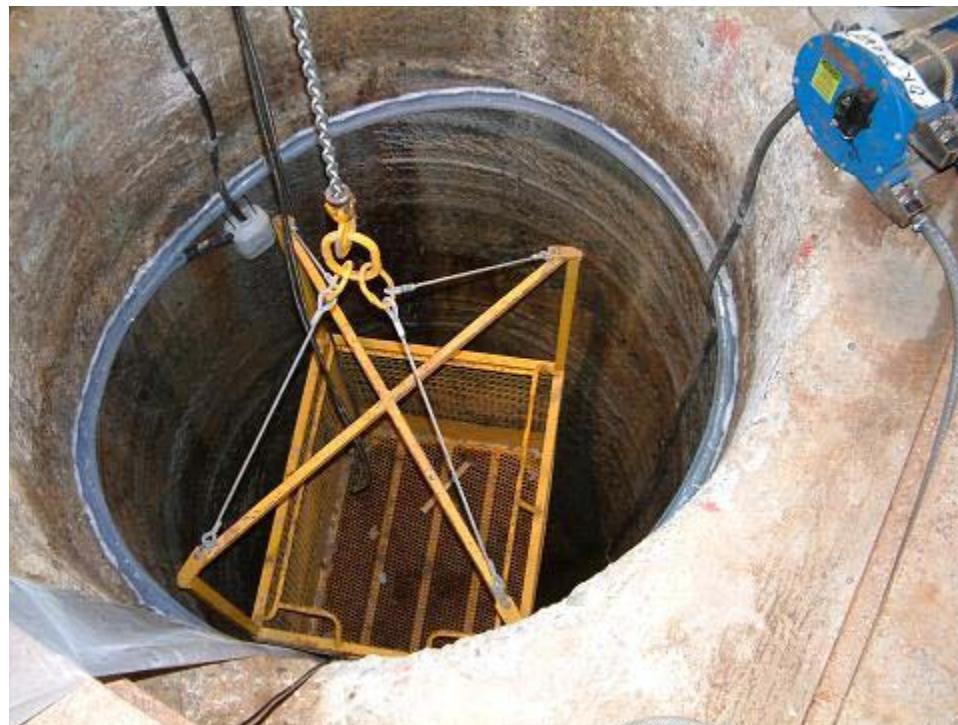
Figure 2-5 Deposition hole DA3147G01 with the circular drain and small plastic container (greyish).

The inflow of water into the Lasgit hole was measured using the setup shown in Figure 2-5. Water originating from the surrounding tunnel floor (termed "external water") was prevented from entering the deposition hole and was measured separately. Ingress of water to the Lasgit hole, entering through the fractures and the rock mass of the hole wall and bottom ("internal water"), was measured by using a level indicator to study the rise of the water level over time.

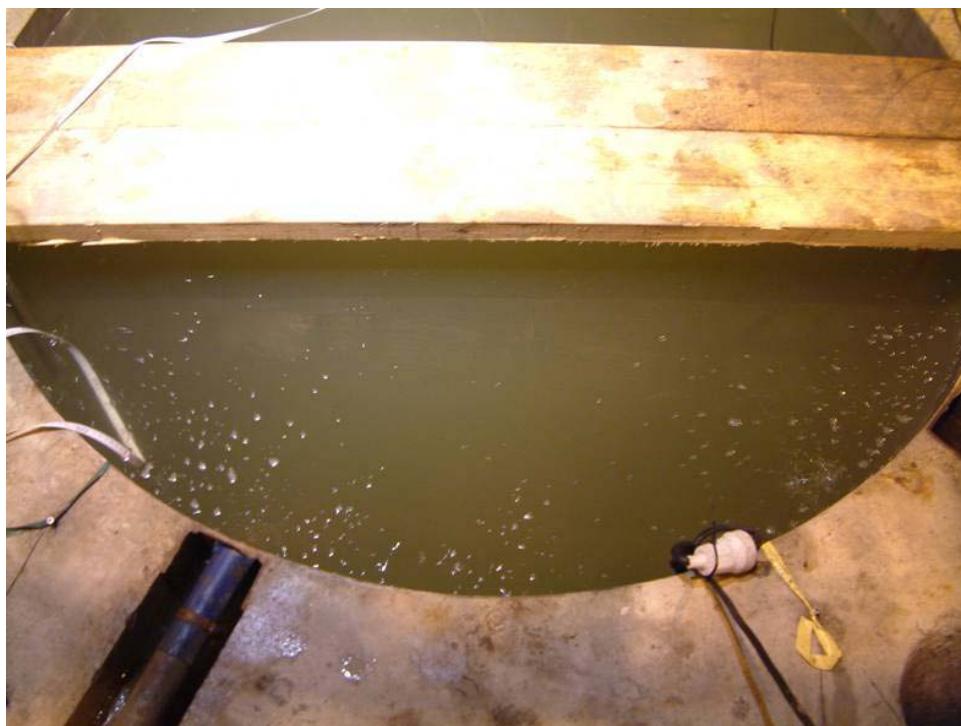
Figure 2-8 Gas bubbles on the water surface in the Lasgit hole.

A gas leakage test was performed in six of the ten anchor holes in order to investigate whether there were any connections between the anchor holes and the water filled Lasgit hole. Anchor holes were incrementally pressurised. Gas leakage was seen as bubbles on the water surface in the Lasgit hole, as shown in Figure 2-8, and in the neighbouring anchor holes. With the help of a video camera the gas leakage was located on the wall of the Lasgit hole and registered on drawings; one example is shown in Figure 2-9. Results from these tests clearly demonstrate that a number of fractures intersect both the neighbouring anchor holes and the Lasgit deposition hole. Table 2-10 summarises the observations during the gas leakage tests.

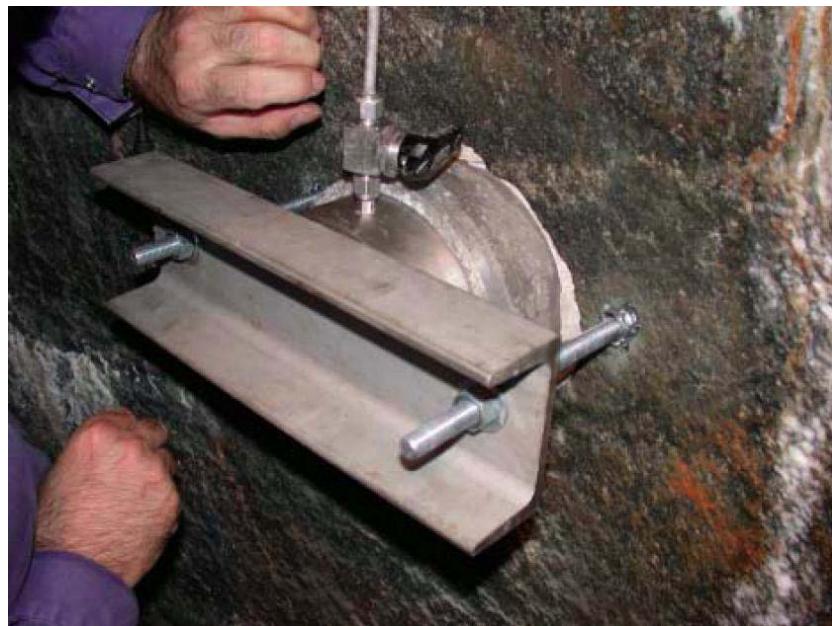
Figure 2-10 The surface packer system of BGR shown *in situ* ready for the start of a test.

A photograph of the surface packer system is shown in Figure 2-10 and as a schematic in Figure 2-11. The packer comprises a circular metal unit sealed to the rock surface using bentonite which is held in place by fixing bolts attached within the rock. Water or gas is introduced and pressure decay is monitored. For the measurements within the Lasgit deposition hole only local water was used as an injection fluid.

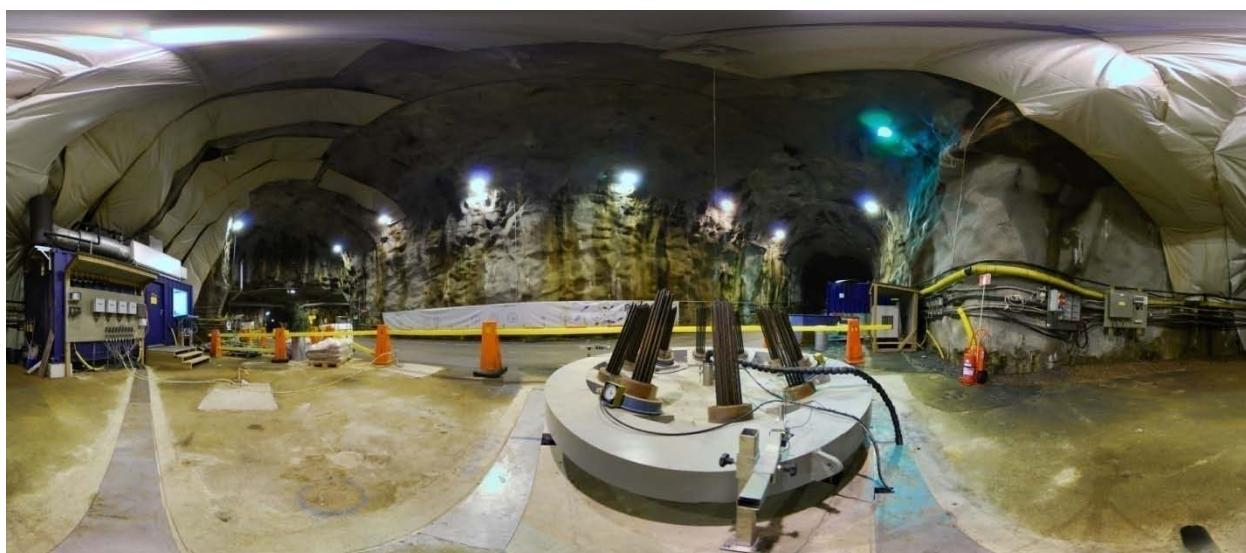
Figure 3-1 A panoramic view of the Large-scale gas injection test (Lasgit) 420m below ground at the Äspö Hard Rock Laboratory in Sweden.

The deposition hole, buffer and canister are equipped with instrumentation to measure the total stress, porewater pressure and relative humidity in 32, 26 and 7 positions respectively. Additional instrumentation continually monitors variations in temperature, relative displacement of the lid and the restraining forces on the rock anchors. The emplacement hole has been capped by a conical concrete plug retained by a reinforced steel lid capable of withstanding over 5000 tonnes of force. Figure 3-1 shows a photograph of the test site following the installation stage.

The pressure that would be exerted by the backfill as the tunnel gallery was closed is generated using a heavy 2600 mm diameter SS2172 carbon steel lid; this also prevents an uncontrolled expansion of the bentonite. At the top of the buffer a waterproof and sealed rubber mat is placed, upon which a conical shaped concrete plug was poured using K 40 quality concrete (Bäck, 2003) to close the deposition hole, the top of which was level with the TBM assemble floor. On top of this plug, the steel lid was anchored to the rock by 10 anchor cables. The lid and rock anchors can be seen in Figure 3-1.

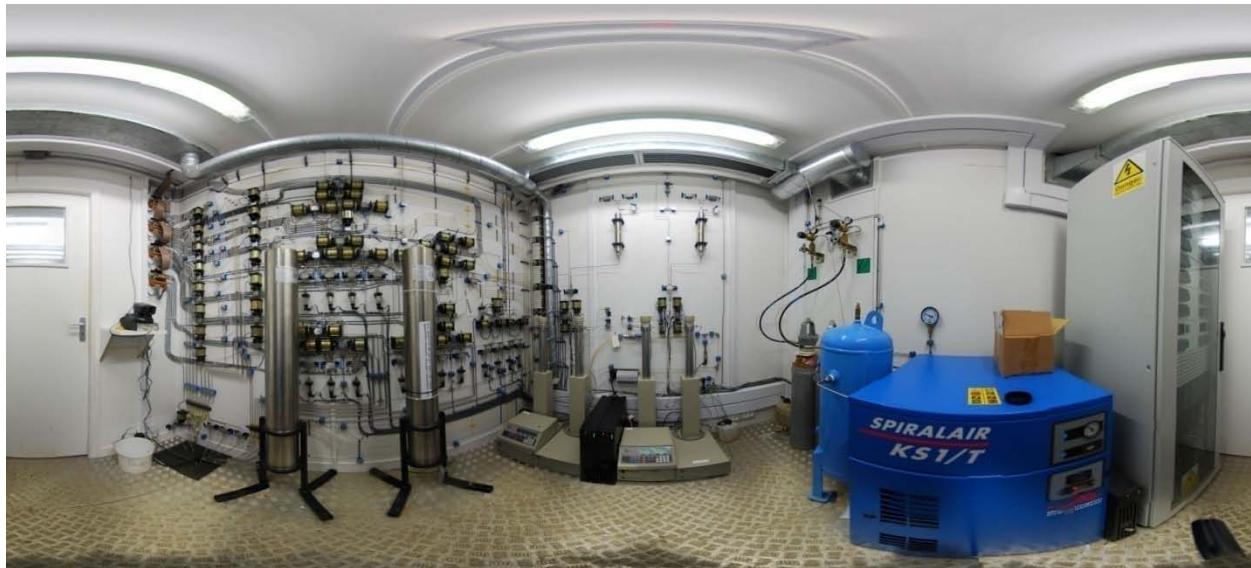
Figure 3-2 A panoramic view of the Lasgit gas laboratory.

The shipping container housing the Gas Laboratory has been partitioned into two sections. The first comprises the office area and contains the workstation plus general office furniture, telemetry system and main electrical consumer unit. The second area contains all of the experimental apparatus, test circuits and data acquisition systems. Figure 3-2 shows a full 360° panorama inside the gas laboratory.

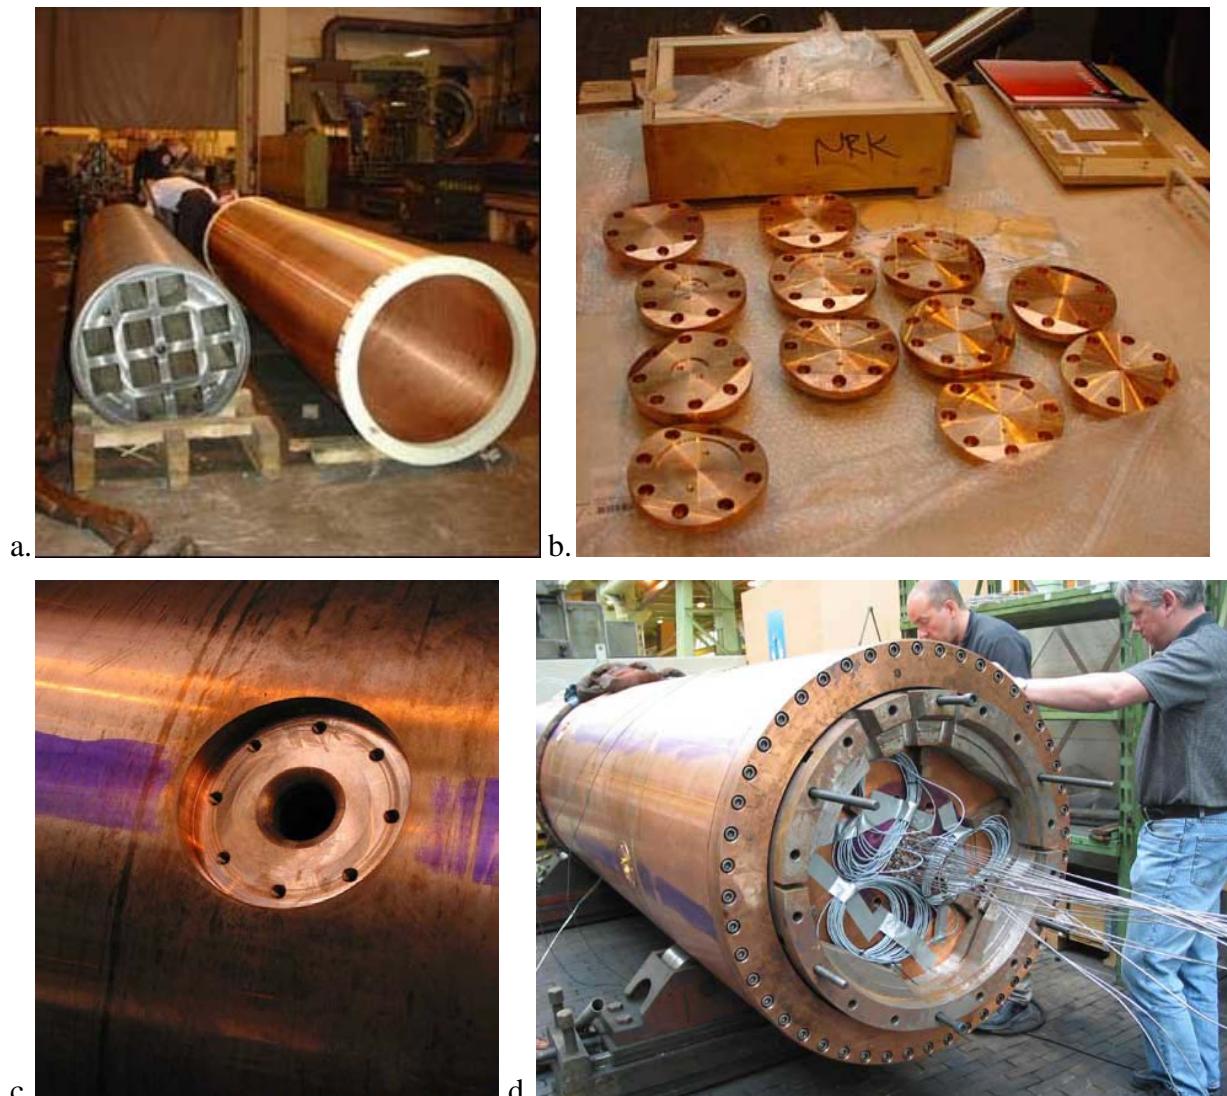
Figure 3-4 The canister as used in the Lasgit test. The canister comprises a standard KBS-3 canister, made up of a copper canister and cast iron insert (a). Twelve filters (b) are placed at three levels along the length of the canister in recesses (c). The complete Lasgit canister is shown in (d) with the filters in place and the associated pipework coming through the canister lid.

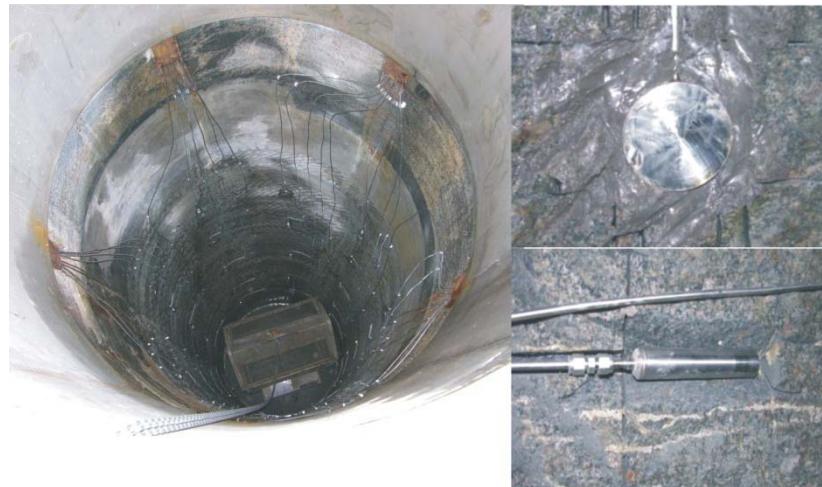
Figure 3-7 The photograph on the left-hand side shows a view looking into the Lasgit deposition hole showing tube work containing the electrical connections from total stress and porewater pressure sensors mounted on rock face. The photographs on the upper and lower right-hand show a total stress and a porewater pressure sensor respectively.

Total stress in the Lasgit deposition hole is monitored at 32 separate locations (Table 3-6). Of these devices, 20 Geokon sensors are mounted on the rock wall (Figure 3-7), 9 Geokon sensors are located within the buffer material itself and 3 Sensotec sensors are positioned at specific locations on the canister surface. Each Geokon sensor incorporates an integrated thermocouple which is used to correct the output signal from each device for fluctuations in background temperature. Factory calibrations are used to process the Geokon data into a stress value. An additional offset is then applied to the data to compensate for “drift” during the installation process. Each device outputs a resistance measurement which is collected by a custom built multilogger and then relayed to the data acquisition and control system (DAC) within the laboratory. The three stress sensors located on the canister output a current directly into the data acquisition system. These devices were calibrated prior to installation.

The Lasgit experiment also uses Geokon porewater pressure sensors to monitor water pressure inside the buffer material and at the bentonite/diorite interface (Figure 3-7). A total of 26 sensors are used in the Lasgit hole, of which 20 are located on the rock face at the bentonite/diorite interface and 6 are positioned inside the buffer mass (Table 3-7). As with the total stress instruments described in Section 3.2.5, each device uses an integrated thermocouple to correct the output signal for thermal fluctuations in background temperature. This data is logged through the multilogger, which in turn passes on the raw outputs to the Lasgit DAC system for scaling into calibrated figures.
