Report WA/93/31(C)

The geology and building stones of Lanercost Priory, Cumbria.

Brian Young
B.Sc., C.Eng., F.I.M.M., C.Geol., F.G.S.

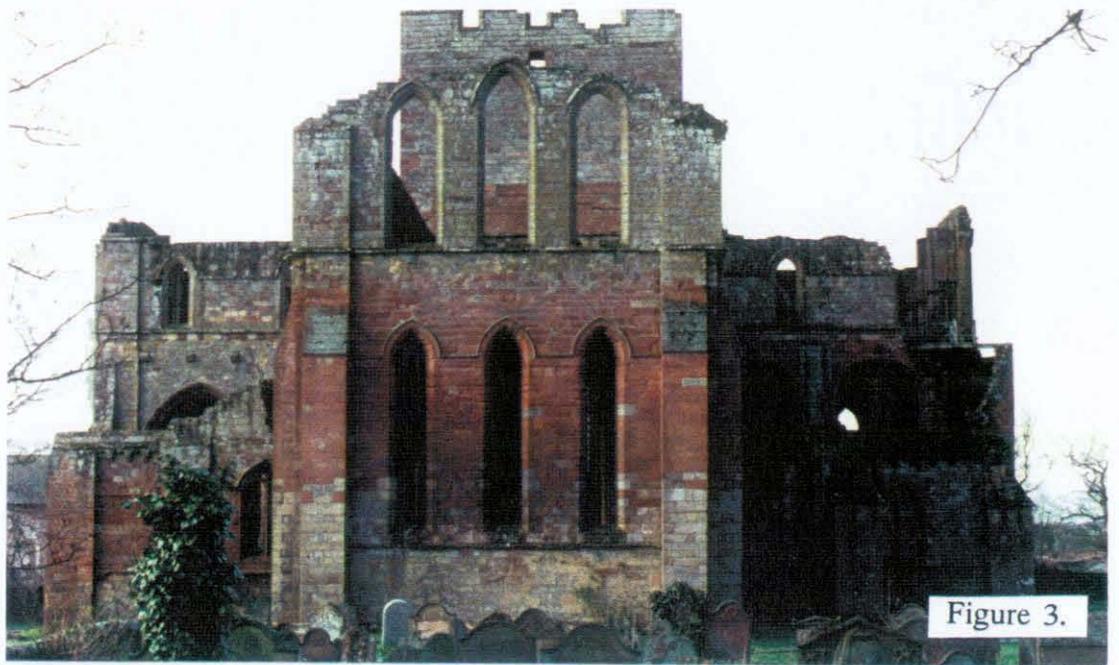
- Figure 3. Eastern end of Sanctuary. St Bees Sandstone (red) and Carboniferous sandstone (grey to buff).
- Figure 4. South wall of Sanctuary and Chapel of St Catherine. St Bees Sandstone (red) and Carboniferous sandstone (mainly grey to buff). Note the reddened Carboniferous sandstone blocks (arrowed) beneath Clerestory window.
- Figure 5. South wall of South Transept. St Bees Sandstone (red) and Carboniferous sandstone (grey to buff).

No records are known to exist to indicate the sites of quarries which supplied stone at any stage during the construction of the Priory. As has been outlined above two principal types of stone comprise the bulk of the fabric. The relative proportion of these stones, the St Bees Sandstone and Carboniferous sandstones, within the buildings have not been determined but large quantities of both have been employed. Apart from the relatively few instances of specialised uses of stone noted the buildings give the clear impression of being constructed from whichever stone came most easily to hand. Even within masonry erected during one period of building stone has either been obtained from two or more sources simultaneously to give the random pattern of stone distribution noted in places (eg Figures 7, 8, 9 and 10) or supplies of stone from these sources may have alternated to give the large areas composed of predominantly single stone types seen elsewhere (eg Figures 3, 4, 47 and 49).

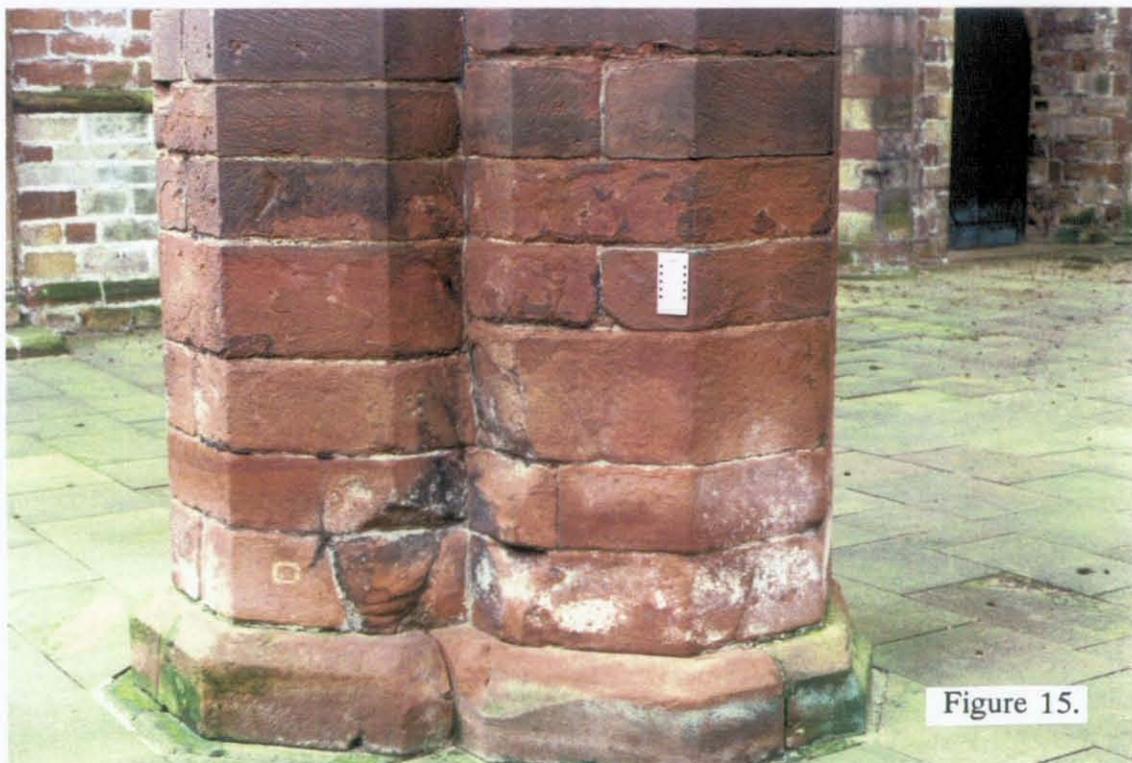
Figure 15. Pillar between Choir and South Transept. Large dressed blocks of St Bees Sandstone.

Where bedding is apparent it is mostly even and parallel. This is best seen where accentuated by weathering, eg in the outer east wall of the South Transept (Figure 9) and in the outer face of the east wall of the Chapel of St Catherine (Figure 10). From the size of the blocks it is clear that stone was obtained from individual beds or "posts" up to at least 0.35 m thick, (Figure 15).

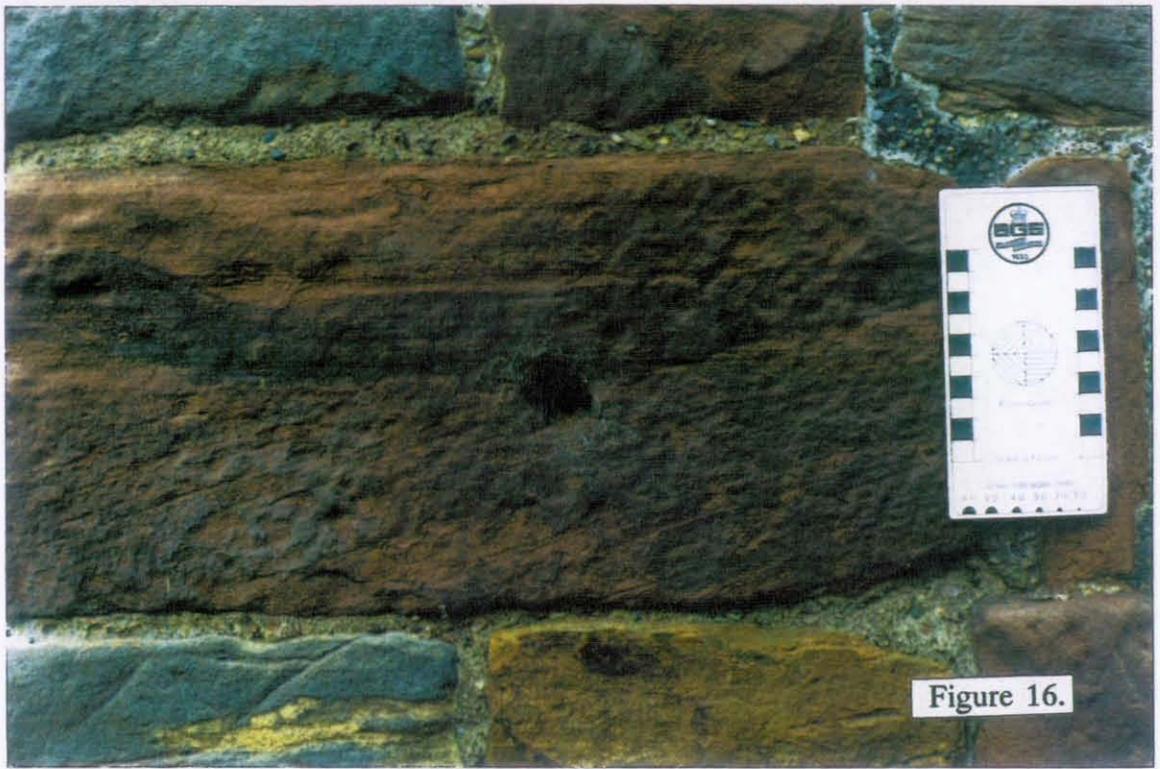
Figure 16. East wall of South Transept. Cross-bedding in St Bees Sandstone.

Cross-bedding is conspicuous in some blocks. Figure 16 shows a block in the outface of the east wall of the South Transept. Other examples may be seen in the west doorway of the Prior's House, in the lintels above one of the windows on the south side of the Cellarium (Figure 17), in parts of the West Front (Figure 18) and elsewhere.

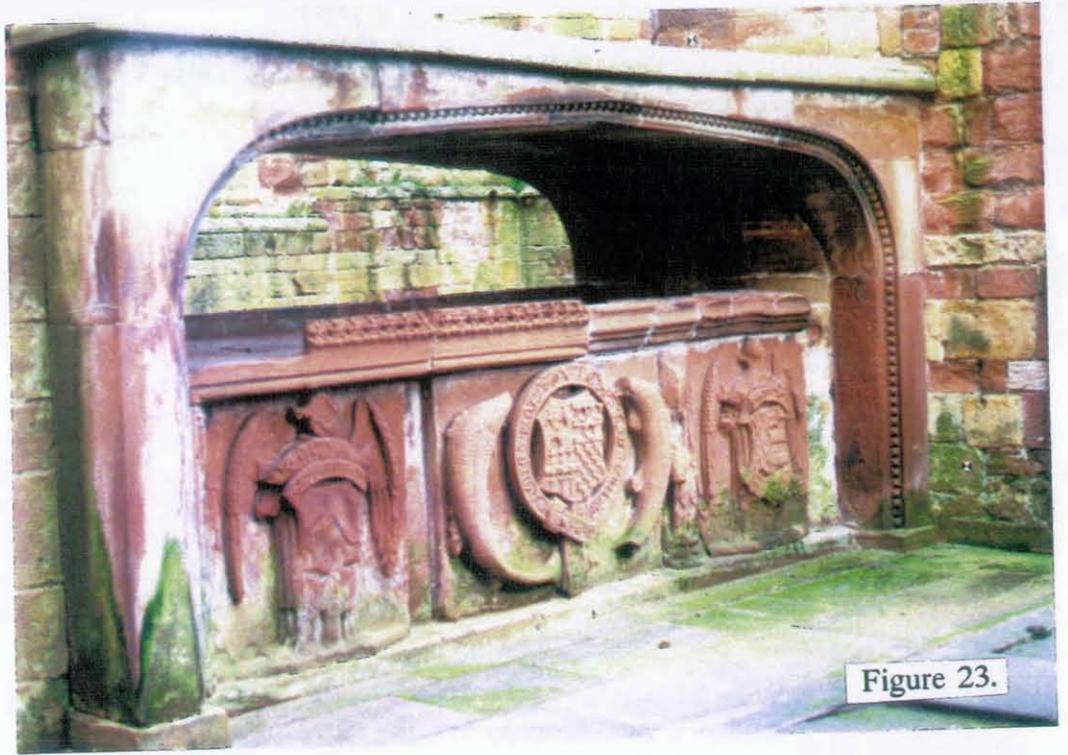
Figure 23. South face of tomb of Sir Thomas Dacre.

The finest example of carved St Bees Sandstone in the Priory are in several of the tombs in the Choir, Transepts and Sanctuary. The tombs of Sir Rowland de Vaux and Sir Thomas Dacre (Figure 23 and 24) both incorporate excellent examples of detailed carving into his

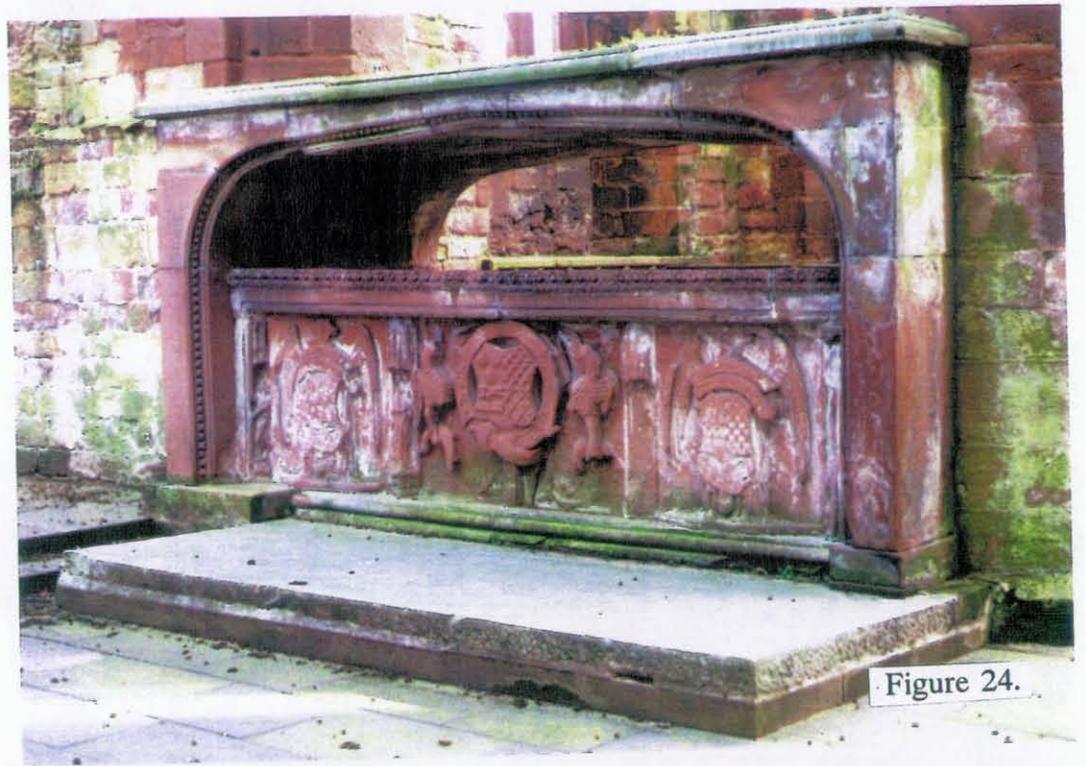
Figure 24. North face of tomb of Sir Thomas Dacre. Large dressed slab of grey limestone at foot of tomb.

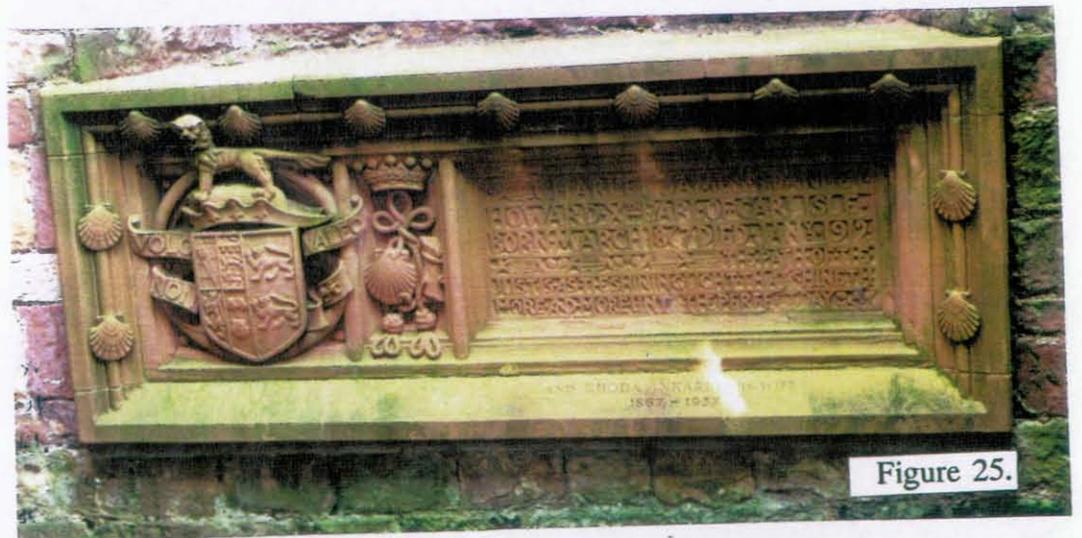
Figure 25. Monument to Charles James Howard.

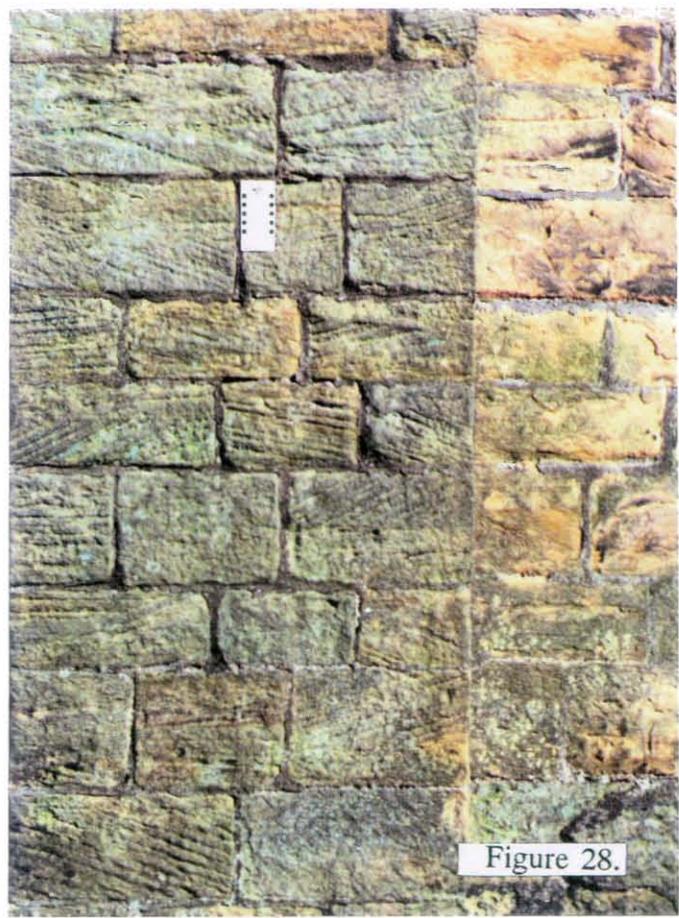
Figure 28. West wall of South Transept.

Throughout the Priory good examples of lamination enhanced by preferential weathering may be seen in both the St Bees Sandstone and the Carboniferous stones (eg Figures 9, 28 and 31). The effect of deep weathering on cross-bedded St Bees Sandstone is illustrated in Figure 50. Severe deterioration of St Bees Sandstone along bedding planes is conspicuous in the arch above the east window of the North Transept. Early attempts have been made to repair this decaying stone with red-coloured cement.

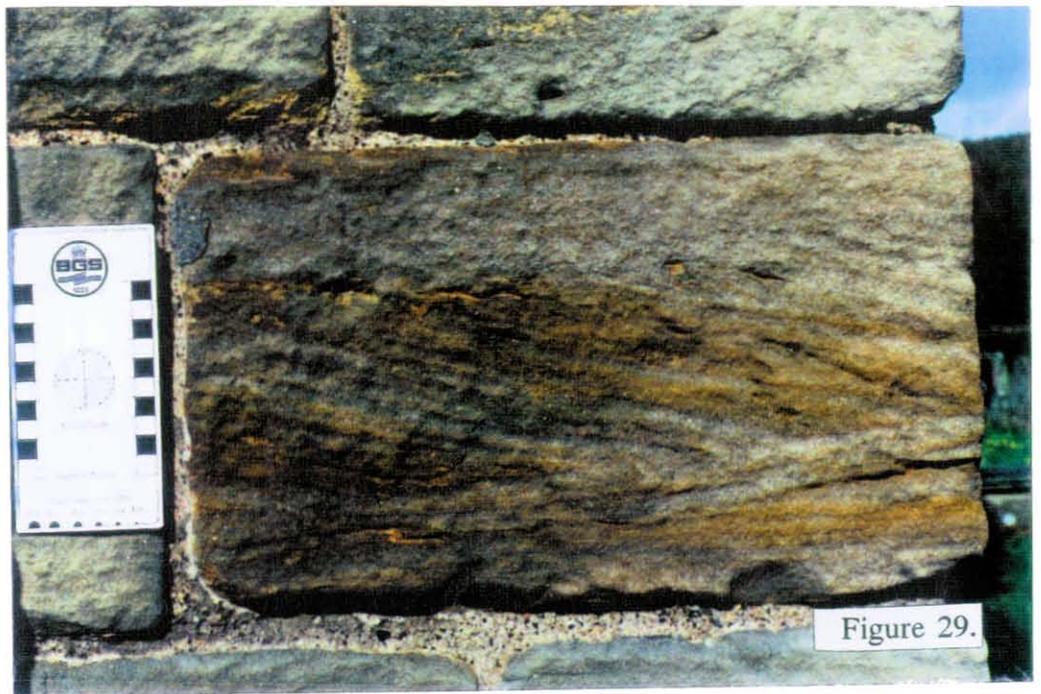
- Figure 29. East wall of Sanctuary. Cross-bedding in Carboniferous sandstone accentuated by brown iron-oxides. A few grains of off-white kaolinised feldspar may be seen in places.
- Figure 30. North wall of Lady Chapel. Cross-bedding in Carboniferous sandstone accentuated by brown iron-oxides. This block is inverted.
- Figure 31. East wall of South Transept. Weathered ripple cross-lamination in Carboniferous sandstone.

kaolinised feldspar, (Figure 29) a feature common in many Carboniferous sandstones. Whereas some blocks show no obvious lamination a considerable number show relatively straight lamination and many exhibit prominent cross-lamination (Figures 26, 28, 29 and 30). Some blocks (eg Figure 29) show small rather tabular hollows which may represent weathered out mudstone or clay clasts or lenses.

In the long-weathered outer faces of the walls blocks of this stone typically exhibit a rather uniform dull pale buff to greyish buff coloration. Some blocks, however, display a strikingly uneven colour variation (eg Figures 29 and 30). In these instances darker brown iron oxide pigments have been preferentially concentrated along certain laminae. This is spectacularly seen in Figure 30 where the inclined cross-laminae in the upper part of the block are strongly iron-stained. The less inclined laminae in the lower part of the block are much less strongly coloured. (This block is laid upside down.)

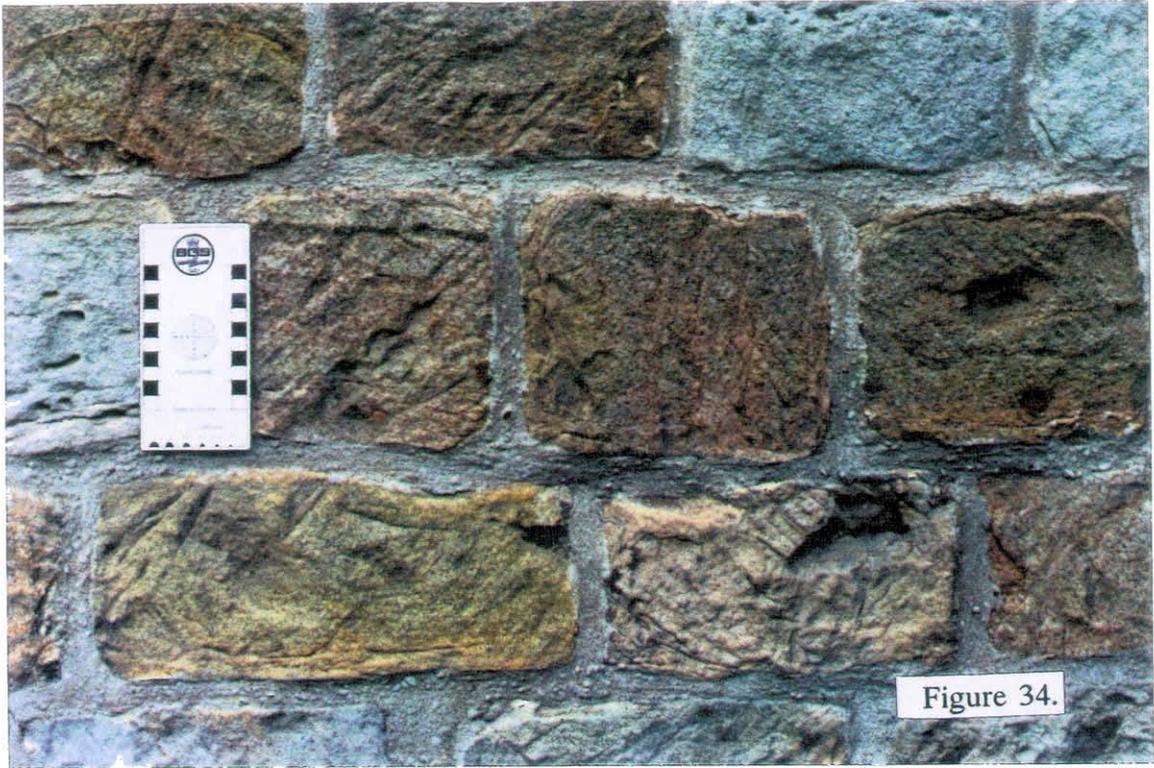
Figure 34. South wall of Nave. Brown-speckled Carboniferous sandstone.

In many examples of this stone a markedly speckled appearance is seen (Figure 34). In these instances brown iron oxide pigment has developed as discrete patches up to only a few millimetres across, perhaps nucleated around preferred mineral grains or conceivably as a result of oxidation of original iron carbonate grains, perhaps sphaerosiderite, within the stone.

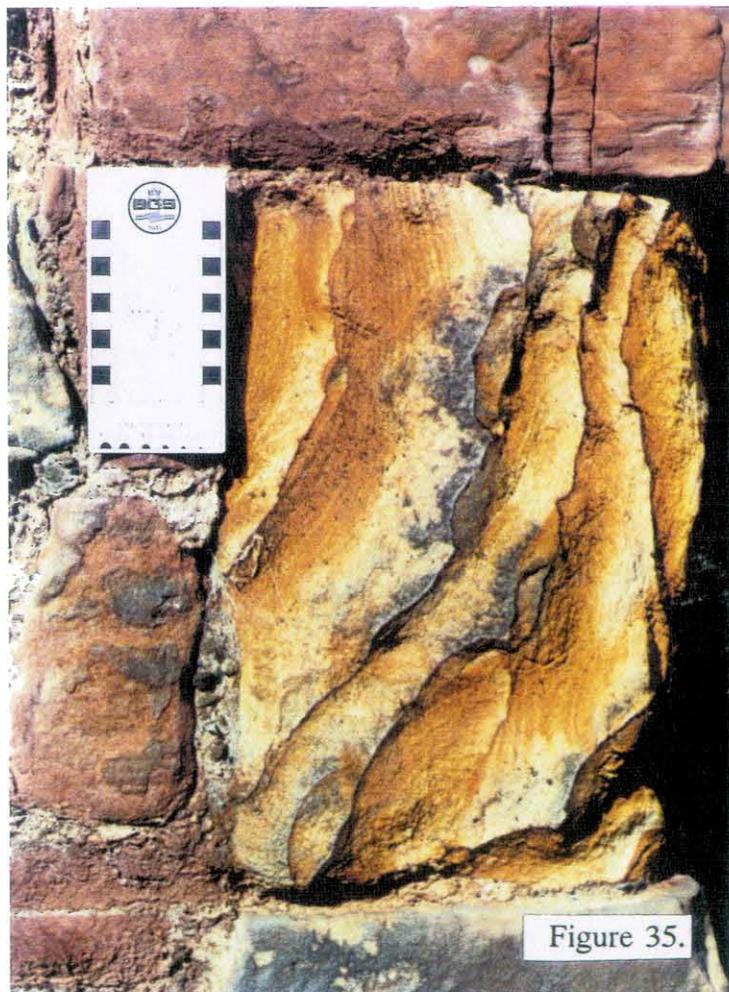
Figure 35. South east corner of South Transept. Liesgang rings of brown iron-oxide in Carboniferous sandstone.

A few blocks show the concentration of iron oxides as irregular bands - 'liesgang rings' - formed as reaction fronts by iron oxide precipitation within the stone, perhaps after the stone was incorporated in the structure (Figures 9 and 35).

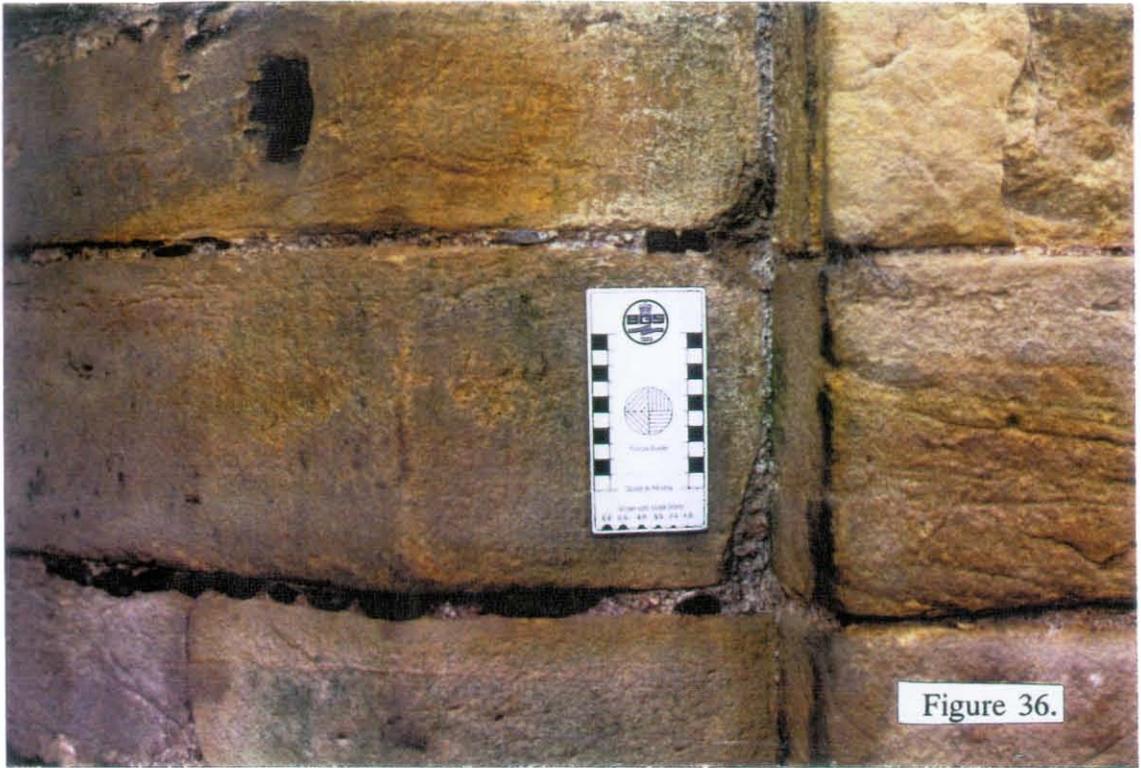
Figure 36. Pillar in North Transept. Yellow Carboniferous sandstone.

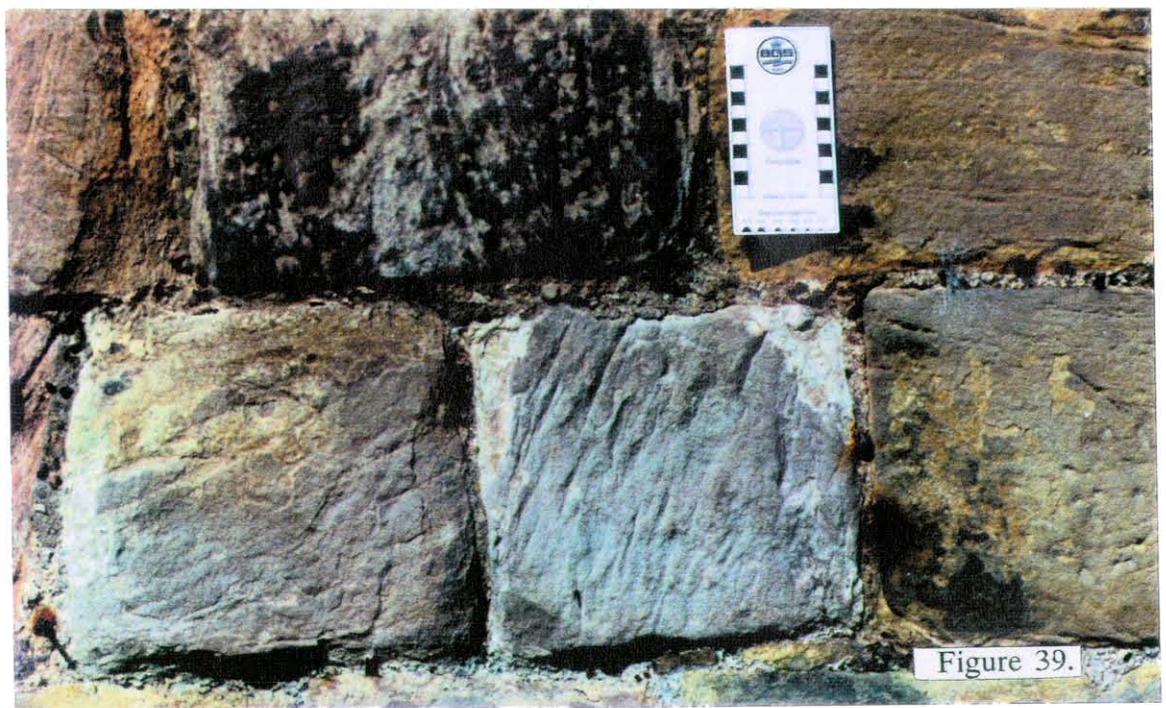
Figure 38.

Figure 38 and 39. South wall of South Transept. Squared blocks, possibly derived from Hadrian's Wall. Traces of cross-bedding may be seen in the lower left-hand block in Figure 39.

A common sandstone type within the fabric, though less abundant than the buff sandstones, is one which in weathered blocks presents a striking very pale grey or white appearance. Examples of this are present in the outer face of the south wall of the South Transept (Figures 38 and 39) and Nave (Figure 40).

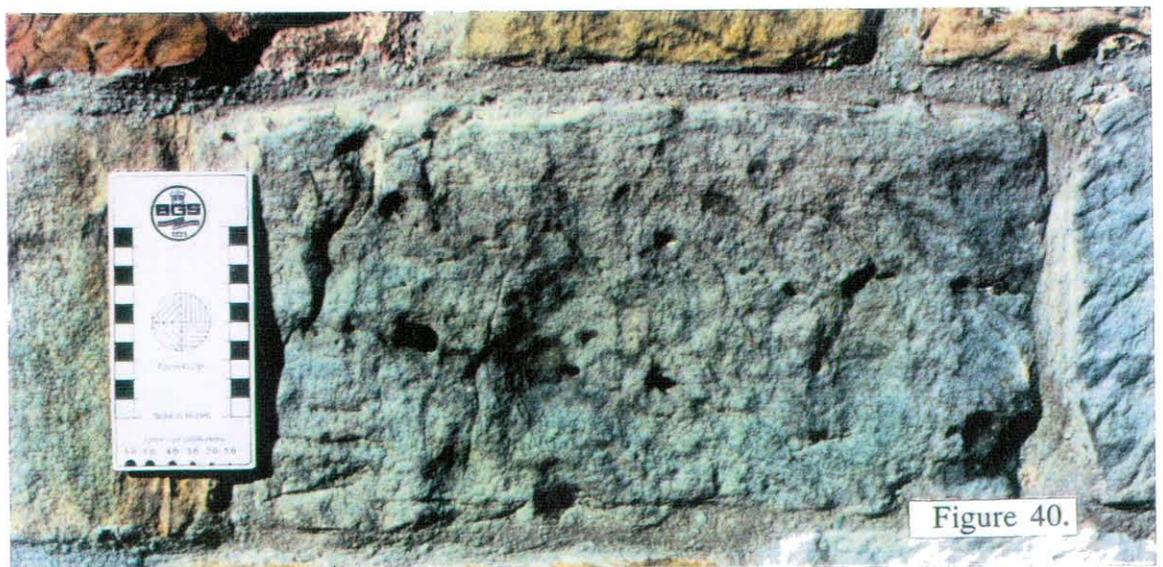
Figure 40. South wall of Nave. Small in-weathered hollows.

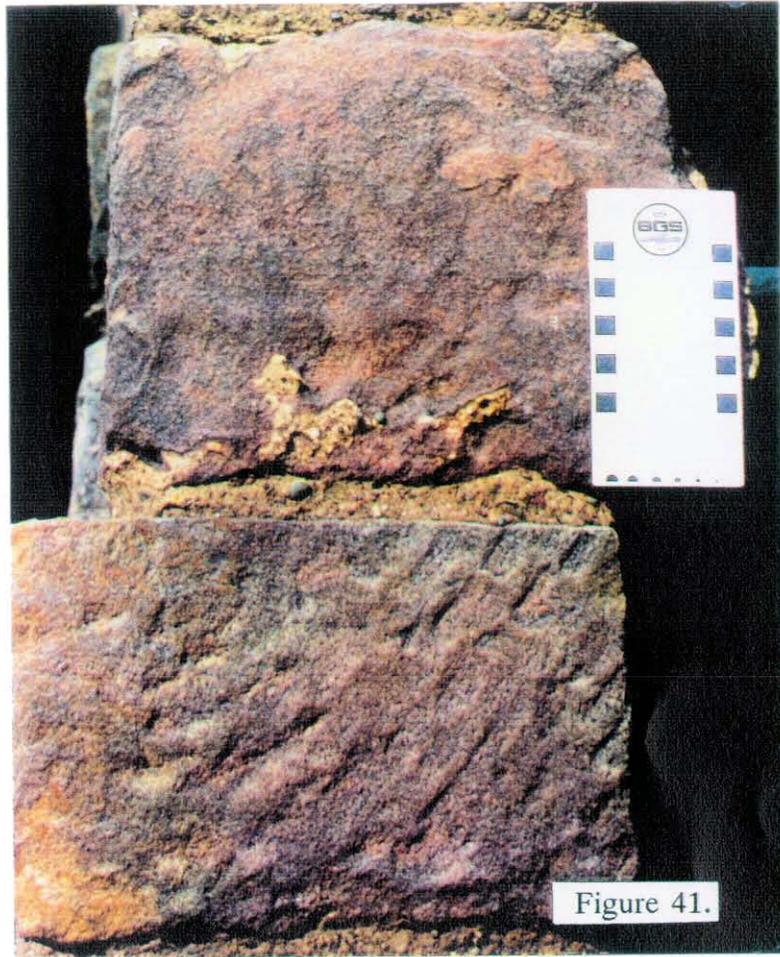
Figure 41. West wall of South Transept.

Several blocks of purplish red sandstone are present, usually scattered throughout the masonry. The red colour which varies from reddish buff (Figure 41) to a more distinct purplish red (Figure 42 and 43) is quite distinct from the dull brownish red of the St Bees Sandstone. The coloration is commonly unevenly dispersed throughout the stone and appears typically to be unrelated to original sedimentary structures within the rock. Concentrations of the red pigment, almost certainly hematite, are conspicuous in a few blocks where preferred grains, clasts or nodules of ironstone or mudstone may have provided a nucleus for deposition (Figures 43 and 44). The texture and overall appearance of these stones is quite unlike that of the St Bees stone. These are typically medium-grained sandstones, in some instances with conspicuous kaolinised feldspar, of the type considered here as of Carboniferous origin.

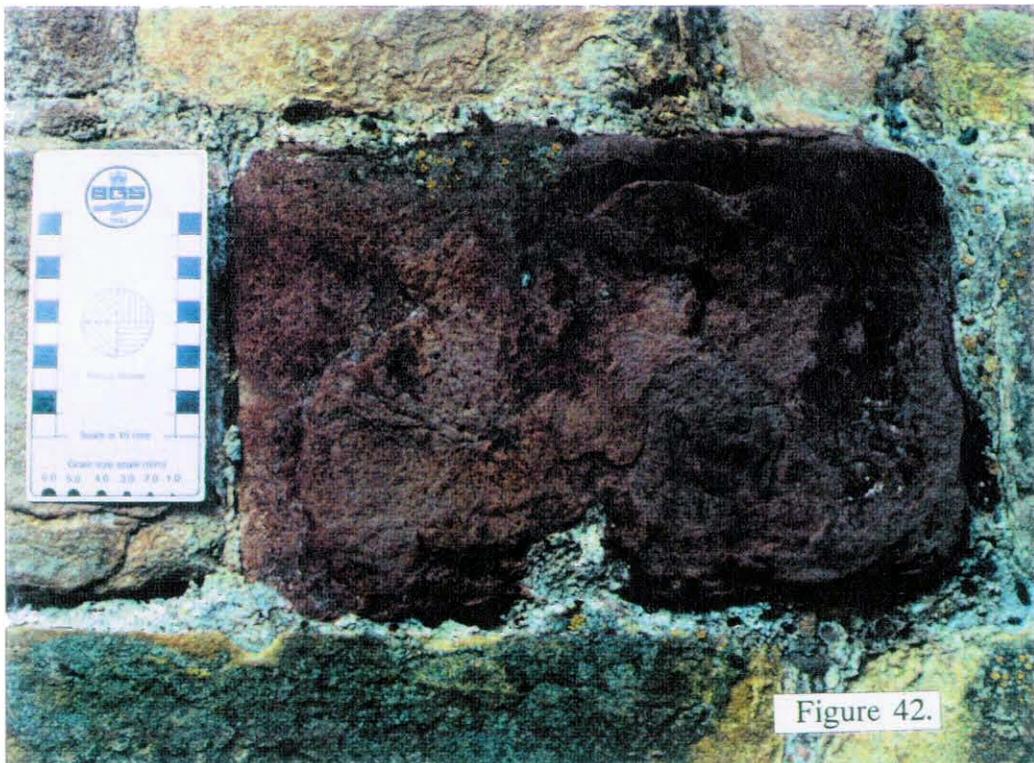
Figure 42. South wall of South Transept.

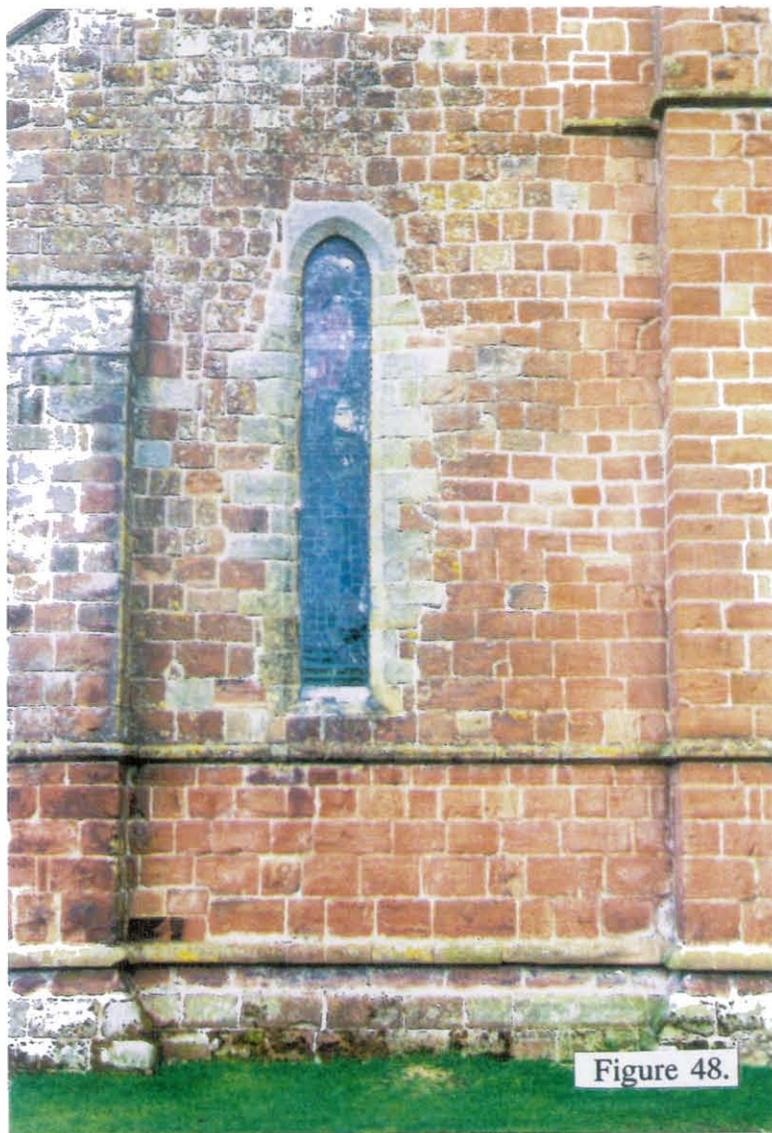
Figure 48. Window in north side of West Front. The red masonry is St Bees Sandstone.

Whereas the walls of the Priory generally reflect no preference for any particular stone, the use of St Bees Sandstone, especially for carved work, has already been noted (3.2.4). In a few parts of the building Carboniferous sandstones have been carved as mouldings and arches. Examples may be seen in the pillars of the Transept and Choir (Figure 37) in the now blocked doorway at the south east corner of the Nave (Figure 45) and in the adjoining outer face of the South Transept (Figures 46 and 47). Carboniferous sandstones have locally been used for window arches eg on the West Front (Figure 48) and for the arches of the clerestory in the Sanctuary (Figure 49).

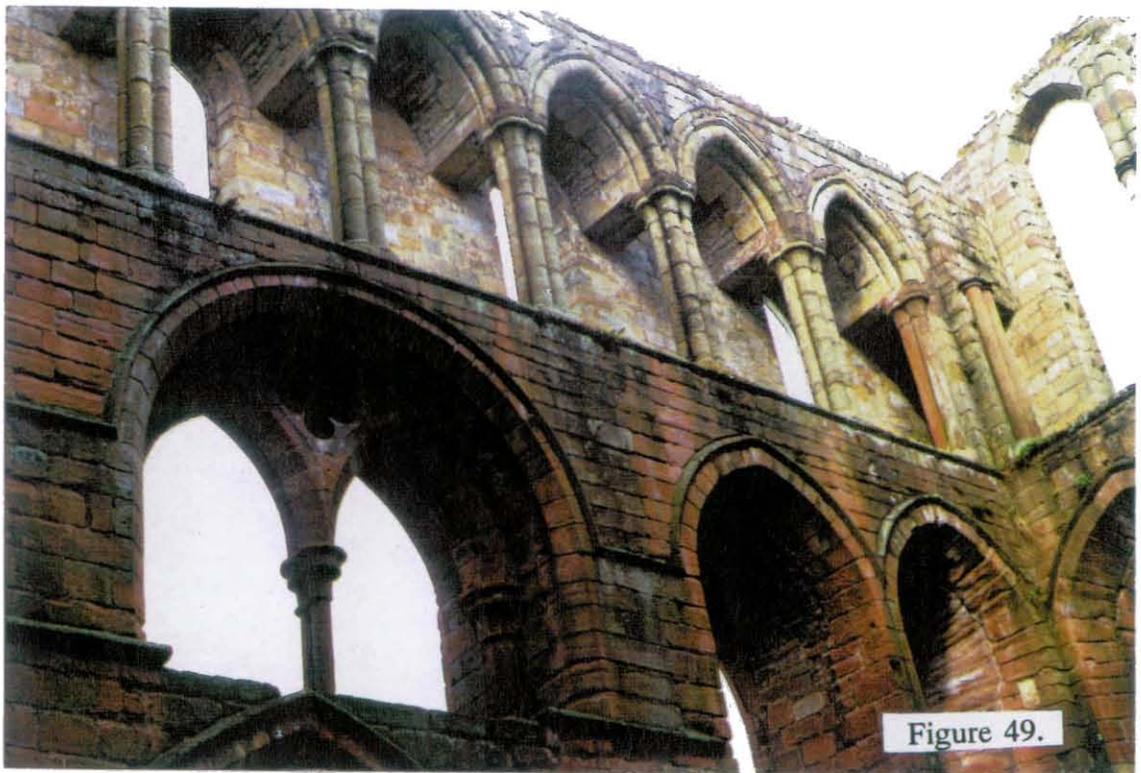
Figure 49. North side of Sanctuary. Arching in Clerestory is of Carboniferous sandstone. The red masonry in the lower walls is St Bees Sandstone.

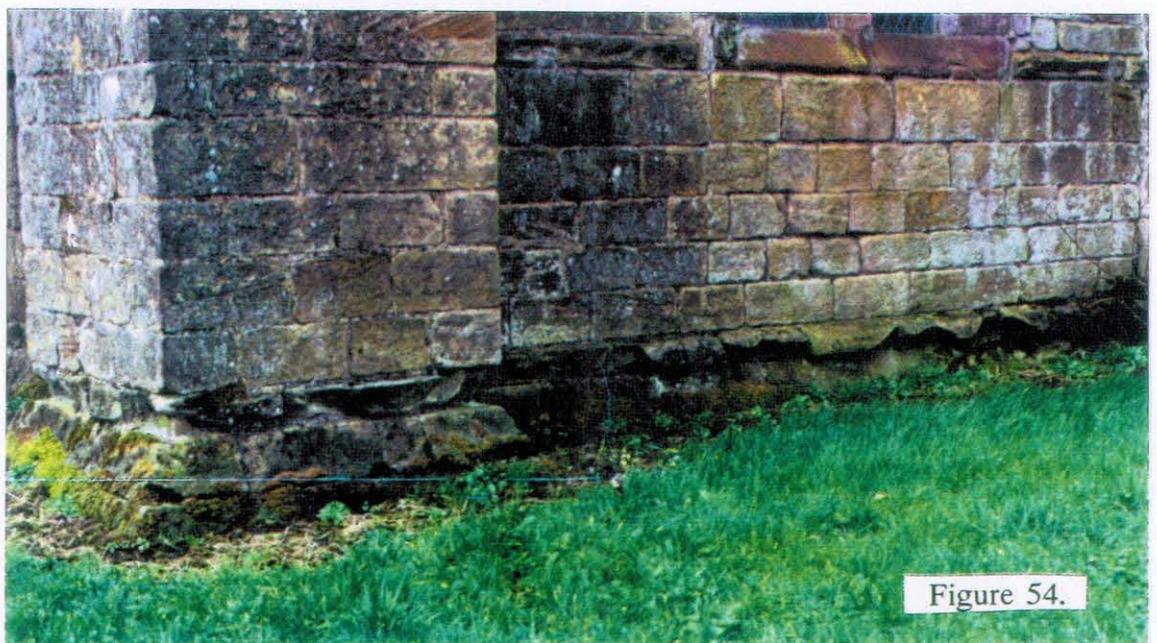
Figure 54. North wall of Lady Chapel. Deterioration of foundation courses of Carboniferous sandstone.

The effect of rising dampness on stone durability is well-seen in the deteriorating lower course of Carboniferous sandstone in the outer walls of the Lady Chapel (Figure 54).
