Vegetation damage and synchronous tephra-fall influence sediment-charged flash floods

Jan Alexander^{1*}, Jenni Barclay¹, Janez Sušnik¹, Sue C. Loughlin², Richard A. Herd¹, Amii Darnell¹ and Sian Crowweller¹

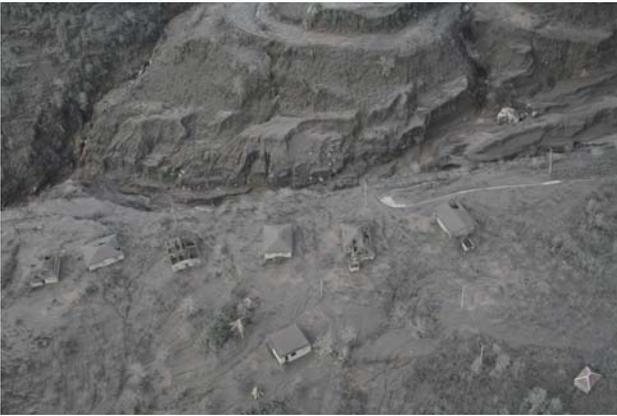
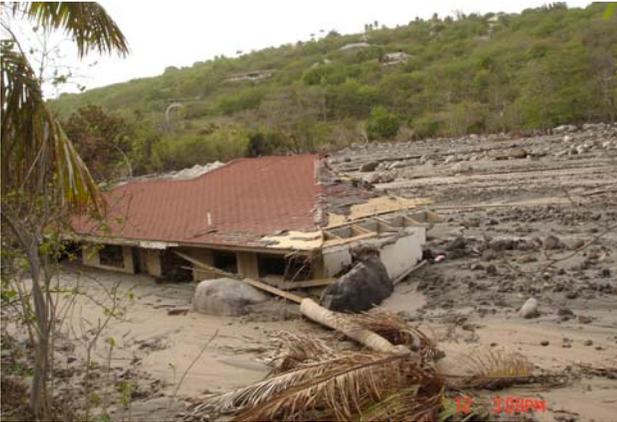
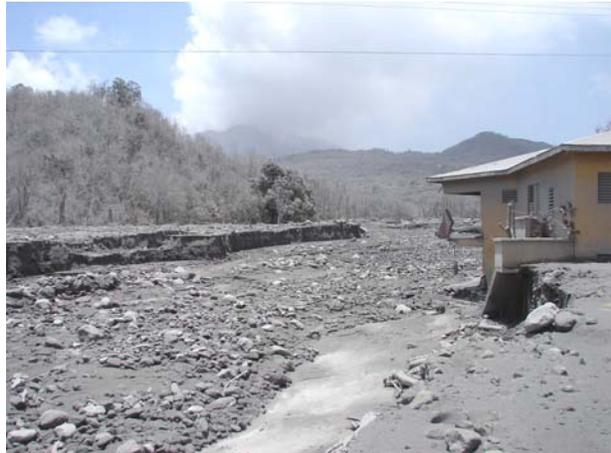
Fig. 2. Photographs of the Belham Valley; **A.** and **B.** are aerial views of the same reach of the upper valley at Dyer's (E on Fig. 1A) taken on the evening of the 20th May 2006 (MVO photograph; copyright NERC) and in November 2006 (photographer RH) showing the extent of tephra deposition and its later partial removal from *e.g.* roofs. The vegetation damage in May was extreme and by November significant re-growth was evident. **C.** A small house towards the lower end of the Belham Valley (A on Fig.1A) on 12th June 2006 (photographer Tina Bretton). Notice particularly the >2 m boulders against the walls that were deposited in May 2006 and the extent of vegetation damage still evident on the far valley side. **D.** View upstream at D on Fig. 1A on 23rd May 2006, (photographer SL; copyright NERC) shows the extent of vegetation damage on the hills and the channel incision into the 20th May and older deposits. The house was well above the valley floor in 1995.

The volcanic-dome collapse on 20th May 2006 was the second largest in the 12-year eruptive history and *c.* 115×10^6 m³ was removed from the edifice in less than three hours with most activity taking place within 35 minutes (3; www.mvo.ms). The associated lahar activity caused more geomorphic change in the Belham Valley (Fig. 1) than observed on any other individual day since 1995. In two days (20th and 21st May) more change occurred within the valley than the cumulative total of the preceding five years (Fig. 2).
