Notes on a site visit to the abandoned Abbey Consols Mine, Mid-Wales

Open Report OR/12/047

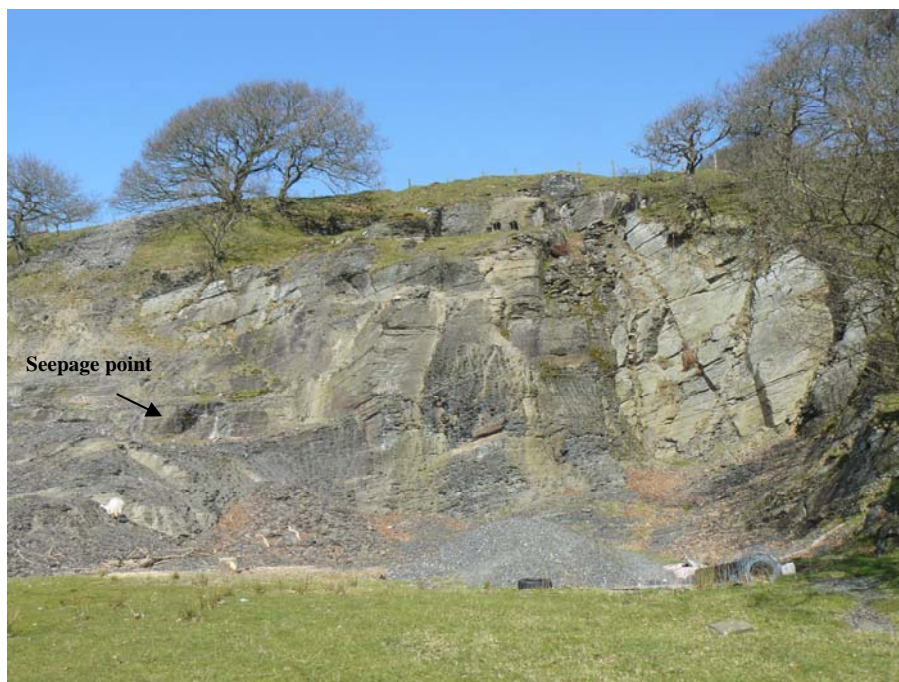
Bedrock was exposed in the quarry immediately to the north of the site (Figure 1) and could be seen to be bedded and jointed (Figure 2). Scour marks on the quarry face are suspected to be wire hose marks made during the removal of plant from the floor of the quarry.

Figure 2 Bedrock exposed in the quarry to the north of the mine site

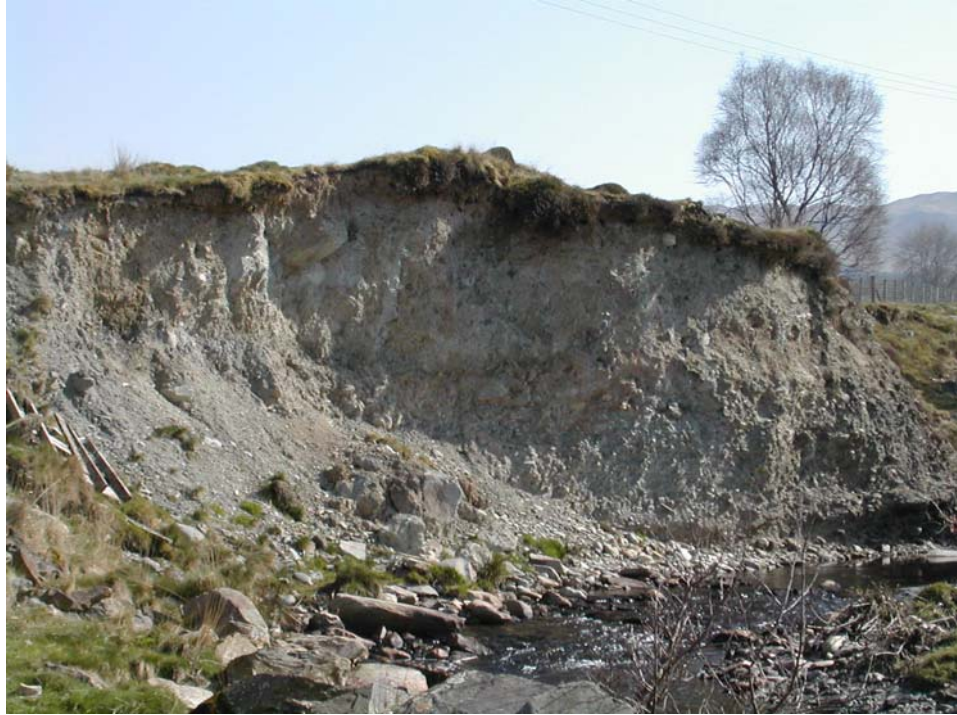
The superficial geology comprises Till (TLLD-DMTN, Figure 3), that is likely to have been derived from the Welsh ice-sheet during the Devensian glaciation, and Alluvium (ALV-XCVZSV, Figure 3). The Till was exposed in a bank adjacent to the river (Figure 4) and was characterised by an upper, paler, more weathered, possibly periglacially affected layer of 1 to 2 m in thickness, underlain by a slightly darker more gravelly lower layer (Figure 4). The boundary between the two layers undulates considerably. Gravels in the lower layer are pseudo-bedded, predominantly subrounded and of medium to coarse gravel grade with occasional cobbles. The clasts are largely locally derived slate and quartz. It is plausible that the upper and lower layers are representative of two different ice sheets, as it is known that the area was overridden by the Welsh and possibly also the Irish Sea Ice sheets during the Devensian glaciation (Davies et al., 2007).

Figure 4 Exposure of Till.

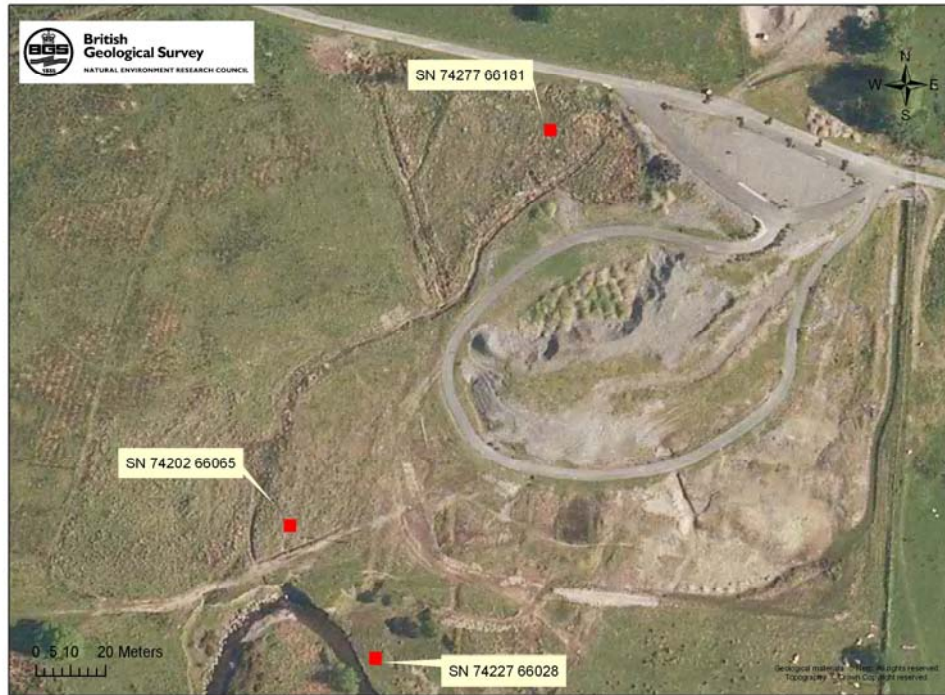
Alluvium was encountered in two areas: i) the near surface soils associated with a spring line at the northern edge of the river flood plain and extending down-slope towards the river ii) adjacent to the river. The field immediately to the west of the abandoned mine area was covered by sedge-like grasses associated with these seepages. It was also exposed by hand augering at a number of locations (Figure 5), including SN 74277 66181 (Figure 6), where 0.80 m of medium brown soft to firm amorphous peat was underlain by soft (becoming firm with depth), bluish-grey silty, clay with occasional peaty rootlets extending to 1.40 m depth. Closer to the river the near surface alluvial soils were found to comprise firm grey silty clay with occasional yellowish brown staining and rootlets (SN 74202 66065) and about 20 cm of firm grey mottled reddish and orange brown silty organic clay river bank deposit (SN 74227 66028, Figure 8) overlying 55 cm of firm grey mottled brown and orange brown silty clay with pockets of fine to medium and occasional coarse gravel grade tabular clasts of mudstone resting on subangular to subrounded medium to coarse gravel and cobble grade tabular bedded gravels that grade into the river bed.

Figure 5 Location of alluvium exposure as noted in the text. (Aerial photography © Getmapping Licence No. UKP2006/01).

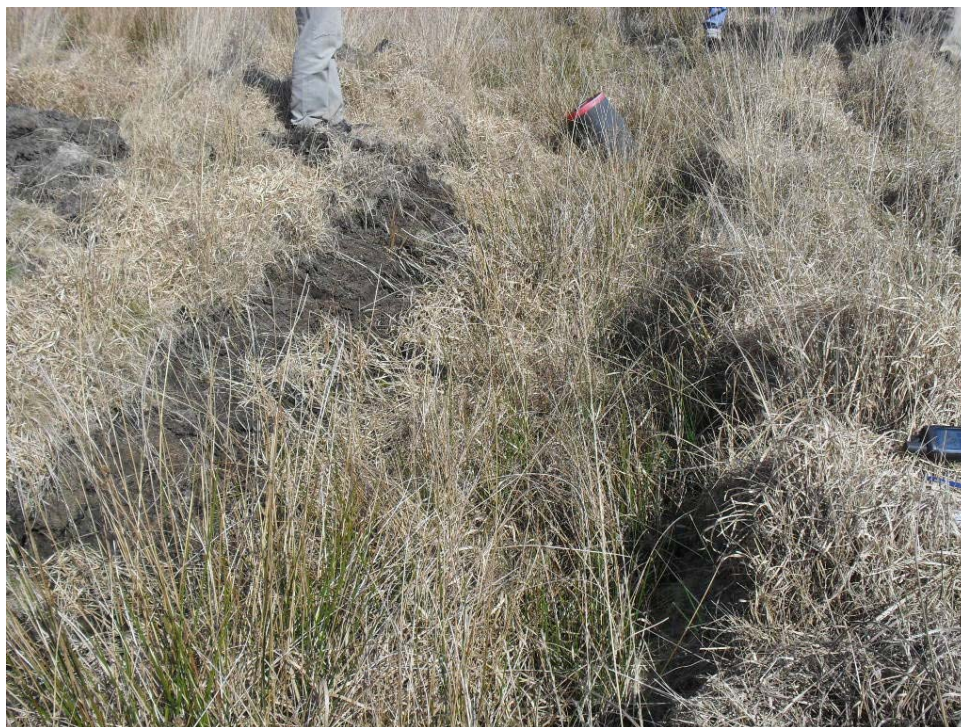
Figure 6 Peat underlain by bluish-grey silty clay in a marshy area to the west of the site (close to SN 74277 66181 in Figure 5).

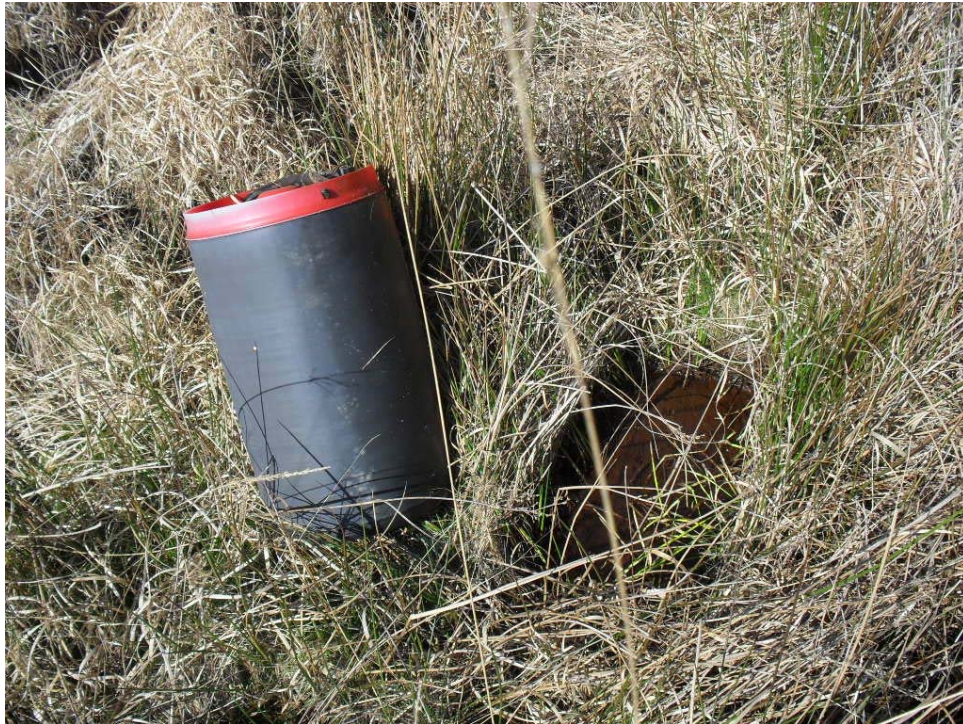
Figure 7 Detail of Figure 6 showing orange brown seepage in the ditch.

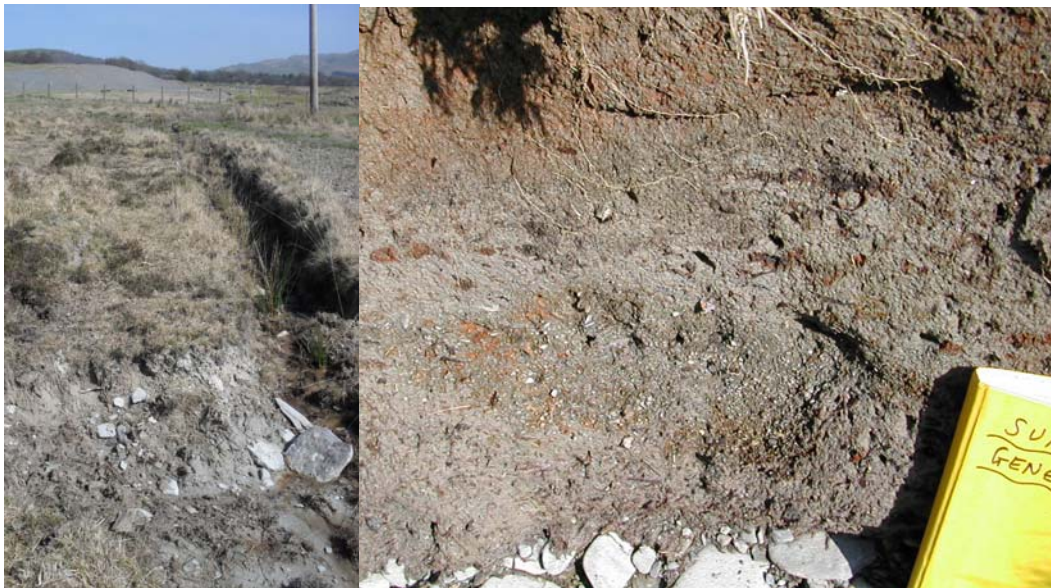
Figure 8 Alluvium, showing iron enrichment associated with seepage to the river.

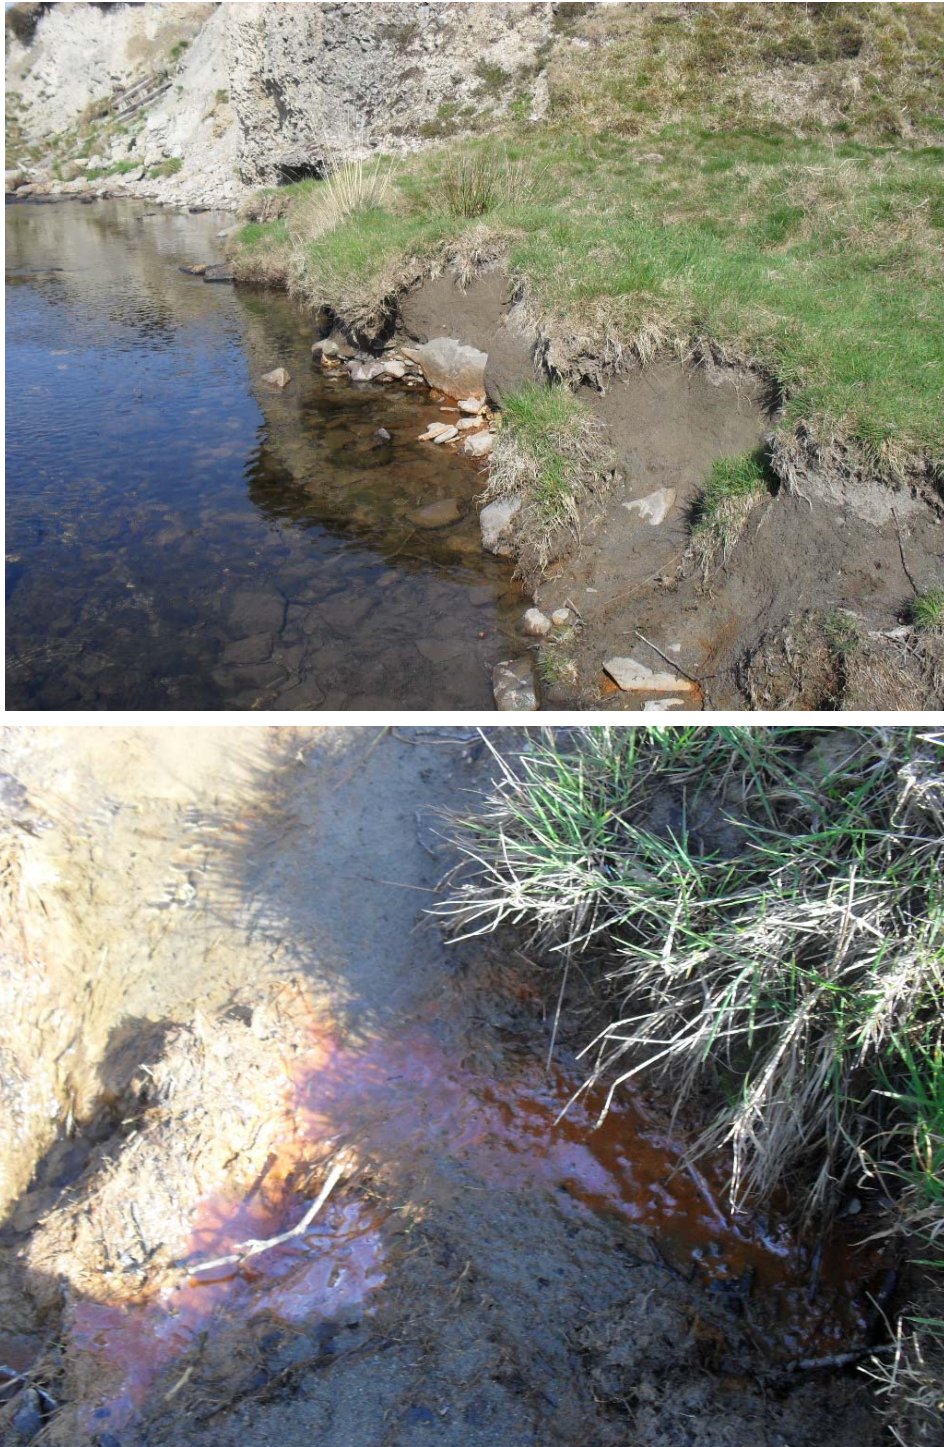
A number of river bank seepages were readily identifiable by orange brown staining in the river bank (Figure 9). Many of these seepages are likely to be naturally occurring. However, a number may represent contaminant inputs to the stream. A survey of the physico-chemical parameters of these seepages may help address this uncertainty (section 8).

Figure 9 River bank seepages identifiable by orange brown staining.

To address these knowledge gaps it is recommended to further understand ground levels (undertake a site survey), consider groundwater chemistry and continuity to the river. A geophysical survey might help locate the adit. A survey of physico-chemical parameters at

closely spaced intervals along the River Teifi in the stretch extending from upstream to downstream of the site may help identify groundwater contributions to the stream.

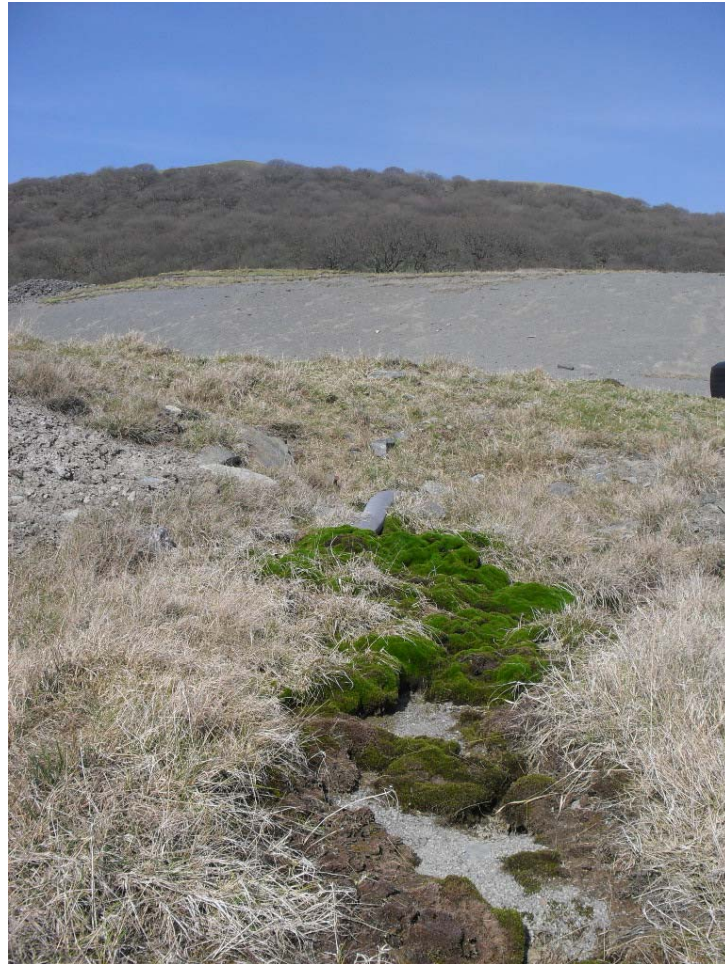
During the site visit, which coincided with a prolonged period of dry weather conditions, surface runoff over the spoils was not evident, however signs of seepage at the base of the spoil heaps were observed (Figure 10). A pipe at NGR SN7425066046 (EA site 82970- Abbey Consols Spoil Runoff 2) is collecting a proportion of the drainage for monitoring the flow and quality of the spoil seepage (Figure 13). A boggy area was noted at the base of the spoil heaps (sample AC-7, SN 74262 66075, Figure 11) and upstream EA monitoring point 82970.

Figure 10 Seepage at the base of the spoil heaps colonised by lichens.

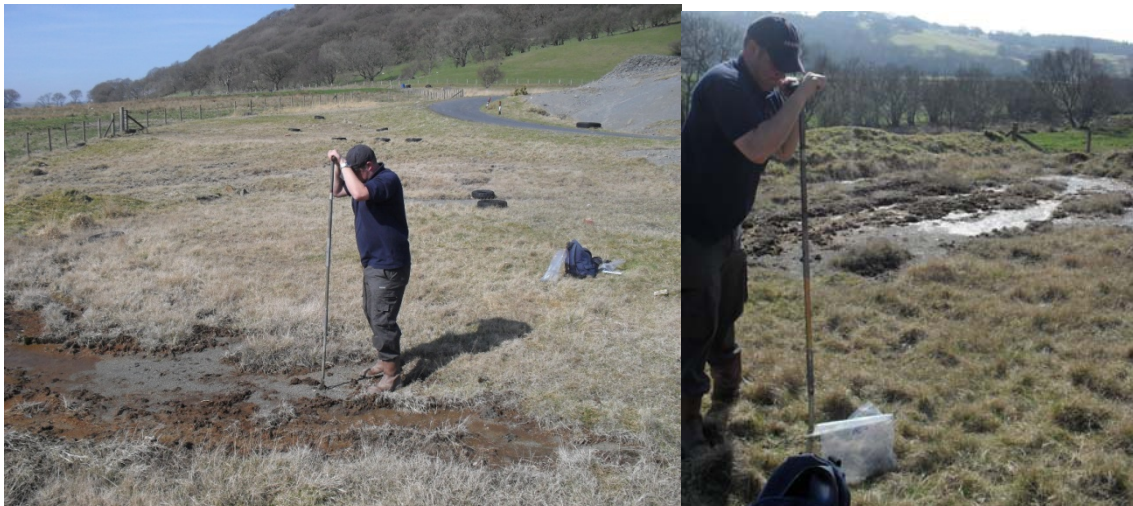
Figure 11 Collection of tailings sample (AC- 7) by hand auger in the marshy area downstream of the spoil heaps. Location is illustrated in Figure 21.

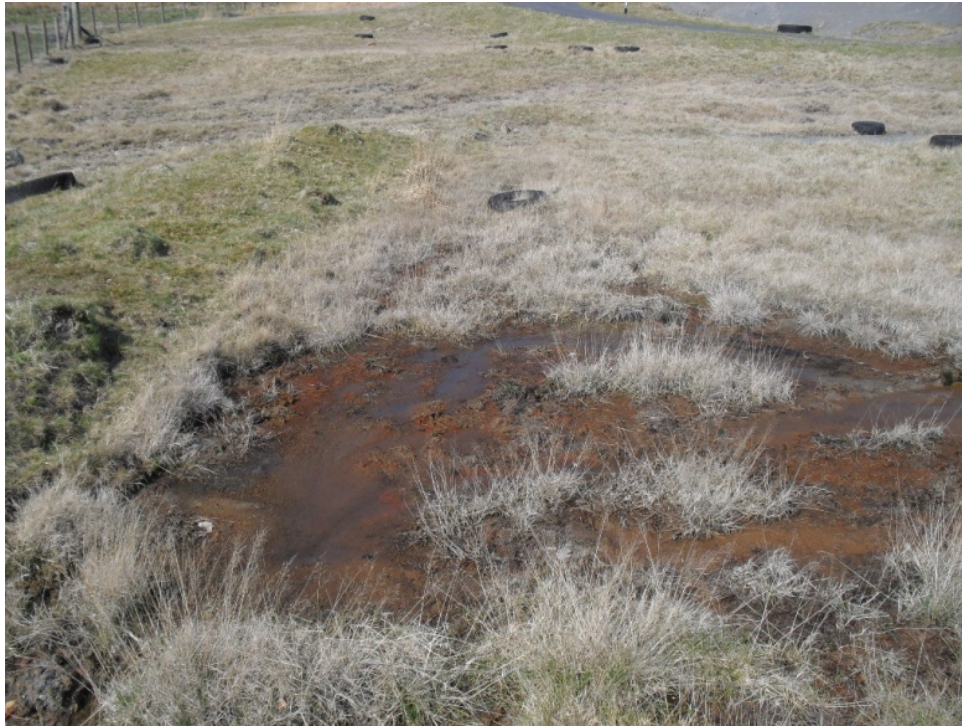
Figure 12 Detail of the marshy area in Figure 11.

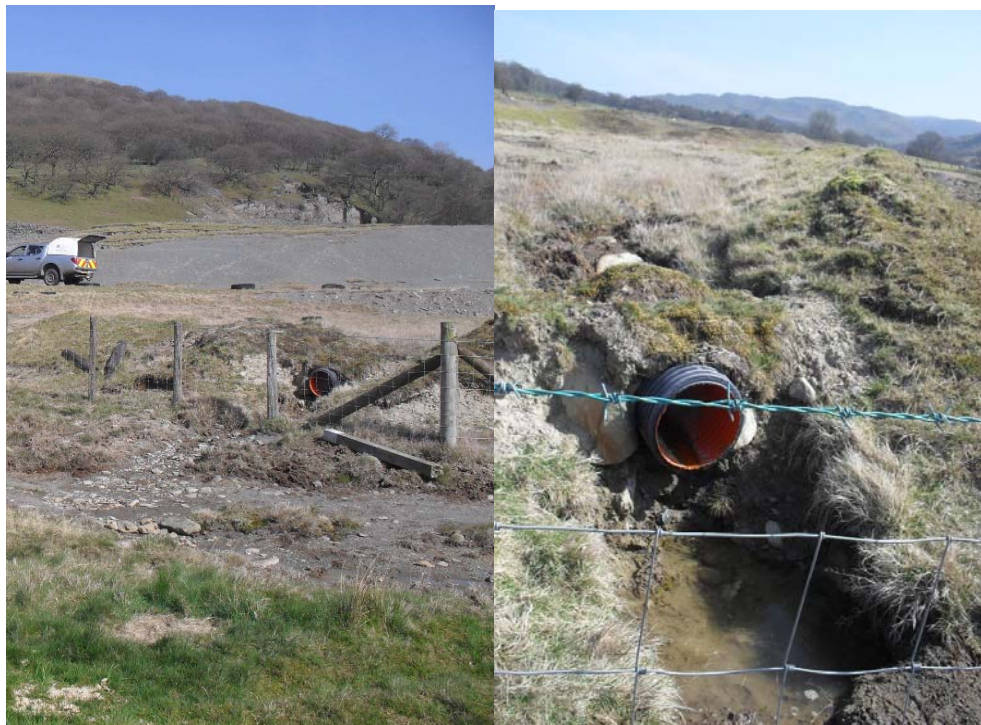
Figure 13 Pipe draining the area at the base of the spoil heaps, EA monitoring point 82970.

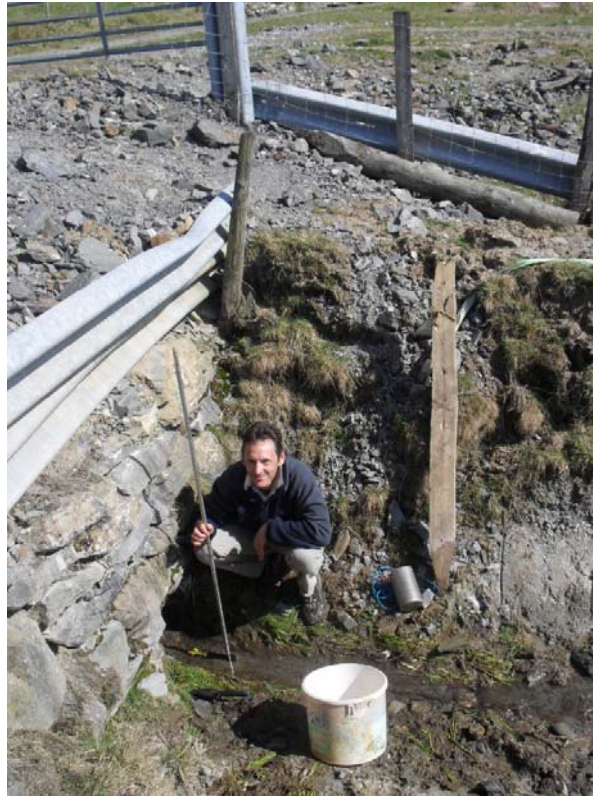
The presence of an issue near the old quarry area, north of the spoil heaps, at SN 7437 6618, as noted by ExCAL Limited (1999), may represent mine water issuing at this point, possibly entering the mine workings from the north-west area of the catchment. This water is sampled by the EA at SN 274378 266161, ID 82988 “ABBEY CONSOLS D/S ROAD” (Figure 14).

Figure 14 EA sampling location ID 82988 “ABBEY CONSOLS D/S ROAD” at SN 274378 266161. Paul Edwards from EA demonstrating flow measurements.

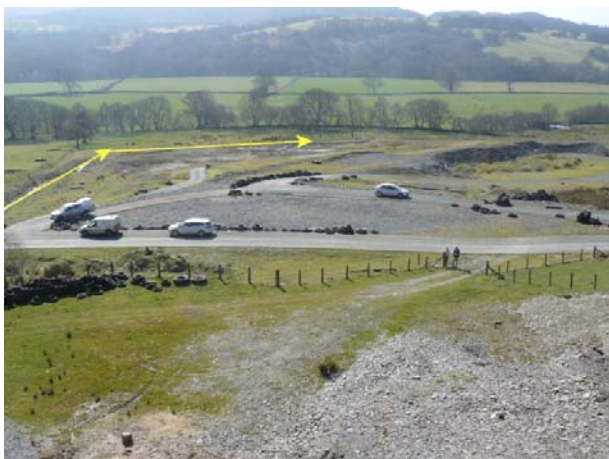
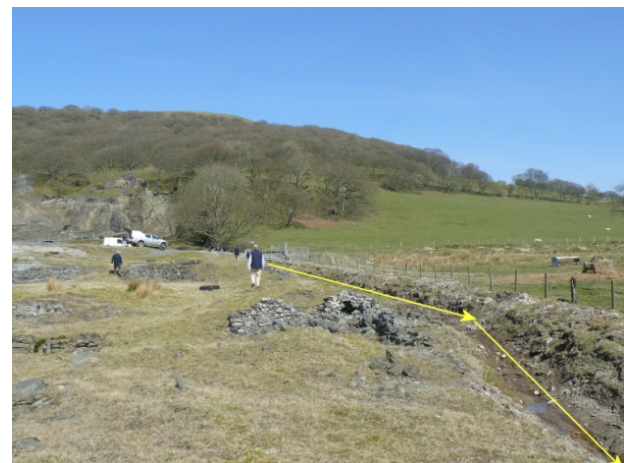
After passing through a road culvert this water flows via a ditch in a southerly and then westerly direction around the site (Figure 15 and Figure 16) and outside the area of the spoil heaps (Figure 17).

Figure 15 Ditch to east of spoil heaps (arrowed).

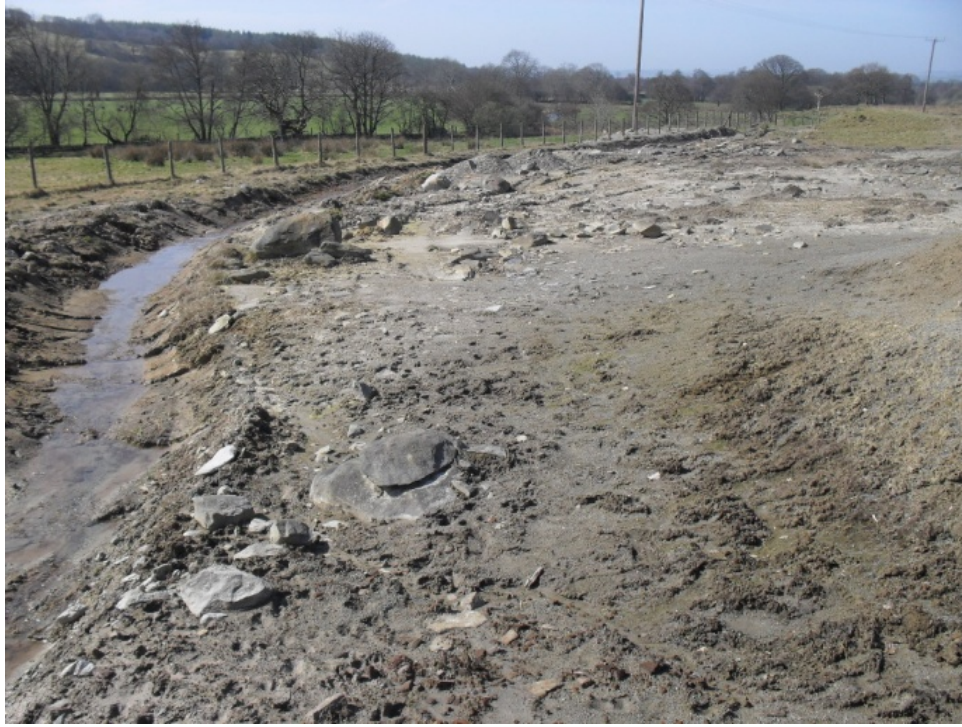
Figure 16 Ditch after it bends around the spoil area flowing in a westerly direction.

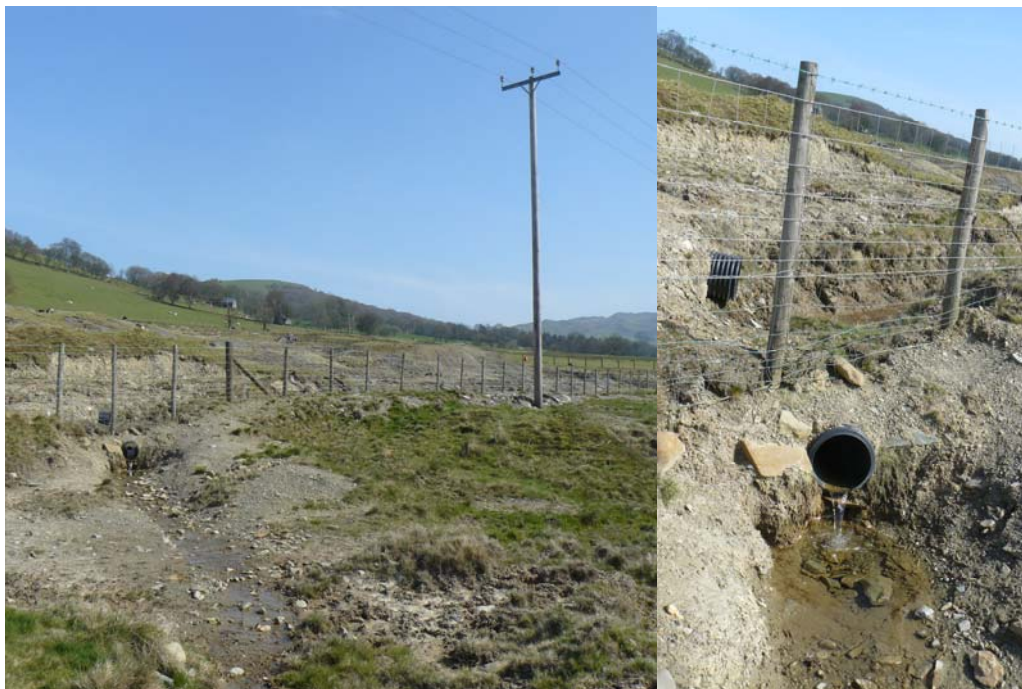
Figure 17 View of mine spoil area with pipe collecting water from ditch running to the east of spoil heaps (EA monitoring site 82989). Behind the fence it is visible an additional pipe collecting ponded water (EA monitoring site 82969).

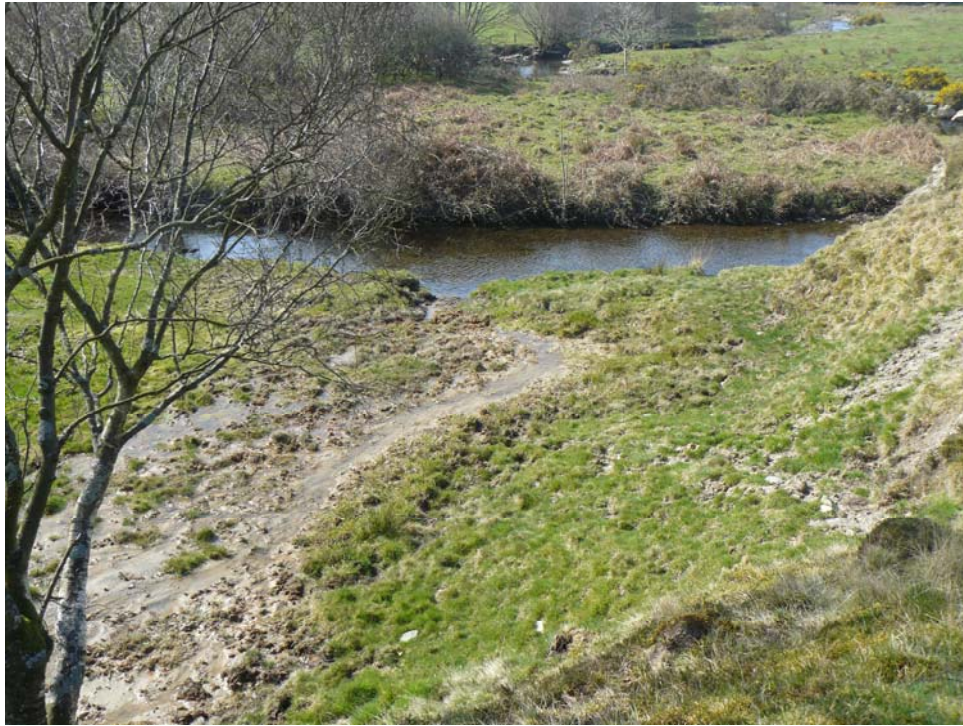
Figure 18 and Figure 19 show the drainage from the mine site entering Afon Teifi.

Figure 18 Drainage from Abbey Consols mine entering Afon Teifi.

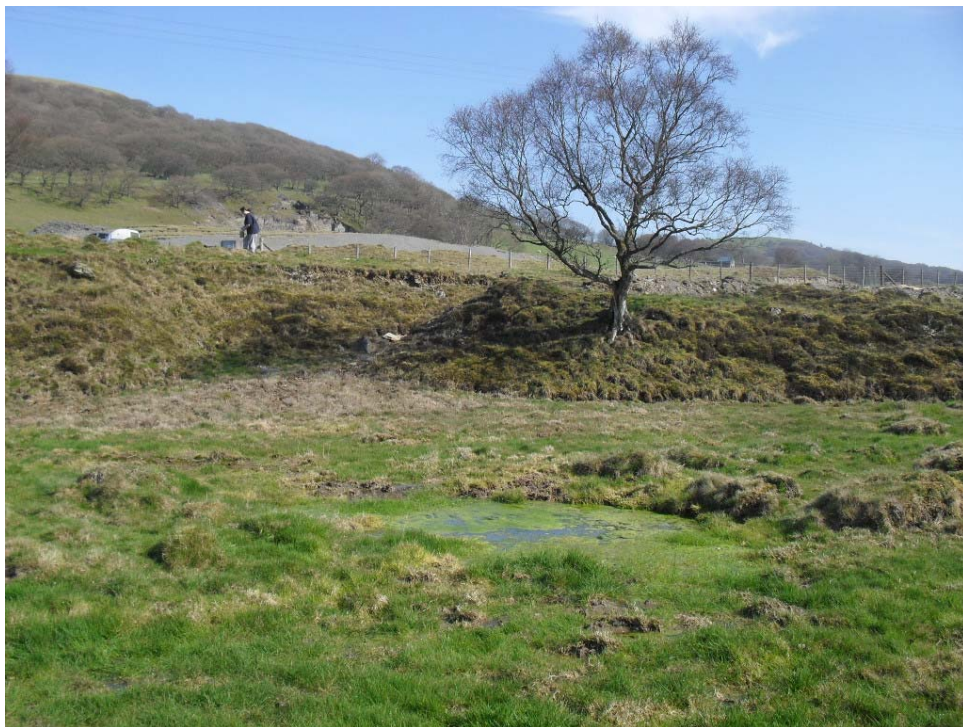
Figure 19 Floodplain receiving the drainage from Abbey Consols spoil heaps.

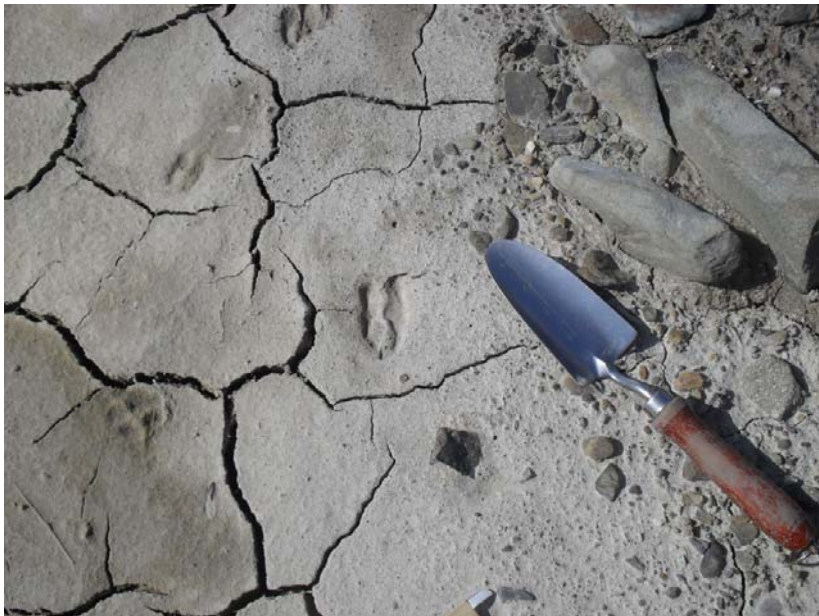
During the site visit on the 29th March evidence of desiccation cracks in the area SN 74319 66075 were visible, a sample AC-9 was collected from the 2-3 cm thick friable pale yellow fine silt crust over the tailings. Mineralogical analysis of the samples could indicate the type of metal salts present and inform on the quality of the potential surface runoff during the flush out at the first rainfall after a prolonged dry period.

Figure 20 Desiccation cracks in the area SN 74319 66075 (sample AC-9).

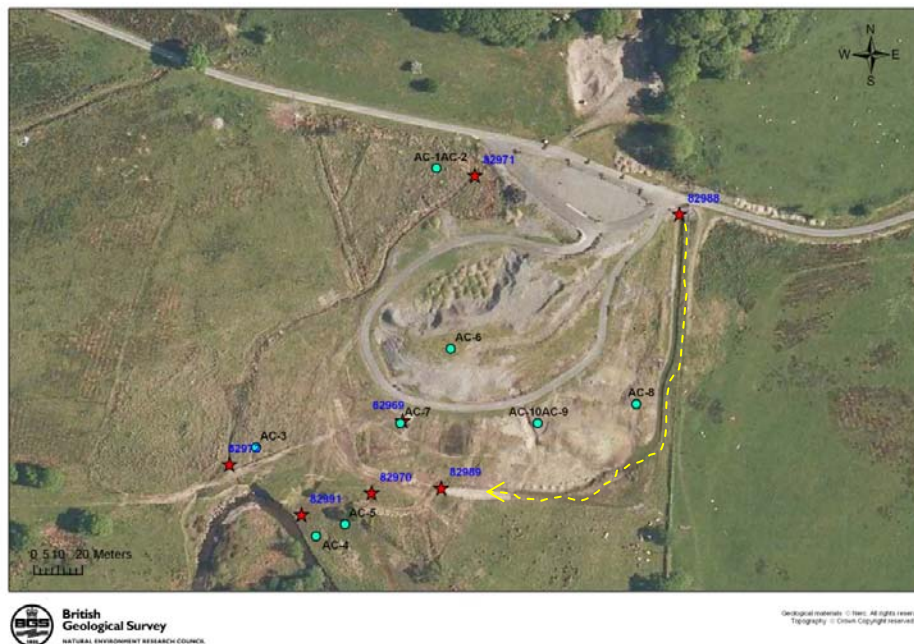
Figure 21 and Table 1 give the location and description, respectively, of the samples taken in occasion of the site visit on the 29th March 2012.

Figure 21 Aerial photograph of Abbey Consols Mine site with EA sampling locations (red stars) and samples collected during the site visit on the 29th March 2012. Boundary ditch marked in yellow with direction of flow (Aerial photography © Getmapping Licence No. UKP2006/01).
