UPGro Hidden Crisis Research Consortium

Unravelling past failures for future success in Rural Water Supply

Survey 1 Country Report – Malawi

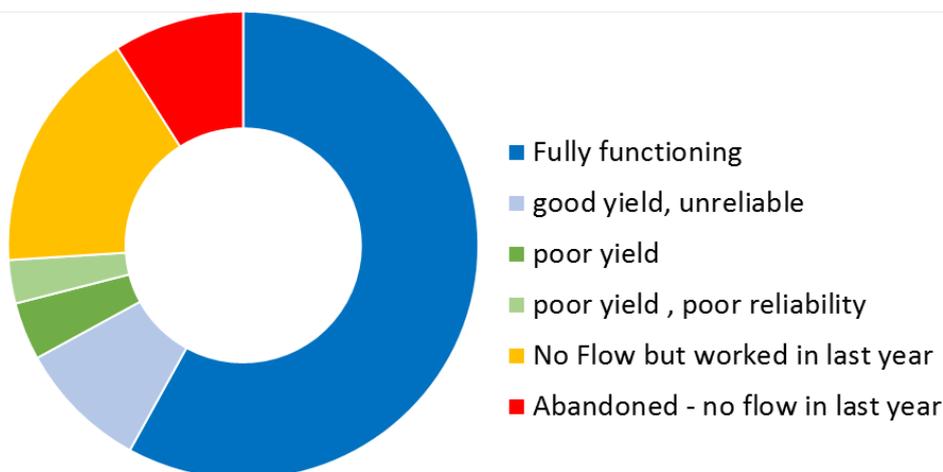
Functionality assessed for boreholes equipped with handpumps within Malawi. The functionality criteria used were: sufficient yield (>10 L/min) on day of survey; and less than 30 days downtime reported for the past year.

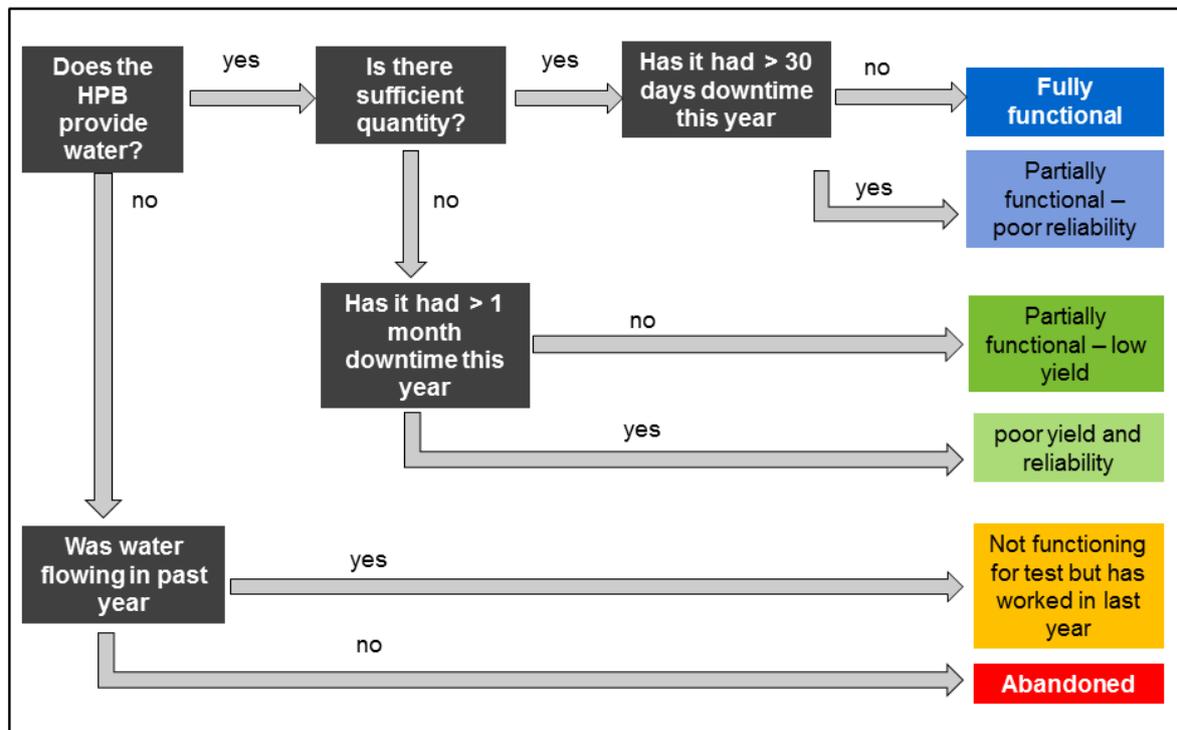
Figure 1 – A schematic diagram showing the different categories of functionality used in the Survey 1 analysis.

Survey 1 of the Hidden Crisis project uses the guidelines above to assess functionality in terms of different levels of performance. This starts with a basic ‘working yes/no’ definition, and moves to a more detailed understanding of the reliability and yield of supply (Figure 1). The final level introduces water quality to the performance assessment. The project is using the following definitions of functionality:

1. **Basic** – is the water point working on day of survey (yes/no)?
2. **Snapshot** – does the water point work and provide sufficient yield (10 L/min) on the day of survey?
3. **Functionality performance** – does the water point provide sufficient yield (10 L/min) on the day of survey, is it reliable (<30 days downtime in last year) or abandoned (not worked in past year)?
4. **Functionality including water quality** – as 3 above, and also passes WHO inorganic parameters, and TTC standards.

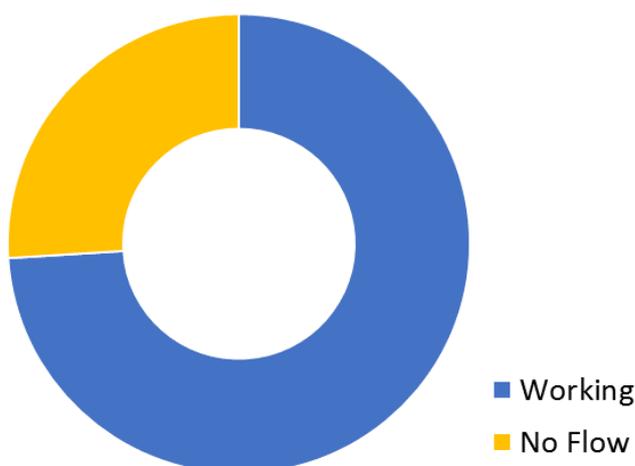
Figure 3 – Functionality assessed as working or not working

The results of the basic survey (74%) are consistent with the estimates from the ministry (MoWDI 2012). The more comprehensive assessments of functionality performance which include yield and reliability are considerably lower.

Basic functionality

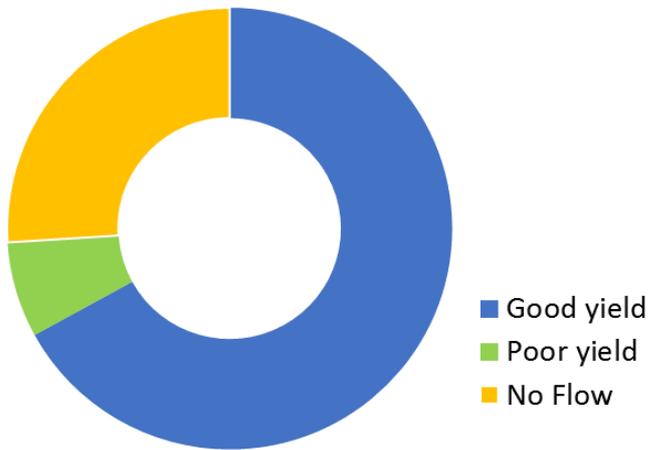
Figure 4 – Functionality assessed as working with sufficient yield (10 L/min)

Snapshot functionality

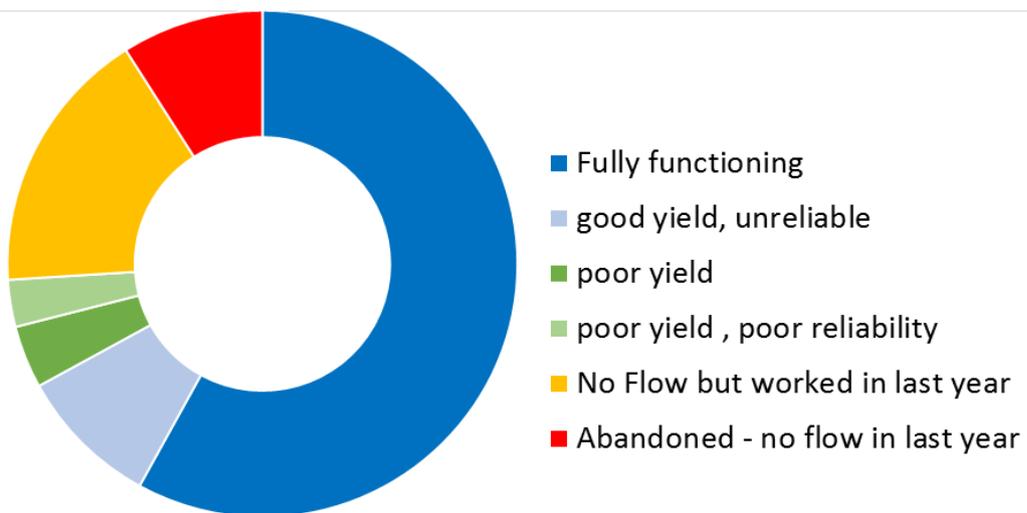
Figure 5 – Functionality performance – functionality assessed as working with sufficient yield (>10 L/min) and reliability (<30 days downtime [day not working] in the last year).

Functionality performance

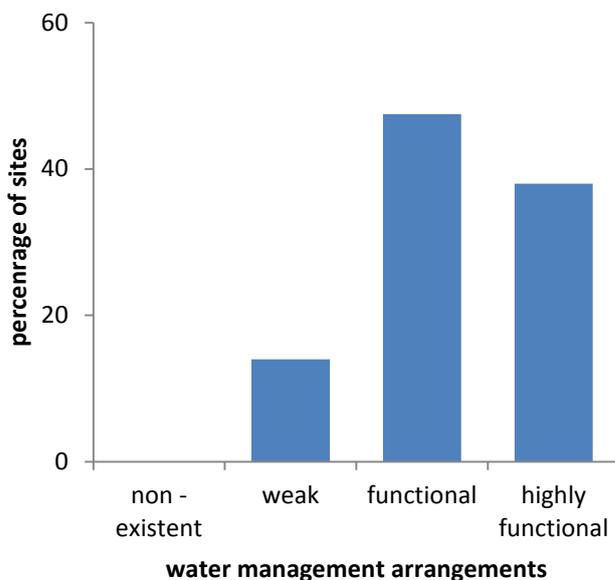
Figure 7 – Percentage of sites assessed to have non-existent, weak, functional or highly functional water management arrangements.

The survey indicates the vast majority of the Water Management Arrangements (86%) are functional or highly functional, but also indicates some differences in the different aspects of governance arrangements. Note the strong difference between *Maintenance and Repair* and the much lower scores for *External Support*.
