# Desk study and walk-over survey of Rhiw Landslip, Lleyn Peninsula

Programme Research Report CR/03/199N

RESEARCH REPORT CR/03/199N

A. D. Gibson, A. Forster, M. G. Culshaw

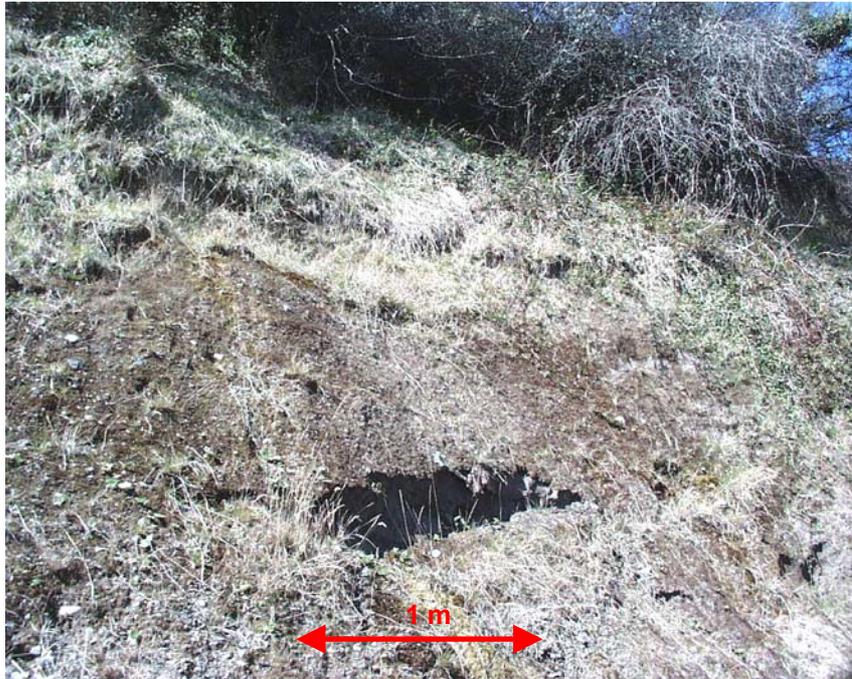
**Figure 7. A shallow failure within the exposure of poorly laminated gravelly silt 10 m NW of the exposure in Figure 6., (looking NNE at approximate grid reference [223774, 328156, z34].**

At the same elevation and 10 m further to the West, recent movements had exposed a section that appeared to consist of a soft, dark grey to dark brown poorly laminated silts. (Figure 7). Further upslope from here, in the cliffs immediately to the East of Bryn Foulk were exposed light brown, irregularly bedded sandy, gravelly diamictons (observed from a distance) which were thought to be of a fluvial/ fluvio-glacial origin. Although it is difficult to make an interpretation based upon so few exposures and it seems reasonable to suggest that these exposures represent the depositional margin of Porth Neigwl where a sloping bedrock surface is overlain by at least one till which in turn is overlain by glacio-fluvial derived deposits.

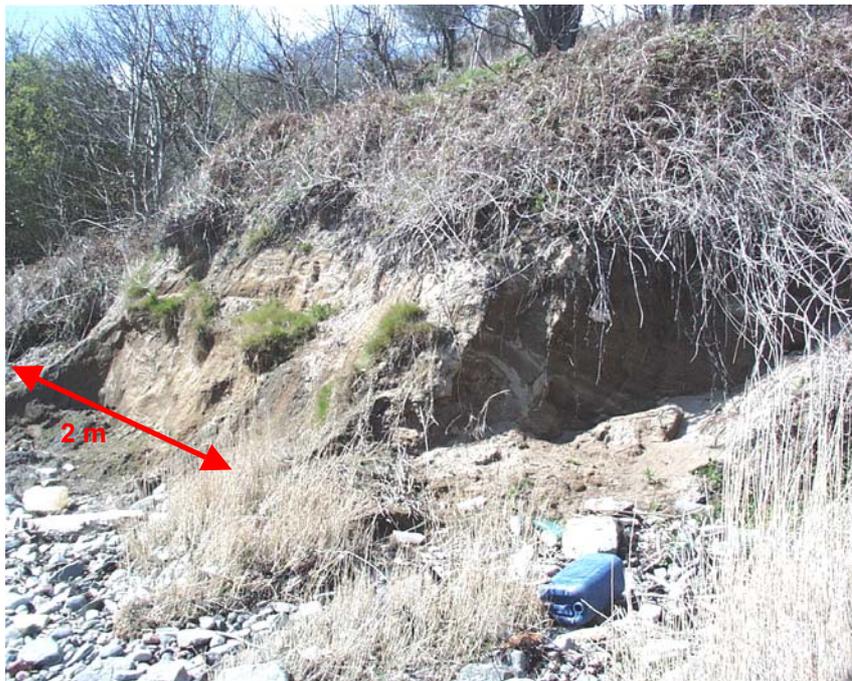
**Figure 8. Exposure of soft, light brown to dark grey laminated, fine grained sands looking NW at [223973 328254, z1.5]. Although intact laminations could be seen in the exposure it is thought that the material had been emplaced as part of a slope movement.**

Cliff top and coastal exposures of material elsewhere in the survey to the east of this location showed the variability of the glacially derived deposits in this part of Porth Neigwl. These included units of soft, light brown, laminated fine sands (Figure 8), soft to stiff sandy clays (Figure 9) and light brown gravelly sandy units (Figure 10).

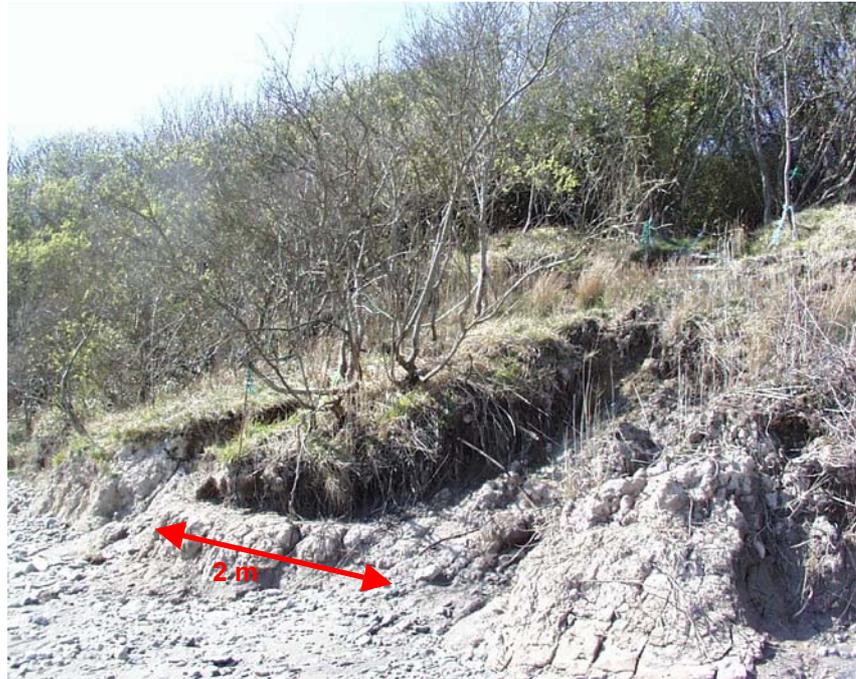
Figure 9. Exposure of disturbed soft to firm, light grey to light brown sandy clays at [224031 328306].

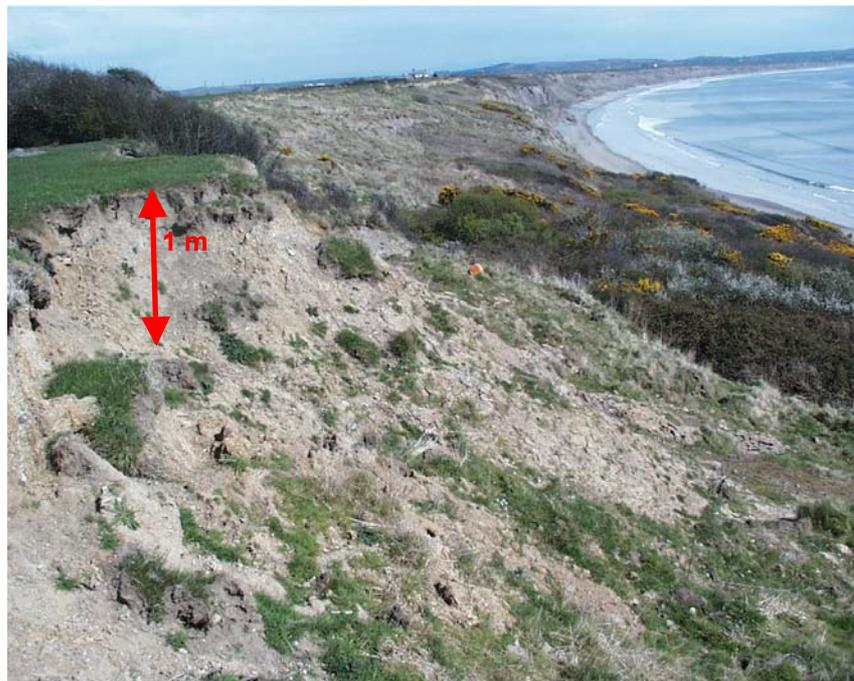
Figure 10. Exposures in the landslide rear-scarp of light brown, gravelly sandy clay diamicton interpreted as fluvio-glacial outwash deposits at the cliff top immediately in front of Treheli at [224131 328518, z35.8 ].

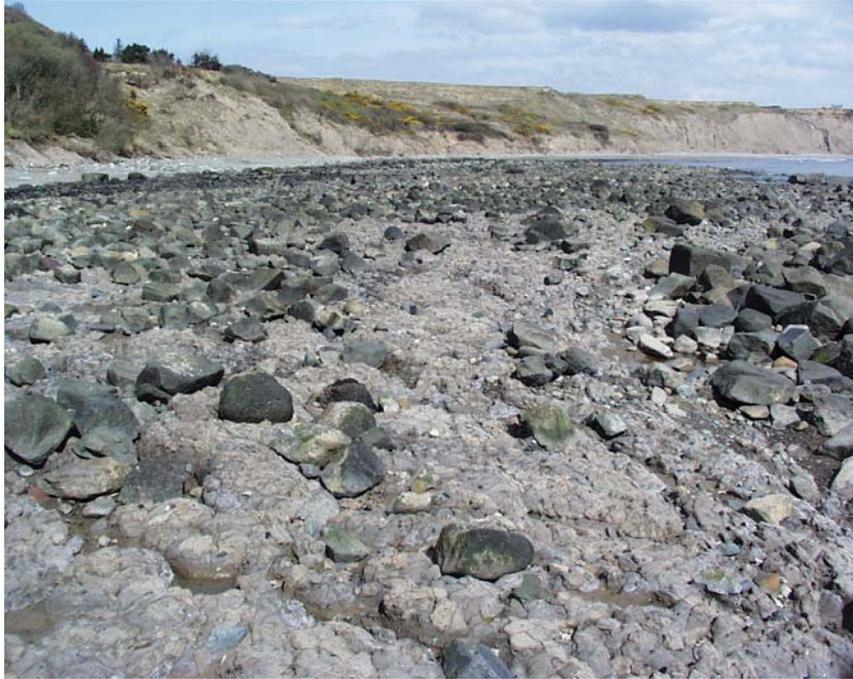
**Figure 11. Remnants of light brown to purple stiff fissured clay on the foreshore in front of Treheli at which is probably the remnants of toe heave resulting from a deep-seated rotational landslide.**

An isolated exposure of fissured, purplish light brown, clay with silt (interpreted by its colour as Irish Ice Till) was observed on the foreshore around 36 m seaward of the foreshore (Figure 11). This unit, with apparent fissuring running parallel to the coastline was thought (in agreement with the Arup report) to represent the toe of a rotational landslide. No purple clay was exposed in the coastal slope section, indicating either that the material must be in-situ below the current beach level and was heaved into its current position by a deep-seated rotational movement or that the clay is present but unexposed in the cliff and had been involved in a fairly shallow rotation. Whichever of these processes is correct the fact remains that there is evidence of an active shear surface beneath beach level.

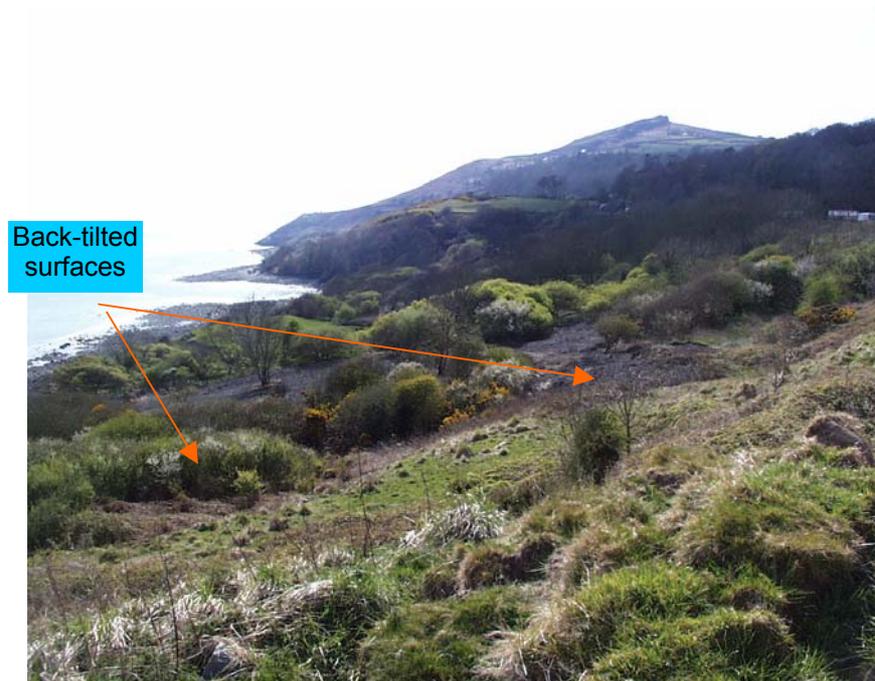
**Figure 12. A typical profile of the landslide area immediately downslope from Treheli. The photograph was taken from the top of the arcuate back-scarp. Visible are the back-tilted ground surfaces indicating the upper surface of rotated blocks.**

Although detailed mapping was not done during this survey, the findings of this walkover survey support the interpretation of the mapping by Arup (2002). The general morphology of the coastal slopes was of a series of two or three back-tilted benches, disturbed by many smaller landslide features (Figure 12). Recent and probably active, was indicated by the presence of fresh tension cracks and small landslides over much of the coastal slopes. The rear scarp, for most of its width, was un-vegetated and appeared to be recently exposed (for instance Figure 10). Many springs were observed to be flowing on the coastal slopes (Figure 13), most notable of these (with observed flow rates estimated at over 600 litres per hour) were the ones emanating near the bedrock-superficial contact at [223846 328091] and at the foot of the slope immediately south of

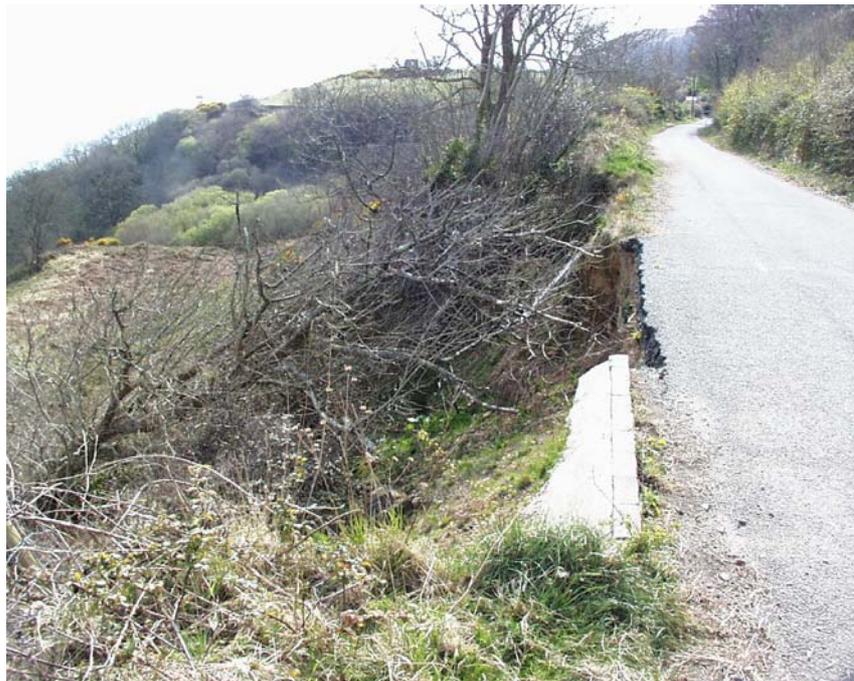
**Figure 20. Loss of kerbing and road surface due to undermining southwest of Sarn y Plas.**

Observations of damage to built structures were made during the walkover survey. None of the habitable buildings within the survey area appeared to be suffering structural distress as a result of slope instability. The northern wall of Sarn y Plas appeared to be in some distress and was not in exact alignment with the rest of the building but this could not be attributed to landsliding directly and could have been a result of processes other than landsliding. All of these buildings are of some antiquity, all appear to be over 100 years old and buildings in their locations appear on the 1888 map of the area. Although this indicates a lack of historic landslide activity in the area it could equally suggest that the rear scarp of the landslide has not yet regressed sufficiently inland to cause disturbance. Cracking was evident in the road immediately in front of Sarn y Plas (Figure 19) with a deep fissure over 10 m in length spanning between [223853 328325] and [223848 328317]. This fissure occurs upslope of a gabion wall constructed in 1988. To the southwest and parallel to that fissure, a recent failure in the rear scarp had resulted in the removal of kerbing and disturbance to the road surface (Figure 20) and fence line (figure 21).

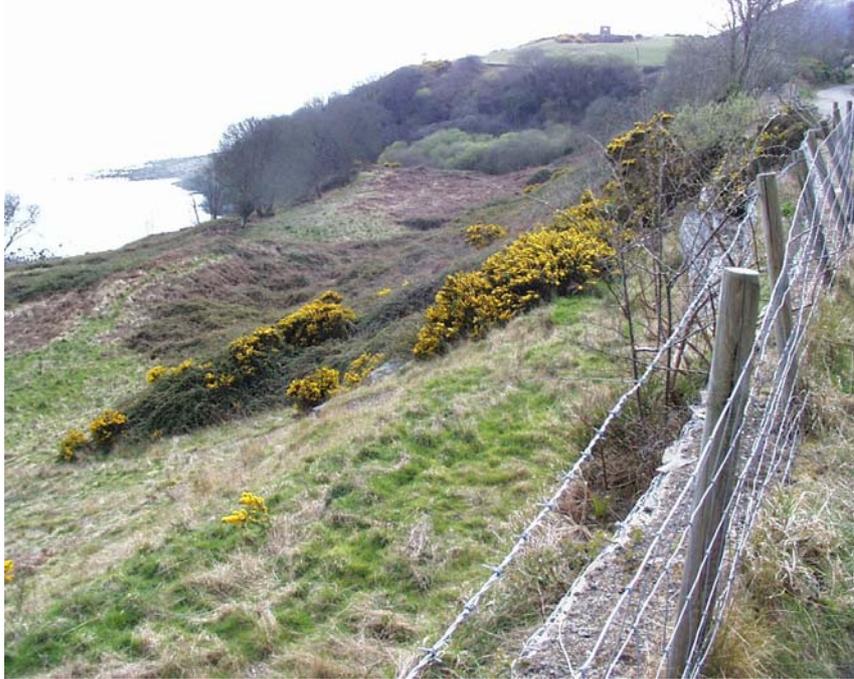
**Figure 21. Distress to the fencing immediately southeast of Sarn y Plas. This photograph, facing towards the southeast is a further illustration of topography interpreted as the back-tilted blocks of rotational landslides.**
