**British  
Geological Survey**

# Analysis of the Hollin Hill Landslide, Low Mowthorpe, North Yorkshire; Field reconnaissance survey and proposed survey recommendations

Internal Report IR/06/110

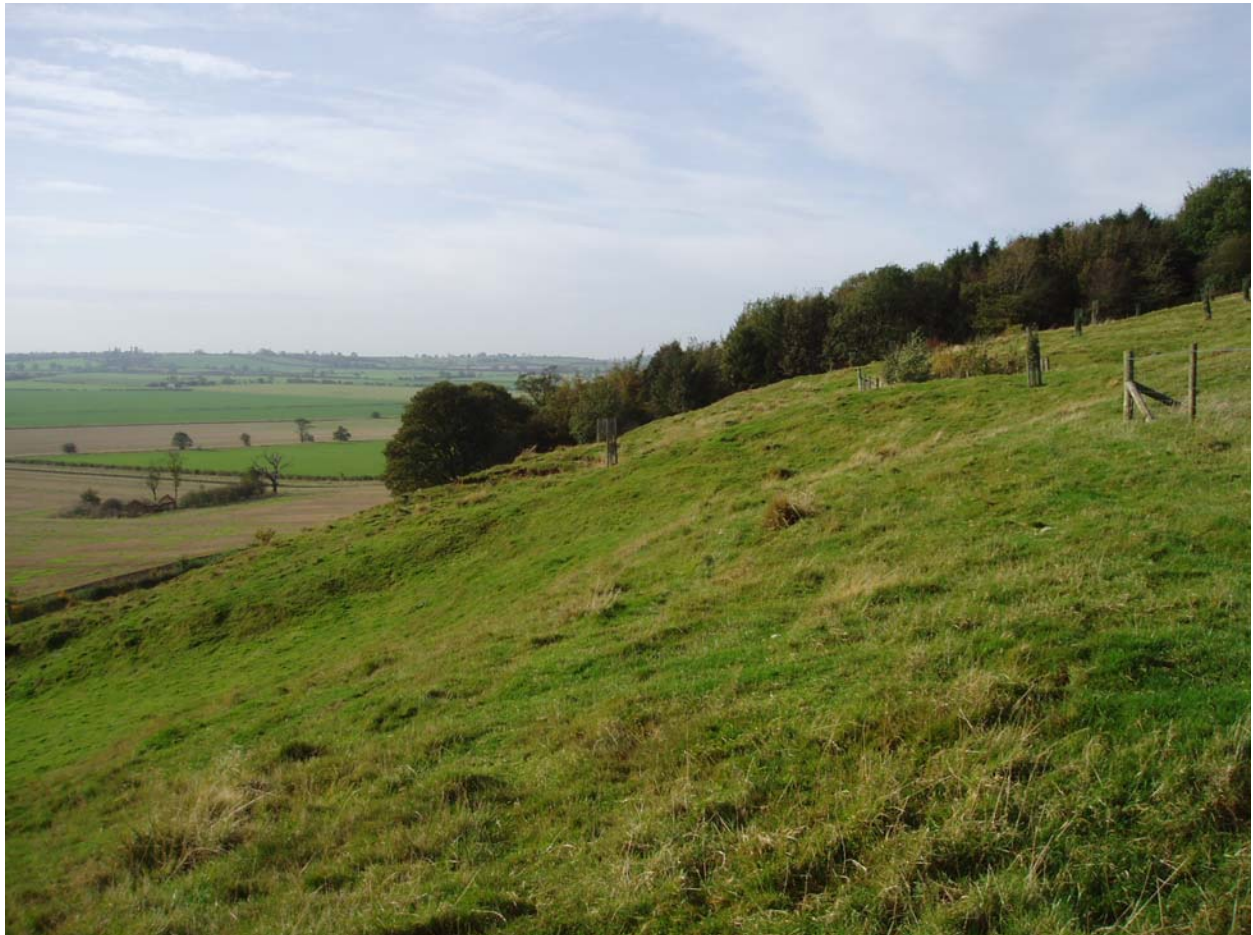
**Figure 2. SW corner of the Hollin Hill landslide. Photograph taken from <sup>4</sup>68046 <sup>4</sup>68799, orientation 250° (ESE).**

Observation of the Hollin Hill landslide during the walkover survey showed it to be approximately 150 metres in length (downslope) with a width of at least 260 metres (across slope). These dimensions refer to the area of unstable ground that will be covered during the monitoring of the slope. The unstable ground was observed to continue into the wooded area to the west of the study area (Figure 2), but due to the dense cover of mixed woodland, it is not

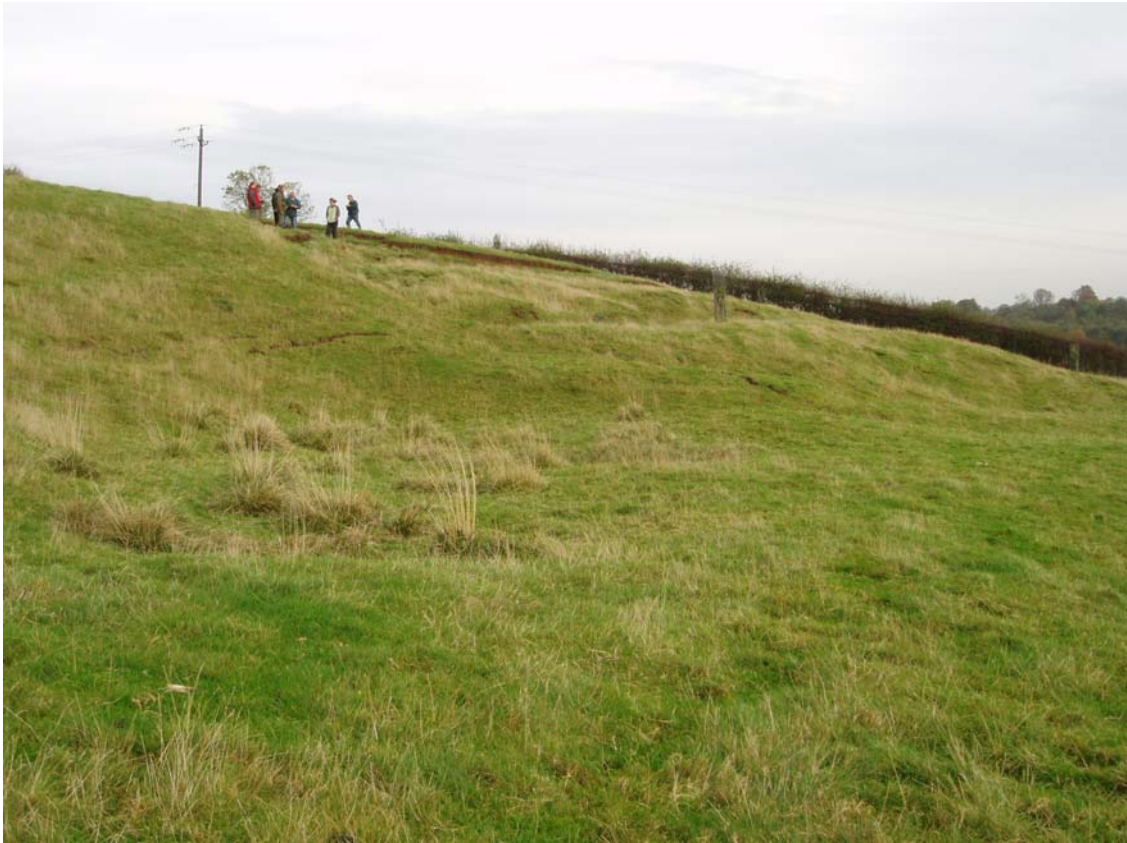
**Figure 3. Shallow rotational failures in the Hollin Hill landslide. Photograph taken from <sup>4</sup>68107 <sup>4</sup>68858, orientation 045° (NE).**

possible to monitor this area. The slope faces south to south-south-east and the gradient shallows to form a wide, flat field to the south of the landslide. The morphology of the slope is complex with numerous isolated shallow failures and slumping (Figures 3 and 4). Locally the slope becomes very steep where slipped material has accumulated to form lobes (Figure 5).

The Dogger Formation is believed to be present in the fields immediately above the landslide (the area is currently being re-mapped by the BGS), and conversation with the landowner suggests that water drains from the Dogger Formation into the Lias sediments that underlie the slope. This causes the sediments to become saturated, leading to increased pore water pressure, which causes the slope to fail.

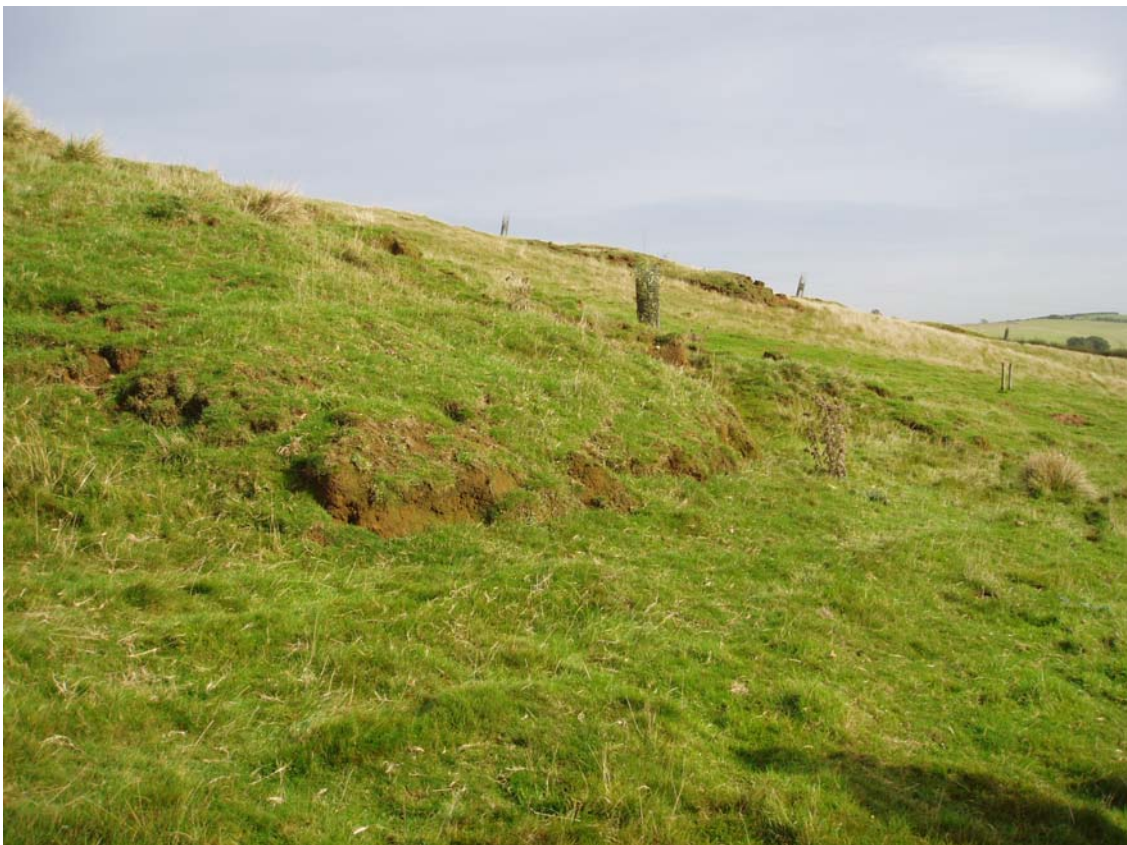
**Figure 4. Small scale rotational failures in the Hollin Hill landslide. Photograph taken from <sup>4</sup>68082 <sup>4</sup>68822, orientation 065° (ENE).**

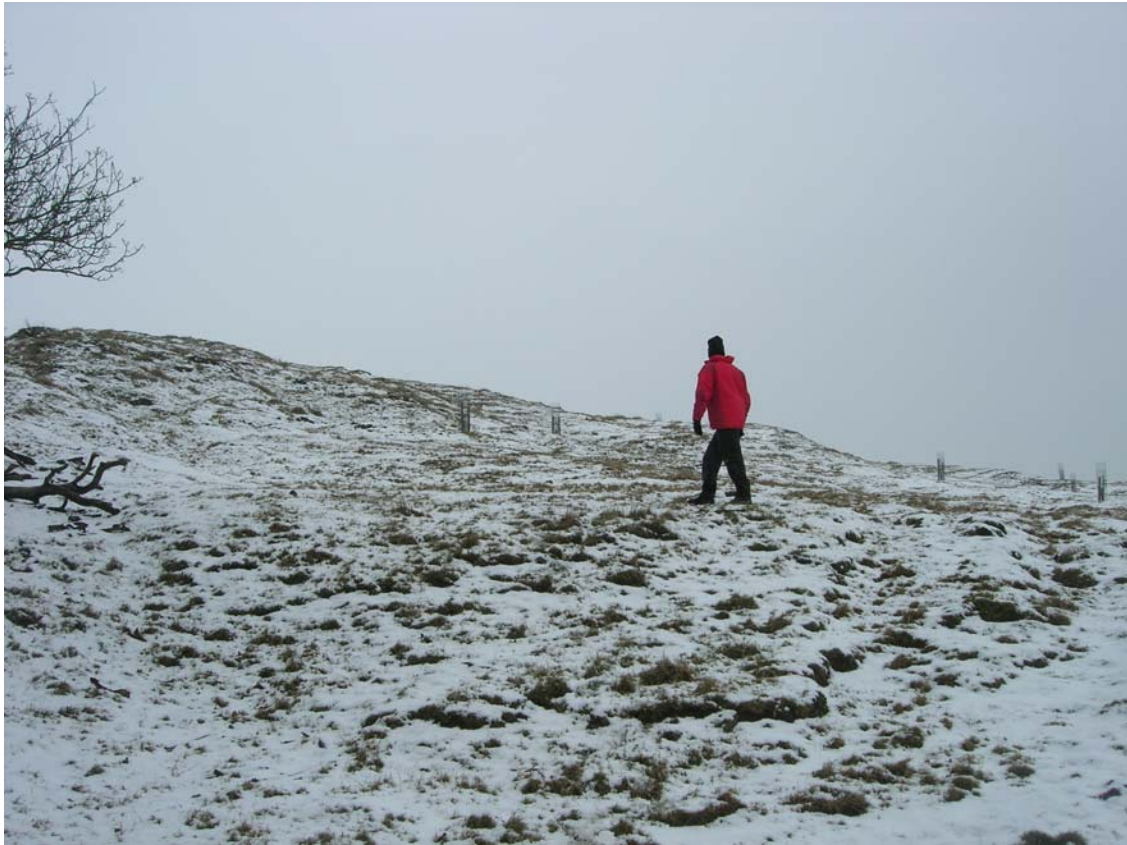
**Figure 5. Localised steepening of the slope from lobe accumulation. Photograph taken from <sup>4</sup>67954 <sup>4</sup>68735, orientation 015° (NNE).**
