**Technical Report WA/01/02**

**The building stones of Thirlwall Castle,  
Northumberland National Park**

**B Young, C L Vye and E R Phillips**

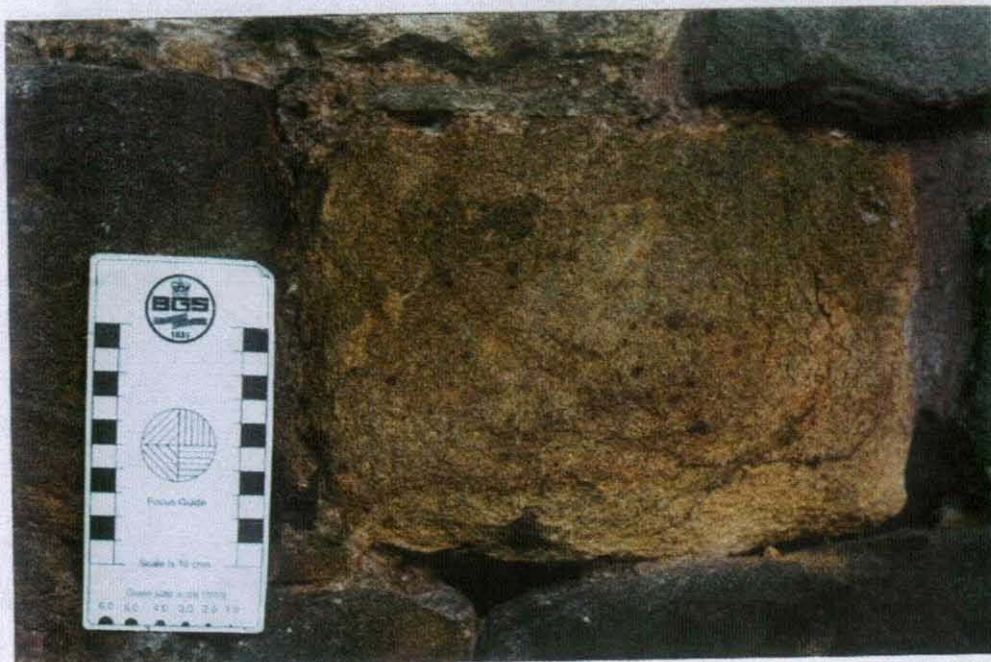
**Figure 2.**

Outer face of north wall.

Massive pale brown Type 'A' sandstone with faint dark brown Liesegang rings. Note also slight exfoliation due to weathering.

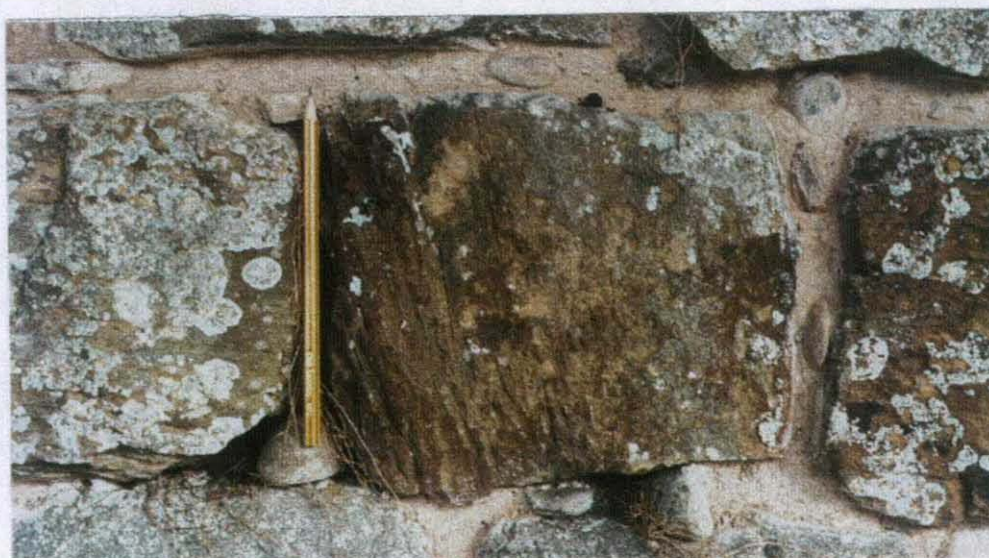
**Figure 3.**

Outer face of south wall.

Type 'A' stone showing weathered-out traces of original bedding, here laid almost vertically.

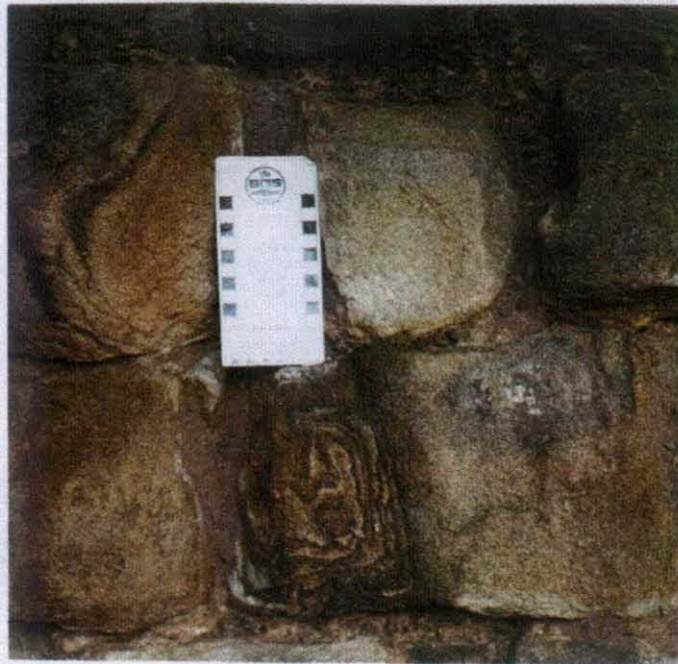
**Figure 4.**

Outer face of north wall.  
Several blocks of typical massive Type 'A' stone. Block beneath scale exhibits marked Liesegang rings of iron oxide.

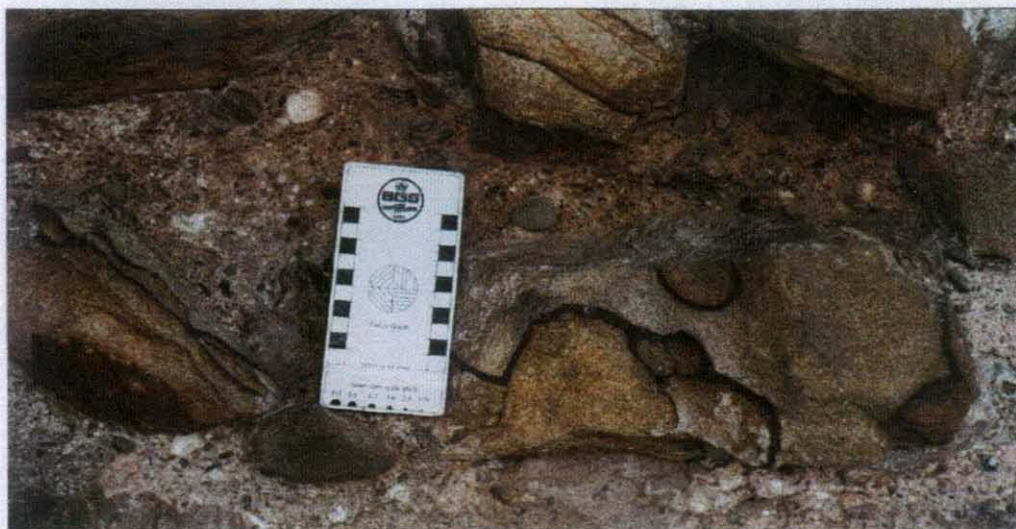
**Figure 5.**

Rubble core of west wall.  
Massive pale brown Type 'A' sandstone with prominent Liesegang rings of iron oxide.

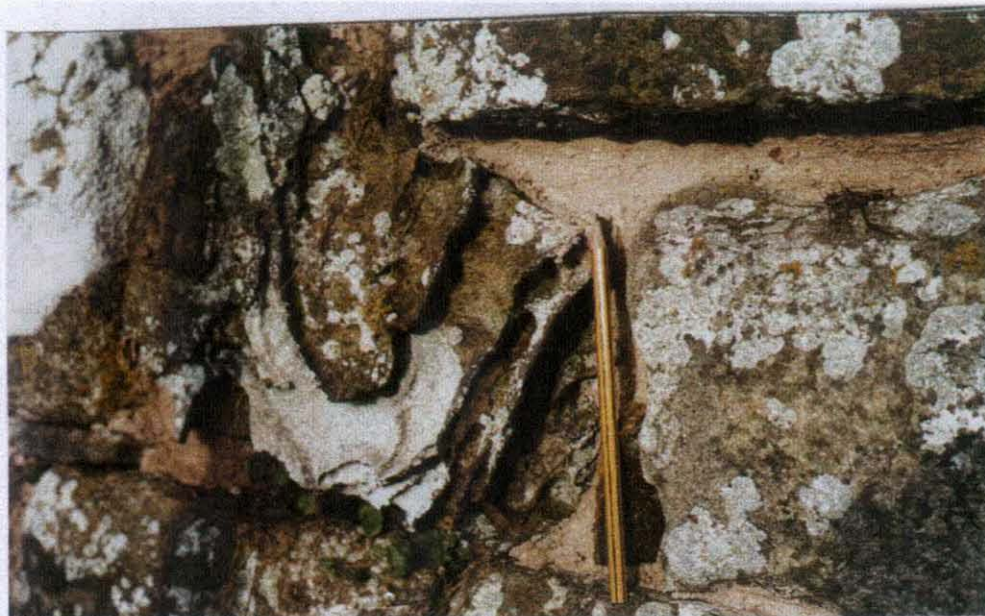
**Figure 6.**

Although clearly a durable stone, 'Type A' stone typically exhibits pronounced weathering. It is much less resistant to weathering than 'Type B' stone. Much of the 'Type A' stone appears to be comparatively massive with many blocks displaying little sign of original lamination. Many blocks exhibit a rather exfoliated form with the successive spalling of thin layers parallel to the sides of the block, removing corners and angles. This results in a very characteristic style of weathering, seen in many parts of the building, particularly the north wall, where a progressive rounding of the outline of 'Type A' stone blocks is conspicuous (Figure 36). 'Type A' stone in which original lamination is conspicuous may be seen in parts of the south wall, where differential weathering of the individual laminae imparts a fluted appearance to the blocks (Figures 3 and 4). In a few blocks, classified as 'Type A' stone, small rounded concentrations of secondary iron oxides form out-weathered nodular protuberances on exposed surfaces (Figure 8). In other blocks similar iron oxides are concentrated in complex Liesegang ring structures. Like the iron oxide-rich nodules these too are comparatively resistant to weathering, resulting in a distinctive 'honey comb' like weathering in affected blocks. Several conspicuous examples of this weathering are present in the south wall (Figures 6 and 7).

Outer face of south wall.

'Honey comb' surface of massive Type 'A' sandstone due to differential weathering of hard ferruginous Liesegang rings. Note also abundant lichen growth on this and adjoining blocks.

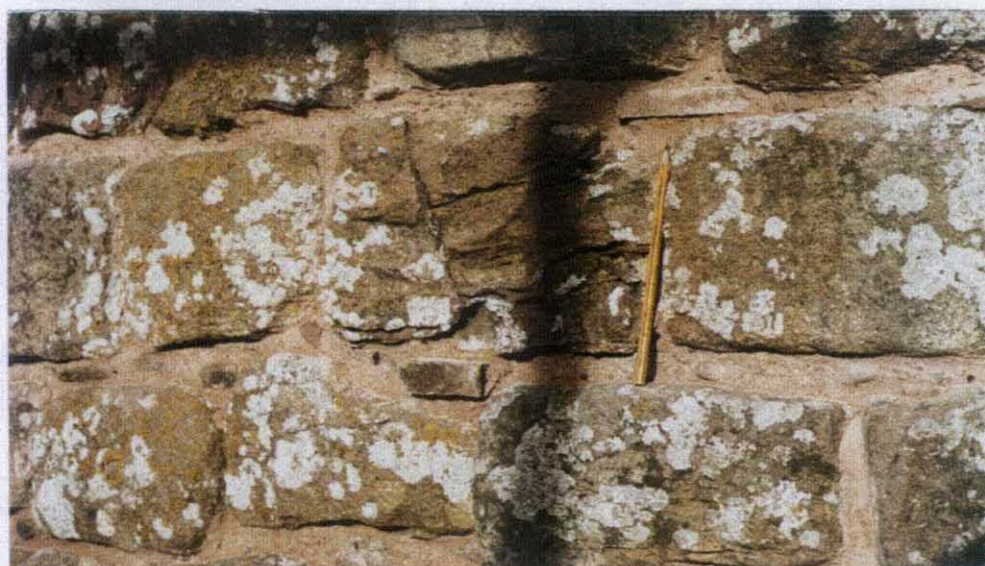
**Figure 7.**

Outer face of south wall.

'Honey comb' surface of massive Type 'A' sandstone due to differential weathering of hard ferruginous Liesegang rings. Note also abundant lichen growth on this and adjoining blocks.

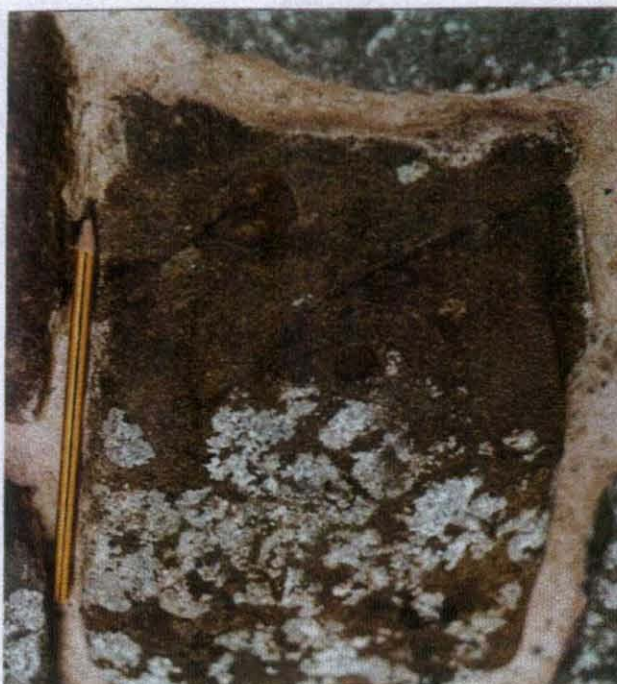
**Figure 8.**

Outer face of south wall.

Roughly spherical nodules of dark brown iron oxide cement in massive Type 'A' sandstone.

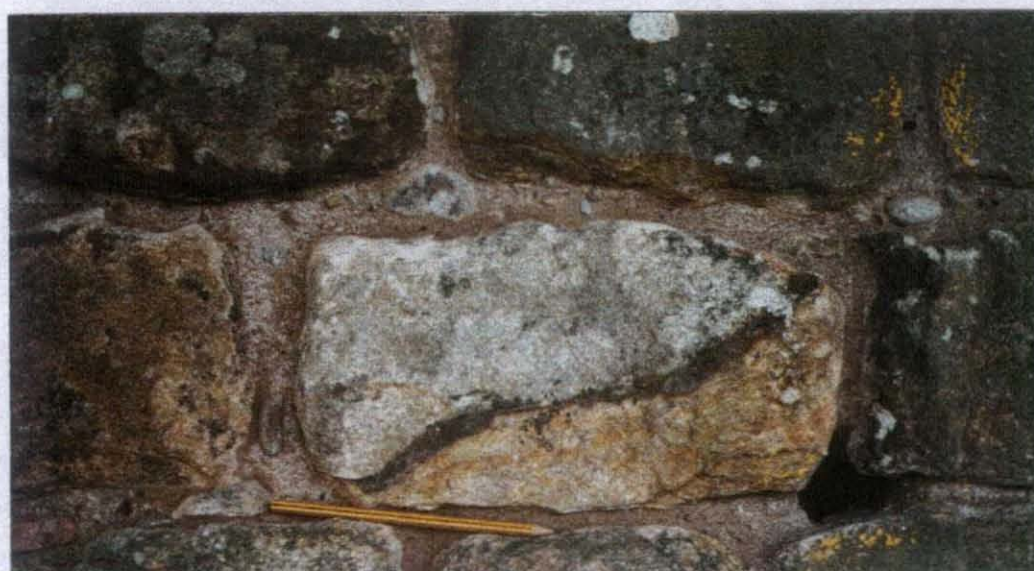
**Figure 9.**

Outer face of west wall.

Very dark brown vein-like concentration of iron oxide cement in Type 'A' stone.

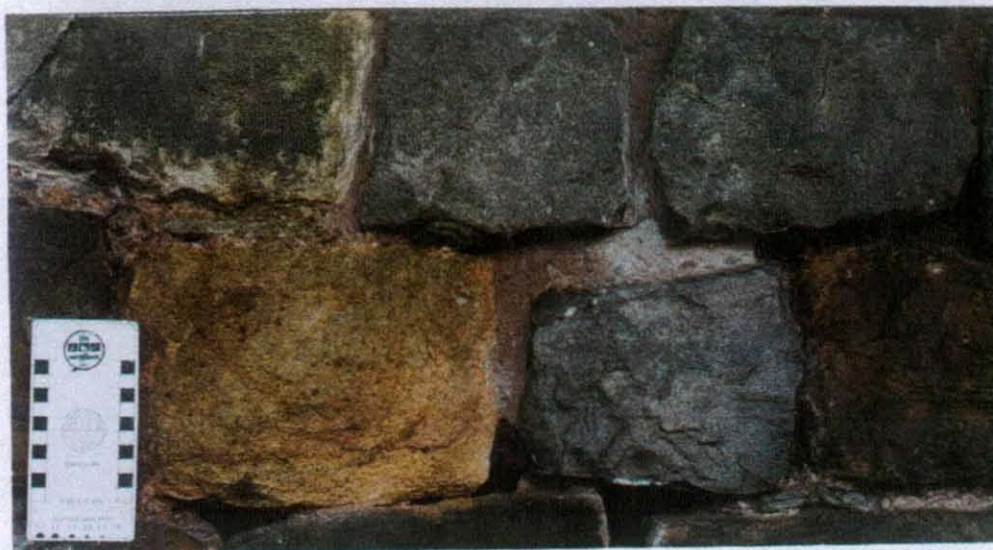
**Figure 10.**

This is typically a fine to medium-grained, massive, dull grey, quartzose sandstone. The stone is characteristically hard and exhibits an irregular hackly fracture suggesting a siliceous cement (Figure 10). The rock exhibits no reaction to 10% hydrochloric acid, indicating that there is no calcareous cement or calcareous components. A few blocks contain vague carbonaceous streaks which may represent rootlet traces. One block of this stone, in the south wall exhibits conspicuous hollows which almost certainly represent weathered-out rootlet traces (Figure 12). Very small brown ferruginous flecks, perhaps due to the oxidation of very scattered original pyrite or siderite grains, are localised in thin bands. The presence of rootlet traces suggests that the rock represents a fossilised sandy soil. Such siliceous sandstones, found within sequences of Carboniferous rocks of this sort, are commonly termed ganister. Most of the blocks of 'Type B' stone are roughly hewn and present a squared section of between 20 and 30 cm across when seen in the faces of the wall. The distinctive grey colour on the weathered surfaces, and the tendency of this stone to stand proud from the castle walls, in contrast to the other sandstones, is a highly characteristic feature of this stone (Figures 10, 11 and 13). Indeed, these weathering features allow comparatively ready identification of 'Type B' stone even in the heavily lichen-encrusted faces of the south wall.

Outer face of north wall.

Predominantly blocks of pale grey Type 'B' sandstone showing characteristic dull grey colour. Note also sharp, comparatively unweathered outlines of Type 'B' blocks in contrast to slightly in-weathered and slightly crumbling block of pale brown Type 'A' stone at bottom left (adjoining scale).

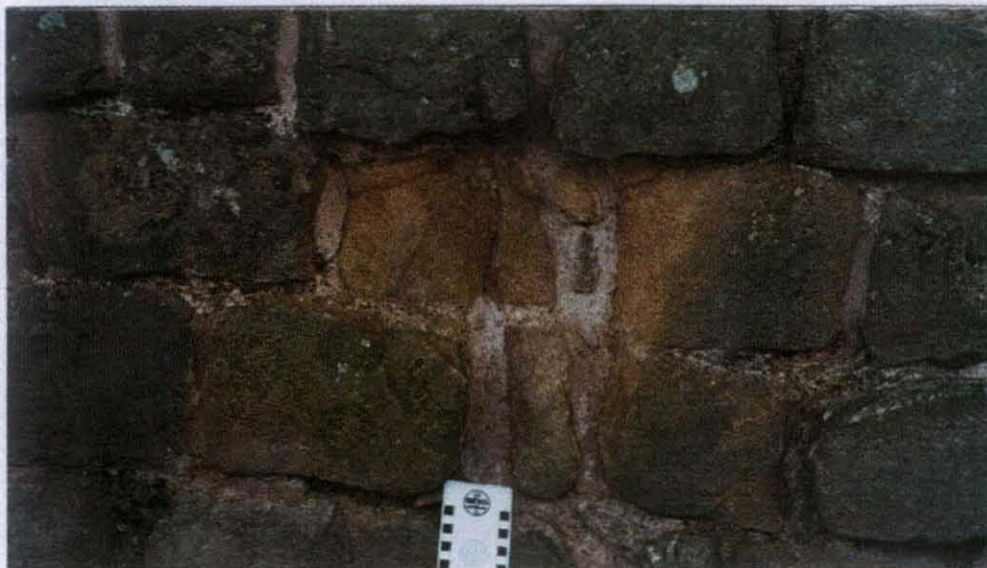
**Figure 11.**

Outer face of west wall.

Advanced in-weathering of two blocks of Type 'A' stone, contrasting with much more resistant pale grey Type 'B' stone in overlying course.

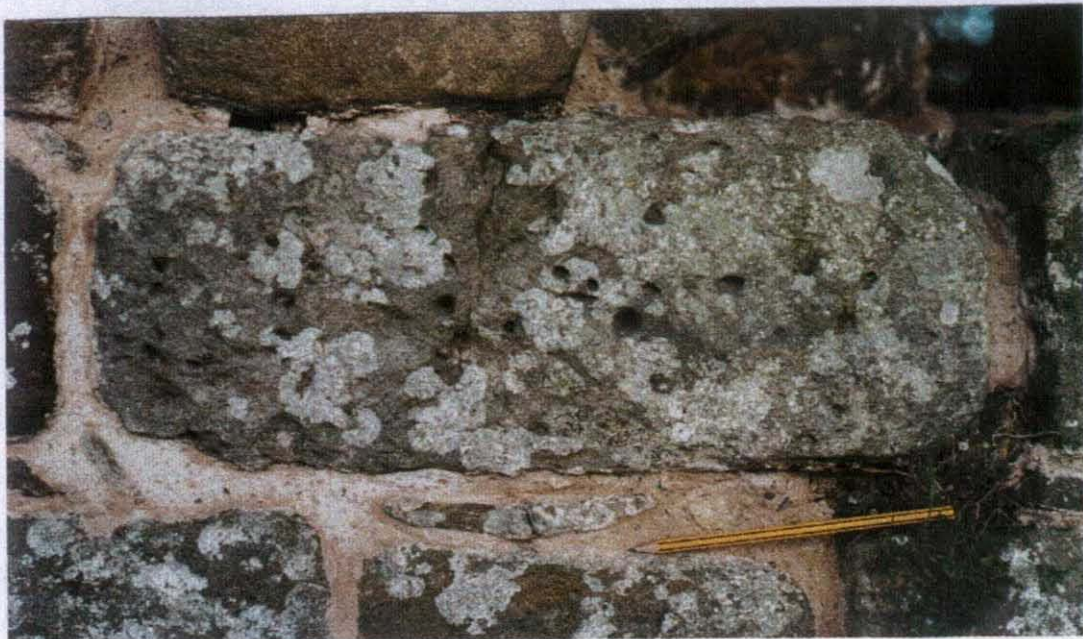
**Figure 12.**  
Outer face of south wall.  
Conspicuous hollows in Type 'B' stone, marking traces of fossil rootlets.

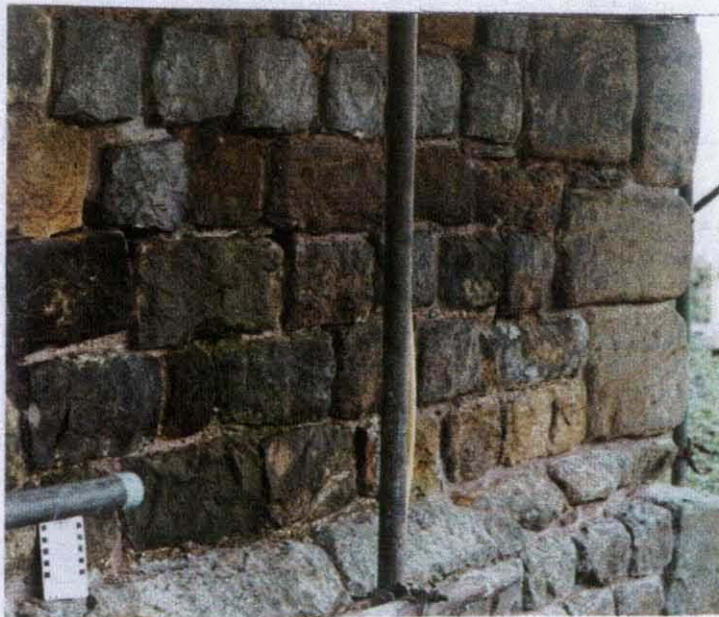
**Figure 13.**  
Outer face of north wall.  
Pale grey Type 'B' stone contrasts conspicuously with dull brown Type 'A' stone.

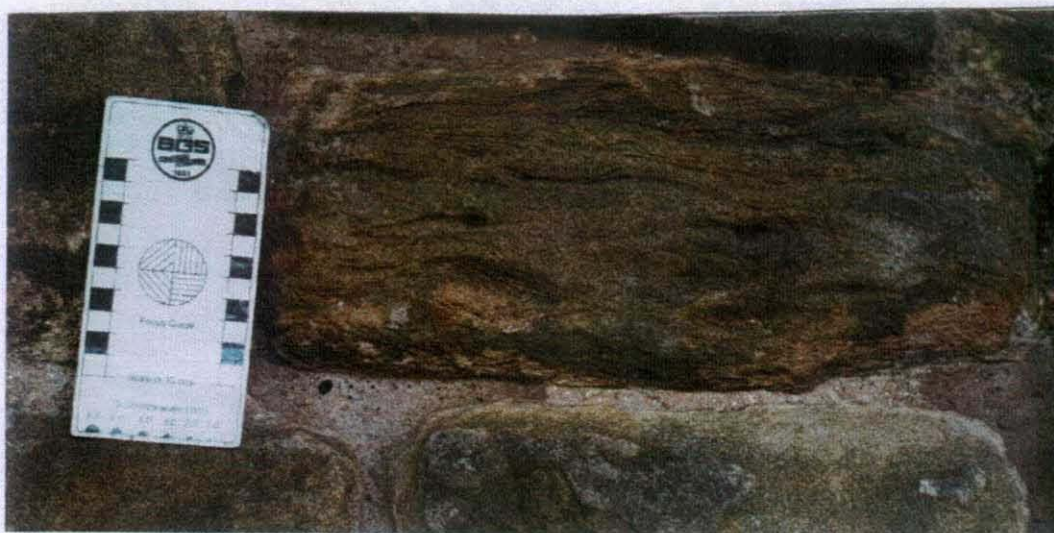
**Figure 14.**

Outer face of north wall.

Conspicuous ripple-cross lamination in block of Type 'C' stone (left of scale).

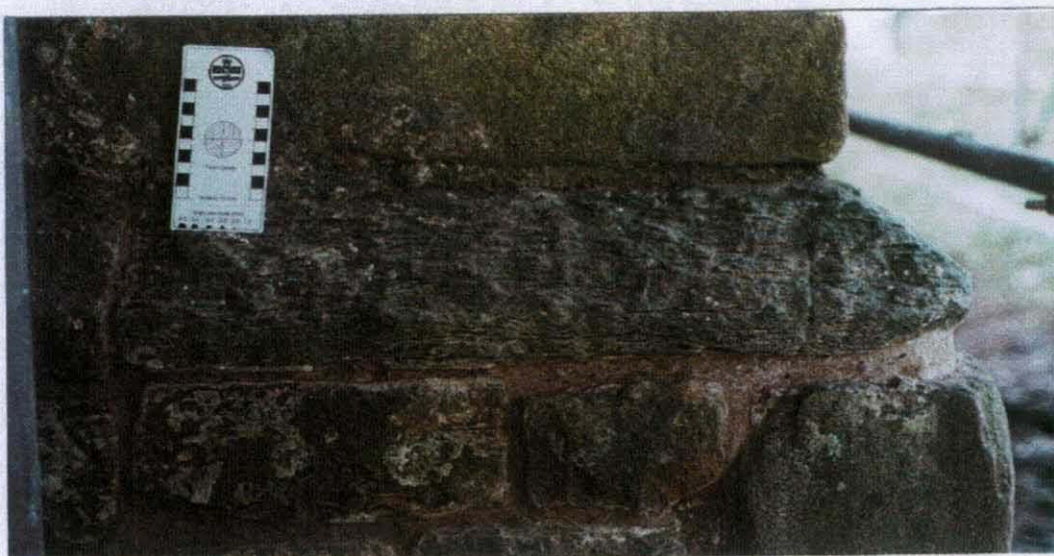
**Figure 15.**

'Type C' stone is found rather sparingly throughout the outer faces of the castle walls. Good examples are to be seen in the topmost course of the plinth near the foot of the north wall (Figure 15).

Plinth at foot of north wall.

Weathered ripple-cross lamination in pale grey Type 'C' stone in block beneath scale.

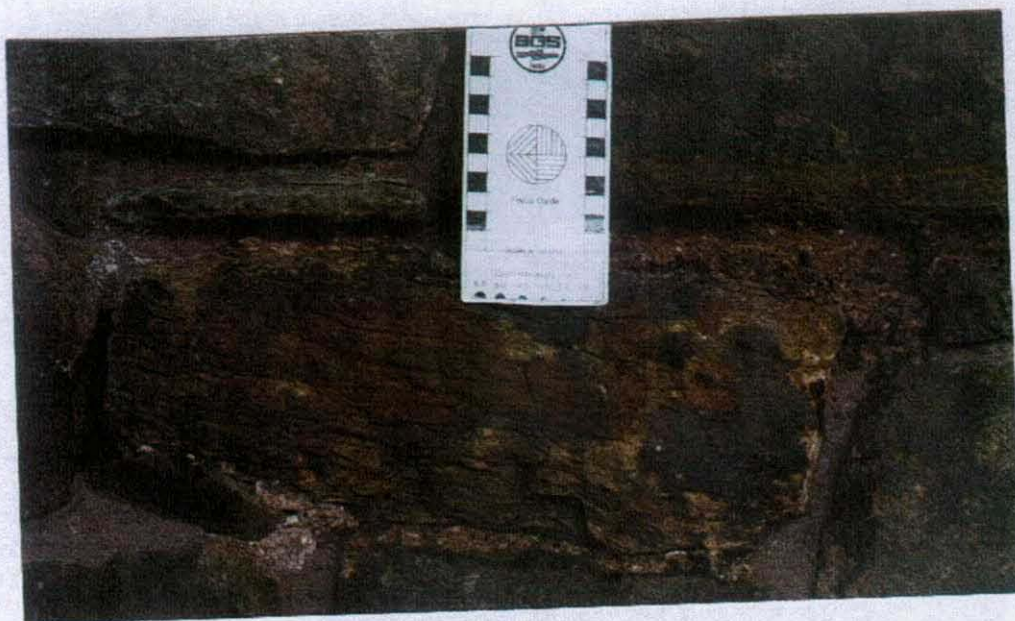
**Figure 16.**

Outer face of north wall.

Crude horizontal lamination cut by very faint traces of vertical fossil rootlets in Type 'C' stone block, immediately beneath scale.

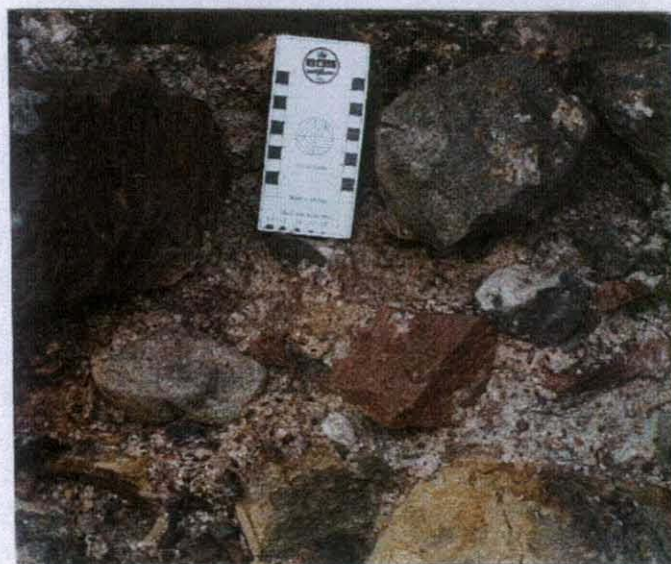
**Figure 17.**

Rubble core of east wall.

Small block of reddened sandstone. Other blocks include grey limestone and pale grey to greenish grey volcanic rocks of Lake District origin.

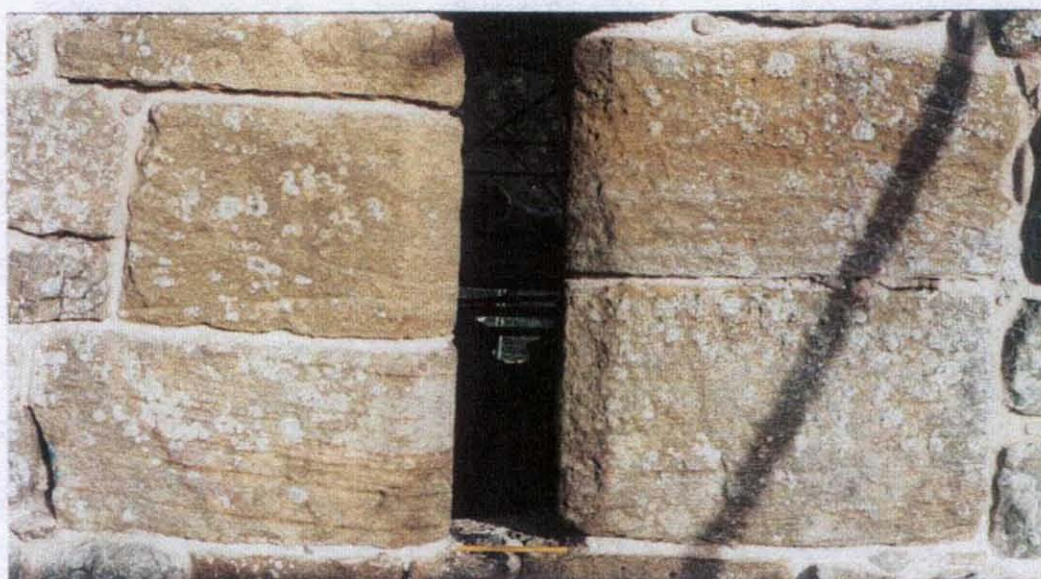
**Figure 19.**

Window casings, south wall.  
Massive pale brown sandstone showing cross-bedding.

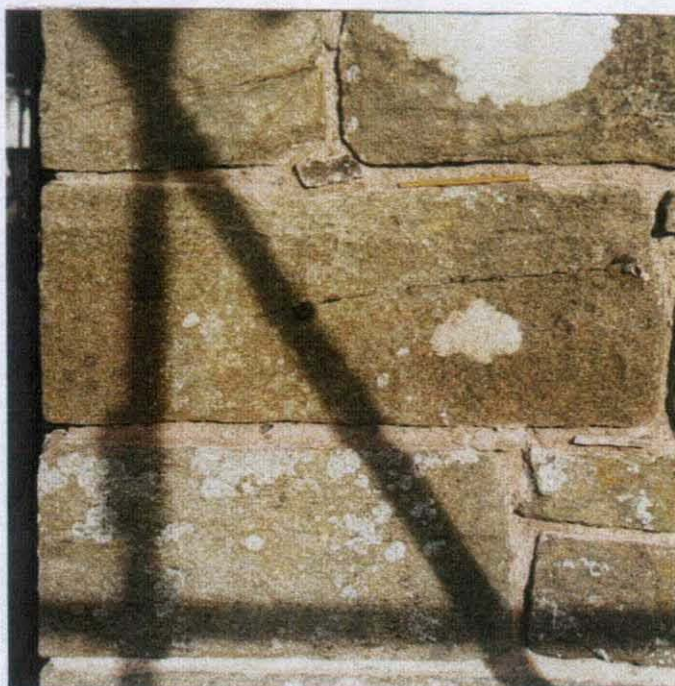
**Figure 20.**

Quoins at west corner of south wall.

Massive pale brown sandstone showing traces of lamination. A single iron oxide concretion is conspicuous in the large block beneath the pencil.

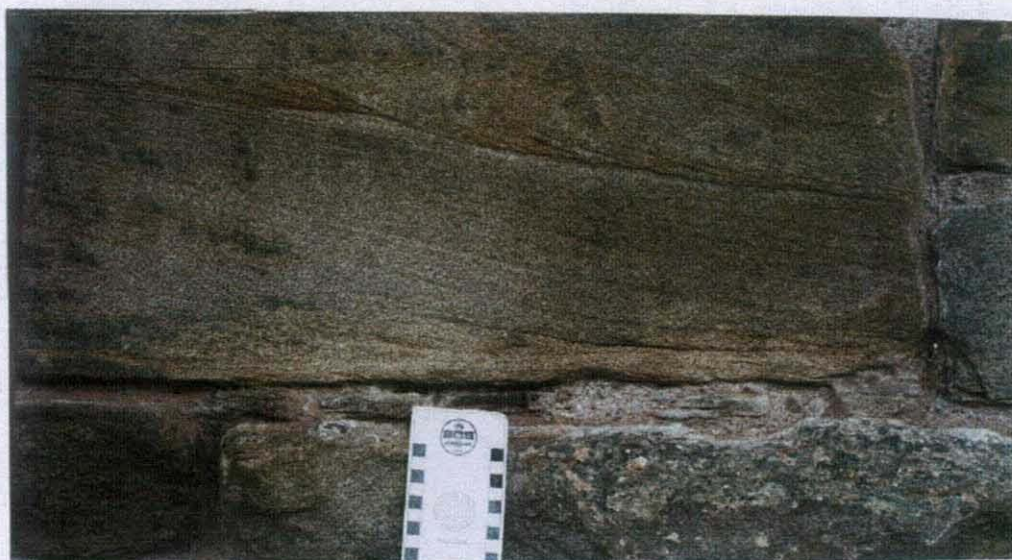
**Figure 21.**

In several parts of the castle small thin slabs of stone have been employed to level courses of stone, particularly some quoins. In most instances thin slabs of sandstone have been employed (Figure 21, 22, 25 and 34). An interesting use of slate for this purpose has been noted in part of the north wall (Figure 25) and the west wall (Figure 26).

Quoin in west wall.

Conspicuous cross-bedding in massive sandstone.

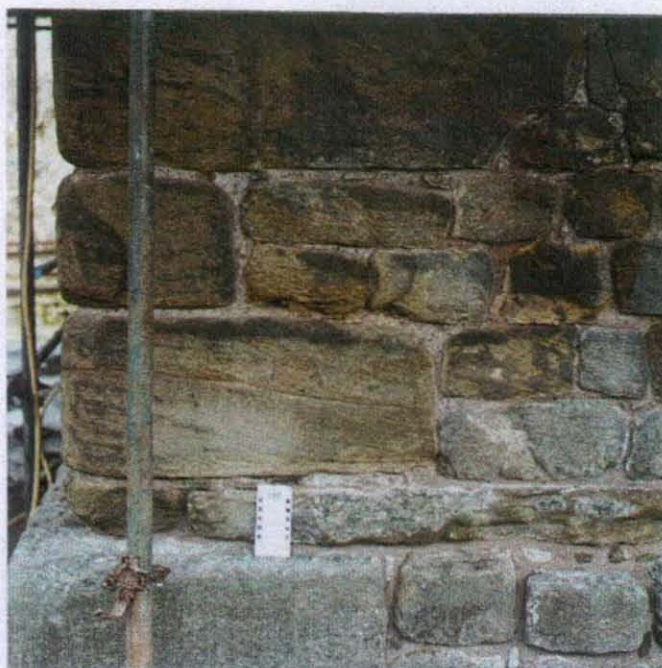
Quoins in west wall.  
Conspicuous cross-bedding in massive sandstone.

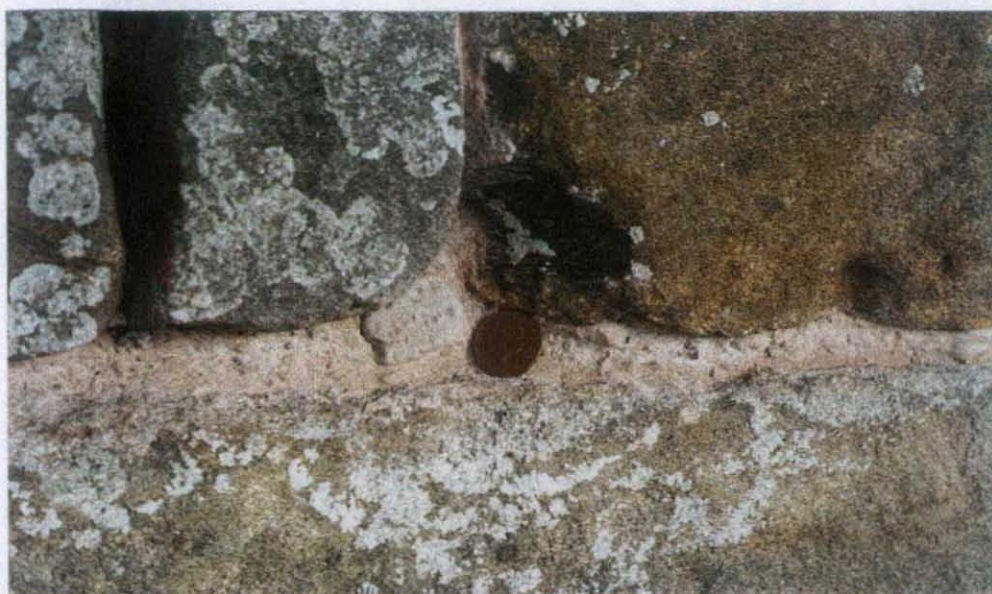
Window casing in south wall.  
Fossilised cast of plant stem in massive sandstone (immediately above 2p coin).

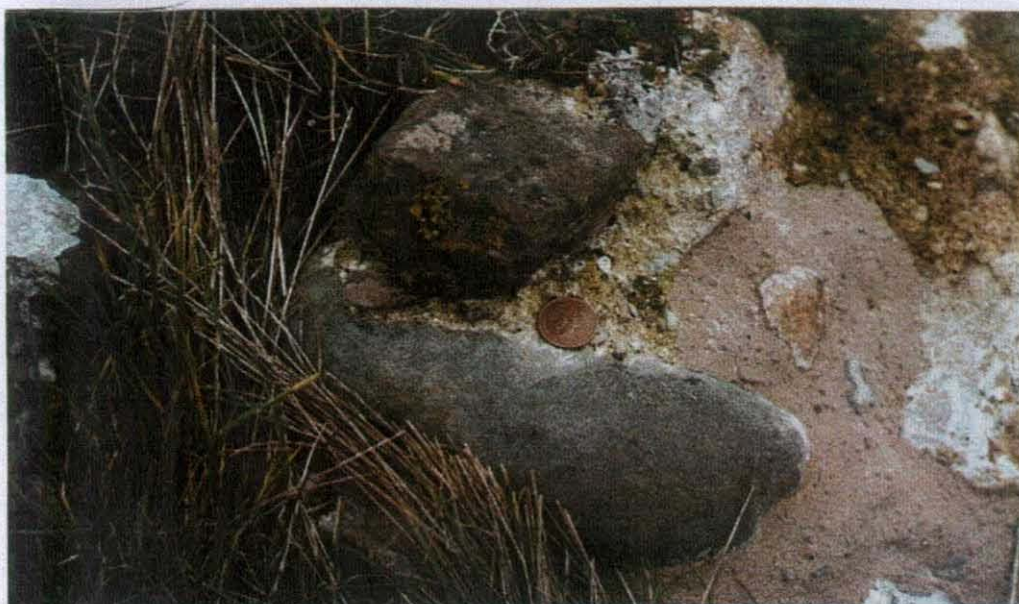
Rubble core at top of west wall.  
Greywacke sandstone boulder (below 2p coin).

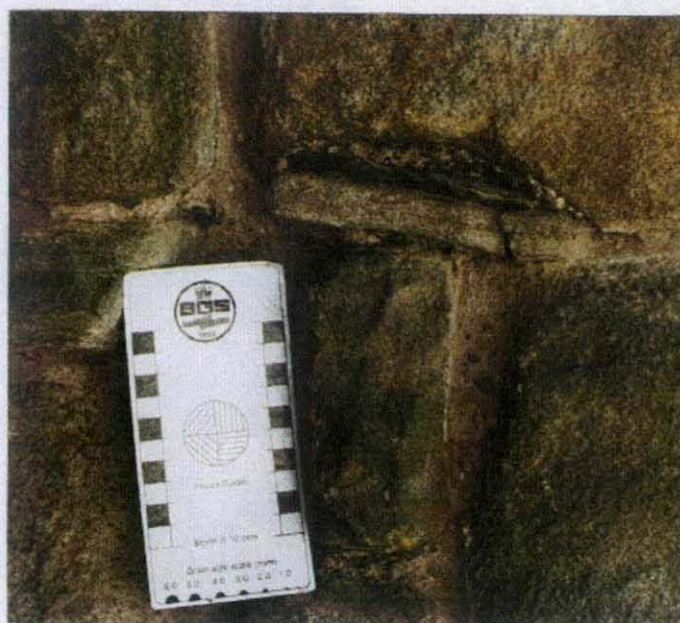
**Figure 25.**

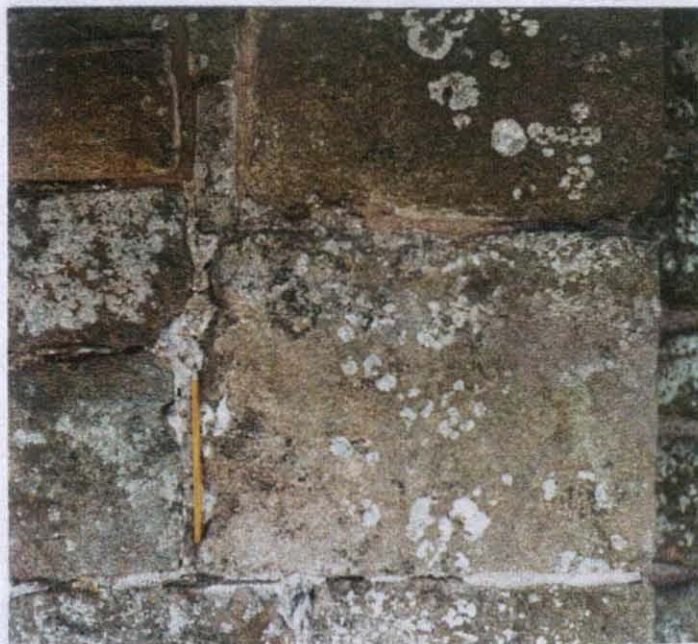
**Figure 26.**

Quoins on outer face of west wall.

Very thin slate fillets used to pack space beneath quoins (below pencil).

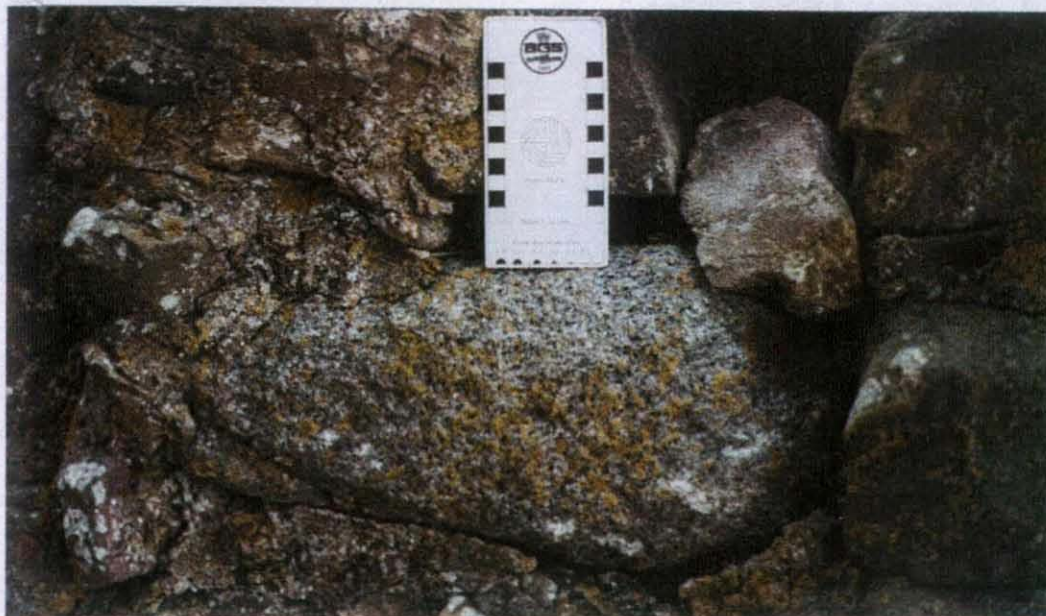
**Figure 27.**

Inner core of north wall.

Ovoid boulder of coarse-grained granite (beneath scale).

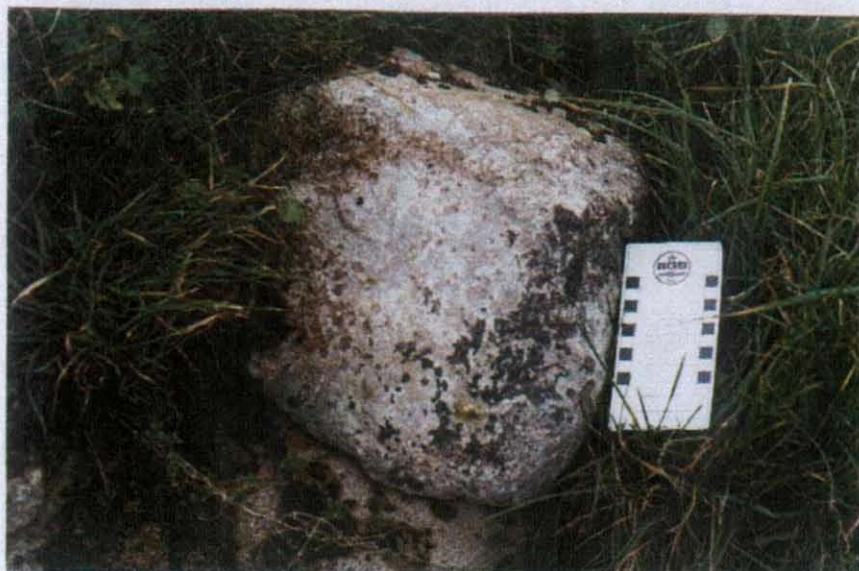
Figure 28.

Rubble core at top of south wall.  
Ovoid boulder of coarse-grained granite.

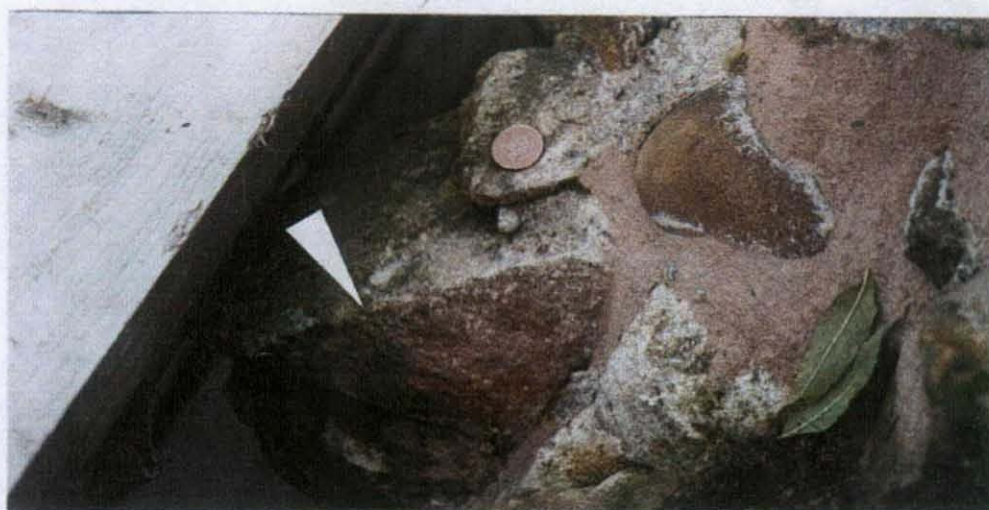
Figure 29.

A single block of this stone occurs within the rubble core at the head of the western wall (Figure 29). The block is up to 25 cm across and is a broken portion of a larger comparatively well-rounded boulder. It is a fine-grained pinkish buff rock in which abundant small (up to 10 mm) phenocrysts of white feldspar and a few glassy quartz phenocrysts, are conspicuous. A thin section (ED 7443) (Figure 44 a & b) of a fragment of this block reveals a fine-grained, altered, microporphyritic to very weakly macroporphyritic dacite (originally would have been termed a porphyry) which comprises an inequigranular assemblage of plagioclase, chlorite, quartz, biotite, K-feldspar and white mica. Alteration of this dacitic rock resulted in the sericitisation of feldspar phenocrysts and the matrix, as well as the total replacement of biotite by chlorite, white mica and opaque oxide.

Rubble core at top of west wall.  
Block of pinkish buff porphyritic dacite (arrowed).

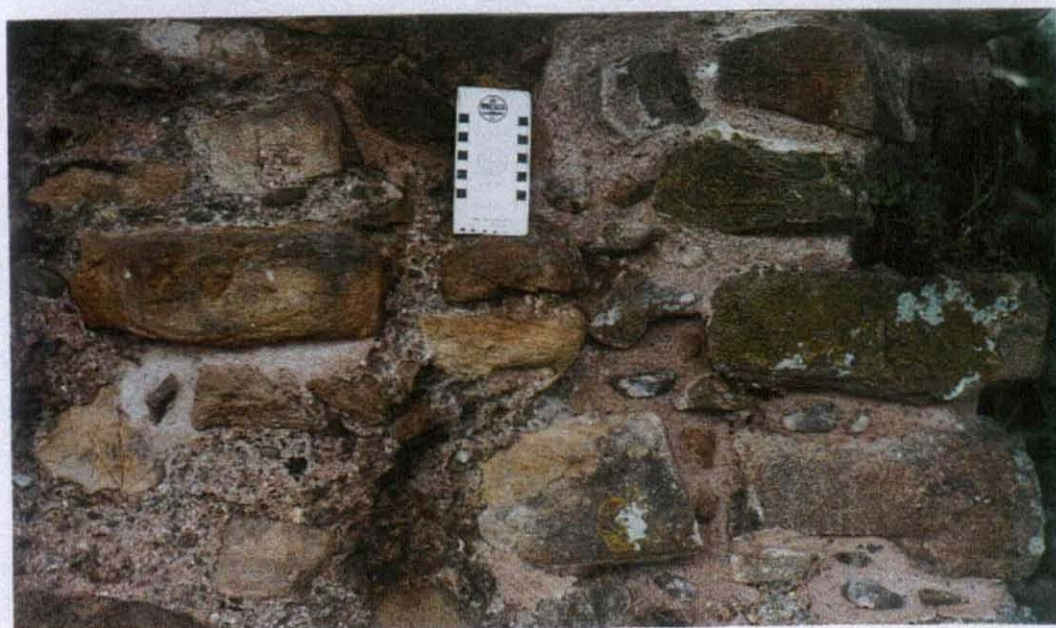
**Figure 30.**

The original mortar exposed in various parts of the building exhibits small (generally less than 1 cm) fragments of coal. These are especially conspicuous in parts of the eastern wall (Figure 30), and in the large block of fallen masonry at the foot of this wall. All coal fragments examined are un-burnt, though are commonly rather friable due to weathering.

Rubble core at northern end of east walls.  
Small black fragments of coal within mortar.

As noted above (4.2.6) coal fragments are locally common within the mortar. It is extremely unlikely that these were deliberately included within the mix, as they would contribute nothing to the properties of the mortar. It seems probable that they represent a form of contamination, perhaps from a stockpile sited near the lime kilns from which the mortar was supplied.

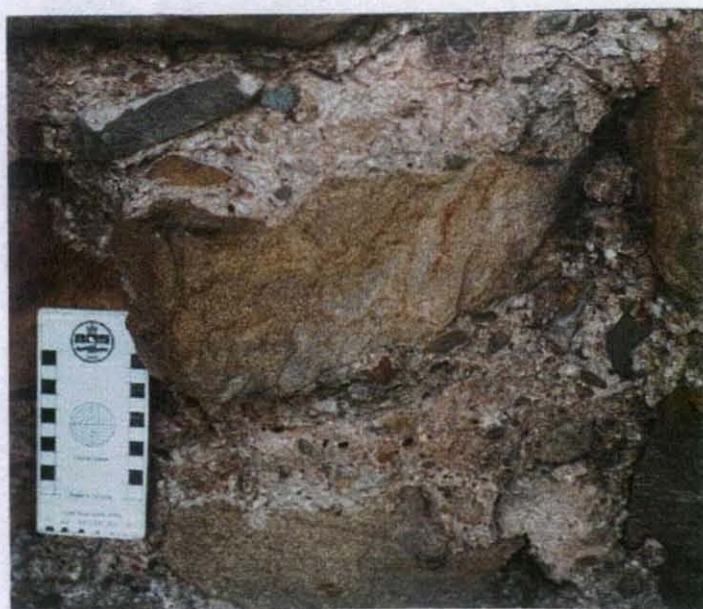
**Figure 31.**

Rubble core at northern end of east walls.  
Small pebbles of grey to greenish grey Lake District rocks in mortar.

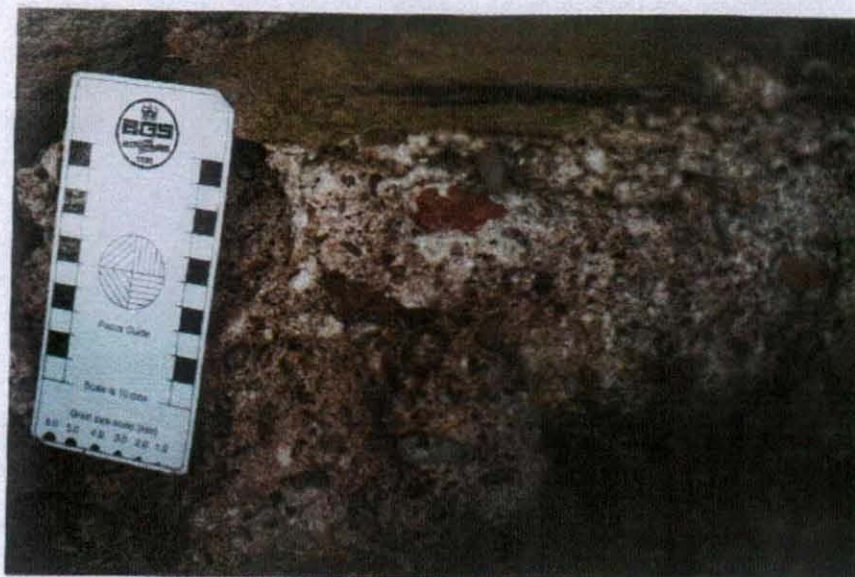
Figure 32.

Although not a rock type, the presence of a fragment of broken brick, up to 4 cm across, was recorded within the mortar in the wall core of the northern part of the east wall (Figure 32). This is clearly an original component of the wall.

Rubble core at northern end of east walls.  
Small fragment of brick within mortar.

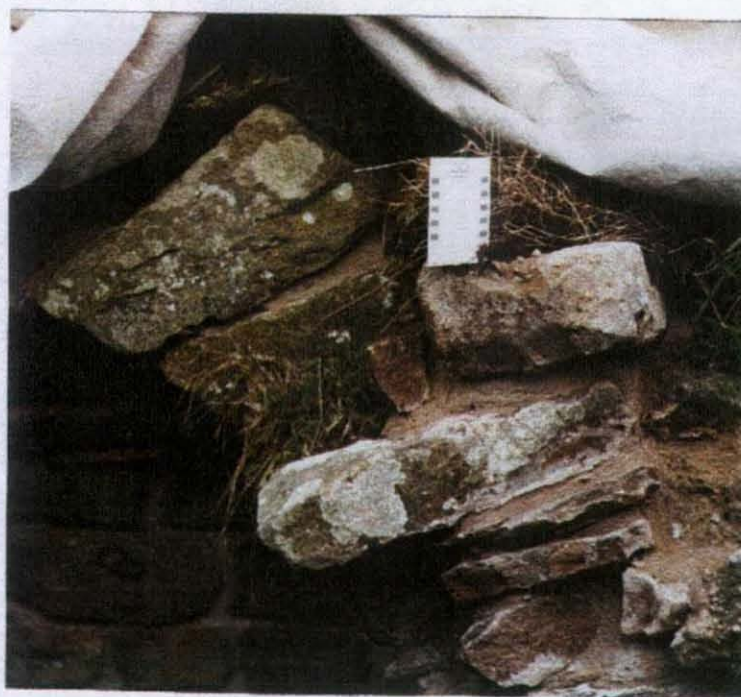
Figure 33.

Arching in north west turret.  
Wedge-shaped blocks of ? Type 'A' sandstone used in arching.

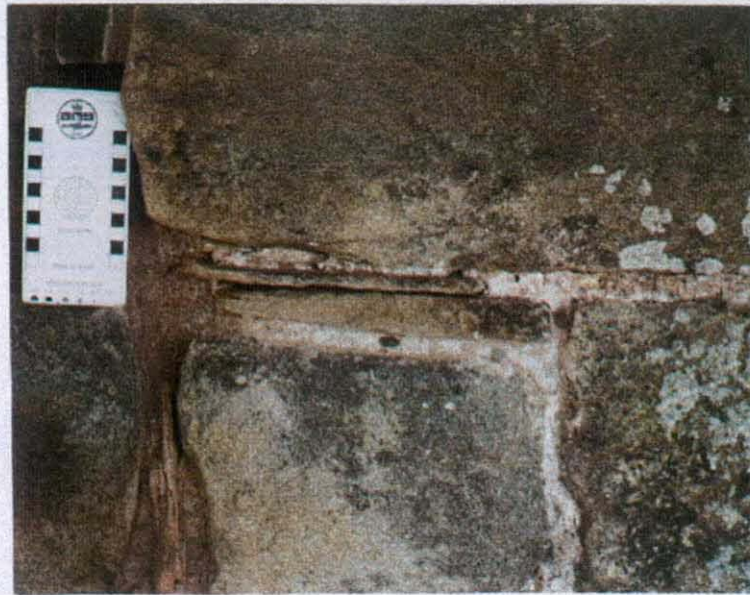
**Figure 34.**

Quoins in west wall.

Thin slabs of sandstone used to level courses of quoins.

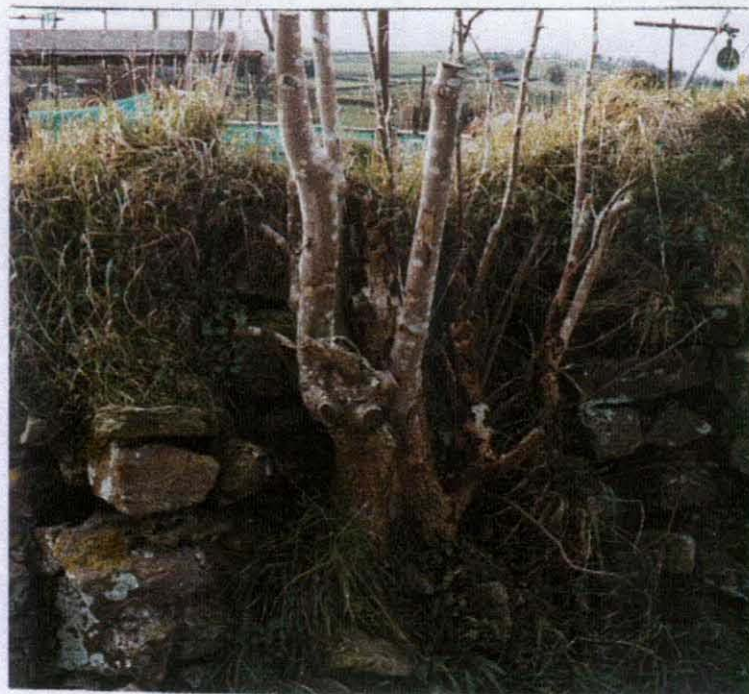
**Figure 35.**

Top of walls at north east corner.

Advanced deterioration of masonry due to growth of vegetation.

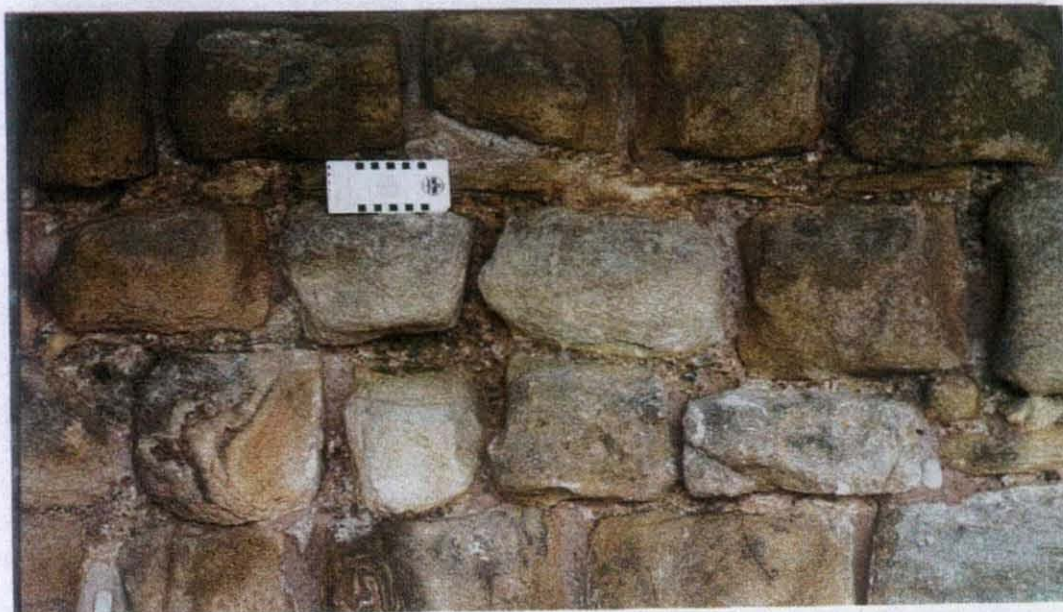
Outer face of north wall.  
Rounding of blocks of Type 'A' stone due to weathering.

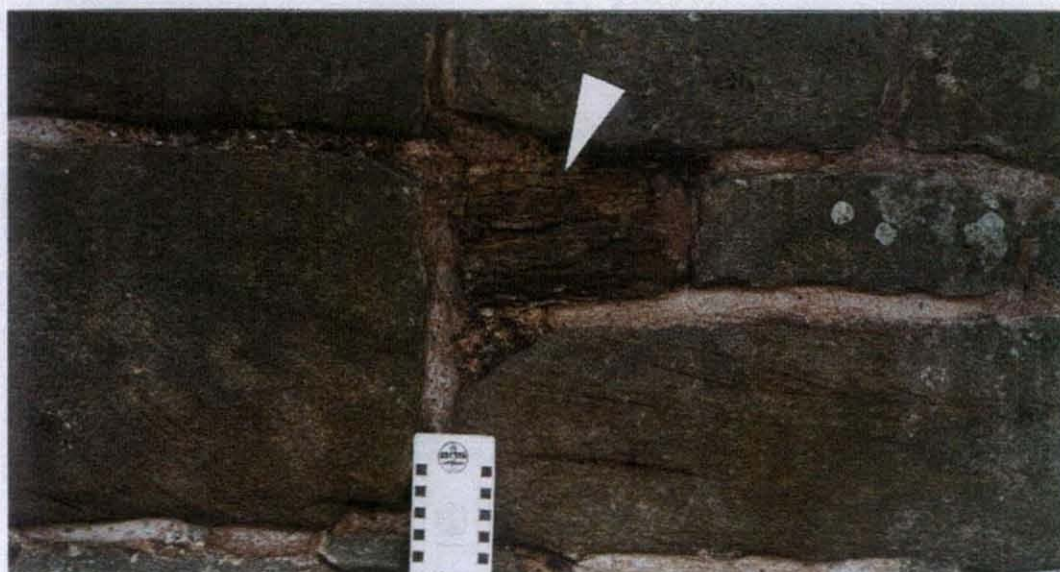
The sandstone here classified as 'Type C' stone characteristically exhibits a strong laminated fabric, commonly with ripple-cross lamination. Weathering typically exploits this lamination and accentuates its appearance on exposed surfaces (Figures 14 and 15). In a few blocks this weathering results in a rather blocky surface deterioration of the stone surface, with fragments a few millimetres across readily becoming detached (Figures 37).

Outer face of west wall.  
Rather 'blocky' surface deterioration of Type 'C' stone (arrowed).

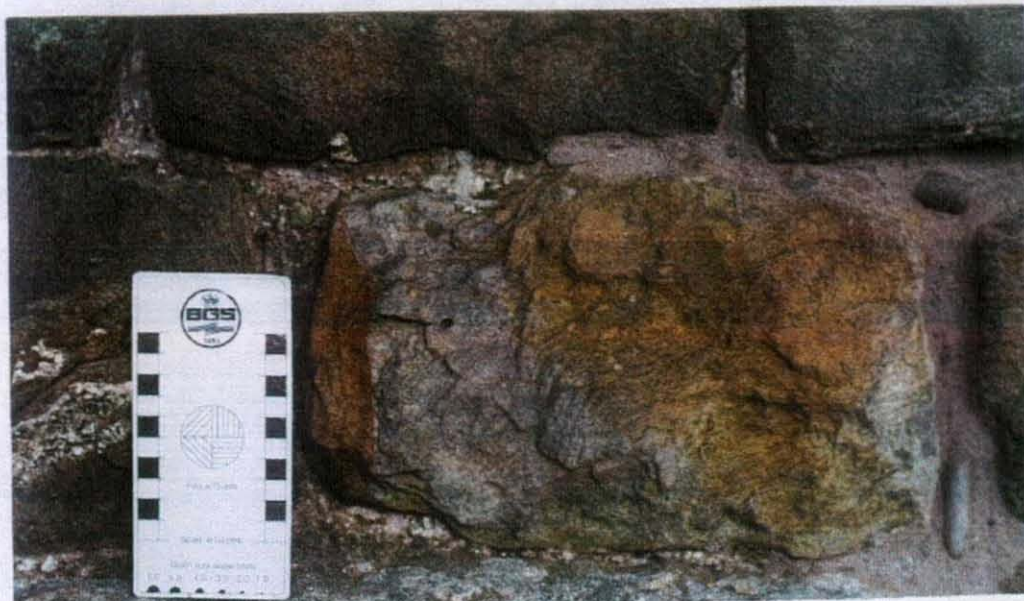
identical composition and texture. Few undoubted examples of 'face-bedding' have been observed in the walls of Thirlwall Castle, though a good example in 'Type C' stone is present in the north wall (Figure 38), and it is possible that some deterioration in 'Type A' stone in parts of the building may also be due in part to them being 'face-bedded'.

Outer face of north wall.  
Face-bedded block of Type 'C' stone.
