# River Dee Estuary deployment cruise report

## March 2007

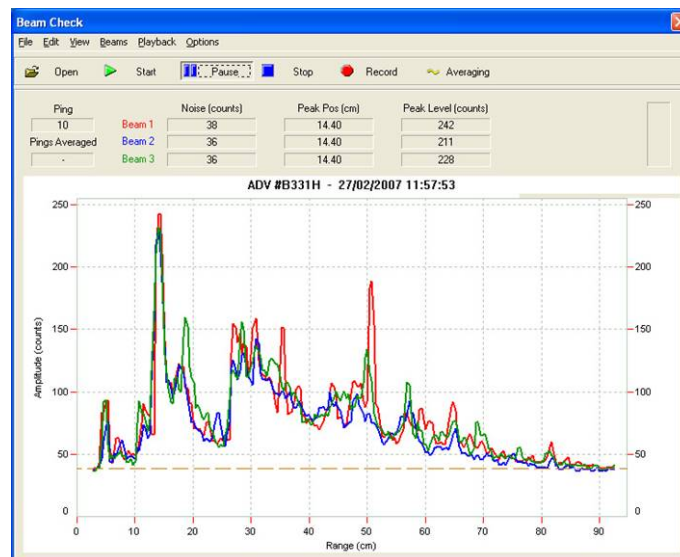
Beam checks were carried out on all three ADV's as a precaution against damage to the transducer arms (example result in Figure 1). No problems were found.

**Figure 1 - Example beam check result for probe head B331**

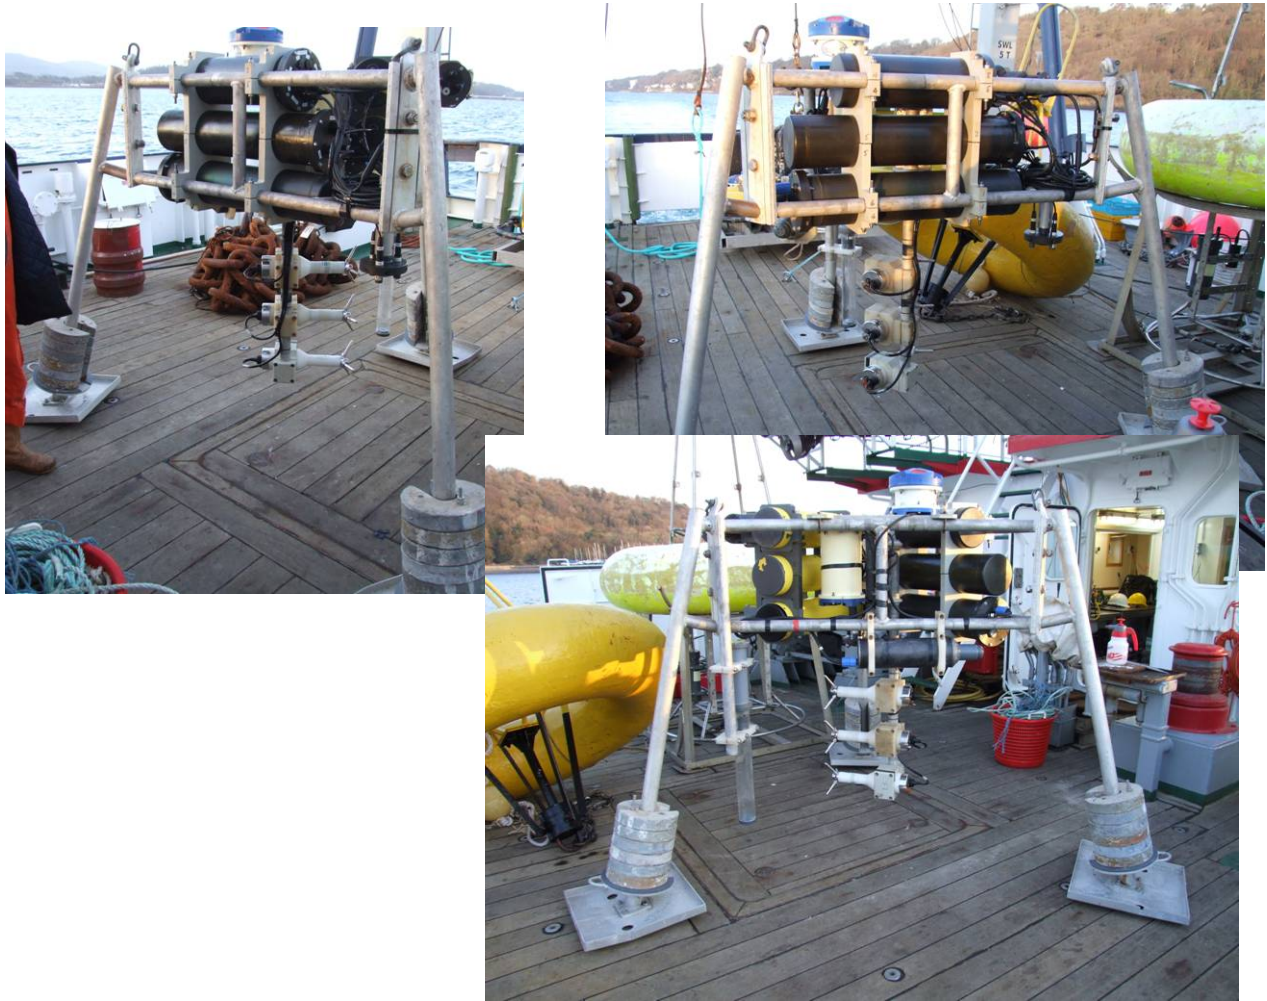
The ADV's were all installed on mini-STABLE as shown in Figure 2. All three were set for 16Hz recording, 20minute bursts, each hour on the hour using an external sync pulse from SyncGen3. Recording was set to start at 6:00am (GMT) 13/3/2007 after the real-time clocks were corrected manually using a radio-clock. All three systems were set to record using ENU coordinates not the normal XYZ, at Alex Sousa's request.

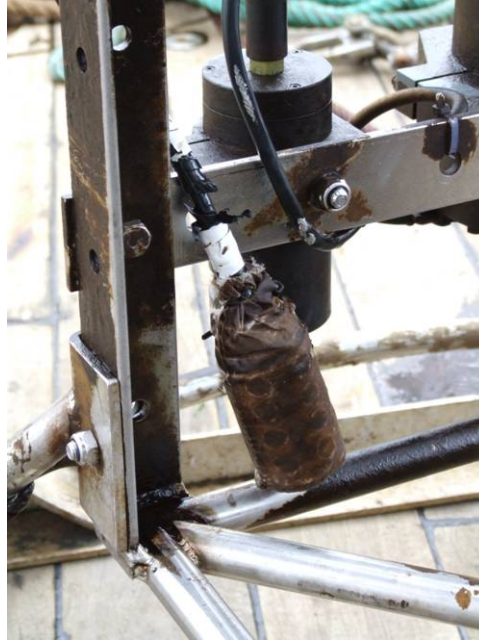
it's memory card. The system software needs to be modified to cope with this type of hiccup more intelligently rather than just shutdown the system. The good news is that the protective cage Conrad Chapman put around the sensor head appears to have worked and is intact. The CEFAS-SMART buoy equipment seems to have suffered some cable chafing on one instrument (Figure 4). This cable needs to be replaced.

**Figure 4 - UoL metal ion probe head and chaffing on CEFAS instrument**
