INSTITUTE of  
HYDROLOGY

Variability of Tropical  
Rainfall in the  
Solomon Islands

Visit Report      March 1988

M C Acreman

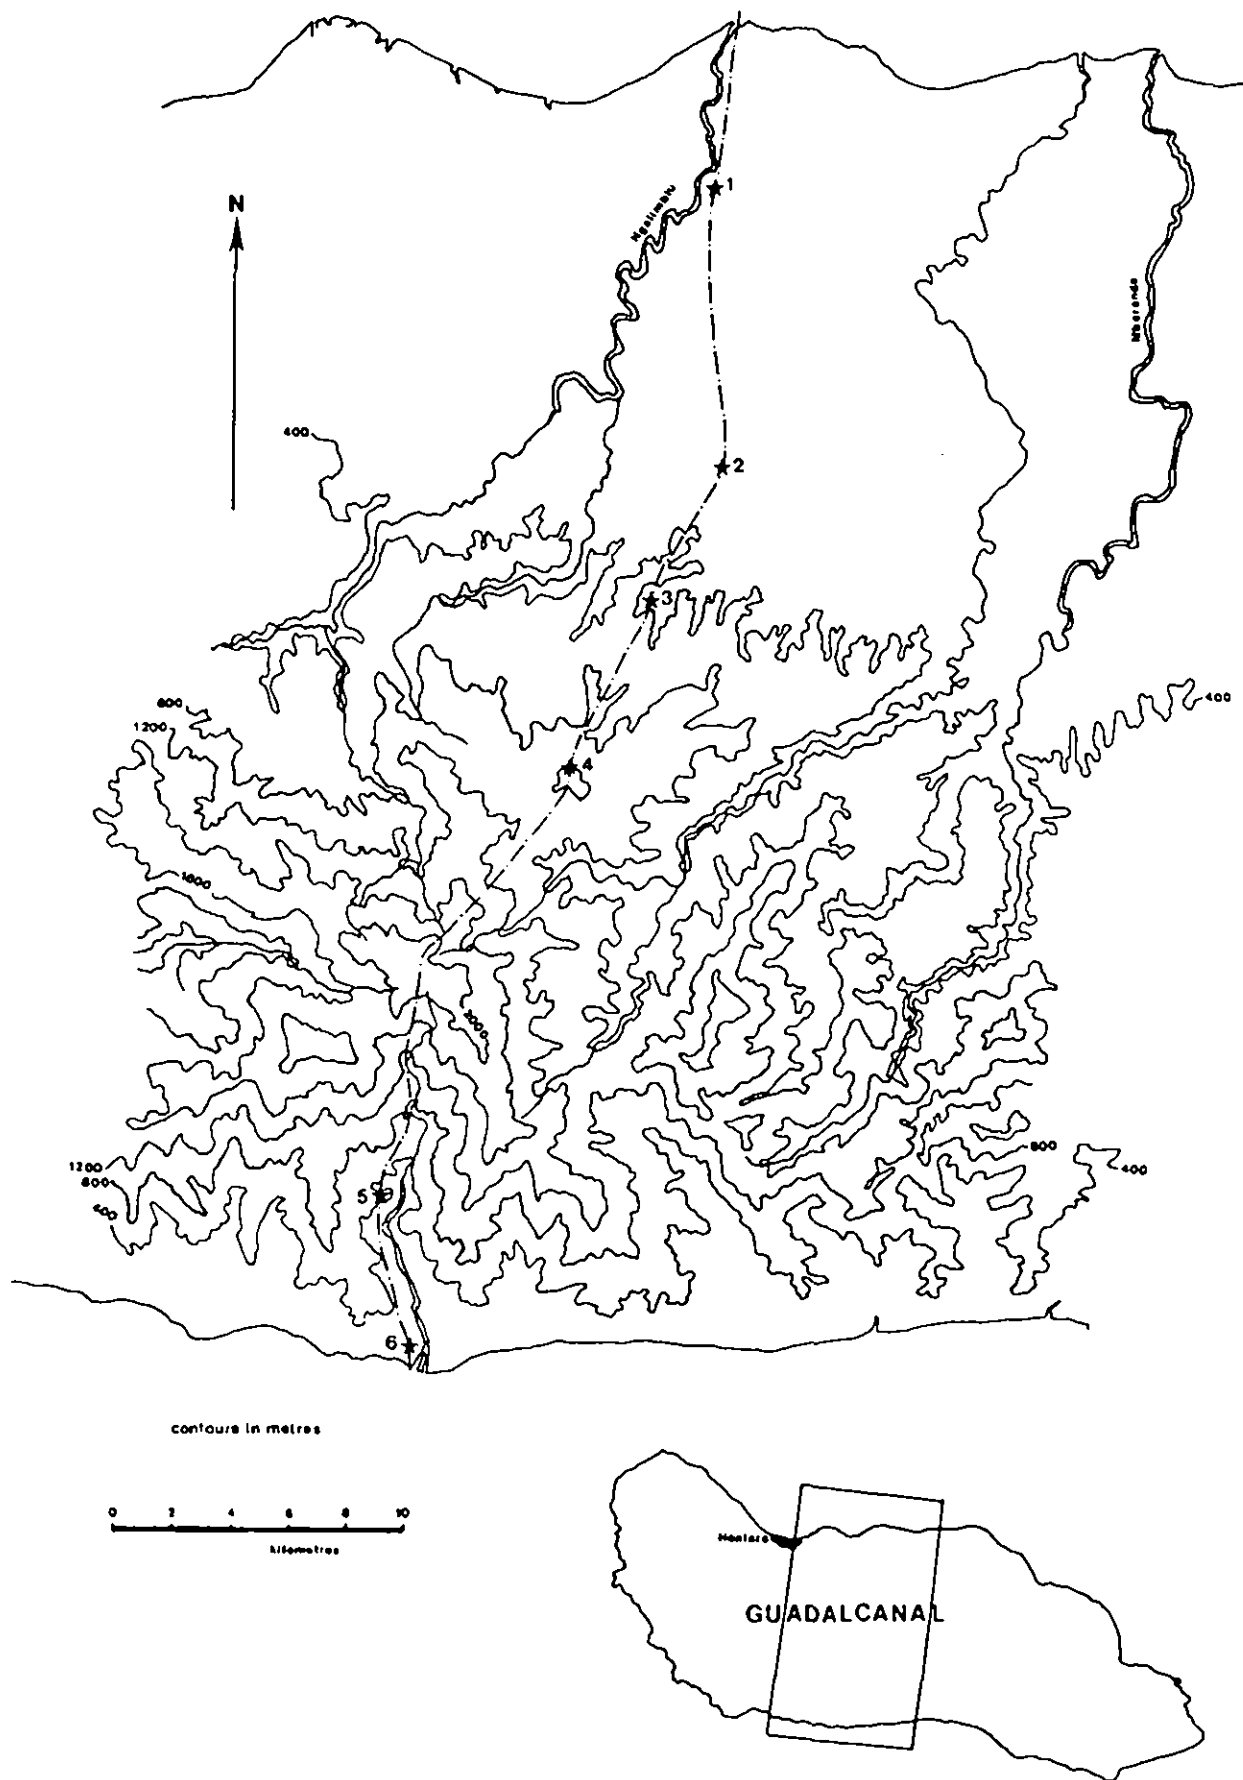
Figure 1 Location of raingauges on the transect

Figure 1 shows the location of the six gauges on the transect. The first four gauges were installed on the northern half of the transect in 1984, whilst the two on the southern part were not commissioned until May 1985. Details of these gauges are given in Table 1. The map references and altitudes of some of the gauges were previously in error, these have now been checked and the values adjusted accordingly.
