Institute of
Hydrology

UPLAND AFFORESTATION AND
WATER RESOURCES

Interim Report on the
Balquhider

Catchment Studies 1981/82

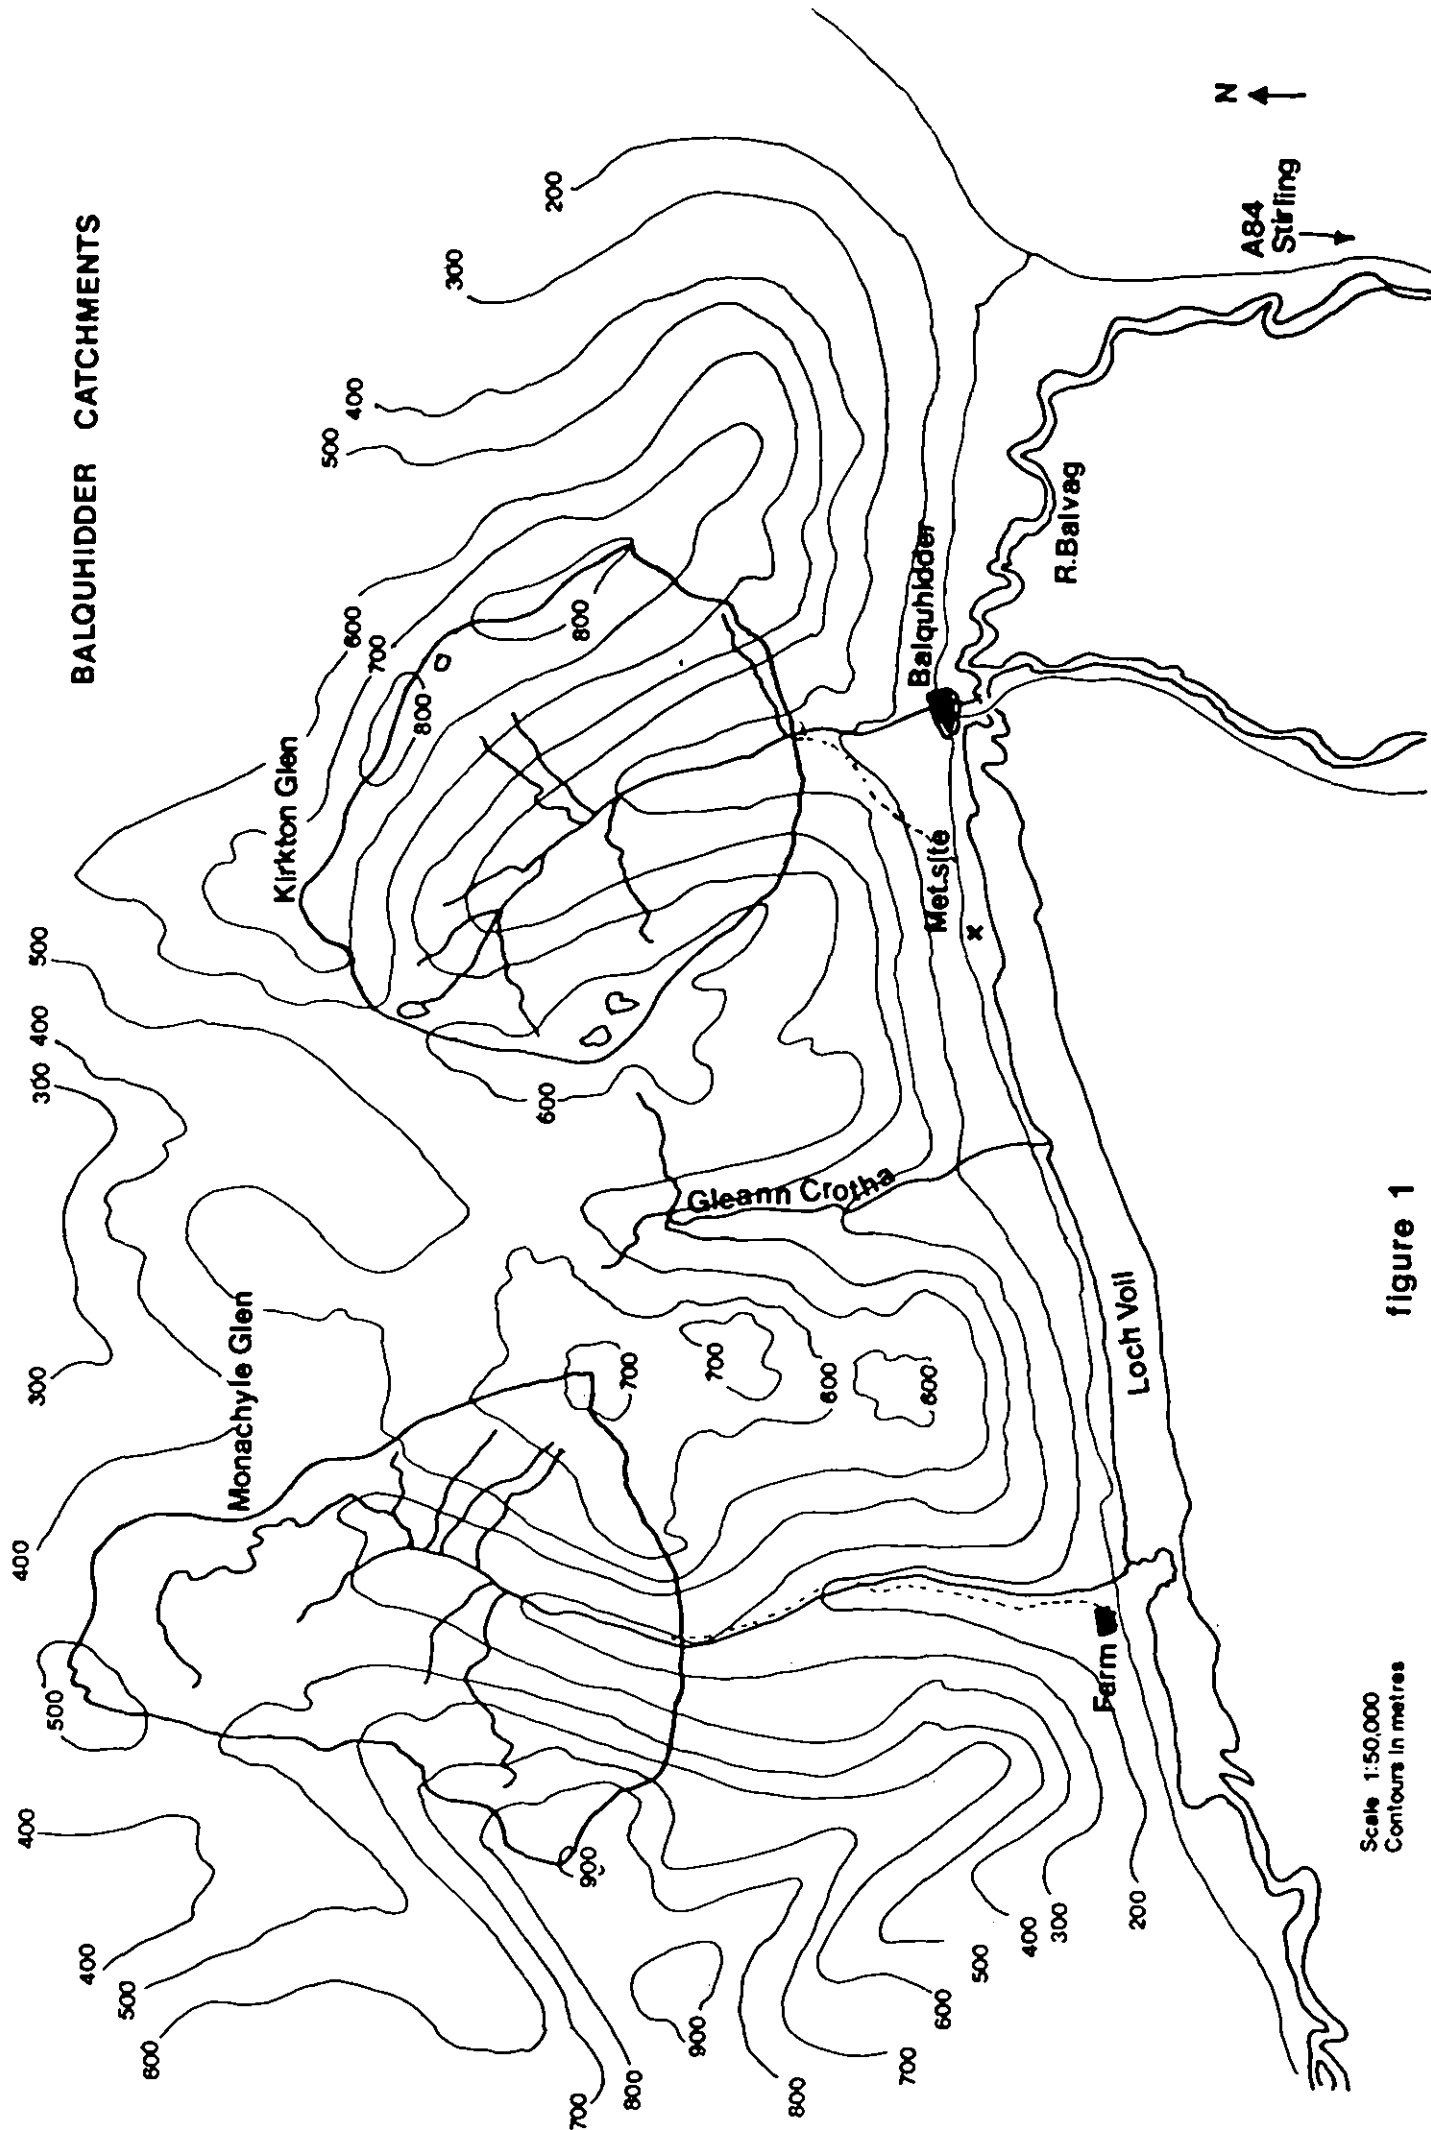
figure 1

BALQUHIDDER CATCHMENTS

Scale 1:50,000
Contours in metres

Figure 1 shows the location and relative positions of the two catchments. Whilst not immediately adjacent they are similar in size, aspect and altitude range. Geology and soils are also similar, though there is an area of relatively flat deep peat in the upper basin of the Monachyle which is absent in the Kirkton. The Kirkton (Fig 2) covers approximately 685 ha of which 275 ha is under mature plantations of spruce, larch and pine. The Monachyle (Fig 3) of 770 ha is under a vegetation cover similar to that above the tree line in the Kirkton; it comprises a mixture of upland grasses, heather and bracken. The grasses dominant on the lower slopes, give way progressively to heather as the altitude increases. There are considerable areas of exposed rock in both catchments.

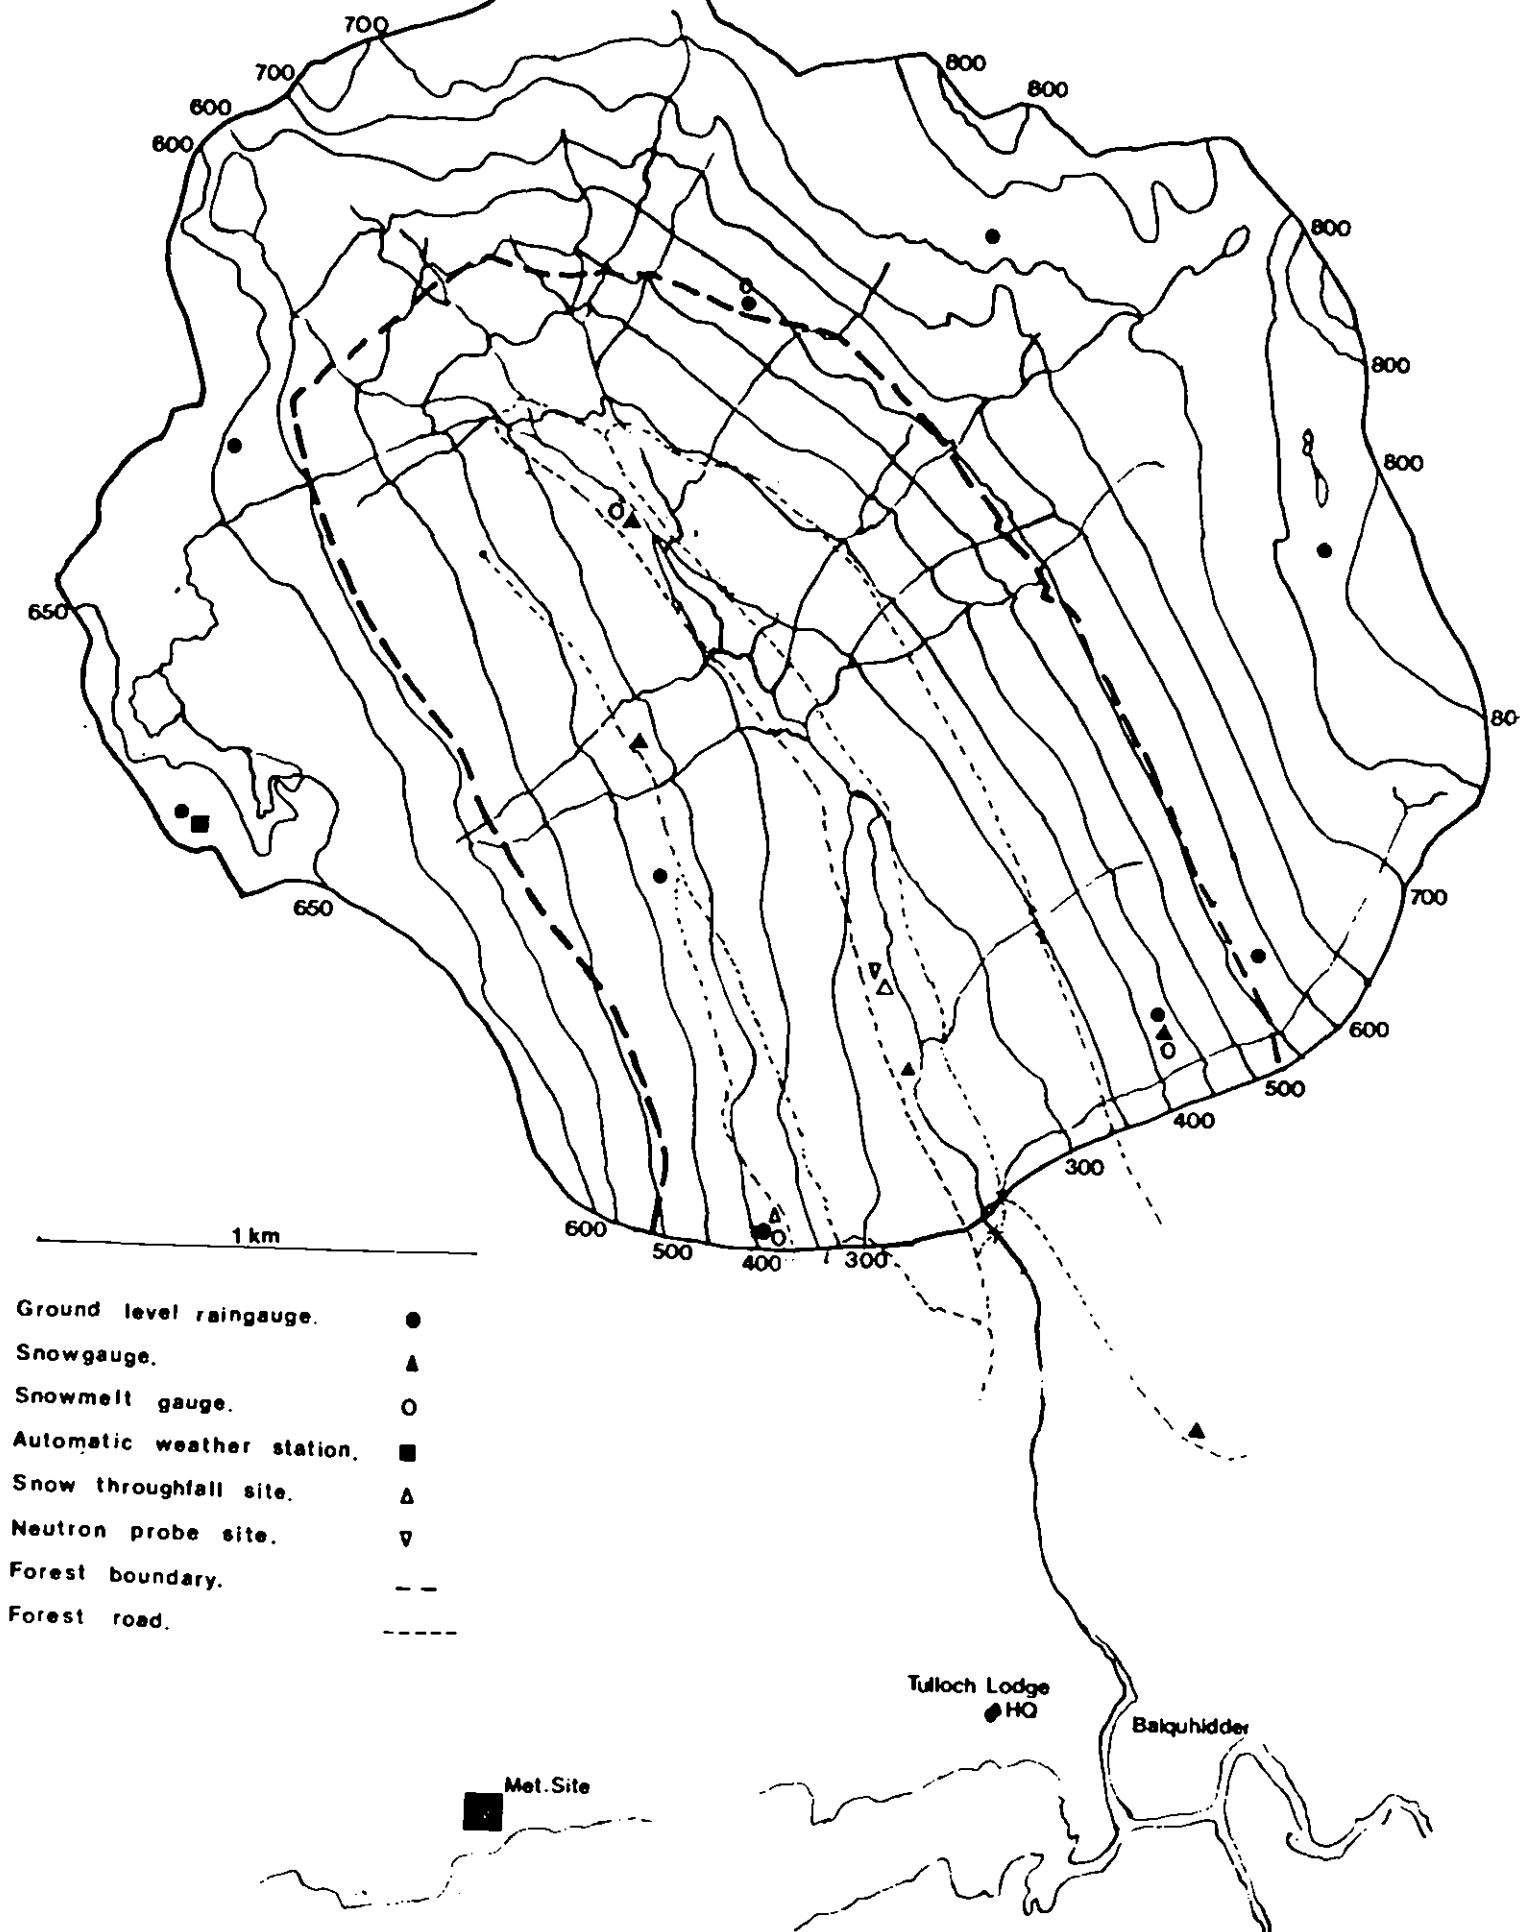
figure 2

KIRKTON CATCHMENT

(area 6.8 km²)

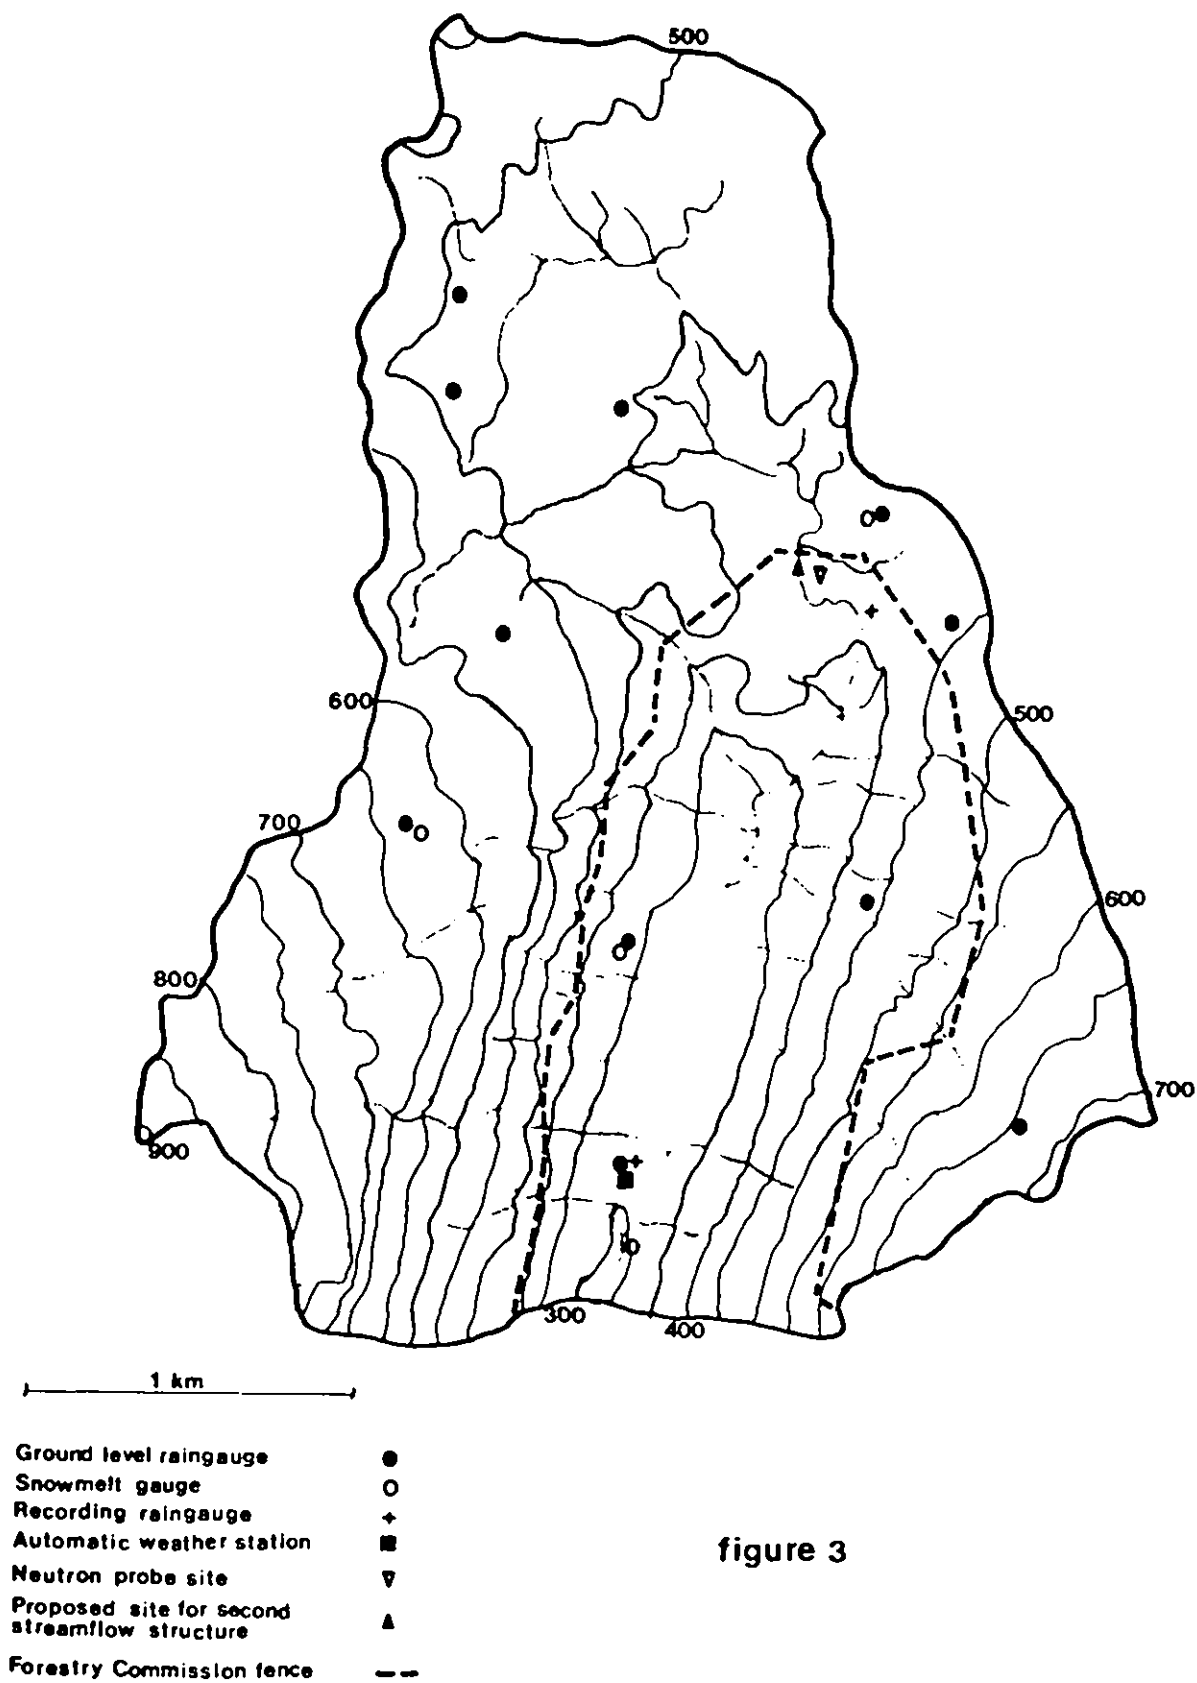
figure 3

MONACHYLE CATCHMENT (area 7.7 km²)

Beyond that, a decision must be made on whether to proceed with the proposed second structure in the Monachyle (Figure 3) and appropriate action taken.

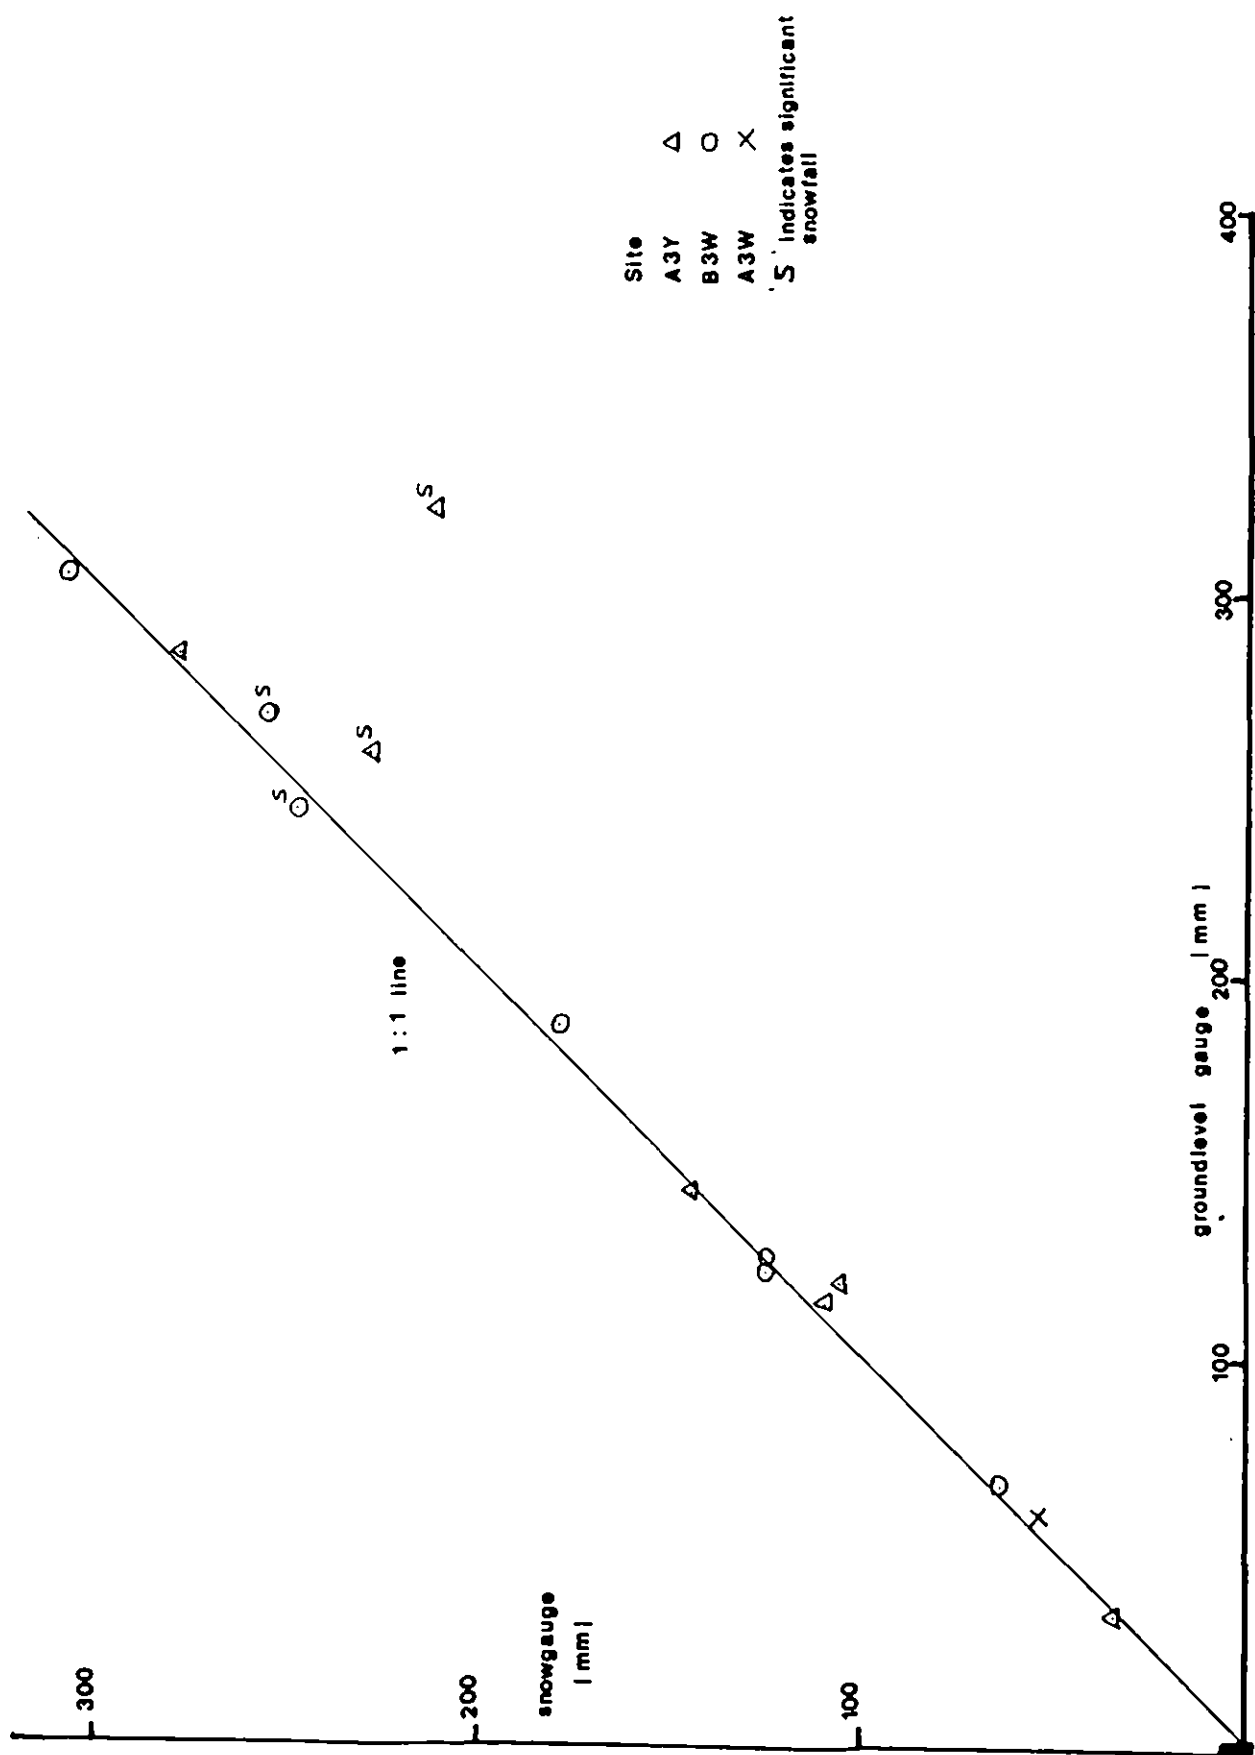
KIRKTON RAINGAUGE COMPARISON

In terms of the overall objectives of the project no meaningful analysis is possible yet on the short runs of data accumulated. Nevertheless these data have provided useful indications of instrument performance and suitability for the job. Figure 4, for example, provides some initial justification for the use of the combined gauges in the forest clearings to provide usable rainfall data. Indirectly it also illustrates a problem during snow events. Whilst the main reason for the discrepancy between the A3Y ground level and combined gauge during the snow period was an accumulation of a snow drift over the ground level gauge, part of it was due to 'bridging' of the combined gauge funnel and partial loss of the snow built up on the bridge. This problem was observed to occur on several occasions. Redesign of the funnel rim of the gauge has been done and a revised version is now on test alongside A3Y.
