Geology as a control on landslides on the Isle of Wight: an overview

G. O. Jenkins^{a*}, C. Foster^a & P. M. Hopson^a

^aBritish Geological Survey, Keyworth, Nottingham, NG12 5GG

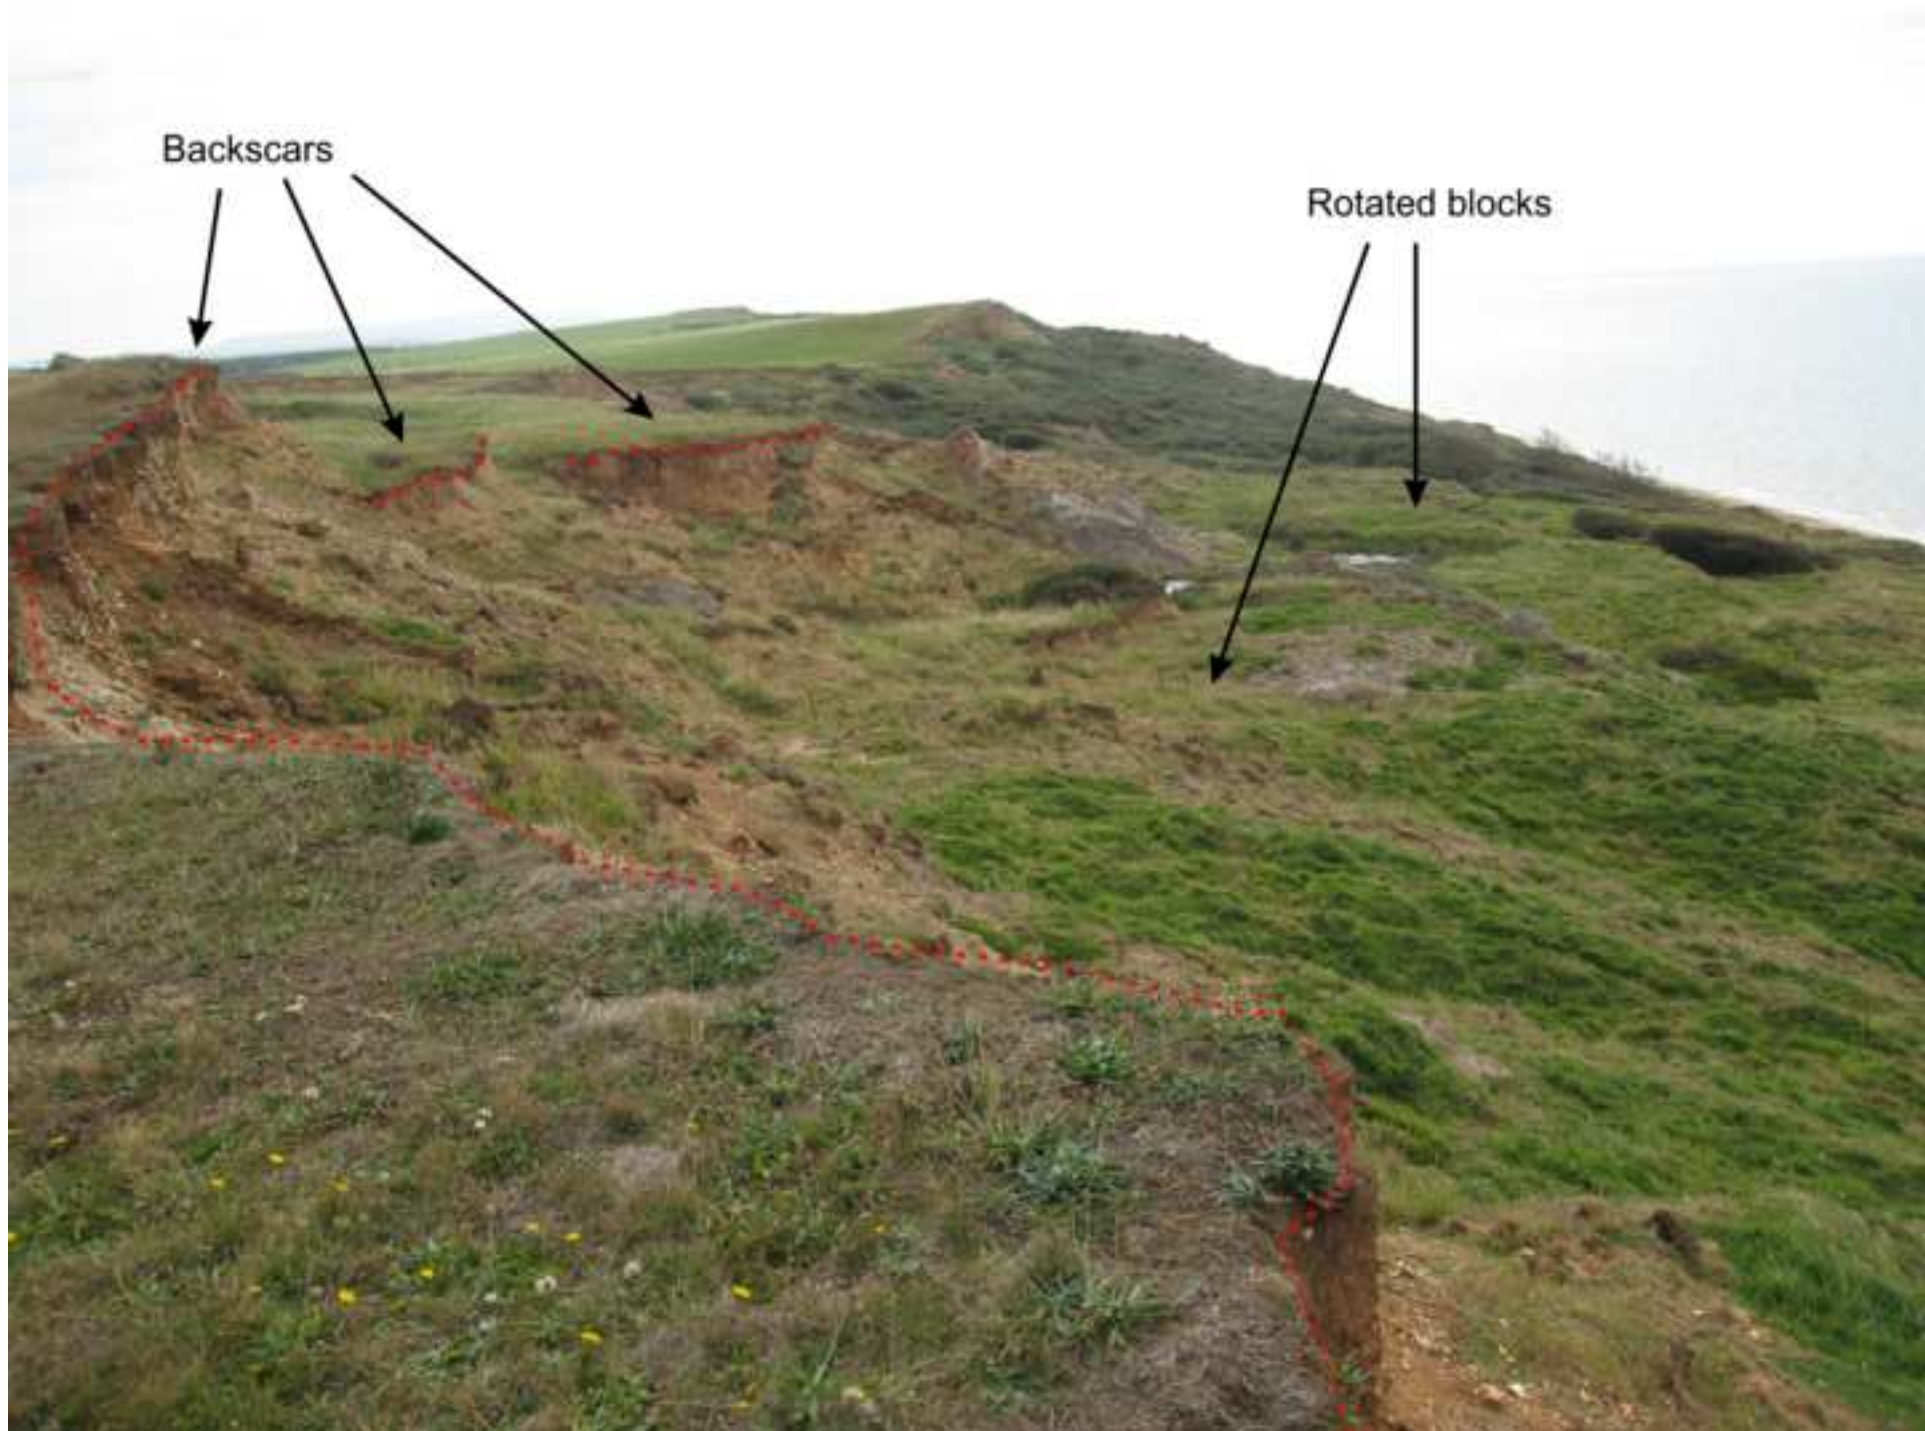
Figure 5
[Click here to download high resolution image](#)

52 where no significant sandstone reinforcement is present and the whole cliff is active
53 even where cliffs are low (Fig. 5). General observations indicate that the retreat of the
54 cliffline is different within each of the zones; there is an increase of activity from
55 Zone B into Zone A and the most severe retreat is associated with Zone C.
56
57
58
59
60
61
62
63
64
65

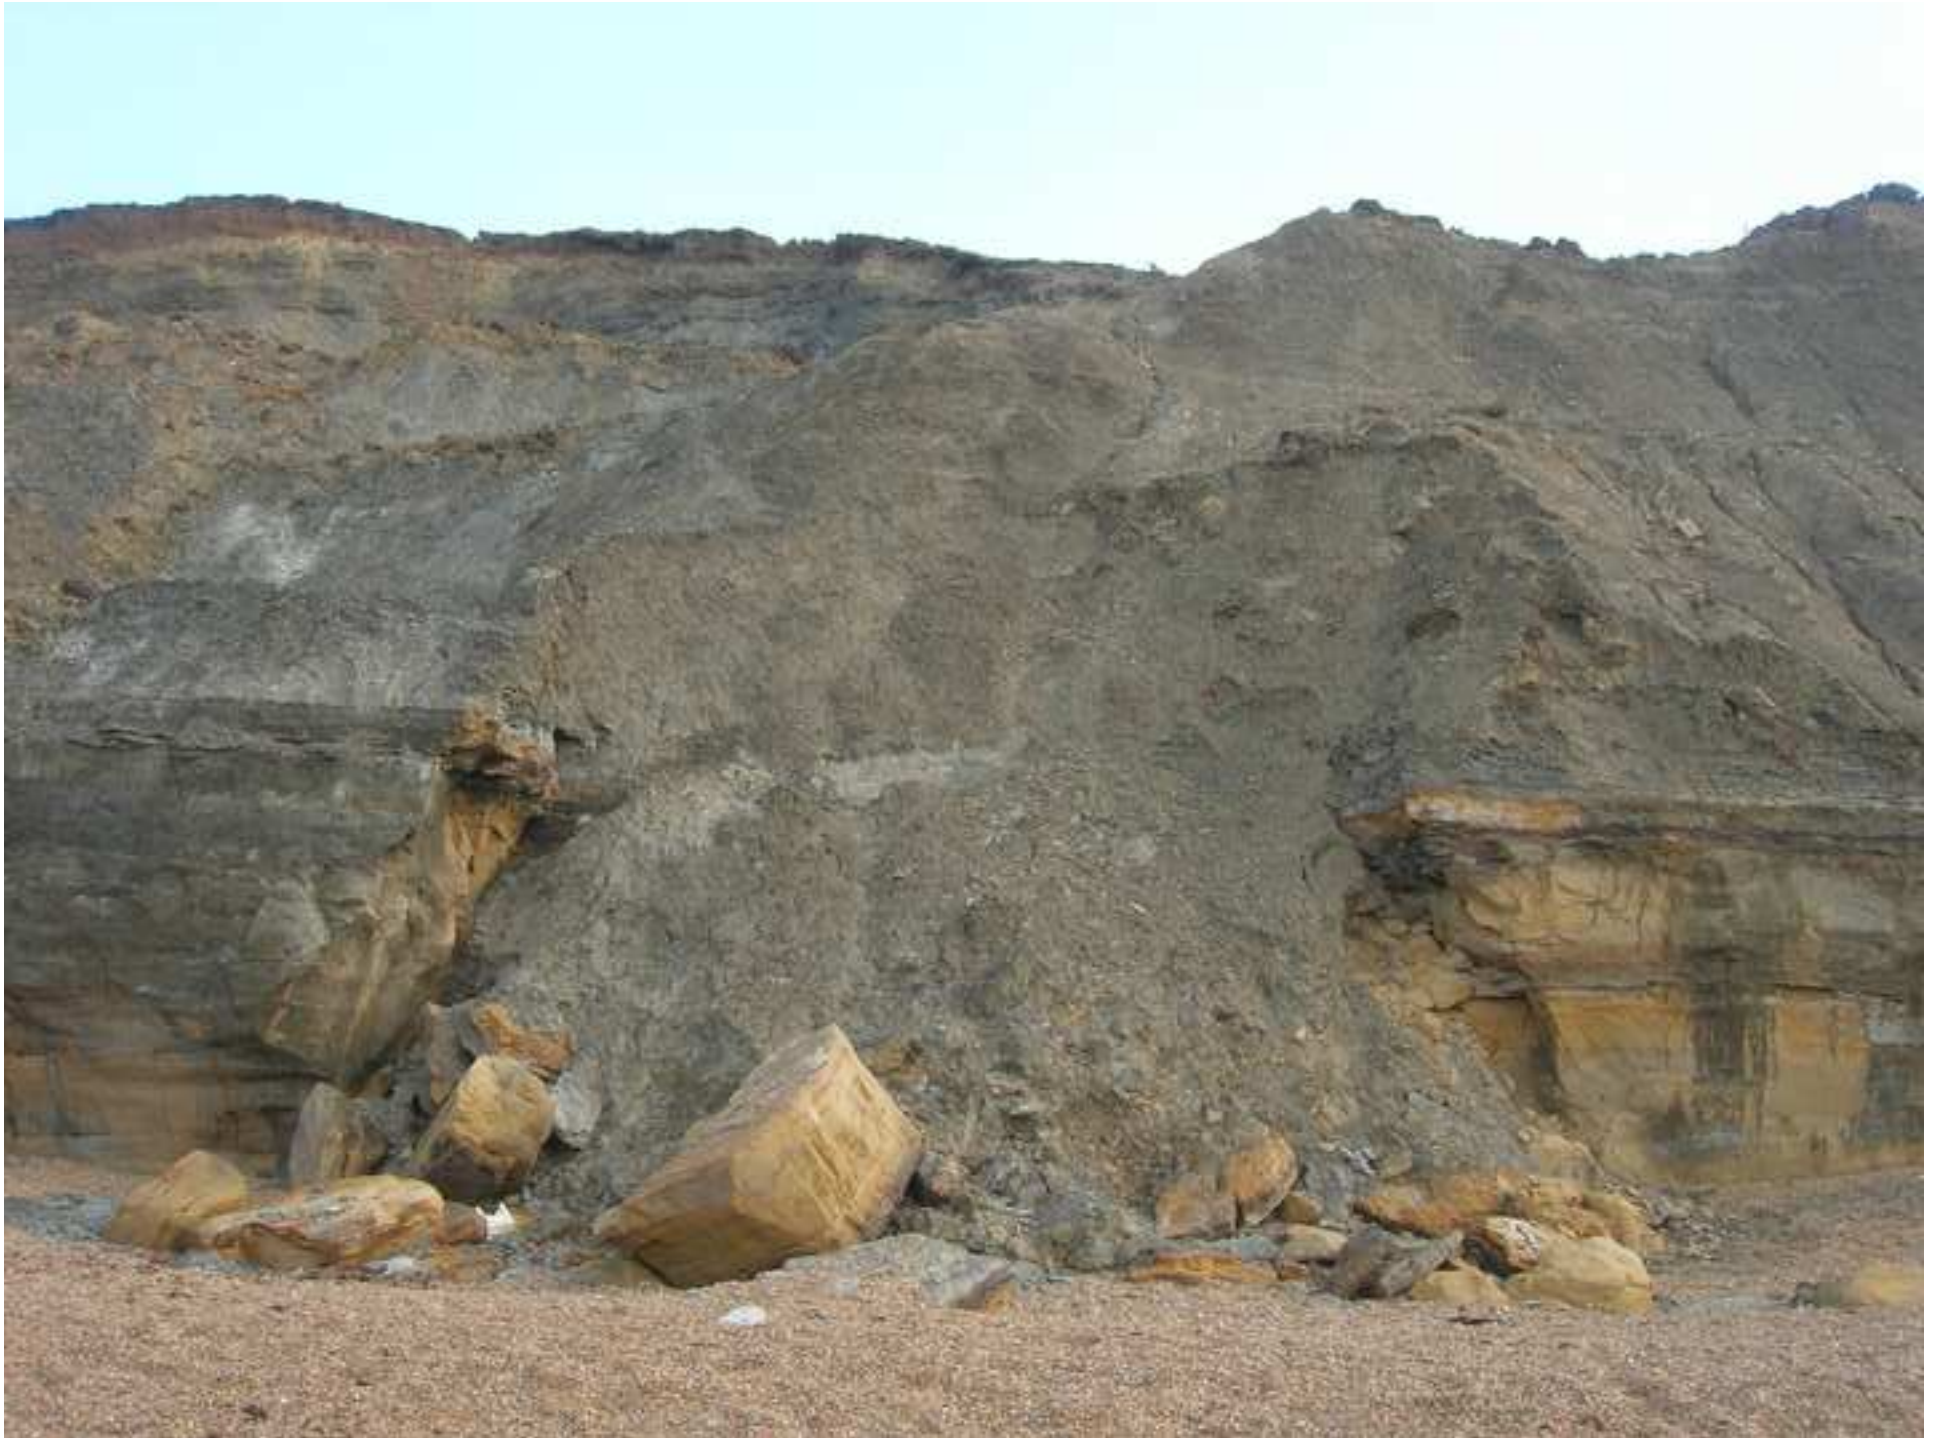
Figure 6
[Click here to download high resolution image](#)

22
23 Fig. 6. Failures in the Vectis Formation of the Wealden Group. P769946.
24

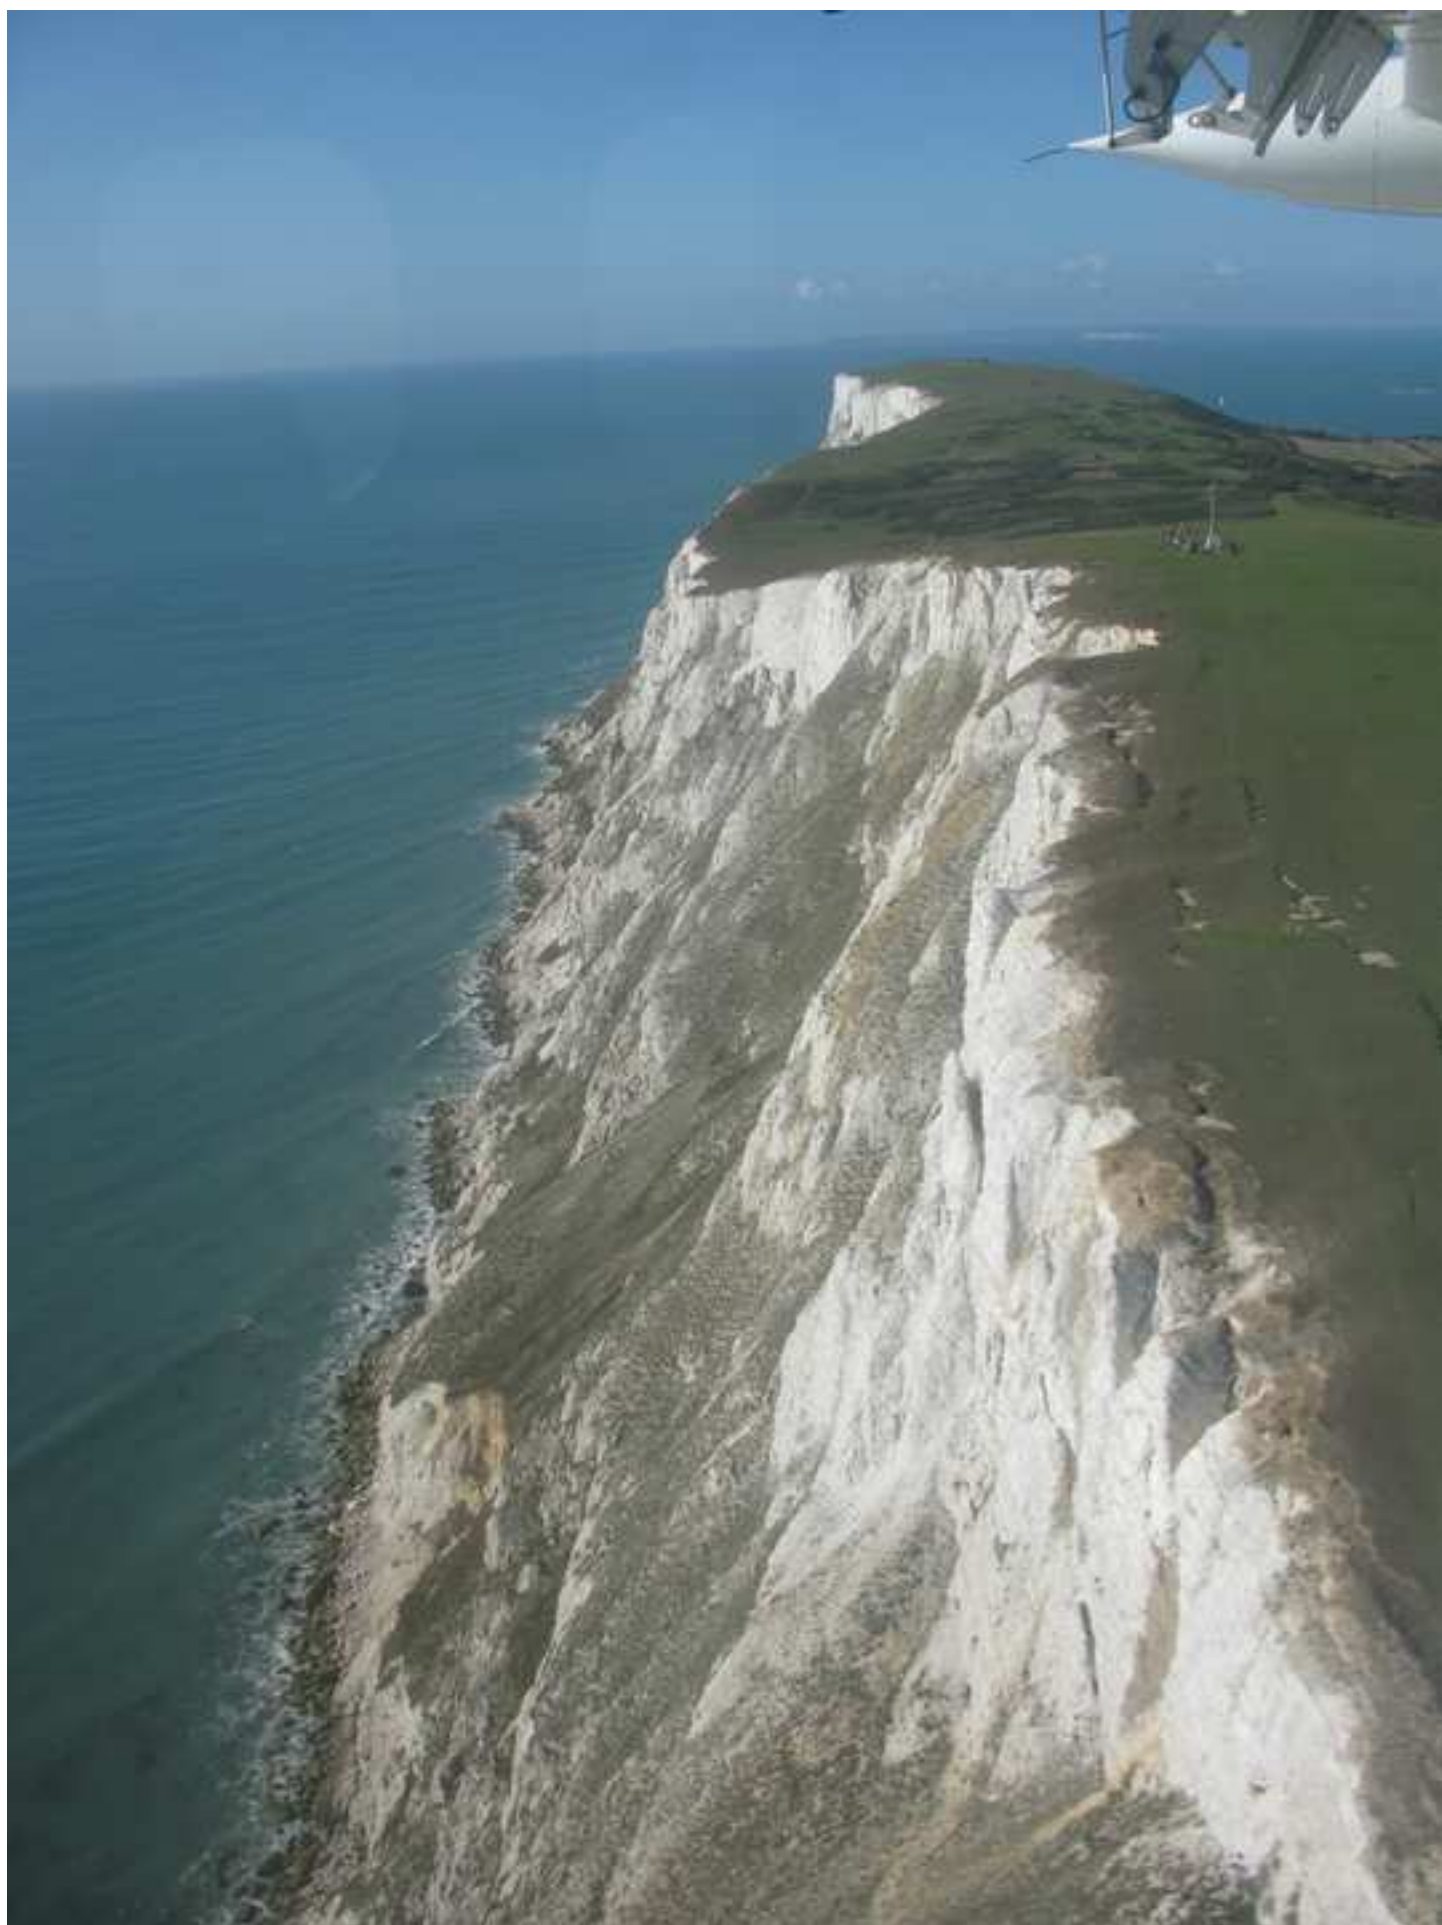
Figure 14

45
46 Fig. 14. Tension cracks above Tennyson Down which could lead to large scale
47 failures. P769938.
48

1 Marine erosion at the site is also a significant factor leading to undercutting of the
2 cliff and failure of material by falling. Similar fissure-like features are found on the
3 southern margins of Culver Cliff where it abuts Sandown Bay [6350 8550], although
4 the fissuring does not appear to be as advanced. Little work has been conducted at this
5 site as it does not directly affect any infrastructure. Photographs collected during an
6 airborne geophysics survey by the BGS in September 2008 reveal the presence of
7 large tension cracks above Tennyson Down at the western end of the island,
8 suggesting that further failures along this section are also likely (Fig.14).
9
