A recent landslide on the east Devon coast, U.K.

R. W. Gallois

Quaternary Journal of Engineering Geology and Hydrogeology, Vol. 40, 29-34.

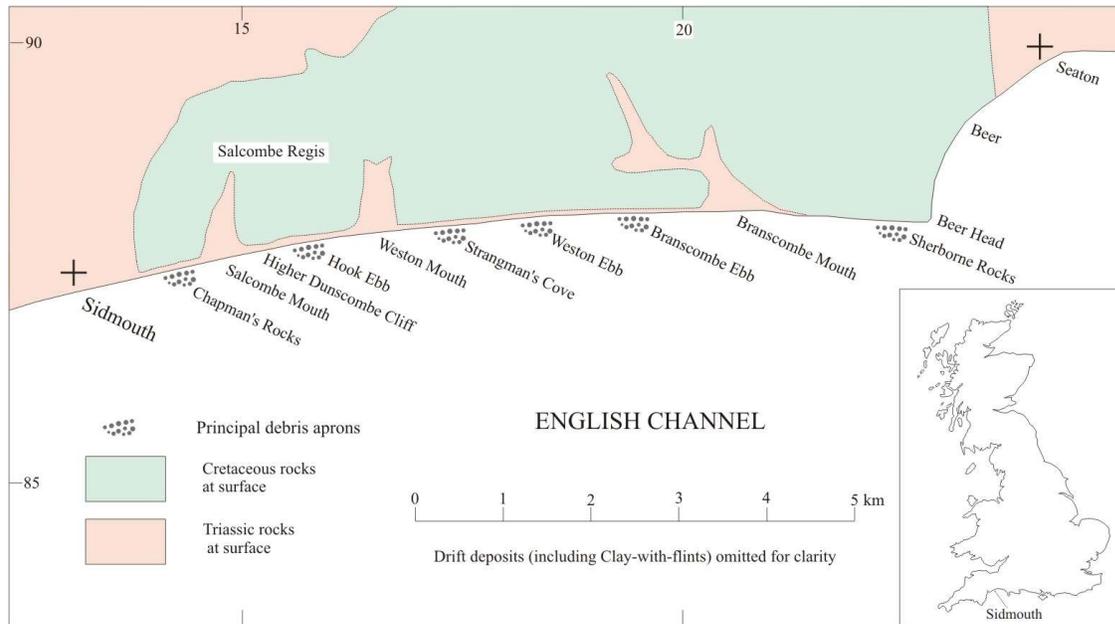
Figure 1. Geological sketch map of the coastal area between Sidmouth and Seaton, east Devon.

Joint/bedding-bounded toppling failures have been observed from time to time in the highest, more massive part of the Upper Greensand along the east Devon coast. The most recent of these occurred after a prolonged period of wet weather in 2001 when a single block of about 3000 tonnes in the highest part of the Upper Greensand fell over 120 m from the western end of Higher Dunscombe Cliff, Salcombe Regis [SY 150 878] and broke up on the beach. A similar mechanism has until now seemed to be the most likely explanation to account for the accumulations of angular blocks of Upper Greensand up to several hundred tonnes in weight that are common in the intertidal area between Beer Head and Sidmouth (Fig. 1).

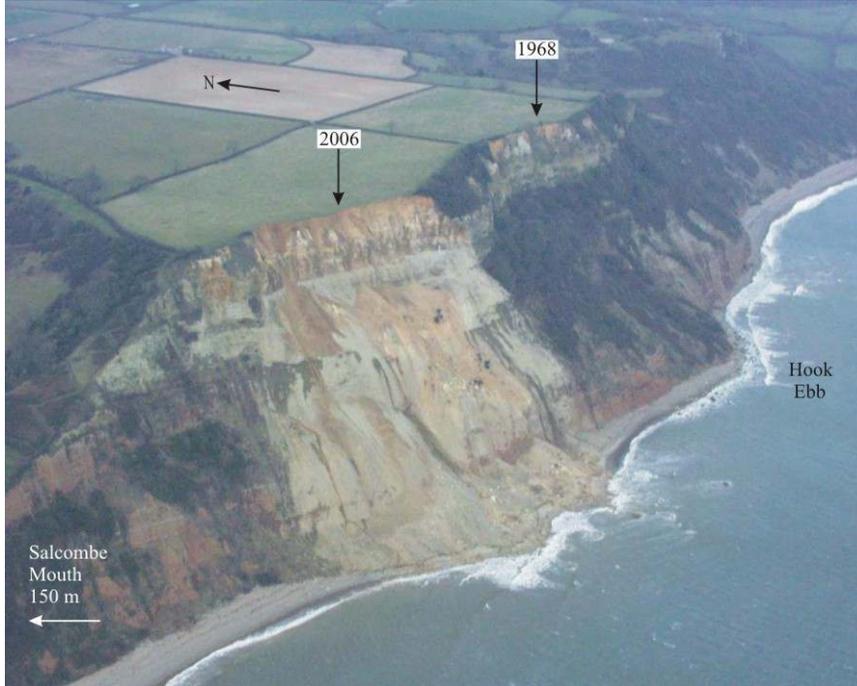
Figure 2. Salcombe Regis landslide, January 4th 2006; viewed from the south west. Photo courtesy Maritime and Coastguard Agency.

The landslide occurred in the early hours of January 4th 2006 at the western end of Higher Dunscombe Cliff, Salcombe Regis, adjacent to the 2001 toppling failure (Fig. 2). No person or property was involved, but a section of about 150 m of the Southwest Coastal Path and an adjacent hedge and fence fell about 160 m to the beach (Fig. 3). The width of the collapsed mass varied at cliff-top level from about 5 to 20 m. It is estimated that the total mass of the landslide was about 250,000 tonnes. The debris spread out to cover a 200+ m width of the beach and intertidal area (Fig. 4A). Individual blocks up to 5x5x4 m of the more durable lithologies came to rest up to 150m beyond the foot of the cliff, below the low-water level of Spring tides (Fig. 4B).

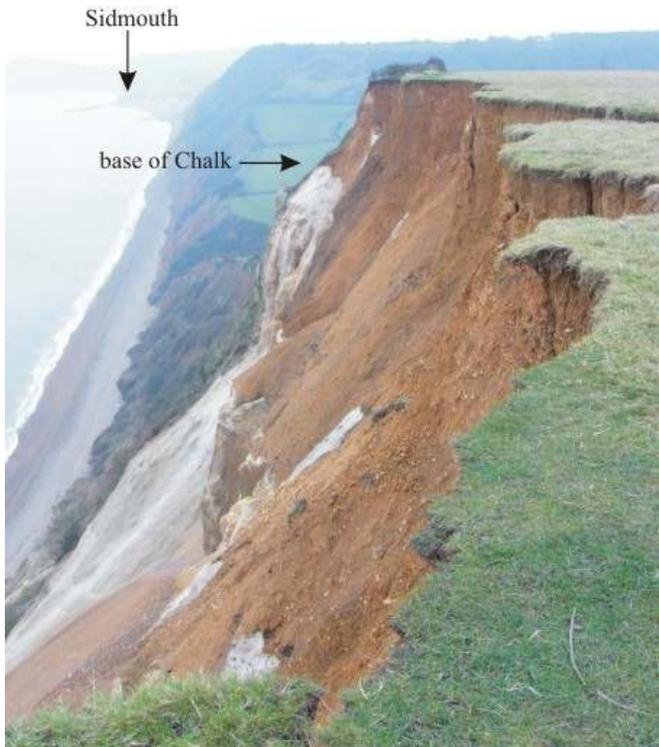
Figure 3. View west from the coastal path. The Clay-with-flints, here composed largely of angular chert and flint clasts in a sand matrix, rests on an irregular, solution-pocketed chalk surface.

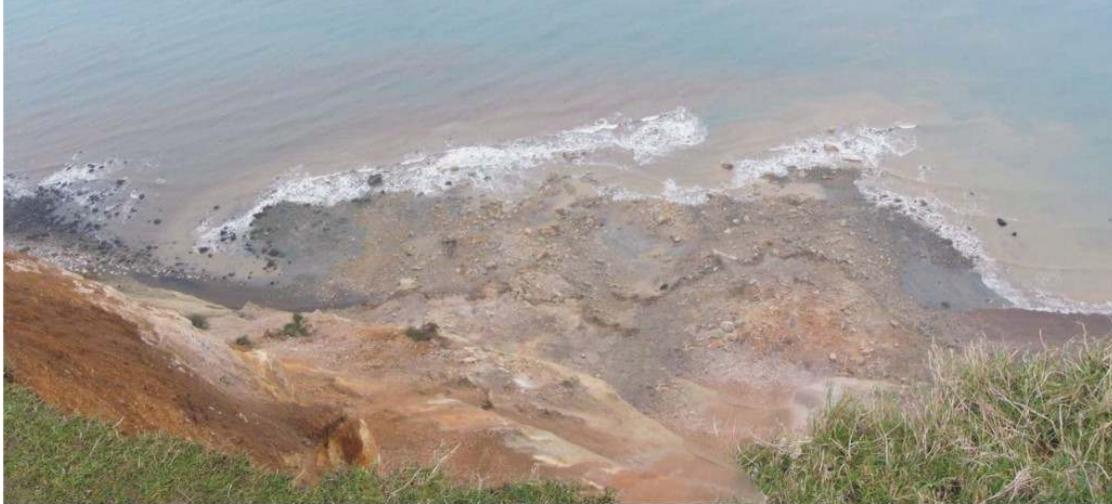
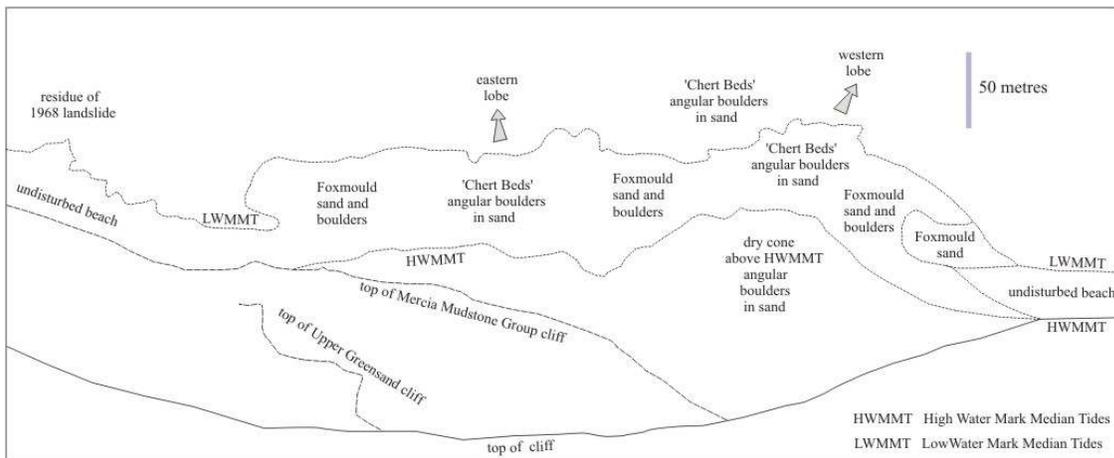
Figure 4. A & B The debris apron viewed from the cliff top. The distribution of the Upper Greensand Formation components indicates that the failure surface was at or close to the base of the formation.

The distribution of the debris in the intertidal area strongly suggests that the principal failure surface was at or close above the unconformity at the base of the Upper Greensand, probably along a thin (10 to 20 mm thick) montmorillonite-rich bed. The oldest strata, the soft glauconitic sands of the 'lower' Foxmould, appear to underlie the whole of the debris cone. Immediately

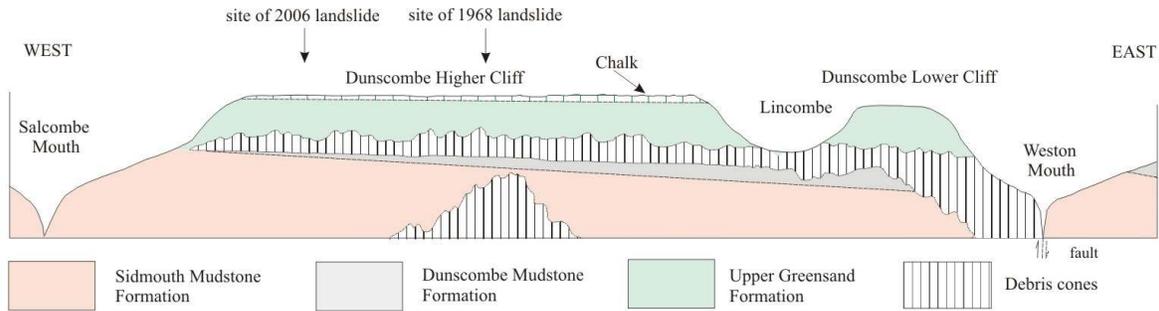
Figure 5. Geological sketch section of the cliffs between Salcombe Mouth and Weston Mouth showing the westward overstep of the Cretaceous Upper Greensand across the Triassic Mercia Mudstone Group.

The cliffs between the Axe Valley and Sidmouth can be divided into two parts (Fig. 5). The lower cliffs (mostly at 40° to 85°) are composed of well-jointed, moderately strong Triassic mudstones and siltstones of the Mercia Mudstone Group (Edwards & Gallois, 2004).

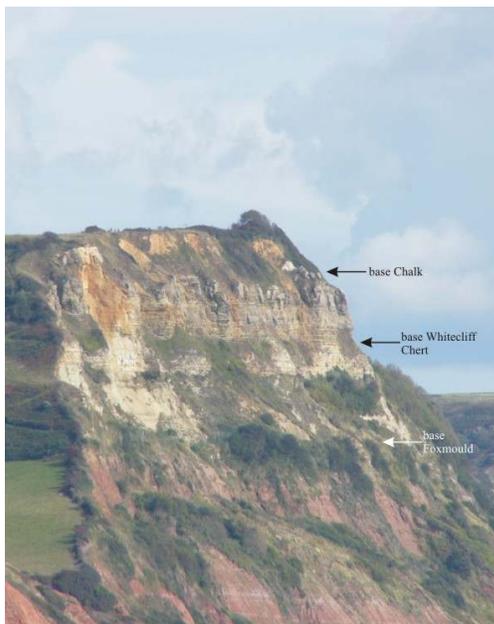
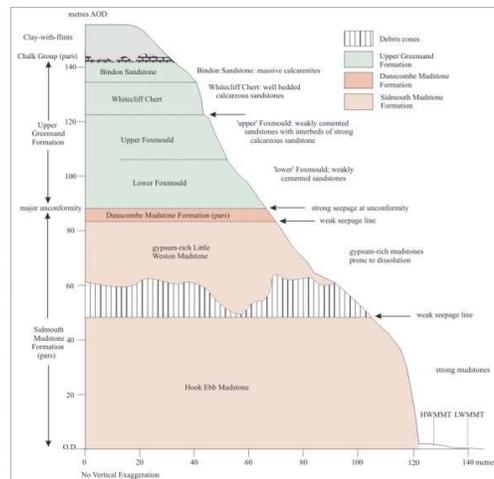
Figure 6. A The upper part of Higher Dunscombe Cliff at the landslide site viewed from the west in 2005. B Cliff profile in the central part of the landslip area prior to the failure.

The distribution of the Upper Greensand lithologies in the 2006 debris cone is in roughly the same stratigraphical order as that in the cliffs. The succession exposed in Higher Dunscombe Cliff can be divided on gross lithology into six stratigraphically controlled units that give rise to a characteristic cliff profile (Fig. 6A). In the lowest part, weakly calcareously cemented permeable sandstones of the 'lower' Foxmould Member are prone to dissolution (Fig. 6B).

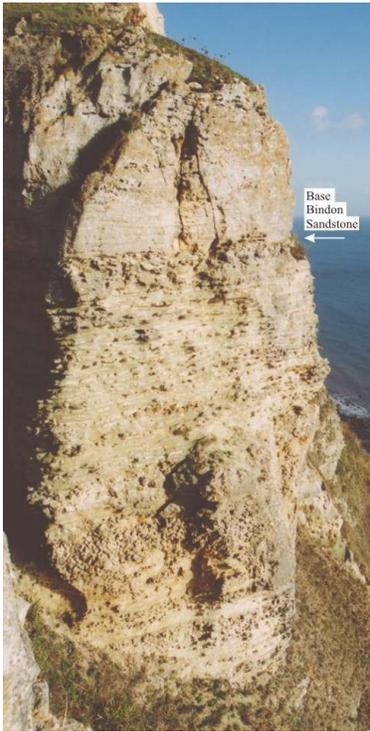
Figure 7. The sandstones and calcarenites of the Whitecliff Chert and Bindon Sandstone form vertical and near vertical cliffs at Higher Dunscombe Cliff. A network of vertical joints and well-defined bedding discontinuities make these beds prone to toppling failure.

The overlying Whitecliff Chert and Bindon Sandstone members (Gallois, 2004), collectively referred to as the 'Chert Beds' by earlier authors, consist of strong, mostly massive calcareous sandstones and sandy calcarenites. They form vertical and near-vertical cliffs with well-defined bedding and joint partings that give rise to toppling failures. At the base of each member, a glauconite-rich bed forms a plane of weakness and a notch in the cliffs. The lower part of the Whitecliff Chert at this locality consists of strongly cemented calcareous sandstones with up to six hardground surfaces underlain by dense nodular sandy limestones.

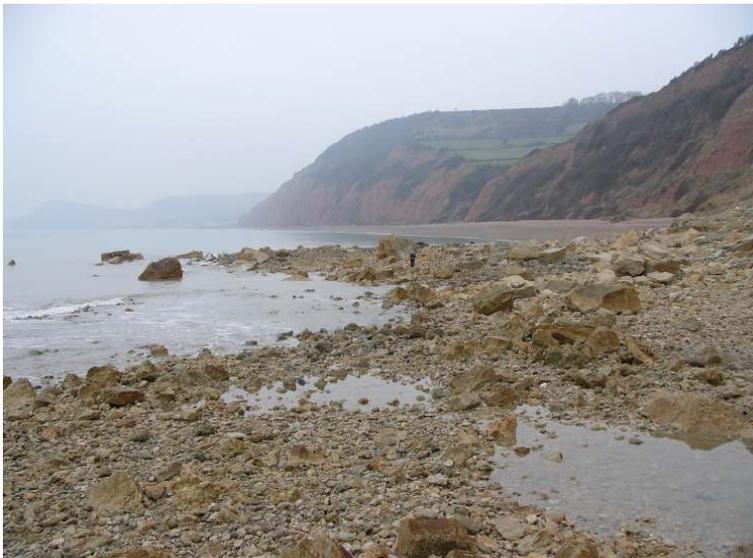
Figure 8. The 2006 debris apron at low Spring tide, viewed from the east four weeks after the landslide. The finer grained materials have been dispersed and all except the hardest lithologies reduced to rounded cobbles and boulders.

Most of the fines from the debris cone in the intertidal area were removed by the sea within a few tidal cycles. Four weeks after the landslide, the weaker lithologies had been reduced to rounded cobbles and boulders. Only the larger blocks of Whitecliff Chert and Bindon Sandstone had retained their angular shapes (Fig. 8). Similar blocks in the residual debris from earlier landslides suggest that they become encrusted by *Mytilus* and other organisms within 1 to 2 years and suffer little further erosion. The matrix-supported nature of the unweathered debris cone can be observed in the supra-tidal part of the 2006 landslide and in cliff sections at the foot of the 1968 landslide.
