TECHNICAL REPORT WC/00/10  
Overseas Geology Series

DFID Project No. R6839

## **Landslide hazard mapping: Jamaica case study**

Project title: An implementation strategy for landslide hazard preparedness

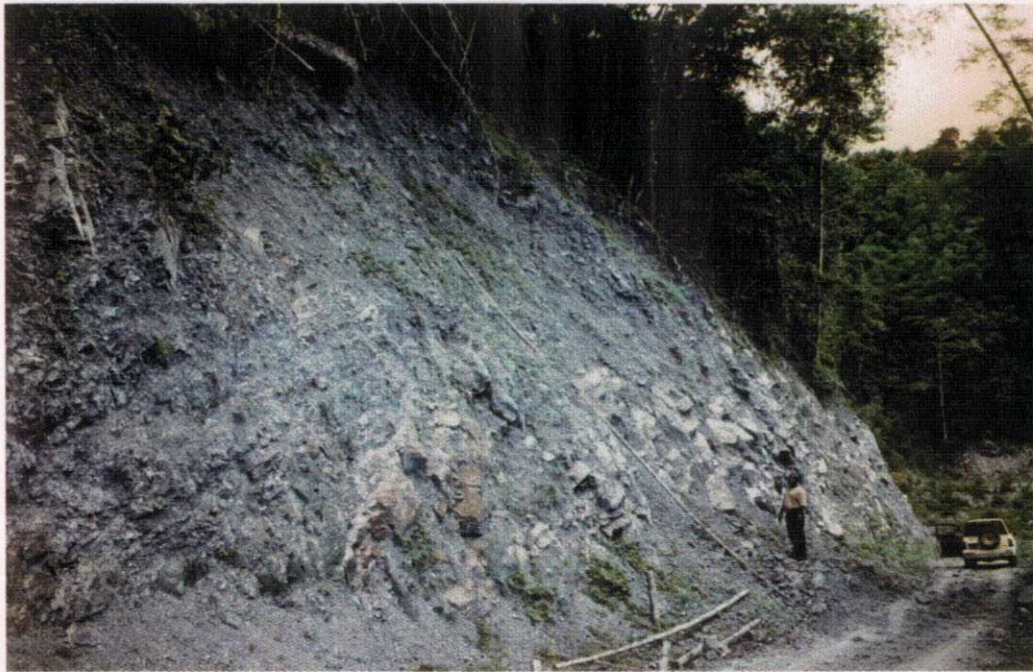
Figure 3.5 Small scale rock and debris fall from a steep road cut in volcanoclastic sediments of the Bullhead Formation, Main Ridge. Debris, recently cleared from road, is derived from the weathered, fractured and jointed bedrock and overlying, 1-2m thick, colluvium comprising earth and rock fragments.

**Debris falls** are common across the area and can occur in weathered bedrock, lithosols and colluvial debris on virtually all lithologies. They are usually less than 5-10 m in the longest dimension and occur on slopes of more than  $20^\circ$ . As with rock falls, they may be triggered by rainfall and/or seismic shock. They are frequently associated with road cuts which tend to cause over-steepening, and hence instability, in the surficial colluvial debris cover which subsequently fails by falling down the face of the cut (Figure 3.5).

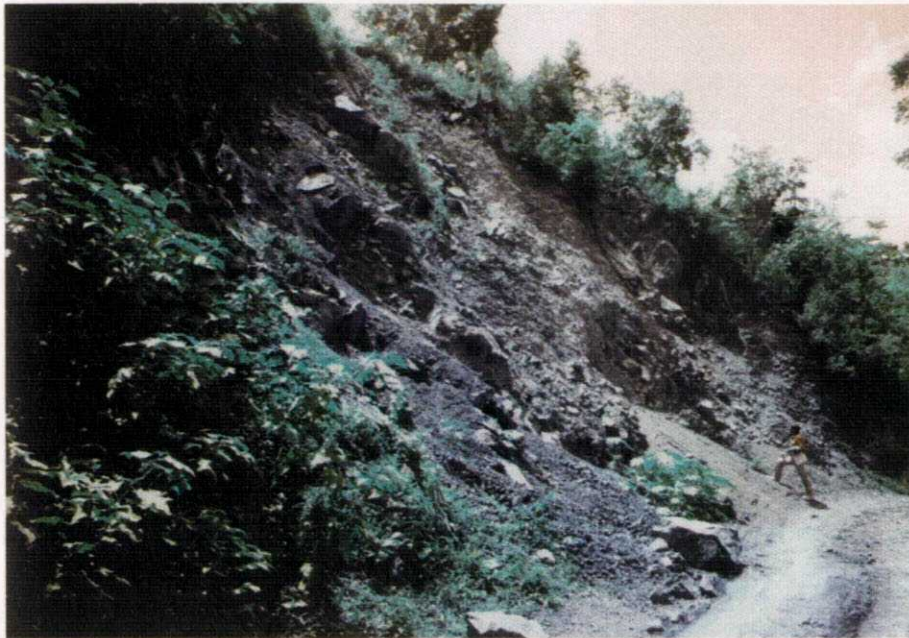
Figure 3.6 Translational debris slide in weathered and fractured rocks of the Arthurs Seat Formation, adjacent to the Crawle River-Arthurs Seat Road. Over-steepening and removal of support from steep sideslopes due to road cutting results in frequent slope failures of this type.

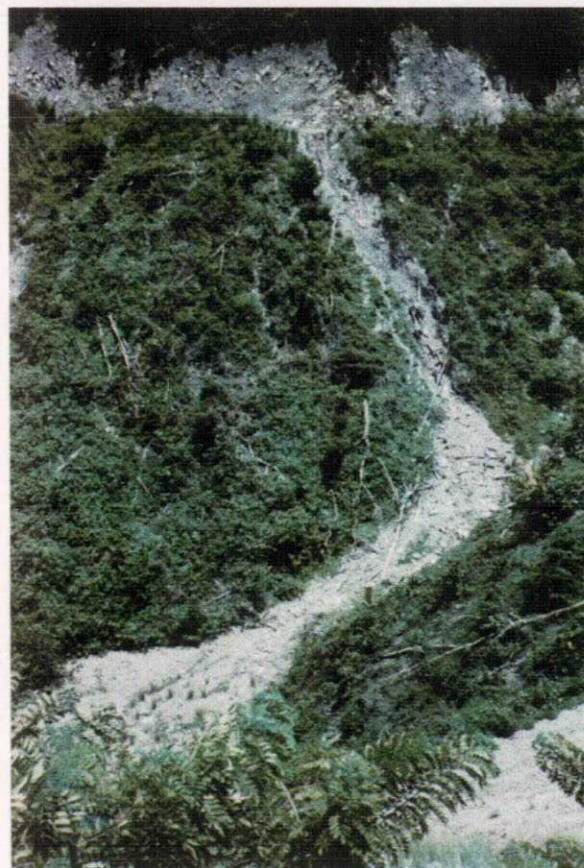
Figure 3.7 Debris flow originating from initial debris slide/fall triggered by road cutting operations in highly weathered and altered Bullhead Formation volcanoclastic sediments, Main Ridge area. The debris flow shows a characteristic narrow mid portion and bulbous toe and flows down a steep gulley leading to the Rio Minho.

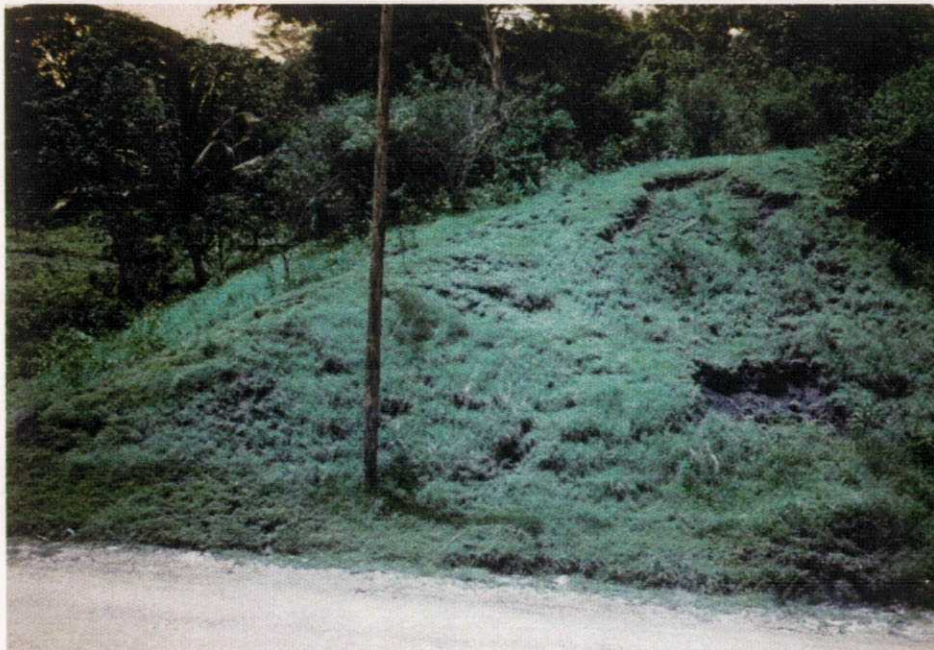
Figure 3.8 Small translational earth slide in clay-rich soil overlying Guinea Corn Formation, adjacent White Shop-Guinea Corn road

**Translational earth slides and earth flows** occur in finer-grained weathered regolith dominated by material less than fine-gravel size, usually with significant proportions of silt and clay. As with debris slides and flows, rainfall is the most common triggering event. However, unlike granular debris, which is often fairly free draining, regolith dominated by fine material may remain saturated or partially saturated during hot dry seasons at variable depths below ground surface depth. Even during periods of prolonged drought, it is likely that seepage horizons or perched water tables within the slopes will maintain parts of the fine-grained regolith in a wet condition. Thus, movements are likely to occur following rainfall of less duration and lower intensity than that required to trigger debris slides and flows. Earth slides and flows are also prone to remain seasonally active in response to annual rainfall cycles. Earth slides are likely to occur on slopes above 10-15° but occasionally occur on shallower slopes, depending on the clay content of the slope materials and the amount of ground water available. These slope movements are particularly sensitive to removal of vegetation cover and almost all of the earth slides observed during the field reconnaissance occurred in areas where the natural tree/scrub cover had been removed for cultivation. Movements are generally shallow, not exceeding depths of about 1 m for the smaller failures and less than about 5 m in the longest dimension (Figure 3.8). However, much larger earth slides, often grading to minor earth flow at the toes, were also observed in the Diamonds Gravelly Clay Loam. These overlie the volcanic conglomerates, grits and shales of the Arthurs Seat Formation (Figure 3.9).

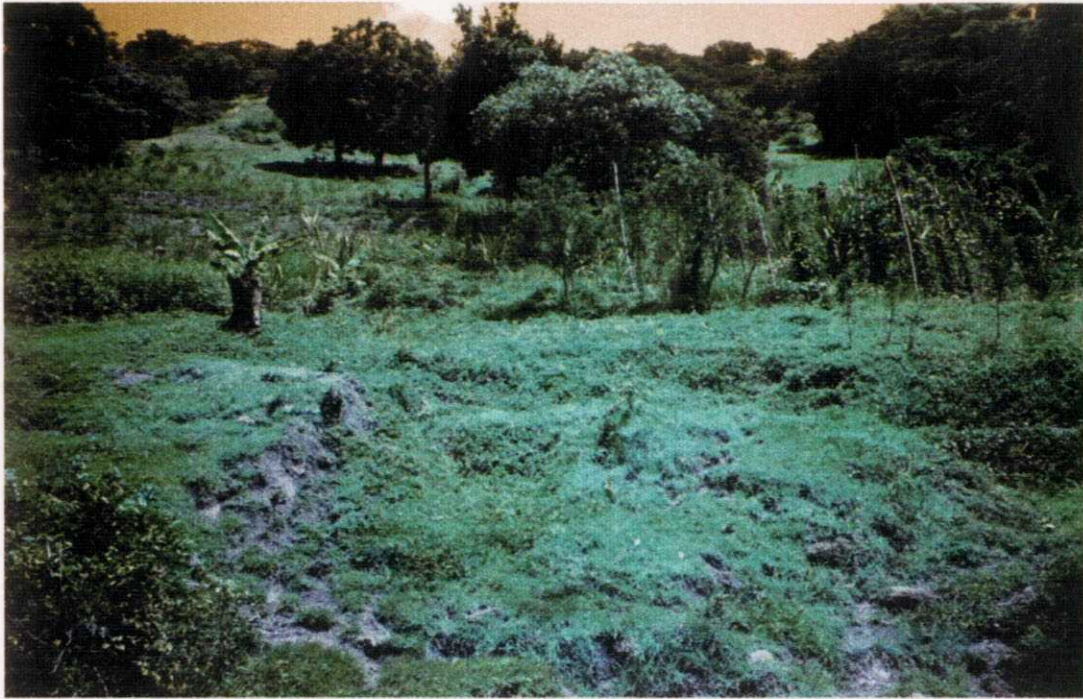
Figure 3.9 Complex earth-slide on a cultivated slope adjacent to the Crawle River-Arthurs Seat road. The slide has occurred in Diamonds Gravelly Clay Loam, overlying weathered shales and volcanic grits of the Arthurs Seat Formation. The entire slope shown in the figure shows evidence of active movement. A small, wet, active earth slide is seen in the toe area in the bottom centre of the figure. To the right, not shown, trees lean severely downslope as a result of recent movements.

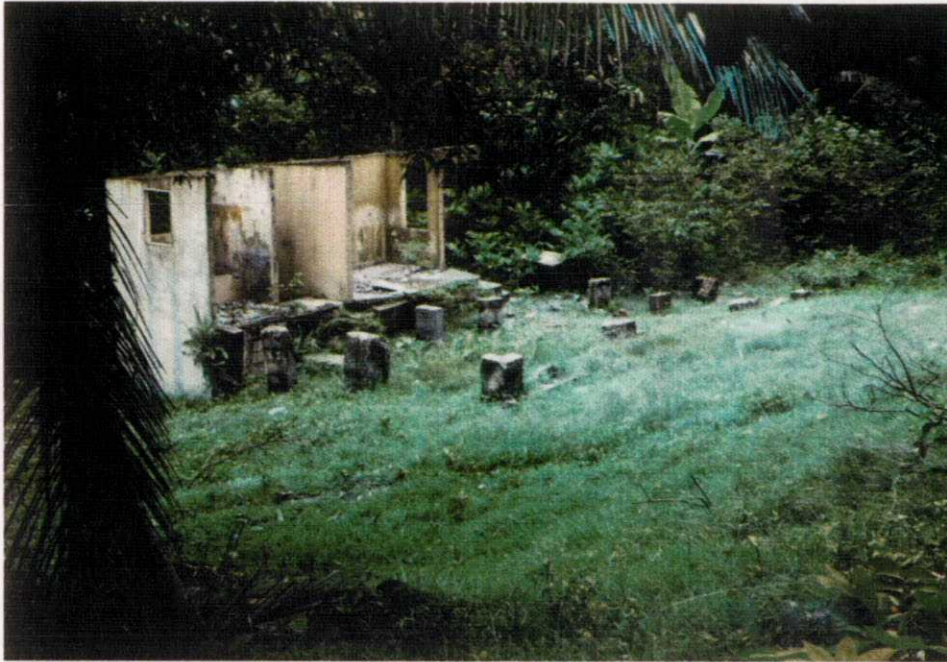
Figure 3.10 Toe zone of a medium-sized rotational landslide that caused destruction and abandonment of a house in 1986 at Ivy Store, near Cross Roads, 1km south of Chapelton.. The slide has occurred downslope of the main road in a clay regolith (Nonsuch Clay) overlying weathered strata of the Yellow Limestone Group (probably red clay and fine grained clastic sediments).

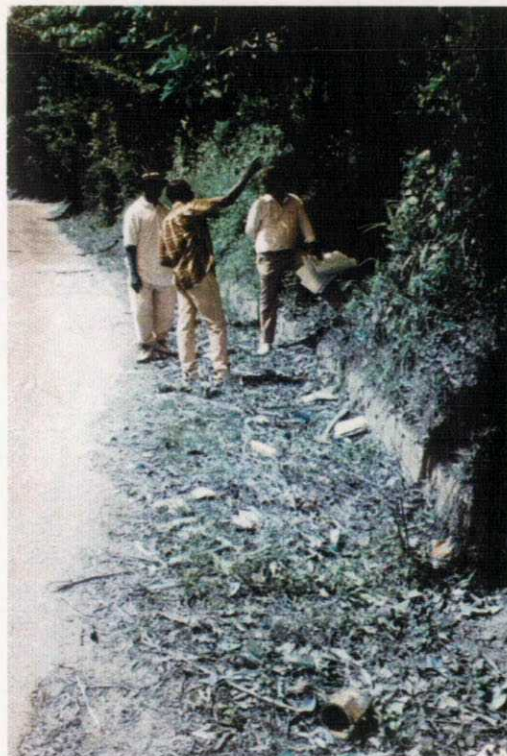
Figure 3.11 Ditch and culvert choked with dirt, leaves and other debris on the upslope side of the main road above Ivy Store landslide. Increased groundwater flow into the slope due to blockage of these water channels and increased run-off from the metallised road surface, may have been critical factors in triggering the landslide downslope of the road. The people in the picture are inspecting a cracked and displaced retaining wall, indicative of further movements in the steep slope above the road.

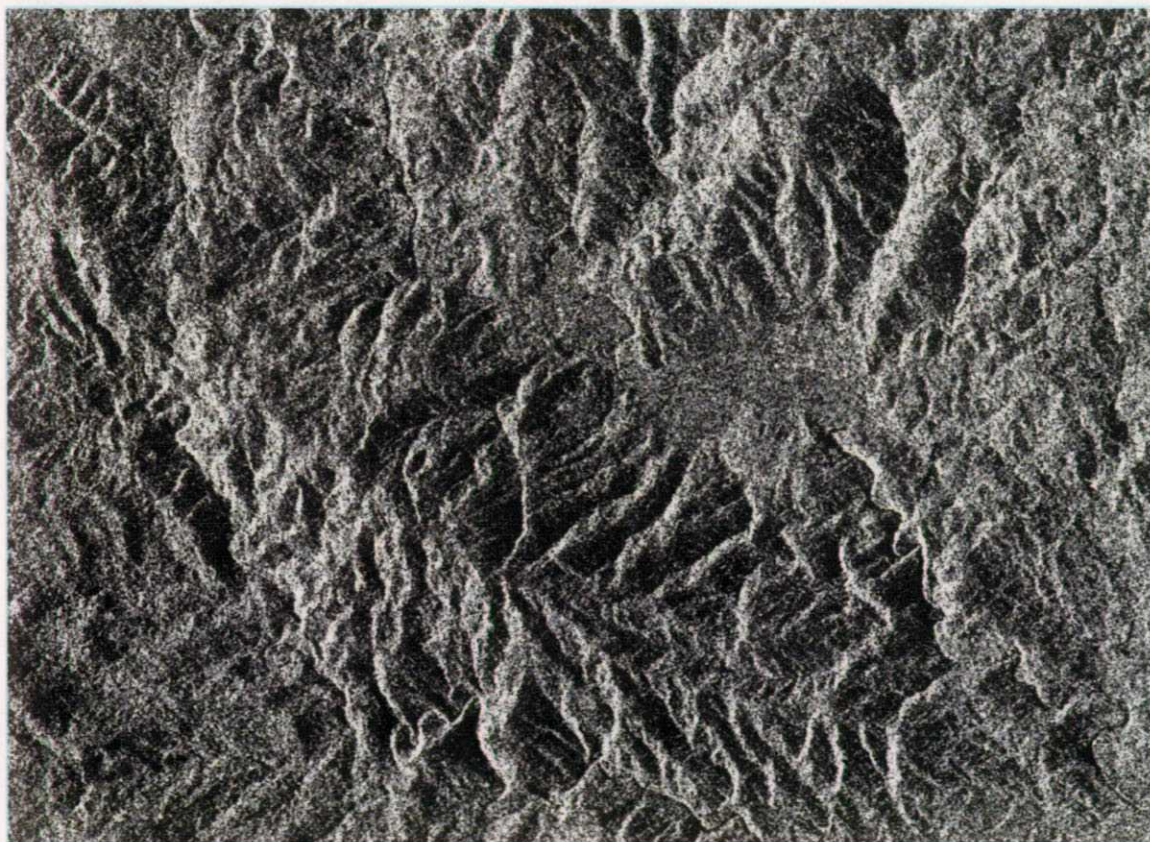
Figure 4.1 RADARSAT, Main Rdge area, Rio Minho District, central Jamaica, Fine beam mode. Approximately 6 m ground resolution. Low Pass filter and contrast stretch. Large scale rotational landslides shown by arcuate radar-shadow features north and south of the Minho river.

The climate in Jamaica would tend to make radar data the most appropriate data type. Modern C-band fine-beam SAR data from Radarsat was acquired over the project area on 31 January 1998. The data was georeferenced to the Jamaican Grid and processed using speckle filter and frequency domain analysis to suppress much of the noise component. The 6.25m resolution of the data allowed large-scale display and feature analysis (Figure 4.1) However, only the larger rotational landslides could be discriminated on the imagery and the small scale of the main landslide types mitigated against their detection on satellite SAR imagery. Airborne radar was not available. Aerial photography proved to be by far the most appropriate remote sensing data type in this study.
