# Landslides and mass movement processes and their distribution in the York District (Sheet 63)

Open Report OR/07/004

C. Foster, G.O. Jenkins and A.D Gibson

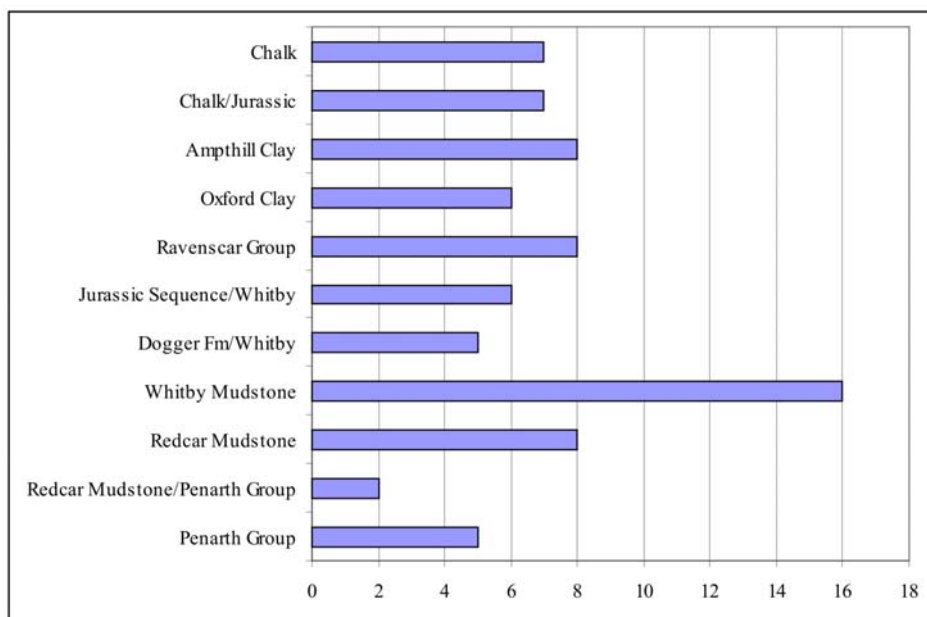
**Figure 9. Landslide numbers for a range of groups, formations and formation combinations on the York Sheet.**

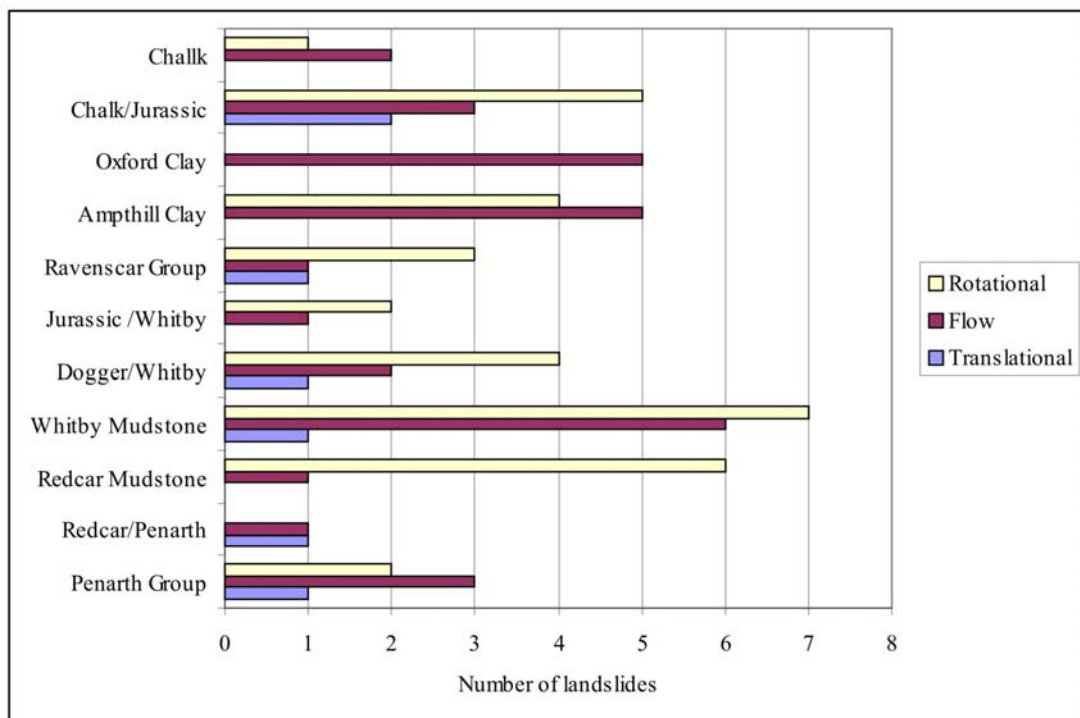
**Figure 10. Numbers and style of landslides for different groups, formations and combinations of formations on the York Sheet.**

The dominant style of landsliding observed in the area of the York sheet was rotational failures; these are particularly prevalent on slopes in the Chalk Group (Figure 10). Failures occurring on the Chalk were characteristically multiple rotational landslides, occurring in slopes where the competent Chalk formed a caprock over relatively weak Jurassic formations. This situation, typified by Birdsall Brow (483309 463764), is common to horizontally/sub-horizontally bedded sequences of weak rocks overlain by stronger more competent rocks. Competent cap rocks, such as Chalk, can also instigate continued failures. After a rotational failure occurs; the cap rock, impedes the degradation of the back scar and maintains unstable conditions allowing further rotations to occur (Jones and Lee, 1994).

Whilst the Whitby Mudstone is known to be involved in larger scale rotational failures along the Cotswolds escarpment it displays a range of shallow failure mechanisms, including planar sliding or flows on the York sheet. In circumstances where the Whitby Mudstone is underlying other formations rotational failures are more prevalent (Figure 10).

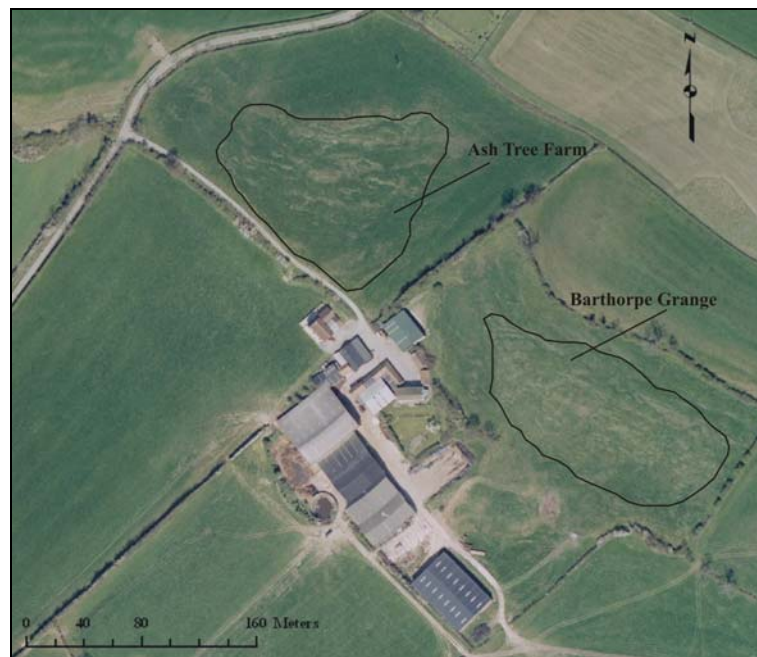
**Figure 14. Outline of landslides in the area of Figure 13 showing hummocky topography of translational sliding and flowing.**

Whilst the Barthorpe and Deng Ings landslides exhibited both shallow translational landsliding and possibly flowing, those at Leppington (Hanging Cliff landslide) were more characteristically flow like, comprising a cluster of earth flows that stretched for nearly 1 km. This cluster of landslides was similar in morphology to that of a landslide in the Penarth Group on the Warwick sheet. This landslide was attributed to the occurrence of springs at the base of the Langport Member, a thinly bedded limestone which acts as an aquifer above the less permeable calcareous mudstones of the Cotham Member (Old *et al.*, 1987). The landslides on the Warwick Sheet occurred at similarly low angles as those at Leppington, roughly 8-10°. The presence of earth flows in the Penarth Group is not surprising as these types of failure are common in clay dominated lithologies where there is an adequate slope angle and moisture (Baum *et al.*, 2003). The low slope angles at which failures were occurring at are most likely due to the material

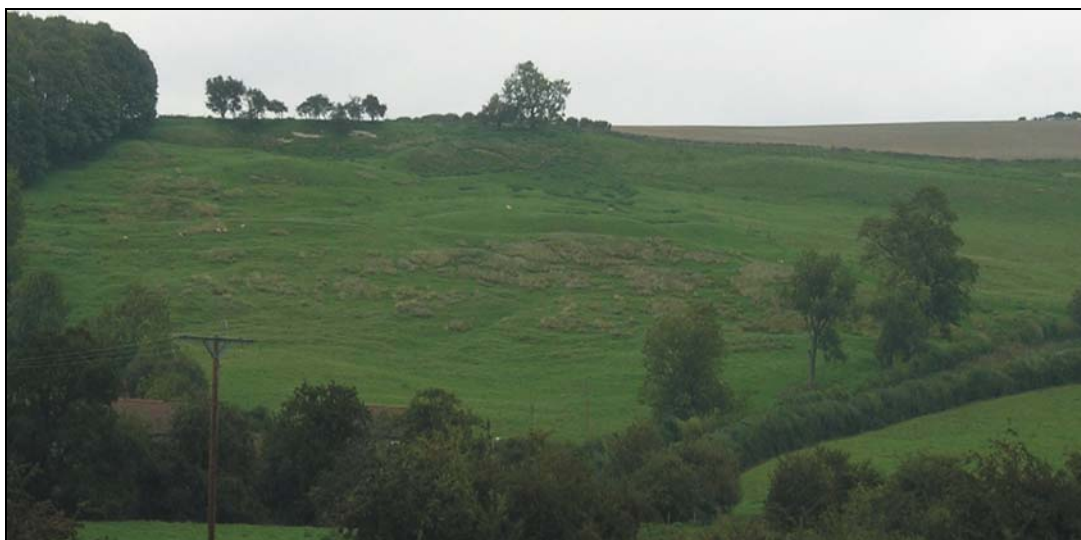
**Figure 17. View of the Ochrepit Lane landslide, Bishop Wilton. Degraded blocks and lobes are visible in the landslide mass. Photograph taken from NGR 480163 455251, orientation  $355^\circ$  N.**

The third unit involved in landsliding in system one is the Redcar Mudstone Formation, which was extensively landslipped in the south of the sheet despite having a larger spatial extent in the NW. A large landslide was mapped here on a moderate ( $9-10^\circ$ ), south facing slope, near the village of Bishop Wilton (NGR 479876 455277). The Ochrepit Lane landslide (NGR 480160 455921) has an element of rotational failure at the head of the slide as well as shallow successive slides within the main body. The landslide seems to degrade into shallow flows near the toe (Figure 17). Unlike with many of the other slides recorded on the York Sheet, the Ochrepit Lane slide occurs close to infrastructure. The toe of the slide underlies the road and is less than 50 m from a street of houses. Active landslides in the Redcar Mudstone are widespread around the village of Bishop Wilton (Figure 18).

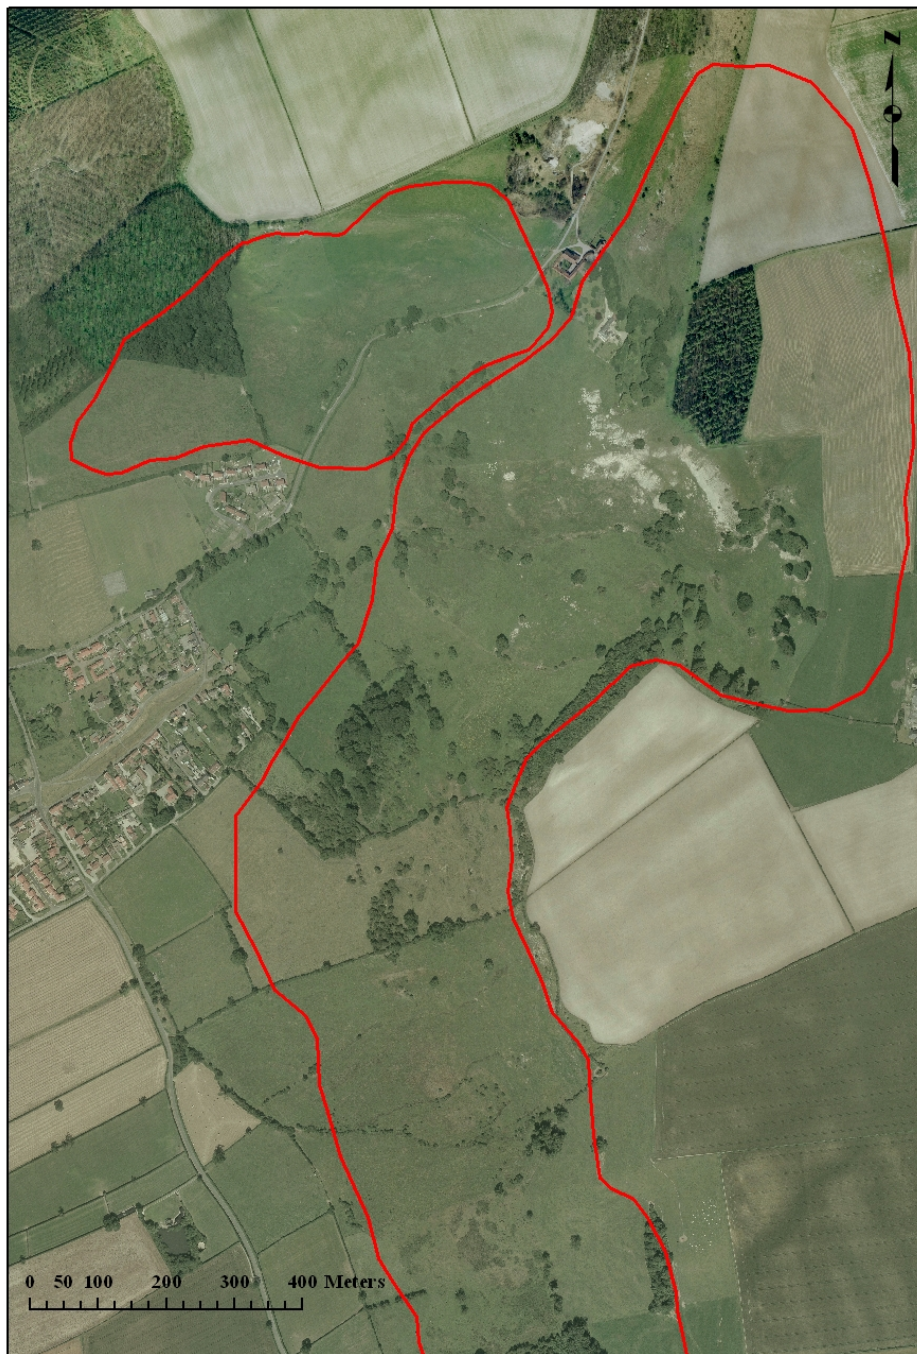
**Figure 18. Aerial view of the Ochre Lane landslide. Movement is from the north to south. The larger, more deep-seated Bishop Wilton landslide is also clearly visible.**

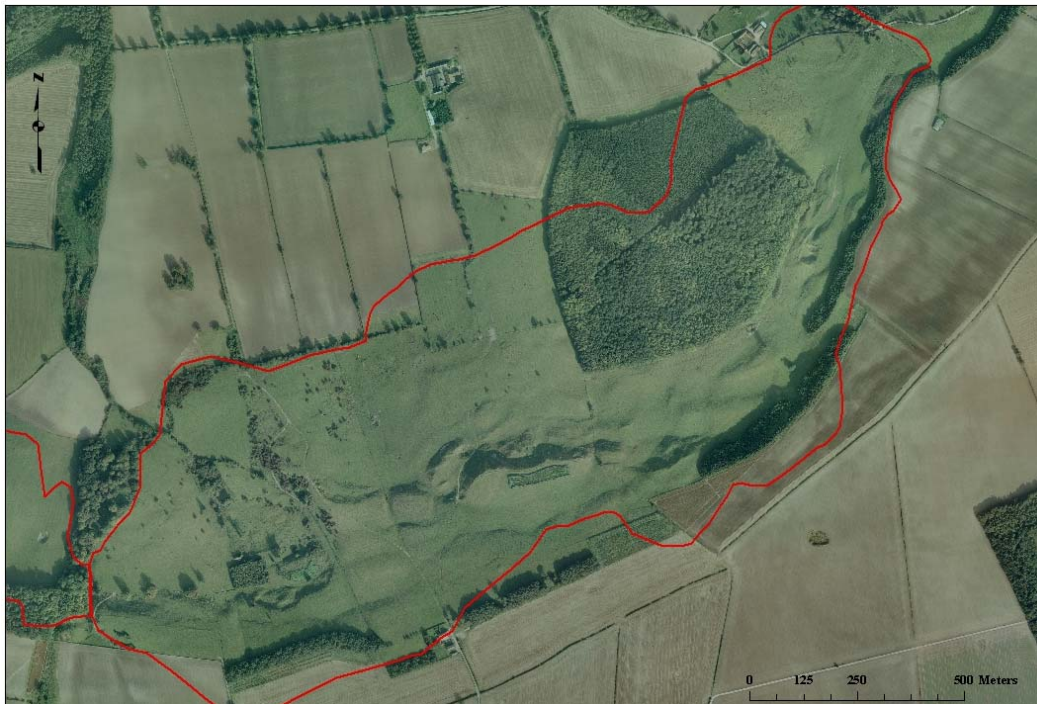
**Figure 19. Aerial photograph of the Birdsall Brow landslide. Mapped landslide polygon in red.**

The Birdsall Brow landslide (NGR 482830 463395) is located on a northerly facing slope with an average slope angle of  $9^\circ$  (Figure 19). The landslide is 800 m wide and 3000 m long. It is not known with any degree of accuracy how deep the shear plane is. The landslide has formed as a result of large chalk blocks (up to 420 m in width and 90 m in length based on geomorphological evidence) successively rotating on the underlying Ampthill Clay Formation. These rotated chalk blocks now produce successive ridges down the slope (Figure 20). The displaced chalk blocks have formed a disrupted, ridged topography, with the leading edges of successive chalk blocks forming ridges up to 30 m in height, with broad troughs, up to 70 m wide in between. Towards the lower part of the landslide complex, more distant from the chalk escarpment, the landslide style changes to shallow flows, probably in the Ampthill Clay Formation. As above, the overall topography, assumed failure mechanism and degree of degradation indicate that this landslide probably occurred during a climate more aggressive than presently found.

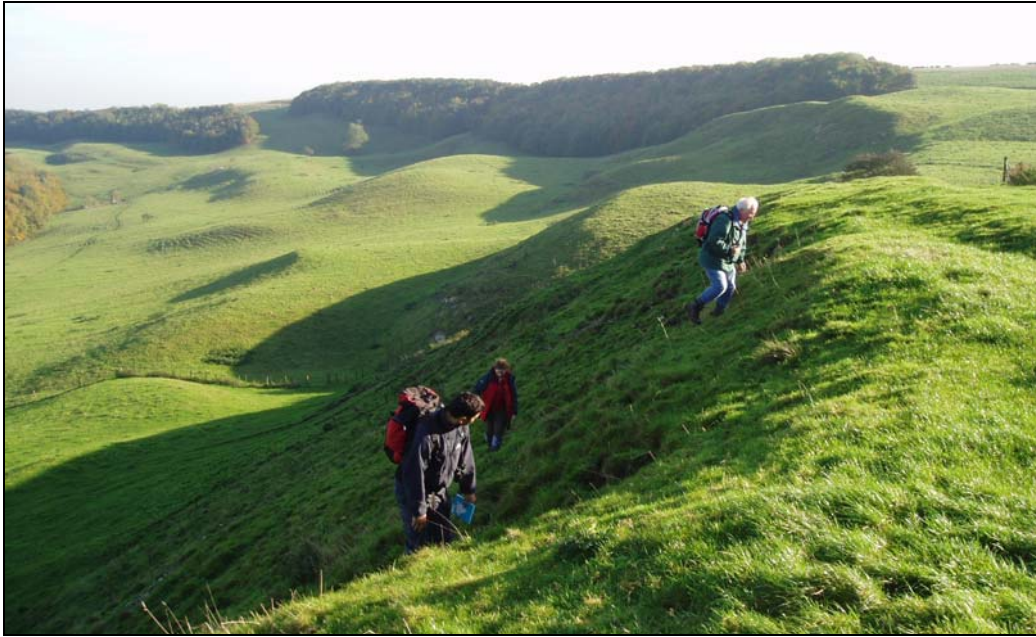
**Figure 20.** View of the eastern edge of the Birdsall Brow landslide, note ridges formed by the leading edge of chalk blocks. Photograph taken from NGR 483309 463764, orientation 045° NE.

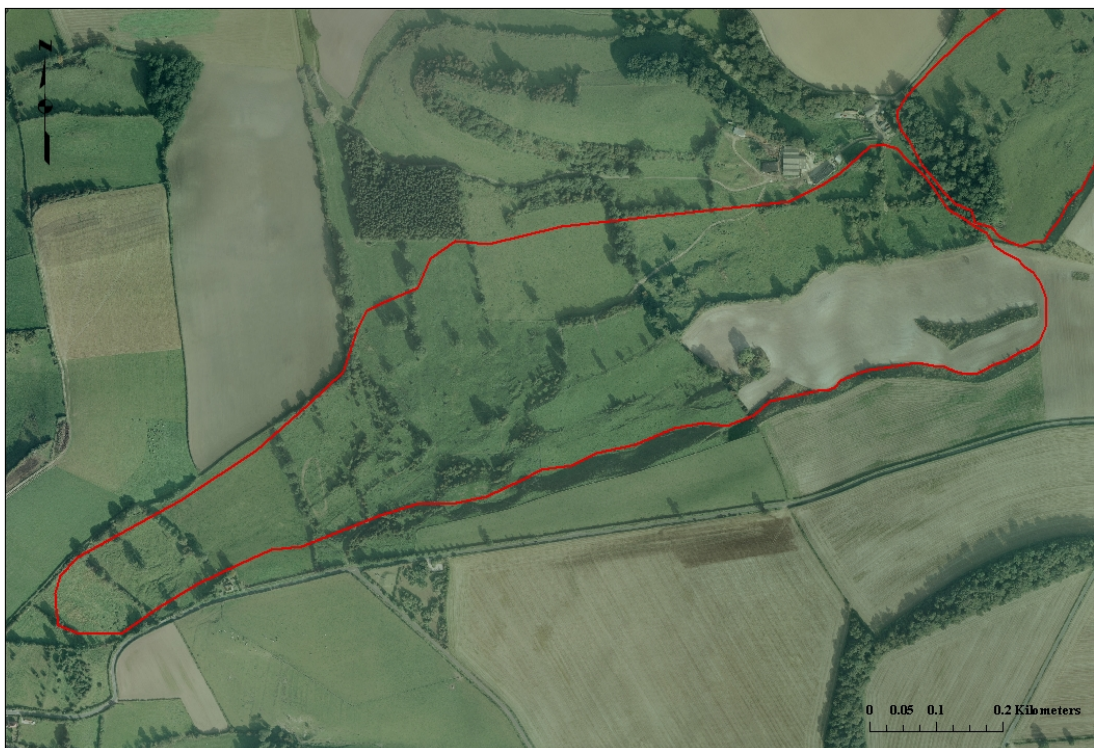
**Figure 21.** Aerial photograph of the Leavening Brow landslide. Mapped landslide polygon shown by red outline.

The Leavening Brow landslide (NGR 480292 463503) is also located on a northerly facing slope 2 km to the west of the Birdsall Brow landslide (Figure 21). The average slope angle is  $9^\circ$ . The landslide is 1000 m in width and 350m in length. The proposed mechanism of failure is similar to that seen on Birdsall Brow, with the overlying chalk successively failing in a rotational manner on the underlying Ampthill Clay. However, the ridged slope profile observed at Birdsall Brow is not replicated here. Those ridges which do have a topographic expression are less frequent and on a smaller scale (10m in height, with 30 – 40m troughs). The landslide style changes to shallow mudflows in the lower part of the landslide, distal to the source of the chalk upslope. Leavening Brow forms a west-east trending peninsula at the western end of the Yorkshire Wolds escarpment. The drainage catchment is considerably smaller in comparison with the Birdsall Brow landslide, and therefore the landslide features are less developed.

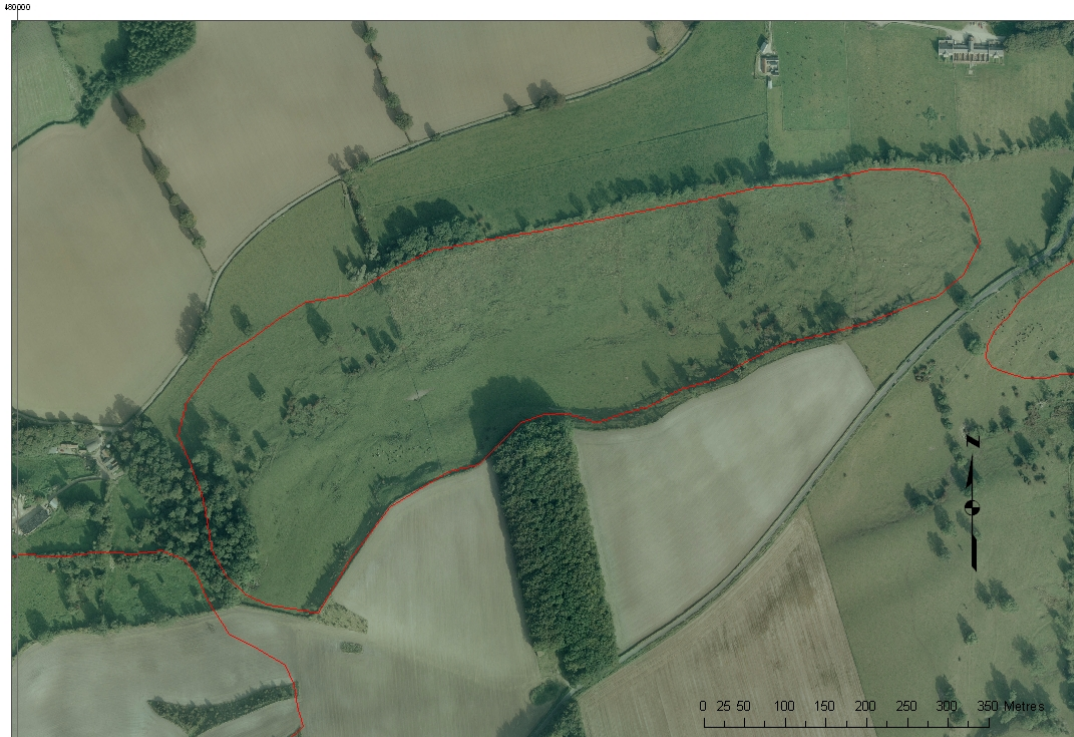
**Figure 22. Aerial photograph of the High Barn Plantation landslide. Mapped landslide polygon shown by red outline.**

in width and 270 m in length. This landslide displays the most subdued topography of those in this system. It is thought that this is possibly because the main drainage of this section of slope was directed away from the landslide, and therefore the landslide and its associated geomorphological features are less developed. The topography formed by rotated blocks within the chalk is clearly seen. Drainage features are visible in the ploughed field to the east of the area indicating that there has been sufficient time elapsed since the landslide formation for a fairly complex drainage system to have formed.

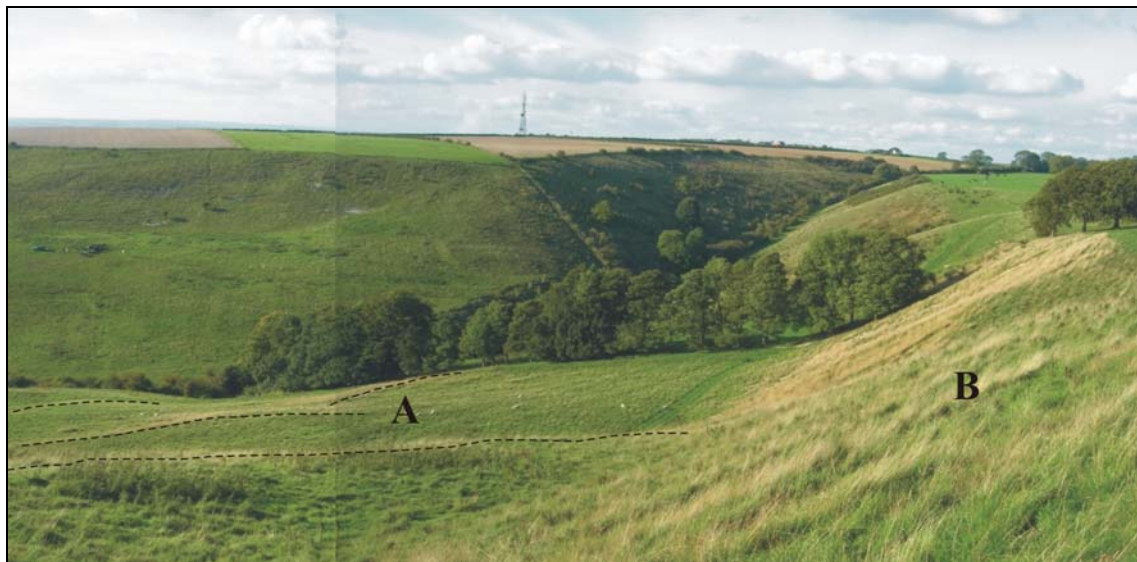
**Figure 24. A view of the Back Warren Plantation landslide taken from NGR 480024 461270, orientation 335° (NW). A: Rotated blocks, B: Back scar.**

The landslide at Back Warren Plantation, 1 km south-west of Acklam (480008, 461133) is an example of a rotational failure not involving a caprock. This landslide was approximately 65 m wide and 250 m long and involves a range of formations from the Cretaceous Chalks through to the Middle Jurassic Ravenscar Group (Figure 23). Topographic benches were observed at different elevations down the slope. Although these could be lithological in nature, it is thought that they represent landslide blocks as the same stratigraphic sequence occurs on the opposite side of the valley, yet no similar bench features are observed (Figure 24). The landslide has been interpreted as a multiple rotational failure. Landslides of this type are common where relatively stiff fissured clays are underlain by a more competent unit and overlain by a strong cap rock. In this instance the presence of the Oxford Clay underlain by the Saltwick Formation and overlain by the Chalk may have provided suitable geological conditions to produce multiple rotational

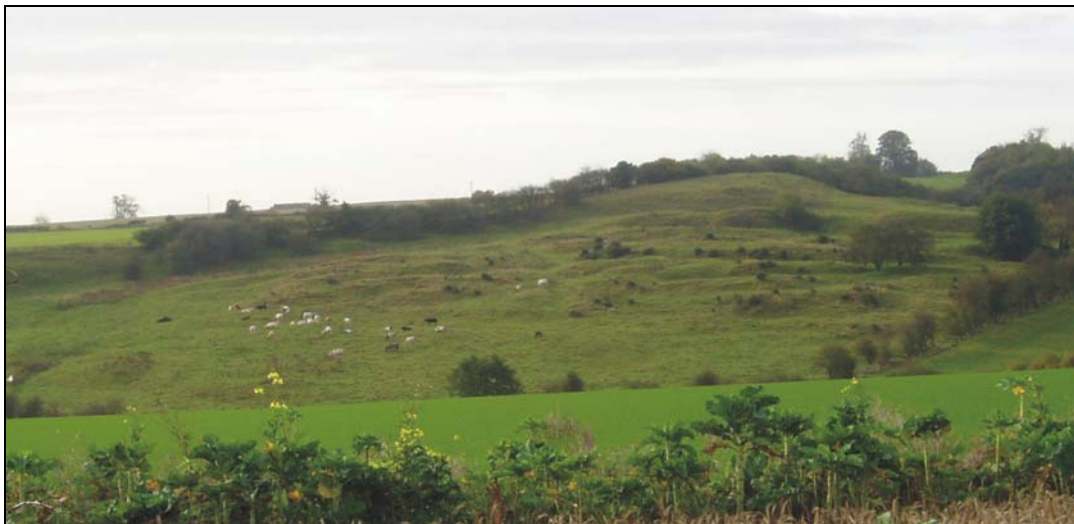
**Figure 26. Mowthorpe Bridge landslide. Photograph taken from NGR 468695 468946, orientation  $200^\circ$  S. Note, shallow, sub-parallel ridges, indicating successive rotational sliding.**

At Mowthorpe (468387, 468258) a moderately deep-seated successive rotational failure (Mowthorpe Bridge landslide) was observed within the Redcar Mudstone Formation (Figure 25 and Figure 26). This landslide had a distinctive rear-scarp, zone of depletion and a series of hummocks, characteristic of shallow rotational failure. Elsewhere in the UK, successive rotational failures are predominantly confined to the weathering mantle and are generally

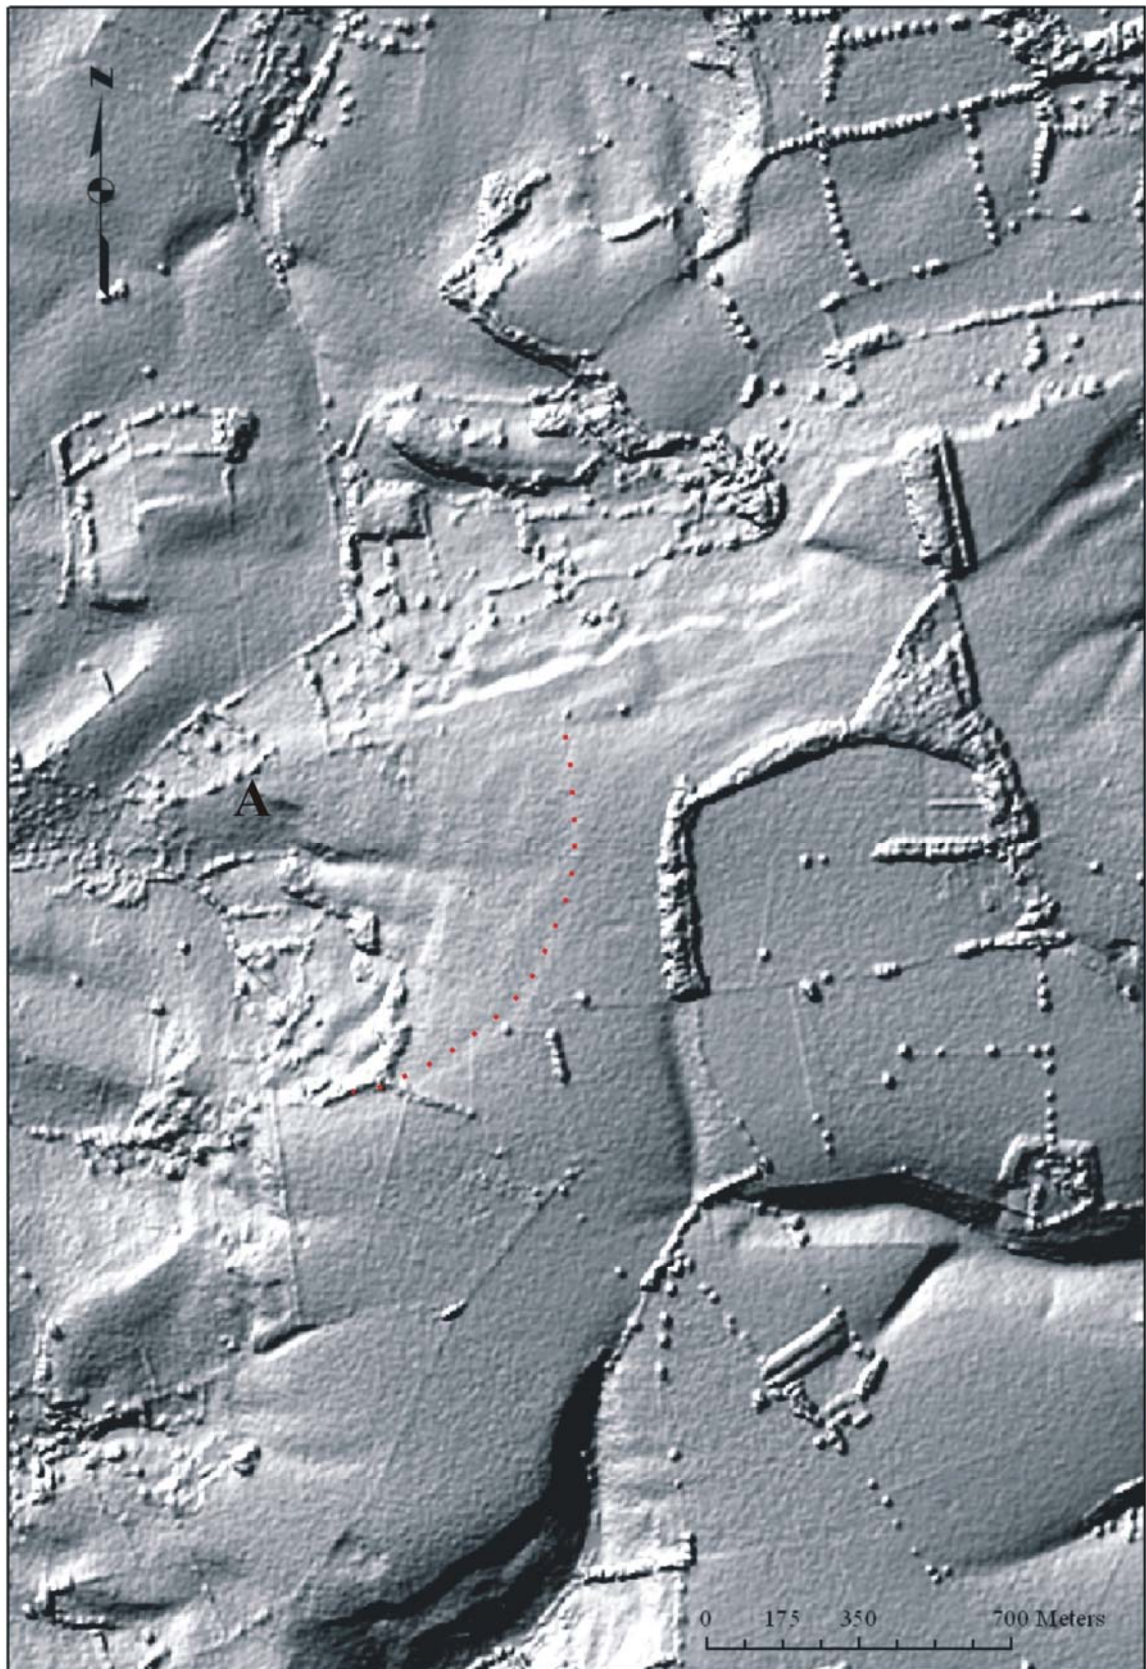
**Figure 31. NextMap image of western limit of escarpment near Leavening. The red dotted line indicates the furthest inland extent of the arcuate scars.**

Within the Landslide System Two the landslides were of a size significant enough to allow mapping of their features using the NextMap DTM. West of the Leavening Escarpment landslides and also on the escarpment another landslide was observed, although its mapping was made difficult by the subdued nature of the features seen in the field. However, landslide features were visible from NextMap, which showed a series of arcuate scars that may indicate the presence of deep-seated rotational failures (Figure 30). These features had not been observed during the aerial photograph interpretation stage of the project. A brief study of other Chalk escarpment was undertaken to determine if these features were indicative of failures on the Chalk. The features were not found to be present on any other large-scale landslides involving the Chalk. The only other presence of these features is on the Scarborough sheet, which is next to be surveyed; however it is not known whether these features are indicative of large-scale landsliding. In the field these scars do not form strong geomorphological features that would be readily mapped. The presence of these features may suggest a mechanism for system two landslides similar to that displayed at Folkestone Warren. At this location the landslide was triggered by lateral extension in the Gault Clay which led to stress in the overlying Chalk and the generation of a shear surface near the base of the Chalk (Figure 30 I) (Hutchinson, 1969). The lack of support for the Chalk at the base of the slope led to the development of a series of slips (Figure 30 II) which continued until these slipped blocks were supported by the slope behind it (Figure 30 III). At Leavening, the Atherfield and Kimmeridge Clay Formations would replace

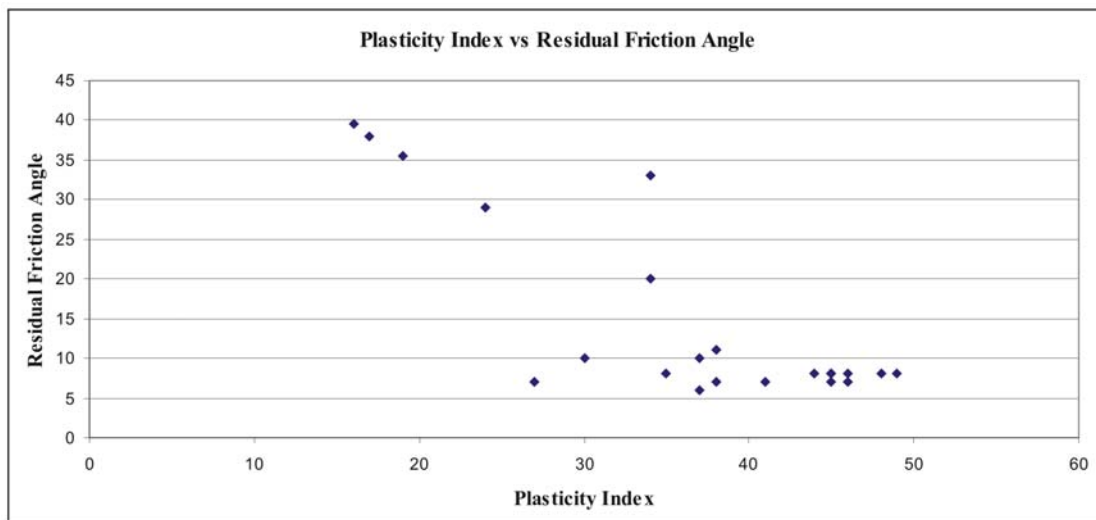
**Figure 35. Plasticity vs. Residual friction angle for the Whitby Mudstone Formation**

The Whitby Mudstone had the most prolific rate of landsliding for any lithology on the York Sheet. An analysis of failures occurring on the Whitby Mudstone was carried out to determine whether there was a limiting slope angles for the failures on the York Sheet. This was to enable a comparison with figures generated by other studies on the Whitby Mudstone carried out by Forster (1992), Penn *et al.*, (1983), Chandler (1970) and Biczysko and Starzewski (1977). Forster (1992) undertook an analysis of landslide slope angles along the Lincolnshire Escarpment between Grantham and Welbourne where the Whitby Mudstone was involved in numerous failures as well as calculating the maximum stable slope using the Skempton-Delory equation. Within the Lincolnshire Escarpment area, Forster (1992) calculated that the Whitby Mudstone had a mean residual friction angle of 13° and by using the Skempton Delory equation a maximum stable slope angle of between 3.8-12.5° (mean of 6.3°) was obtained. A comparison of maximum calculated slope angles for the Whitby Mudstone across the country is shown in Table 4. Along the Lincolnshire Escarpment steep and upper slopes were measured to compare with the maximum stable slope angle. This comparison showed that whilst the mean calculated slope angle for stability was 6.3° the mean upper slope angle was 8° and many of the slopes were close to their threshold of stability (Forster, 1992). In the York area, figures for bulk density and internal angle of friction are not known so that does not allow the Skempton Delory equation to be used to produce a maximum stable slope angle. However, an analysis of average slope angles for both the Whitby Mudstone and landslides occurring within the formation was carried out. The analysis showed that within the York area the mean angle for Whitby Mudstone slopes was 8.5°, similar to the upper slope values for the Lincolnshire Escarpment. The mean slope angle for failures was 11°, calculated both manually and also derived from a GIS calculation. To further this analysis of slope angles, data from the National Geotechnical Database for the Whitby Mudstone concerning residual friction angle and plasticity index were plotted. The spread of data
