TECHNICAL REPORT WD/92/27
Hydrogeology Series

COLLECTOR WELLS FOR SMALL-SCALE IRRIGATION:
Construction and Testing of a Well at
Tamwa/Sihambe/Dhobani Kraals and Further
Work at Chiredzi

P J Chilton and J C Talbot

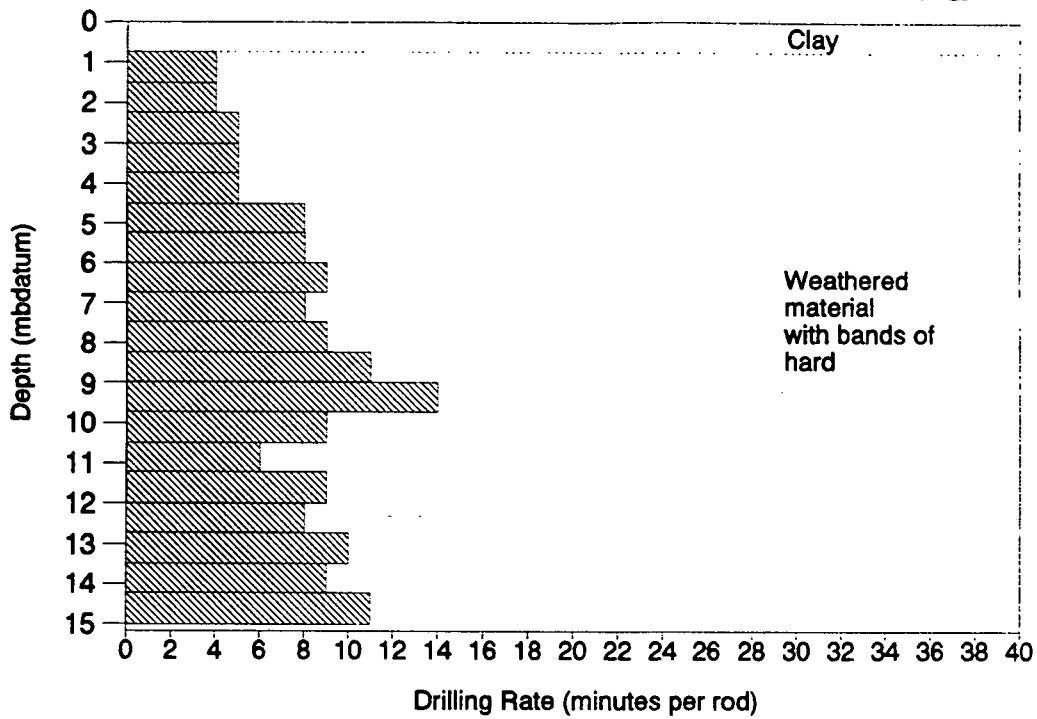
Figure 3. Rate of penetration log, borehole 1, Village 5A, Nyahombe Resettlement Scheme.

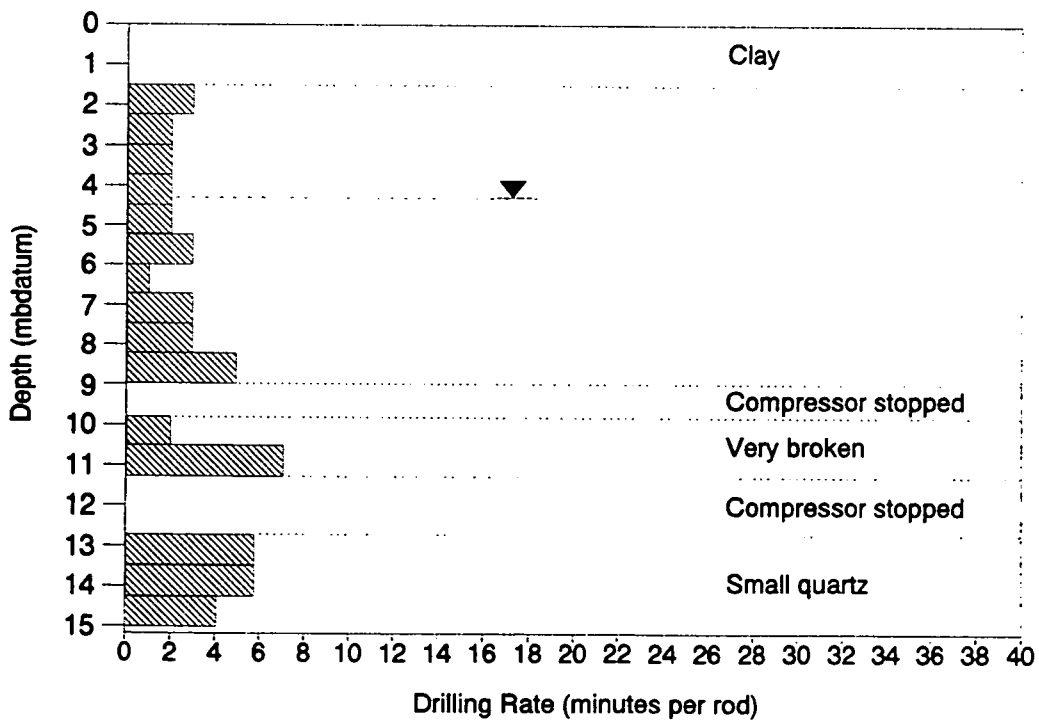
Figure 4. Rate of penetration log, borehole 8, Village 10A, Nyahombe Resettlement Scheme.

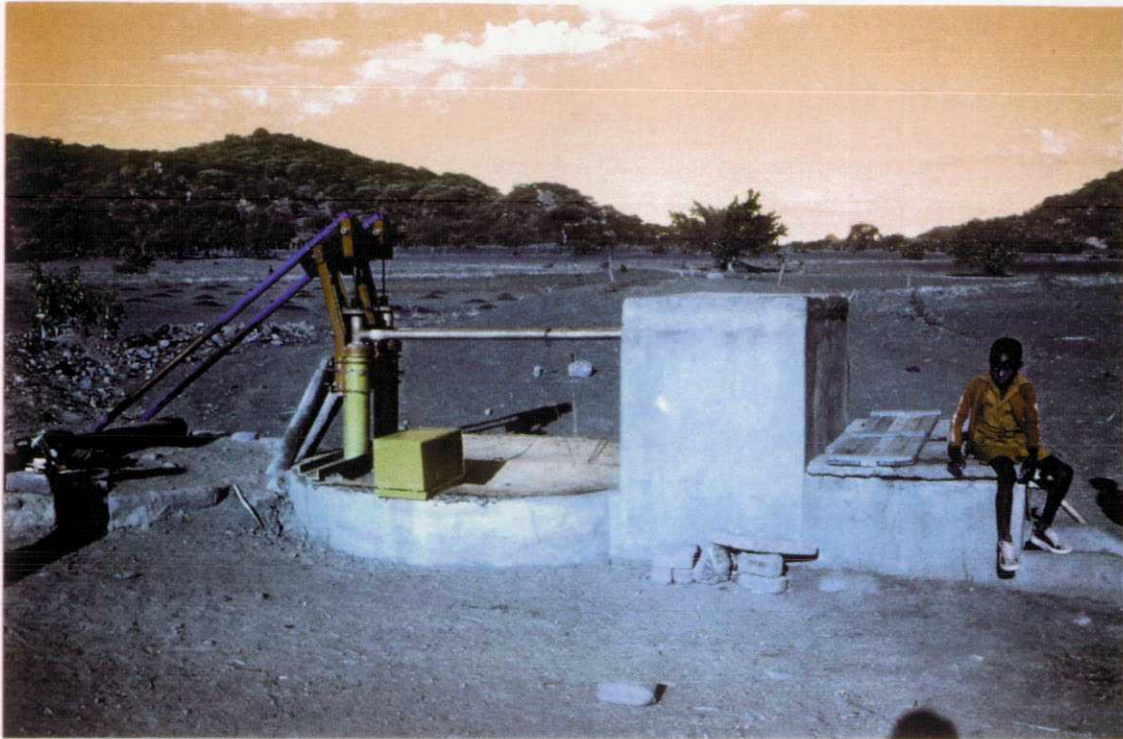
Figure 10. View of well completion showing two Bush pumps, well cover, water level recorder, header tank and meter box.

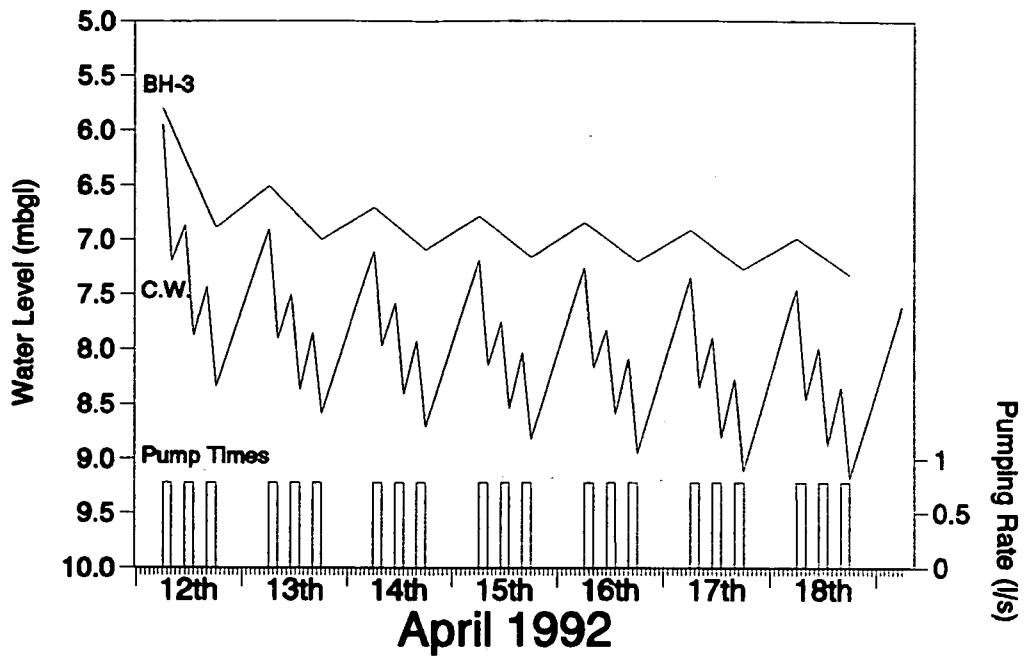
Figure 12. Pumping periods and water levels in long-term test.

This is an approximate figure and in this case is only just greater than the tested yield. On an operating schedule similar to the test pumping, therefore, the long-term sustainable yield of the well is estimated at about 21,000 litres per day. The straight line extrapolation is, however, subject

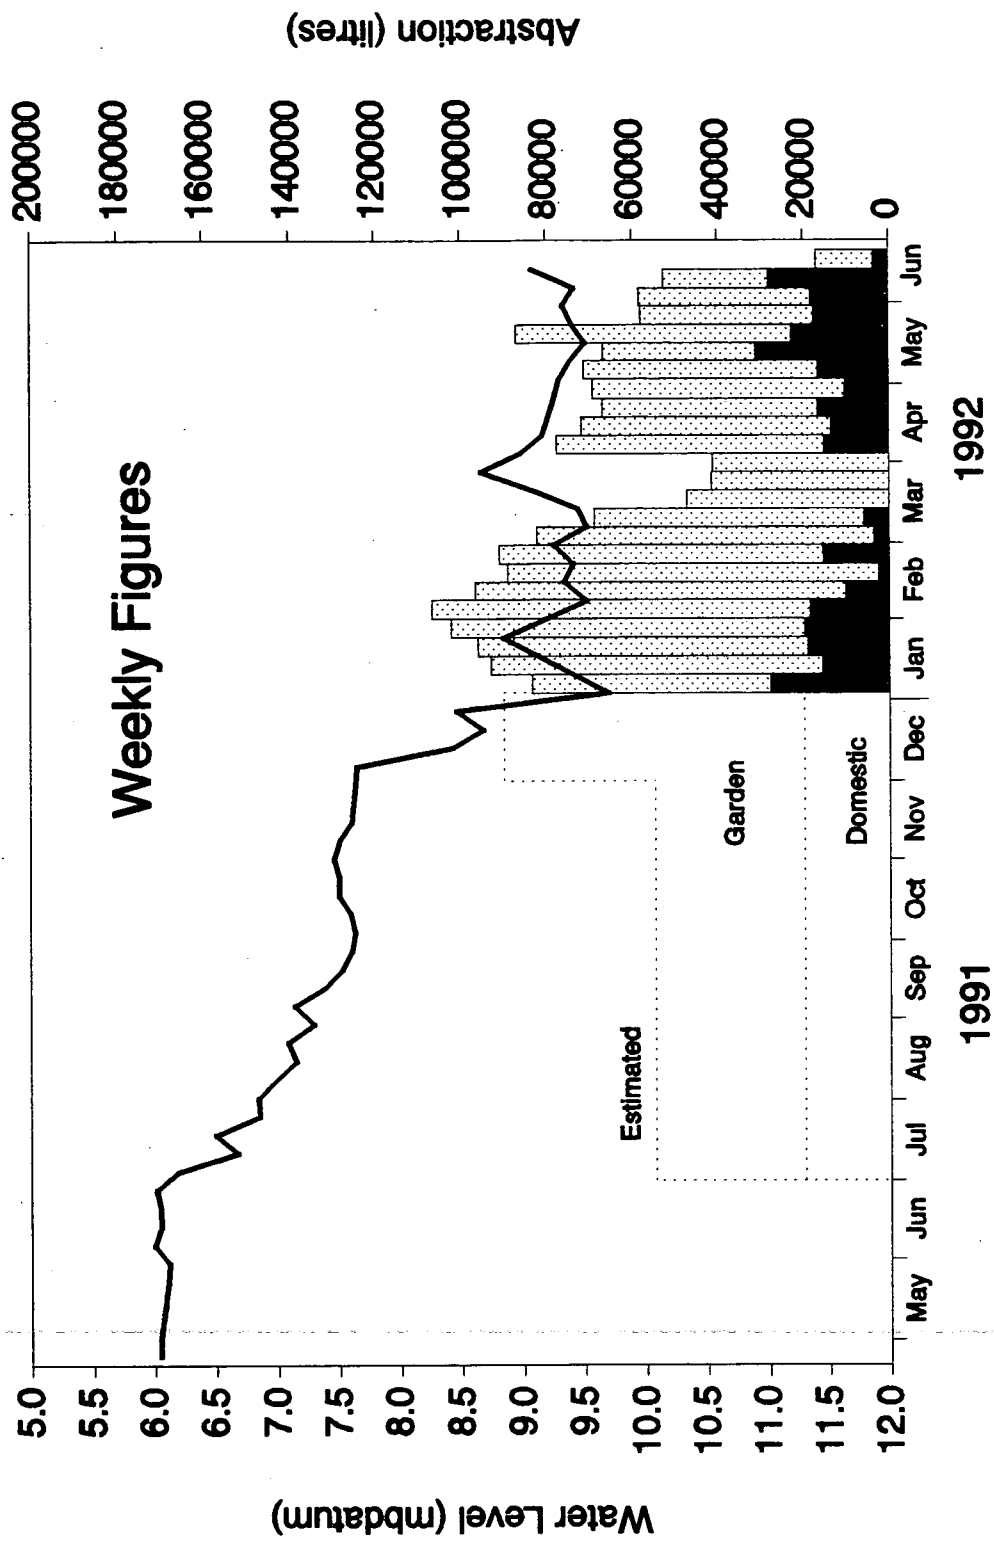
Figure 16. Collector well abstraction and water level at Tamwa/Sihambe/Dhobani kraals.

The water level in the well fell steadily from July to December and more rapidly since then (Figure 16). From July to November only half the garden was planted and the operating regime for the well was not properly established (Lovell et al, 1992). Since the middle of December, the whole garden has been planted and irrigated. The present regime is:

Though serious in many other ways, the 1991-92 drought in southern Africa provides an opportunity to test the projected long-term sustainable yield against actual abstraction and drawdown data. Figure 17 shows a semi-log plot of the same water level data used to construct Figure 16. There is a distinct breakaway point and change in slope which appears to coincide with the increase in abstraction required to cultivate the whole garden. As stated above, there has also been a slight increase in abstraction for domestic use, with more people coming to the well as other sources dry up. The increase in abstraction for irrigation may have been more gradual than shown in Figure 16.
