The Monitoring of Environmental Conditions within Corporate Collections at Keyworth and Murchison House: 2002-2003

Internal Report IR/04/032

INTERNAL REPORT IR/04/032

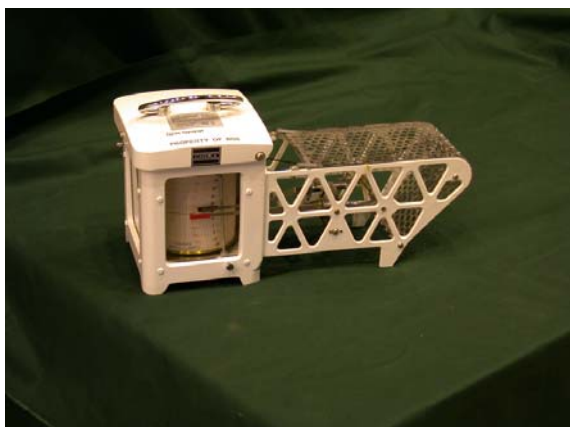
Plate 2: Casella Thermohygrograph.

The Casella Thermohygrograph measures temperature and relative humidity continuously via two pens connected to two sensors, which in turn draw coloured lines on a chart around a rotating drum. The unit is powered via a mechanical wind-up mechanism. The hygrograph is also portable and can be situated in any room where monitoring is required. This device is used on the Keyworth site. Readings are taken at every six-hour interval. See Plate 2.

The advantages is that the results produced on the graph are continuous, and can be viewed at any time when “passing by”. Therefore it provides an indication of the environment at that time, and also when the graph is removed.

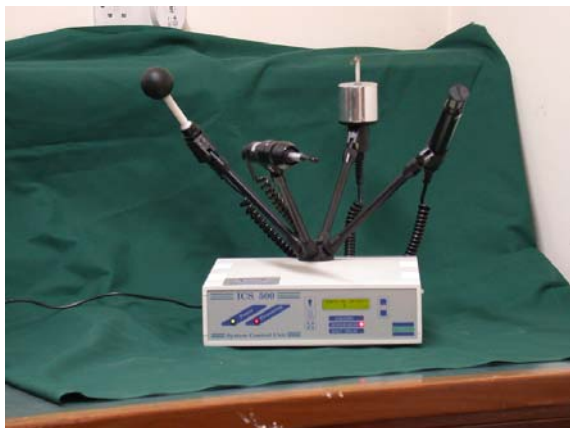
Plate 3: Casella Microtherm ICS 500+.

The Casella Microtherm ICS 500+ can measure a variety of parameters depending on the number of sensors attached to the instrument. In our case four sensors are attached, a temperature and humidity probe, an air velocity probe, a natural wet bulb thermometer and a black globe thermometer. Unfortunately the temperature and humidity probe are producing inaccurate results therefore the black globe temperature sensor is used instead. This sensor integrates air temperature, solar radiation and air movement to give a temperature. Readings are taken every ten minutes, which are stored to the instrument and downloaded weekly. This device is used at Keyworth. See Plate 3

The advantages of this monitor is that the results can be viewed and analysed by using the instrument’s software package, or converted into a format which can be read by Microsoft Excel or Access. The current results from the sensors can even be displayed on the instrument using scroll keys.

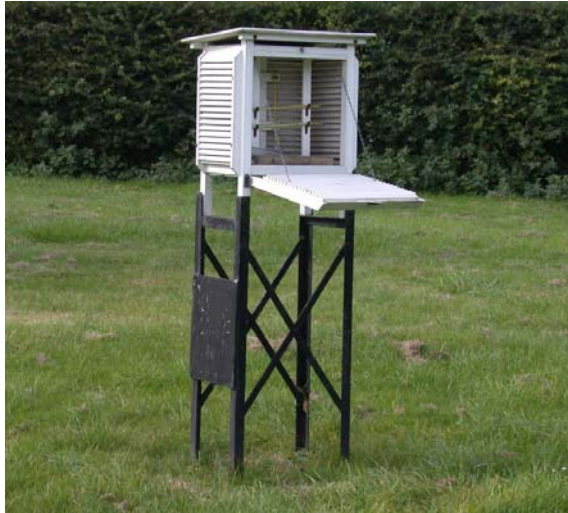
Plate 4: Stevenson Screen.

has a double roof, with louvered sides and some ventilation through the base. The whole screen is painted white and is situated in an open space away from any structures. A selection of readings can be taken from this station including dry bulb, wet bulb, maximum and minimum temperatures, grass minimum temperatures and rainfall. Visual observations for cloud cover, wind speed and direction are also taken. Readings are taken every 24 hours at 09:00 GMT (Greenwich Mean Time) over a five-day period, excluding weekends. Relative humidity readings are calculated by the difference between the wet bulb and dry bulb values, from this figure a value is then calculated using hygrometric tables. This monitor is situated at Keyworth.

The advantages of this station are that readings of external weather conditions can be taken throughout the year and a variety of thermometers and probes can be placed inside the station.

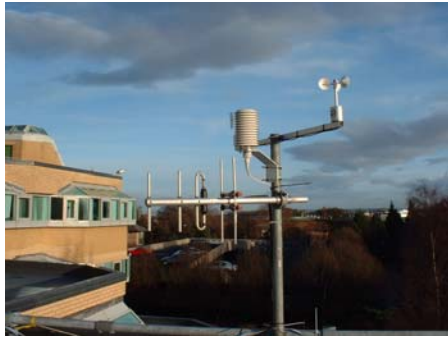
Plate 5: Weather station at Murchison House.

The logger is situated on the south roof of level 4 of Murchison House. It is located on a pole 2.5 meters off the base of the roof, which is approximately 16m meters from the ground: see plate 5. It is 2.25 meters from the wall of an office and is therefore sheltered from the excesses of the weather that affects the north-facing storerooms.

There is no method of calibrating the measurements acquired by this instrument. However as the sensors are all reputable monitoring instruments their suitability is not an issue. The accuracy and resolution is unknown and therefore only trends and not precise readings should be compared.

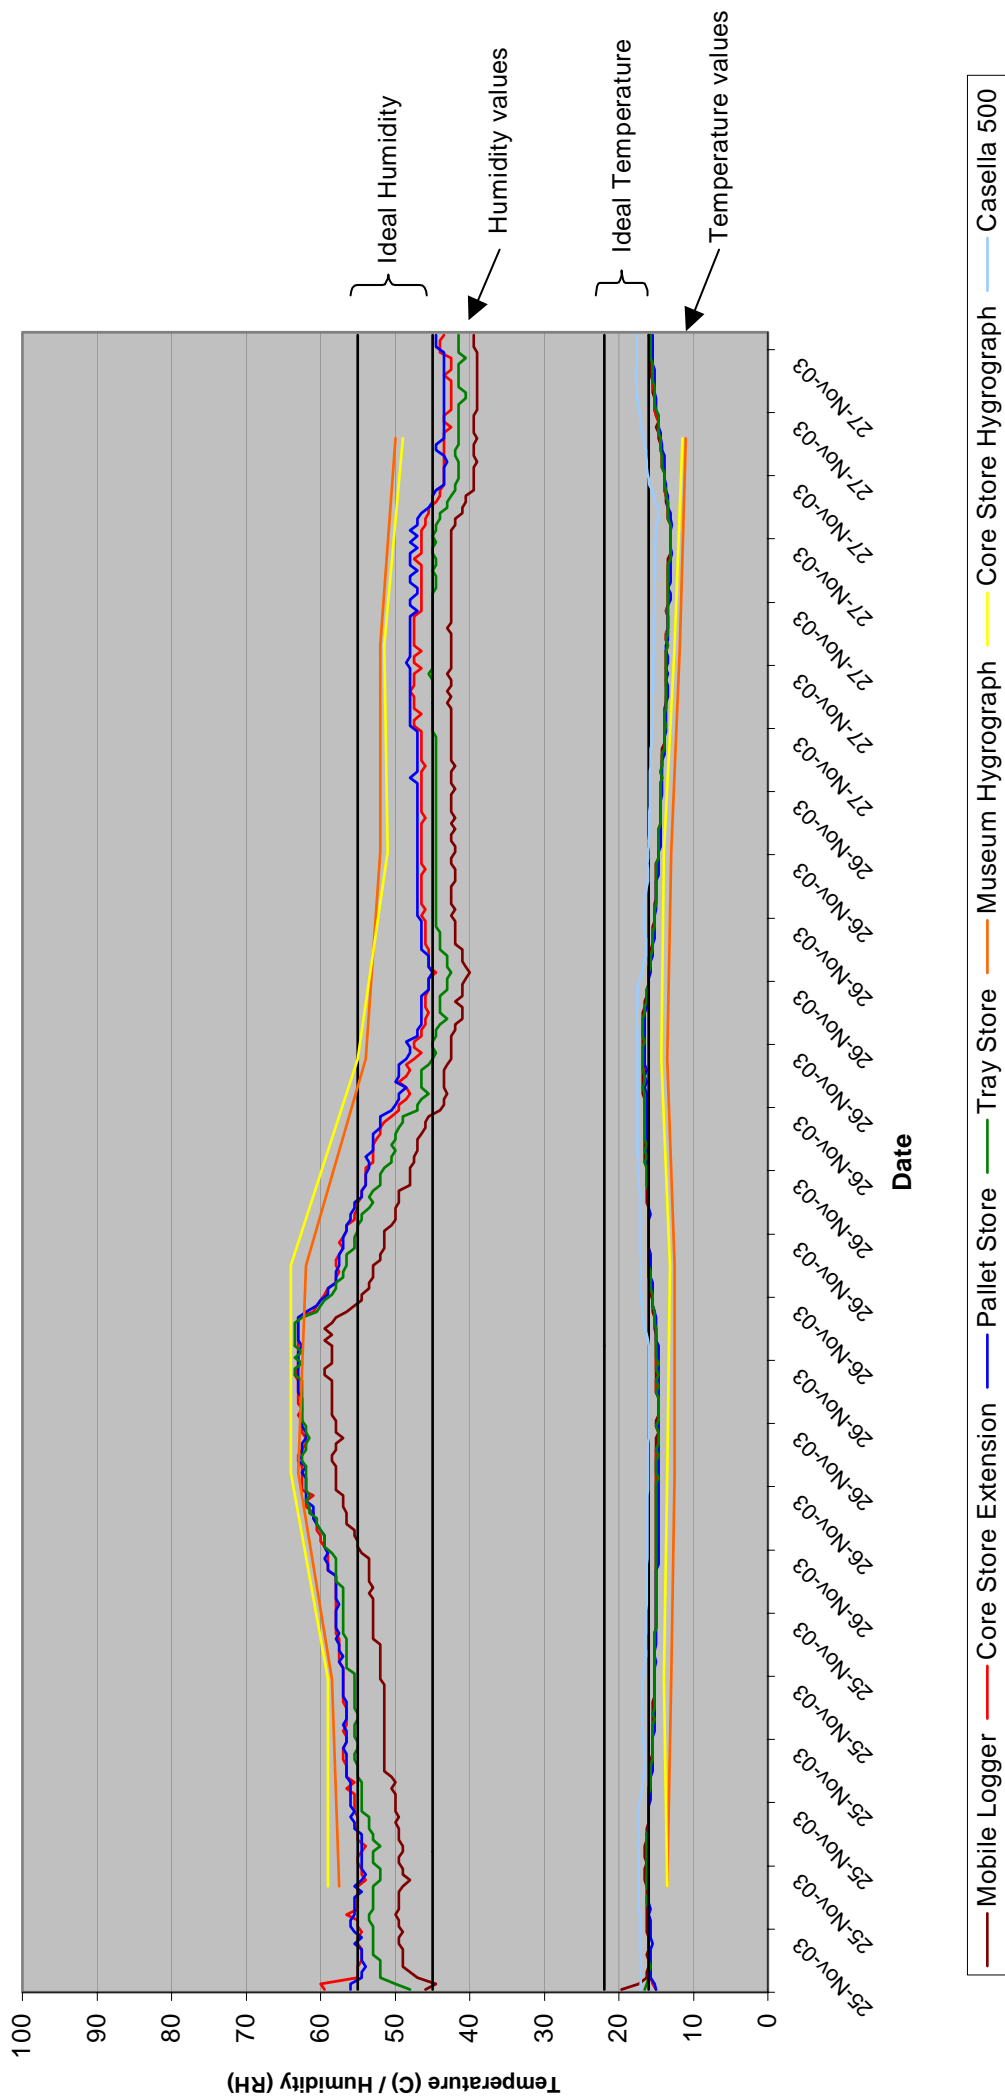
Figure 1: All Loggers Prior to Calibration Period– Keyworth 2003

The layout of the graph is as follows; the temperature readings are situated towards the bottom of the vertical axis with the ideal temperature ranges of 16-22°C indicated by solid black horizontal lines. The humidity readings are positioned above the temperature values; the ideal humidity ranges of 45-55% indicated in the same manner as the temperature. This layout applies to all the line graphs within this report.

Over this two-day period there isn't much variation in temperature, but they are almost all within the recommended temperature range. However, there is a variation in humidity, showing a gradual decrease over the two days, with some of the loggers being within the acceptable humidity range.

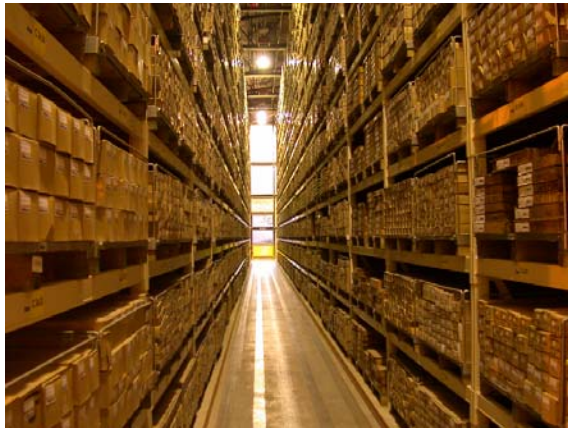
Plate 6: The Pallet Store.

Three monologgers have been located in the pallet store, core store extension and tray store, which are all located within the core store. The pallet store has six aisles containing the Borehole Collection. See Plate 6. A logger has been placed in the second aisle, about a third of the way down, two metres above the ground. The position of this logger should give us an indication of the climatic conditions that can develop in these confined spaces between the aisles.

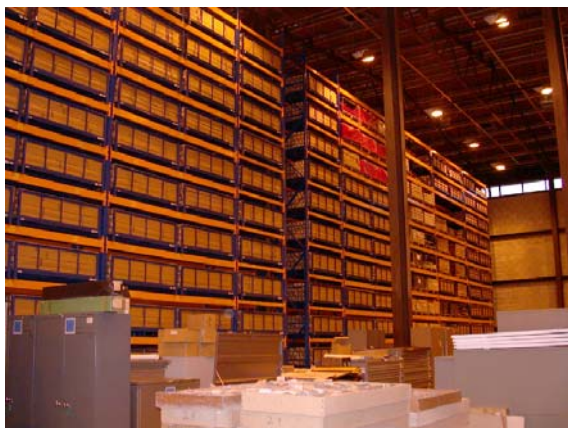
Plate 7: The Core Store Extension

The core store extension was officially opened in November 2002 and houses over 20km of continuous drill core from boreholes originally collected to examine the suitability of the ground conditions to locate an underground repository for radioactive material. This area is currently approximately a quarter full. This logger is located at the end of the first fully filled rack. It was decided to place the logger between a full aisle and the open section of the core store extension where there should be the maximum variation in readings between each of these two areas. See Plate 7.

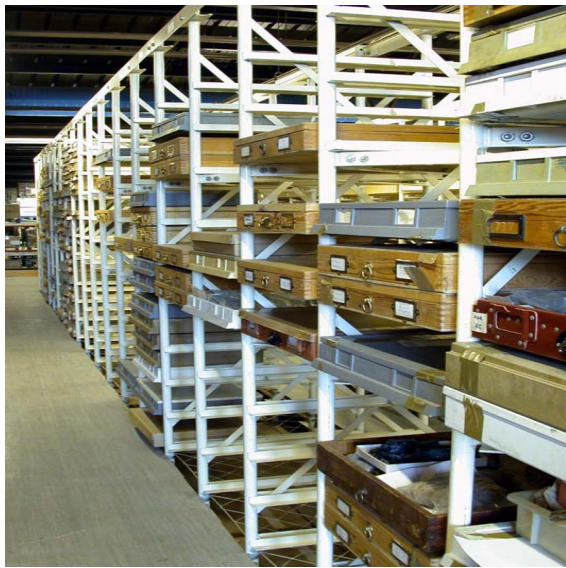
Plate 8: The Tray Store.

The tray store has twenty-two aisles on four levels; the first two levels hold registered samples and chippings from a variety of boreholes. See Plate 8. The third and part of the fourth level contains the Palaeontological specimens, whilst the remainder of the fourth level contains the Petrological Collection. The specimens in the tray store are stored in either a lidded wooden, plastic or cardboard tray. A logger is positioned on the top floor, 77cms above that floor level and adjacent to the main open area of the core store, which is approximately 7.5 metres below. This would hopefully show any variation in temperature and humidity between the confined areas of the tray racking and the open void of the main core store area. The heating within in the core store is based on an air blown system that is set to keep to the temperature above the dew point. On each level of the tray store there are vents that direct air between each aisle. A series of radiators are also situated around the edge of the core store extension and the main area of the core store.

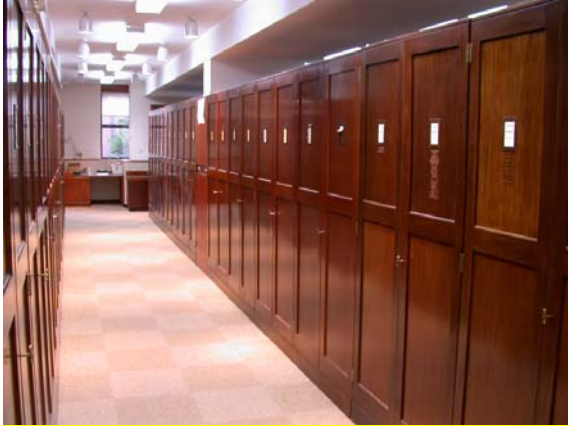
Plate 9: The Museum.

The Casella 500+ is located on the top floor of the museum, on the corner of a workbench that runs the along the southeast facing wall of the museum. The heating system in the museum consists of radiators on each floor together with an air circulation system, which draws air in from the outside and heats it up to the desired temperature. There is also an extraction system, which extracts the air from within the museum. See Plate 9.

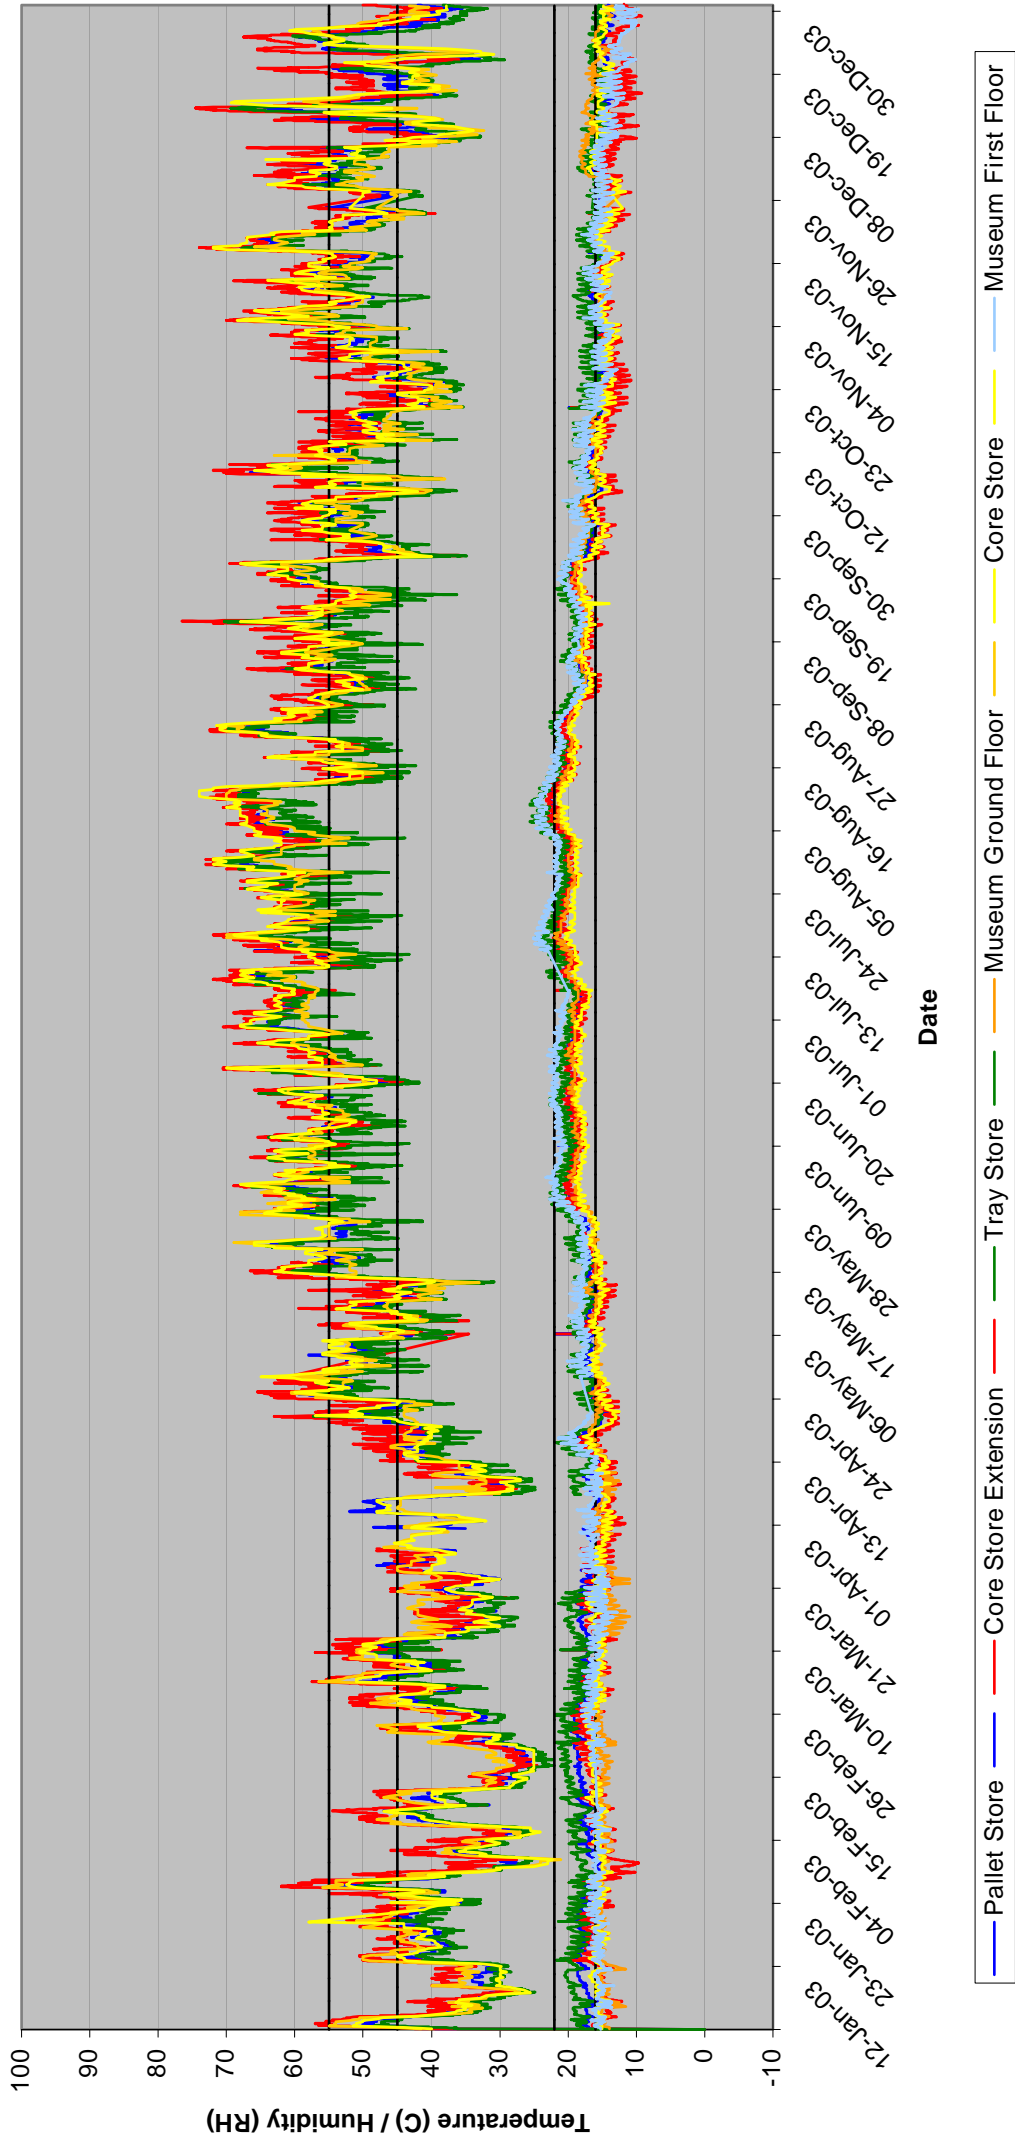
Figure 4: Yearly readings from Environmental Monitors - Keyworth 2003

The results from Figure 4 show that there are major variations in humidity throughout the year 2003, for all the localities mentioned. However the temperature ranges are more stable with slight variations of about 10°C.

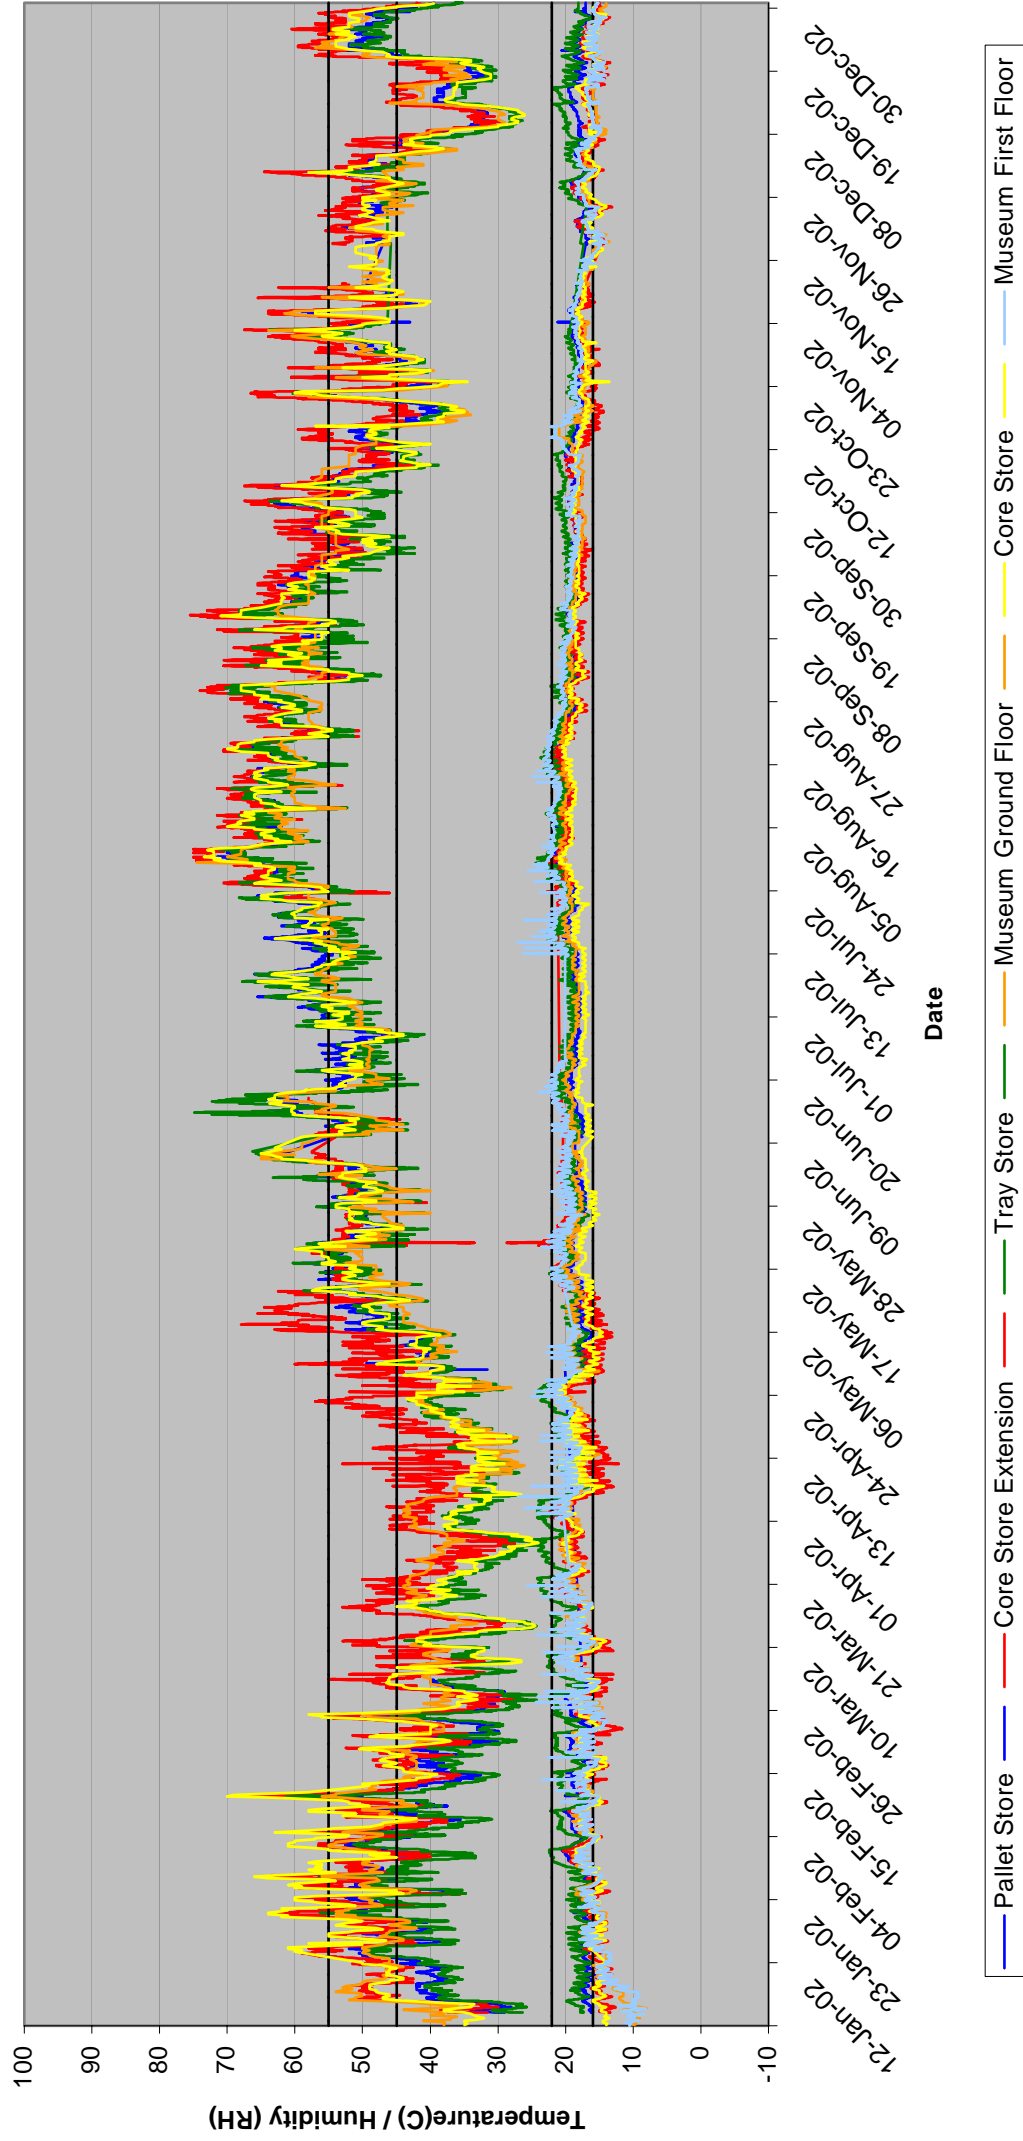
Figure 6: Yearly readings from Environmental Monitors - Keyworth 2002

Readings from 2002 have also been examined. These show a similar trend as 2003 where the temperature readings are within 16-22°C. The winter months show a drop in readings below 16°C except in the tray store and part of the time in the first floor of the museum. During the summer all of the monitors are within the ideal temperature range except for a couple peaks reaching 25°C on the first floor of the museum. It is likely that the peak associated with the core store extension, around the 21st May 2002, is an irregular value as this does not appear on any of the other loggers within the Core Store.

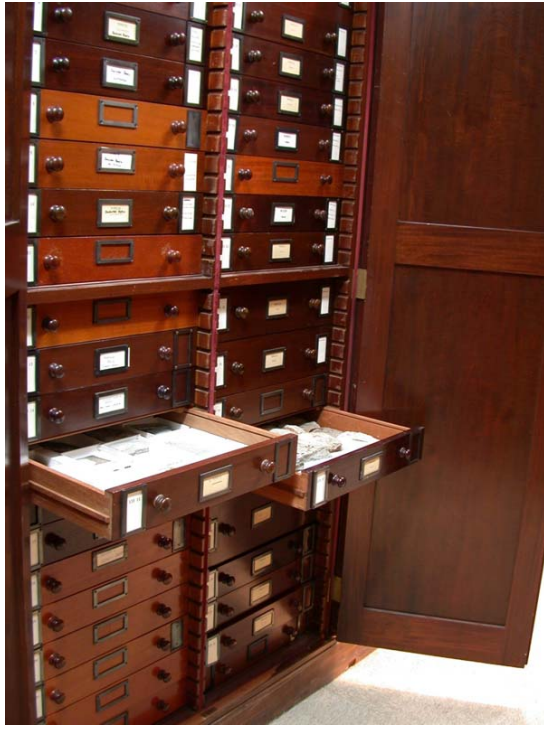
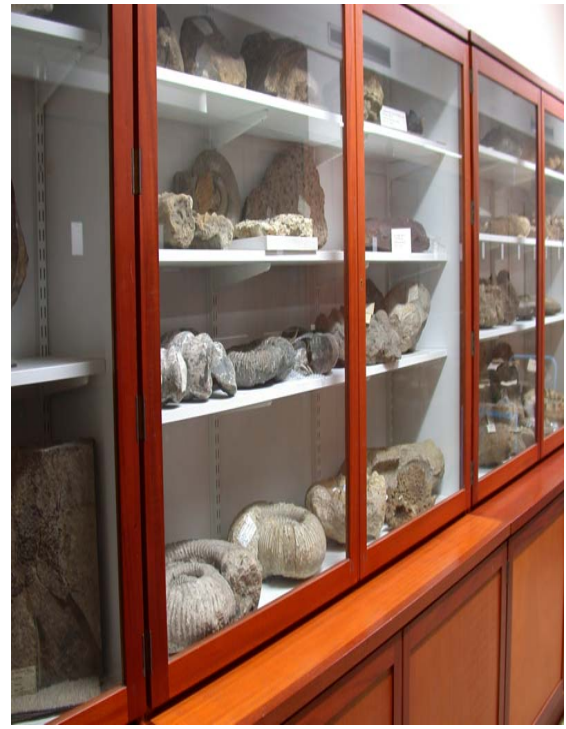
The monologger situated in the pallet store was used for this project. For the first two weeks the monitor was placed in a randomly selected cabinet and, for the remaining four weeks, within a randomly selected wall cabinet, both of which are located on the ground floor. The data was initially collected every two minutes. During this period a thermohygrograph and the Casella 500 were also present on the ground and first floors of the museum, respectively. Please note; the humidity sensor on the Casella 500+ is faulty and therefore humidity values for the first floor are not included.

Plate 10: Mahogany Cabinets

Plate 11: Wall Cabinets.

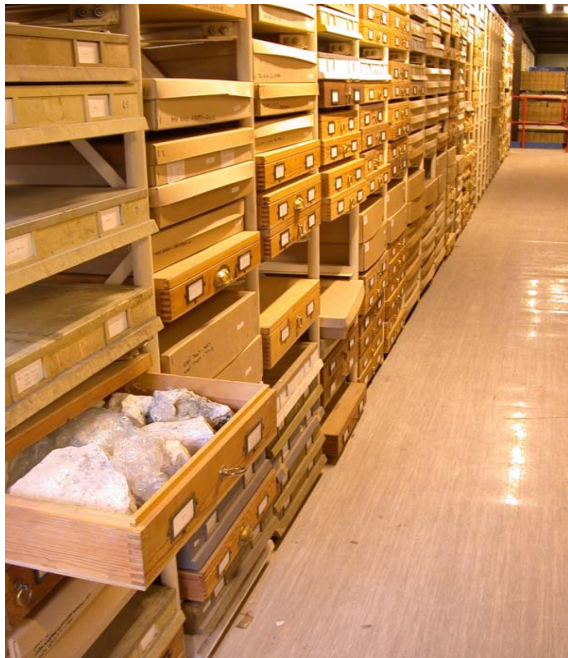
Plate 12: Wooden Tray in the Tray Store.

Mini projects have been carried out in the storage cabinets within the museum so it was decided to monitor the conditions for samples held within the tray store. This would hopefully show us any differences between the storage containers and their surrounding environment. The monitoring exercise was carried out between the 4th and 11th November 2003. The tray (23133) was randomly chosen. It is situated on the fourth floor of the tray store amongst the Palaeontological collection. This deep wooden lidded tray contains large chalk samples collected from Beer, Nr. Sidmouth, Devon, of the Upper Cretaceous period. See Plate 12. The monologger used was from the tray store area so no information will be available on the surrounding location but instead comparisons can be made from readings taken from the thermohygrograph in the main area of the core store.

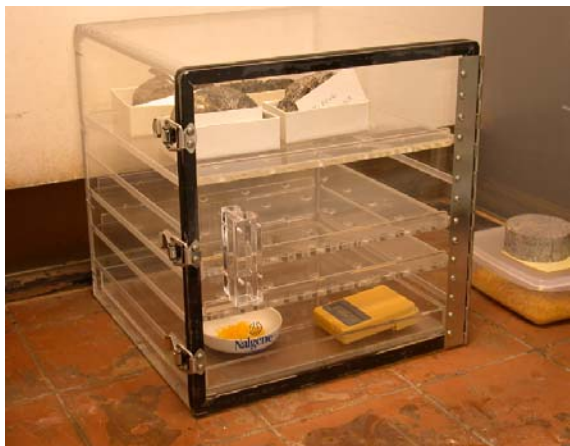
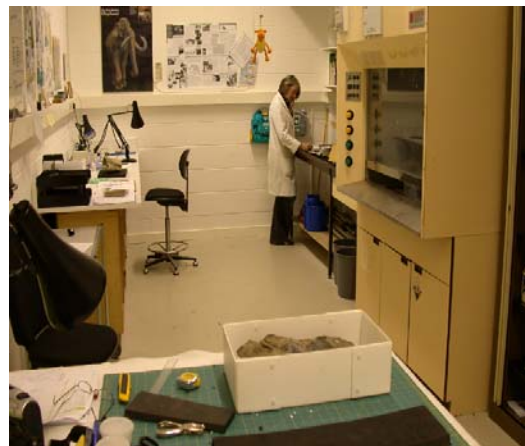
It would be useful to monitor the conditions where specimens requiring conservation are being worked upon including within the desiccator. The monologger from the core store extension was used for this experiment and was initially placed in the desiccator from 17th June 2002 until 1st July 2002. See Plate 13. This is situated in the fume cupboard in the laboratory. The monitor was then removed from desiccator and placed in the main area of the laboratory, until 22nd July 2002. See Plate 14. Readings were initially taken at two-minute intervals. The laboratory is situated opposite the core store extension and has no windows or central heating. The only ventilation is via the sliding door into the core store reception area and through the fume cupboard.

Plate 13: Desiccator in the Laboratory.

Plate 14: The Conservation Laboratory.

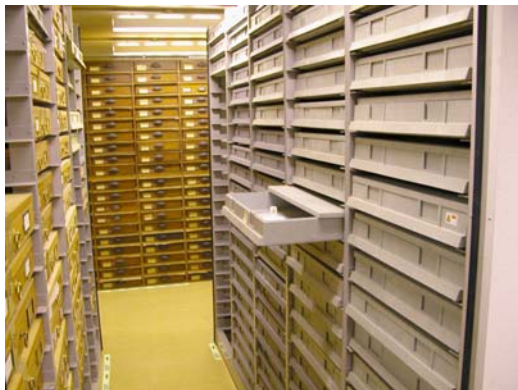
Plate 15: Plastic Tray

The offset is not large, however the results are made more accurate by applying the calibration factor. The benchmark used was the monitor for the Plastic tray (the green line) as it was one most recently purchased, Plate 15 below.

Two loggers in the Palaeontological area are in trays in the general store, Plates 15 & 17, and the other in a Museum specimen's cabinet, Plate 16. These loggers have been in place from the beginning of the monitoring programme in December 2000/March 2001.

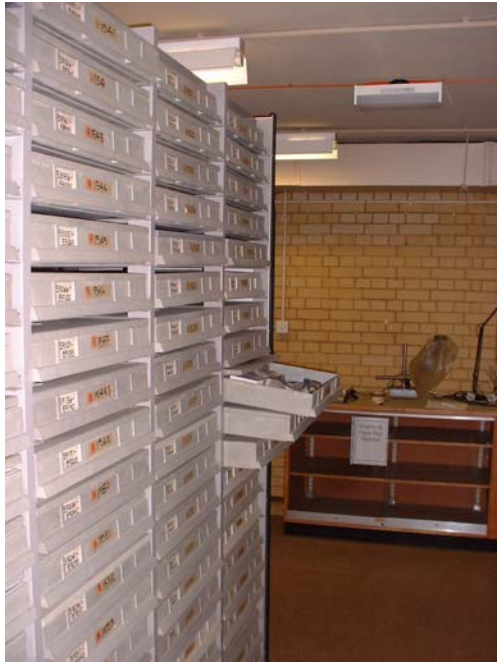
Plate 18: Tray B1

Tray B1, Plate 18, is similar to the Plastic tray in the Palaeontology store. The NE Corner, Plate 19 and E831, Plate 20, are the only two loggers that are not covered; this could go some way to explain why these two measurements are consistently the highest. They are also close to each other, which could explain why the peaks for these two loggers show the highest increase.
