38th WEDC International Conference, Loughborough University, UK, 2015

A hidden crisis: strengthening the evidence base on the current failures of rural groundwater supplies

BRIEFING PAPER

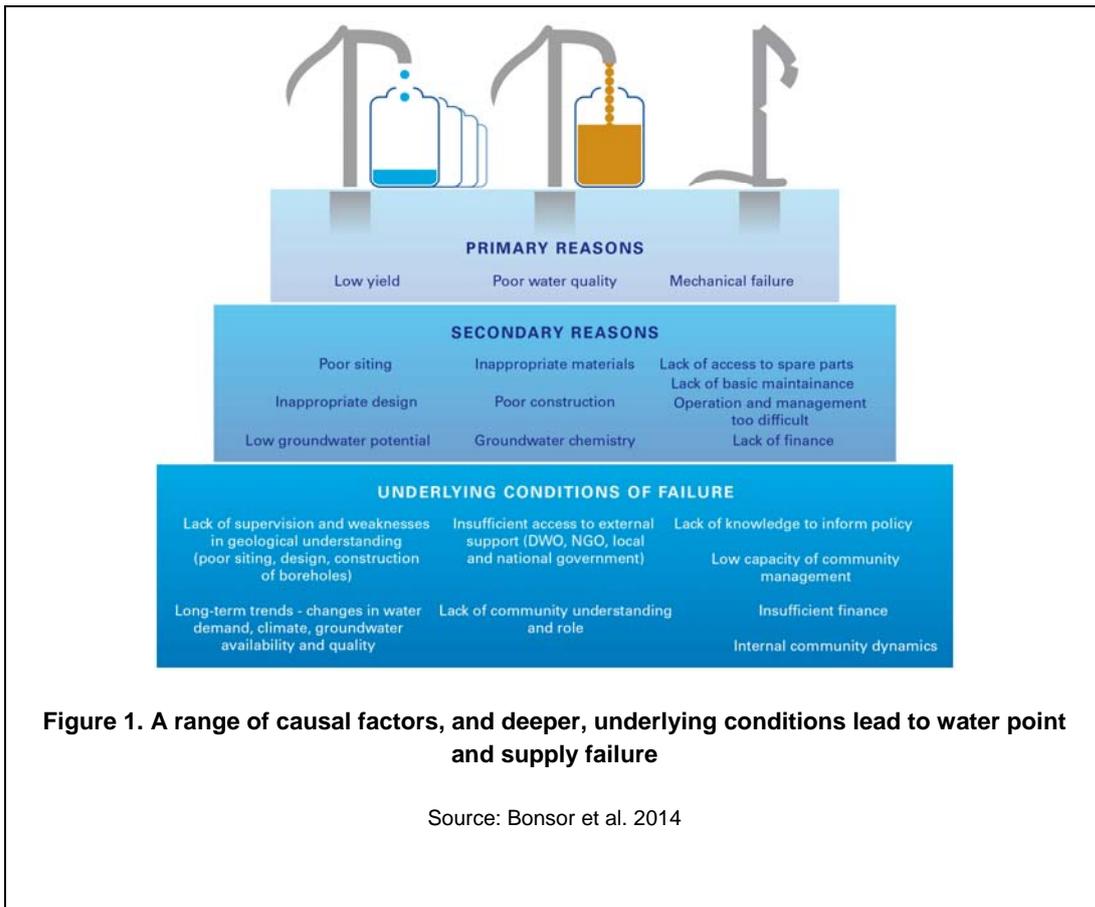
Figure 1. A range of causal factors, and deeper, underlying conditions lead to water point and supply failure

New international goals aimed at achieving universal access to safe drinking water depend critically on the ability of development partners to *accelerate and sustain* access to groundwater (UN Water 2013). However, available evidence for Sub-Saharan Africa (SSA), albeit fragmented and methodologically unclear, suggests more than 30% or more of groundwater-based water supplies are non-functional at the time of monitoring and a greater number can experience seasonal problems (for example ~50% in Sierra Leone; RWSN 2009). Achieving improved sustainability of supplies and universal access to safe water will, therefore, require a step-change in understanding of the inter-related causes of water point failure and unreliability, and actions that can be taken to mitigate risks. Growing evidence indicates that this is not a simple problem solved by just capacity building, or additional finance, strengthening post-construction support to water facilities, or a new design of pump. The roots of failure are likely to lie in a complex set of multifaceted issues, in which there are immediate causal factors of failure (e.g. poor siting, basic maintenance) and more systemic, deep-rooted underlying conditions that shape an environment in which failure is more or less likely – Fig. 1.

sustainability cannot be reduced to a single cause and a comprehensive diagnostic assessment approach framework is essential to begin to understand causes of failure across different socio-economic and physical environments (Dessaelgn et al. 2013). Unravelling the different inter-related contributory causes requires an understanding of (1) groundwater resources, (2) water point siting, design and construction, (3) financing, management, external support and community arrangements, and (4) demand pressures.

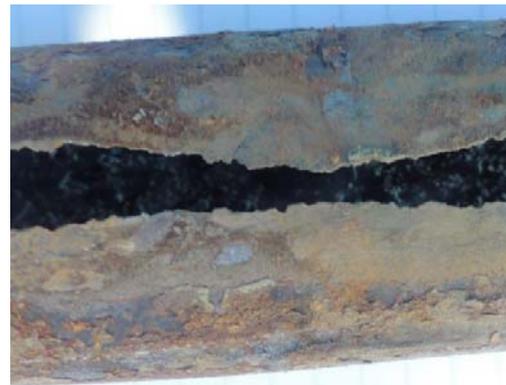
Corrosion of galvanized iron (GI) handpump components is clearly shown to be a significant causal factor to many of water point failures in the study, with corrosion having led to, or contributed, to mechanical and/or water quality failure symptoms in almost all of the water points examined. Photograph 2 shows an example of corrosion having led to complete perforation of a 0.5 m long section of hand-pump rising main pipe.

Photograph 2. Perforation of a rising main from corrosion

In the absence of a robust evidence base it has not been possible for the Ugandan Ministry of Water and Environment (MWE) to assess the main causes of water point failure in the Amuria and Katawki districts to inform better practice. The results of the pilot study begin to provide this robust evidence base, and the MWE are now working to enforce tighter regulation of hand-pump material quality with the Uganda Bureau of Standards. This should move to find more appropriate hand-pump materials in the region, in which GI material have been advised against in Eastern Uganda since the 1990s for reasons of corrosion.
