# RISK INFORMATION SERVICES FOR DISASTER RISK MANAGEMENT (DRM) IN THE CARIBBEAN

## OPERATIONAL DOCUMENTATION

reference/référence	OR/15/001
issue/édition	1
revision/révision	2
date of issue/date d'édition	19/02/2015
status/état	Final
Document type/type de document	Technical Note

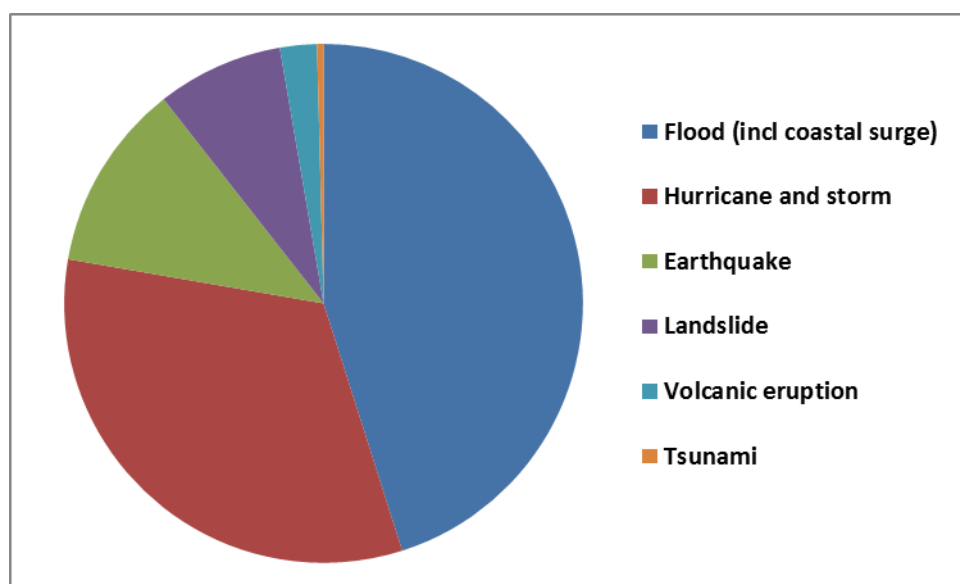
Figure 1 Natural disaster occurrences in the Caribbean region. Source: CRED database

The Caribbean is heavily affected by natural (and geo-) hazards with over 5 billion US\$ in losses in the last 20 years (source: CRED database). Figure 1 illustrates the division of natural disaster by occurrence in the region over the last 30 years, providing an insight into the impact in the region over a significant time period. A specific example of the environmental, social, economic and political issues that the project is addressing is highlighted by the effects of Hurricane Tomas on St Lucia in October 2010. The hurricane resulted in seven deaths with 5952 people severely affected, while the cost of the damage was estimated at US\$336.2 million, representing 43.4% of GDP (ECLAC, 2011). Understanding and mitigating these “geo-environmental disasters” (as they are termed in ECLAC, 2011) is a primary concern in the region.

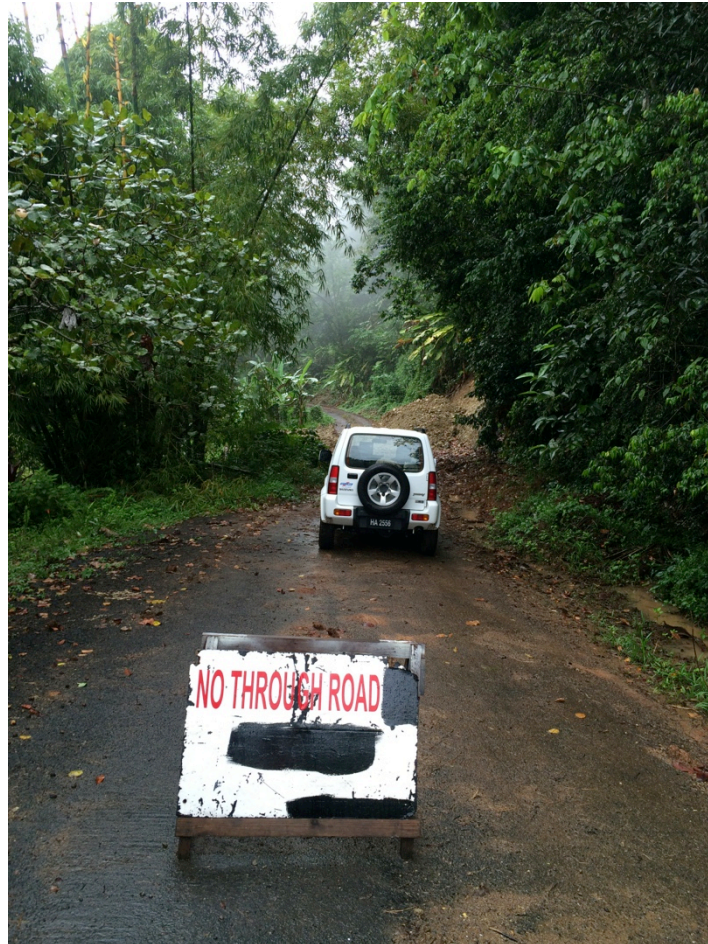
Figure 2 Road closure due to landslides – the type of problem the project is addressing

Of the natural disasters listed above, BGS has been tasked with producing an inventory of landslides; over 1200 landslides were identified in St Lucia alone from the satellite imagery. The impact of this geohazard on the island was noted at first hand during the fieldwork when travel was curtailed e.g. roads were closed due to landslides (Figure 2).

At the **Roseau Dam** many landslides were observed from the 2011 image and the road provided good access to the interior. Along the way it was possible to field check many sites mapped as landslides, with those generated in 2010 close to the dam still clearly recognisable (Figure 13). The road was in many places affected by recent landslides, including on the stretch from the Roseau Dam to L'Anse la Raye (Figure 2).

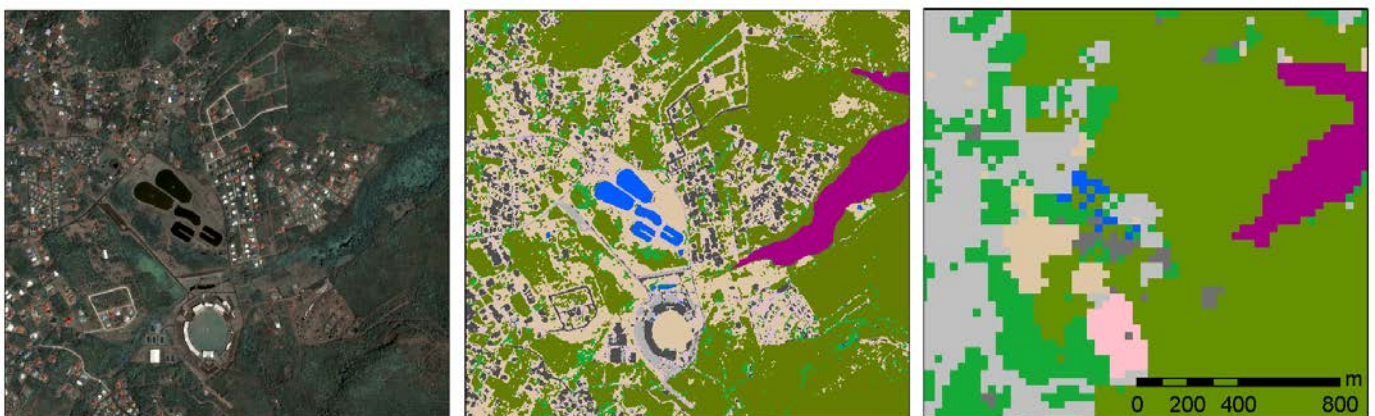
**Figure 5. Comparison of the level of detail provided in the new 2m land use/land cover maps (middle) and the existing 30m maps (right, © Nature Conservancy Mesomerica and Caribbean Region). Pleiades imagery is shown on the left (includes material © CNES 2014, Distribution Airbus DS / SPOT Image S.A., France, all rights reserved)**

The final land use/land cover maps are raster images with a spatial resolution of 2m, and thus provide an order of magnitude increase in the amount of detail they contain in comparison to the existing maps (Figure 5). Each 2m pixel in the raster is attributed with its associated land use/land cover class.

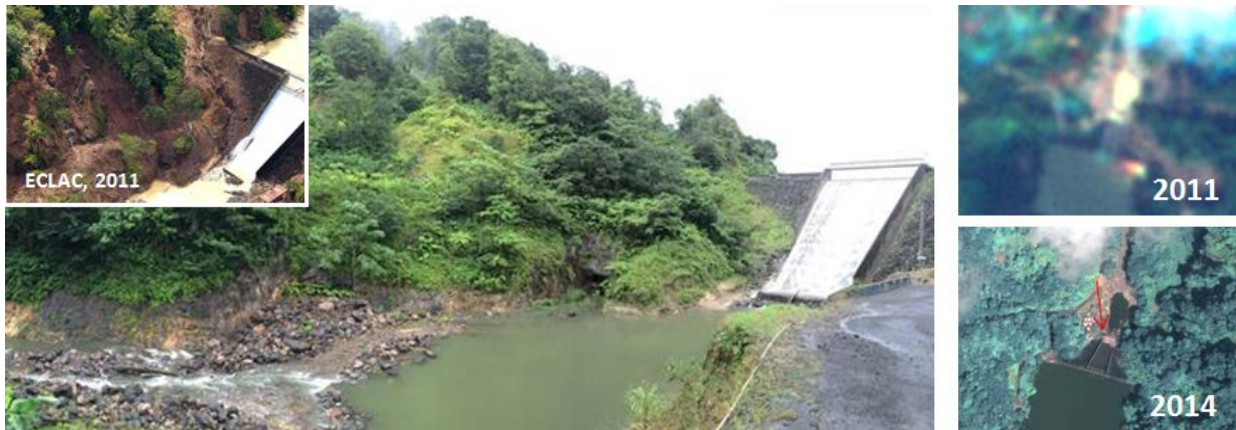
Figure 13 . Landslides near the Roseau Dam. Multiple events in 2010 seriously affected the water quality of the reservoir and a large landslide occurred to the east of the dam (see inset photo from ECLAC 2011). The remains of this landslide are still clearly visible. The direction of the photo is indicated by a red arrow on the satellite image of 2014. Compared with the 2011 image it is evident how much more detail can be observed. Includes material © CNES 2014, Distribution Airbus DS / SPOT Image S.A. France, all rights reserved and material © 2014 BlackBridge, all rights reserved.

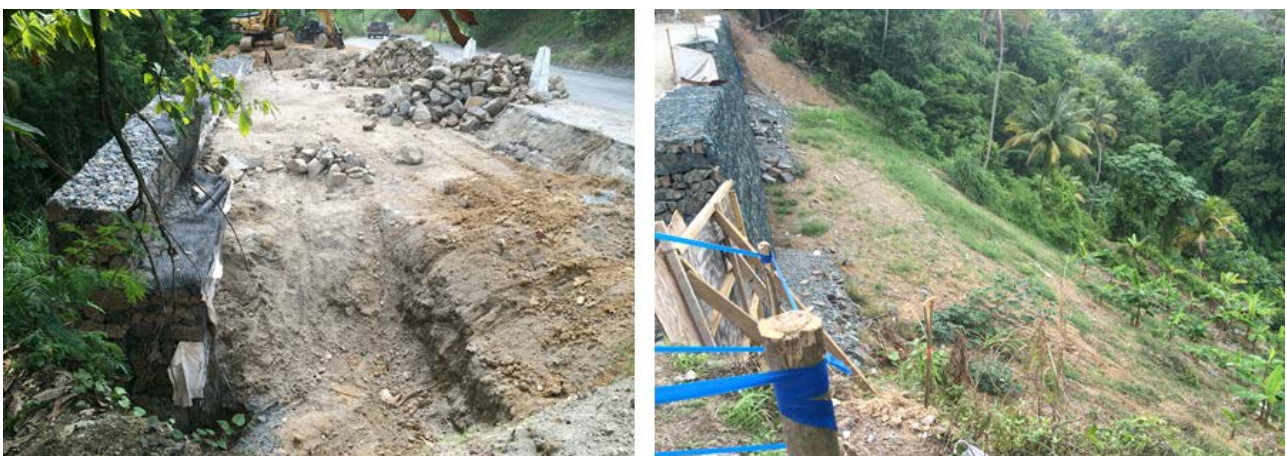
**Figure 16 Landslide stabilisation works along the Vieux Fort-Castries road at Thomazo.**

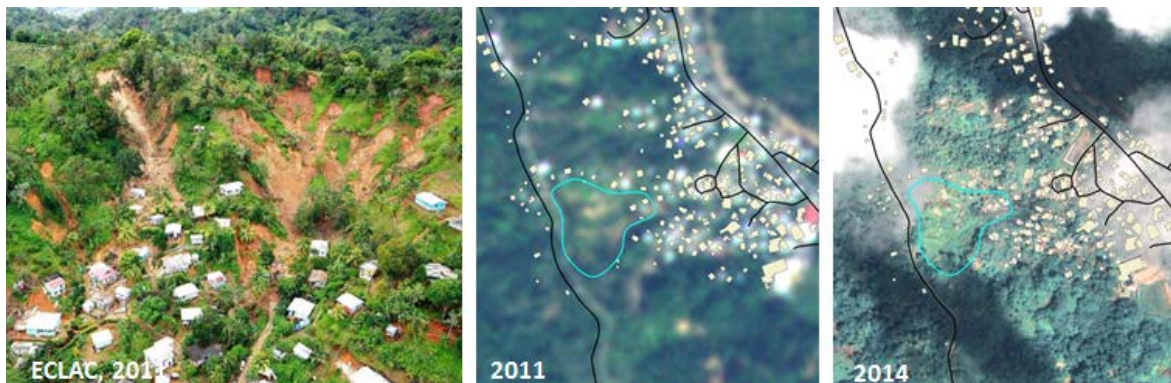
Figure 18. Landsliding near Marc. The oblique photo on the left (source ECLAC 2011) shows the extent of the area affected. The blue outlines in the 2011 image follow the outline of the valley. In the 2014 Pleiades image the landslide complex is barely recognisable. Includes material © CNES 2014, Distribution Airbus DS / SPOT Image S.A. France, all rights reserved and material © 2014 BlackBridge, all rights reserved.

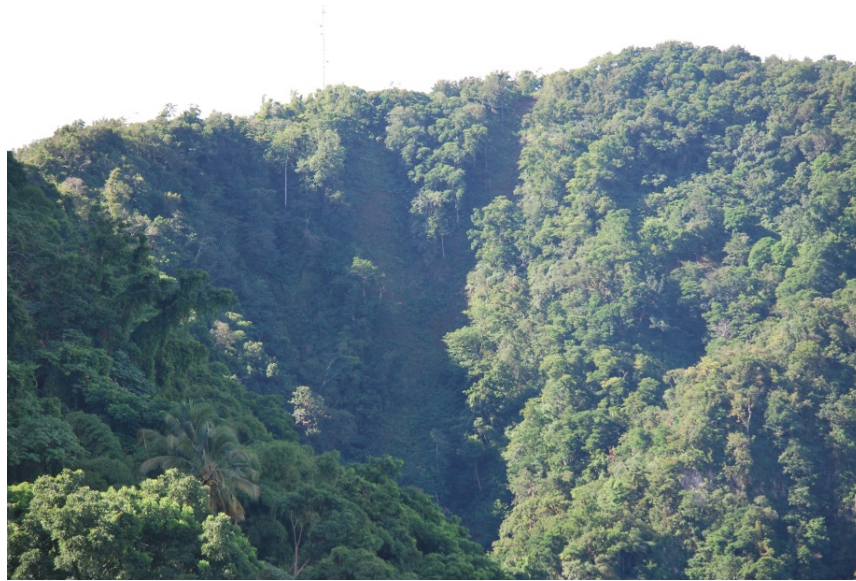
Figure 20 . An example of landslide scars along the main ridge connecting the two Pitons. These events were generated during Hurricane Tomas but could not be picked up in the satellite images because of size, terrain steepness, shadow effects and overhanging vegetation.

**The Pitons** form arguably the most charismatic images representing St Lucia. These steep rock slopes are generating rock falls and several trails were mapped following Hurricane Tomas. Since then the interpretation was downgraded to 'inactive'. However, during the field visit a loud rockfall was heard and the scars of recent events were observed. Local narratives report regular rockfalls from the Petit Piton. It is evident that this area remains one of continued activity and could benefit from careful observation and monitoring (Figure 19 and Figure 20).

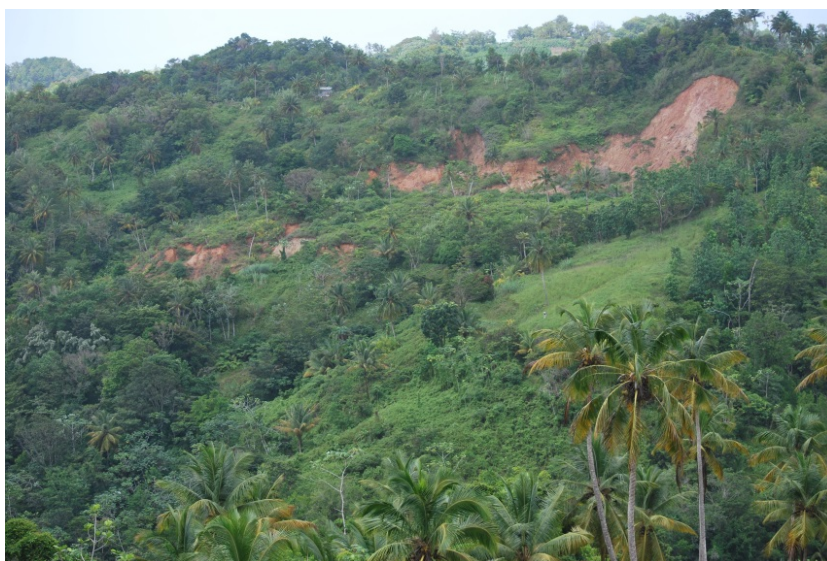
Figure 23. The Chateau Belair landslide as seen from a vantage point during field verification.

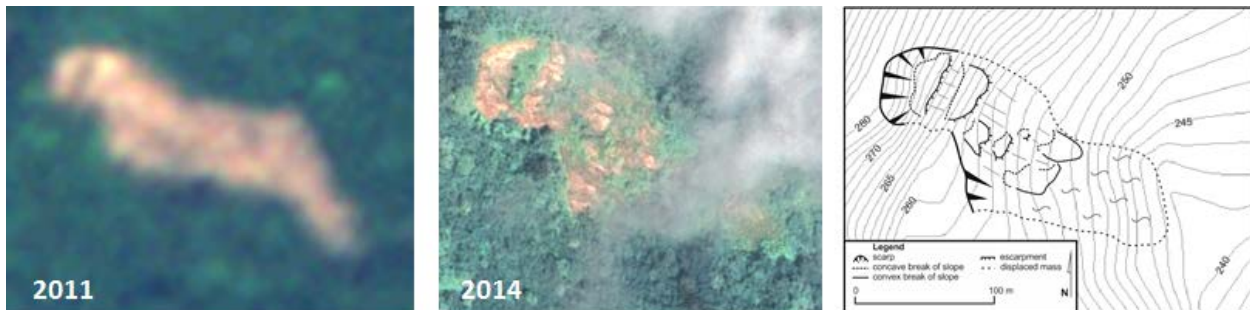
**Figure 24.** The 2011 image of a landslide enables establishment of just an outline of a landslide feature near the Roseau Dam. However, the 2014 Pleiades image can be used to draw a tentative morphological map of a landslide complex. Field checks are required to ensure these interpretations are realistic. Includes material © CNES 2014, Distribution Airbus DS / SPOT Image S.A. France, all rights reserved and material © 2014 BlackBridge, all rights reserved.

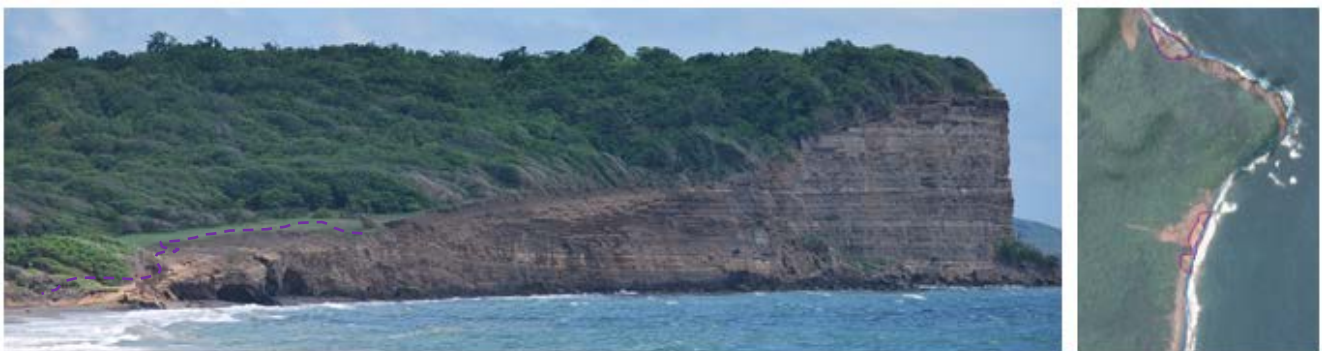
**Figure 27 . Southern cliffs of the headland at Antoine Bay and landslide polygons mapped using the Pleiades 2013 image. Vegetation alignment indicates strong coastal effects reducing vegetation growth potential near the edge of the cliffs and wind and water erosion of local soils leading to exposure of the underlying bedrock. The small landslide to the north of the headland was also dismissed from the landslide record. Includes material © CNES 2014, Distribution Airbus DS / SPOT Image S.A. France, all rights reserved.**

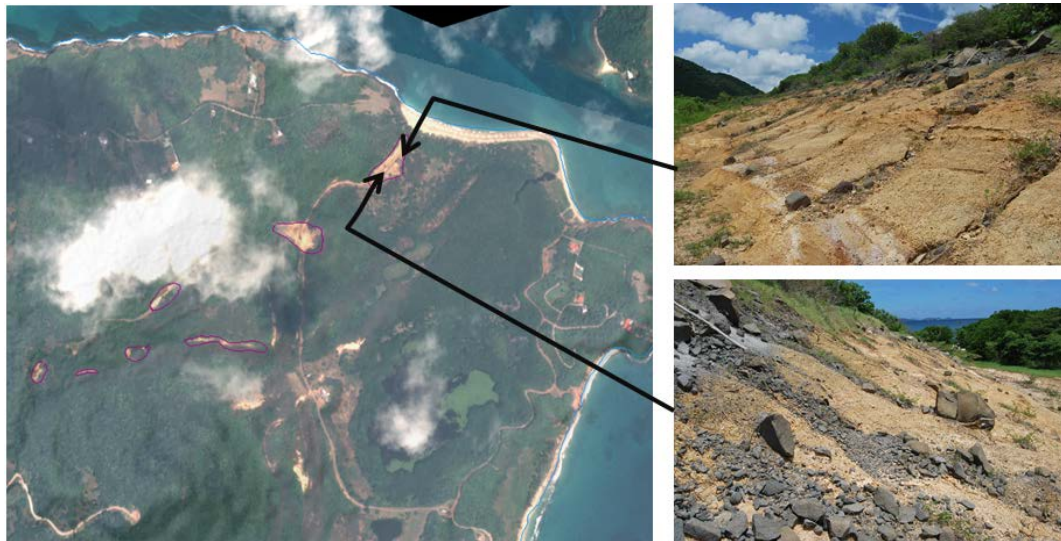
**Figure 28. Levera Point. Initially mapped as landslides, ground truthing indicated that these are predominantly surface erosion features. Includes material © CNES 2014, Distribution Airbus DS / SPOT Image S.A. France, all rights reserved.**

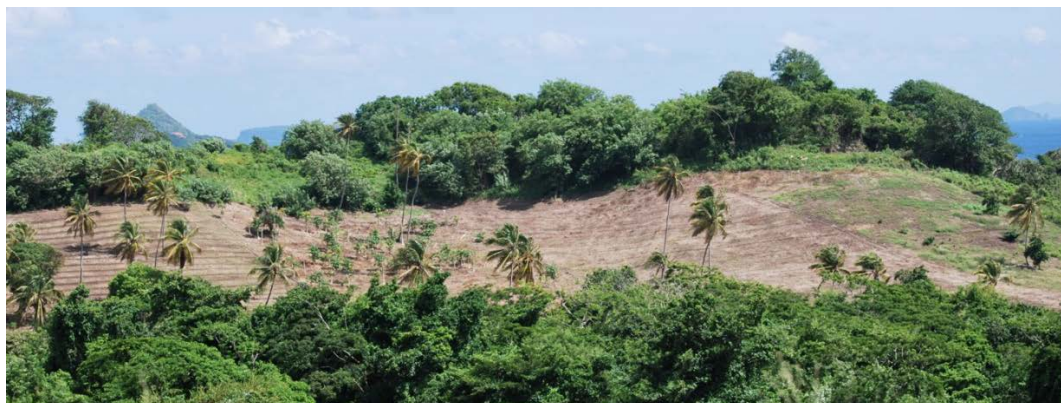
**Figure 29. Landscape looking north from the tufaceous explosive crater rim of Lake Antoine in NE Grenada.**

**La Fortune and Levera region.** In the NE of the Island several coastal landslides were identified (tentatively) from satellite images on the basis of morphology and exposed soils. Field checking of these sites near Antoine Point indicated that the dominant processes involve surface erosion and that there was a lack of vegetation development along the coastal cliff (Figure 27). A cluster of potential landslides associated with an unpaved road system were identified (again tentatively) on the satellite images. Their features were quite persistent and some morphologies suggested rather substantial movement, on relatively gentle terrain (Figure 28). Instead it turned out that road construction near Levera point has resulted in extensive erosion in soft bedrock (tuffs) with overlying fractured basalts (members of the Levera volcanics) flowing down into erosion gullies. Topography and exposed soils observed in the vicinity of Lake Antoine could lead to classification as a potential landslide, but field inspection concluded that this site was not affected by landsliding (Figure 29).

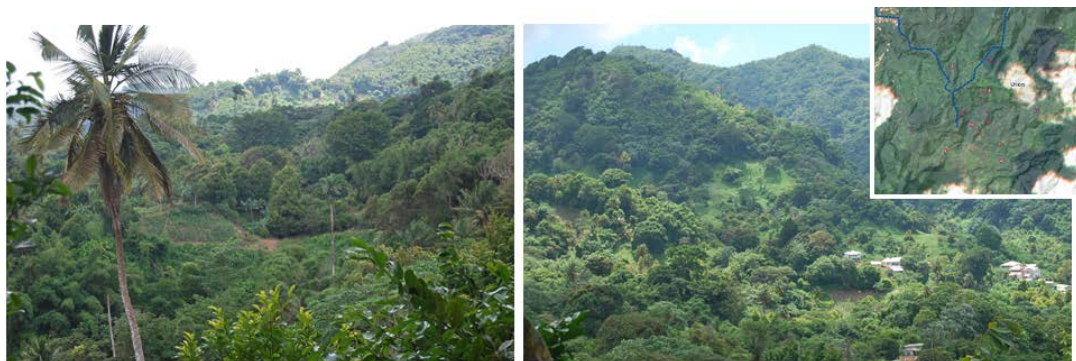
**Figure 30. Typical landscapes in St Patricks (Union/Castle Hill) showing a patchwork of cultivated fields where several potential landslides had been mapped (see inset map with landslide polygons in purple outlines and the route taken in blue). Includes material © CNES 2014, Distribution Airbus DS / SPOT Image S.A. France, all rights reserved.**

**The uplands of St Patrick between Union, Castle Hill and Tricolet.** During the brief fieldwork phase this area was investigated at, but none of the sites offered sufficient evidence to warrant a landslide classification. Instead, the patterns observed in the satellite images from 2011, 12 and 13 are most likely the result of cultivation of these slopes. Many of the discounted landslides represented small banana plantations. It was checked whether these were coincident with old landslides (as was observed at a small number of sites in St Lucia), but this did not appear to be the case (Figure 30, Figure 31).

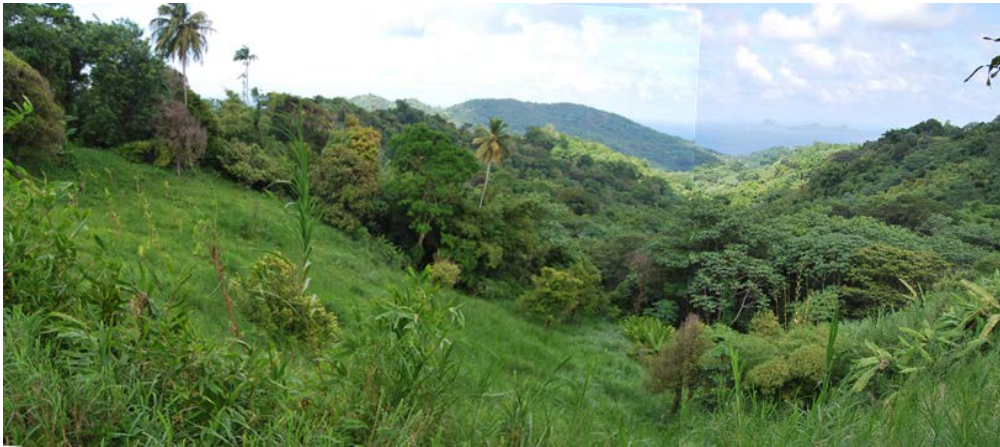
**Figure 31.** A field in the St Patricks area. This was initially mapped as a landslide because of the position in the landscape and a bare earth signature that gradually re-vegetated.

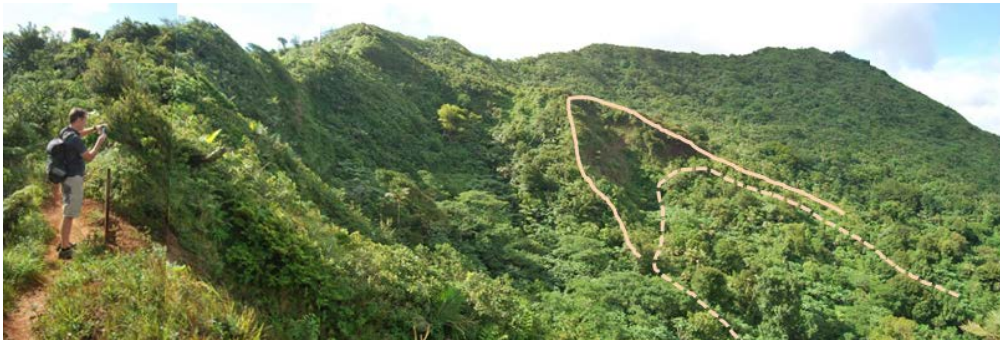
**Figure 32.** View looking north of the upper slopes of Mt Qua Qua and the outlines of the only positive identification of a landslide. The steep slopes that make up this ridged landscape are characterised by morphologies that are indicative of phases of landsliding and surface erosion. However, during the current mapping exercise, no evidence of active mass movements was found.

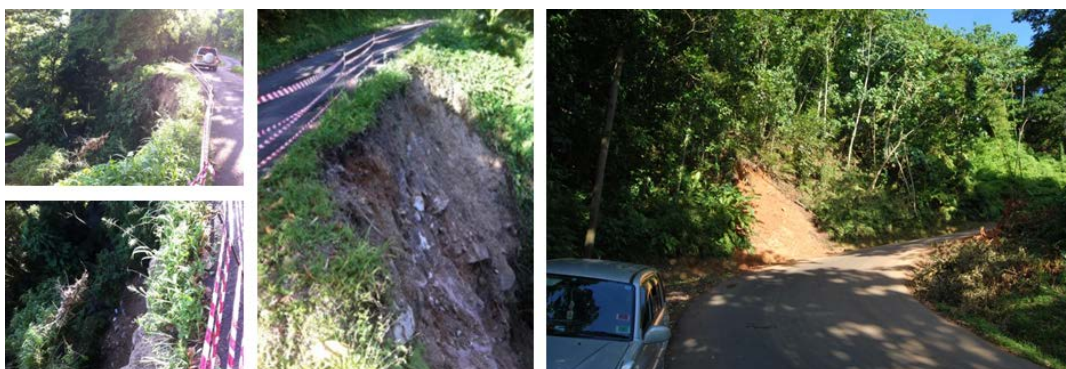
**Figure 33.** Shallow translational and rotational landslides generated by undercutting along the road to Concorde Falls and, right, a small roadside failure NE of Constantine. These small failures were generated in 2014 but are not visible on the latest satellite image available for this study as these would have occurred since the images were taken. However, given the dimensions of these events, it is highly improbable that these will be picked up by an EO survey.

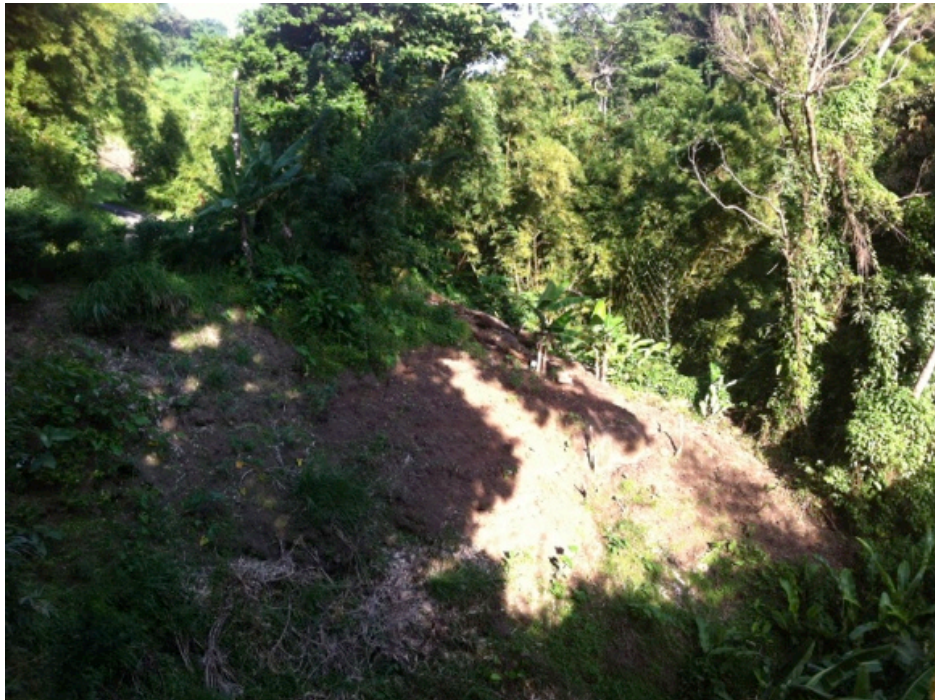
**Figure 34.** A field along the Concord falls road. This field is typical of many in this area that have been picked up during the satellite image interpretation as potentially being a landslide. The identification as potential landslide or cultivated field are affected by slope, shadows and overhanging, patchy vegetation.

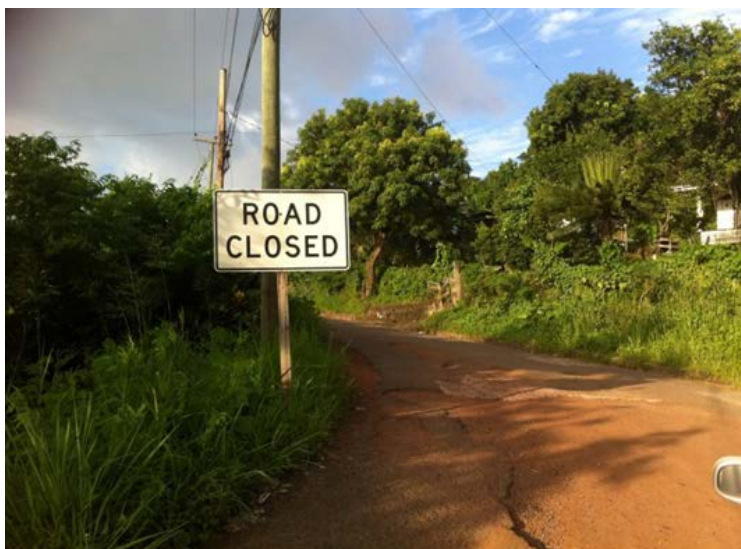
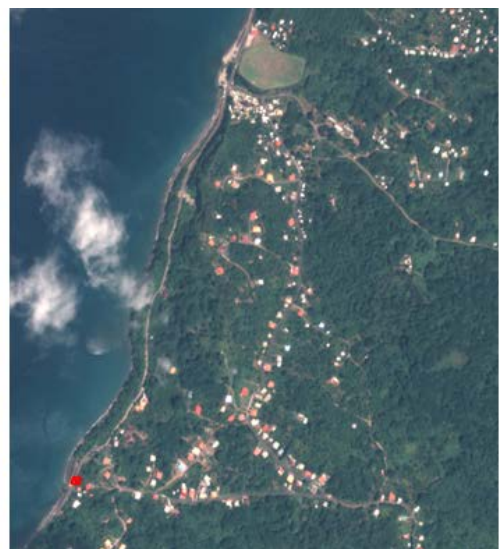
**Figure 35.** Road closure at Palmiste Lane, south of Gouyave. This closure sign is positioned at the red dot on the coastal road, as indicated in the image scene on the right. A lengthy detour (the Mt Nesbit Detour) reconnects with the coast road, just south of Cuthbert Peters Park. Unfortunately, satellite interpretation alone is not sufficient to draw a boundary around a region of unstable slopes with confidence. Includes material © CNES 2014, Distribution Airbus DS / SPOT Image S.A. France, all rights reserved.

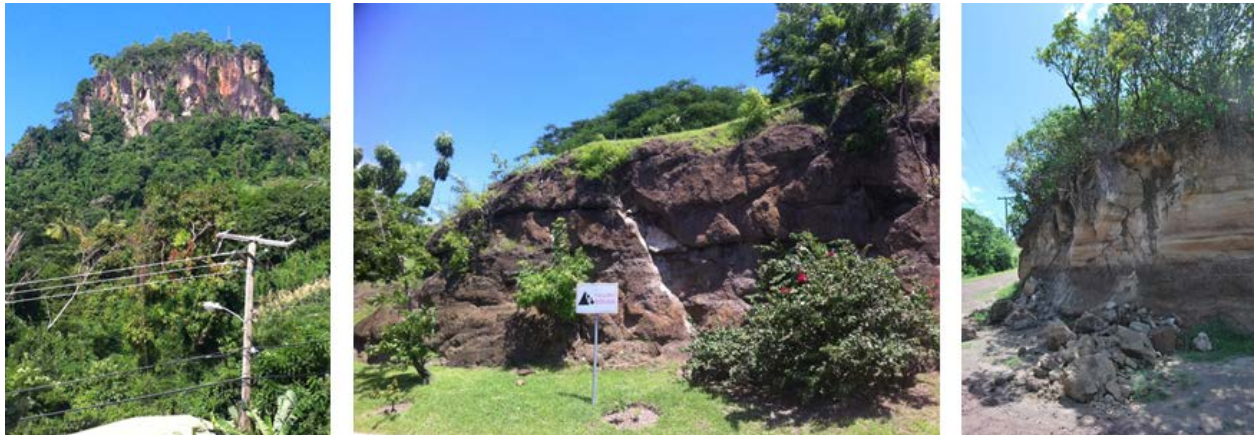
**Figure 36.** The potential for rockfall is apparent at many sites across the island. A large cliff face near Molinere Point provides an example of many steep cliff faces found throughout the Island from where it is not inconceivable that the occasional rock fall can be generated. Differences in coloration of the cliff faces provide an indication of the dynamic nature of these cliffs. However, dense vegetation along the base of these cliffs will reduce the magnitude of the zone away from the cliff where the effects of rockfalls will be felt. In the absence of vegetation, e.g. near the airport (centre) and along roads (e.g. at Levera, right) rockfalls can pose a hazard with a more direct impact pathway.

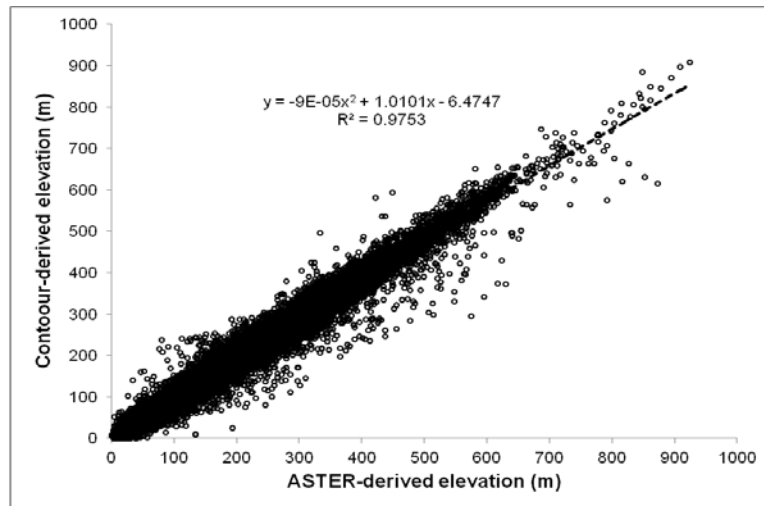
**Figure 39. Vertical calibration of the ASTER-derived elevation data using regression analysis.**

For St. Lucia, the ASTER-derived elevation data were first vertically calibrated with a subset of contour height data using regression analysis. Next, the calibrated ASTER elevation dataset was merged with the contour height data to form a single file containing x-y-z coordinates of all points. These points were then interpolated to generate the 30m DEM. The vertical accuracy of the DEM was determined using 18 GPS control points provided by the Physical Planning Office, and found to have a root-mean-square (RMS) vertical accuracy of 1.4m.

Similarly, for Grenada, the ASTER-derived elevation data were vertically calibrated with a subset of airborne Light Detection And Ranging (LiDAR) data using regression analysis. Sizeable ‘pit’ artefacts in the DEM were subsequently rectified with the aid of elevation data acquired by the Shuttle Radar Topography Mission (SRTM). The vertical accuracy of the DEM was determined using an independent subset of 500 LiDAR data points and found to have an RMS vertical accuracy of 4.9m.

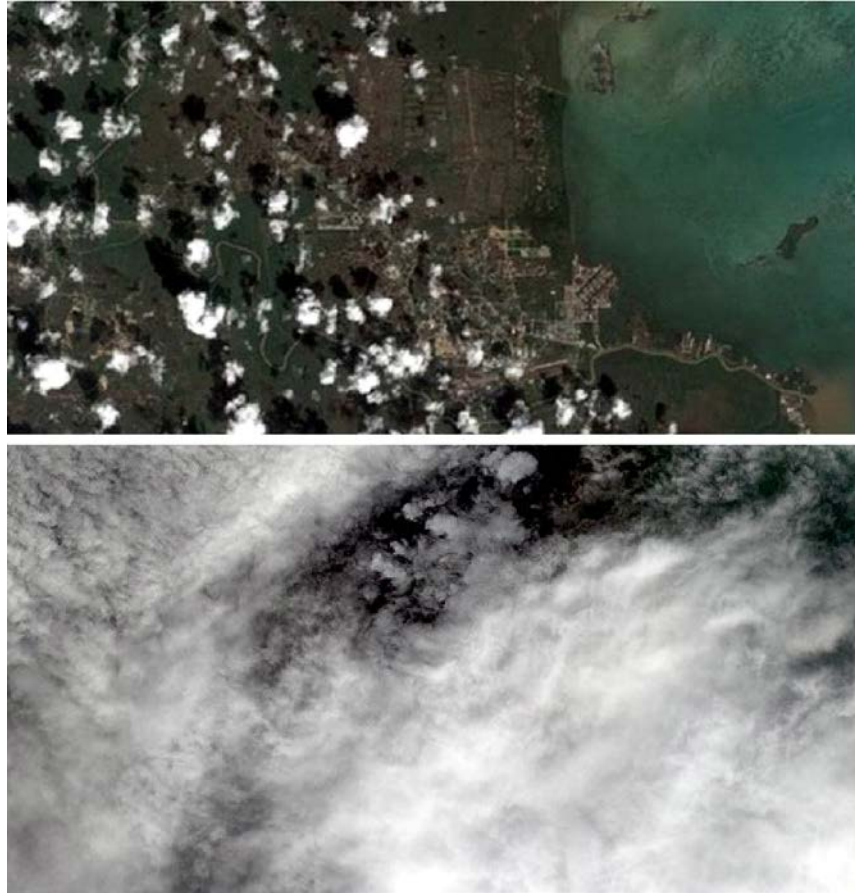
**Figure 43. Selected attempts to acquire fresh Pleiades tri-stereo imagery for an area of Belize. Includes material © CNES 2014, Distribution Airbus DS / SPOT Image S.A. France, all rights reserved.**

The second aspect of Service 3 was to generate a high precision 1m resolution DEM from very high-resolution optical satellite imagery for a subset of Belize encompassing an area to the north of Belize City. To satisfy these requirements, a tasking request was submitted to Airbus Defence & Space in early August 2014 in order to have fresh Pleiades tri-stereo (triplet) imagery acquired for an area of 100km<sup>2</sup> situated to the north of Belize City, encompassing the town of Ladyville. However, the timing of this request coincides with the hurricane season in the Caribbean region. As a result, all attempted acquisitions to date have been affected by considerable cloud and haze cover (Figure 43), thus rendering them inadequate for the generation of a precise 1m DEM. Acquisition attempts for this area of Belize are still ongoing, and it is intended to generate the precise DEM upon acquisition of suitable tri-stereo imagery.
