Things that go

BUMP

in the night

The UK's largest earthquake since 1984 struck Market Rasen earlier this year. **Susanne Sargeant** discusses the British Geological Survey's response to this event.

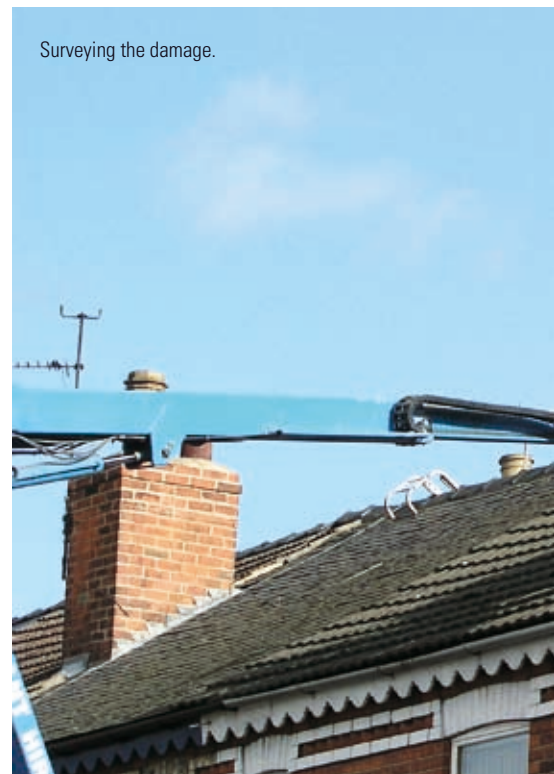
Surveying the damage.

we would have expected to see more severe effects near the epicentre. Instead, the responses to the questionnaire indicated that there were sporadic incidences of damage over a wide area rather than a distinct 'hot-spot' near the epicentre. This was borne out by our field survey. Most of the damage in Gainsborough was to the tops of chimneys. But there was also some secondary roof damage caused by falling bricks.

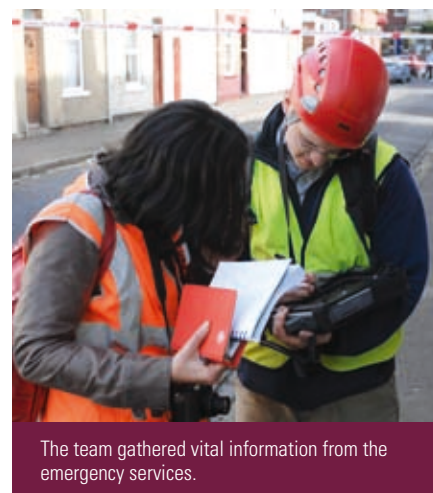
The epicentre was 4km north of Market Rasen.

We now had confirmation that Earlybird's initial estimate was spot on: the epicentre was around four kilometres north of Market Rasen in Lincolnshire. The constraint on the depth was poor although indications were that it was probably fairly deep in the crust at about 20km.
