# Landslides in the Ironbridge Gorge, Shropshire

## Landslides

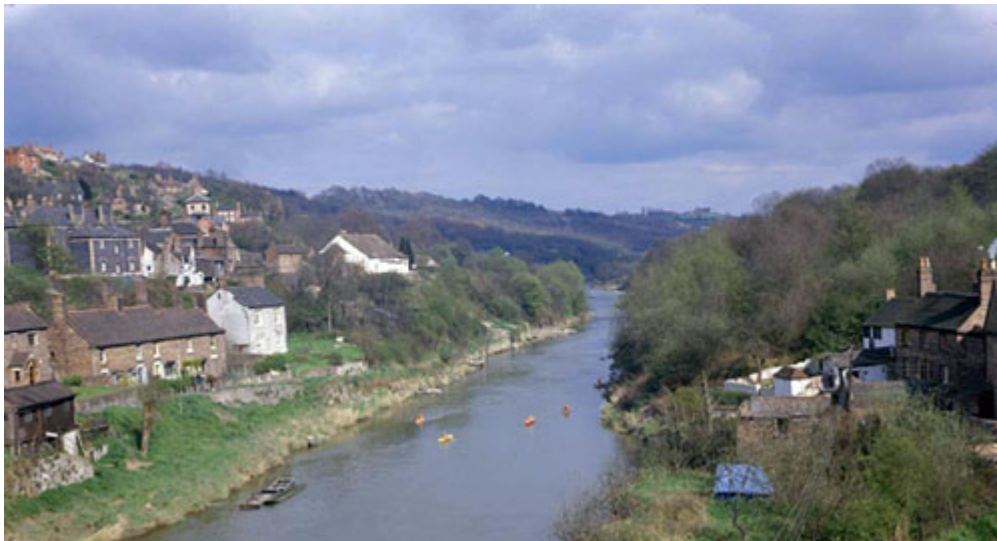
**Figure 1** Ironbridge Gorge photograph taken in 1974 (BGS photo number P211697).

The River Severn flows through the Ironbridge Gorge (location map and Figure 1) which is located to the south of Telford in Shropshire and is a World Heritage Site. It is named after the famous Iron Bridge designed by Thomas Farnolls Pritchard and built by Abraham Darby III, the first arch bridge in the world to be made from cast iron (Figure 2).

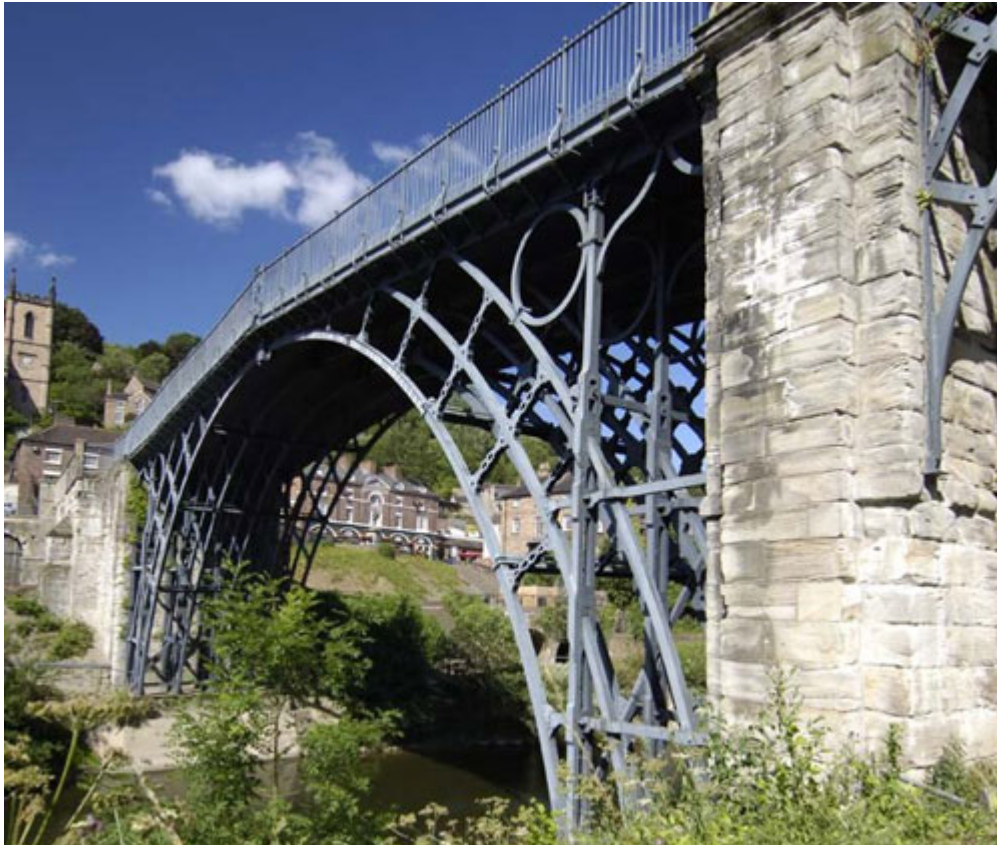
**Figure 2** The Iron Bridge, Shropshire. Photograph taken in 2003 (P626433).

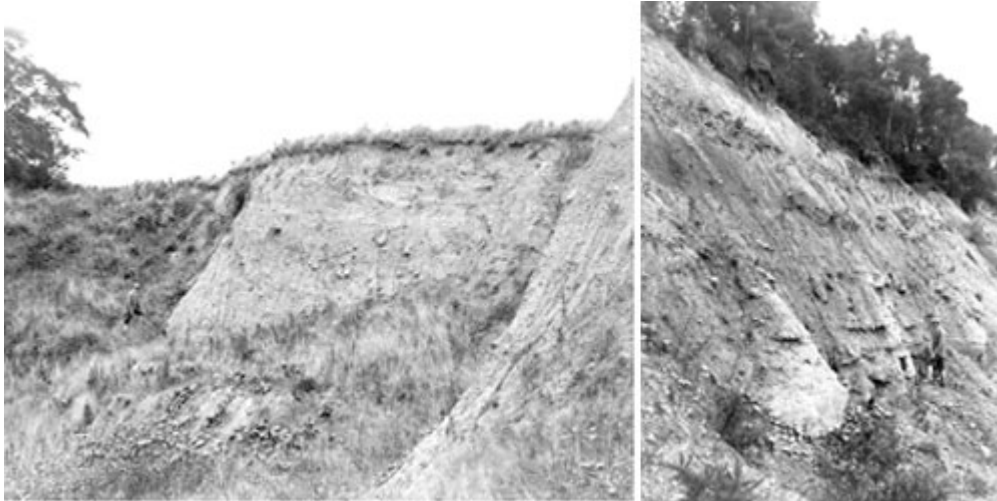
**Figure 6** The backscarp of Lloyd's Coppice landslide from 1924

This landslide (National Landslide ID 4338/1) is actively moving as a series of rotational and translational slides. Craggs of sandstone have moved down from their outcrop near the top of the hill, bringing with them the overlying thick till. Geological faults, ground water, surface water, the nature of the geology, construction and mining are all associated with the instability of this slope.

The backscarp of this landslide was photographed in 1924 (Figure 6)

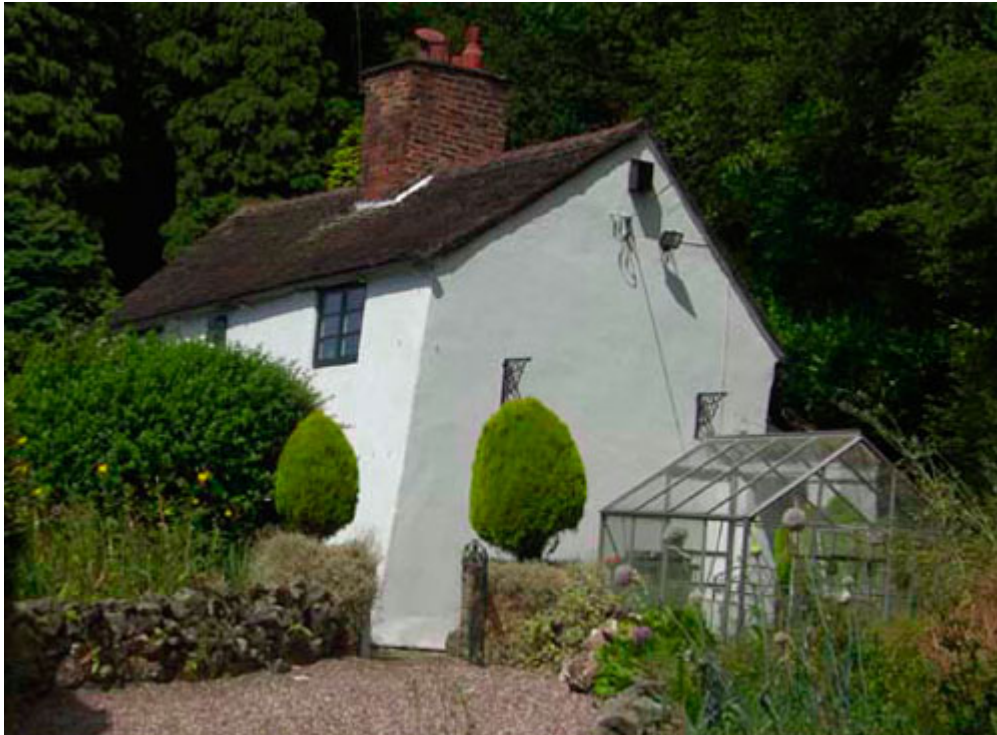
**Figure 7** Movement of a house within the Lloyd's Coppice landslide. The greenhouse is vertical.

This landslide is within the Halesowen Formation which is particularly susceptible to movement in this area as it includes more silty strata and less sandstone than elsewhere. Buildings and roads have been affected by the landslide (e.g. Figure 7).
