Landslides at Beachy Head, Sussex

The section of cliff surveyed at Beachy Head is situated to the east of the modern lighthouse. The survey spans a 400 m south-facing stretch of beach with a cliff height of between 120 and 160 m.

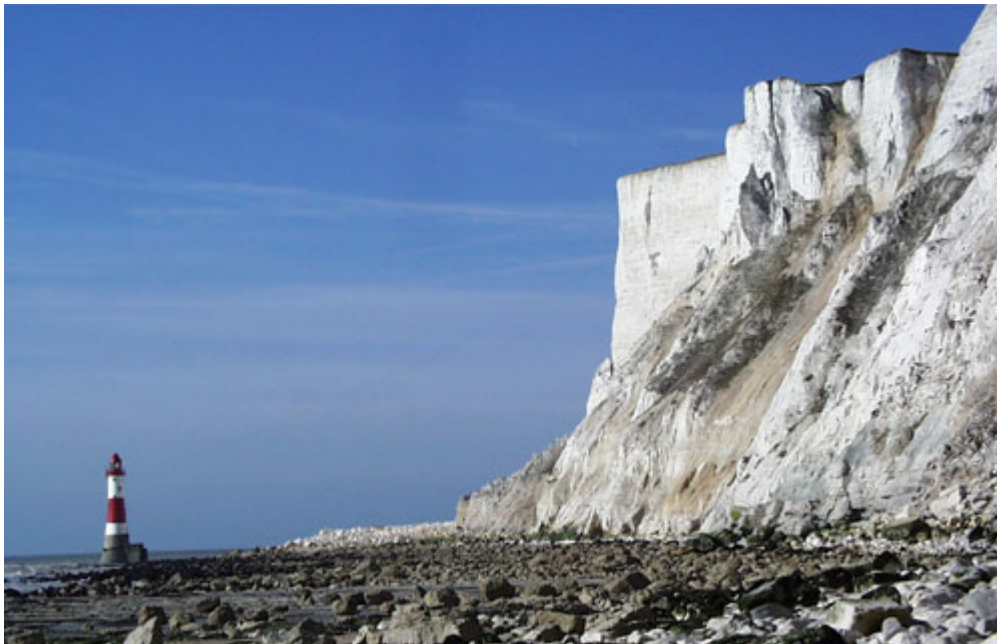
Figure 1 Cliffs and lighthouse at Beachy Head

Beachy Head (Figures 1 and 2) is a famous natural and historic site and tourist attraction on the south coast. The cliff top area is part of the Downland Country Park managed by Eastbourne District Council.

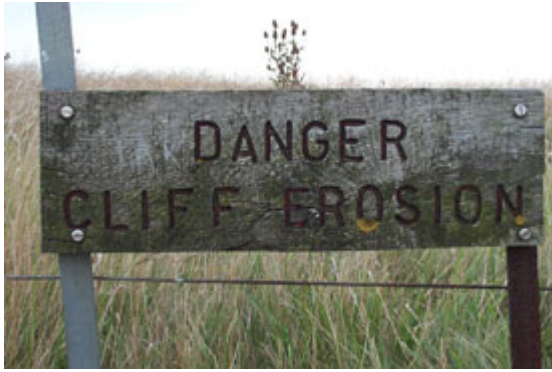
On the foreshore, the chalk platform is littered with debris aprons from recent and earlier rockslides and rockfalls. The dominant landslide mechanism is a type of sliding failure with a very deep tension crack penetrating most of the Seaford Chalk Formation. This mechanism is described in Duperret et al. (2004) as being characteristic of cliffs in the Seaford Chalk and Lewes Nodular Chalk formations in England and their equivalents in France due to the prominent vertical and sub-vertical joint and fault patterns within these formations.

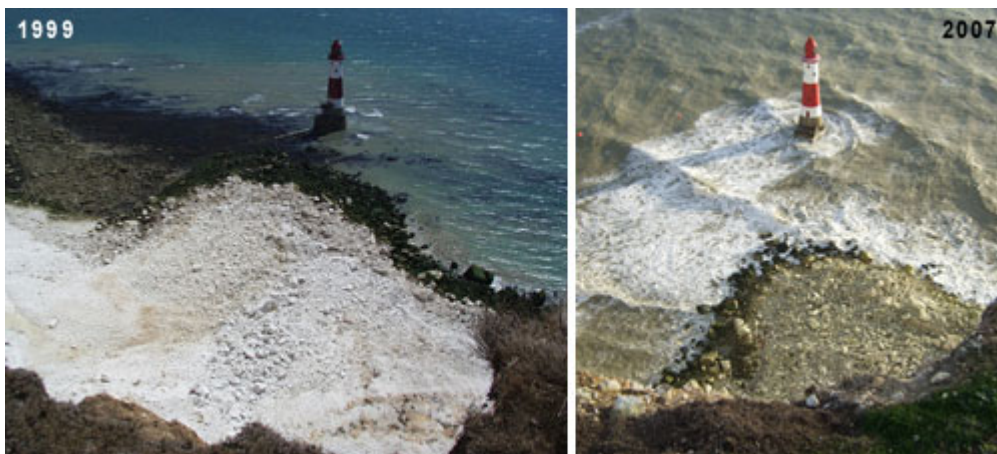
Figure 3 January 1999 landslide debris apron. Photographed July 1999 (left) and October 2007 (right) showing how the debris apron is still present after several years of erosion.

On the night of 10 January 1999, a large landslide occurred at Beachy Head severing power and telecom cables from the cliff top bunker to the lighthouse. For several months, the failure required emergency manning procedures by Trinity House Lighthouse Service. The volume of this landslide is estimated to have been $128\,000\text{m}^3$ (Hobbs et al., 1999) and between $100\,000$ and $150\,000\text{m}^3$ (Mortimore et al., 2004). This landslide produced a large debris apron (Figure 2), which persists to the present day.

The lighthouse base is situated at approximately 192 m from the cliff toe at high tide. The debris apron extended originally about 115 m from the cliff toe and came within 65 m of the lighthouse. The cliff at this point is 126 m high.

A further minor landslide occurred on 8 April 1999 and involved a displaced 'slice' of chalk left by the January slide.

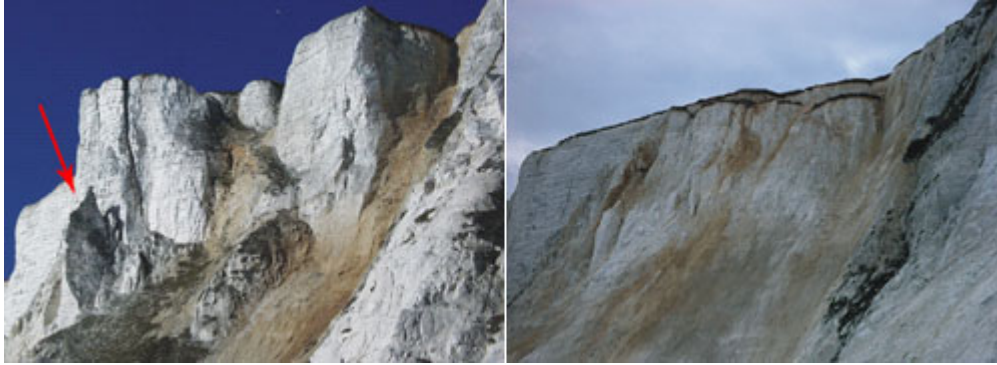
Figure 4 Devil's Chimney before (left) and after (right) the landslide

This landslide occurred at 14.30hrs on 3 April, 2001 and destroyed the landmark known as the 'Devil's Chimney' (Figures 3 and 4). The landslide followed three days of preliminary subsidence and detachment movements amounting to a displacement of a few metres.

A deep tension crack, probably penetrating the entire thickness of the Seaford Chalk Formation, developed following pre-existing joints. The separated block tilted seaward further opening the tension crack and increasing the vertical stresses at its base. Debris and water were able to enter the fissure over many years, before the final slide where failure occurred. This failure is thought to have occurred in two stages separated by a few days or hours.

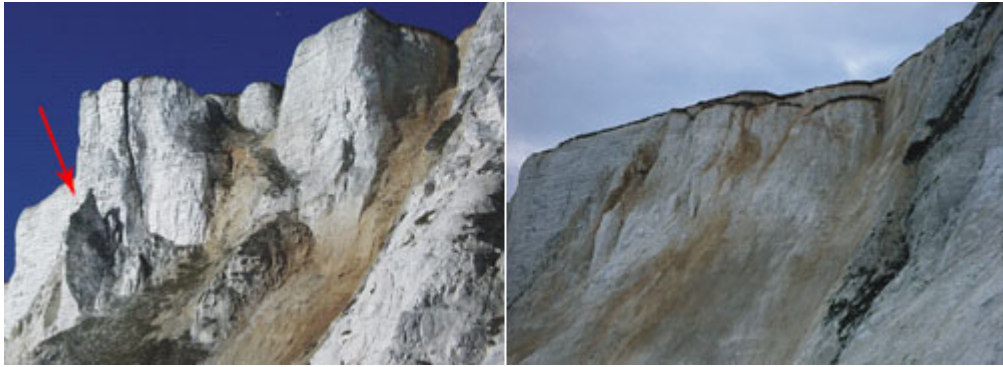
Devil's Chimney before (left) and after (right) the landslide.

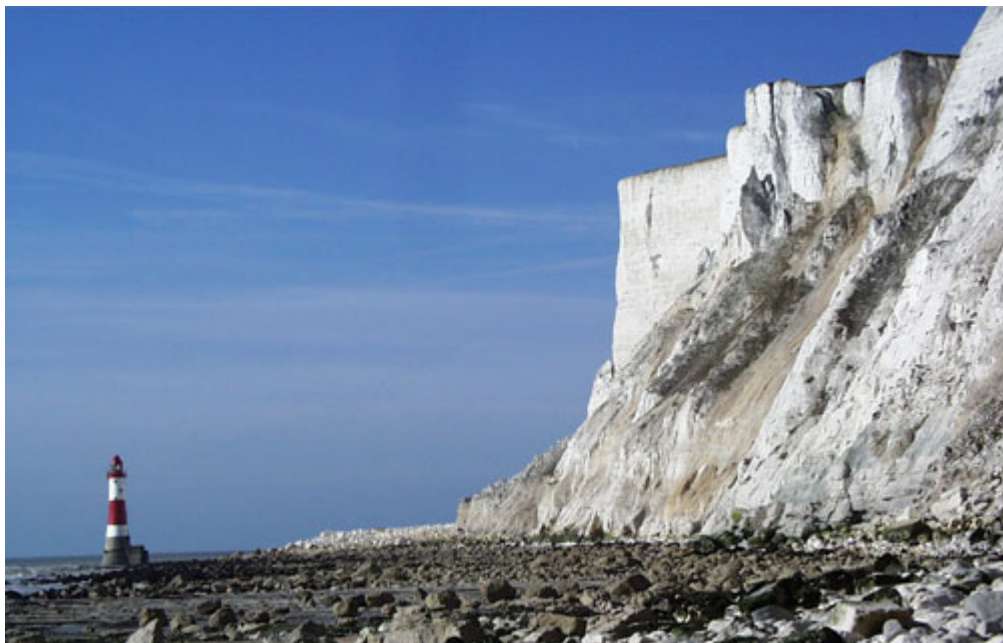
Cross Section: BEACHY HD LIGHTHOUSE + EAST CLIFF

Location: BEACHY HEAD
