# Slope Dynamics Project Report: Holderness Coast - Aldbrough, Survey & Monitoring, 2001 - 2013

Internal Report OR/11/063

Aldbrough, Holderness, coast, erosion, landslides, geotechnics, till, terrestrial LiDAR.

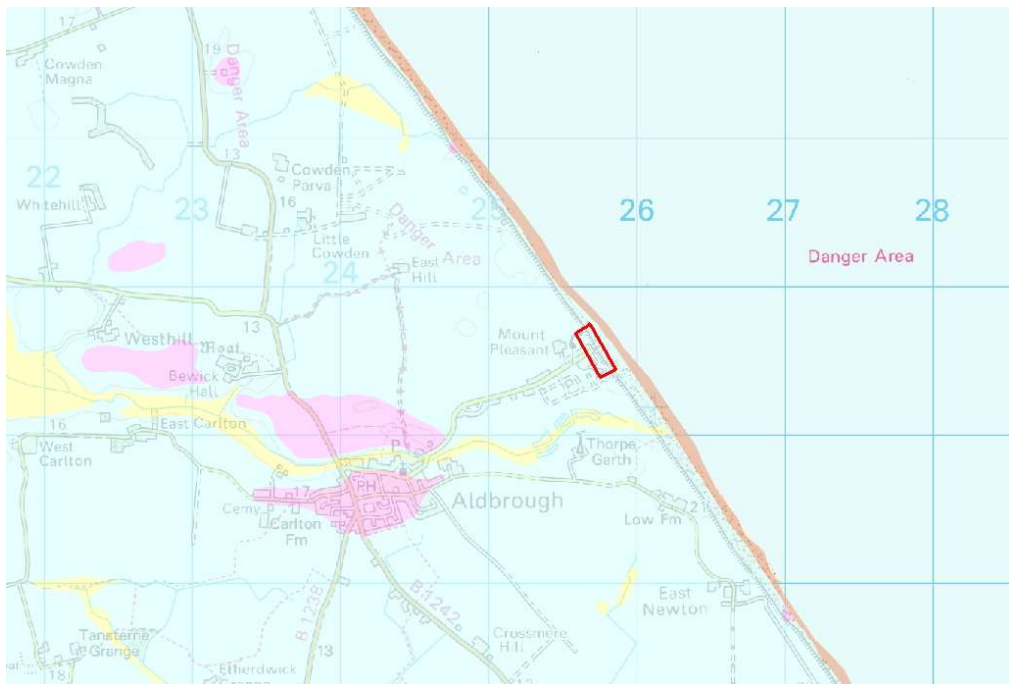
**Figure 4 Superficial geology at Aldbrough showing BGS test site (red)**

(Blue=Till, Yellow=Alluvium, Pink=Glacio-fluvial)

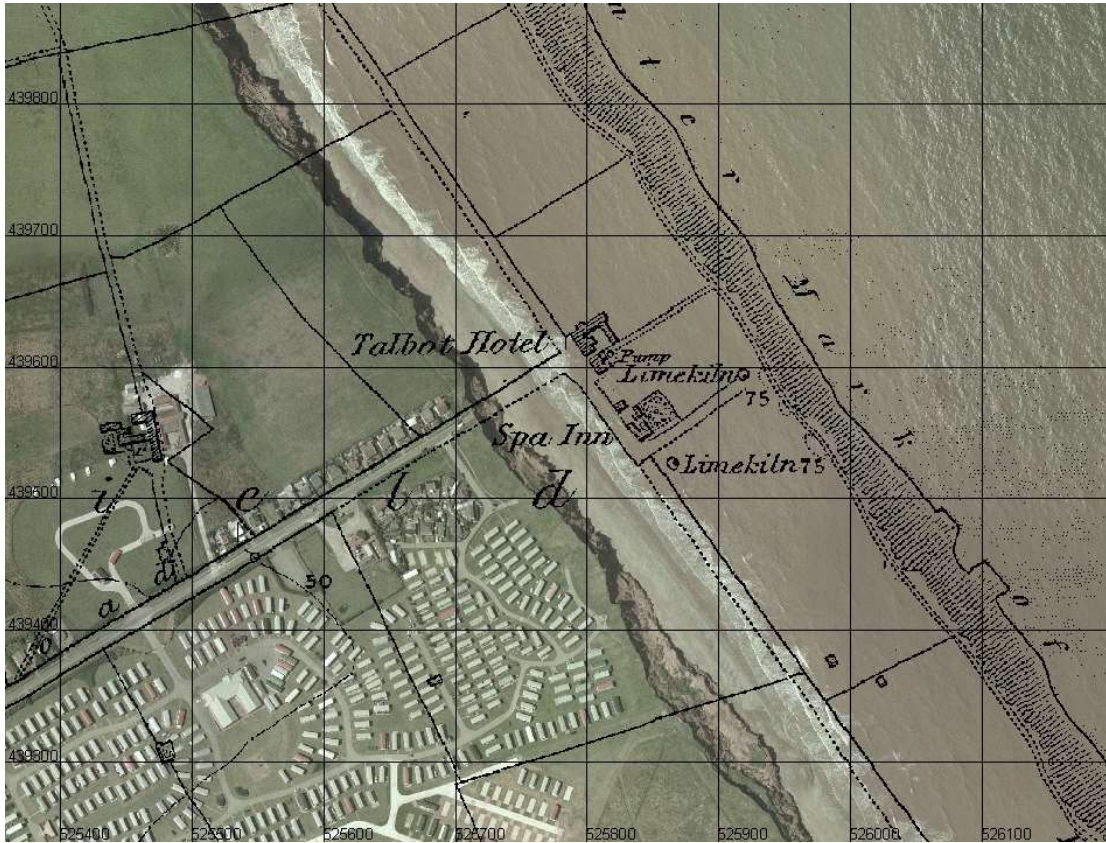
**Figure 7 Historic OS map dated 1855 showing features now lost to the sea (overlaid on 2000 aerial photo)**

Note: registration error at Mount Pleasant farm

Historic OS maps from 1855, 1892 and 1929 ([Figure 8](#), [Figure 9](#) & [Figure 10](#)) show the parts of the coastal settlement at Aldbrough that have been lost to the sea. These include, at different times, a hotel, guest houses, pub, amusement arcade, lime kilns and a coastguard station. They all show a short coastal road running parallel with the cliff (the southward part of which formerly connected with East Newton) and branching from Seaside Road. The 1929 map also shows a long line of what appear to be beach huts or bungalows along this road; the cliff at this time being very close to the road. It is difficult to draw quantitative conclusions regarding recession rates from these maps as the date of publication of the map does not necessarily match the date of the survey used to produce it. As recently as 1980 there was an

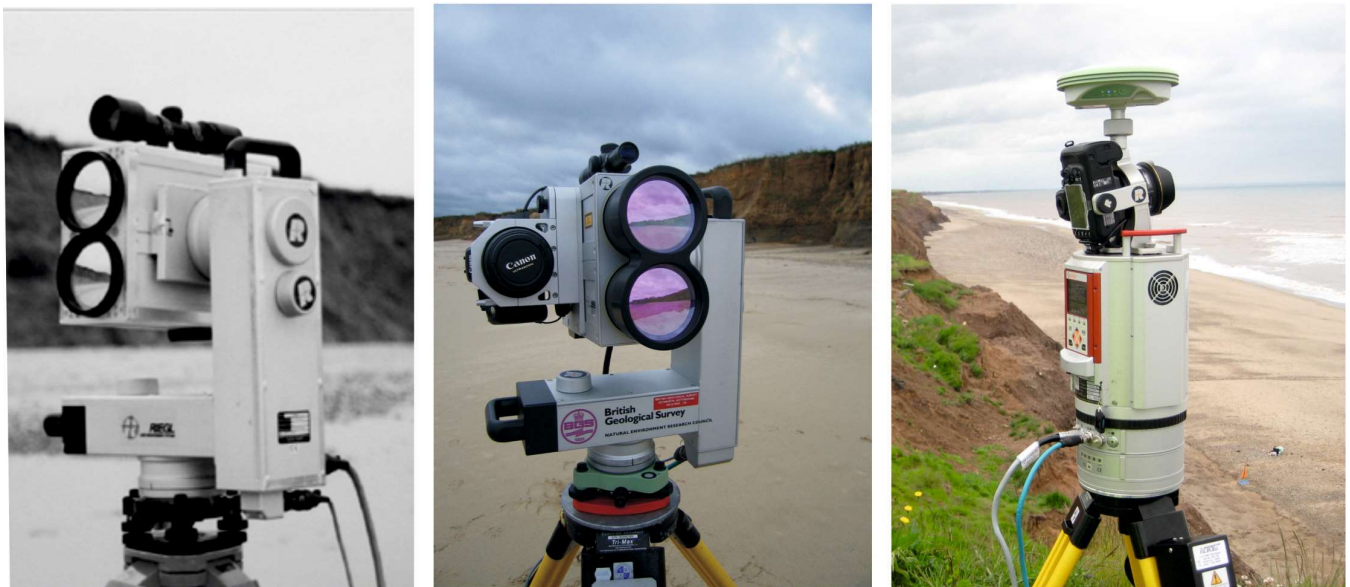
**Figure 10 Riegl LPM2K (left), LPM-i800HA (middle) and VZ1000 (right) laser scanners**

The range-finding accuracy is quoted as 50 mm for the Riegl LPM2K, 25 mm for the Riegl LPMi800HA and 15 mm for the VZ1000, though repeatability in each case is considerably better; for example, it was found that baseline distances of 100 m were capable of repeat measurement to 1 mm (1 in 250000) under ideal conditions with the LPM scanners. These values are largely unaffected by range if atmospheric conditions are ignored. The pan/tilt mount has a stepper motor resolution of  $0.009^\circ$ . This represents a movement of 16 mm per 100 m range (Figure 12). The laser beam divergence for the LPM2K and LPMi800HA scanners is 0.8 mrad. This is equivalent to an 80 mm increase of beam width per 100 m range (Figure 13). Other ranges are linearly proportional in each case. The significance of this is that where a scan involves large distances, those far objects will be less well defined in terms of position and form than close objects. For example, at a range of 500 m, the laser footprint is about 0.4 m in diameter. This factor particularly affects objects inclined at an acute angle to the direction of the laser beam. An estimate of the improvements in the overall positional accuracy of the combined TLS (scanner + dGPS) during the task is shown in Figure 14 showing how accuracy has improved during the early days of the task from around 2.5 m to <20 cm in the later scans. These improvements have been largely due to equipment upgrades. The general picture, however, is of continuing improvement both in accuracy and ease of use.

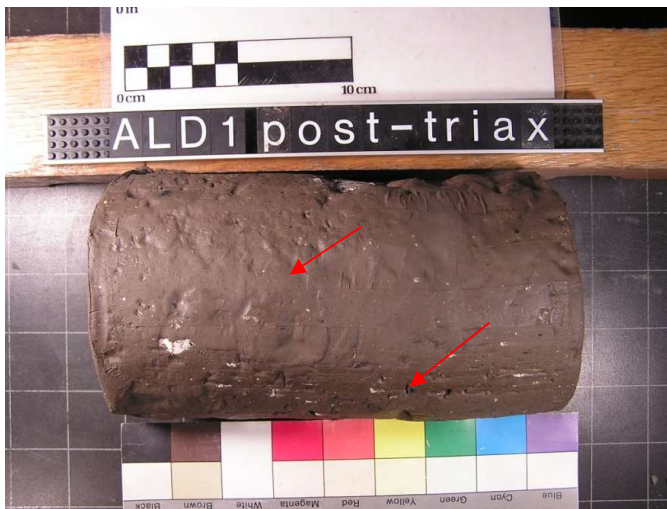
**Figure 16** Post-failure 100mm diameter triaxial test specimen of Withernsea Till Member (principal shear surface shown by red arrows)

The laboratory *mechanical* testing programme consisted of triaxial testing using a GDS 100 mm stress-path system. The test used was the multi-stage ‘consolidated isotropic undrained’ (CIU) with pore pressure measurements ([Head, 1996](#)), allowing ‘peak’ effective strength parameters to be measured at effective average stresses of 100, 200 and 400 kPa applied to a single specimen. The specimen size was 102 mm diameter with a target length to diameter ratio of 2:1. Top, bottom, and side drains were used to facilitate consolidation. The specimen was saturated, prior to stage 1 isotropic consolidation, by staged ramping-up to an elevated (back) pressure; the final value being determined by the ‘B-test’ (i.e. pore pressure response to applied load increment). Axial compression was applied in the undrained state following each consolidation stage, with pore pressures measured at either end of the specimen. Stages 1 and 2 of axial compression were discontinued when the stress ratio reached a peak, whereas the stage 3 axial compression was continued beyond shear failure. A post-failure specimen is shown in [Figure 16](#).

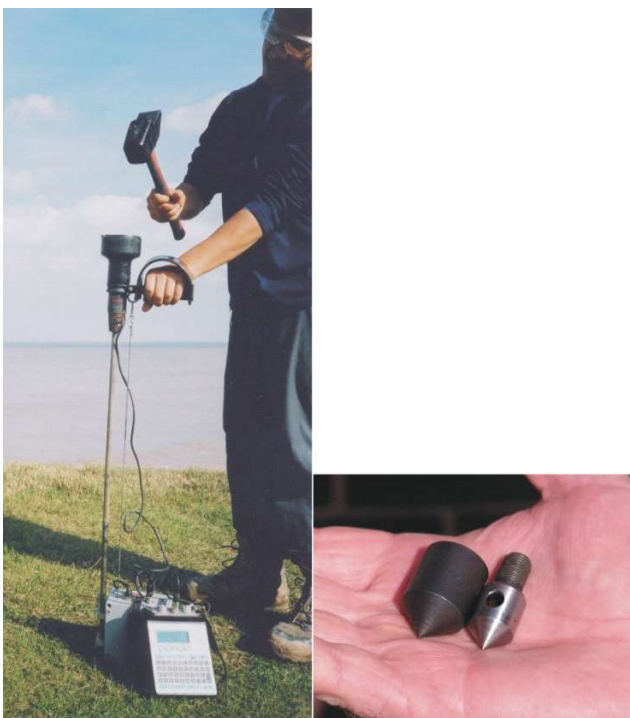
**Figure 17** Panda™ ultra-lightweight penetrometer (Type 1) Note: alternative cones (right)

Field testing consisted of cone penetrometer tests on the cliffs using the Panda (types 1 and 2) ultra-lightweight penetrometer apparatus ([Figure 17](#)). This apparatus is capable of penetrating to depths of 5 m in most types of soil. There are two types of cone available; the larger is disposable and the smaller is fixed ([Figure 17](#)).

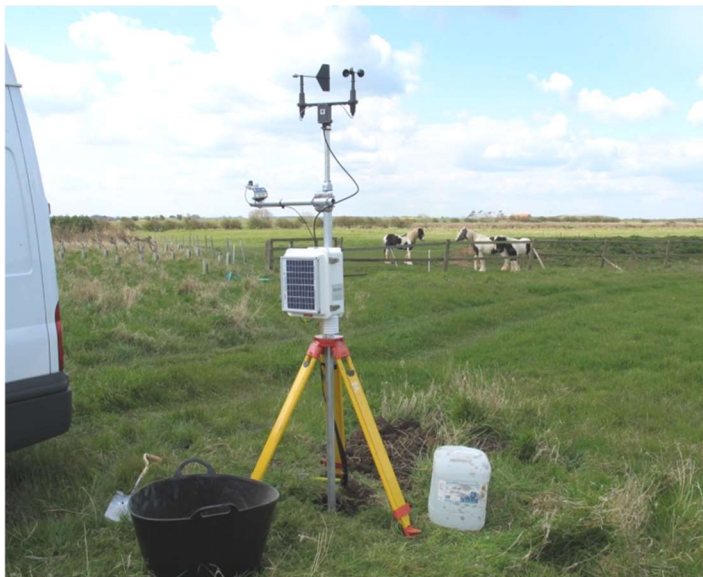
**Figure 21 Installation of ‘BGS Aldbrough’ weather station (16<sup>th</sup> April, 2012)**

On 16th April 2012 a Campbell Scientific CR200X weather station was installed on farm land adjacent to, and owned by, the Aldbrough Leisure Park at Mount Pleasant Farm to the rear of 333, Seaside Road [NGR 525461,439627] ([Figure 21](#)). This is currently 250 m WNW from the centre of the test site. The weather station is solar/battery powered and automatically records rainfall, wind speed/direction, temperature, relative humidity, barometric pressure and solar radiation, currently at 10 minute intervals. The purpose of the weather station is to permit continuous monitoring of weather conditions at a location very close to the test area and to determine its effect on cliff stability. Rainfall and wind data in particular will be relevant to landsliding and coastal erosion, respectively. The sensors also allow evapotranspiration (ET<sub>o</sub>) to be calculated.

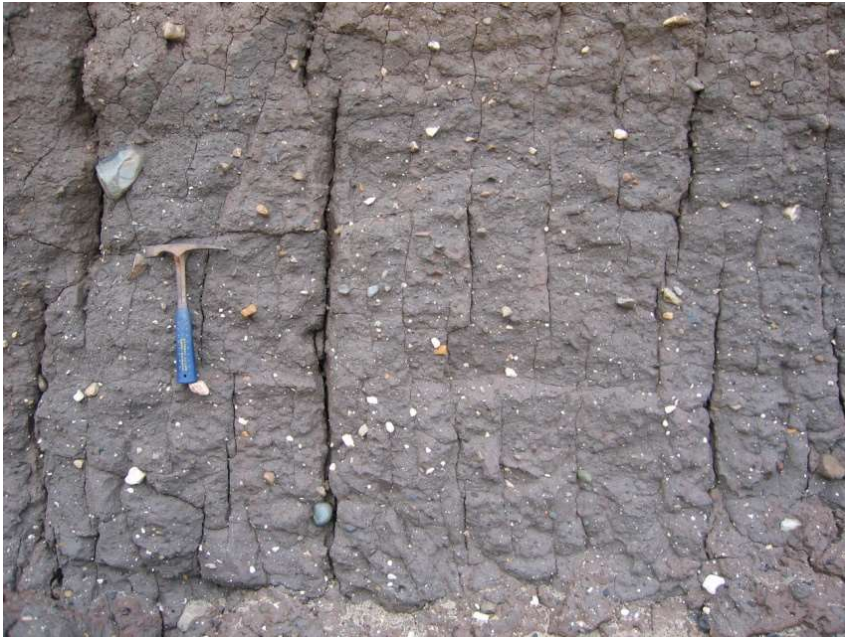
**Figure 22 Skipsea Till Member fabric (Holderness Formation)**

Note: closely-spaced vertical jointing

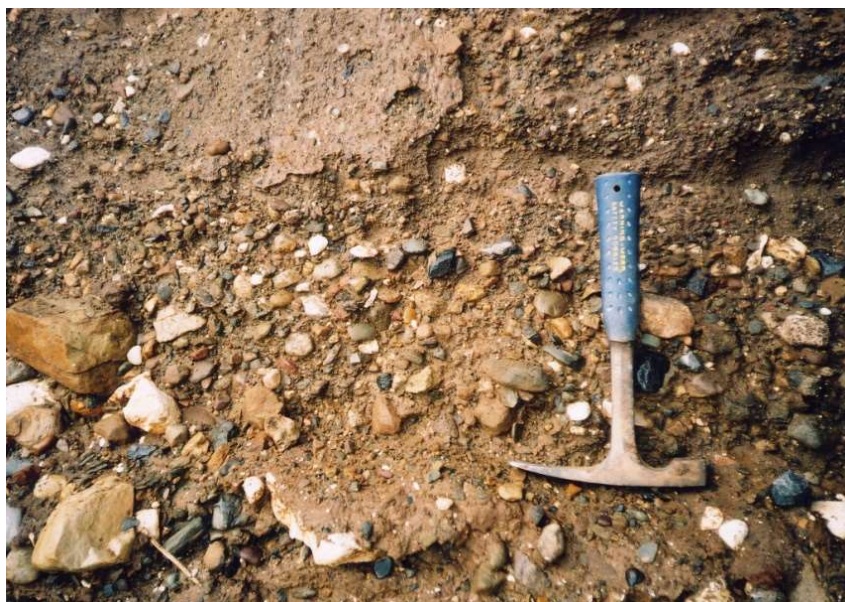
**Figure 25 Mill Hill Member sands and gravels (Holderness Formation)**

Note: active seepage

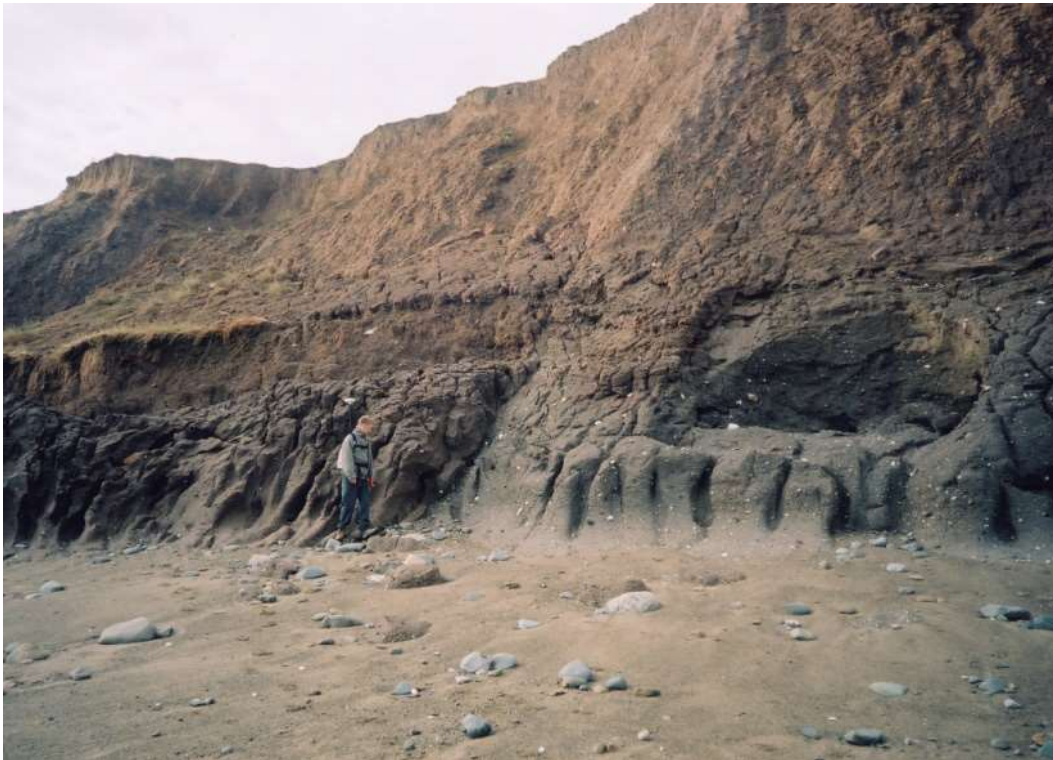
**Figure 27 Marine erosion of cliff toe tills**

Note: water-worn unslipped grey till beneath slipped brown tills and scour hollow (right) (Sep 2003)

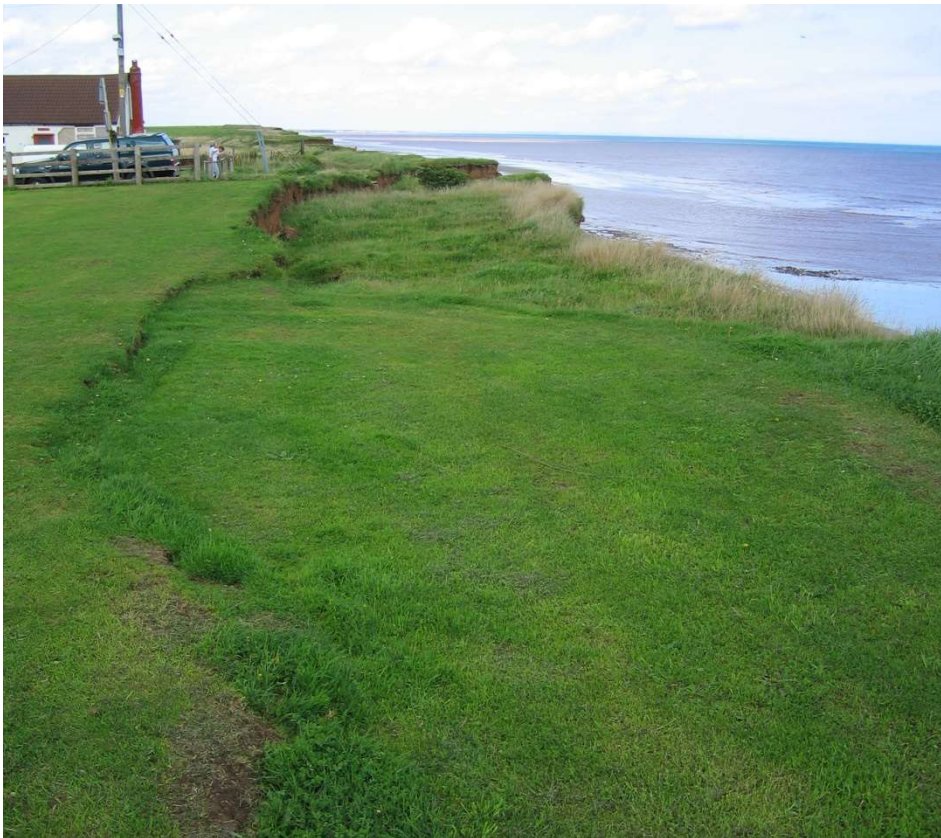
**Figure 30 Early stages of deep-seated rotational landslide development, central embayment (Aug 2004)**

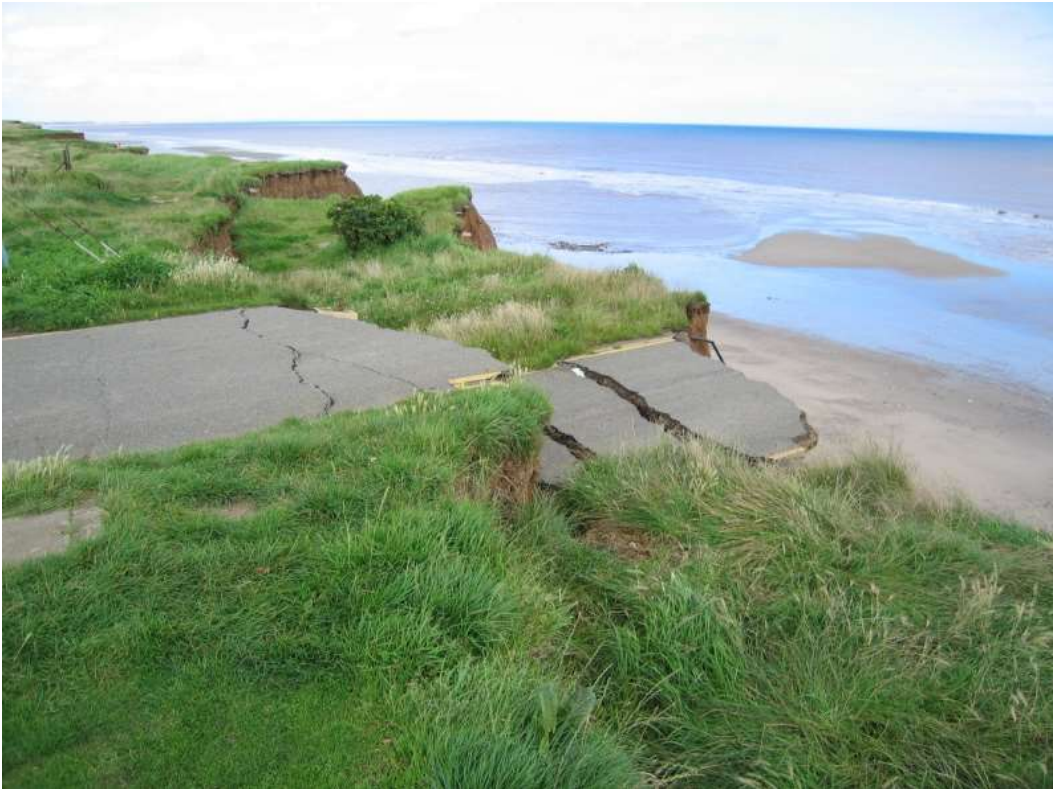
**Figure 31 Principal mode of landsliding in upper cliff: rotations**  
(Note: Seaside Road and lateral development of elongate embayment) (Sep 2004)

The pattern of rotation development frequently follows that shown in Figure 29 with examples in Figure 31 to Figure 35 whereby lateral development of rotations results in an elongate embayment, frequently with greatest subsidence within the initiating semi-circular embayment, and decreasing subsidence away from it. Developing pre-subsidence tension cracks may also be found further along the cliff-top. The mechanism is due to the fact that the initial rotation reduces lateral support to the adjacent block which initiates its own rotation, and so on. This is made possible by the very prominent jointing pattern in the tills and stress relief cracking inferred to be running parallel to the cliff. During the later stages of the process the individual embayments tend to amalgamate with further rotation and break-up, the rotated masses adopting a characteristic tilt towards the original movement.

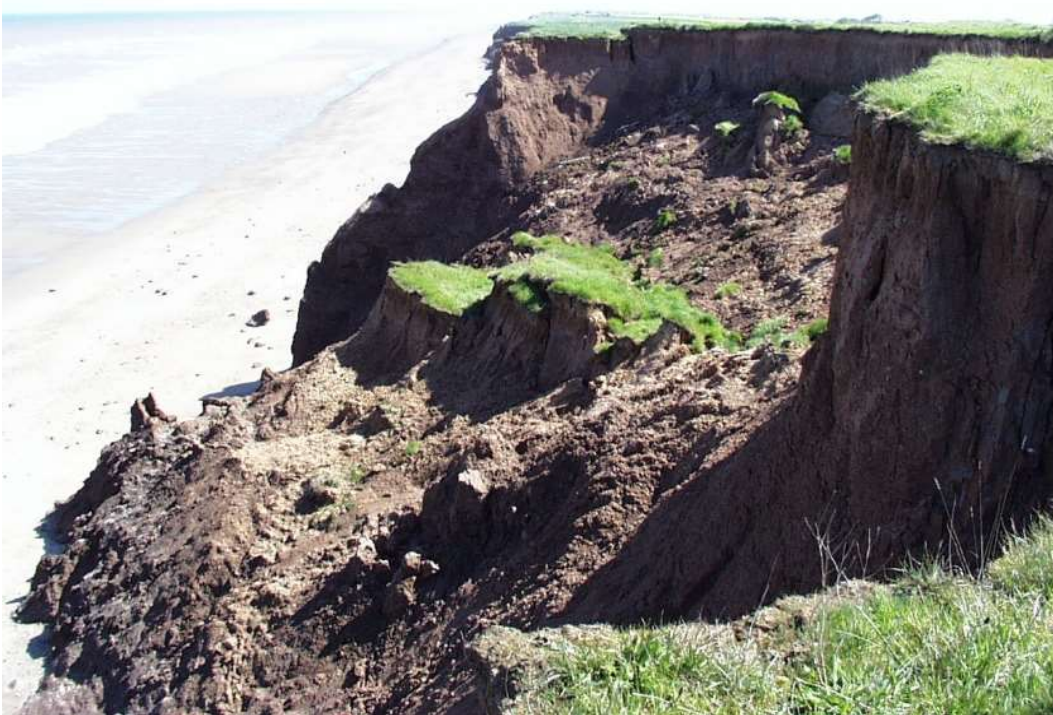
**Figure 32 Well-developed deep-seated rotations forming or deepening an embayment, Sep 2002**

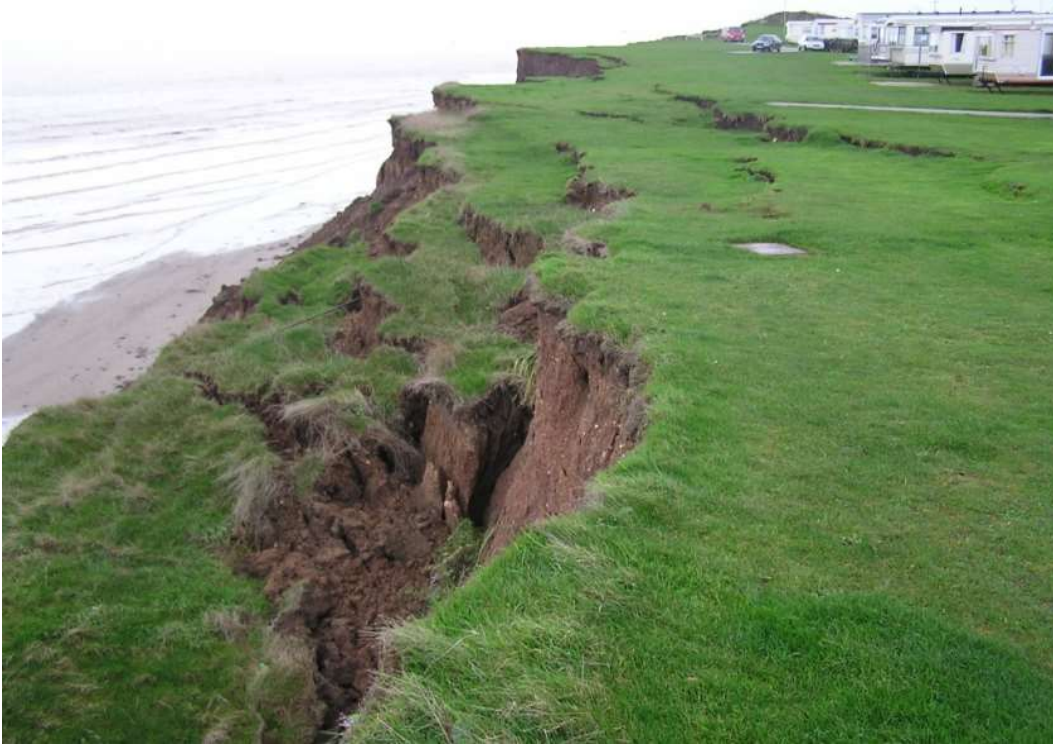
**Figure 33 Early stages of en-echelon rotations showing enhanced deformation northward (towards camera) Refer to [Figure 29](#), Nov 2005**

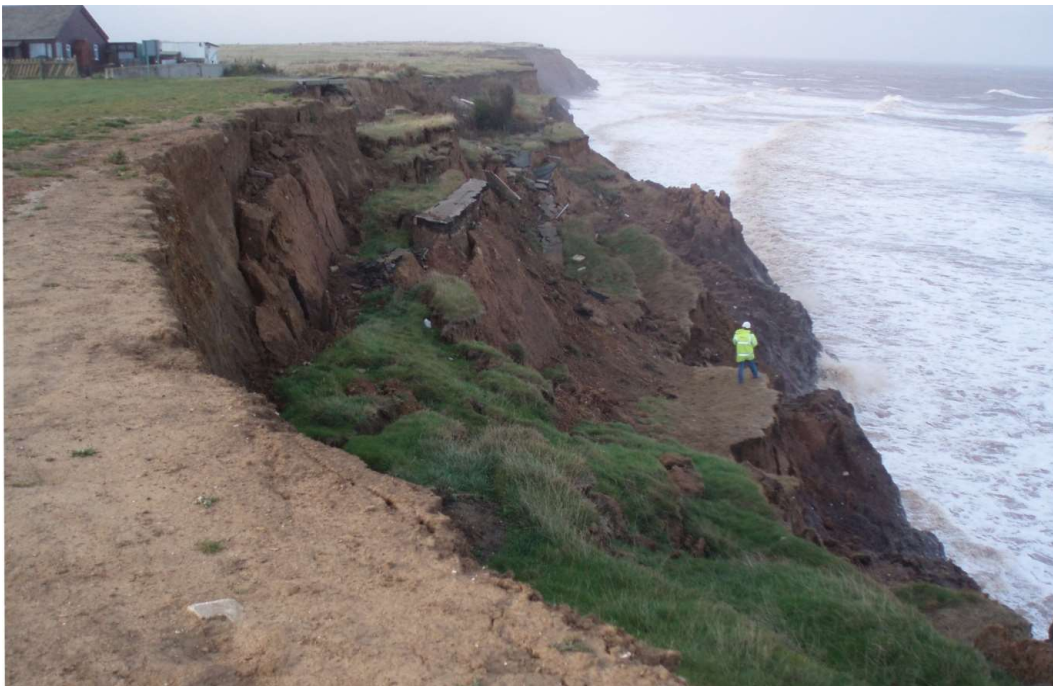
**Figure 34 Central embayment of test area, looking northward, showing well-developed multiple deep-seated rotations and embayment development (Oct 2011)**

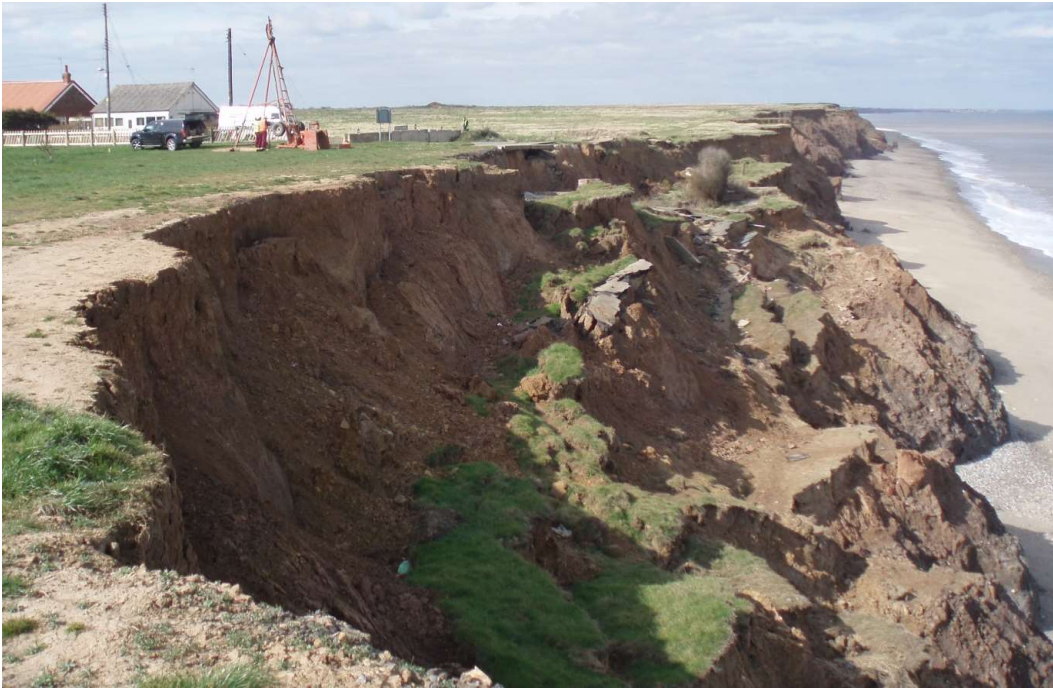
**Figure 35 Central embayment of test area, looking northward, showing the latter stages of multiple deep-seated rotational landslide degradation and embayment development (Mar 2012)**

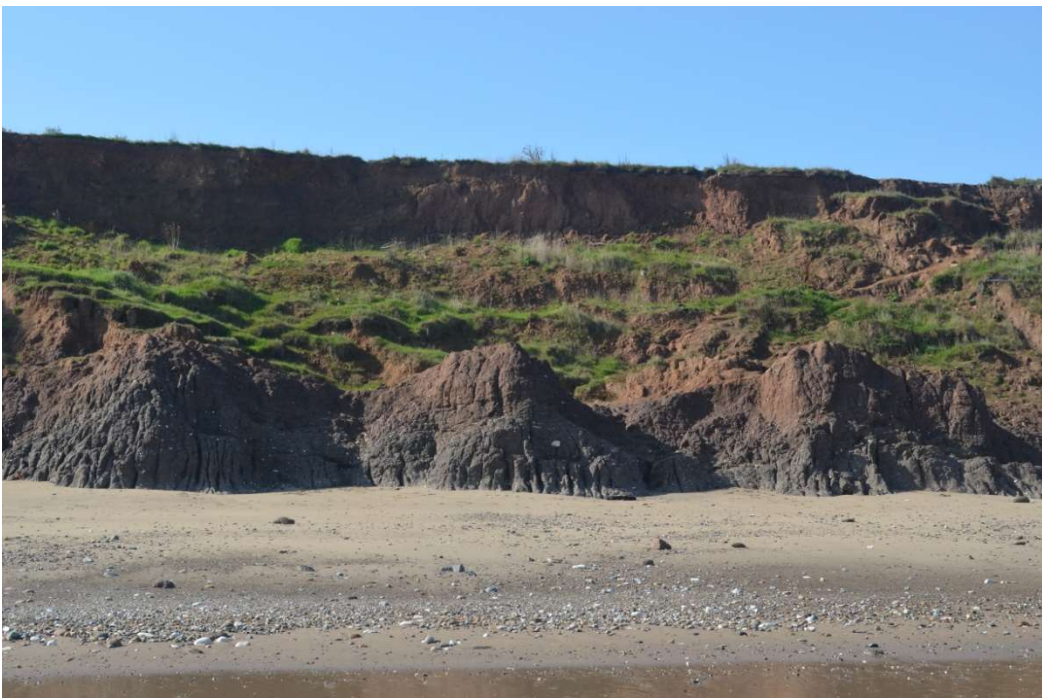
**Figure 36 Individual rotational slip masses in latter stages of degradation (Sep 2014)**

Degradation of the large rotational landslides progresses by means of the individual slipped masses reducing in size and becoming isolated, forming small ridges perpendicular to the cliff ([Figure 36](#)). Ultimately, these break up, some of the debris forming armoured mud balls; clay balls surrounded by gravel collected from the beach.

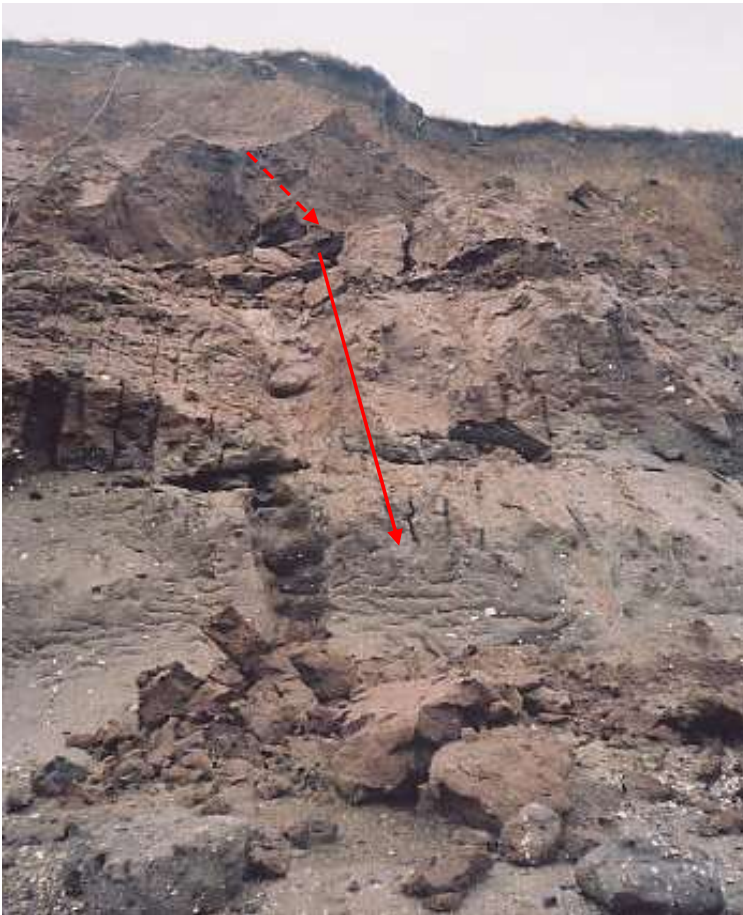
**Figure 37** Fall/topple from Skipsea Till Member in cliff depositing debris onto beach (20/09/01) (NOTE: estimated 3 m<sup>3</sup> of material)

The toppling failures and falls have been observed to emanate from the Skipsea Till Member, and consist of blocks about 2 to 3 m in height. These are produced by virtue of the pre-existing closely spaced, vertical and sub-vertical, orthogonal jointing patterns within the till on the cliff, notch development by extreme wave action at the base of the cliff removing support, development of stress-relief fractures parallel to the cliff and by seepage from the sand and gravel horizon. *These failures are frequent and present a particular hazard to members of the public at the foot of the cliff.* Such a fall was observed (at close hand!) on 20<sup>th</sup> September 2001 within a particularly active zone (**Figure 37**). The debris from this topple and fall broke up on impact with the beach. It was estimated to be around 3 m<sup>3</sup> in volume.

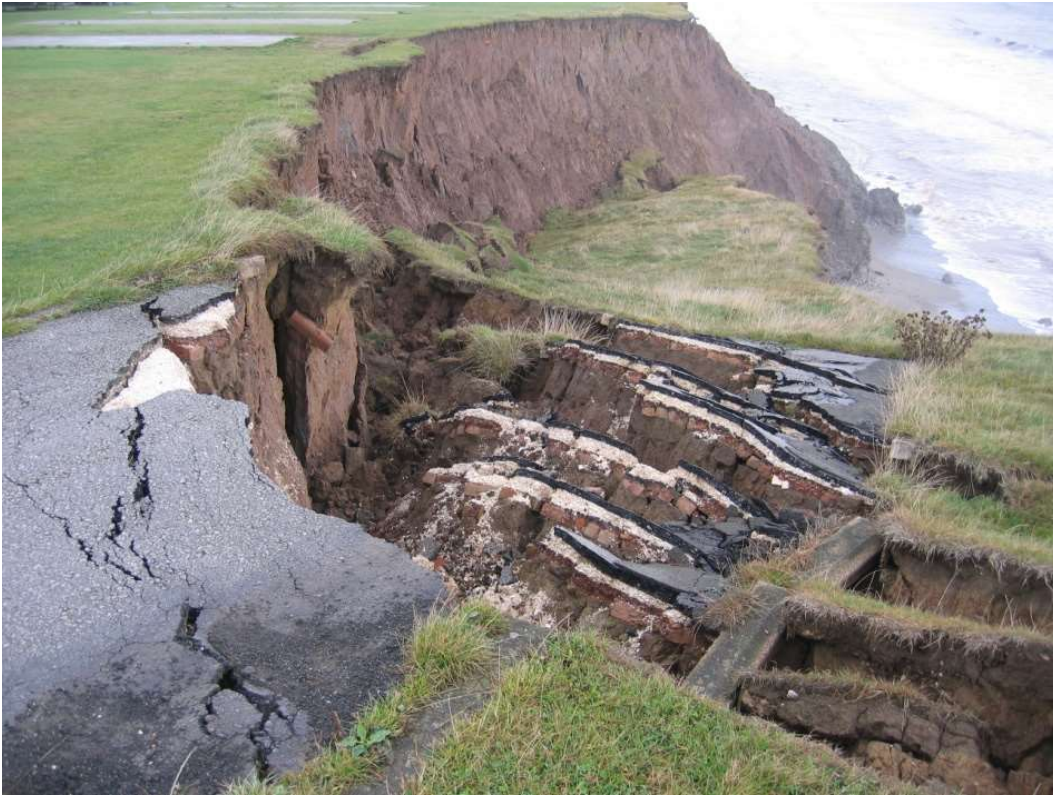
**Figure 38 Fresh multiple topple within (temporary) backscarp at rear of large, well-developed rotational failure (Oct 2009)**

An example of a multiple topple within one flank of a backscarp formed by an earlier large rotational failure is shown in **Figure 38**. These features appear to have formed as a result of short-term stress relief within a near-vertical backscarp, rather than having developed along pre-existing structural features within the till.

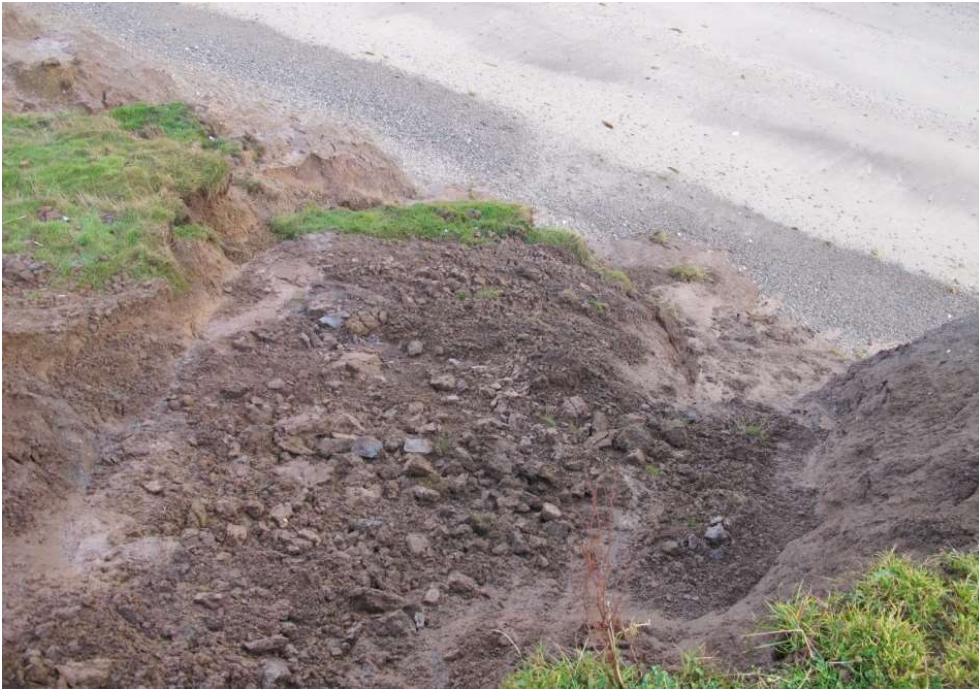
**Figure 39 Debris (or earth) flow within upper and mid-cliff (Dec 2012)**

Debris or earth flows are only occasionally observed. These tend to form on mature slopes which have established a relatively shallow slope angle following a cycle of rotations or topples/falls and subsequent degradation, and are in response to heavy or prolonged rainfall events with the possible contribution of seepage. An example of such a debris flow is shown in **Figure 39**. This is sourced within the Withernsea Member, possibly involving break-up of a multiple topple or rotation, and has a depth of about 1 m.

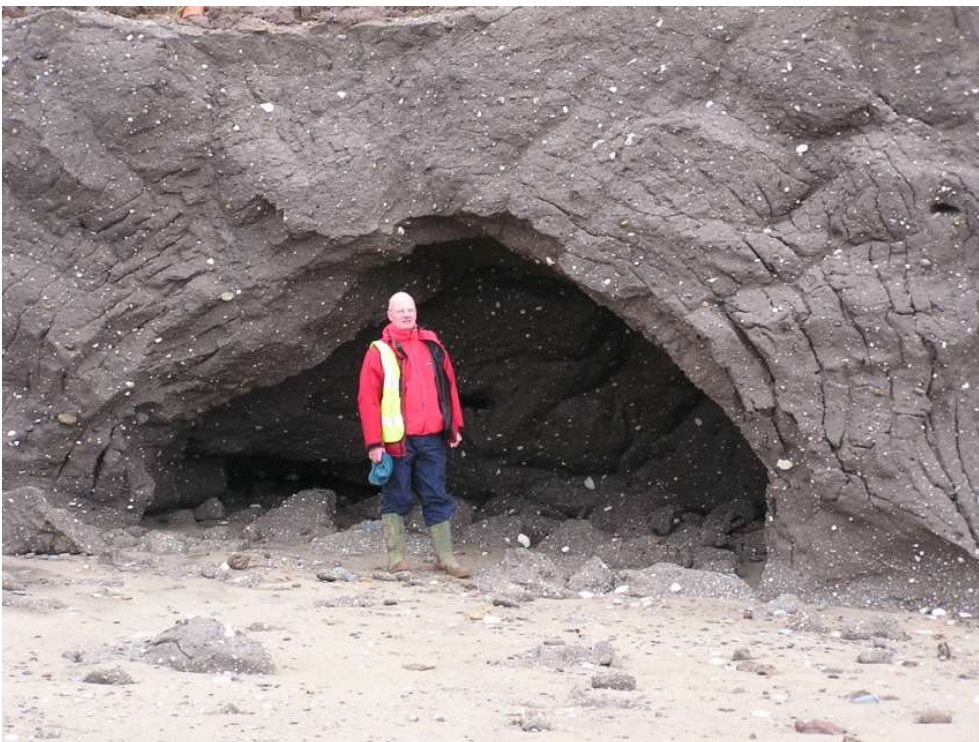
**Figure 40 Cave developed at beach level within Skipsea Till Member (Sep 2001)**

Note: Active hoop stress fractures

Notch cutting by wave action and falls at the cliff toe within the grey Skipsea Till Member occasionally develop into small caves (Figure 40). These may in turn collapse, creating further cliff instability, though this process has not been observed first hand.

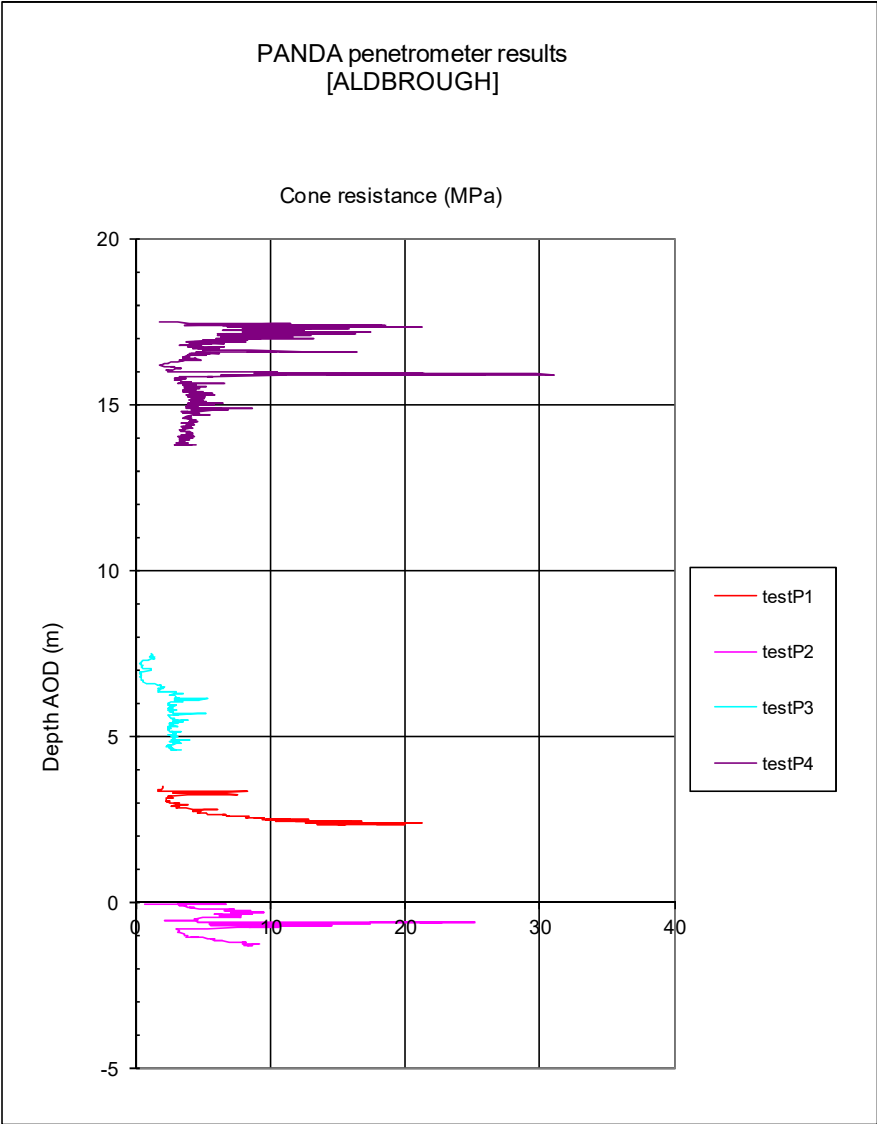
Figure 42 PANDA penetrometer profiles, Aldbrough (tests refer to Figure 41 and Table 6)

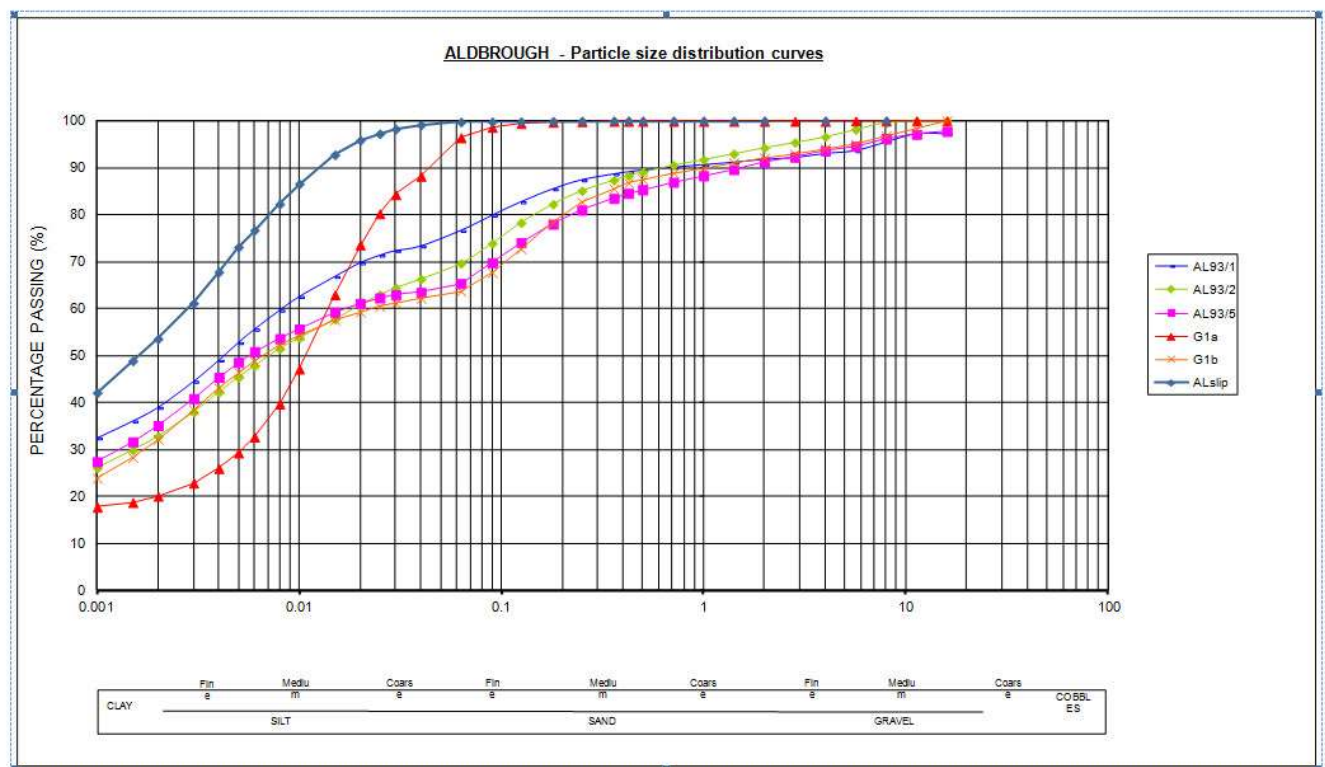
**Figure 44 Particle size distribution plot for tills**

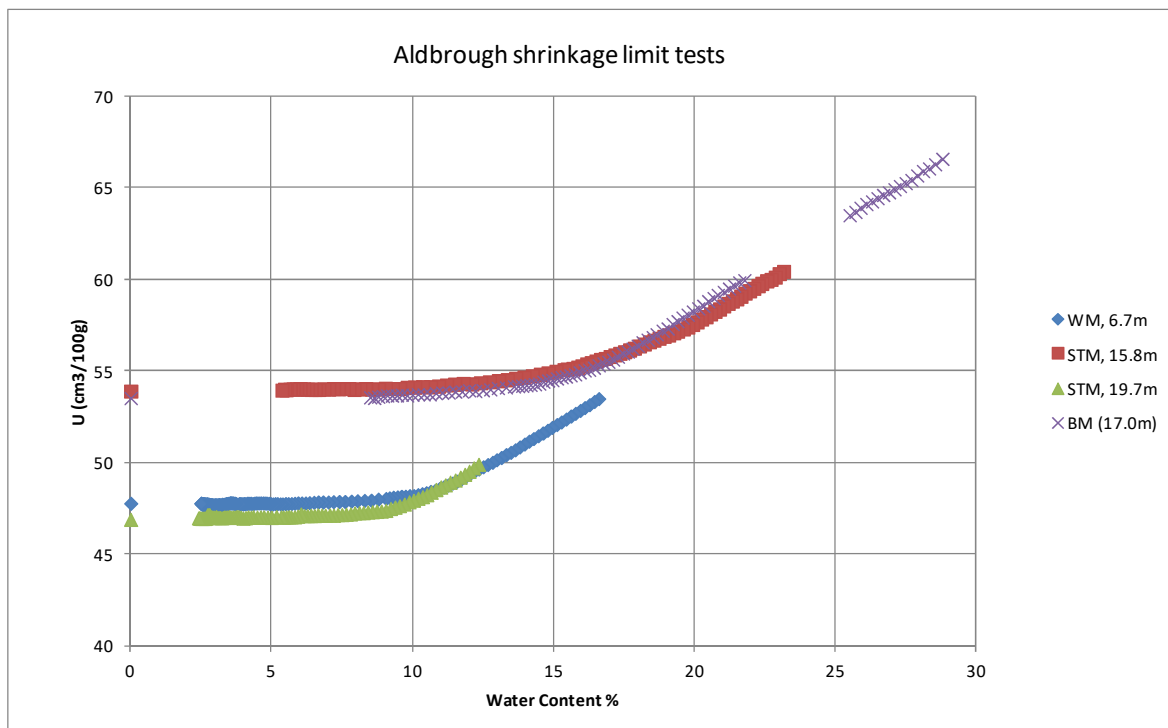
**Figure 45 Shrinkage limit test plot for four Aldbrough till samples from BH1a core and from cliff face (slip)**

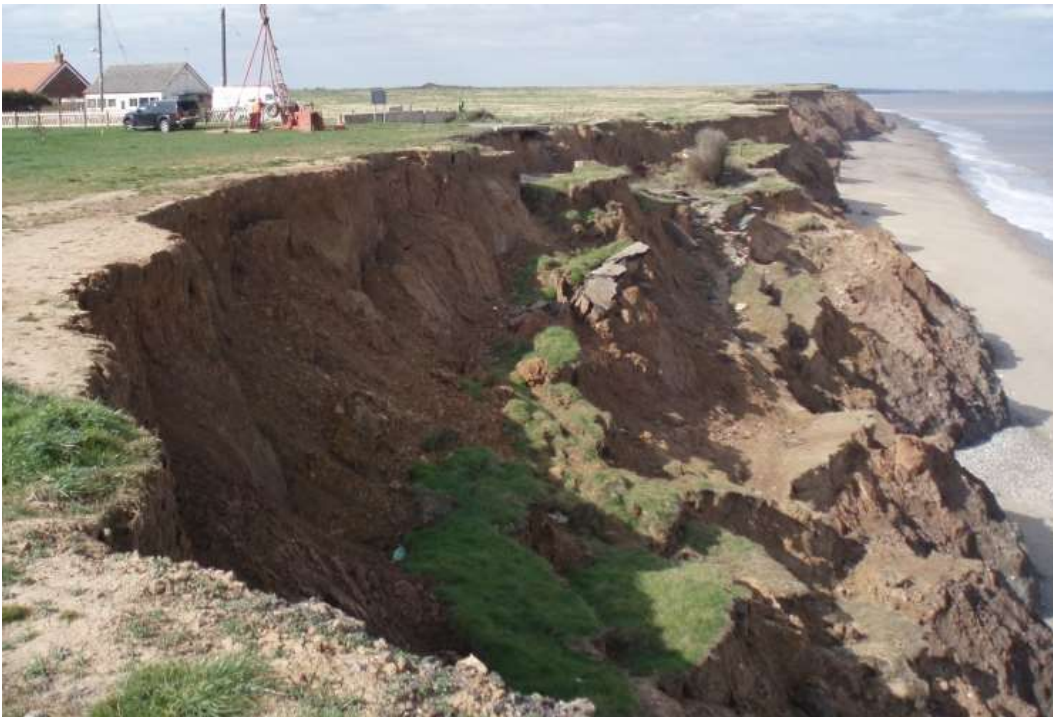
**Figure 73 Renewed movement and progressive degradation of pre-existing rotations (upper and mid cliff) in central embayment (April 2012)**

March 2012, shown in **Figure 69**, reveals major loss throughout the upper and mid cliff due to renewed rotations and degradation of previous slipped masses (**Figure 73**). The lower cliff features several newly established promontories which have not undergone slipping or significant erosion. Between these there has been moderate to major loss, due to mudflow / debris flow. Once again, the reason for the presence of many small patches of apparent gain is not clear, but may be the presence of random building debris on the slope. The final change model between March 2012 and June 2013, shown in **Figure 71** reveals moderate loss throughout with a small area of enhanced loss at the northern extremity (upper cliff). This is due to continuing degradation of previously slipped masses. Small promontories within the lower cliff in the southern embayment have remained essentially intact.

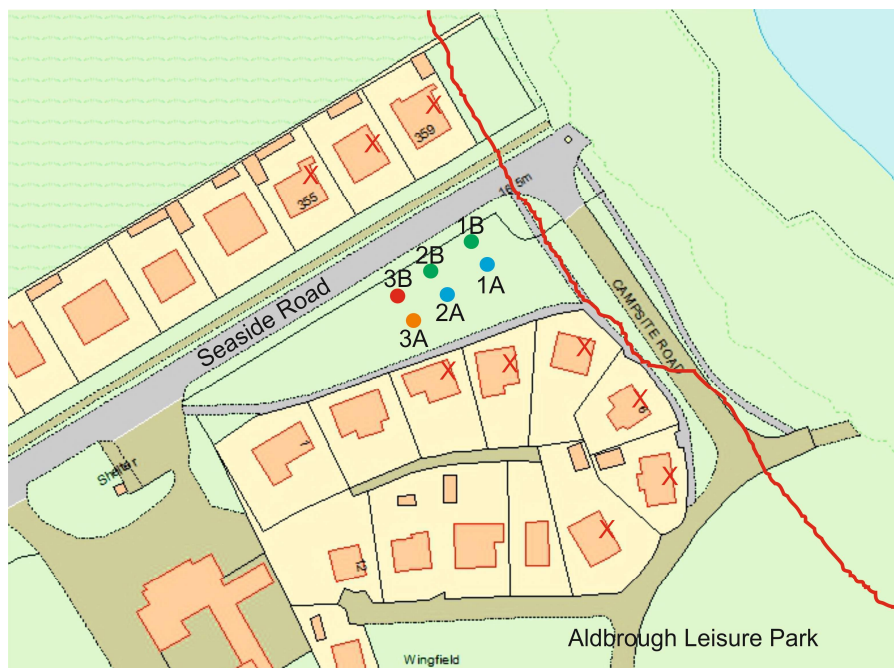
**Figure 84 Location of boreholes at Aldbrough test site**

Borehole No.	BH Depth (m bGL)	Location (Easting, Northing), Ht. (aMSL.)	Method	Instrumentation	Instrument depths (m bGL)
1a	20.5	525684.3, 439529.7, 16.52	Cable percussion (sampled)	VW Piezo array (x5)	4.0, 8.0, 12.0, 16.0, 20.0
1b	20.5	525681.4, 439533.7, 16.56	Rotary (open-holed)	Inclinometer casing (70mm, QJ)	0.0 – 20.0
2a	20.5	525676.5, 439523.6, 16.18	Cable percussion (sampled)	VW Piezo array (x5)	4.0, 8.0, 12.0, 16.0, 20.0
2b	20.5	525673.4, 439527.5, 16.41	Cable percussion	Inclinometer casing (70mm, QJ)	0.0 – 20.0

3a	19.90	525670.1, 439518.8, 16.1	Geobore-S triple barrel wireline	VW Piezo array (x6) PRIME array	1.7, 3.7, 7.7, 11.7, 15.7, 19.7m  1 m intervals 0.9 - 19.9m
3b	19.85	525667.3, 439522.8, 16.3	Geobore-S triple barrel wireline	Inclinometer casing (70mm, QJ) PRIME array	– 19.85m  1 m intervals 0.85 - 19.85m
<i>Survey pin No.</i>		<i>Location / ht. (aMSL.)</i>	<i>Description</i>		
X1 pin		525690.6, 439537.7, 16.70	Pin with yellow disc on kerb	Caravan Road	
Pin 1		525676.9, 439539.9, 16.40	Pin in road parallel to BH's 1A and 1B	Seaside Road	
Pin 2		525667.7, 439534.7, 16.33	Pin in road parallel to BH's 2A and 2B	Seaside Road	
Pin 3		525659.8, 439529.8, 16.23	Pin in road	Seaside Road

NOTE: Dwellings marked X have been demolished by time of reporting

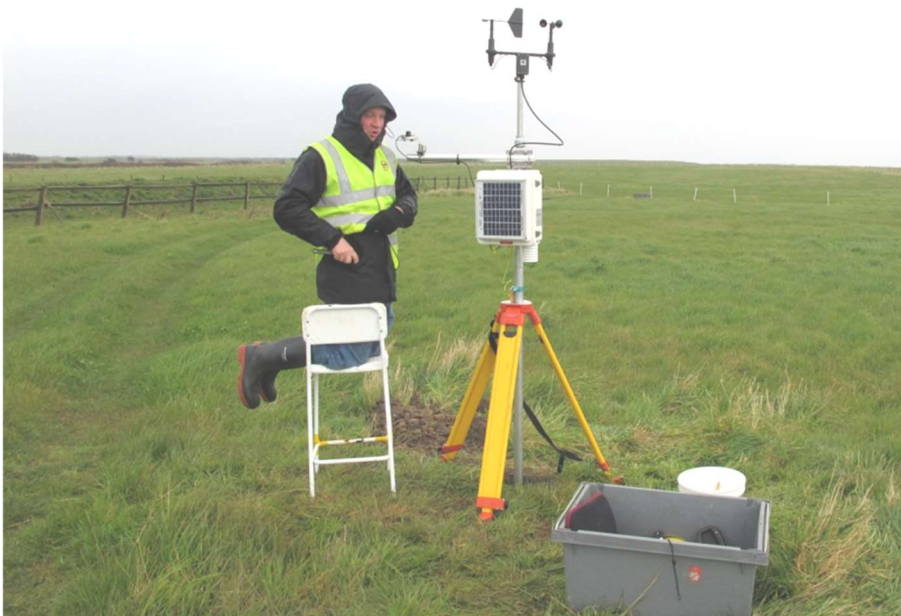
**Figure 85 BGS's Campbell BWS-200 weather station newly installed at Aldbrough (Apr 2012)**

The BGS's 'Slope Dynamics' team installed a Campbell BWS-200 weather station (Figure 85) at Aldbrough on 17<sup>th</sup> April, 2012. The location is NGR 525459, 439627, that is, 250 m WNW of the centre of the test site (at the time of installation). The weather station measures the following parameters automatically at preset time intervals (currently hourly):

- Air temperature
- Dew point
- Wind speed
- Wind direction
- Precipitation
- Solar radiation
- Air temp
- Relative humidity
- Evapotranspiration
- Barometric pressure
- Battery voltage

Data are logged to a built-in CR200X datalogger and are retrieved manually to a laptop via PC200W software for Windows using an RS232 cable or RS232 - USB converter cable.
