New exposed section in the Ardersier Silts Formation; November 20th-21st, 2017

Engineering Geology and Infrastructure Programme

Open Report OR/19/016

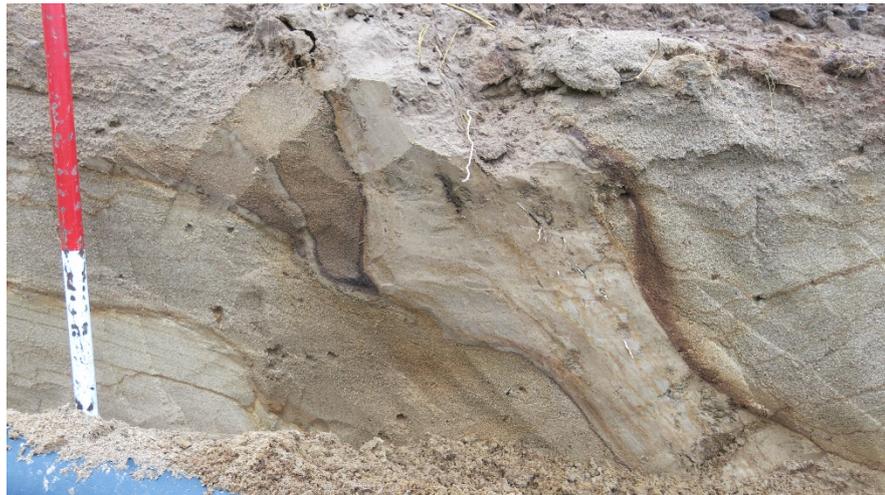
Front cover

Field photograph of a clay vein intruding into a sand unit in the newly exposed Ardersier Silts Section.

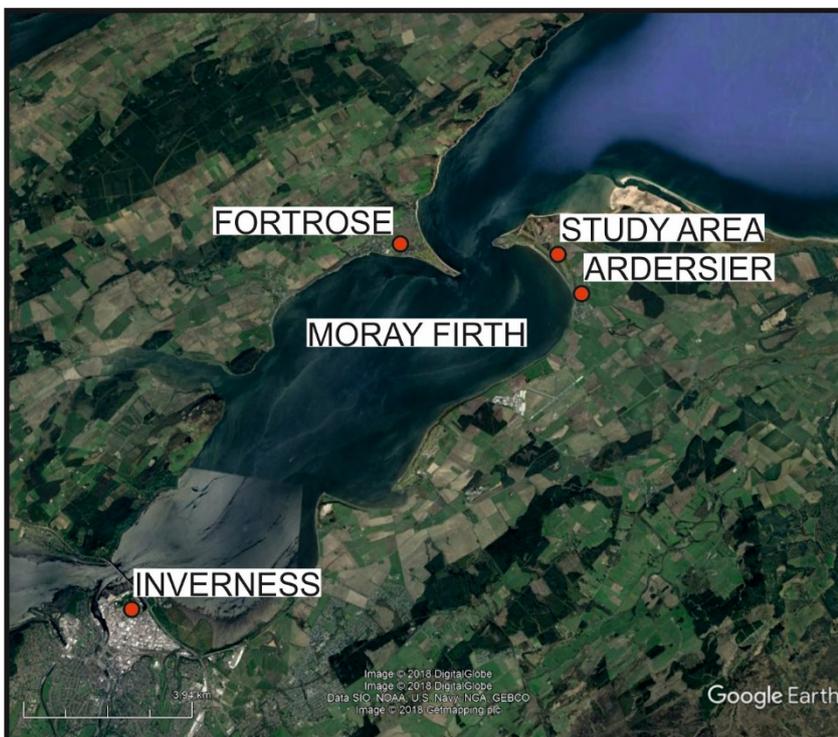
Figure 1. Google Earth © image of the study area, near the village of Ardersier in the Highlands.

The study area is north of the small village of Ardersier (Figure 1), which is approximately 12 km to the east of Inverness. The route of the pipeline is shown in Figure 2. The pipeline runs north to south from the sewage works at the shore, towards Ardersier Village. The examined trench section corresponds with the portion of the pipeline that takes a short uphill incursion up to the top of the degraded Lateglacial cliff at c. 15 m above OD (Ordnance Datum), to provide a head, for flow between the sewage works and the village.

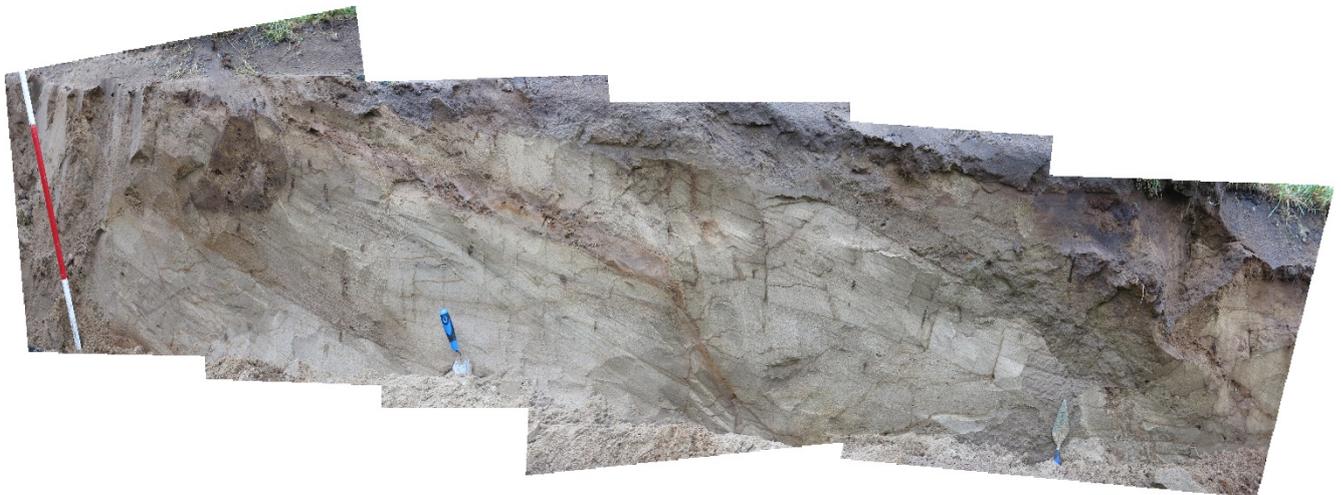
Figure 8. Overview of section with SW dipping clay layers (injections?) in laminated and occasionally layered sand.

Two sub-horizontal to sub-vertical clay veins are observed in the upper part of the middle section (Figure 3 and Figure 8). The larger of the two clay veins is sub-horizontal in the upper most part of the sand, and then steeply dips down to truncate the entire exposed sand section (Figure 10). The clay vein is *c.* 20 cm in thickness when sub-horizontal, but reduces in thickness to 5 cm thick where it becomes sub-vertical. The sub-horizontal part of the clay cuts acutely across the parallel lamination preserved in the sand, and then follows the path of a reverse fault, which has approximately 20 cm of displacement. The clay is a pinkish red in colour with discontinuous reddish brown staining. The orientation of the reddish brown staining is variable, but it is generally parallel to the orientation of the clay vein and predominantly observed along the edges of the vein. A number of brown-coloured fluid staining pathways are noted. These start in the clay vein and continue into the sand unit, before fading out after 30–50 cm. The staining pathways have highly variable orientations, but tend to both follow and also cross-cut sedimentary structures (Figure 11).

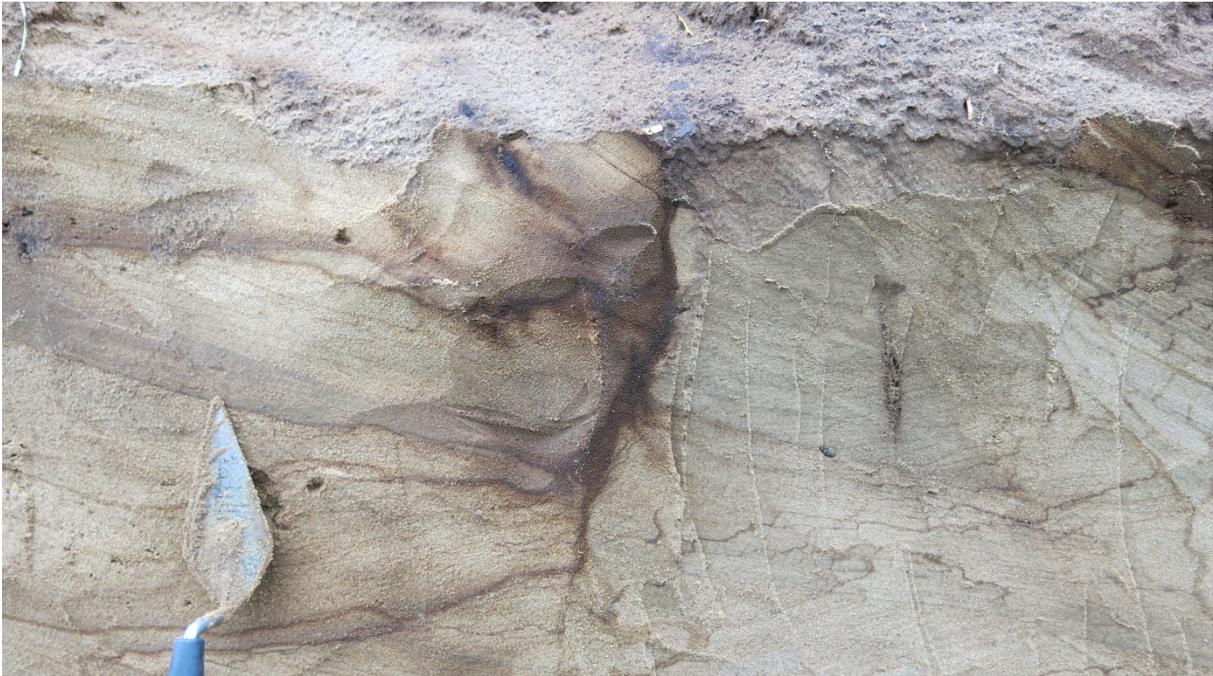
Figure 17. Oxidation along fault with diffusion along bedding.

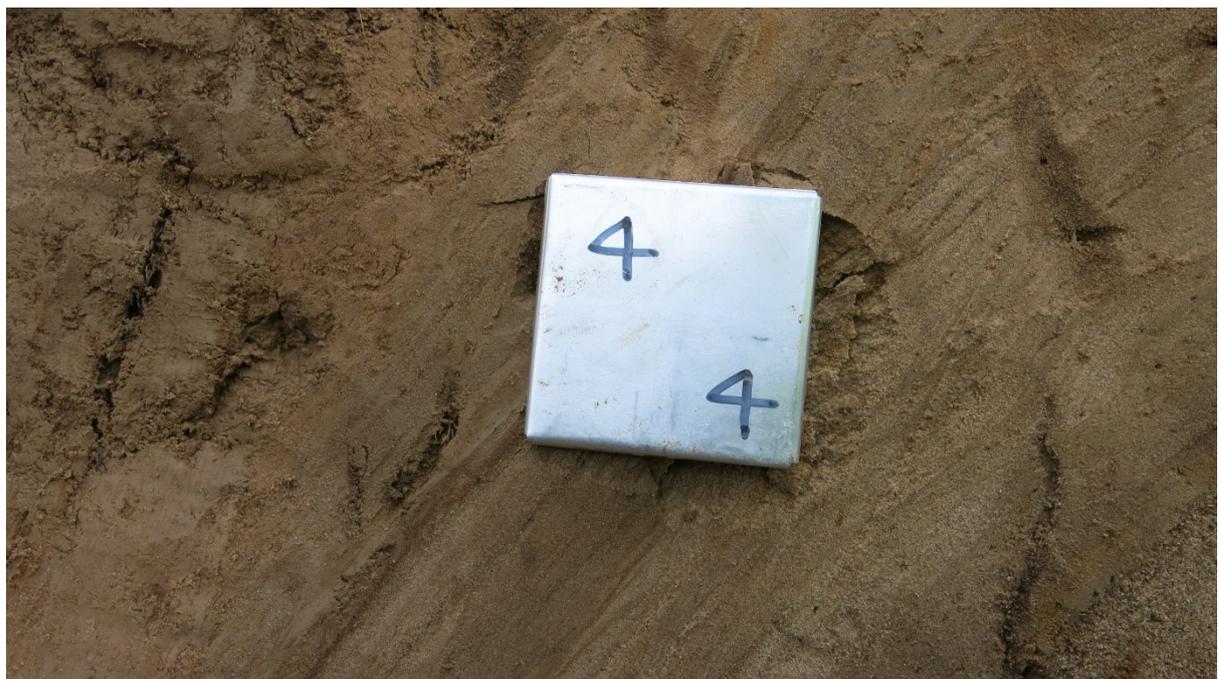
Figure 21. Close up of the sample 4 box.

Micromorphology Sample No. 4 (Figure 21) was taken from a part of the section comprising sub-vertical interbedded clay and silt layers, to investigate microstructures related to emplacement of the hydrofracture sediment.

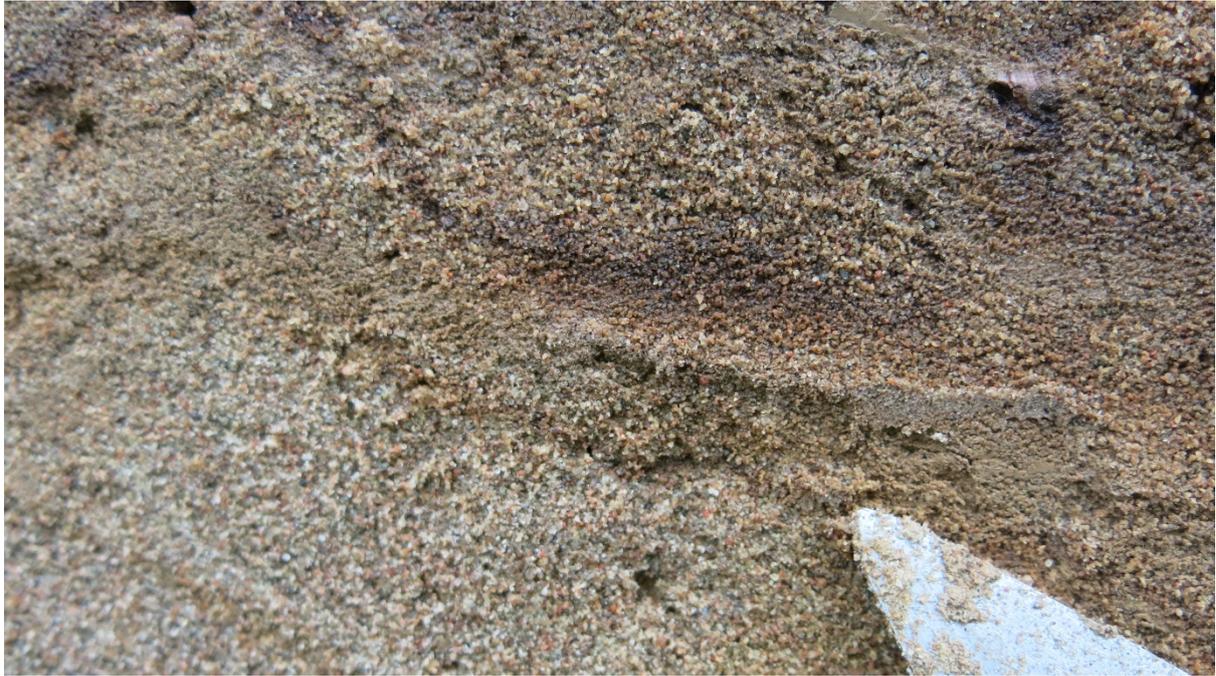
Figure 22. Diffusive oxidation in a cross-bedded sand.

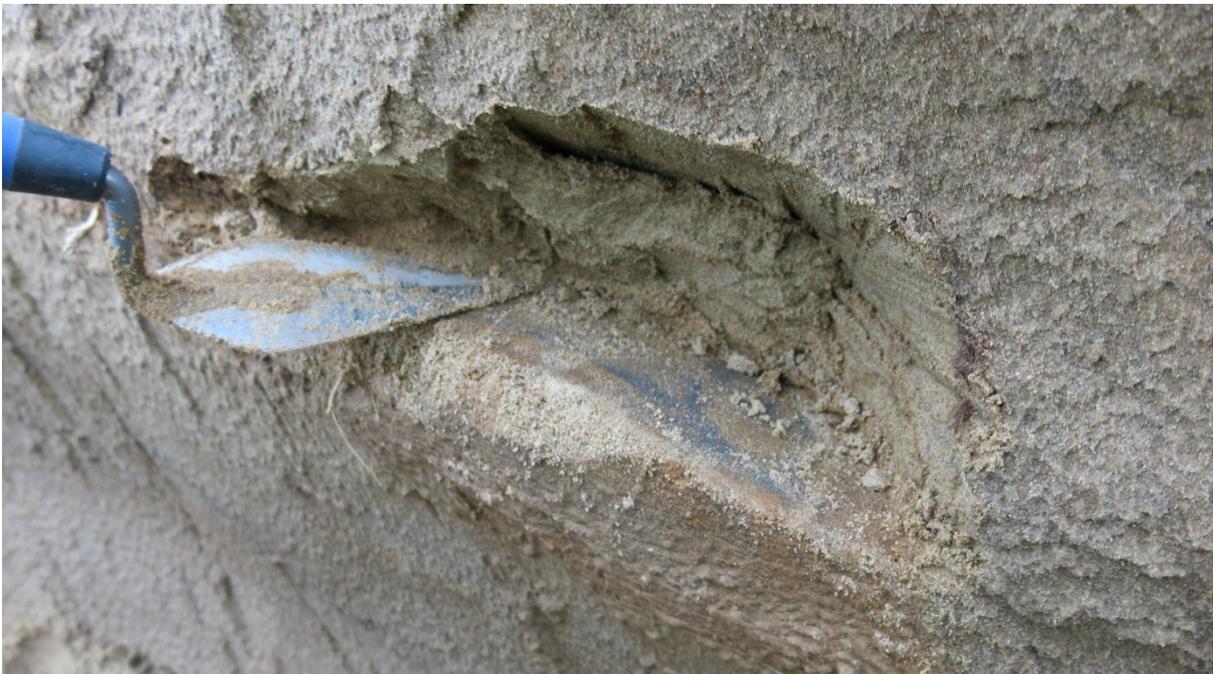
Figure 28. Dug out clay vein surface, for dip measurement.

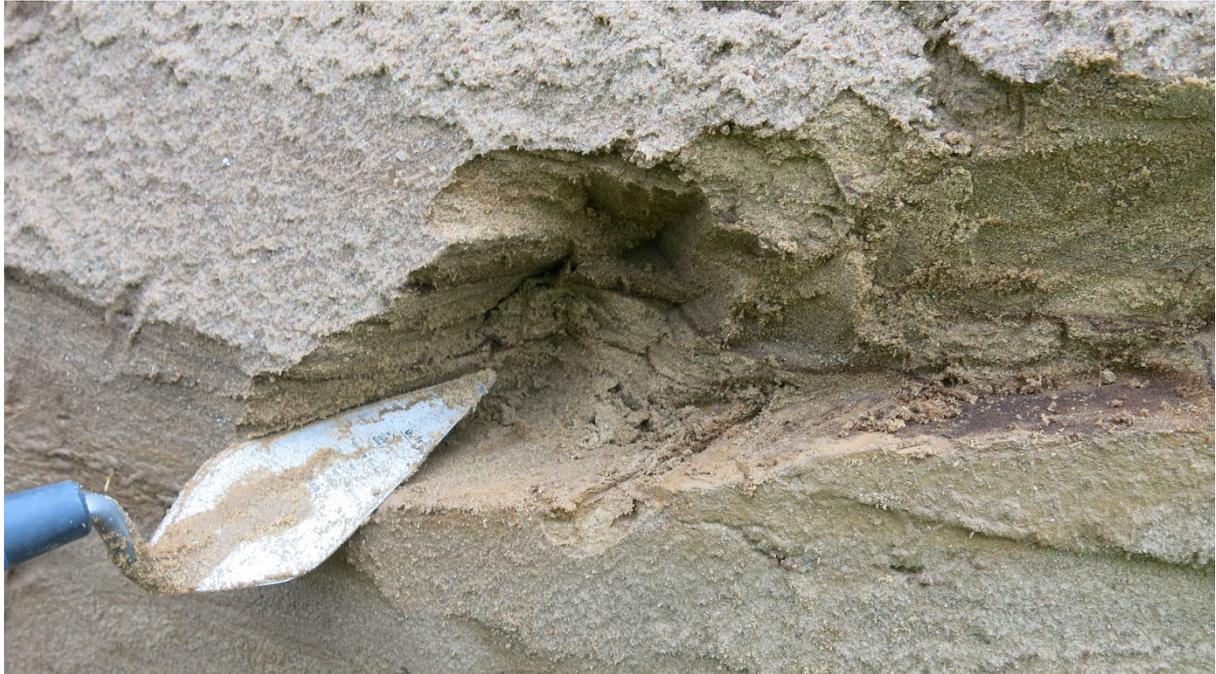
Figure 29. Dug out clay vein surface for taking dip measurement.

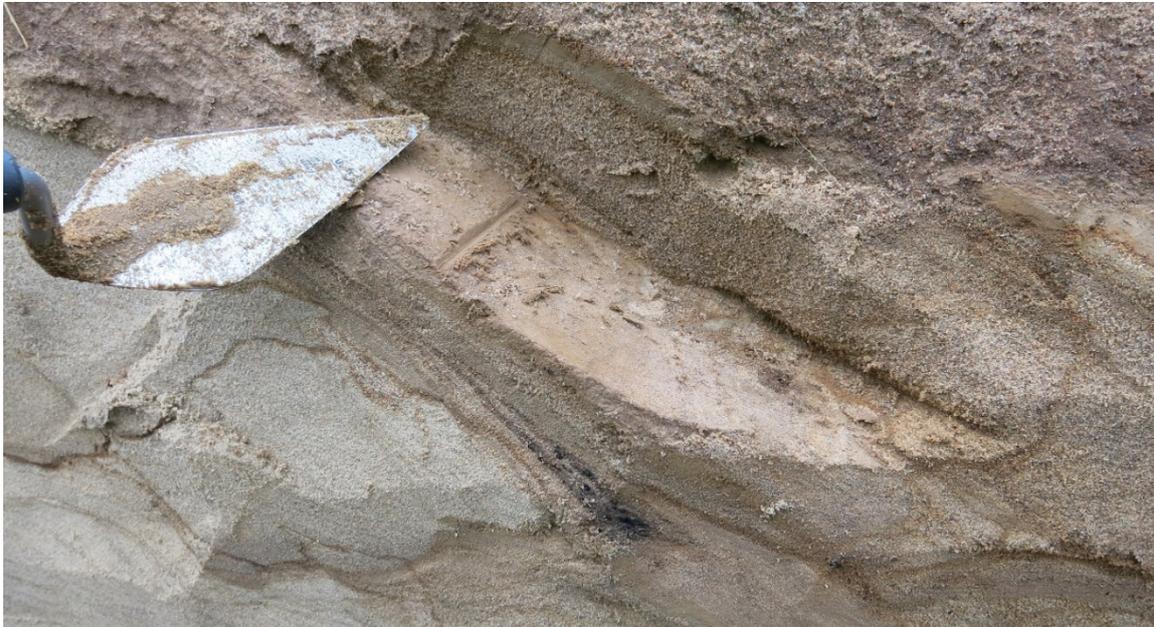
Figure 30. Dug out clay vein surface for taking dip measurement.

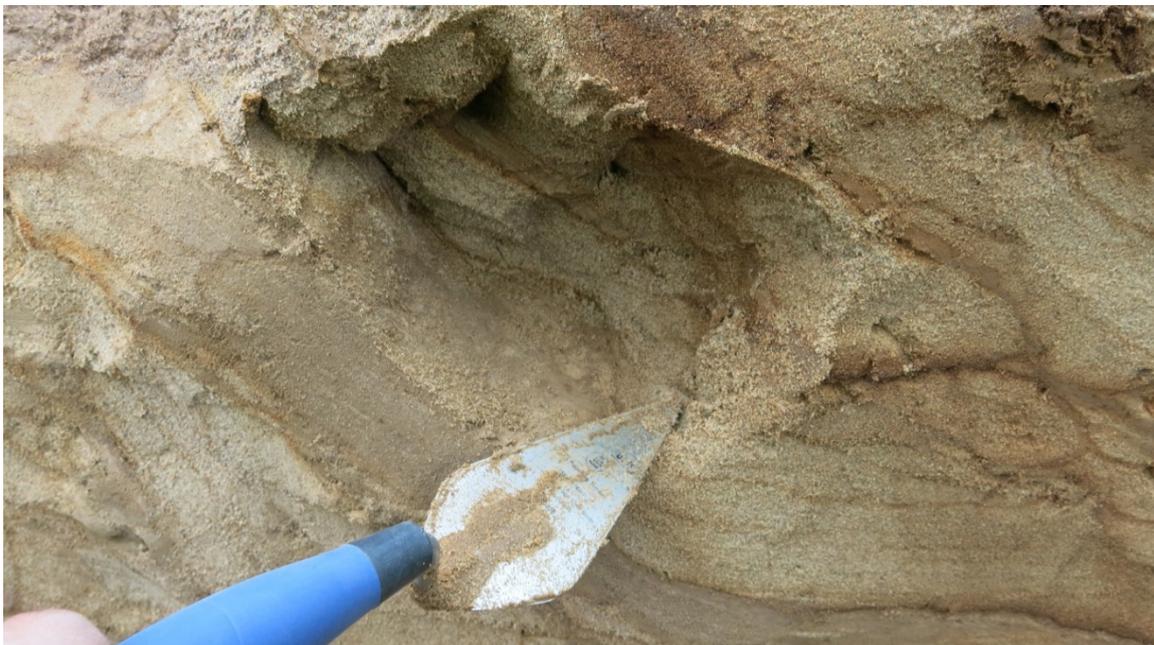
Figure 31. Dug out clay vein surface for taking dip measurement.

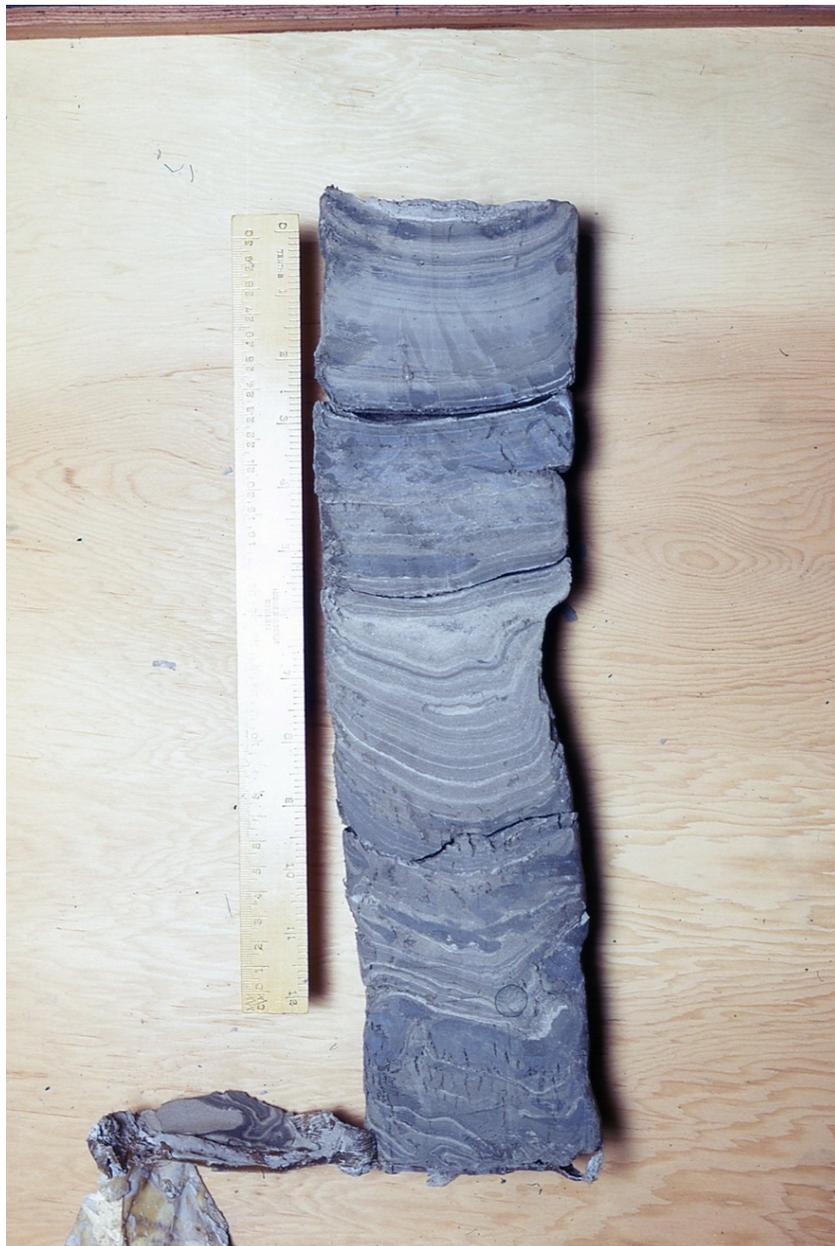
Figure 33. Photograph of core sample of Ardersier Silts, from a Kessock Bridge offshore site investigation borehole, collected and photographed by J D Peacock c. 1969-70.

From detailed study of the photograph, the sample comprises thinly interbedded blue-grey silty clay and rhythmically laminated olive grey sandy silts, which show intricate involuted sedimentary contacts (Figure 33). Some deformation of the margins of the core are evidently a result of the drilling and extraction of the core (clearly visible in the ‘dished’ appearance in the top 5cm of the

sample). However, the involuted nature of the silt-clay interbeds in the middle and lower portions of the core, are the result of soft sediment deformation that is likely associated with the original deposition of the sediment. These features are characteristic of the Ardersier Silts in nearby onshore exposures, such as those at Balnaglack, and at the Kirkton section (Merritt, Auton and Firth, 2017). The olive grey silt units comprise upward-fining rhythmites and there appears to be the presence of possible clay intraclasts, notably within the zone between 5–10 cm from the top of the sample. Incipient ball and pillow and flame structures are associated with small-scale flat-lying rootless folds in the bottom portion of the sample. All of these features are characteristic of the Ardersier Silts exposed in the coastal hinterland between Inverness and Nairn.
