**National Oceanography Centre  
Cruise Report No. 63  
RRS James Cook Cruise JCI80**

25 APRIL – 30 MAY 2019

Strategies for the Environmental Monitoring of Marine  
Carbon Capture and Storage, STEMM-CCS

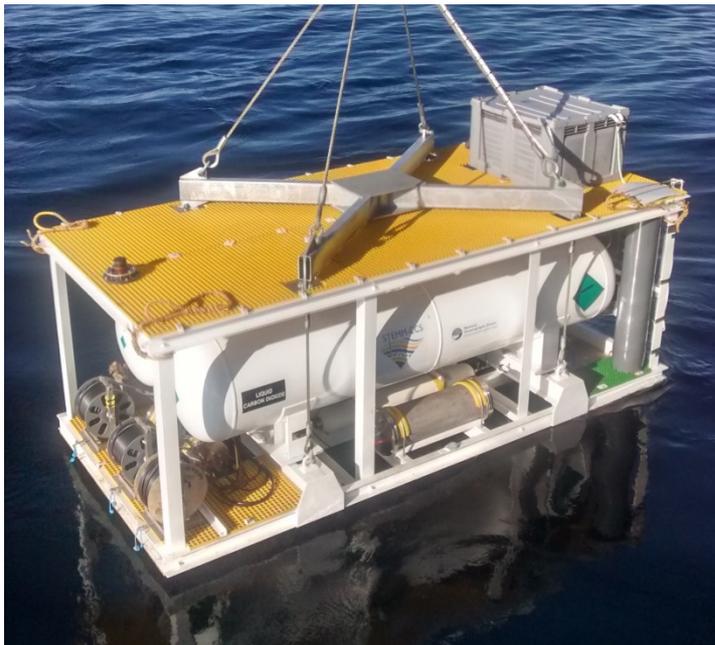
#### 4.1.2 CO<sub>2</sub> Gas Rig

The CO<sub>2</sub> Gas Rig was designed and built in-house by OTEG. The rig carries ~3 tonnes of liquid CO<sub>2</sub> and 200 litres of gaseous tracer mix comprising 0.3% C<sub>3</sub>F<sub>8</sub>, 3.8% SF<sub>6</sub>, 25.1% CO<sub>2</sub> and 70.8% Kr, by mass. The Rig is self-contained and gas flow is controlled by a pair of mass flow controllers (Bronkhorst) which together maintain a CO<sub>2</sub> to tracer mix ratio of 10,000:1. Outlet flow rate is selectable in the range 2 to 80 'normal' litres per minute ('normal' defined as 0°C, 1.01325 bar). Power is provided by two banks of two 12 V 160 Ah dryfit lead acid batteries configured to provide 24 V. Outlet pressure is controlled by a pressure regulator that references to seawater pressure (for a given regulator setting, outlet pressure remains

constant despite changing water pressure due to tidal height) and can be adjusted by the ROV. Max outlet pressure is 6.8 bar above ambient.

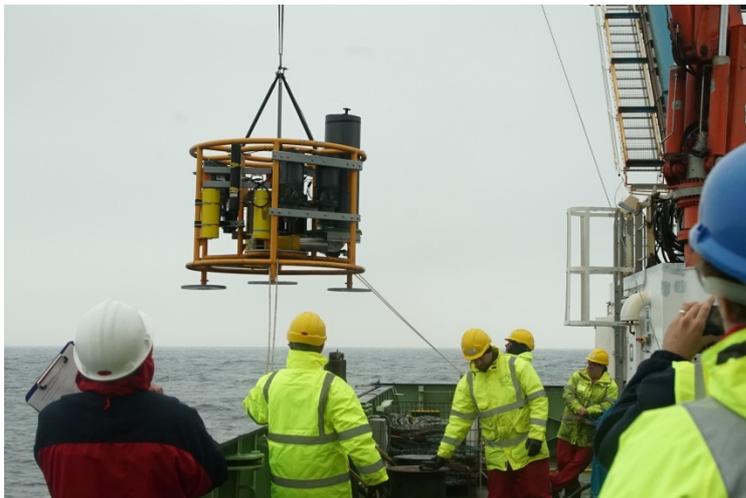
Photo: Ben Roche

Due to the failure of the original Develogic baseline lander that was deployed in October 2017, a replacement lander was built at short notice by OTEG engineers for deployment 'off-site' for the duration of the release experiment. The lander carried the following sensors:

The Lander was deployed at 1226h on 27 April at position 57° 59.471' N, 00° 22.171' W in 122 m of water. It was subsequently checked by the ROV and found to have landed in good condition.

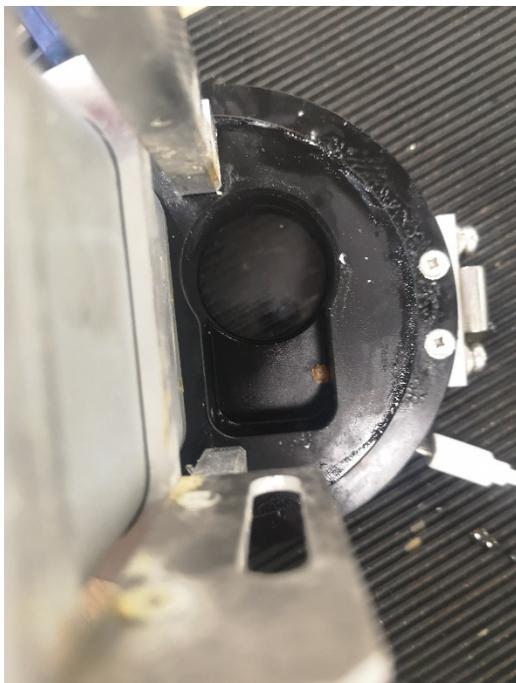
Figure 6.3. An internal view of the camera housing revealing the fatal screw that allowed water to enter. This was initially hidden from view as the Sony Action cameras sat directly over it.

The cause of this failure was identified to be a small manufacturing fault in the camera housing. A screw designed to attach the lens cover to the main body of the housing pierced the housing creating an ingress point (figure 3). Whether this was a fundamental design flaw or a manufacturing error is yet to be determined.

Repairs were successfully made to the camera housings by the engineering team and tested by lowering the housing to 110m depth over the side of the ship. The spare Sony action cam

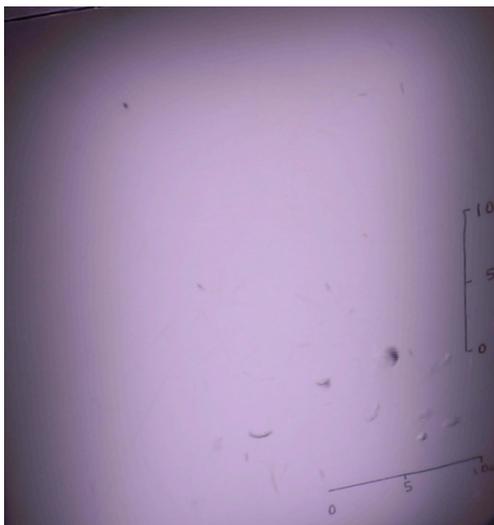
**Figure 6.7. The bubble panel on the 2<sup>nd</sup> deployment as seen by the Scorpio camera at 2m height**

The second deployment of the bubble screen on 20/05/19 was more successful, recording bubble footage at up to 6m height. Here deployed was aligned with a slack tide making the plumes easier to follow whilst the lighting panel was still bright. Preliminary observations of the data suggest the largest bubbles seen at the sea bed 2-3cm in diameter were able to rise between 6 and 6.5m in the water column. The experiment was terminated because the ROV had other higher priority operations to perform.

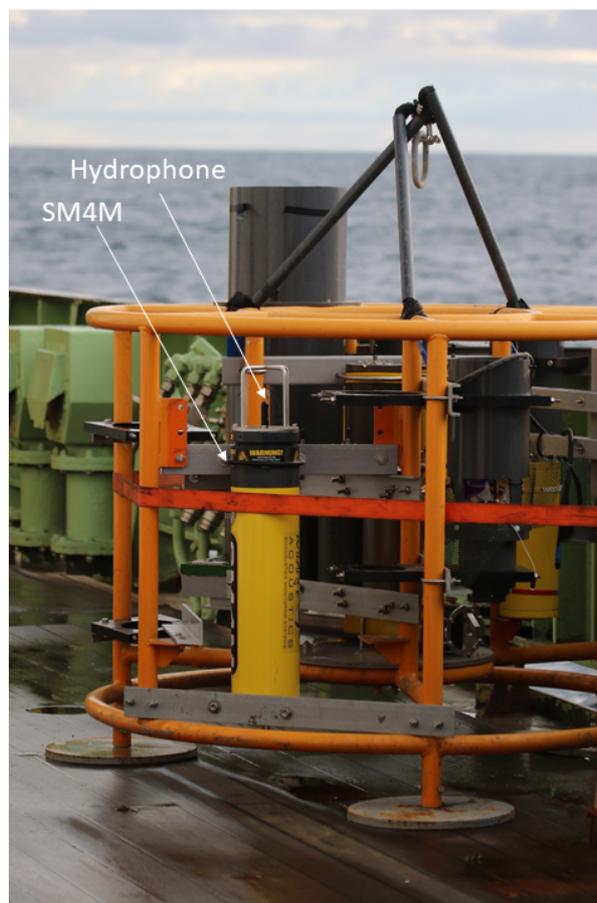
**Figure 7.2: SM2M Acoustic Recorder on the Frame of the Baseline Lander**

In addition to the hydrophone walls, there was a recorder capturing data from a single hydrophone on the baseline lander, shown in Figure 6.2. The recorder was an SM4M recorder (Unit number S4A05592, Wildlife Acoustics Ltd), using the hydrophone (serial #681945) with a nominal sensitivity of  $-155$  dB re  $1$  V/ $\mu$ Pa. This data was collected using a duty cycle of 5 mins recording, 25 mins off, so collected 2 five minute records every hour, at a sample rate of 32 kHz (16 kHz bandwidth) and 16 bits of resolution. This was deployed during the period from 11:00 on 27/4/19 until 19:00 on 24/5/19.

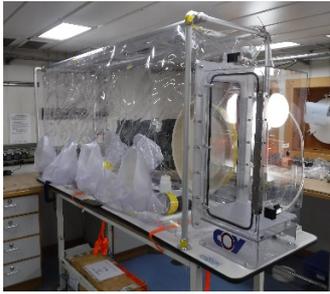
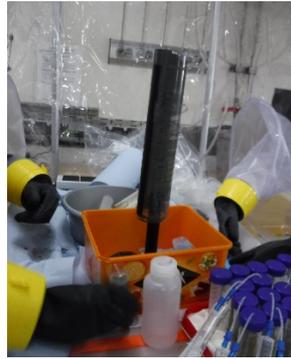
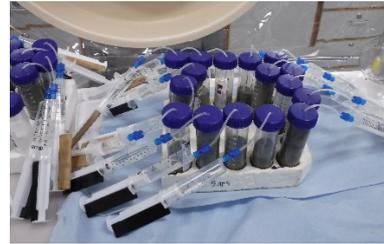
Figure 8.2 a) nitrogen filled glove box in CT lab; b) extruding and slicing a core inside the glove box; c) and d) porewater extraction from sediment slices with rhizon and syringe.

The whole core was then immediately transferred to a nitrogen filled glove-box to minimise contact with atmospheric oxygen (Figure 8.2 a) The bung was removed from the base of the core and it was moved onto a core extruder, the core tube could then be lowered gradually exposing the sediment at the top (figure 8.2 b) Successive layers were sliced and removed with a plastic plate in 1cm depth intervals for the top 10 cm, then 2cm intervals until the bottom was reached. The slices of sediment were put into 50 ml centrifuge tubes with holes pre-drilled in the lids. Water was extracted with Rhizon Soil Moisture samplers (Rhizon CSS: length 5 cm, pore diameter 0.2  $\mu\text{m}$ ; Rhizosphere Research Products, Wageningen, Netherlands). These samplers consist of a small microporous polymer tube that is supported by a stabilizing glass fibre wire and connected to a PVC tube<sup>1</sup>. The porewater was extracted by attaching a syringe held open to maintain a negative pressure (Figure 8.2 c and d) The negative pressure was reapplied several times over several hours to extract the maximum amount of porewater from the sediments. Between 2 and 10 ml of porewater was extracted from each section in this way.

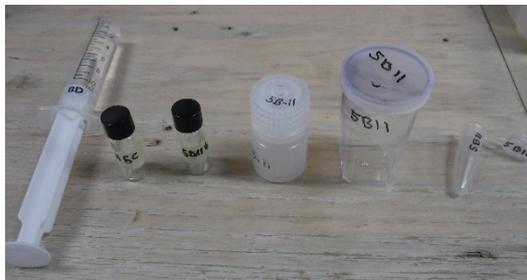
Figure 8.3 vials used for sub-sampling; from left: water extracted with syringe; glass vials for DIC/ $\delta^{13}\text{C}$  and  $\delta^{18}\text{O}/\delta\text{D}$ ; acid-washed Nalgene bottle for cations; plastic pot for TA and nutrients; Eppendorf tube for anions.

Following extraction porewater was sub-sampled into different vials (Figure 8.3) for subsequent analysis as follows:

- i) 2.2ml into a glass vials for DIC/ $\delta^{13}\text{C}$  with no headspace;
- ii) 2.2ml into a glass vials for  $\delta^{18}\text{O}/\delta\text{D}$  with no headspace;
- iii) 1ml into a plastic pot for Total Alkalinity (TA);
- iv) 2ml in an acid cleaned Nalgene bottle for cations;
- v) 1ml into an Eppendorf tube for anions;
- vi) 1ml into a plastic pot for nutrients.

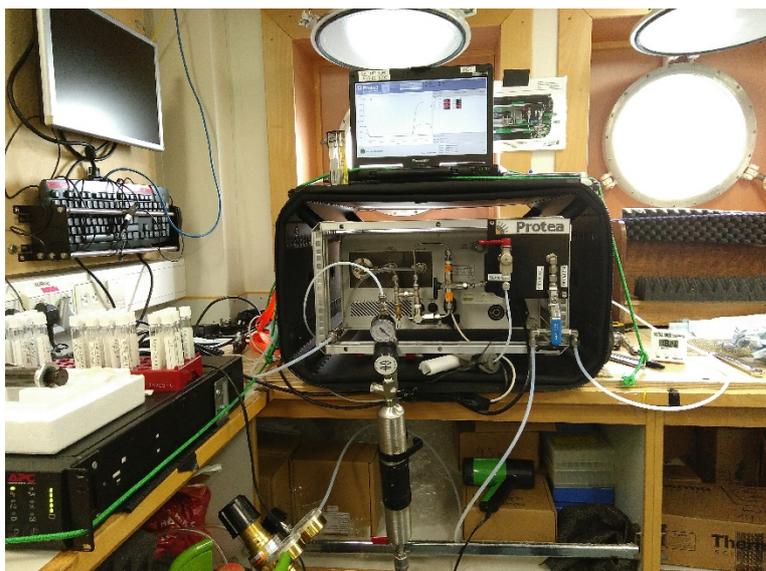
Figure 9.2 FTIR used for on board analysis of gas composition (photo A. Flohr)

A flow-through Fourier-Transmission Infra-Red (FTIR) analyser (*atmosFIR*, Protea Ltd UK) (Fig. 9.2) was used to measure the gas composition with respect to  $\text{CO}_2$ ,  $\text{CH}_4$ ,  $\text{SF}_6$  and  $\text{C}_3\text{F}_8$ . **Prior** to sampling the GBS was warmed up by flushing with hot water to increase internal pressure and thus measurement time. The GBS was connected to a regulator to reduce the outlet pressure to 10 psi ( $\sim 0.7$  bar) above atmospheric pressure. The gas then passed a water trap ( $\text{Mg}(\text{ClO}_4)_2$ ), a temperature logger (Lascar Electronics) and the sampling port before entering the analyser (at 0.2 mL/min). The sampling port allowed for retrieving discrete samples for later analysis of  $\delta^{13}\text{C}_{\text{CO}_2}$ ,  $\delta^{18}\text{O}_{\text{CO}_2}$  signature and Kr composition of the gas.

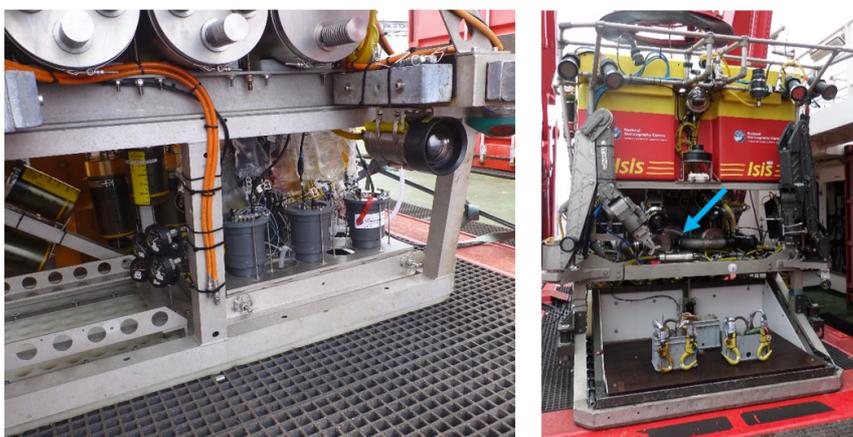
Figure 10.4. (Left) View of the ISIS from the back, showing the LOC sensors mounted on the rear starboard bottom corner on their aluminium sled. (Right) Front view of the ISIS with the position of the intake pump marked with a blue arrow.

For two of the long overnight dives a SBE Deep SeaFET was also mounted on the ROV to collect higher temporal resolution pH data (1 Hz). The SeaFET was approximately 5 cm lower, 43 cm further back, and 80 cm to the starboard side of the ROV than the Seabird pump intake point. From dive 366 onwards a Seabird MicroCAT (SBE37SM) was mounted on the ROV to measure temperature and salinity. The MicroCAT was mounted approximately 20 cm from the Seabird pump intake point.

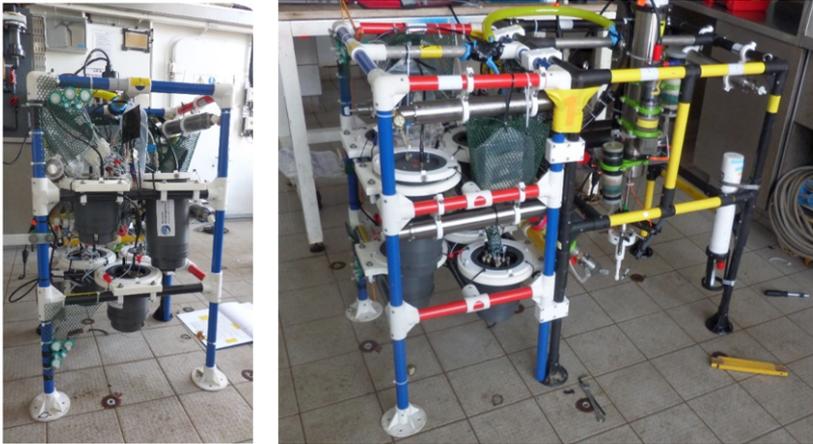
**Figure 10.5.** MPI BBL lander with the LOC sensors mounted on the blue and red portion of the frame. The photo on the left shows the (as-deployed) east side of the frame with the sensor intake filters at the top and bottom of the left-hand side of the lander. The right photo shows the north face of the lander.

The intake filters for the sensors were attached facing east near the top and bottom of the frame in the southeast corner of the frame in the deployment orientation. The bottom intake filters were at an average height of 16.9 cm above the seabed and the top intake filters an average height of 87.2 cm.

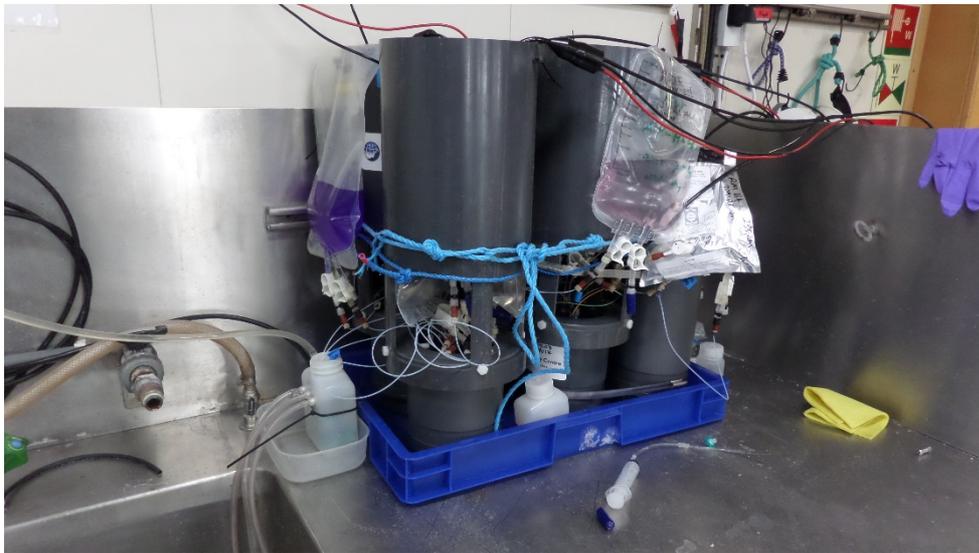
**Figure 10.7. 5 LOC sensors sampling from the ship's underway system.**

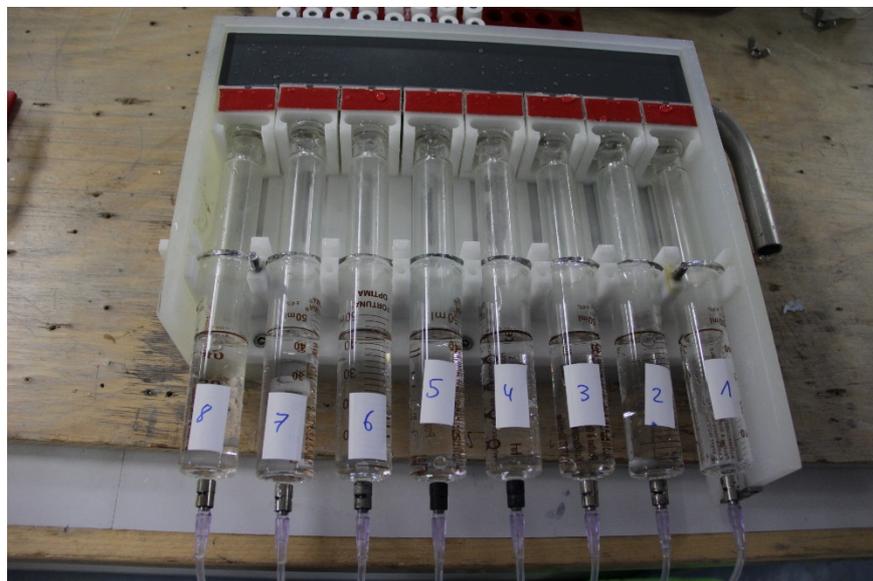
Figure 11.3. The eight syringes filled with seawater in the syringe sampler (benthic chamber 2, deployment 1, May 15, 2019 at 7 pm). On this photo, syringes are numbered according to sampling order (sampling interval: 3 h 23 min).

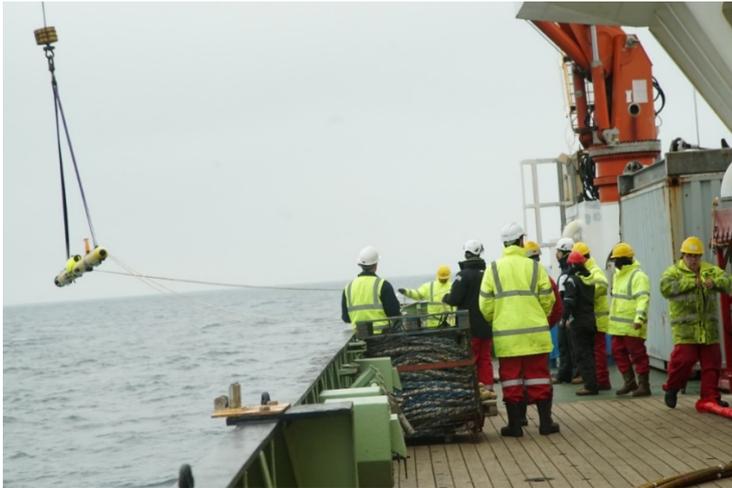
For the ballast check we had the Gavia connected with 6m strops directly onto the crane so it couldn't be accidentally released from the crane, we had guide lines attached forward and aft and the crane operator was instructed to try and keep the strops out of the water as much as possible.

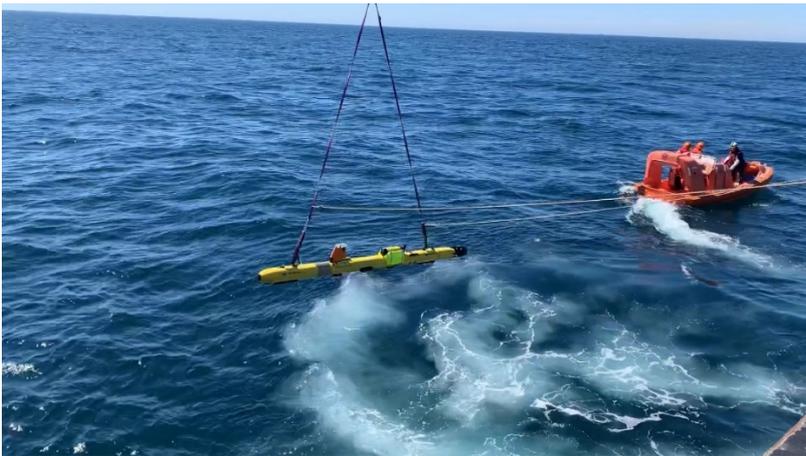
Once underneath the starboard aft crane we connected the gavia in the usual manner with a short line going through each lift handle and connecting to a metal snap hook that was end of a long strop with the other end of the strop already in it.

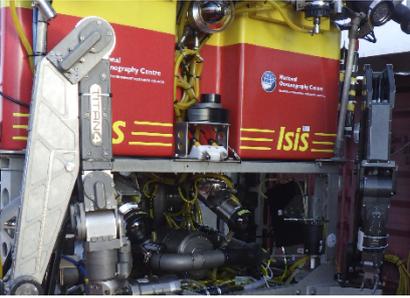
One pair of the NOC lasers were mounted onto the Scorpio stills science camera, and pair was mounted central to the vehicle below the science dome camera.
