**British
Geological Survey**

A petrological examination of the provenance of stone masonry from three medieval churches in Shetland

Open Report OR/19/014

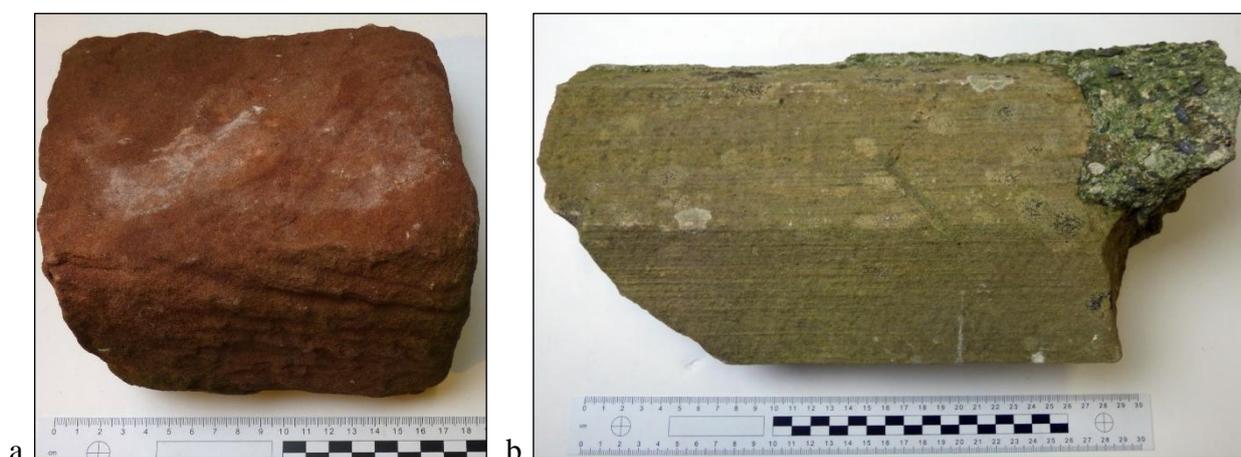
Figure 2. Sandstone samples believed to be spolia from the medieval St Laurence's Church

a) The block from which sample ED11912 ('P1') was cored. b) The block from which sample ED11913 ('P2') was cored. c) Sample ED11914 ('P3'), one fragment from a rubble masonry block. Photographs supplied by the client.

- An 8 x 4 cm piece of dull reddish brown sandstone core, collected from a rubble block measuring c. 18 x 16 x 11 cm (Figure 2a). The sample, labelled 'P1' by the client, was assigned the BGS number **ED11912**.
- A 4 x 4 cm piece of very light yellowish buff sandstone core, collected from a dressed rubble block measuring c. 35 x 15 x 9 cm (Figure 2b). The sample, labelled 'P2' by the client, was assigned the BGS number **ED11913**.
- A 9 x 5 x 4 cm fragment of dull reddish brown sandstone (Figure 2c), collected from rubble walling. The fragment, labelled 'P3' by the client, was assigned the BGS number **ED11914**.

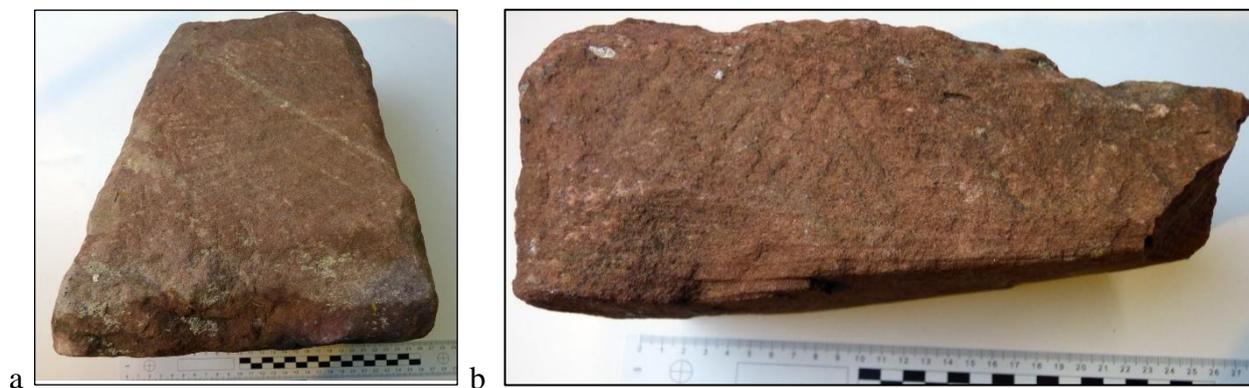
Figure 3. Sandstone samples believed to be spolia from the medieval St Mary's Church

a) The block from which sample ED11915 ('IR1') was cored. b) The block from which sample ED11916 ('IR2') was cored. Photographs supplied by the client.

- A 3 x 2 cm piece of dull reddish brown sandstone core (now broken into two pieces), collected from a piece of a dressed masonry block measuring c. 20 x 15 x 15 cm (Figure 3a) that is reputed to be the cupola of the steeple of St Mary's Church. The sample, labelled 'IR1' by the client, was assigned the BGS number **ED11915**.
- A 4 x 1 cm piece of mottled, dull reddish brown sandstone core, collected from a piece of a dressed masonry block measuring c. 25 x 20 x 12 cm (Figure 3b) found at a croft in Ireland, and

which is reputed to be an example of masonry from St Mary's Church. The sample, labelled 'IR2' by the client, was assigned the BGS number **ED11916**.

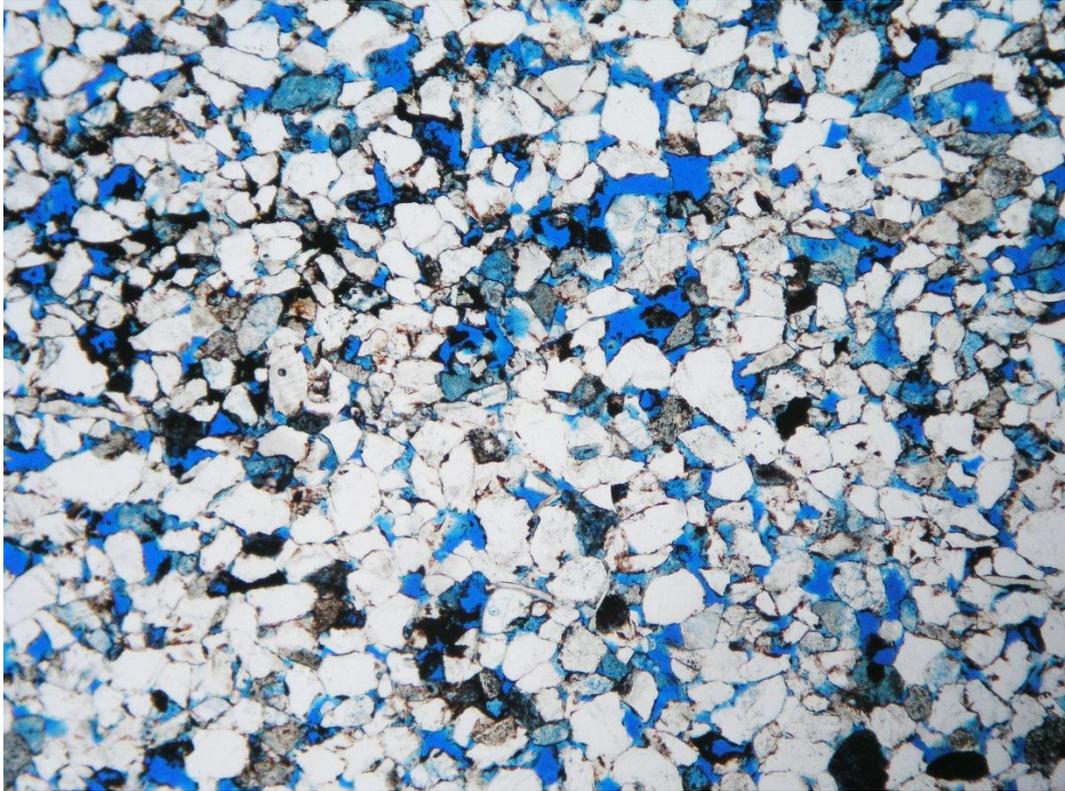
Thin section photographs of sample ED11910 ('T1': St Magnus's Church, Tingwall). Grains of quartz and feldspar appear white. Rock fragments appear mottled grey. Iron oxide appears brown to black, and forms very thin coatings on the detrital grains. Pore space appears blue. The images were taken in plane-polarised light, and the field of view is c.3.3 mm wide.

1. The sample consists entirely of fresh (un-weathered) stone.
2. A bedding fabric is defined by alternately lighter and darker, parallel layers of stone. In thin section, the darker layers are observed to contain a greater proportion of iron oxide minerals. Bedding is also represented by mm-scale thick layers of stone that vary slightly in grain size.

5. The minerals zircon and tourmaline are present in trace amounts (together accounting for <<1% of the total thin section area).
6. The sample contains numerous ‘moldic pores’ (pores that preserve the shape of grains or crystals that have dissolved), which are fringed with iron oxide minerals. Almost all of the detrital grains have a thin coating of iron oxide. Together, these observations suggest that a significant volume of an intergranular, iron-bearing carbonate mineral was formerly present in the stone, but that this mineral has since dissolved due to chemical alteration.

7. The relatively high proportion of intragranular pores (i.e. formed within partly dissolved grains), and the presence of grains that appear to be ‘floating’ in the plane of the thin section, suggest that the stone formerly contained a greater volume of feldspar grains, which have since dissolved due to chemical alteration.

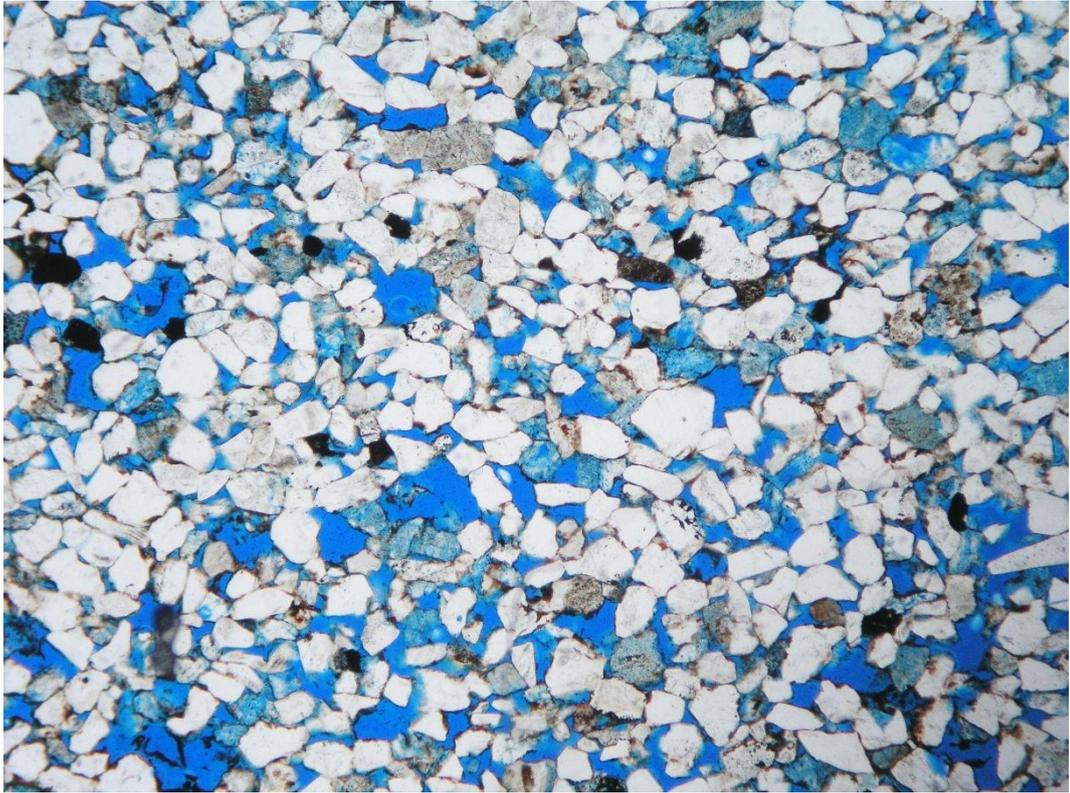
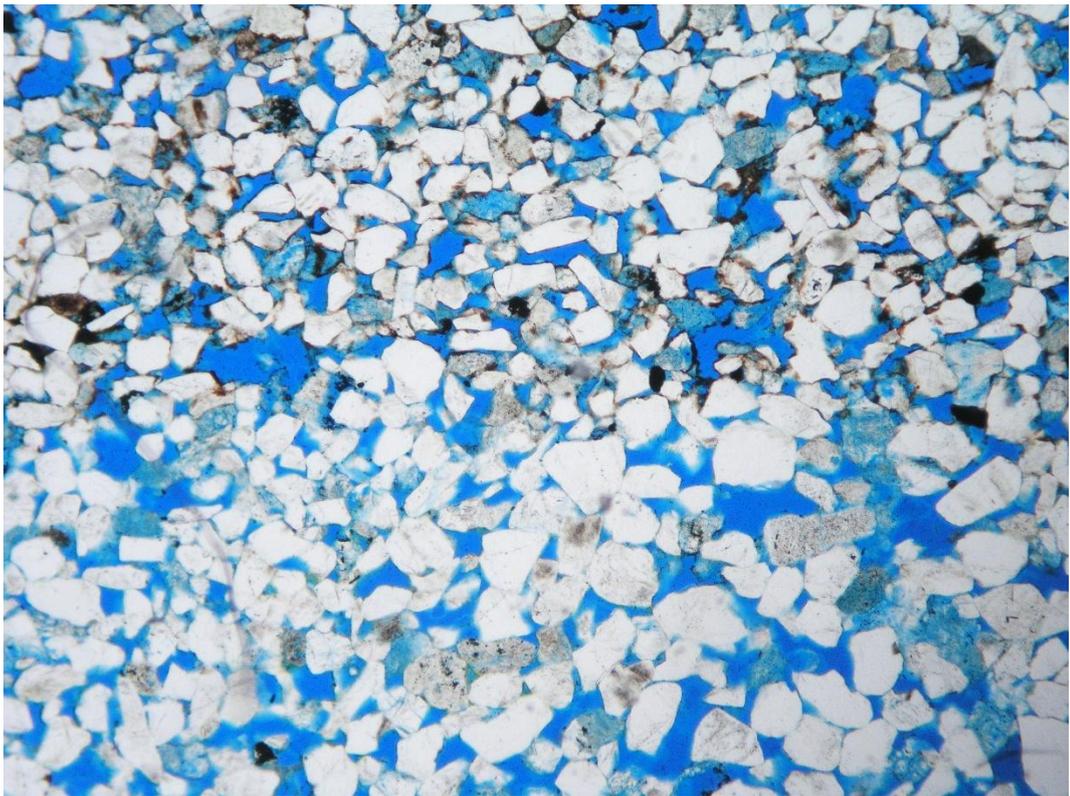
Thin section photographs of sample ED11911 ('T2': St Magnus's Church, Tingwall). Grains of quartz and feldspar appear white. Rock fragments appear mottled grey. Iron oxide appears brown to black, and forms very thin coatings on many of the detrital grains. The bottom half of the lower image is of a portion of yellowish buff stone within which iron oxide coatings on detrital grains are absent. Pore space appears blue. The images were taken in plane-polarised light, and the field of view is c.3.3 mm wide.

4. The hand sample features yellowish buff colour mottling and spots, and several patches of dark grey material (which are likely to represent local concentrations of manganese oxide minerals). In thin section, iron oxide coatings on detrital grains within the yellowish buff portions of stone are absent.

5. The relatively high proportion of intragranular pores, and the presence of grains which appear to be ‘floating’ in the plane of the thin section, suggest that the stone formerly contained a greater volume of feldspar grains which have since dissolved due to chemical alteration.

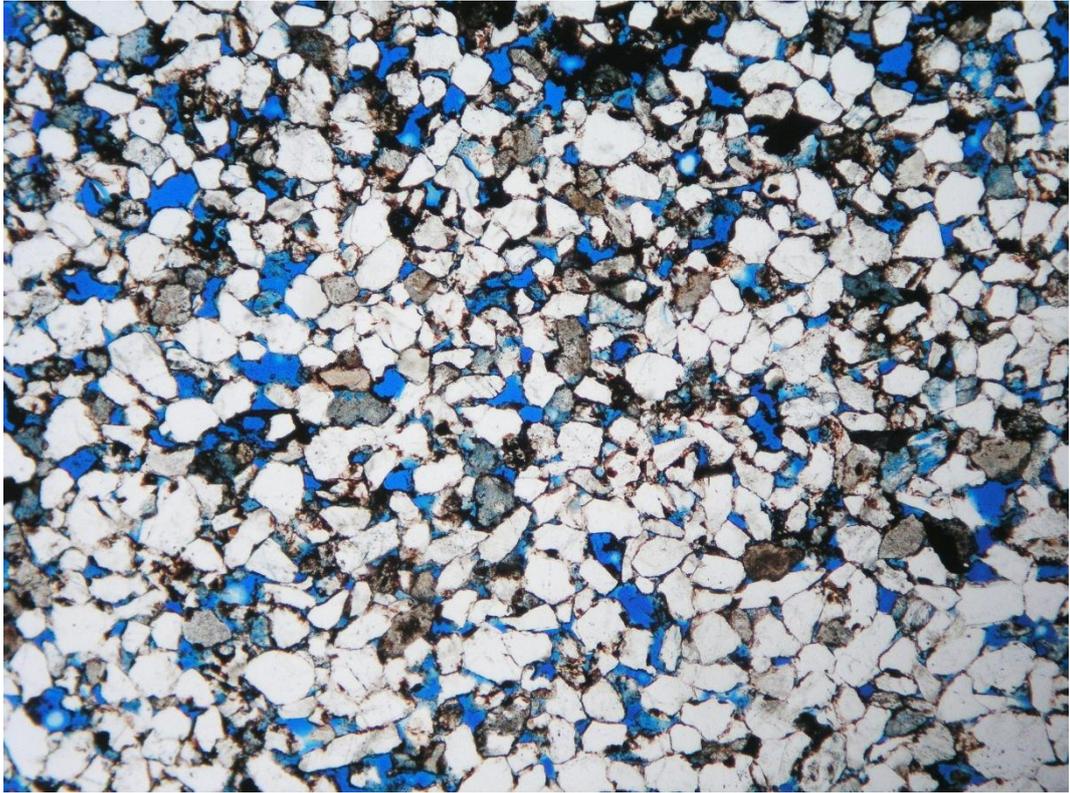
Thin section photographs of sample ED11912 ('P1': St Laurence's Church, Papil). Grains of quartz and feldspar appear white. Rock fragments appear mottled grey. Iron oxide appears brown to black, and forms very thin coatings on the detrital grains. Pore space appears blue. The images were taken in plane-polarised light, and the field of view is c.3.3 mm wide.

1. The stone at one end of the core sample is covered in a thin greyish brown patina; this is assumed to be the exterior surface of the sampled block.
2. An irregular cross-bedding fabric is defined by alternately lighter and darker layers of stone. In thin section, the darker layers are observed to contain a greater proportion of iron oxide minerals. Bedding is also represented by mm-scale thick layers of stone that vary slightly in grain size.

5. The sample contains numerous ‘moldic pores’, which are fringed with iron oxide minerals. Almost all of the detrital grains are also coated in iron oxide. Together, these observations suggest that a significant volume of an intergranular, iron-bearing carbonate mineral was formerly present in the stone, but that this mineral has since dissolved due to chemical alteration.

6. The relatively high proportion of intragranular pores, and the presence of grains which appear to be ‘floating’ in the plane of the thin section, suggest that the stone formerly contained a greater volume of feldspar grains that have since dissolved due to chemical alteration.

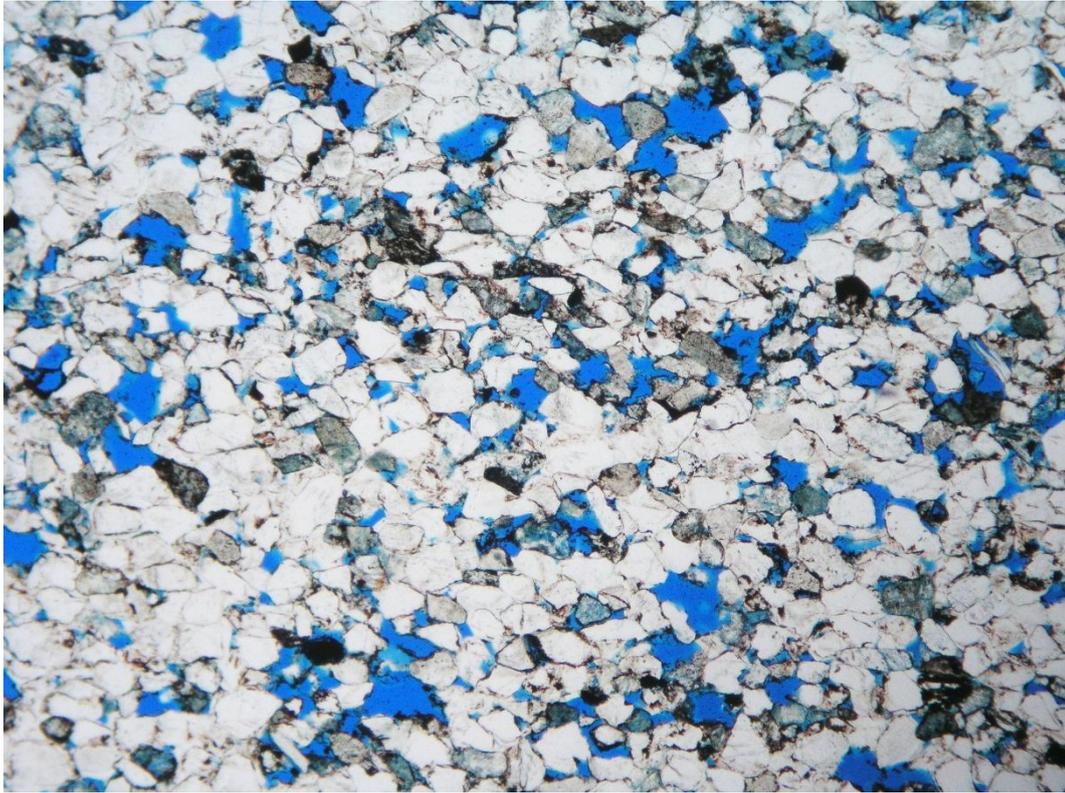
Thin section photographs of sample ED11914 ('P3': St Laurence's Church, Papil). Grains of quartz and feldspar appear white. Rock fragments appear mottled grey. Iron oxide appears brown to black, and forms very thin coatings on the detrital grains. Pore space appears blue. The images were taken in plane-polarised light, and the field of view is c.3.3 mm wide.

2. A parallel bedding fabric is defined by alternately lighter and darker layers of stone. In thin section, the darker layers are observed to contain a greater proportion of iron oxide minerals. Bedding is also represented by mm-scale layers of stone that vary slightly in grain size.

5. The sample contains numerous ‘moldic pores’, which are fringed with iron oxide minerals. Almost all of the detrital grains are also coated in iron oxide. Together, these observations suggest that a significant volume of an intergranular, iron-bearing carbonate mineral was formerly present in the stone, but that this mineral has since dissolved due to chemical alteration.

6. The relatively high proportion of intragranular pores, and the presence of grains that appear to be ‘floating’ in the plane of the thin section, suggest that the stone formerly contained a greater volume of feldspar grains, which have since dissolved due to chemical alteration.

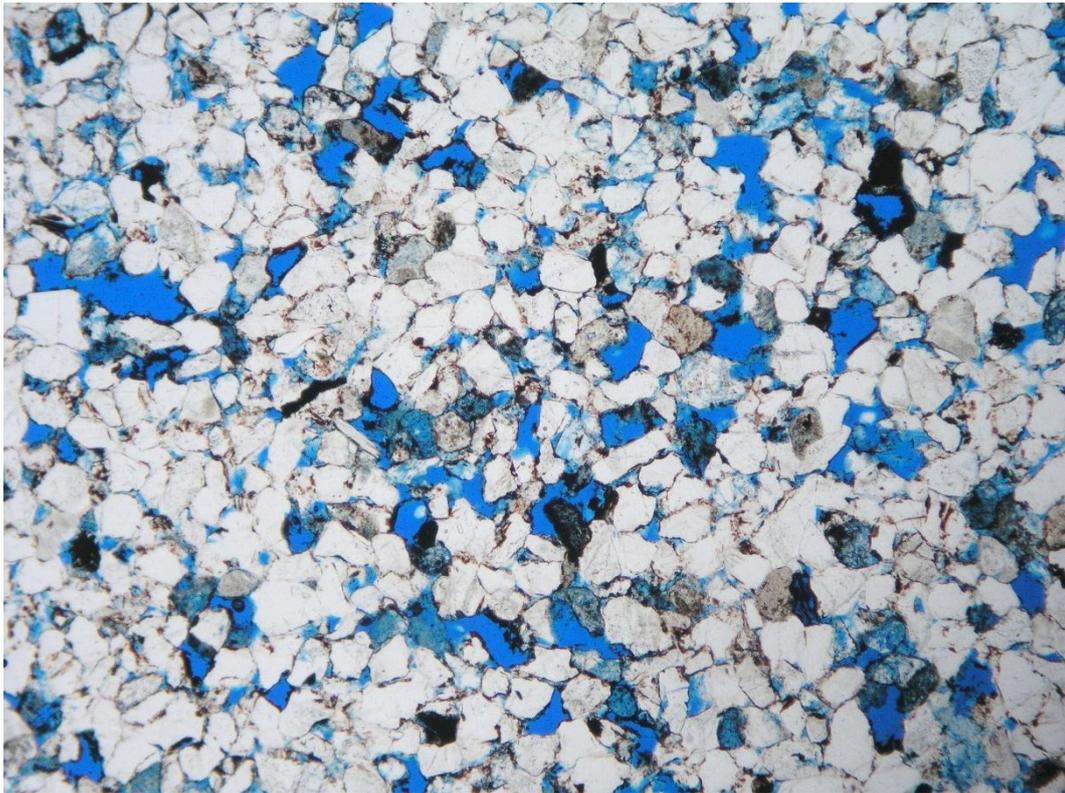
Thin section photographs of sample ED11916 ('IR2': St Mary's Church, Ireland). Grains of quartz and feldspar appear white. Rock fragments appear mottled grey. Iron oxide appears brown to black, and forms very thin coatings on many detrital grains. The upper left corner of the lower photograph displays a portion of stone within which iron oxide coatings on detrital grains are absent; this stone is yellowish buff in the hand sample. Pore space appears blue. The images were taken in plane-polarised light, and the field of view is c.3.3 mm wide.

5. The hand sample features yellowish buff colour mottling and spots. In thin section, iron oxide coatings on detrital grains within the yellowish buff portions of stone are observed to be absent.

6. The relatively high proportion of intragranular pores, and the presence of grains which appear to be ‘floating’ in the plane of the thin section, suggest that the stone formerly contained a greater volume of feldspar grains, which have since dissolved due to chemical alteration.

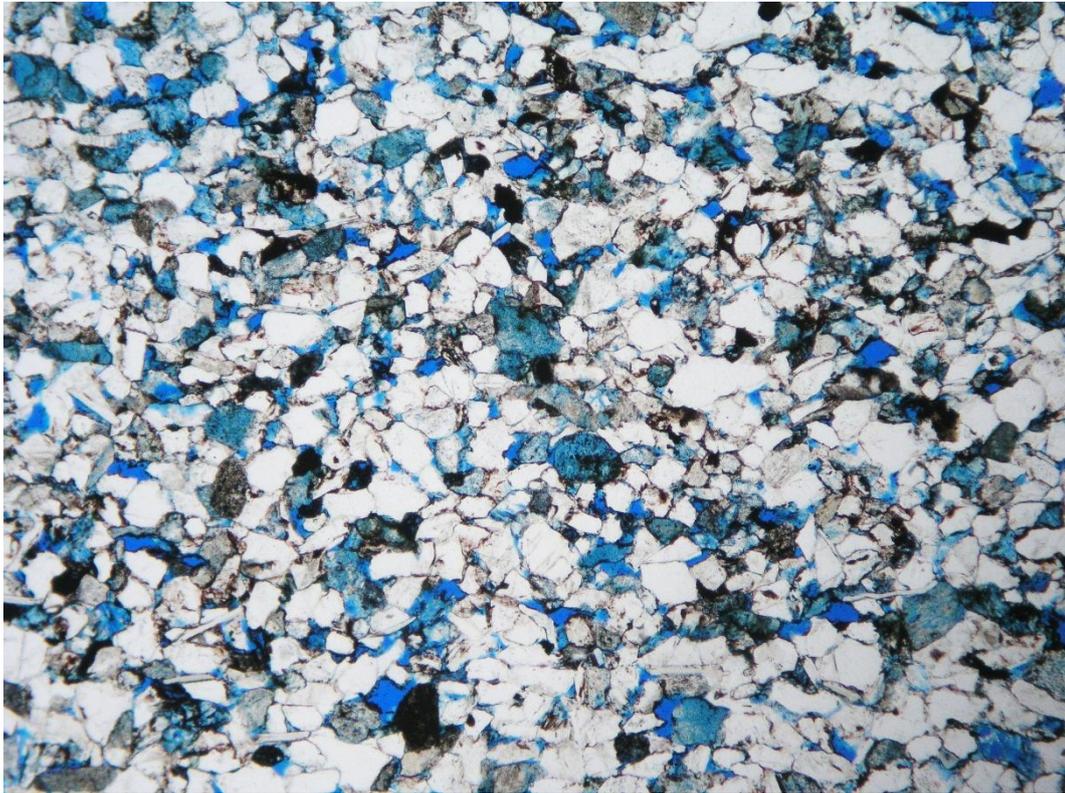
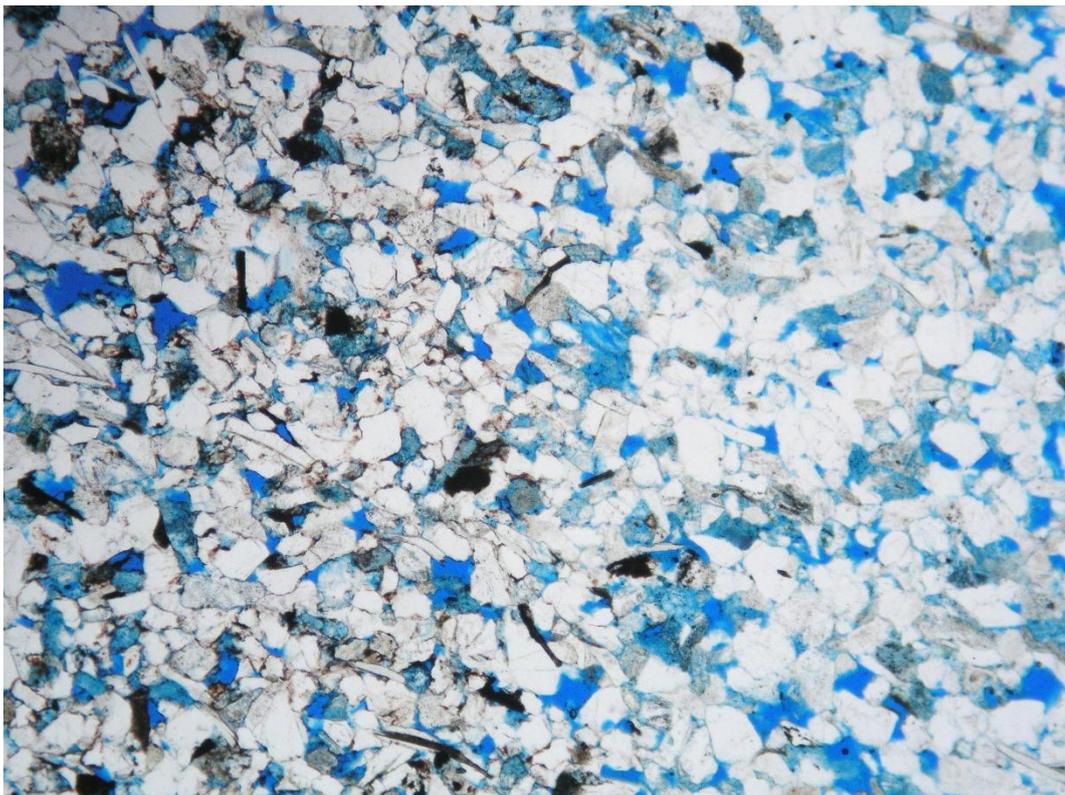
Thin section photographs of sample ED11917 ('HH1': Head of Holland quarry). Grains of quartz and feldspar appear white. Rock fragments appear mottled grey. Iron oxide appears brown to black, and forms very thin coatings on the detrital grains. The right half of the lower image is of a portion of yellowish buff stone within which iron oxide coatings on detrital grains are absent. Pore space appears blue. The images were taken in plane-polarised light, and the field of view is c.3.3 mm wide.

2. Irregular cross-bedding is defined by alternately lighter and darker layers of stone. In thin section, the darker layers are observed to contain a greater proportion of iron oxide minerals. Bedding is also represented by mm-scale layers of stone that vary slightly in grain size.

7. One edge of the sample is formed of yellowish buff stone. In thin section, iron oxide coatings on detrital grains within this part of the stone are observed to be absent.

8. The relatively high proportion of intragranular pores, and the presence of grains which appear to be ‘floating’ in the plane of the thin section, suggest that the stone formerly contained a greater volume of feldspar grains, which have since dissolved due to chemical alteration.

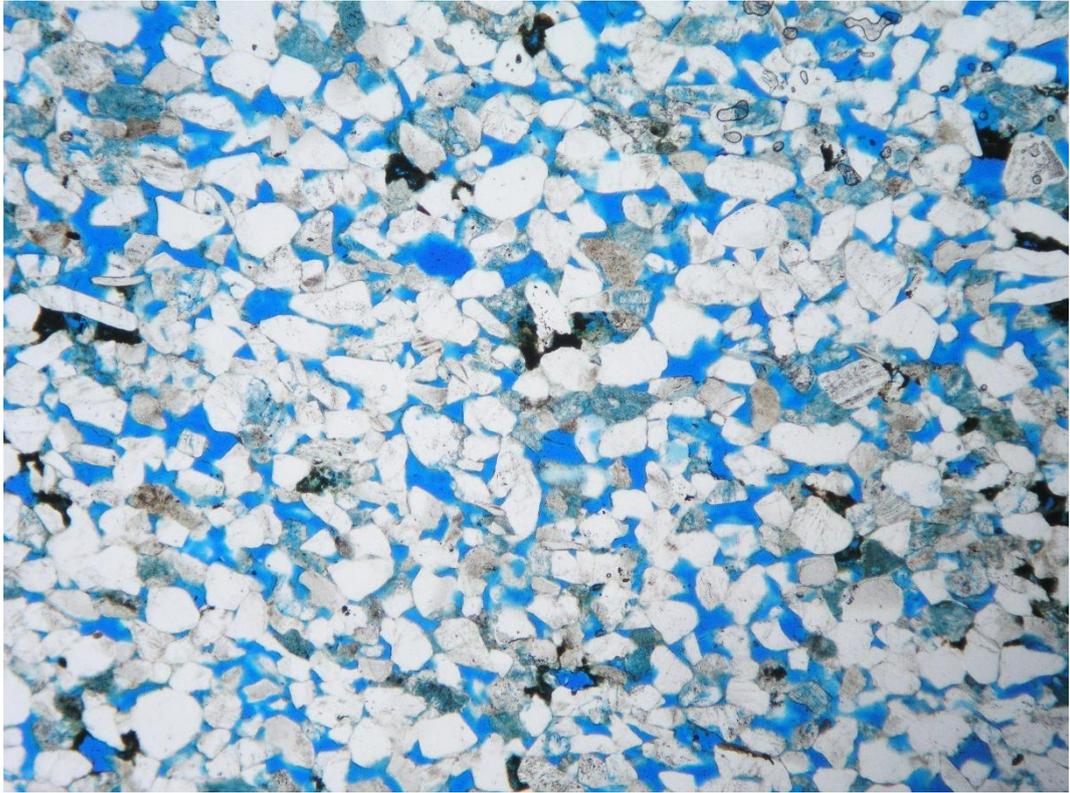
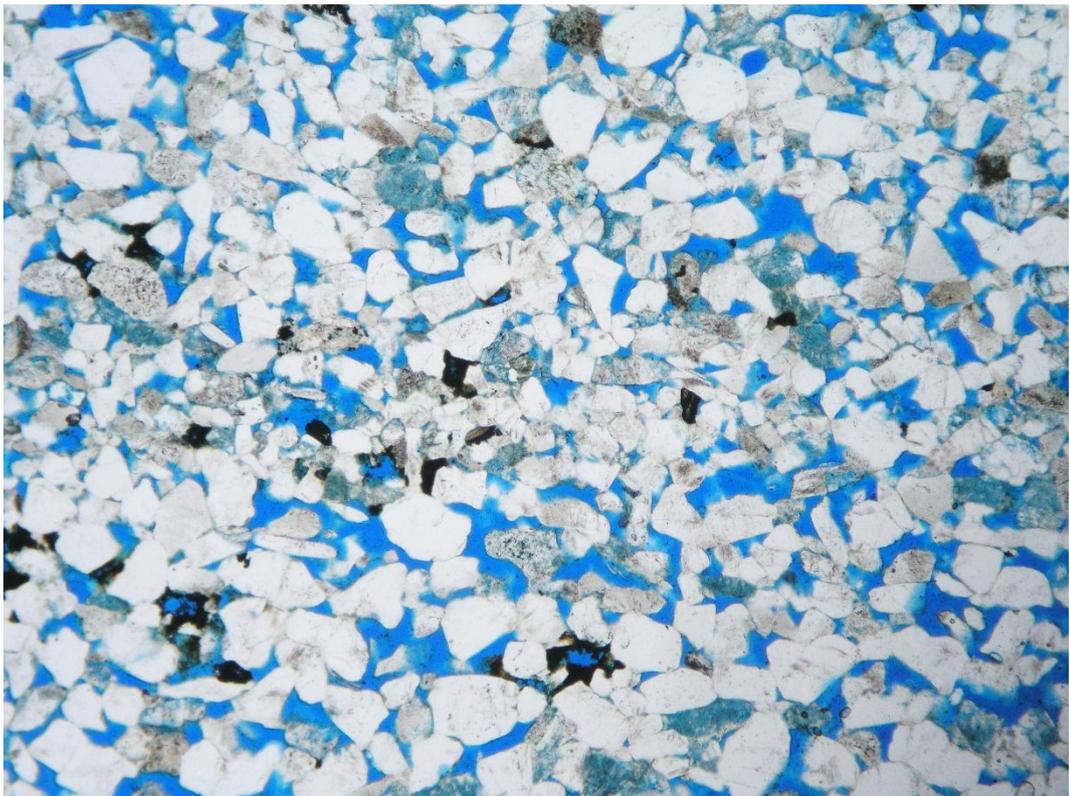
Thin section photographs of sample ECON7740 ('F1': Fersness quarry). Grains of quartz and feldspar appear white. Rock fragments appear mottled grey. Iron oxide appears brown to black, and is distributed in patches throughout the stone. Pore space appears blue. The images were taken in plane-polarised light, and the field of view is c.3.3 mm wide.

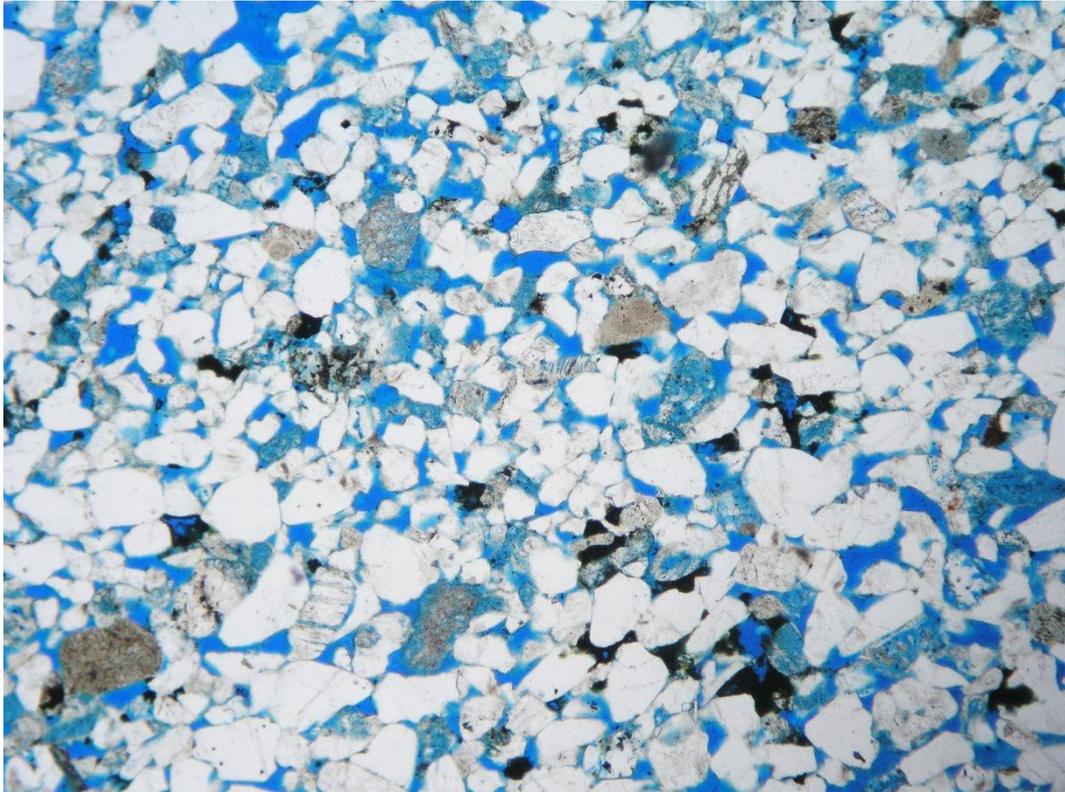
Thin section photographs of sample MC4167 ('F2': Fersness quarry). Grains of quartz and feldspar appear white. Rock fragments appear mottled grey. Iron oxide appears brown to black, and is distributed in patches throughout the stone. Pore space appears blue. The images were taken in plane-polarised light, and the field of view is c.3.3 mm wide.

3. The mineral zircon is present in trace amounts (accounting for <<1% of the total thin section area).
4. The sample contains a few ‘moldic pores’, which are fringed with iron oxide minerals. Iron oxide is also distributed as intergranular patches throughout the stone. The presence of moldic pores, in particular, suggests that an intergranular, iron-bearing carbonate mineral was formerly present in the stone, but that this mineral has since dissolved due to chemical alteration.

5. The relatively high proportion of intragranular pores, and the presence of grains which appear to be ‘floating’ in the plane of the thin section, suggest that the stone formerly contained a greater volume of feldspar grains, which have since dissolved due to chemical alteration.
