Den Haag, The Netherlands, 12 – 14 March 2019

1. ALL SYSTEMS GO! WASH SYSTEMS SYMPOSIUM

A methodology for assessment of the physical sub-system of hand pumped boreholes: initial insights from Ethiopia.

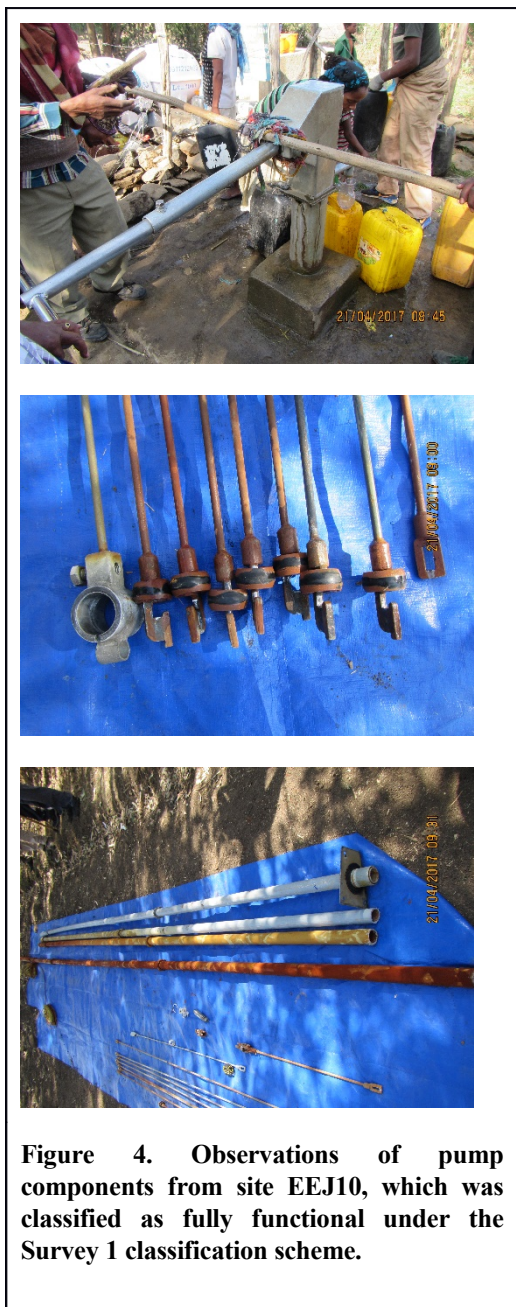
An example of above and below ground observations for a fully functional, partially functional (poor reliability and low yield) and non-functional hand pumped borehole are shown, respectively, in Figure 4 for site EEJ10, Figure 5 for site EEJ06 and Figure 6 for site EEJ20. The fully functional and partially functional boreholes appear very similar from a quick interrogation of the images, the main difference is that the rods from the partially functional borehole appear to be more corroded. The non-functional borehole is in a very poor condition and has many missing components. Further work is required to utilise these images and the manually recorded observations and quantitative measurements to draw conclusions about influence of the component condition on functionality outcomes and whether these represent causes or symptoms of poor functionality.
