Cooper, A.H. 2020. Geohazards caused by gypsum and anhydrite in the UK: including dissolution, subsidence and heave. in Giles, D. P. & Griffiths, J. S. (eds) 2020. Geological Hazards in the UK: Their Occurrence, Monitoring and Mitigation – Engineering Group Working Party Report. Geological Society, London, Engineering Geology Special Publications, 29, 403–423, <https://doi.org/10.1144/EGSP29.16>

## **Geohazards caused by gypsum and anhydrite in the UK: including dissolution, subsidence, sinkholes and heave**

Anthony H. Cooper

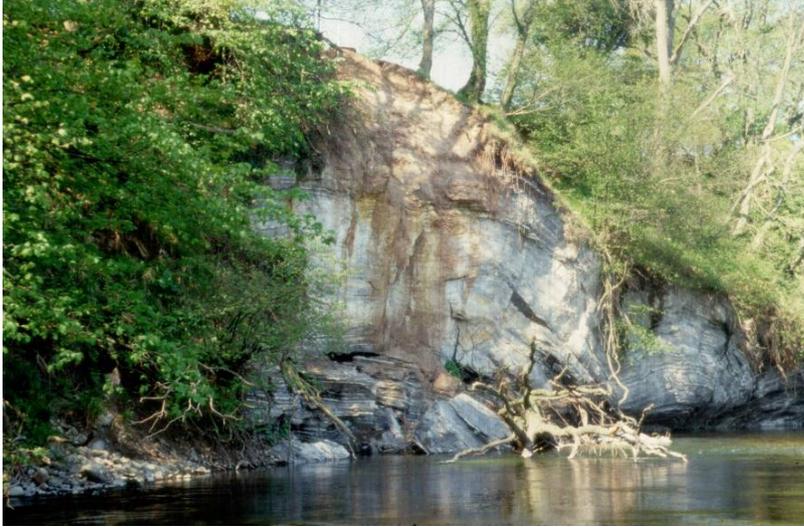
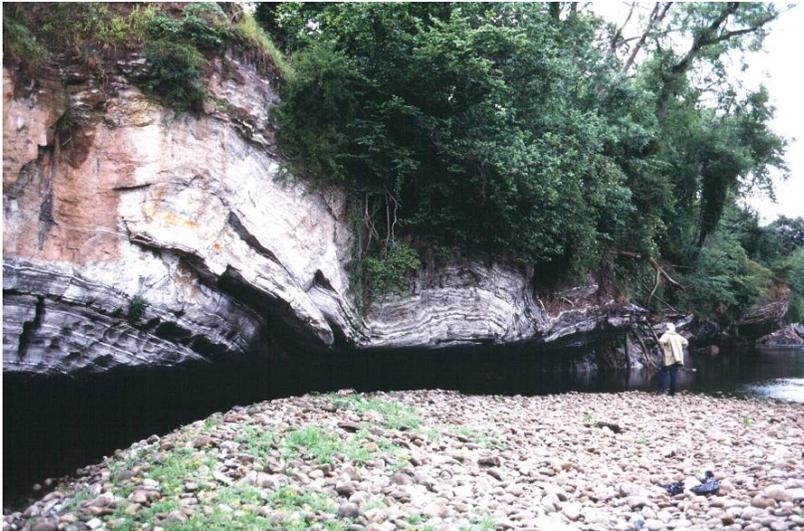
**Figure 1. Ripon Parks gypsum in 1979 (top) when it had just collapsed and 1990 (bottom) showing the undercutting of the cliff by about 6 metres due to dissolution from the River Ure. Soon after this lower picture was taken the cliff collapsed again. (Photos A H Cooper © NERC/BGS).**

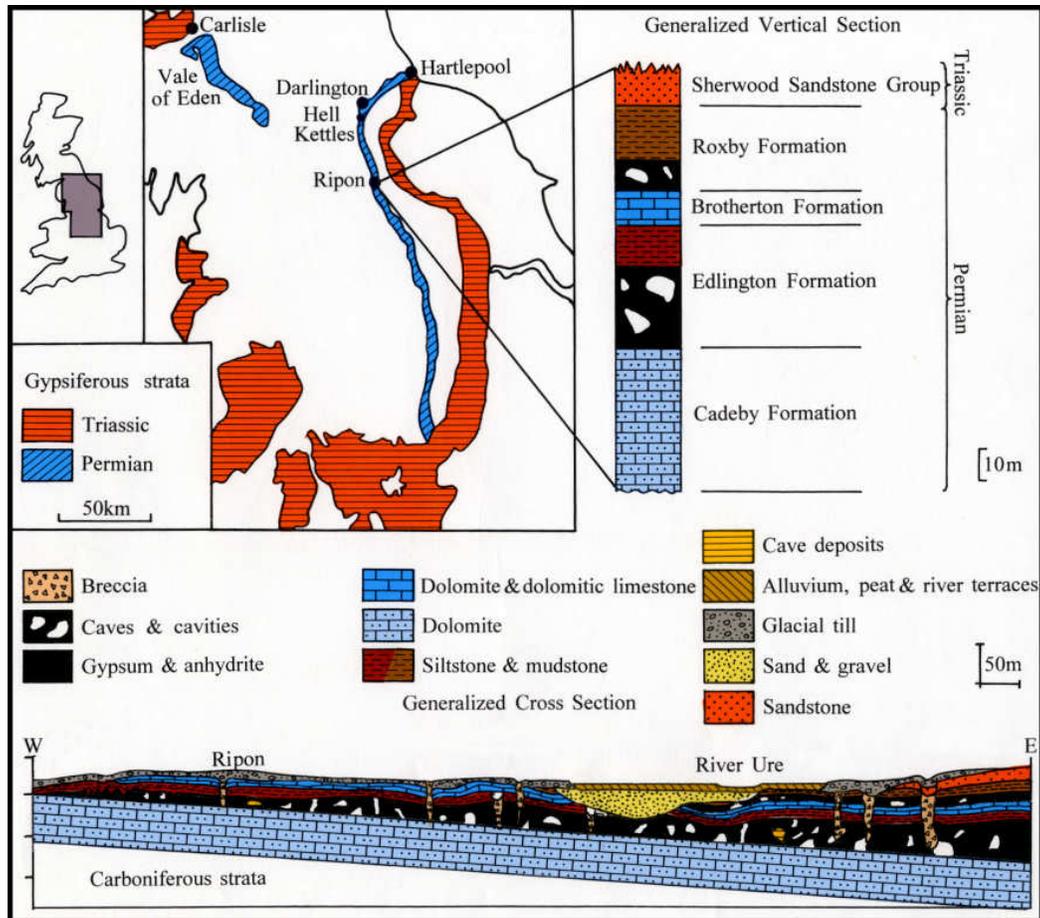
Figure 2. Regional geology of the Permian and Triassic gypsiferous sequences with a cross-section from west to east through the Ripon area showing the easterly dipping dolomite and gypsum sequence cut into by the glacial valley of the River Ure.

The subsidence-prone belt extends from Ripon northwards to Darlington and Hartlepool (Figure 2), where the sequence is similar to that at Ripon, but the carbonate formations have different names. Around Darlington up to 40 m of gypsum is present in the Edlington Formation and up to 7 m in the Roxby Formation. Two types of subsidence occur in this northern area - catastrophic collapse similar to that at Ripon and more widespread settlement. The distinction between the two types is controlled by the hydrogeology and the thickness and lithology of the overlying glacial deposits (Lamont-Black *et al.* 1999, 2002).

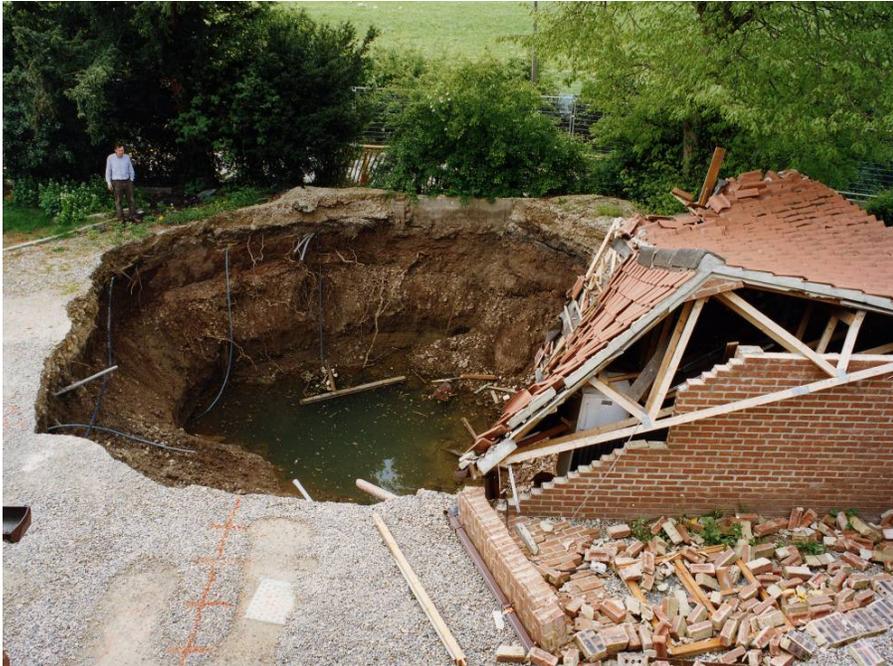
**Figure 3. Sinkhole that formed in 1997 on Ure Bank, Ripon destroying 4 garages (category 7 damage) and damaging the adjacent house (Photo P Tod © NERC/BGS).**

The subsidence has been mapped from its surface expression as sinkholes or dolines and by looking at building damage (Figures 3, 4 and 5). Several building damage surveys have been carried out; the technique used is based on an extended version of the subsidence damage recording scheme introduced by the National Coal Board (Cooper 2008a) and scores the damage from 1 which is very minor to 7 which is complete collapse. Information from a survey by is shown in Figure 6. Information about building damage, sinkholes, springs, stream sinks and caves for Ripon have been gathered by the British Geological Survey and stored in a Geographic Information System and associated databases (Cooper 2008b; Cooper et al. 2001; Cooper et al. 2011; Farrant and Cooper 2008). This database now has information for gypsum and salt karst features covering most of the country; it also contains information about limestone and chalk for about half of the country.

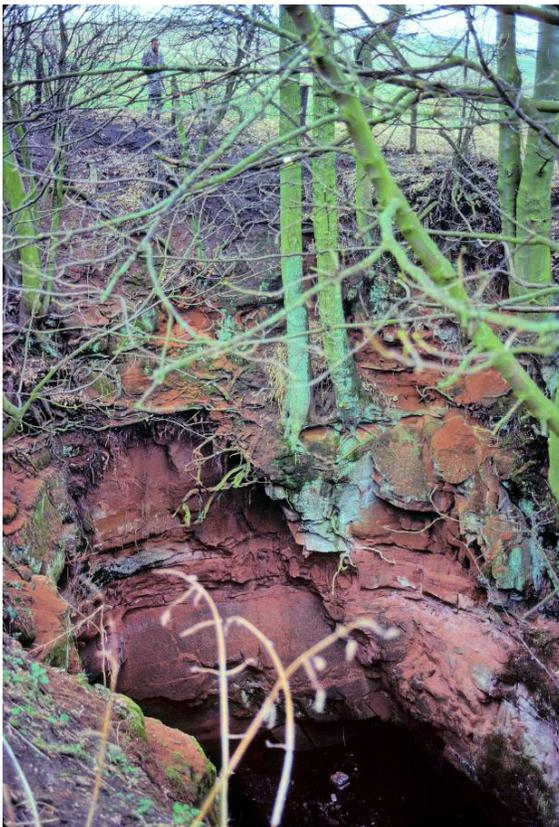
**Figure 4. Sinkhole that formed in July 1834 near Ripon Railway Station. The hole is in red Sherwood Sandstone and was 20 m deep and 14 m across when it formed (Photo A H Cooper © NERC/BGS).**

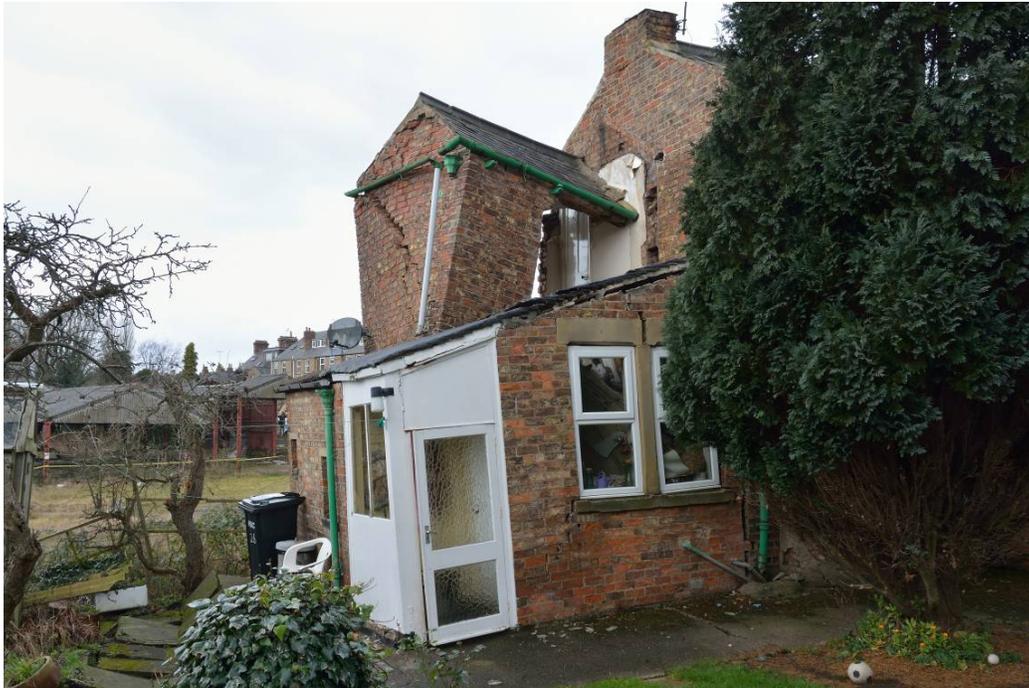
**Figure 5. Severe building damage (category 7) that occurred on the night of February 17<sup>th</sup> 2014 at Magdalens Close, Ripon caused by a sinkhole, possibly triggered by heavy antecedent rainfall. (Photo A H Cooper © NERC/BGS).**

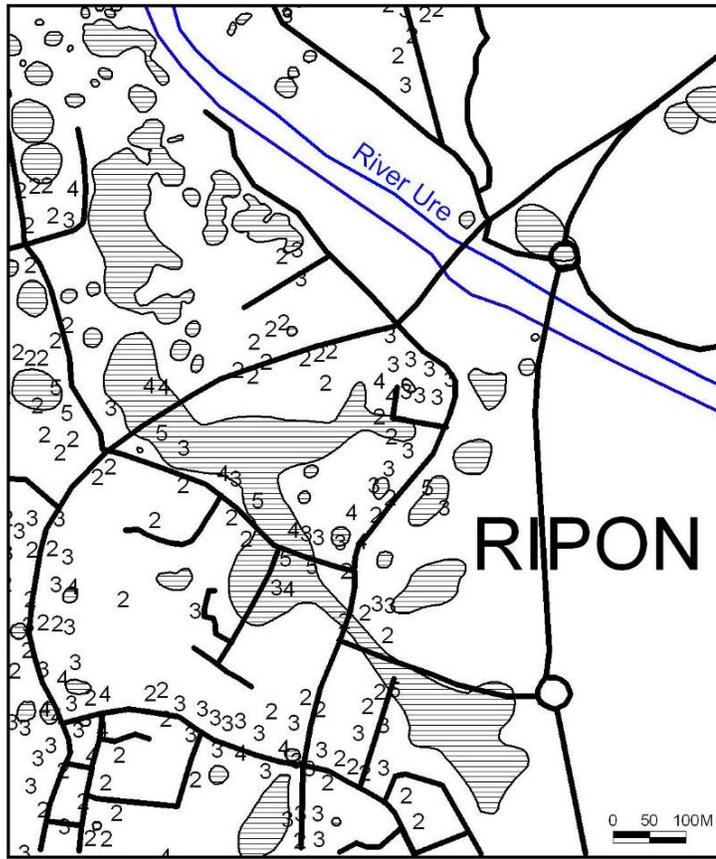
**Figure 6. Building damage recording in Ripon by McNerney (2000) and included in the British Geological Survey karst GIS database; subsidence hollows shown with horizontal ornament in part of Ripon; from Cooper 2008a. See also Figure 10.**

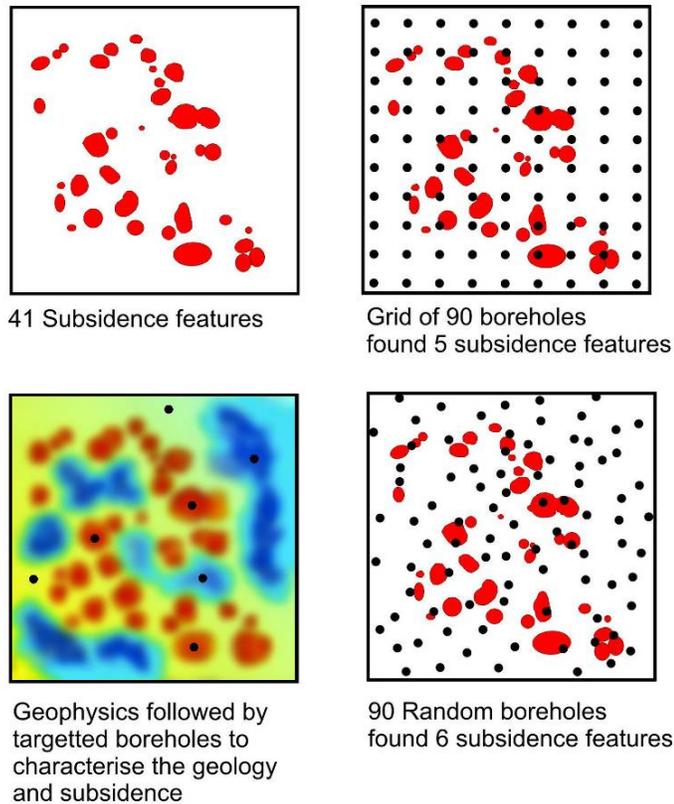
**Figure 7. Actual subsidence features and the potential success of boreholes and geophysics for locating them.**

In summary, areas underlain by gypsum can pose difficult problems for developers and engineers. Drilling on either a grid or on a random sample pattern both have little chance of finding all the anomalies on a site (Figure 7). Breccia pipes and near surface cavities can be present, and physical investigations of their locations, by all but the closest spaced borehole survey, is difficult. Geophysics can help to delineate anomalies, which can then be avoided or investigated as part of the site development (Thompson *et al.* 1996). Successful techniques include microgravity (Patterson *et al.* 1995) and various forms of resistivity and conductivity survey with 3D resistivity tomography being particularly effective (Cooper 2009; Kaufmann and Romanov 2009). Ground probing radar (GPR) has also been used in areas where the surface material is not clayey (Benito *et al.* 1995), but has not been used in Ripon. Geophysics combined with trenching has also proved effective in Spain (Gutiérrez *et al.* 2009). Detailed seismic reflection techniques have been used near Darlington and Ripon, but the method is very labour intensive and more expensive than the other methods including microgravity (Sargent and Goulty 2009, 2010). Geophysics is best used in conjunction with limited amounts of drilling; a phased approach of using geophysics to target “anomalies” and “normal” areas, followed by drilling has proved effective (Figure 7).

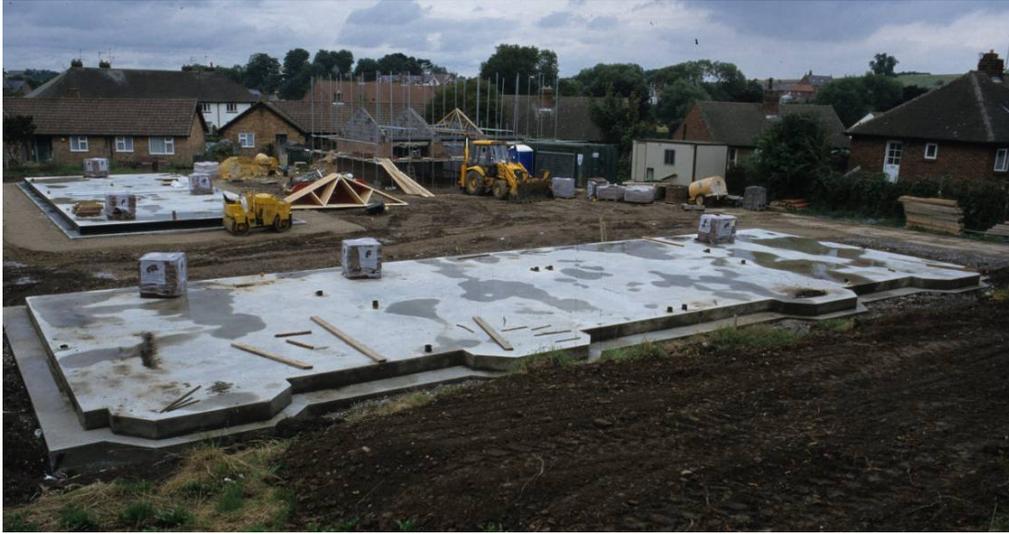
**Figure 8. Massive rafted foundations at Ripon designed to cope with subsidence, note that the identified subsidence feature (just left of this picture) was avoided in this construction (Patterson et al, 1995; Photo A H Cooper © NERC/BGS).**

buildings are now constructed on reinforced raft foundations (Thompson et al. 1996 and Figure 8); additional protection could be afforded by extending foundations with supporting beams outside the main footprint of the property (Cooper and Calow 1998). In subsidence-prone karstic areas it is important to use flexible service pipe materials and to guard against water loss and infiltration that itself could trigger subsidence. In some places, service trenches have been lined with waterproof membranes to stop this happening.

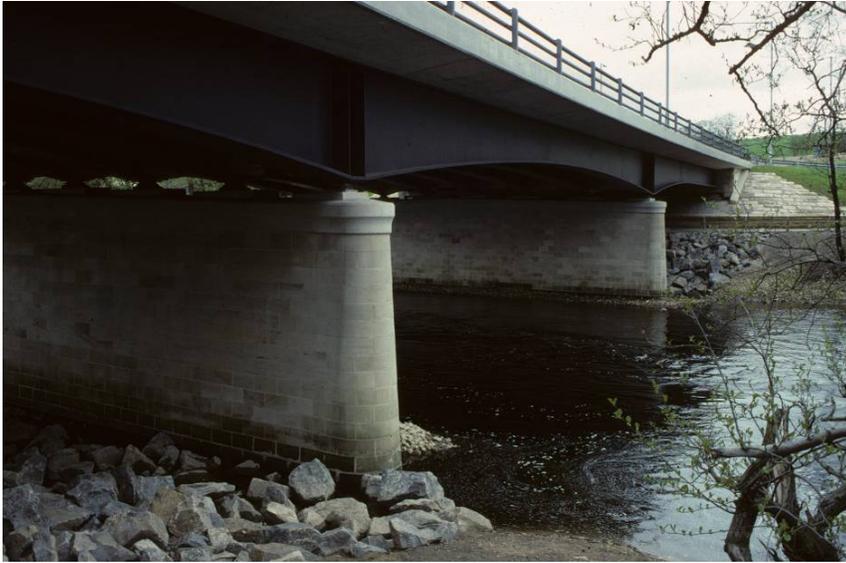
**Figure 9. Ripon bypass bridge over the River Ure. The bridge span is one continuous structure designed not to collapse if subsidence removes the support of a pillar. Electronic monitoring is incorporated in the bridge bearings. (Photo A H Cooper © NERC/BGS).**

Linear structures such as roads and bridges are very prone to subsidence damage. At Ripon, the new Ure Bridge is built with redundant strength and the capability for the structure to lose any one of its pillar supports without collapse - Figure 9 and Figure 10 (Cooper and Saunders 2002). On the same stretch of road, the embankments are protected by two layers of strong geogrid material sandwiched in the embankment fill (Cooper and Saunders 2002; Jones and Cooper 2005; Thompson et al. 1996). This sandwich of material is designed to span cavities up to about 15m across and sag rather than fail so that an indication of any problem becomes visible at the surface. Sensitive structures such as bridges and viaducts can be equipped with monitoring and warning systems such as those installed in the Paris road viaducts (Arnould 1970) and the bridge at Ripon (Cooper and Saunders 2002).

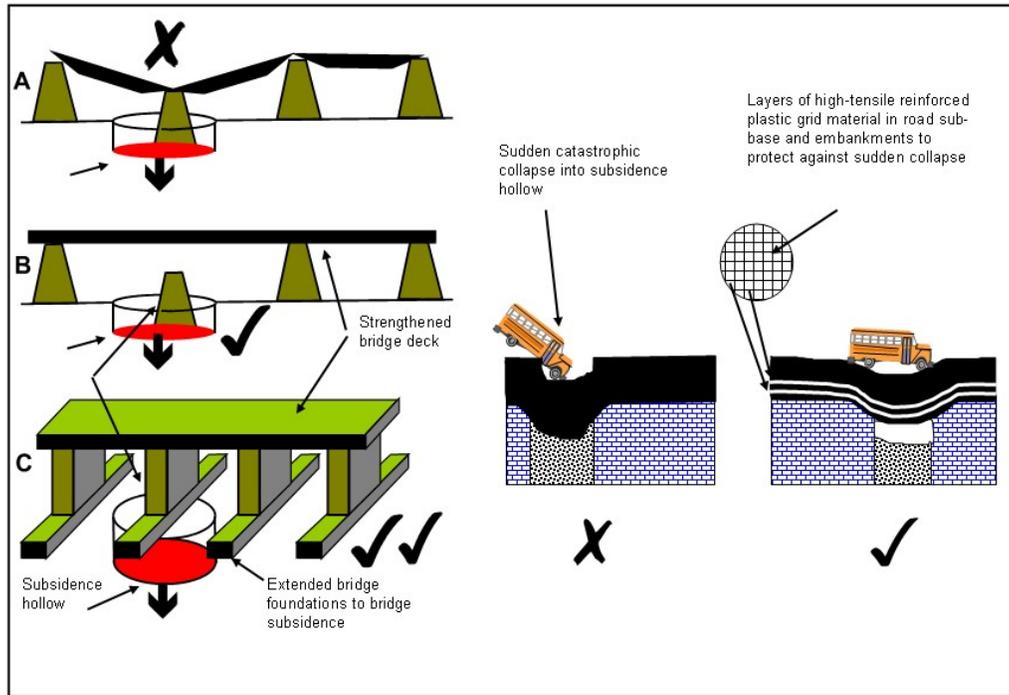
**Figure 10. Reinforced bridge and road at Ripon designed to cope with subsidence problems (Cooper and Saunders, 2002; Jones and Cooper, 2005; Thompson et al. 1996).**

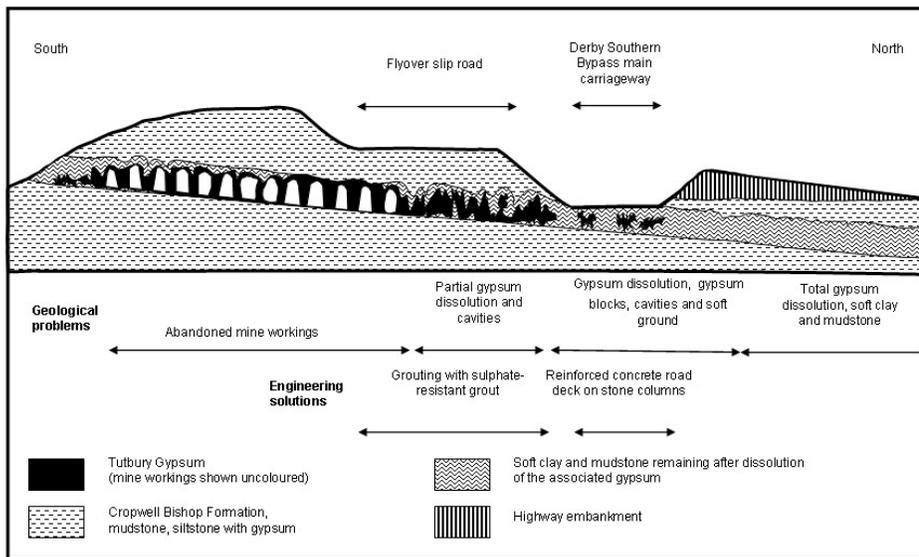
**Figure 11. Section through the Tutbury Gypsum and associated strata on the Derby Southern Bypass (Cooper and Saunders, 2002)**

Over gypsum dissolution in the Triassic strata, the Derby Southern Bypass used geophysics to locate cavities that were then filled. During construction large blocks of gypsum were excavated and removed while dissolved areas and old mine workings were grouted with sulphate-proof grout. Subsequently, the road was constructed of reinforced concrete to avoid any subsidence problems - Figure 11 (Cooper and Saunders 2002). Similar geophysical techniques and the removal of the gypsum have recently been undertaken for the improvement constructions on the A453 near Ratcliffe Power Station in Nottinghamshire (authors observations 2013).

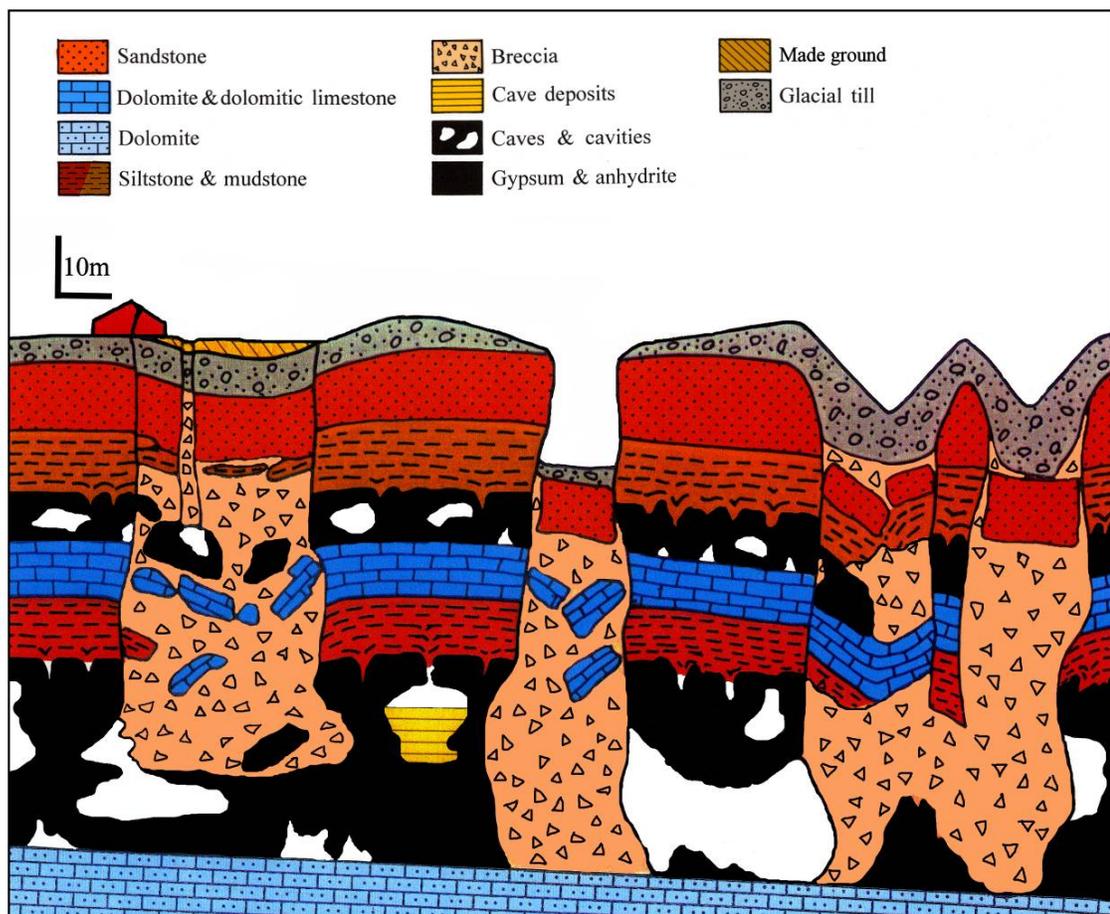
Figure 12. Stylised cross-section through gypsum dissolution subsidence features in the east of the Ripon subsidence belt.

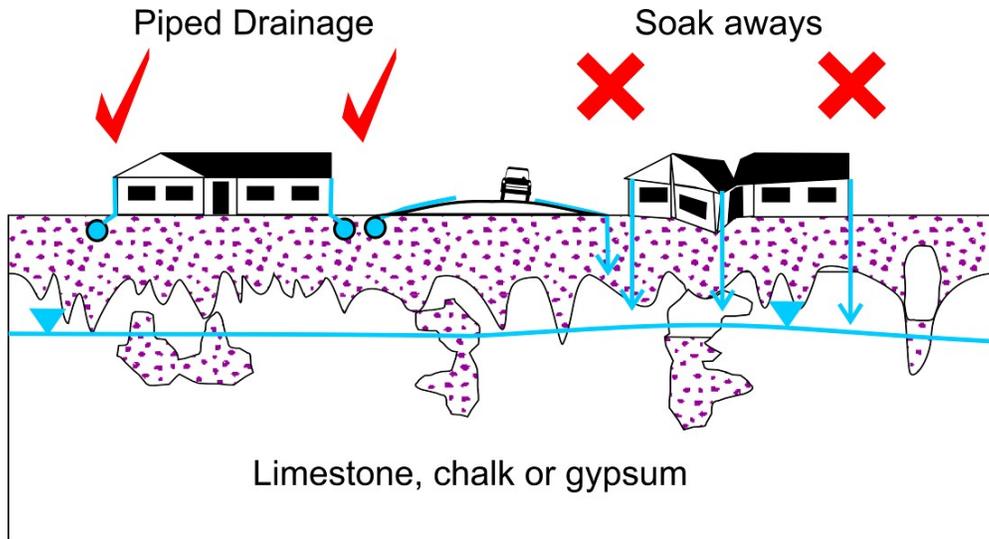
Figure 13. Subsidence problems caused by soak aways and their avoidance by correct drainage.

Soak-aways from surface runoff or septic tanks are a well-known anthropogenic trigger that has caused subsidence in many places (Waltham et al. 2005). Within England and Wales there are policies for groundwater protection related to foul water soak-aways (Environment Agency 2010; Environment Alliance 2006) and information about infiltration testing and system design (British Standards Institution 2005, 2007). Septic tanks are not allowed in Zone 1 groundwater protection areas (which are the areas most susceptible to groundwater pollution), but the only apparent constraints are pollution prevention and suitable ground permeability assessed by percolation testing (Office of the Deputy Prime Minister 2002). No mention is made of potential karstic ground instability problems that can result from changes in the local input of water into the ground; these need to be considered in gypsum karst areas.

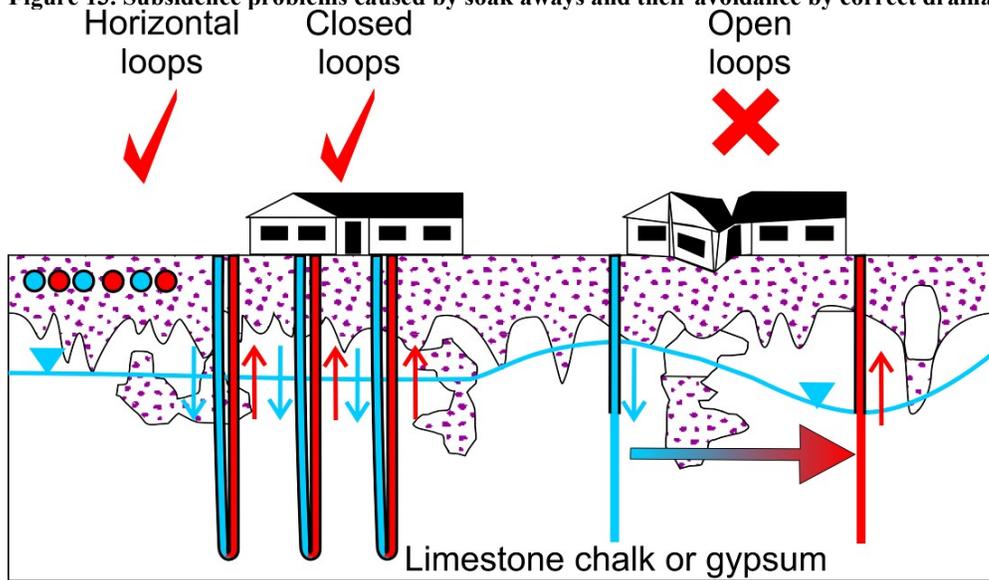
Figure 14. Subsidence caused by open loop ground source heat pump installations and their avoidance by using closed loop systems.

Ground source heat pumps and ground cooling systems (Arthur et al. 2010; Busby et al. 2009) are becoming popular as a source of green energy or an energy efficient cooling system. However, they could be problematical. Open loop installations must be avoided in gypsum and anhydrite not only because of the dissolution problems, but also because of the potential to hydrate anhydrite to gypsum (see section “The gypsum-anhydrite transition, expansion and heave”). This has happened in Staufen, Germany where a well-meaning “green” heat pump installation has caused severe heave to the recently restored town hall and 131 houses causing in excess of 40 million euros of damage (Goldscheider and Bechtel 2011; Staufen City Administration 2012). In addition to the dissolution and heave problems, the changes in groundwater levels associated with extraction and injection of water in open loop systems also has a potential to cause reactivation of breccia pipe features and subsidence/sinkholes due to the suffusion of overlying materials (Figure 14).

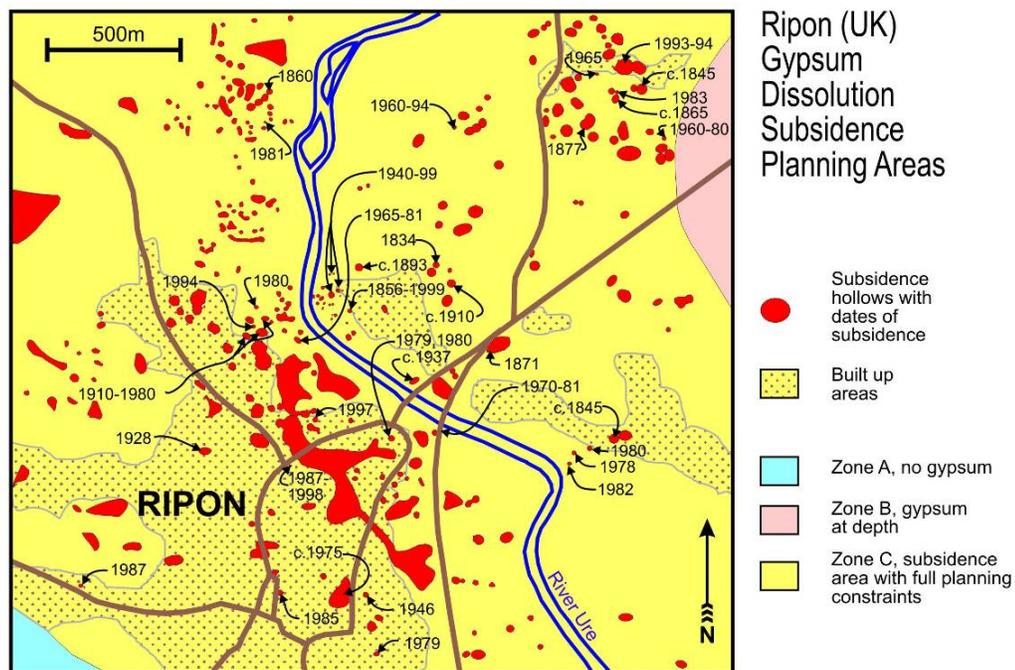
**Figure 15. The planning zones and distribution of subsidence hollows in the Ripon area with the dates of collapse where they are known.**

The dates and locations recorded for the historically recent subsidence events suggest concentration of water flow in the cave systems along certain specific paths (Figure 7 and (Cooper 1986, 1989, 1998)). The close grouping of subsidence hollows suggests that once a collapse has occurred the cave partially chokes and the dissolution continues in the adjacent strata. This commonly produces linear belts of subsidence related to the joint pattern. It also means that localities adjacent to, or in line with, existing subsidence hollows are probably more at risk from future subsidence. From the distribution of the subsidence features and their sizes, the worst areas can be avoided and development in the less susceptible areas tailored to cope with the magnitude of the likely subsidence events.

In Ripon there is a formal planning policy with check-lists and signed documents to help control and protect development in the area (Thompson *et al.* 1996; Thompson *et al.* 1998). To support this process the Ripon area has been divided into three development control zones: (A) no know gypsum present; (B) some gypsum present at depth; (C) gypsum present and susceptible to dissolution.

Within zone A no special planning constraints are imposed. In zone B, where the risk of subsidence is small, a ground stability report prepared by a competent person is usually required and the problem is considered in local planning.
