A Hidden Crisis: unravelling current failures for future success in rural groundwater supply

Introduction and background

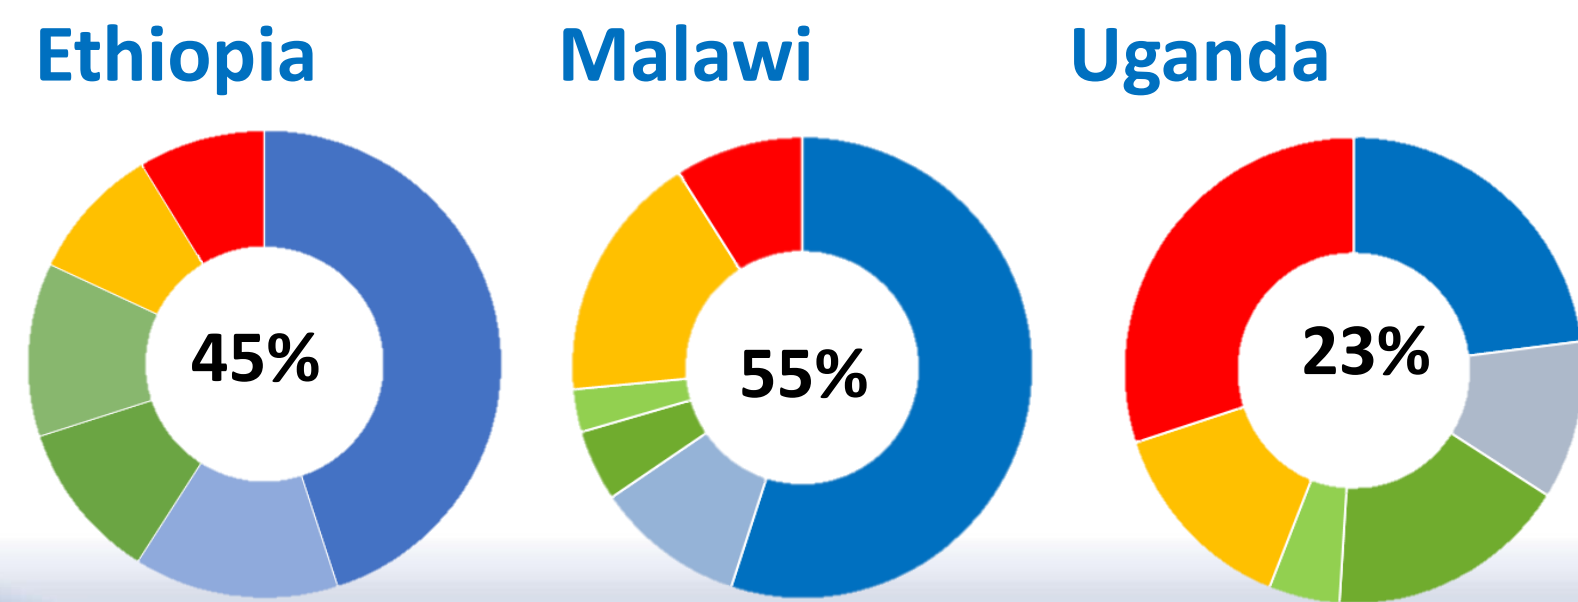
Survey 1 consisted of a stroke test, water point committee interviews and water quality sampling. The results, obtained using the new definition of functionality, are shown below (**figure 4**).

Figure 4 – Results of survey 1 using the definition (and colour scheme) shown in figure 2.

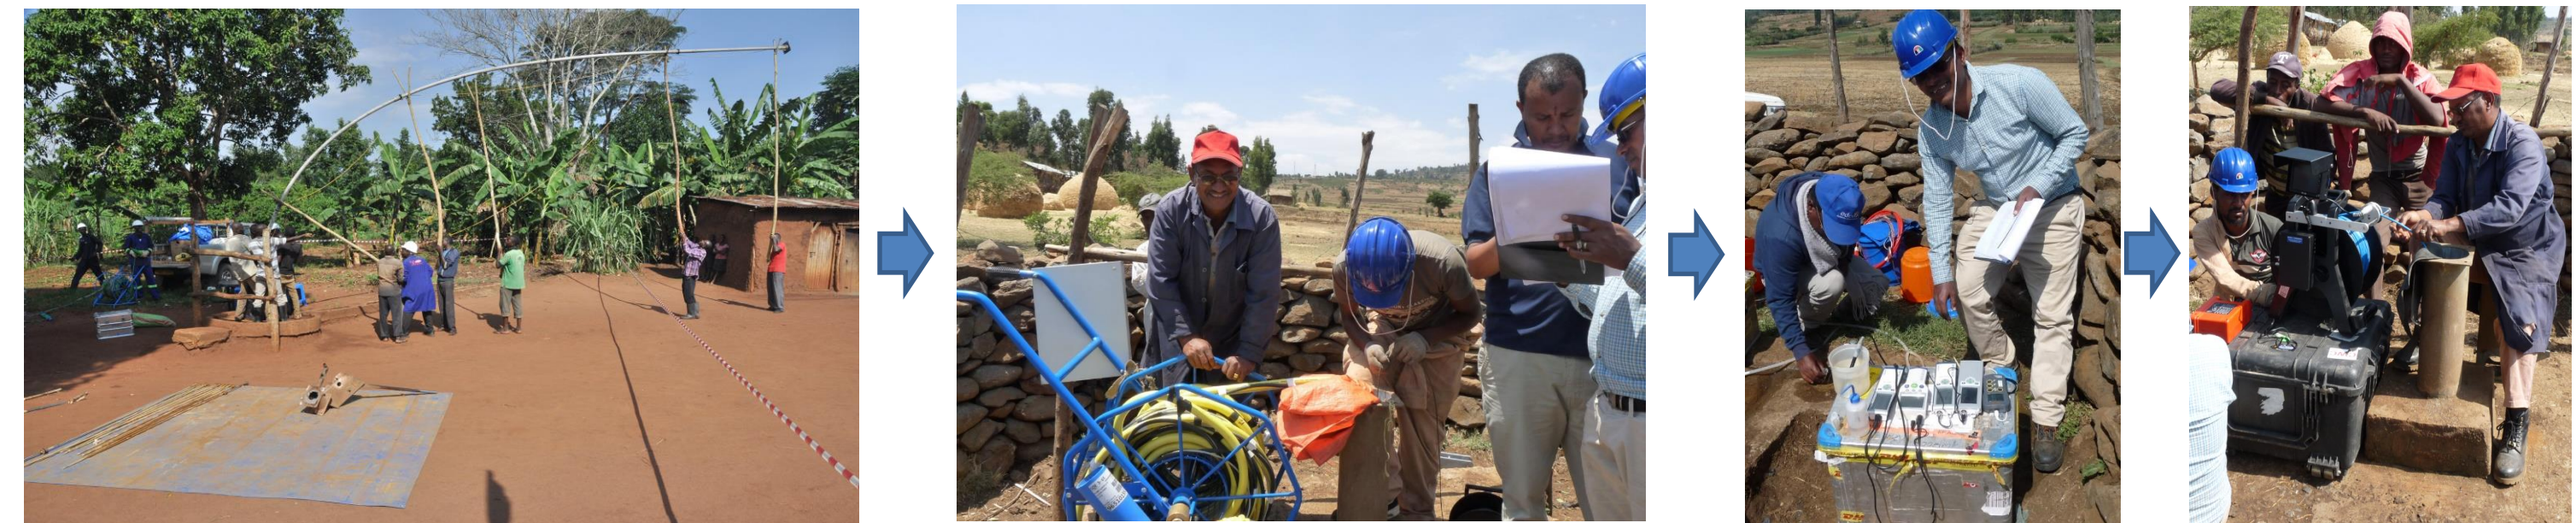
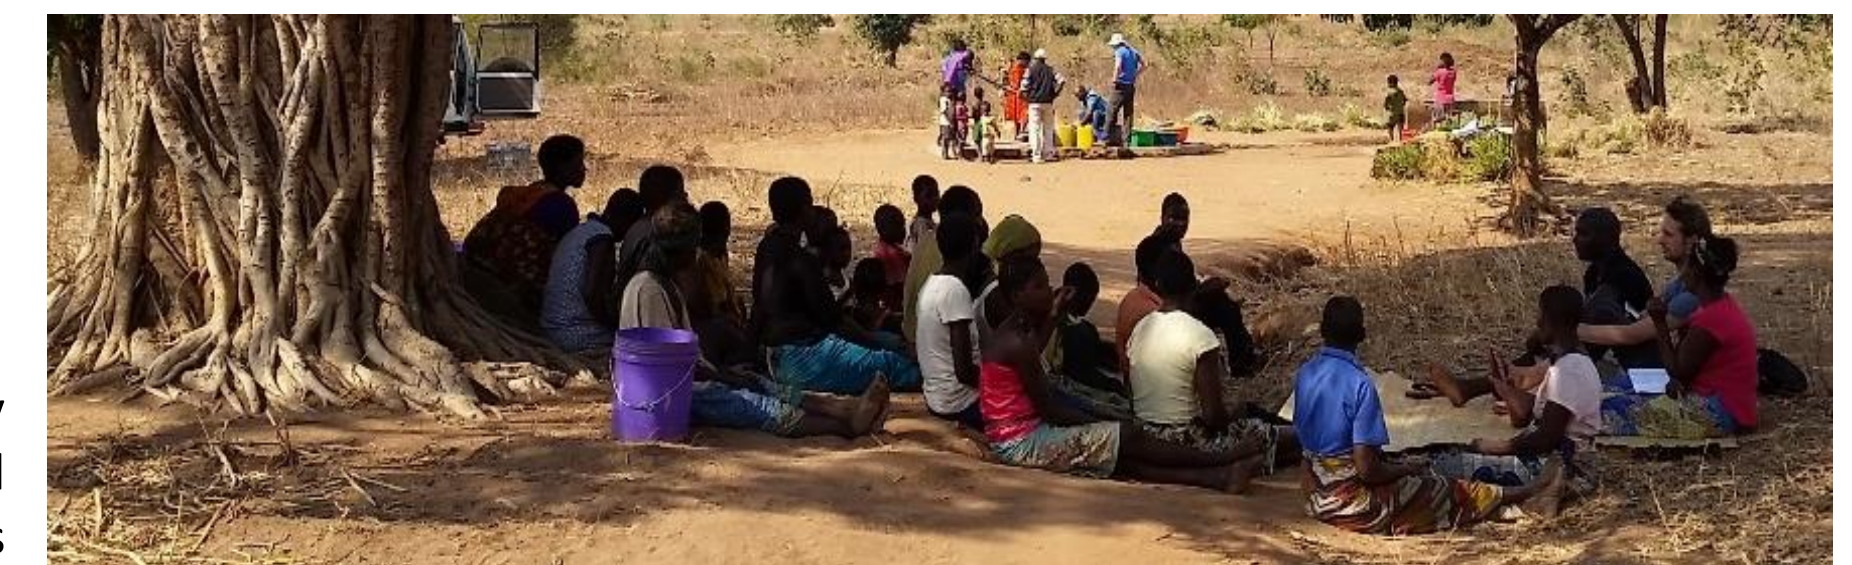
- HPB was dismantled and thoroughly inspected.
- Three hour pumping and recovery test.
- Water quality and residence time sampling.
- Downhole CCTV surveys.
- Discussion of communities experience of HPB.

Figure 5 – Field methods, from left to right; pump inspections; pumping test; field chemistry; borehole inspections. Bottom; discussions with communities.

Survey 2 used a subset of survey 1 HPBs to develop as detailed understanding of the factors underlying functionality (**figure 1**). The methods used in survey 2 are shown below (**figure 5**).
