RRS *Discovery* Cruise 116

Time-series studies at the Porcupine Abyssal Plain
Sustained Observatory

Cruise report number 73

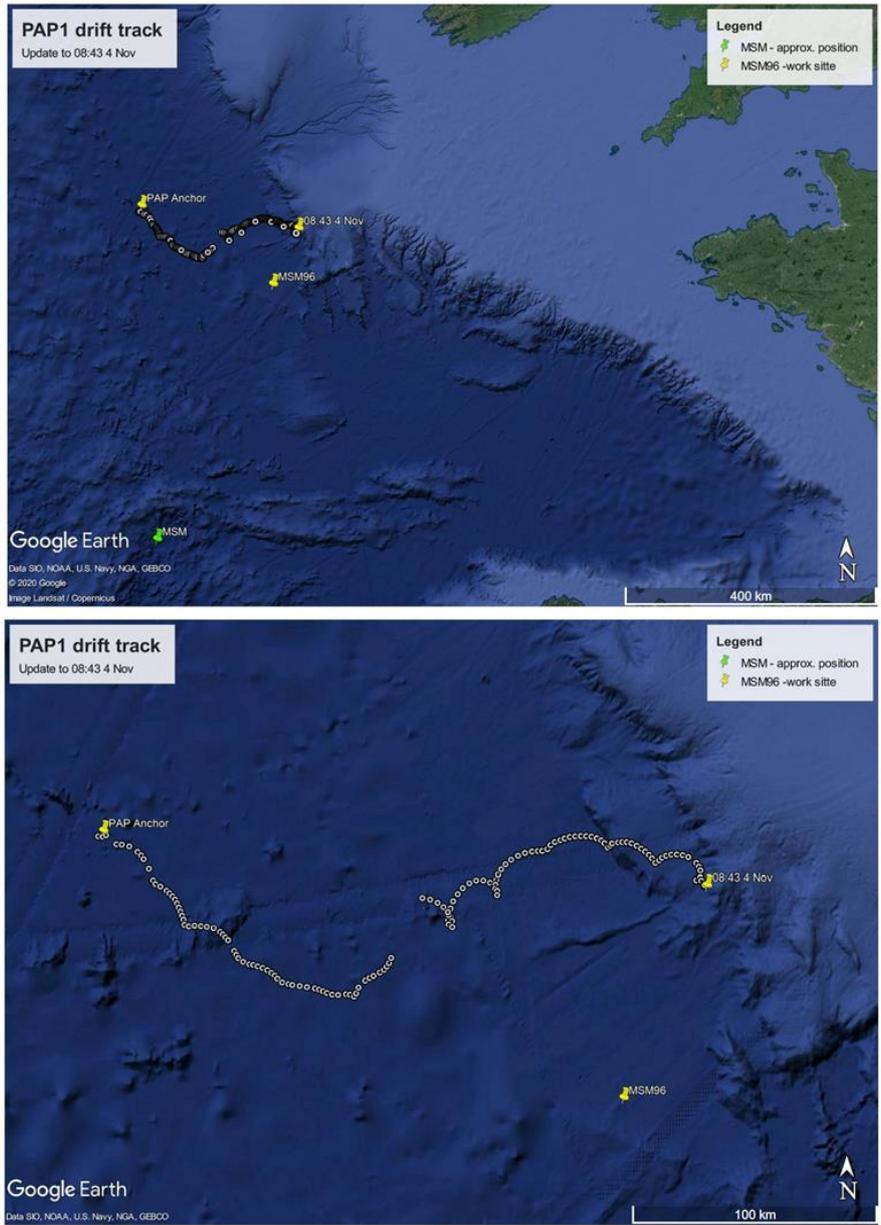
Positions of the drifting PAP-1 surface buoy in the lead up to recovery by the FS Maria S. Merian (lower map is zoom in on upper map).

At the time of boarding RRS *Discovery* there was some uncertainty about the exact requirements for recovery of the PAP-1 mooring. On the 23/10/2020, 18 days prior to DY116 departure, the surface buoy from the PAP-1 mooring was adrift following high winds and waves associated with the remnants hurricane Epsilon. When the DY116 team boarded RRS *Discovery* we were awaiting news of an attempted recovery by the FS *Maria S. Merian*. This was successfully achieved on 5th November after 12 days adrift.

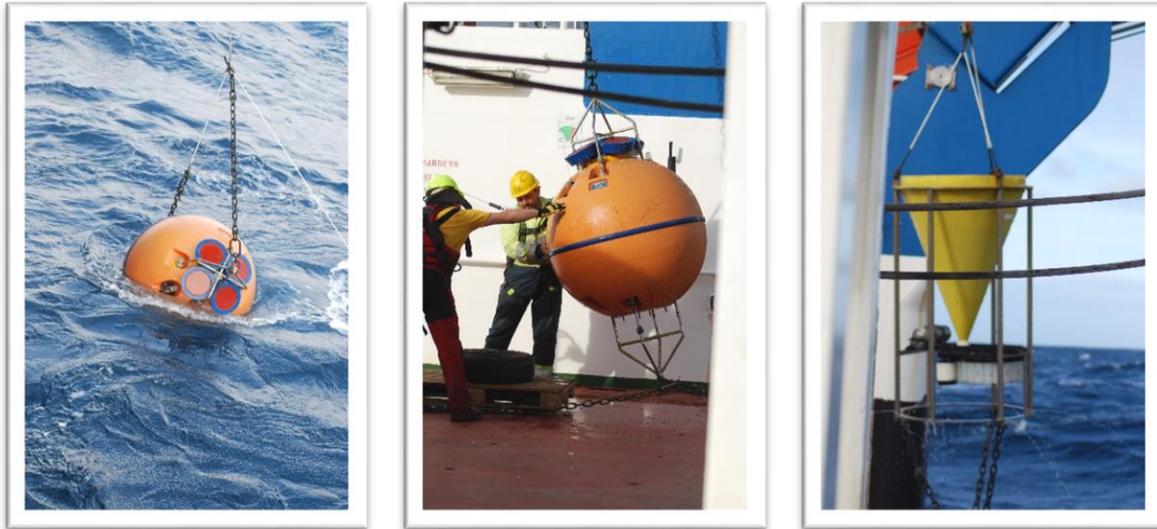
The sediment trap funnel was two thirds full with an unknown deposit on retrieval adding to its weight and negative buoyancy of the end of the mooring, this being the reason the 600 kHz buoy did not quite reach the surface.

Images of recovery of the ADCPs and sediment trap from the Whittard Canyon mooring

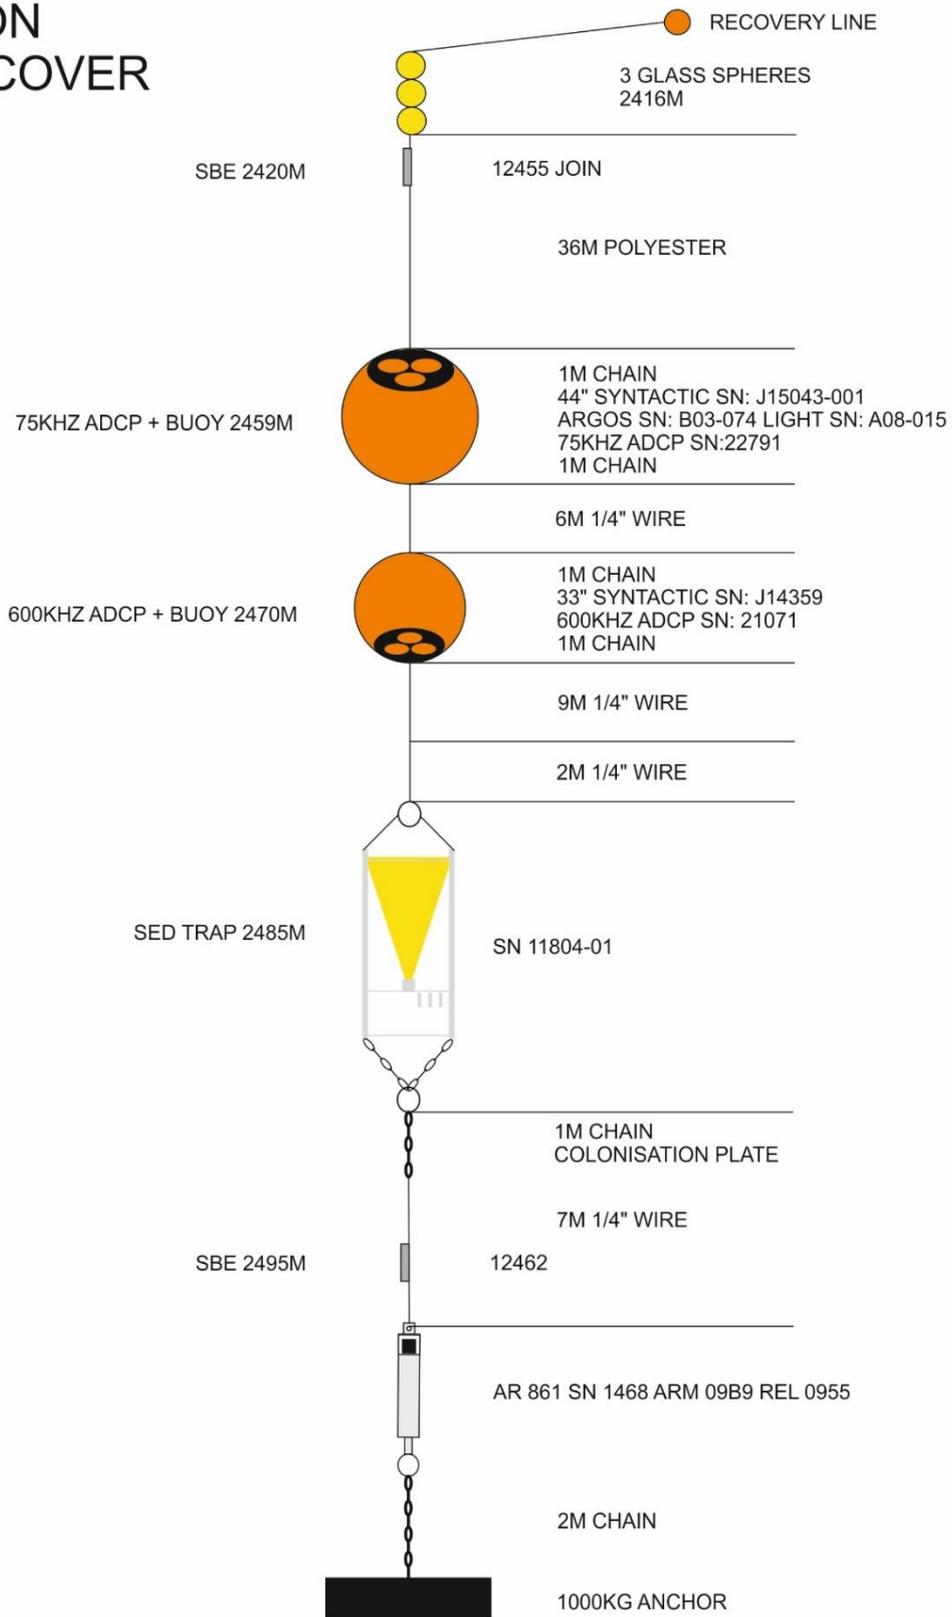
WHITTARD CANYON TO RECOVER 2020

WATER DEPTH
2500M

The polyester rope had stainless steel thimbles instead of galvanised. This is an error by the supplier, but needs to be picked up during pre-cruise prep. The ½” shackles were nut and split pin instead of euro-shackle, which is the preferred style for all moorings.

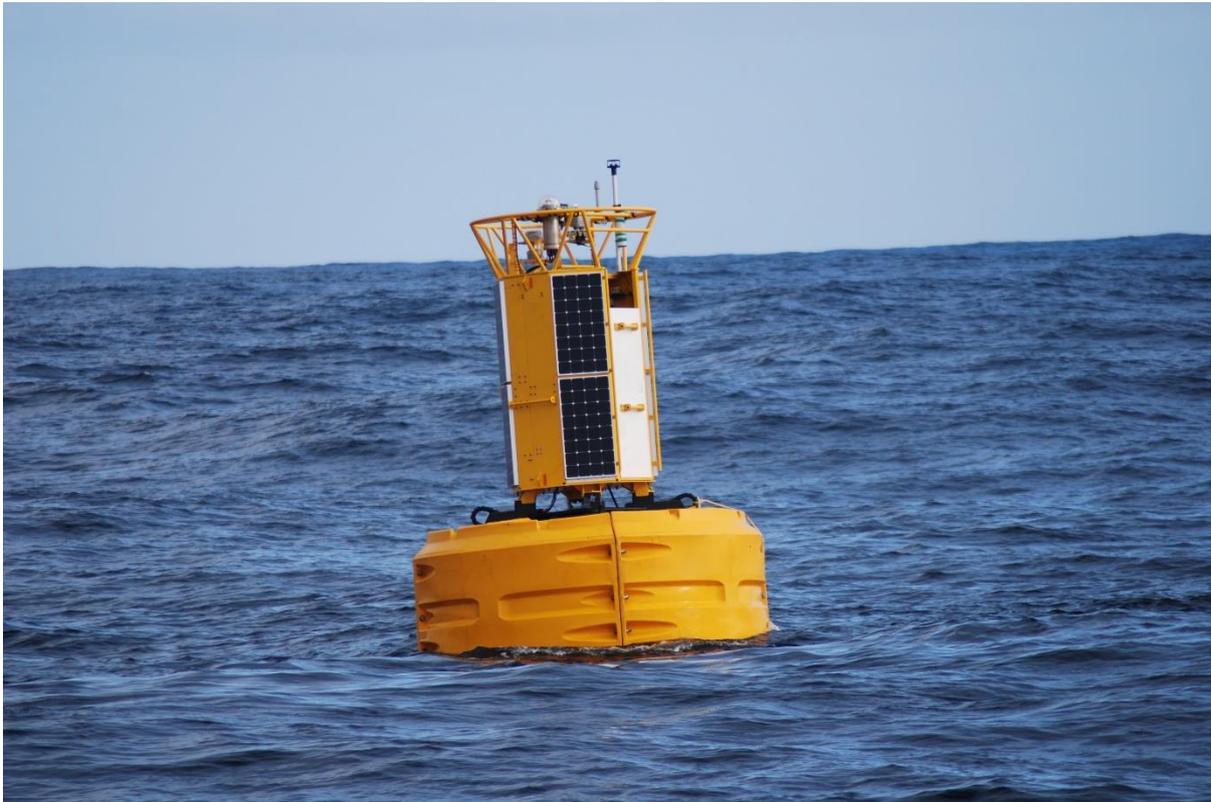
The new Mobilis PAP-1 buoy shortly after deployment (DY116-008)

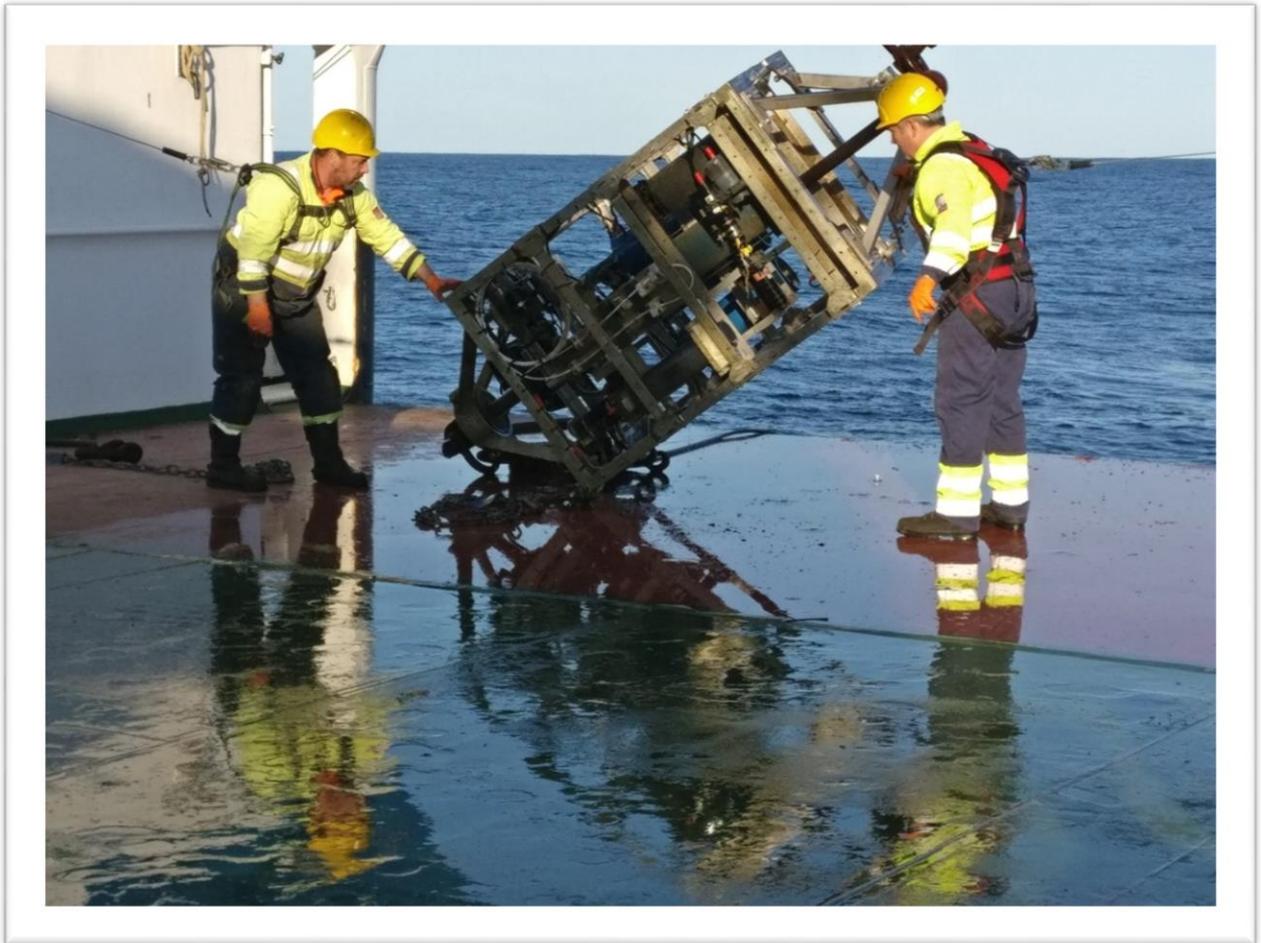
Recovered sensor frame from PAP-1 (DY103-028)

The PAP 1 mooring was released about 9:30 am and the subsurface buoy was spotted on the surface around 10:30 am. The rope spread over a distance running northwest, with a significant loop highlighted by birds at the surface at one end. This loop was where it was eventually decided to grapnel the line and begin recovery. The line was doubled up onto the winch and reeled in until the mid- water buoy came on deck about 14:45. The buoy was removed from the live line and the rope reconnected to wind in the remainder of the mooring. Star Oddis were removed from the last 200 m of rope before the instrument frame was retrieved to the deck at about 15:15 when over-side mooring work ended. At this point it became clear that the failure point of the mooring had been an un-welded shackle above the strain gauge link. The shackle was not welded on deployment because the requested weld set had not been supplied on the previous cruise.

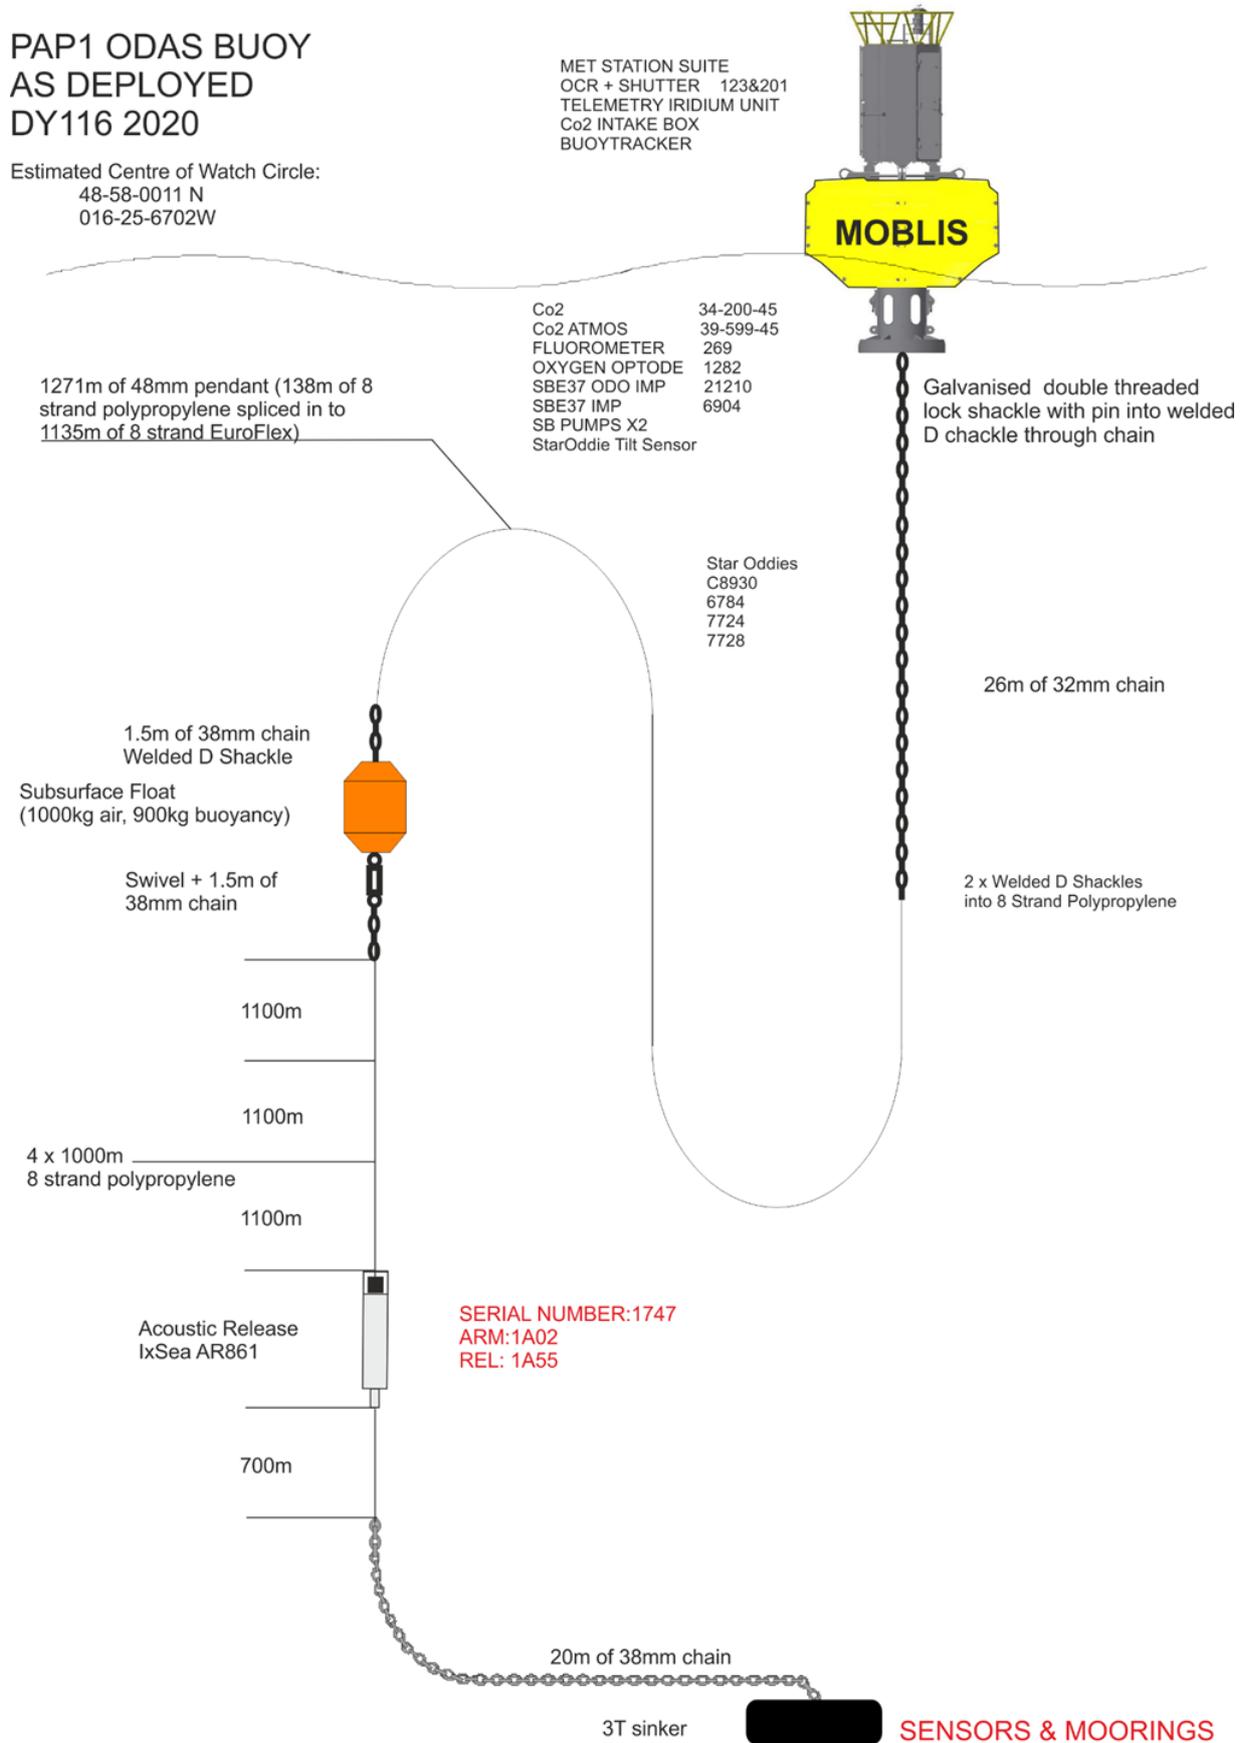
MET STATION SUITE
OCR + SHUTTER 123&201
TELEMETRY IRIDIUM UNIT
Co2 INTAKE BOX
BUOYTRACKER

PAP-1 as deployed (DY116-008)

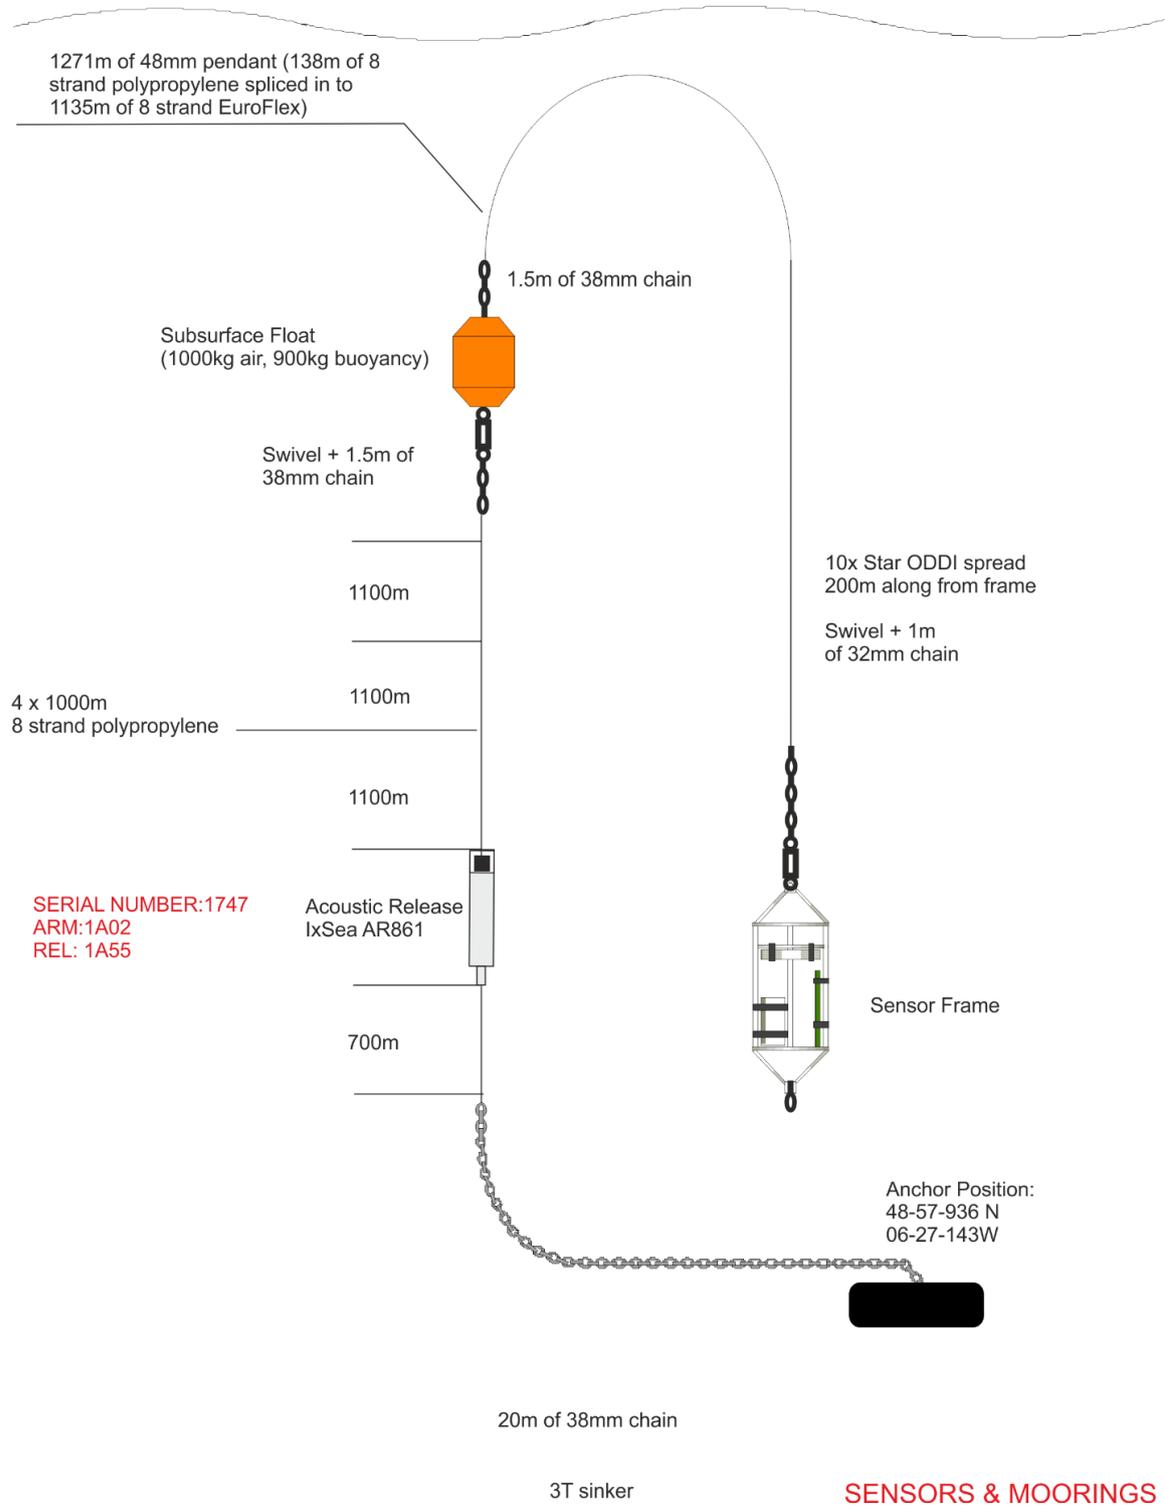
PAP1 ODAS BUOY
 AS DEPLOYED
 DY103 2019
 (-Remains after buoy separation
 to be collected Dy116 20202)

PAP-1 as recovered following loss of surface buoy (sensor frame – DY103-028, remainder of mooring - JC165-058)

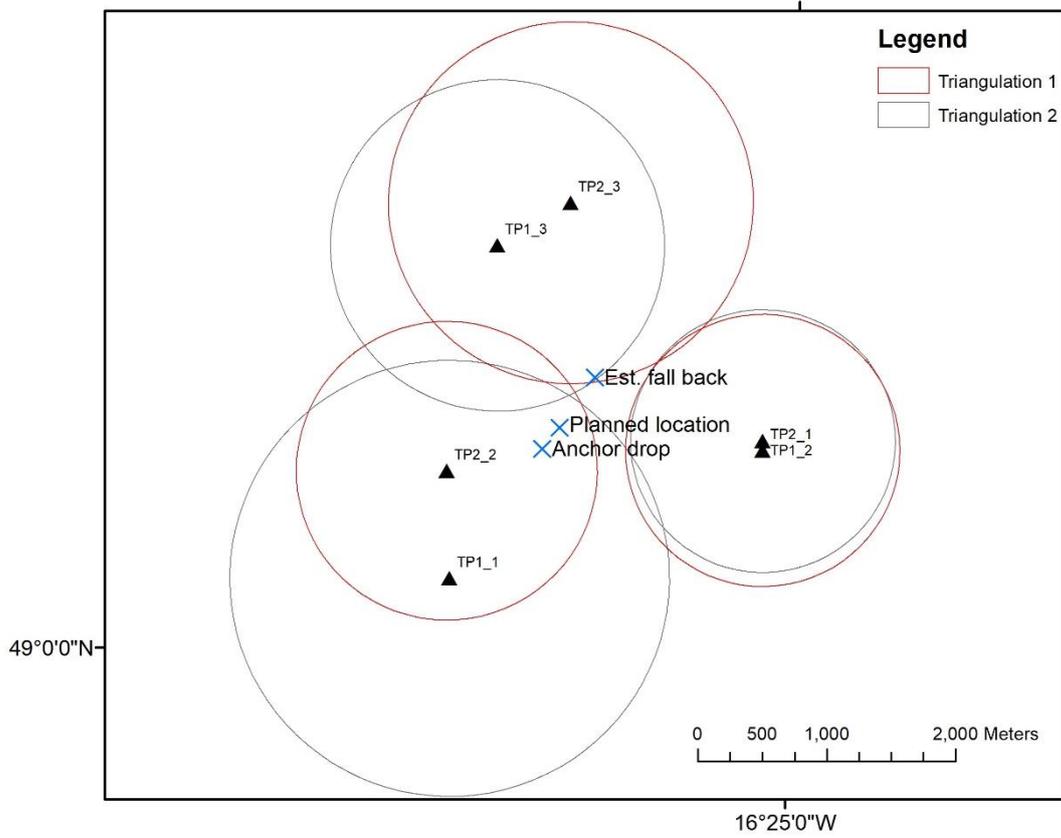
PAP 3 Triangulation Attempts

Chart showing attempted triangulation of PAP-3 mooring (TP = triangulation point)

At 1425 we begin PAP-3 deployment (DY116-007) 49° 2.536 N, 016° 24.695 W, 4810 m, 2 km layback. A billings float sheared on deployment and floated away. It was efficiently recovered and replaced and long pay out and slow tow starts. Lay back is now further than intended because of the time spent sorting the float. 3 triangulation points at 1500 m radius from the expected location. TP2 is not giving a good range. We will try that range again later in the trip.

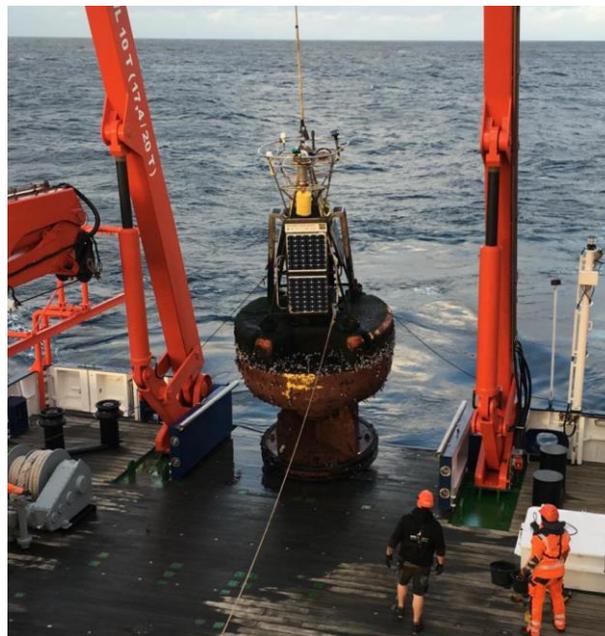
DY103 PAP1 buoy onboard FS Maria S Merian, showing the extent of biofouling

Met Office Odas buoy with NOC sensors deployed on DY103. PAP1 ODAS buoy was adrift from ~23rd October 2020, after over 15 months deployment. It headed east towards the Channel and was tracked using the external GPS Tracker (4 hourly alerts). The priority was to retrieve the buoy and get the data back as there was no near real time data transmission. Maps were plotted daily (with thanks to Jon and Brian, see start of this cruise report) so that the buoy could be collected by German colleagues working in the area. Dan Comben liaised with the ship and the buoy was retrieved on the FS *Maria S Merian* (5th Nov 2020). We are very grateful to them for the recovery, cleaning, dismantling and for shipping the buoy back to us.

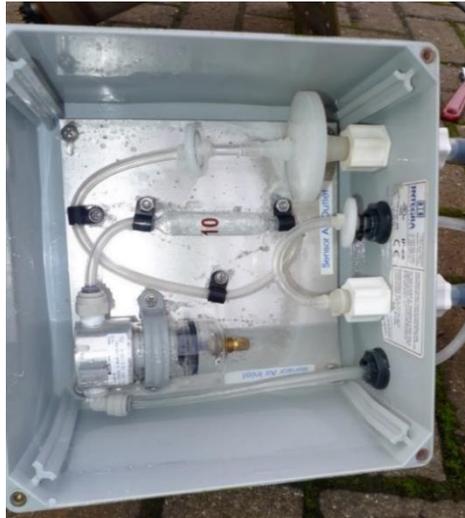
'Dry box' section of Pro-CO2 atmos sampler

The Pro-Oceanus CO2-Pro- atmospheric sn 34-201-45 had flooded and very little data were retrievable (~1 month) suggesting that the flooding happened early in the deployment.

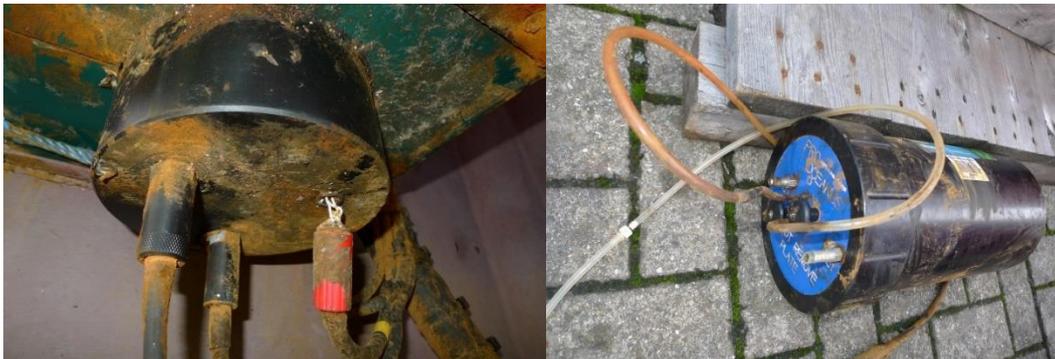
Photos of the Pro-CO2 atmos back at NOC (water side of the instrument)

At the time of writing the air-side box may be salvageable and has been returned to Pro-Oceanus. If water was able to get past the water trap and hydrophobic filters in it, there are two additional hydrophobic filters inside the submersible sensor portion of the sensor to prevent water ingress this way. The damaged bulkhead looks more problematic on the ATM sensor. Also, the ATM tubing had a connector part way up from the sensor. This was added on DY103 as the ATM was turned around at

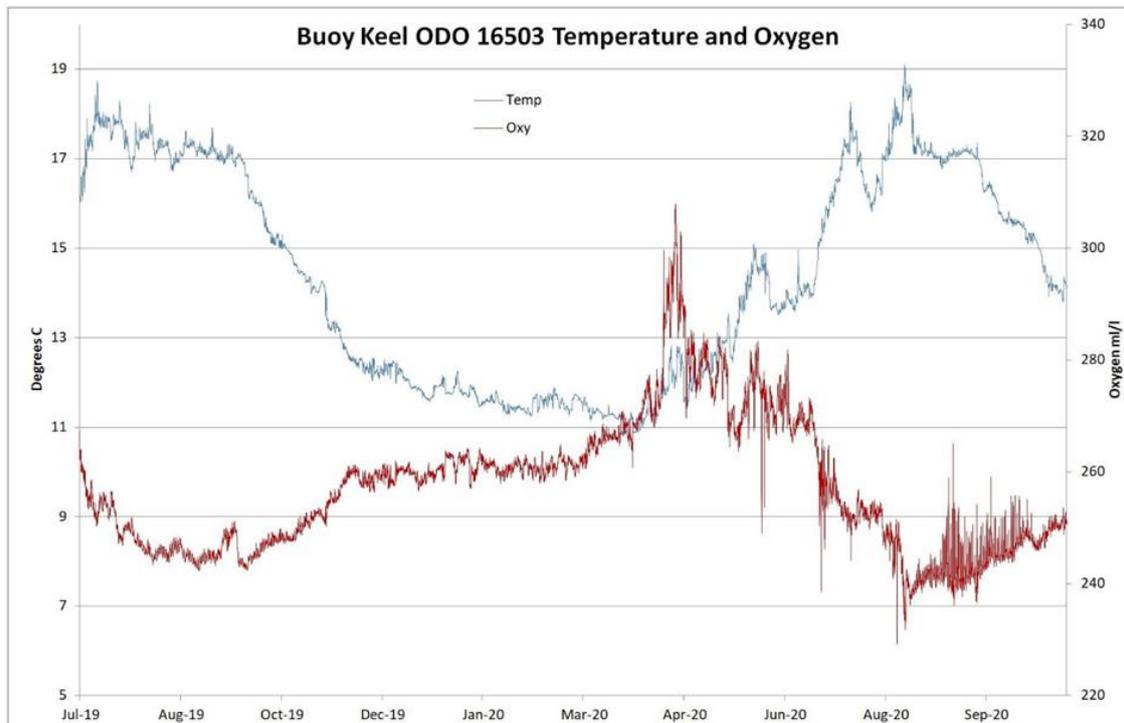
Microcat ODO SN16503 temperature and oxygen data from DY103 deployed buoy

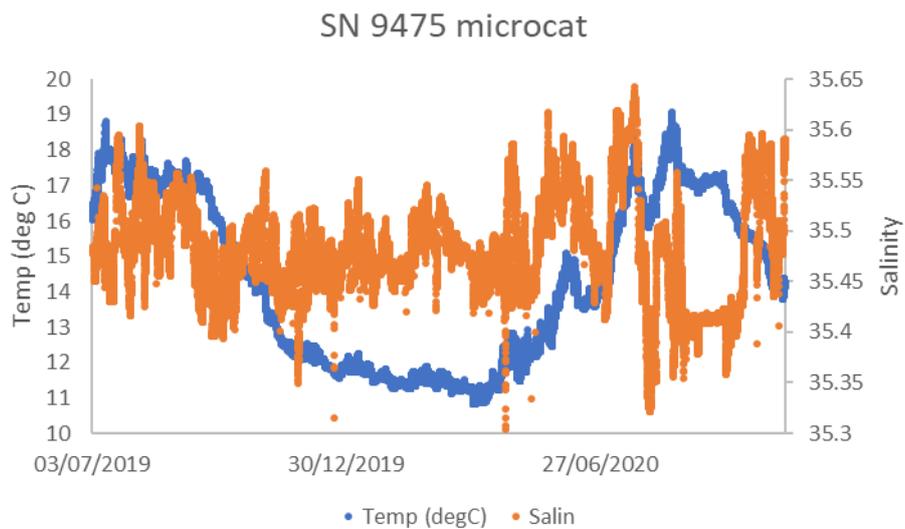
Microcat SN9475 T/S data from DY103 deployed buoy (3/7/19-5/11/20)

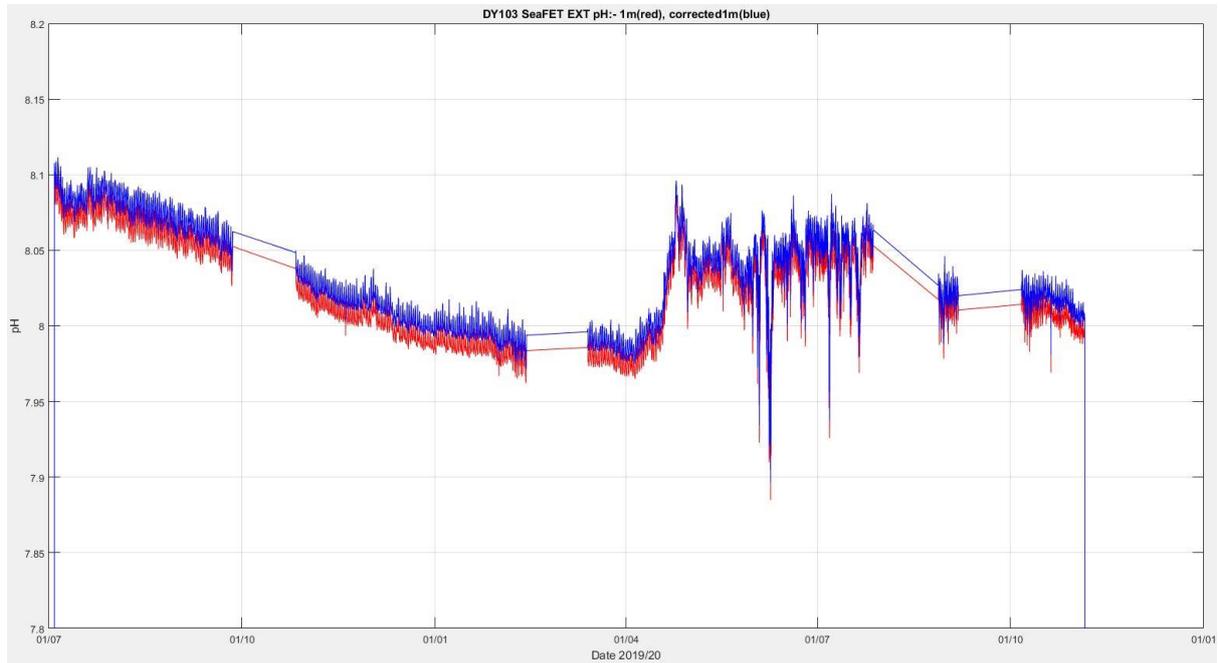
pH data from the buoy SeaFET deployed on DY103

When the cables and loggers were back at NOC after DY116 other data were downloaded from Star Oddi and SeaFET sensors.

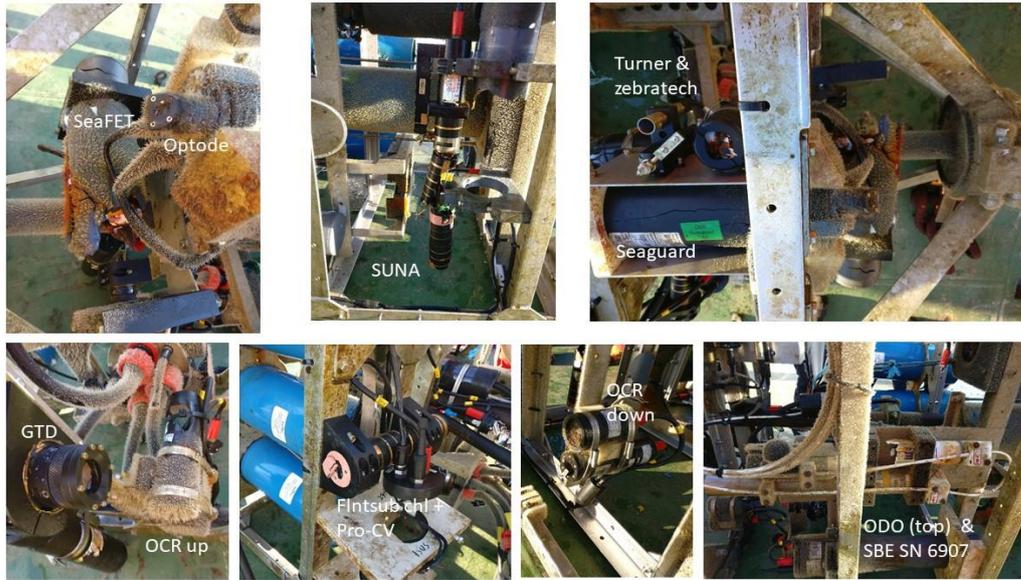
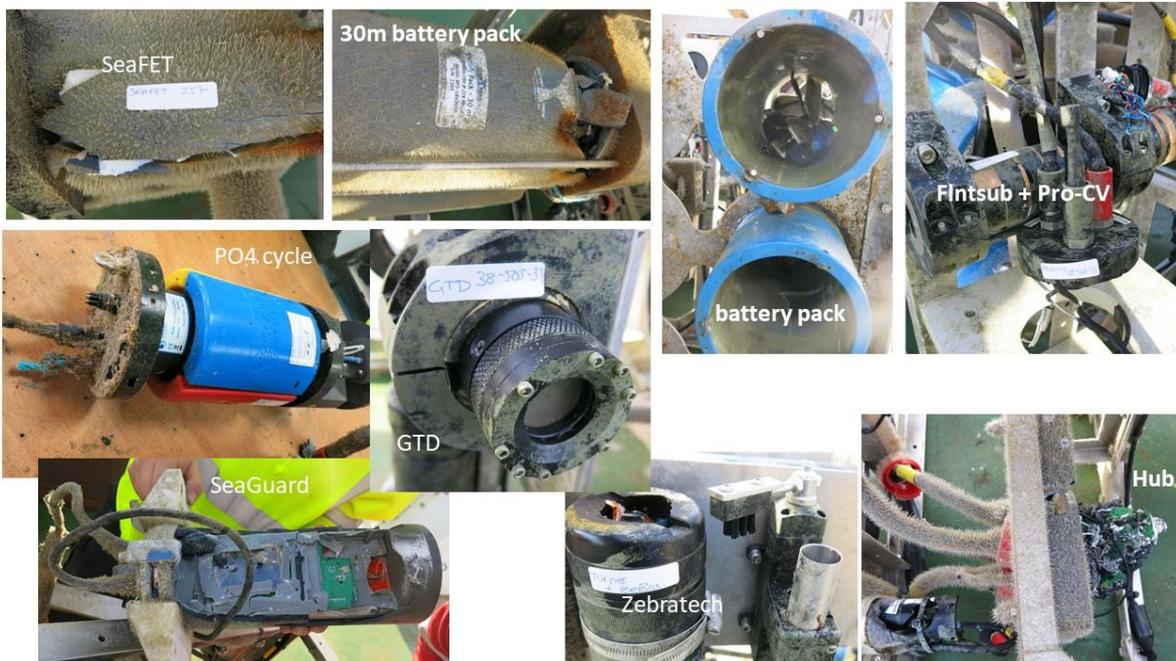
Some of the PAPI frame sensors at NOC. SBE SN 6907 was functional and possibly the PO₄ cycle.

The mooring broke above the sensor frame (which then sank below the midwater buoy at 1000 m). The frame went deeper than most of the sensors are pressure rated to. The sensors (data and batteries) are mostly lost. These will all have to be reported as a write off on IMS.

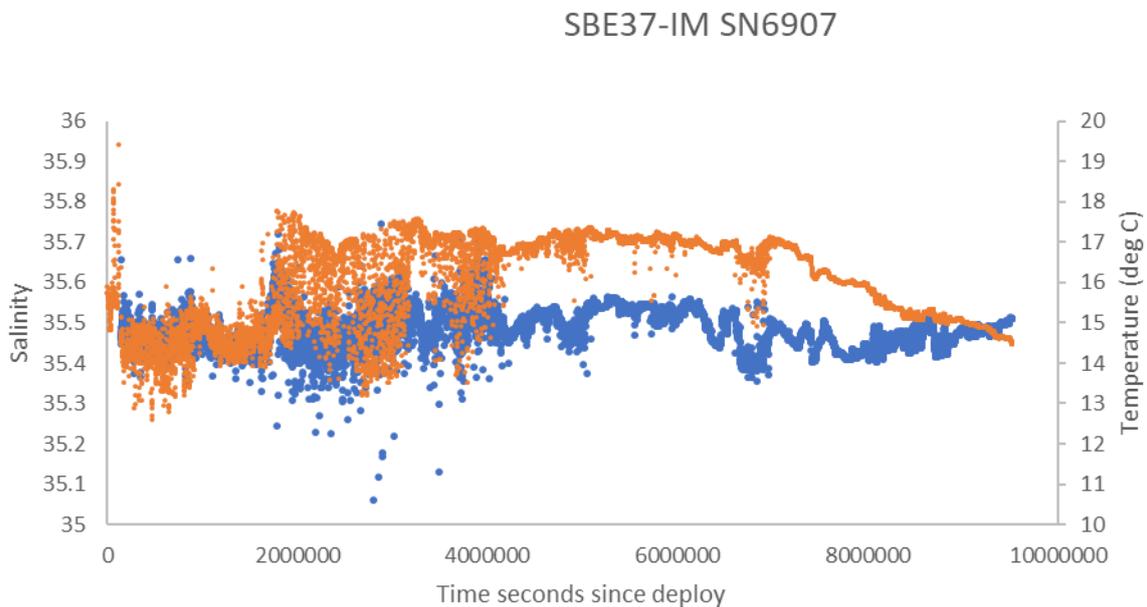
Data retrieved from SBE37-IM SN 6907 microcat

The **MicroCAT SN 6907** (temperature and salinity), was rated to 1000 m. Despite going below this depth it was possible to retrieve some data, though the battery was low. The instrument had been set up at 15-minute intervals from 02/07/2019 00:00:01 on DY103. However, it only ran for 4 months, until 20/10/2019 05:00.

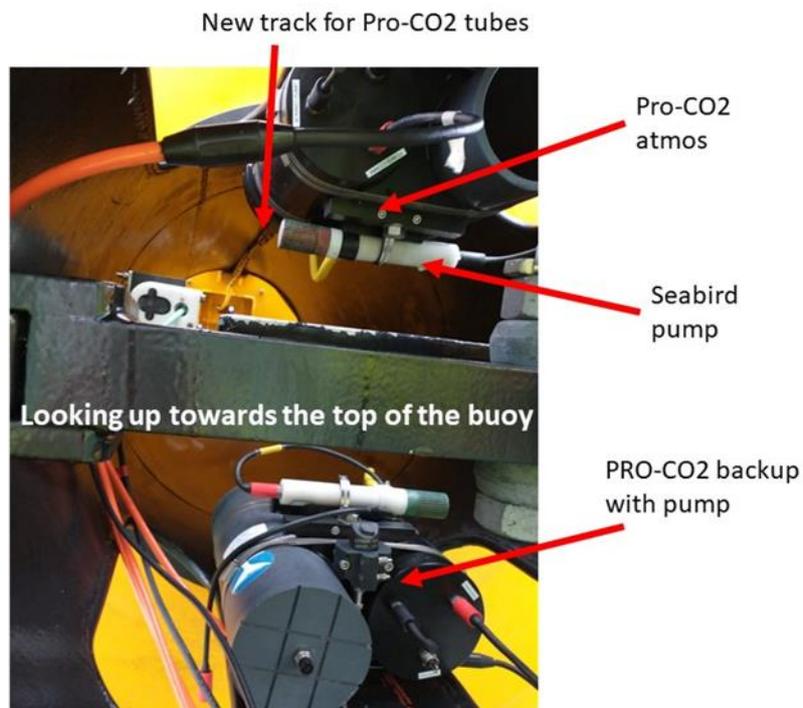
View from under the buoy, showing two Pro-CO₂ sensors with associated pumps (and O₂ optode)

It's important to avoid having the two CO₂ sensors sampling at the same time because they're quite power hungry. Initially planned to power the CO₂ sensors from the buoy when they are sampling, and from their battery packs when they are asleep. If the buoy batteries start to get drained over the winter, the plan was to send a command so that the CO₂ sensors run entirely from their dedicated battery packs. However, this didn't happen and the CO₂ sensors have been deployed with dummy battery packs (tubes).

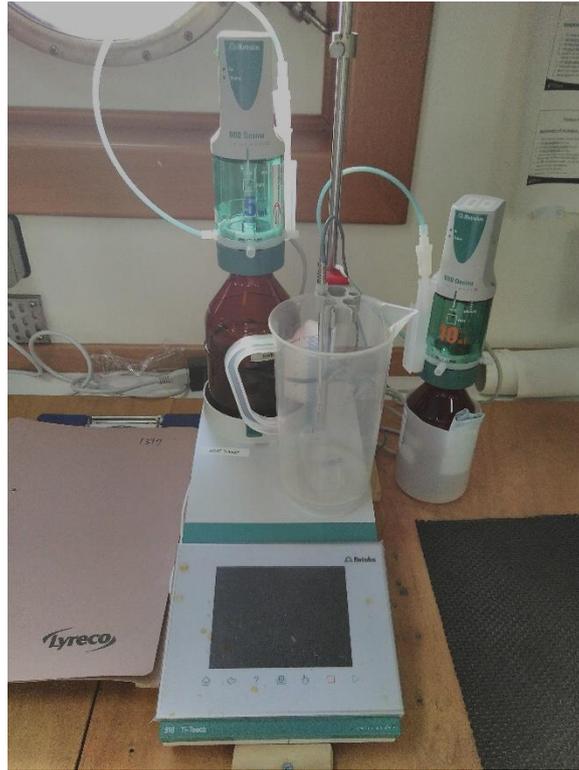
The Metrohm Ti-touch 916 setup used for oxygen analysis system on DY116.

At least 3 blank checks of the reagents and 4 standardisations of the sodium thiosulfate were measured using 5 mL additions of a 1.667 mol/l certified iodate standard (OSIL) for each set of analyses.

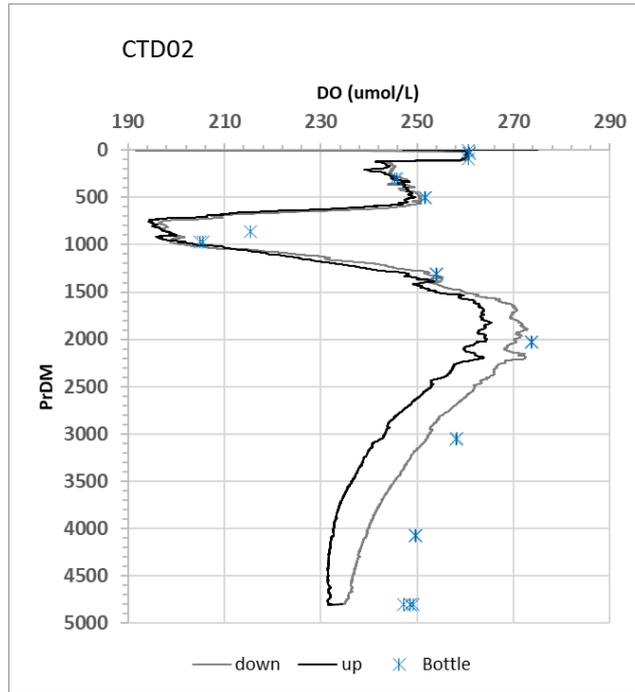
Example cast (CTD02) shows extent of hysteresis between up (black line) and down casts (grey line) for Sbeox O2 sensor (SN 0862). Bottle values are indicated (blue asterisks). No corrections applied yet.

The CTD SBE oxygen data (SN0862) was converted into µmol/l for comparison with the bottle data. It should be noted that there was considerable hysteresis on the CTD oxygen sensor (above). The 10 minute mirocat calibration stops carried out may help to improve the CTD to bottle calibration fit.

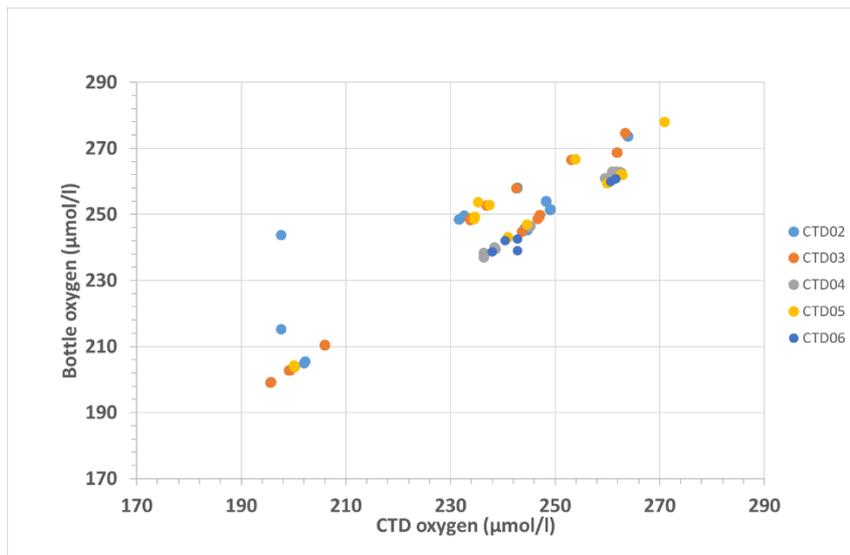
Relationship between bottle oxygen and CTD oxygen data. No corrections applied.

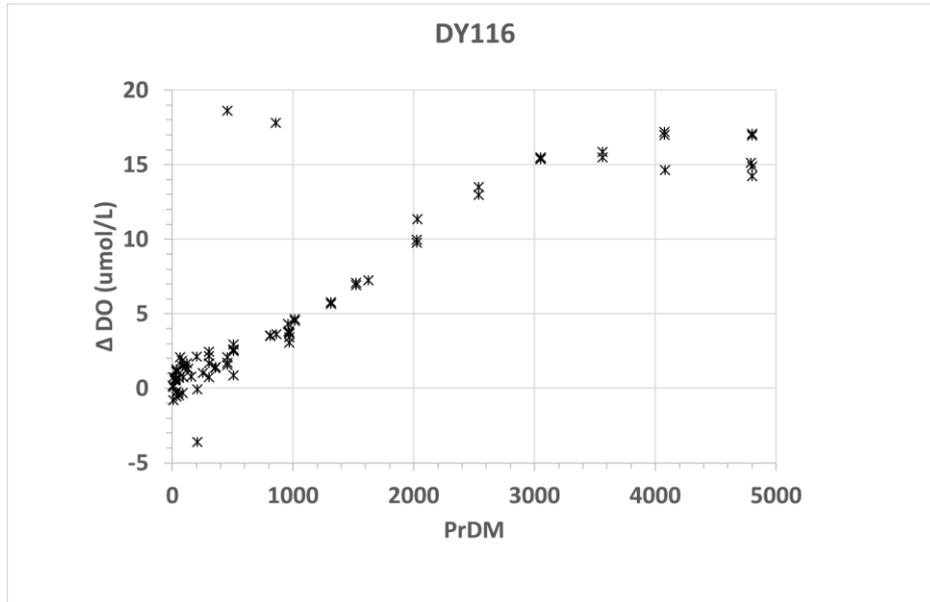
Residuals between bottle oxygen and CTD oxygen data as a function of depth. No corrections applied.

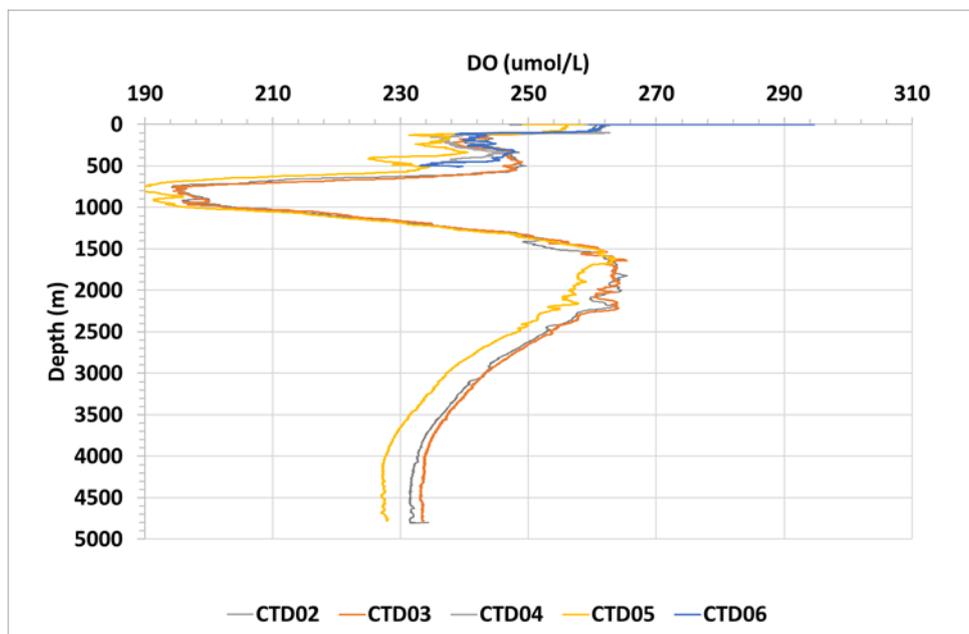
The full depth profiles show a clear oxygen minima around 850 m (Med water influence) and oxygen increases again around 2000 m before decreasing in the Lower deep water (below).

Vertical DO profiles of upward CTD casts during DY116. Nor corrections applied.

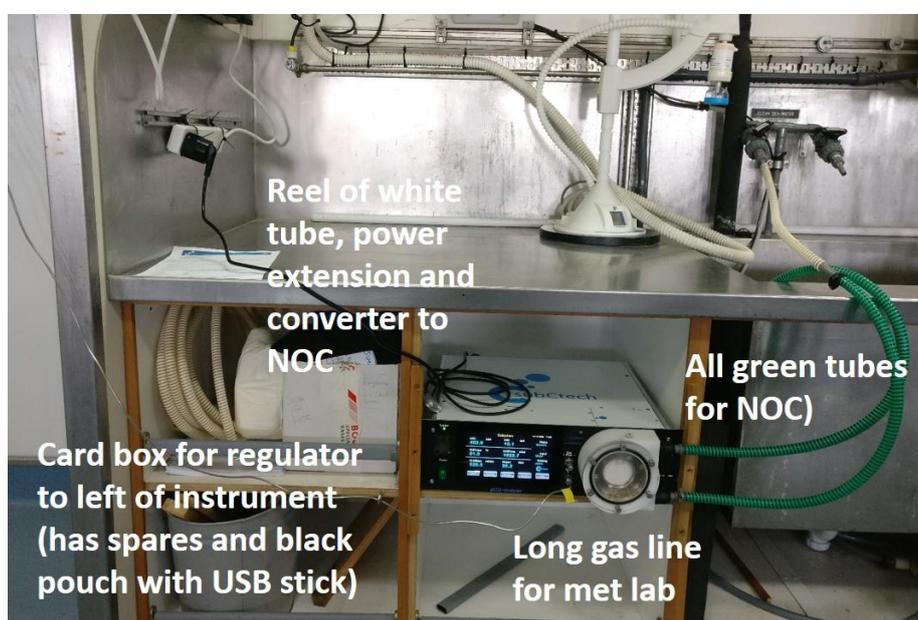
On DY116 a SubCtech Flow-through pCO₂ Analyzer (OceanPack™ Family) was connected to the underway seawater supply in the deck lab, measuring underway pCO₂. The system uses a combination of membrane equilibration and Licor gas measurements. It is designed to be small and light enough to work on round-the-world sailing vessels (using dive bottle gas standards). The SubCtech system was used until recently on the Plymouth-Roscoff ferry, operated by Yann Bozec and Stefan Raimund. Stefan set up the instrument in Roscoff just prior to DY116 and is planned to also run on the following RAPID cruise. This work was disseminated on a blog on our website (noc.ac.uk/pap) and SubCtech was also in one of our @PAP_observatory Dy116 tweets.

SubCtech installed in the deck lab

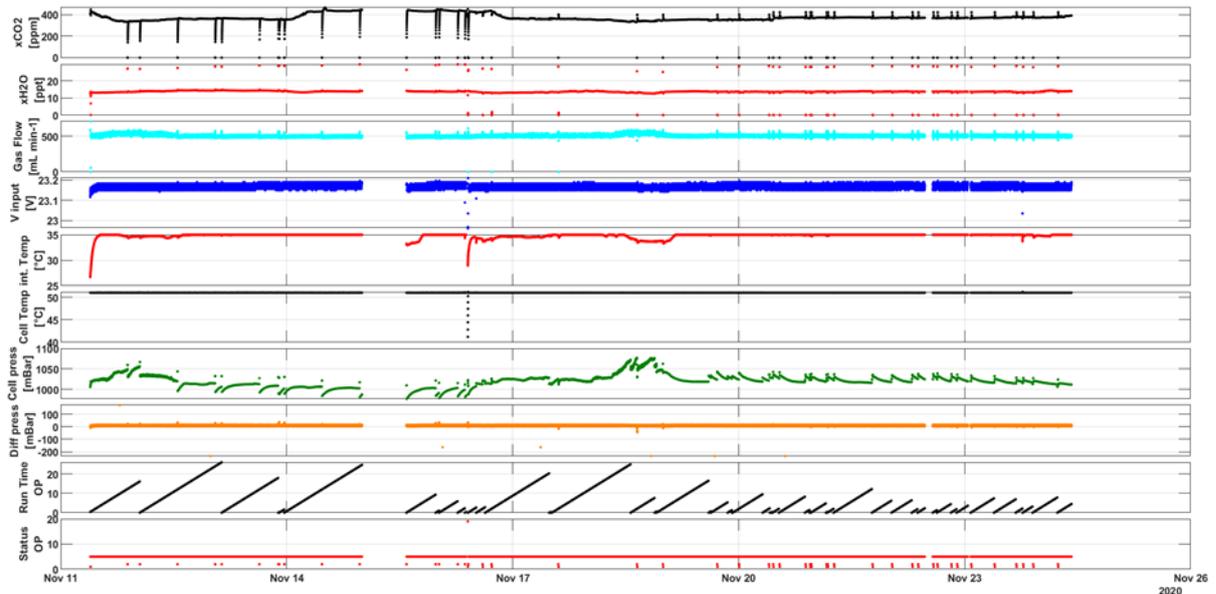
Raw data output of the SubCtech covering the entire duration of the cruise.

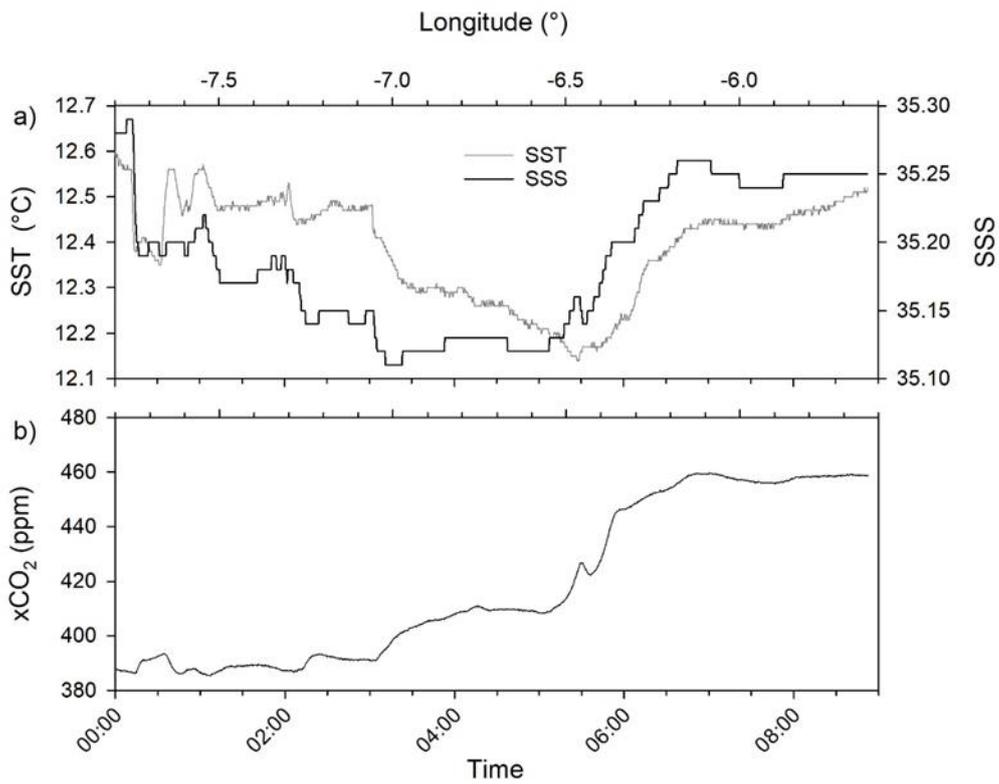
Excerpt of underway raw data collected on 25th November on the transit from the PAP site to Southampton.
