RRS *Discovery* Cruise 116

Time-series studies at the Porcupine Abyssal Plain
Sustained Observatory

Cruise report number 73

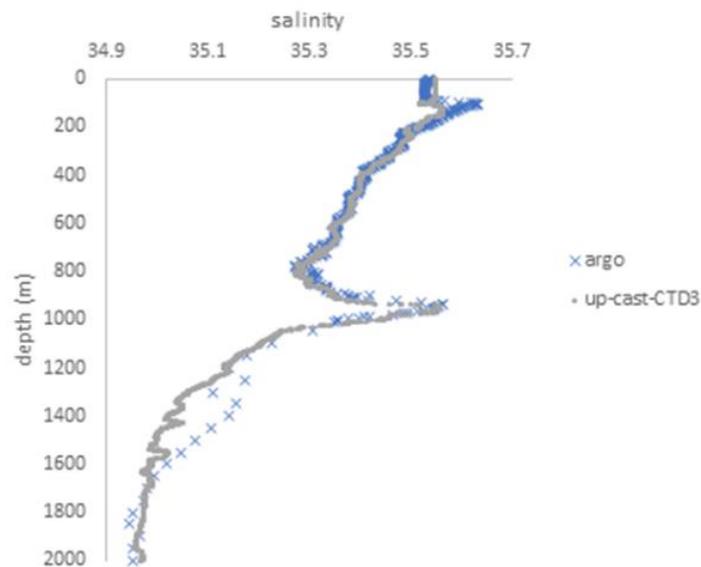
Plot showing salinity from the first BGC Argo dive and data from CTD cast just prior to deployment

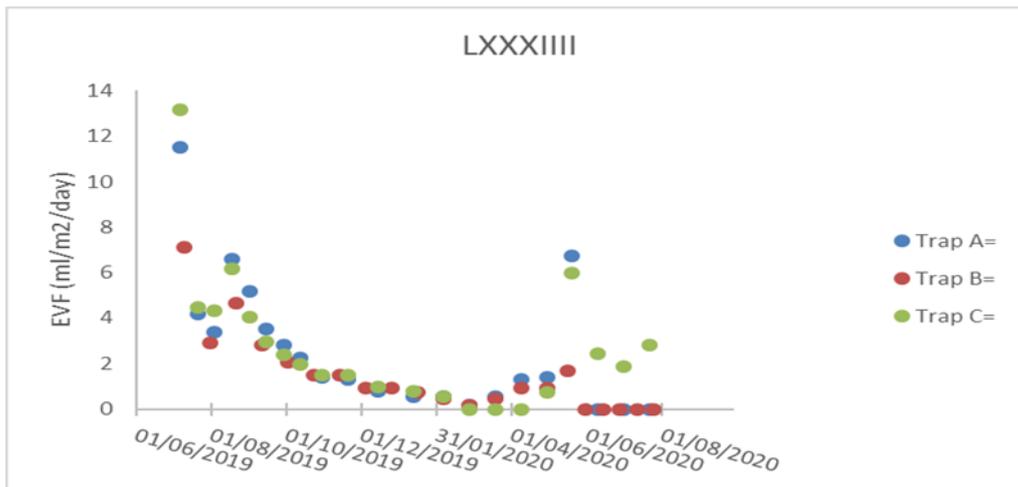
EVF from the three sediment traps during the deployment duration

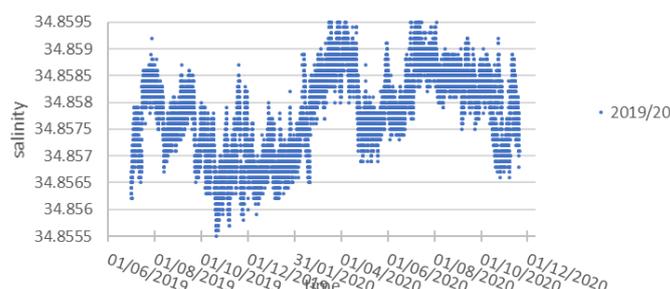
Temperature and salinity data from Microcat sensor on PAP-3 sediment trap mooring (DY103-009) at 100 m above the seabed

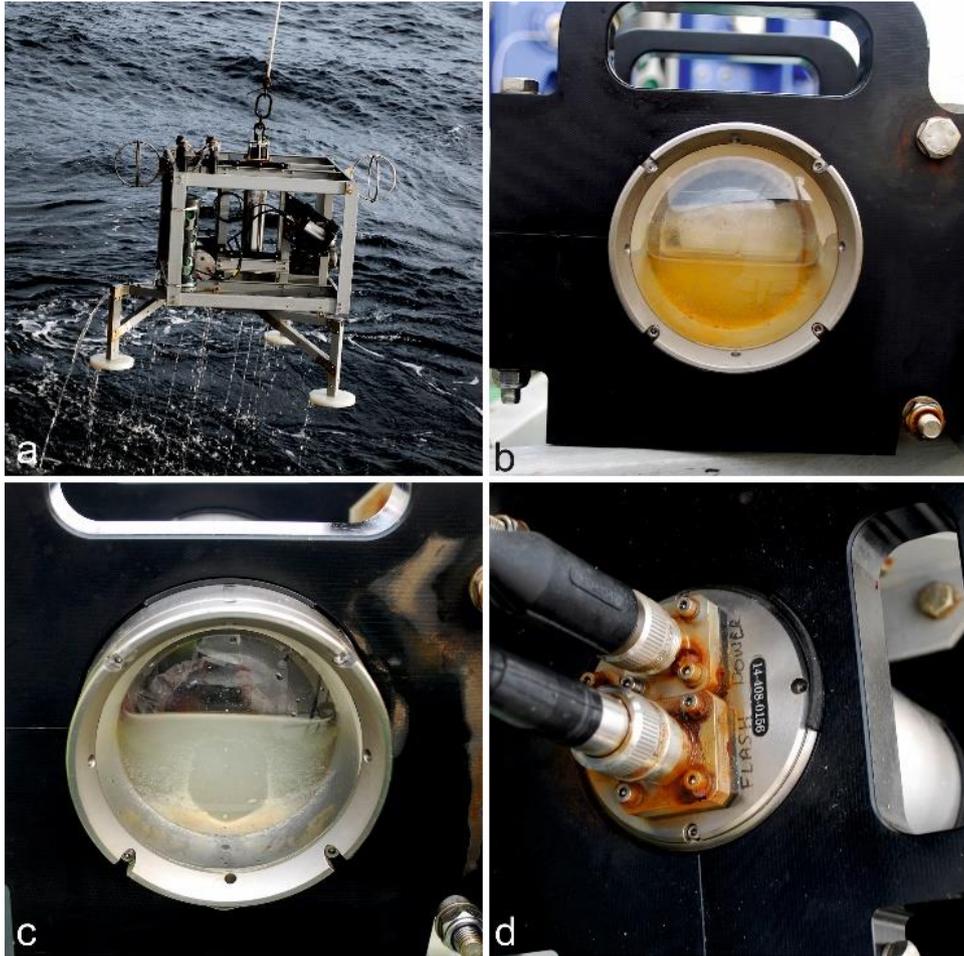
On inspection of the *Bathysnap* system it was immediately clear that the camera and flash units had both flooded (below, b & c). The corrosion around the bulkhead connectors (below d) suggest that this is the likely source of water ingress. Inspection of the underwater cables suggested they appeared quite loose but the pins inside remained in good condition. The camera and flash were left on the *Bathysnap* frame for closer inspection at NOC to aid the development of the new system.

a) Recovery of the Bathysnap time-lapse camera system, b) the flooded flash, c) the flooded camera and d) corrosion around the bulkhead connectors.

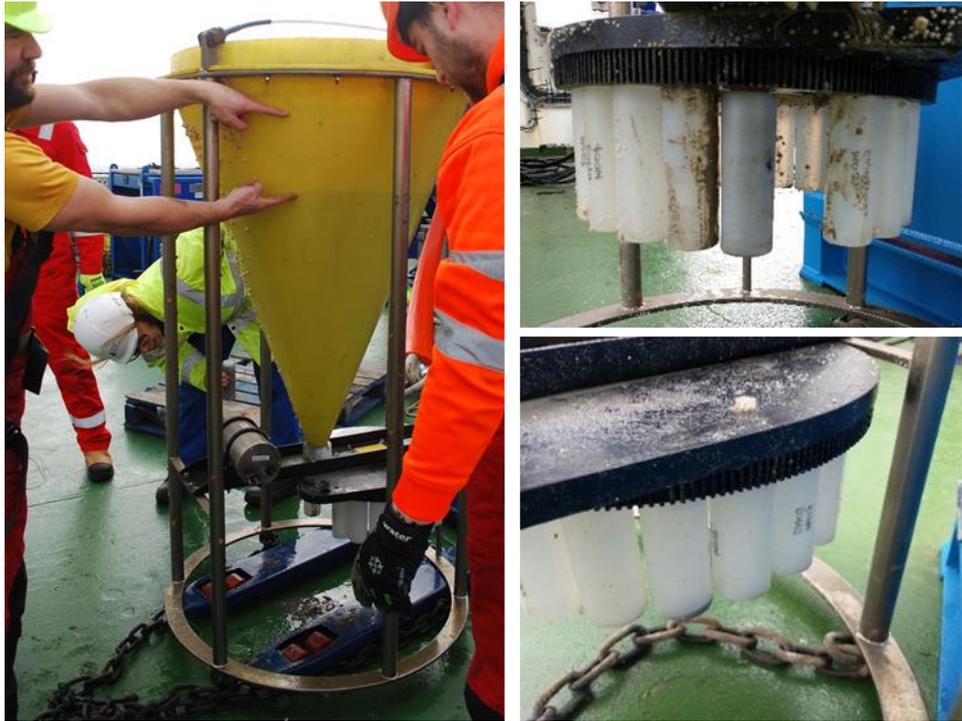
Inspection of the sediment trap from the WCM, filled with sediment on recovery to deck

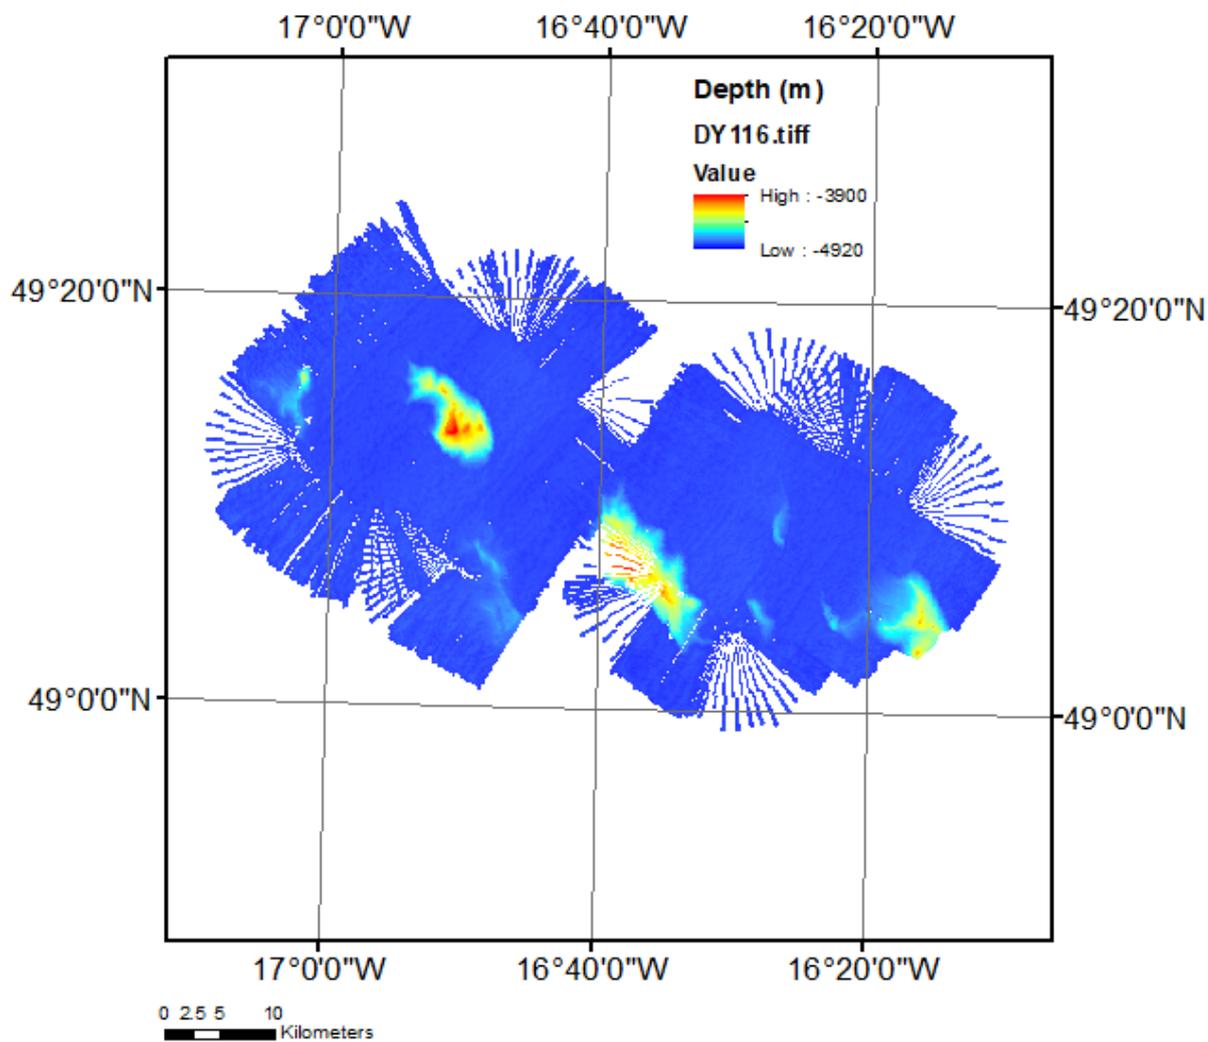
New PAP-SO area bathymetry collected on DY116
