Determinants of hand-pumped borehole functionality: preliminary evidence from Ethiopia, Malawi and Uganda

The Hidden Crisis project

Unravelling current failures for future success in rural groundwater supply

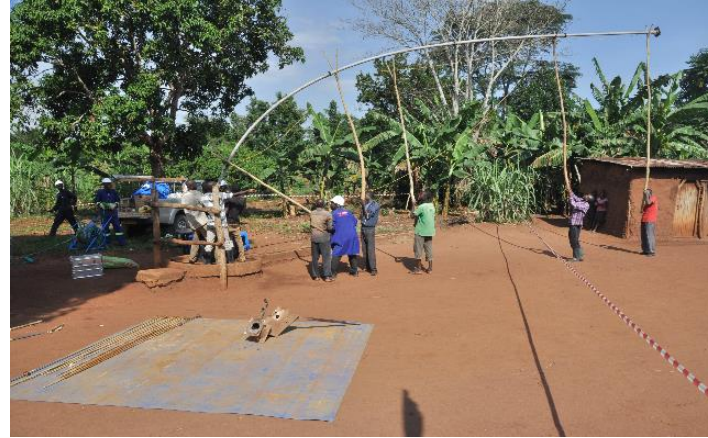
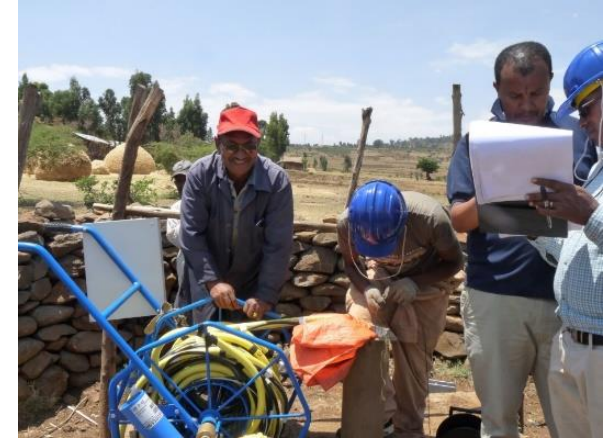
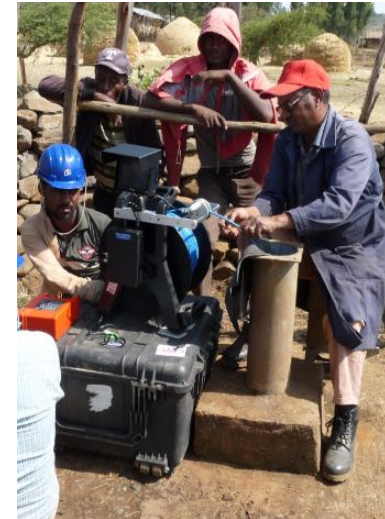
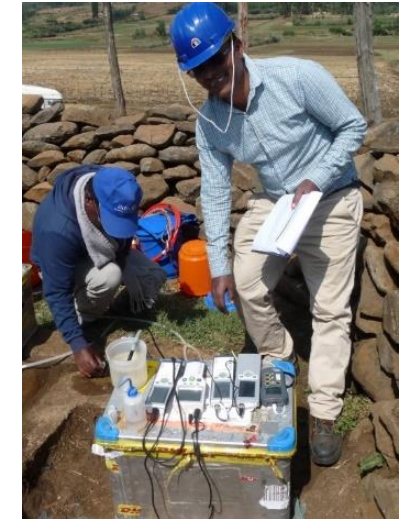
- Physical survey:
 - sanitary & engineering survey,
 - pumping test,
 - water chemistry,
 - CCTV survey,
 - questionnaires (reliability, downtime, quantity, quality).
- Social science: focus groups, transect walks.

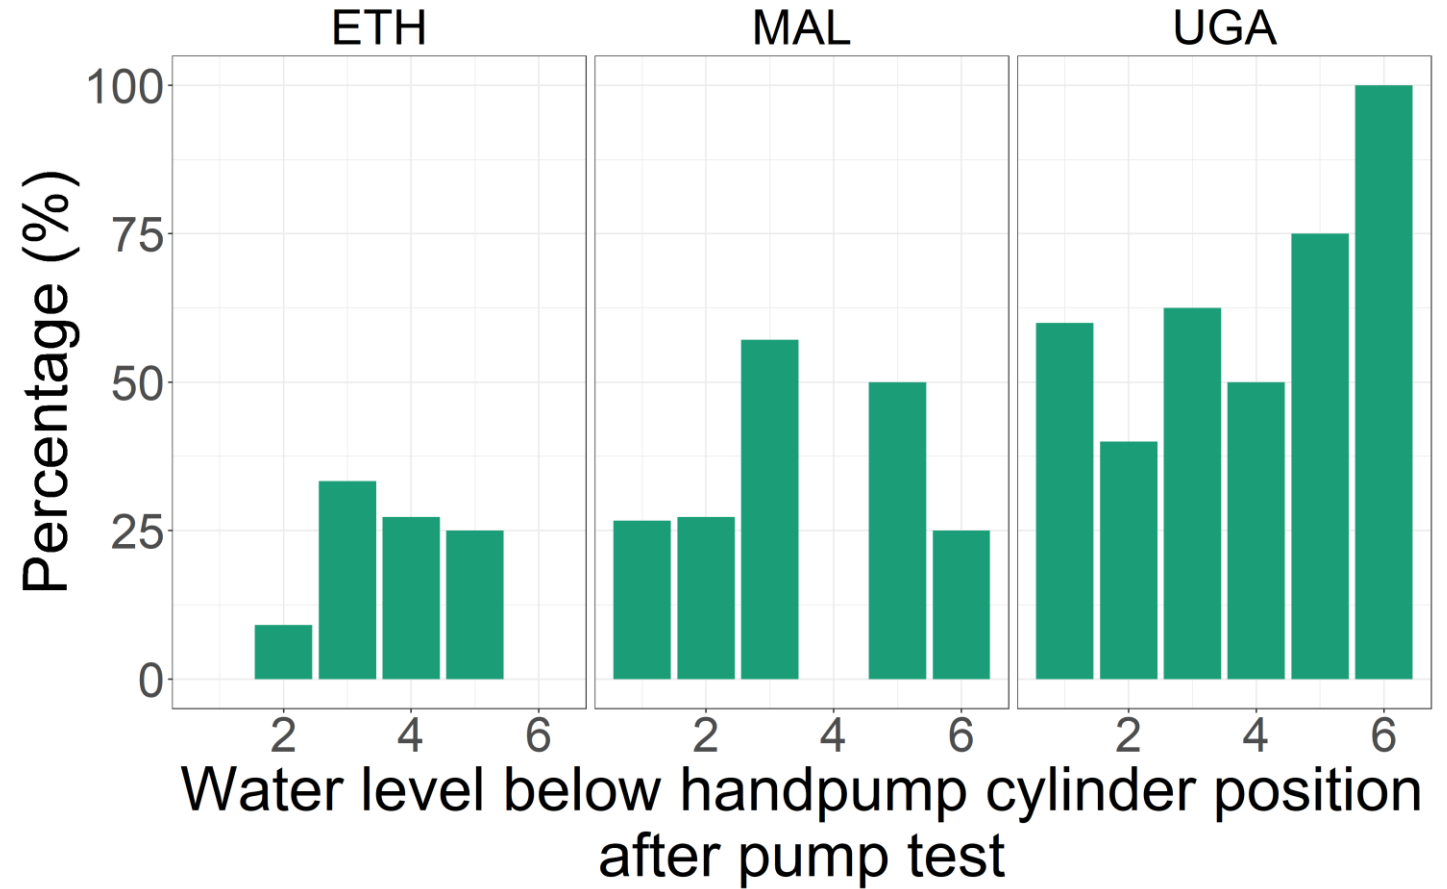
Cylinder position and dynamic water level

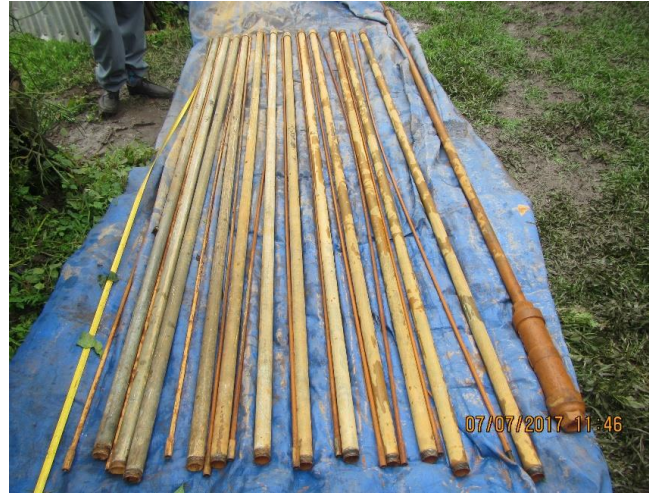
Handpump – IMII rising main and rods

- Ethiopia:
 - **60%** RM thickness below spec. ($3.25 \text{ mm} \pm 0.2 \text{ mm}$).
 - **55%** galvanising thickness below spec. ($70\text{-}80 \mu\text{m}$).
- Uganda:
 - **65%**
 - **90%**

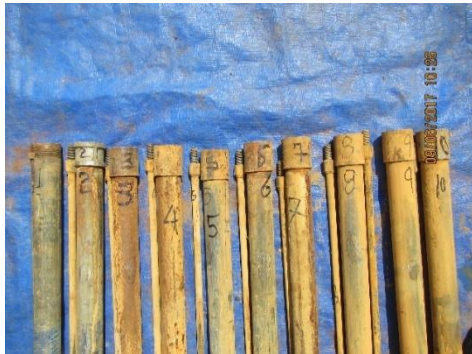
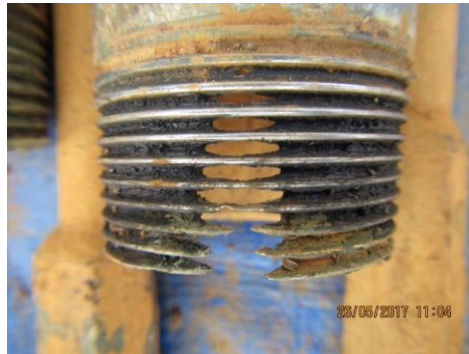
Water chemistry

- pH as an indicator of corrosion:
 - Low risk > 7
 - Intermediate risk: 6.5 - 7
 - High risk: 6 - 6.5
 - Severe risk < 6
