# BGS Karst Report Series: C6. Karst in the Chalk of the North Downs

Environmental Change, Adaptation & Resilience Programme  
Open Report OR/20/064

Mathewson, E., Maurice, L.D., and Farrant, A.R.

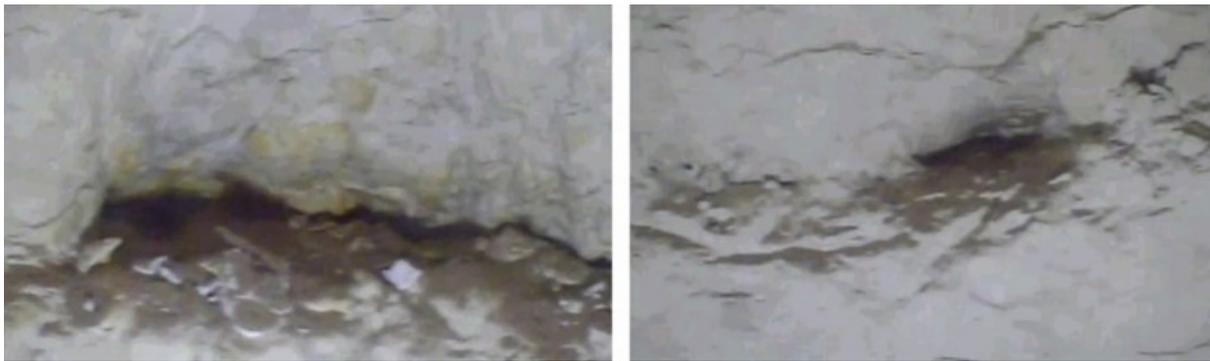
Figure 6. Solutional conduits with sediment at 102 and 107 m below the surface (image from borehole in the North Downs area). Images provided by South East Water.

Solutional conduits and fissures, associated with karstic inception horizons and with apertures of very approximately ~ 1-10 cm, are observed in many abstraction boreholes in the area (Knowledge exchange meetings; Farrant et al., 2018; Farrant et al., 2021; Mathewson et al., 2021; Bunting et al., 2021). They occur at depths of up to ~110 m below the surface, and some contain sediment suggesting connectivity with the surface through solutional networks (Figure 6 and Figure 7).

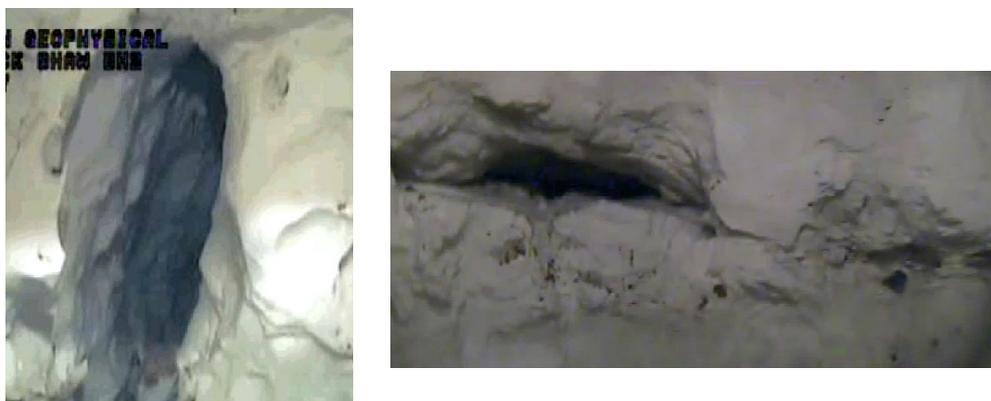
Figure 7. Solutional conduits at depths of ~40-45 m below the surface (images from boreholes in the North Downs area). Images provided by South East Water.

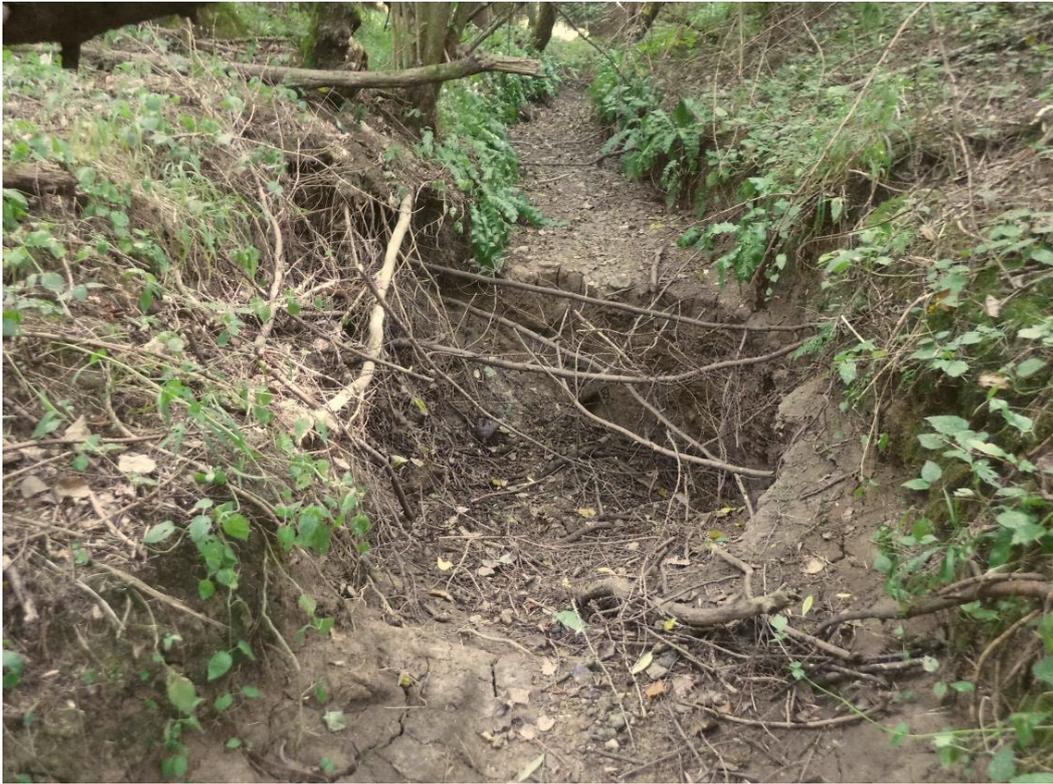
Figure 22. Sink point collapse in streambed in the Farnham area during dry conditions.

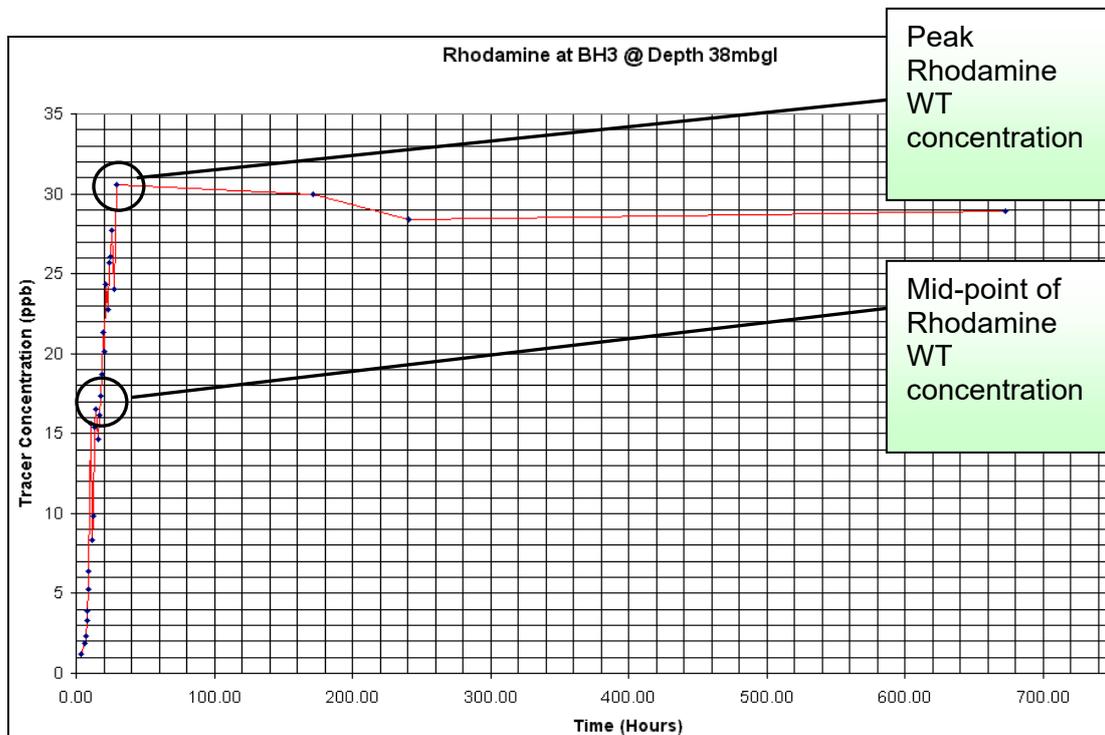
Figure 35. Example breakthrough curve from tracer testing at Tilmanstone (Tim Atkinson, personal communication, 2019; from work carried out by Patel, 2001 and Watson, 2005).
